HEADBOLT LANE STATION, LIVERPOOL.

# Arboricultural Impact Assessment

Buckingham Group Contracting

17<sup>th</sup> June 2021

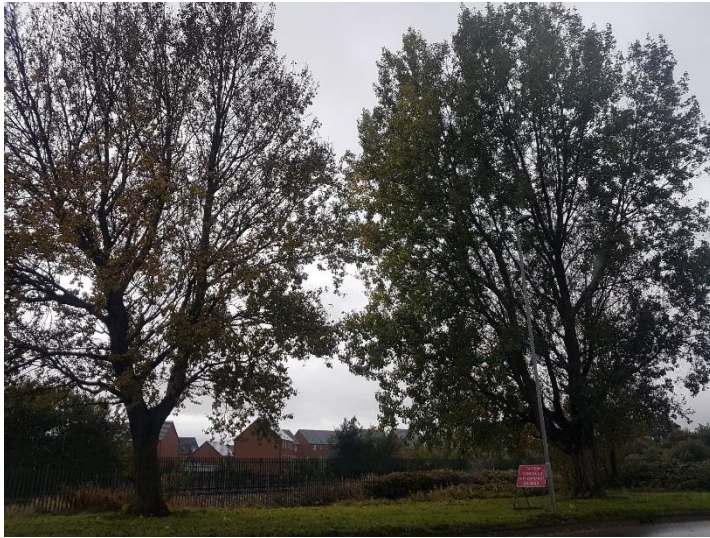
Plate 1: poplar trees, T1 – T4 within amenity grassland

It is recommended that full consideration is given to the retention of individual trees and tree groups and that the RPA is protected by installation of Tree Protective Fencing. Individual poplar trees T1-T4 and notably large specimens where it is recommended that retention is given high priority.

| Schedule of Existing Trees | | | | | | | | | | | | | | |
|---|---|---|---|---|---|---|---|---|---|---|---|---|---|---|
| T1 | Poplar species<br><i>Populus</i> sp. | 17 | 290 | 3 | 3 | 3 | 3 | 3 | SM | F | F | Small tree with upright leading stem, balanced canopy spread. Even distribution of leaves with no discoloration. | B1 | 3.5 |
| T2 | Poplar species<br><i>Populus</i> sp. | 21 | 710 | 7 | 7 | 7 | 7 | 2 | M | G | G | Upright leading stem, wide-spreading balanced canopy spread. Evidence of an old occluded pruning would on main stem, approximately 3 m above ground level. Small attached branches (c. 30 mm) within canopy extent. | B1 | 8.5 |
| T3 | Poplar species<br><i>Populus</i> sp. | 23 | 930 | 8 | 7 | 5 | 7 | 2.5 | M | G | G | Upright leading stem, balanced canopy spread. Even distribution of leaves with no discoloration. | B1 | 11.2 |
| T4 | Poplar species<br><i>Populus</i> sp. | 22 | 710 | 7 | 7 | 7 | 7 | 2 | M | G | G | Upright leading stem, balanced canopy spread. Even distribution of leaves with no discoloration. | B1 | 8.5 |

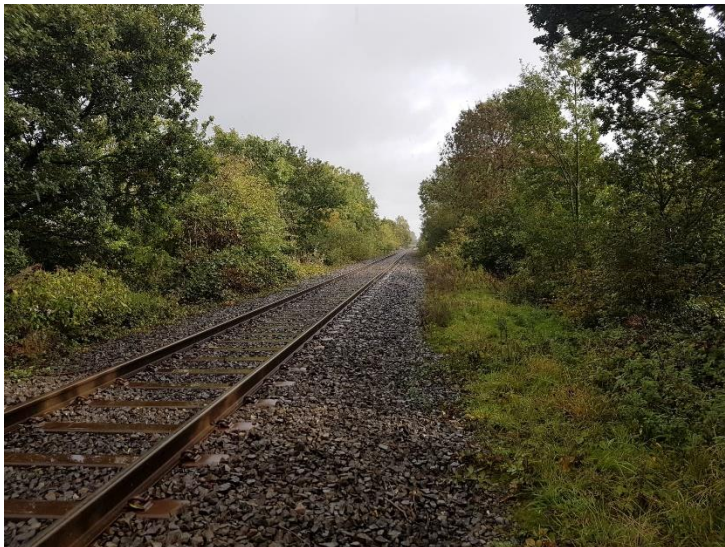
Plate 2: typical example of grouped trees (G3 & G4) on the railway embankment, although shrub communities largely dominate.

| Schedule of Existing Trees | | | | | | | | | | | | | | |
|---|---|---|---|---|---|---|---|---|---|---|---|---|---|---|
| G3<br>28m/ 74ch<br>to 29m/ 6ch | Pedunculate oak<br><i>Quercu robur</i><br>Sycamore<br><i>Acer psuedoplatanus</i><br>Common ash<br><i>Fraxinus excelsior</i><br>Crack willow<br><i>Salix fragilis</i> | 9-16 | 540(a) | - | - | 6 | - | 0 | SM-M | G | G | Tree group located on Network Rail embankment slope, trees mostly mature and regularly spaced. Eight common ash, ten pedunculate oak, three willow trees and two sycamore were counted, which included the more mature specimens. There is a break in the group where Simonswood Brook flows under the railway, where there is also a bridge. A number of sycamore specimens are ivy clad. | B1/2 | 6.5 |
| G4<br>28m/ 74ch<br>to 29m/ 6ch | Pedunculate oak<br><i>Quercu robur</i><br>Sycamore<br><i>Acer psuedoplatanus</i><br>Common ash<br><i>Fraxinus excelsior</i><br>Goat willow<br><i>Salix caprea</i><br>Cherry <i>Prunus</i> sp.<br>Hawthorn <i>Crateagus monogyna</i> | 9-16 | 540(a) | 6 | - | 6 | - | 0 | SM-M | G | G | Ten common ash, six pedunculate oak, three willow trees, three sycamore and one cherry were counted, which included the more mature specimens. All trees did not display any signs of obvious decay. The trees are also interspersed with hawthorn shrubs. | B1/2 | 6.5 |
