Phase I and II Geo Environmental Site Assessment

Windy Arbor, Whiston  
Phase I and II Geo Environmental Site Assessment  
Site Investigation Location Plan

### Windy Arbor

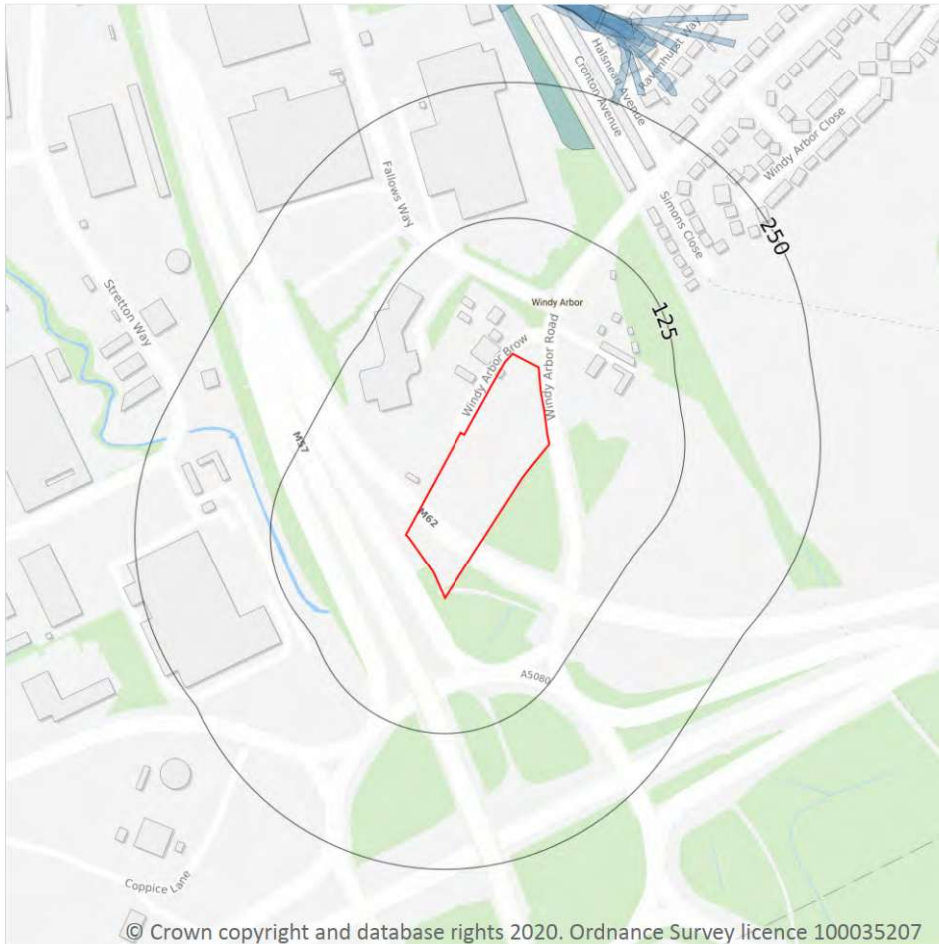
## 21 Railway infrastructure and projects

- Site Outline
- Search buffers in metres (m)
- C1 Crossrail 1 Stations
- Crossrail 1 Route
- Crossrail 1 Worksites
- C2 Crossrail 2 Stations
- Crossrail 2 Route
- Crossrail 2 Worksites
- Crossrail 2 Safeguarding
- Crossrail 2 Headhouses
- 🚂 Railway stations
- ⋯ Active railways
- ⋯ Active tunnels
- ⋯ Abandoned railways
- Historic railways
- Historic tunnels
- 🚂 Underground stations
- Underground Lines
- Royal Mail tunnels
- HS2 optimised route
- HS2 Stations
- HS2 Depots
- HS2 Surface Safeguarding
- HS2 Subsurface Safeguarding
