**Prescot Picture House**  
**8-14 Kemble Street, Prescot**

**Mortar and Paint analysis results and an assessment  
of the historic render, plaster and paint schemes used  
on the front elevation and within the main  
auditorium space**

**December 2022**

**M. WOMERSLEY**  
Historic Building Specialists

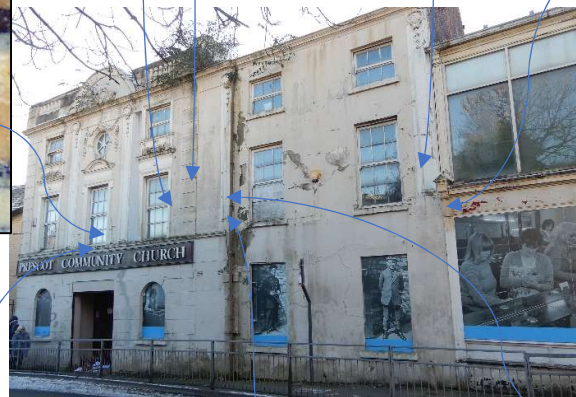
**Diagram A: The Paint Layers of samples that were taken and their location**

The areas of original rendered surfaces that remain, that is samples ii, iv, and vii, shown on diagram A, appear to have originally been coated with staining water based paints, (see paint references No.1, diagram A), as oil paints could not be applied within at least the first year to

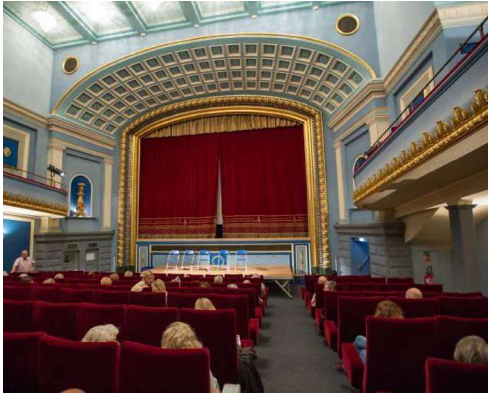
**Photo 1: The Coolidge Corner Theatre**

A similar combination of the second set of light blue, stone, and gold colours, perhaps dating to after the insertion of the balconies can be found at Coolidge Corner Theatre, Massachusetts which became a cinema in 1933,<sup>17</sup> and is illustrated in photo 1 below. The slightly later rose and stone colour combination found at Prescott Picture House could be seen at the Regent Centre In Christchurch, in 1936, five years after it was built, when it was given a plush makeover, featuring a deep rose, gold and silver colour scheme and art deco signage.<sup>18</sup> This decorative scheme has recently been recreated and is shown in photo 2.

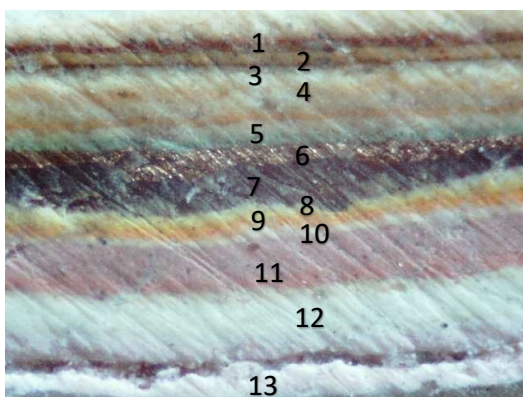
Sample 5: Lowest convex (light pink) band to fibrous cast cornice

1. First Prep Coat, red and white lead with a larger portion of linseed oil and turpentine
2. Second Prep Coat, similar to 1 above
3. Flatting coat, white lead, driers, and turpentine
4. Creamy White/stone
5. Magnolia
6. Gilding/'Gold powder'
7. Red Brown
8. Oil rich undercoat
9. Yellow-Orange or Golden Yellow
10. Magnolia/undercoat
11. Dark Pink
12. Creams
13. Modern white and pink paints

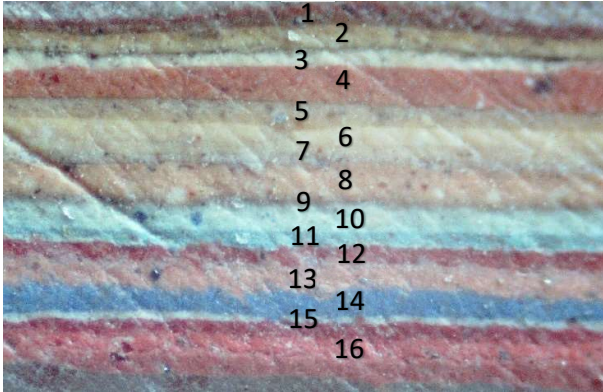
Sample 7: Top of fibrous plaster pilaster, above freeze moulding

1. First Prep Coat, red and white lead with a larger portion of linseed oil and turpentine
2. Second Prep Coat, similar to 1 above
3. Flatting coat, white lead, driers, and turpentine
4. Rose, 2 coats
5. Stone
6. Prep Coat
7. Stone
8. Salmon
9. Prep Coat
10. Light Blue
11. Medium Violet Blue
12. Red Brown
13. Pink
14. Medium Ultra blue
15. Prep Coat
16. Modern Magenta and Pinks

The pilasters that divide the wall into bays were originally painted in a rose colour, over at least two decorative cycles and then later with stone colours, (see sample 7, appendix 1). Perhaps originally standing out from the first cream/stone background colours, used in the main auditorium area before the insertion of the balconies. After which they were painted in as stone colour, although it is possible that they retained a rose colour above the level of the freeze band.

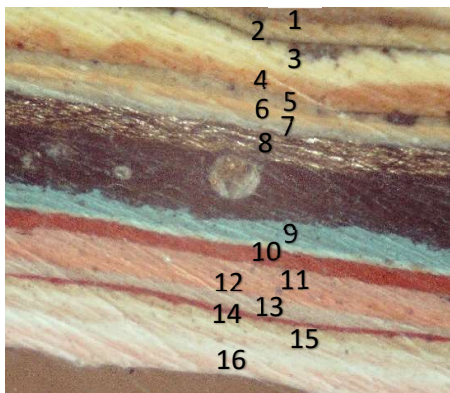
Sample 25: Central part of the fibrous plaster Keystone

1. First Prep Coat, red and white lead with a larger portion of linseed oil and turpentine
2. Second Prep Coat, similar to 1 above
3. Flatting coat, white lead, driers, and turpentine
4. Brown-Red Stone
5. Blue Grey
6. Prep Coat
7. Blue Grey
8. Gilding /'Gold Powder', split below
9. Light Blue
10. Red Brown
11. Salmon Pink
12. Rose
13. Light Violet
14. Red Brown
15. Cream Stone
16. Modern white and pink paints

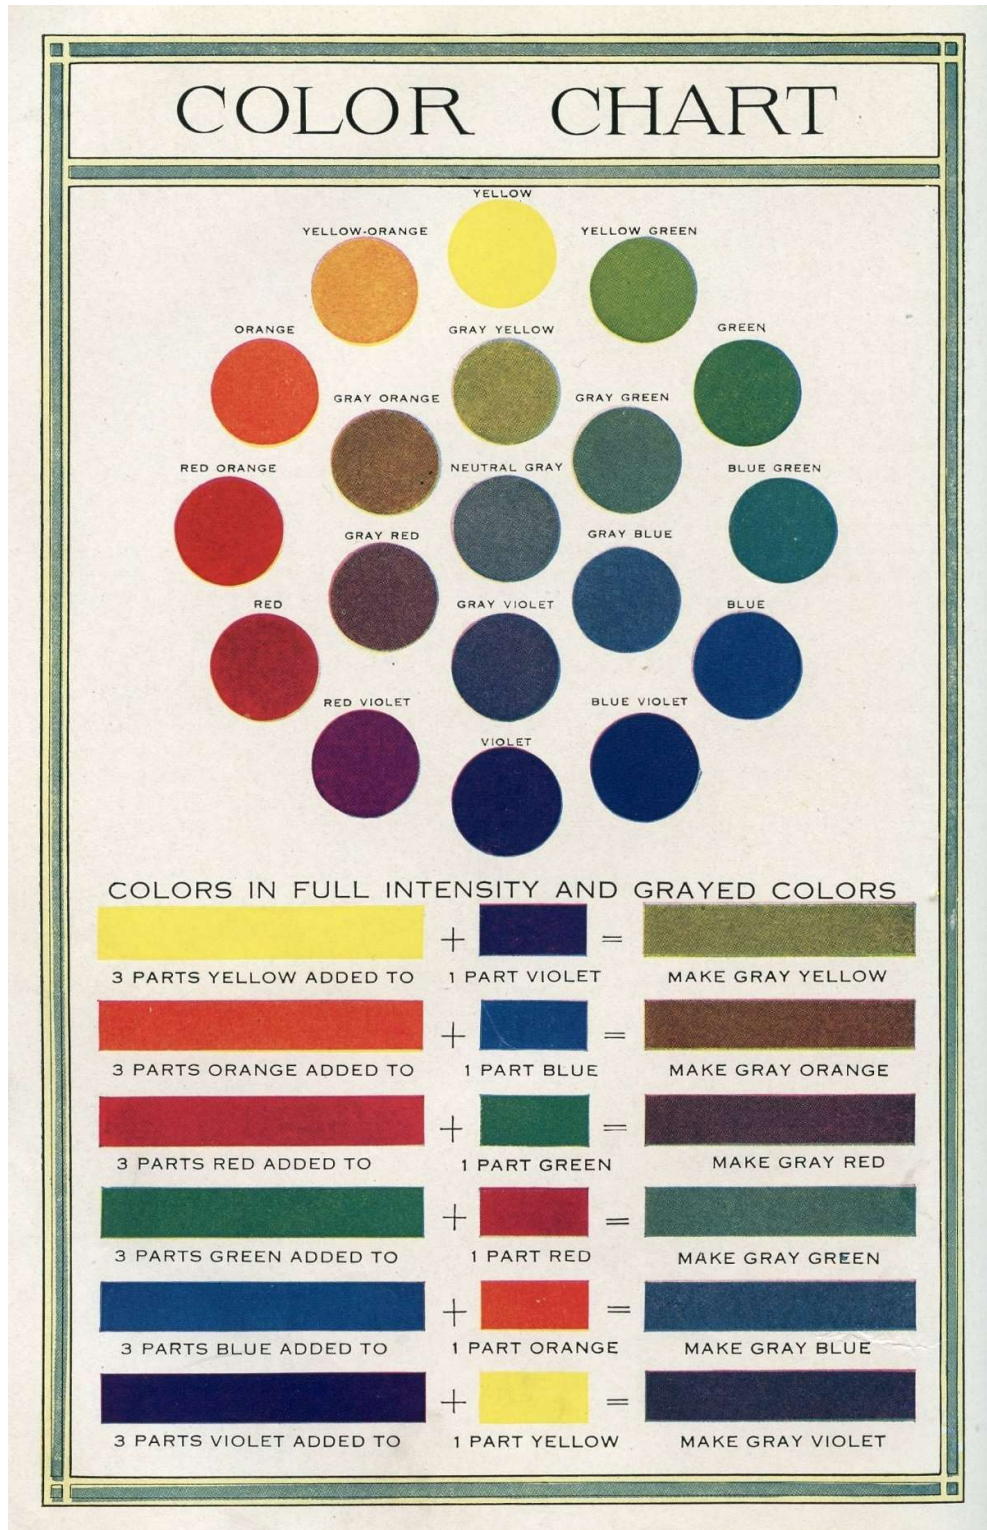
## APPENDIX 3: EXAMPLES OF HISTORIC COLOUR CHARTS

Color," *The World Book*, 1920. "
