**BAT SCOPING & BAT PRESENCE / ABSENCE SURVEY**

**North End Garage**

Gerrards Lane  
Halewood  
Liverpool  
Merseyside  
L26 5QA

| UES reference: | UES03125/03 |

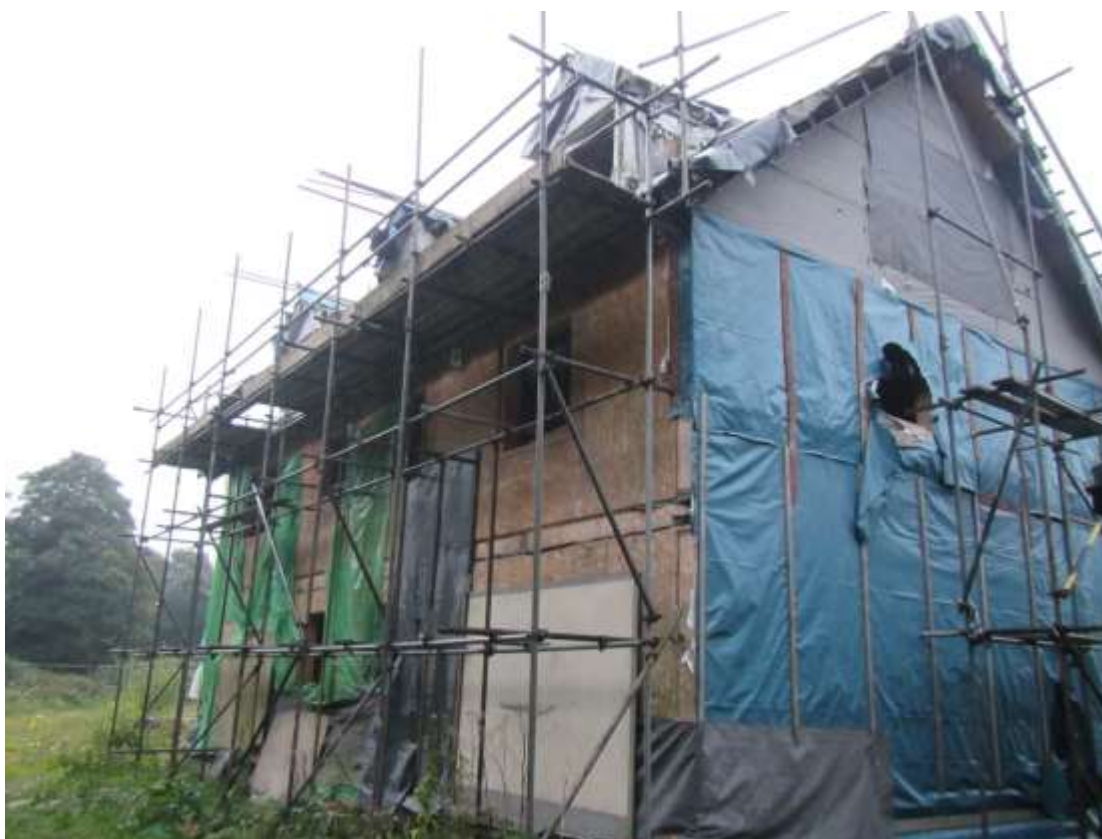
**Building 1** is the frame of a partly constructed two-storey residential dwelling with a pitched roof. The building is entirely constructed from wood and is currently lacking brickwork and roof tiles. Scaffolding is present around the building and sheets of waterproof material currently line the roof and walls. No windows or doors have been fitted and large cavities are present in their place, which provide potential bat access points into the building. Due to its construction, no external PRFs were observed within the building.

Photograph 2 – The north-eastern and north-western aspect of Building 1.

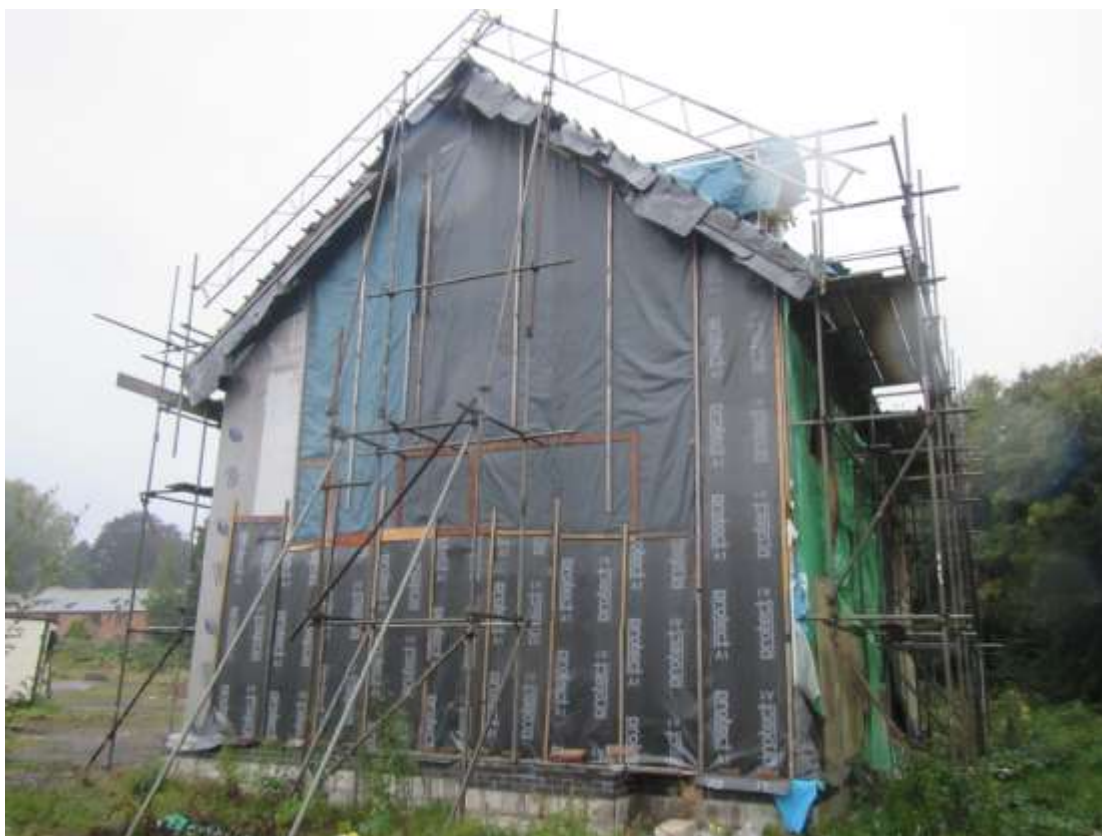
Photograph 3 – The south-eastern aspect of Building 1.

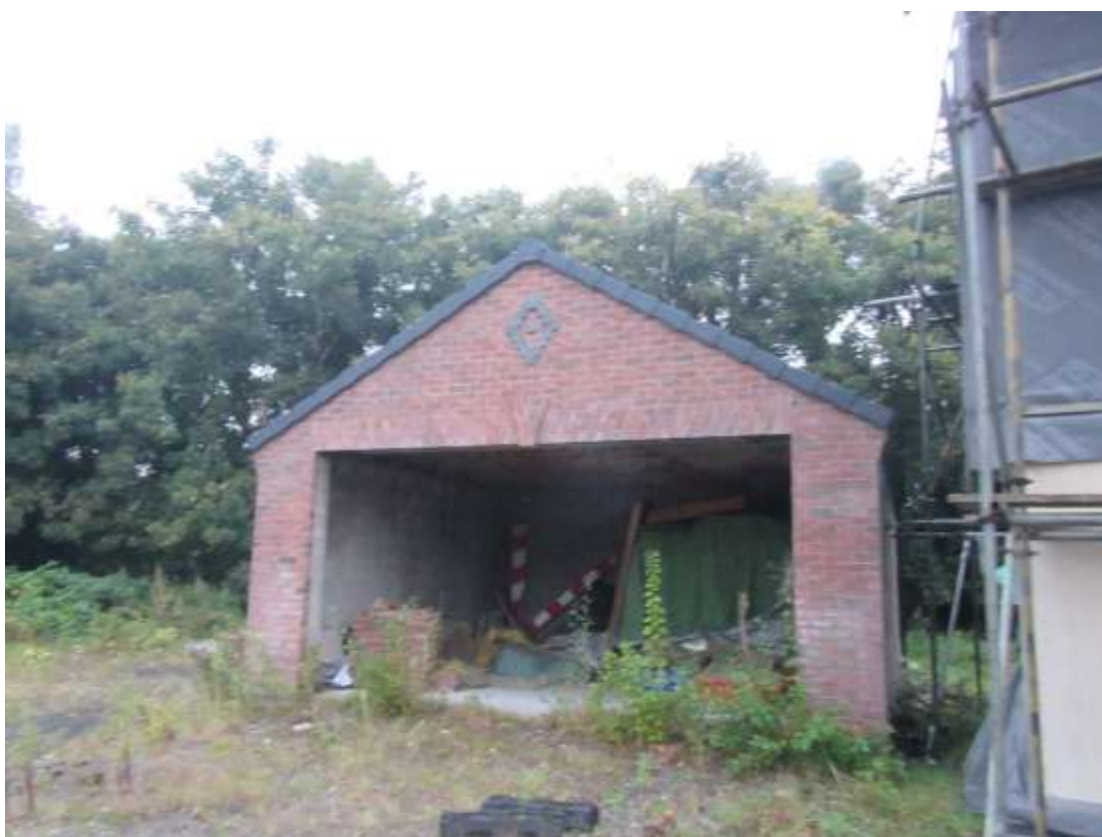
**Building 2** is a single-storey double garage with a pitched roof. The walls have been constructed from brick and has intact roof and ridge tiles. The plastic verge capping and fascias are all in good condition, although a small number of large gaps are present at the ends of the roof capping (See Appendix 3 – Photographs, Photograph 6). These features are not considered to provide a suitable roosting feature as they do not lead to an enclosed cavity that could be used by roosting bats. No door is present, allowing access into the internal area. The building is in good condition and no external PRFs were observed.

Photograph 4 – The south-western aspect of Building 2.

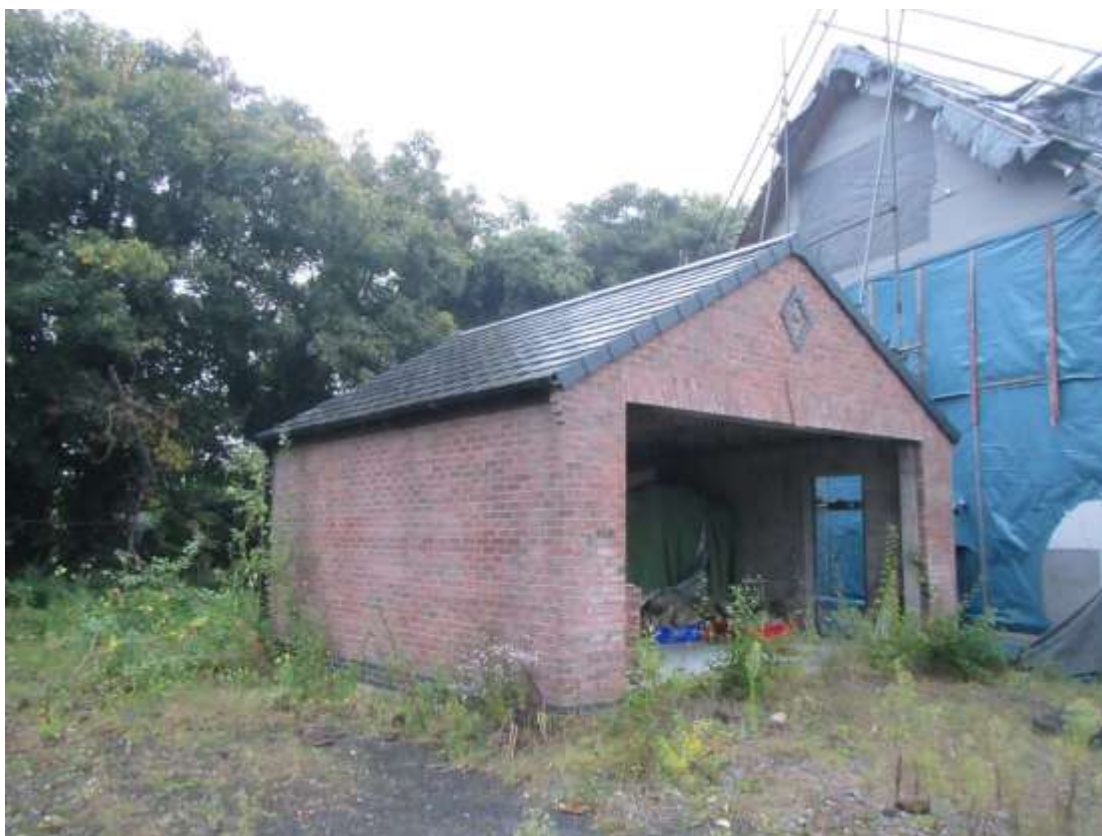
Photograph 5 – The north-western and south-western aspect of Building 2.

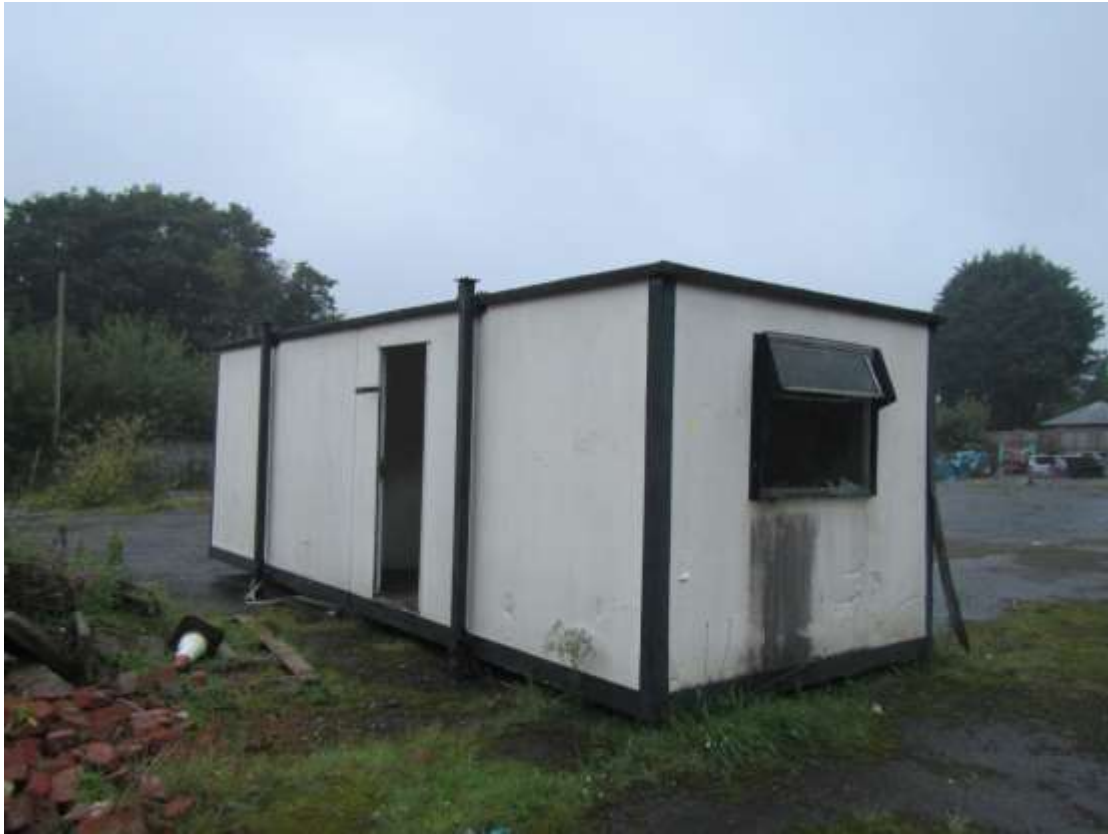
**Building 3** is a small single-storey portable work cabin with a flat roof. The entire building is constructed from metal and plastic and the roof is lined with bitumen felt. The building is in good condition and no external PRFs were observed.

Photograph 7 – The north-western and north-eastern aspect of Building 3.

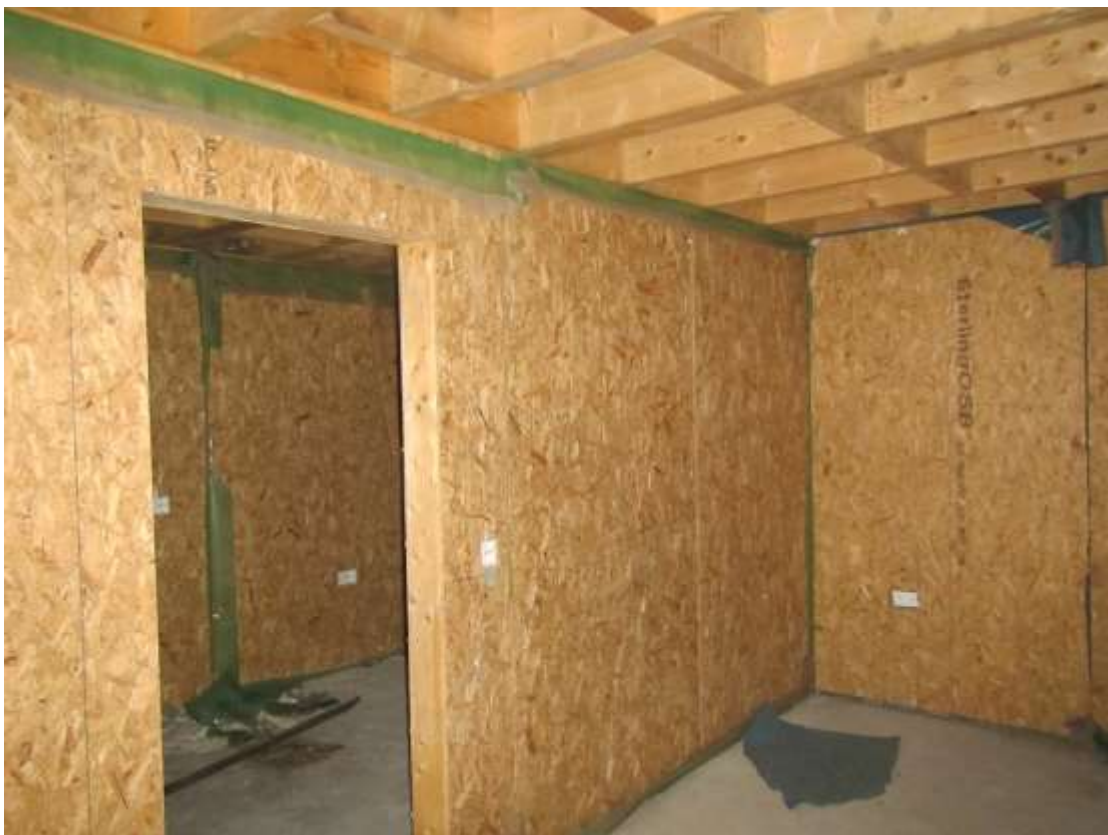
Internally within **Building 1**, the bare wooden walls are visible and the underside of the roof is lined with wooden panels. No loft void is present, and the third floor is open from floor to ceiling. No insulation is present within the building and the internal areas are cold, draughty, and well-lit during the day. A few small and mostly superficial cavities are present between the woodwork (Photograph 11). These features are mostly superficial and are very exposed, further reducing their suitability for roosting bats. These features could be fully inspected during the survey and no evidence of roosting bats was observed.

Photograph 8 – Internal area of Building 1.

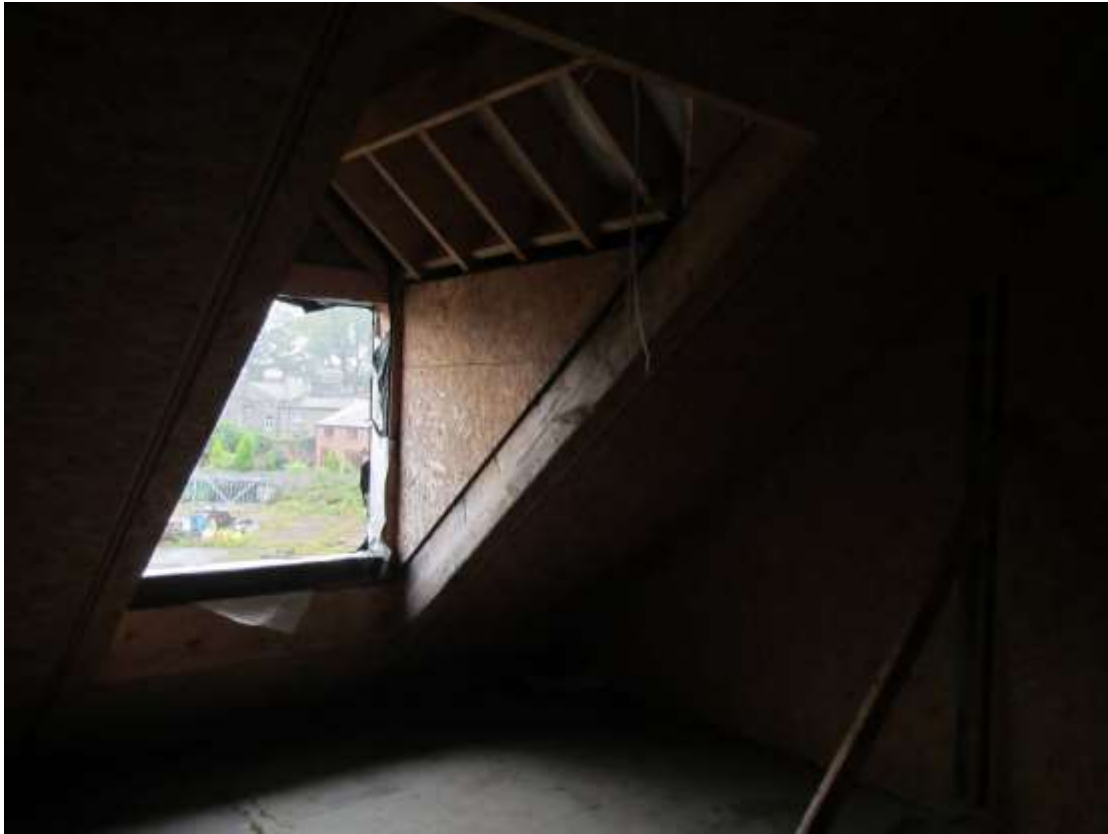
Photograph 9 – Within the third floor of Building 1, showing no glass in the windows.

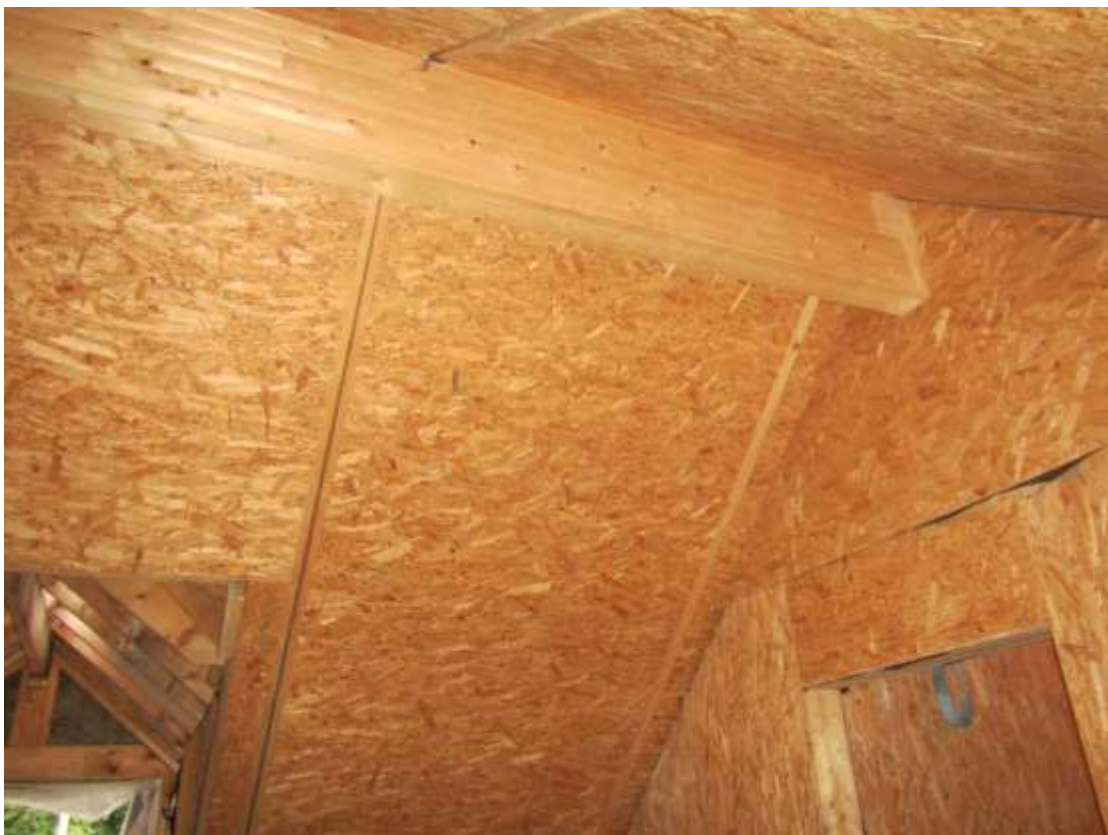
Photograph 10 – Looking at the underside of roof within Building 1.

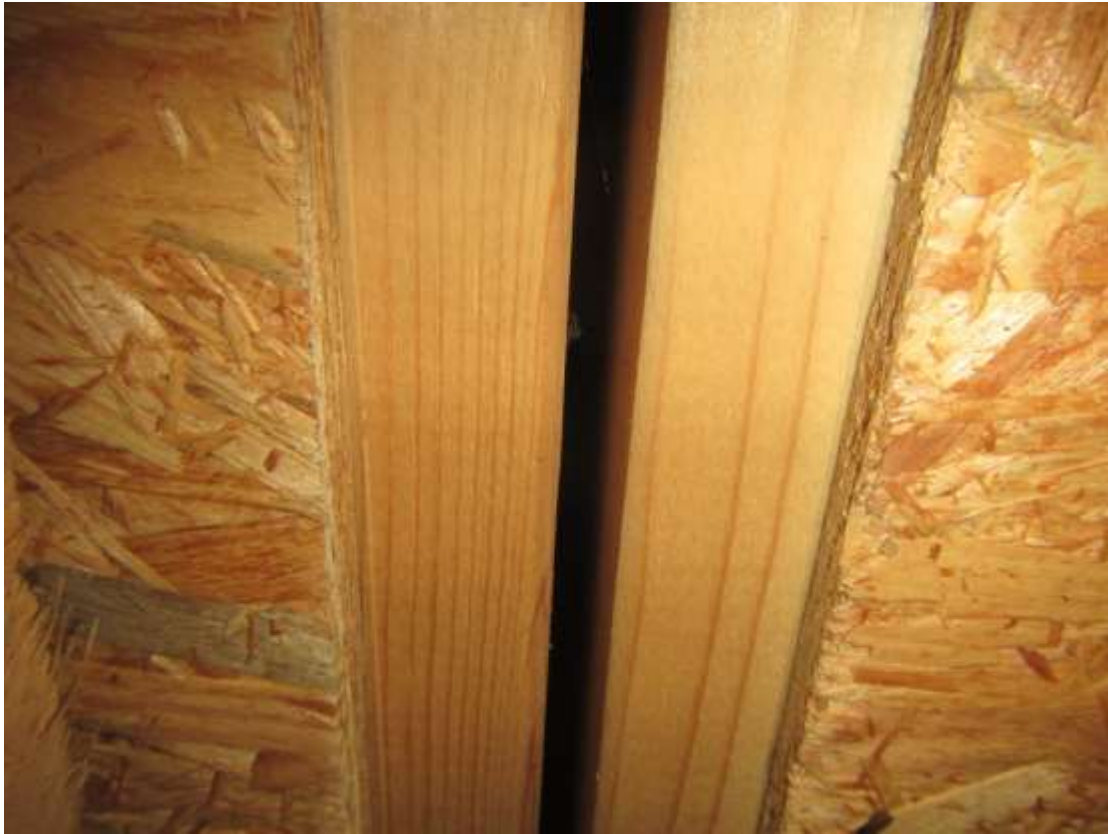
Building 1 on site presents a few poor-quality PRFs which could be used by individual bats on a transitional basis and was assessed as having low potential to support roosting bats. Having said this, no field signs of bats, such as droppings, were found during the building inspections. Buildings 2 and 3 were assessed to have a negligible potential to support roosting bats due to a lack of PRFs.

Photograph 11 – Superficial cavities in between the woodwork in Building 1.

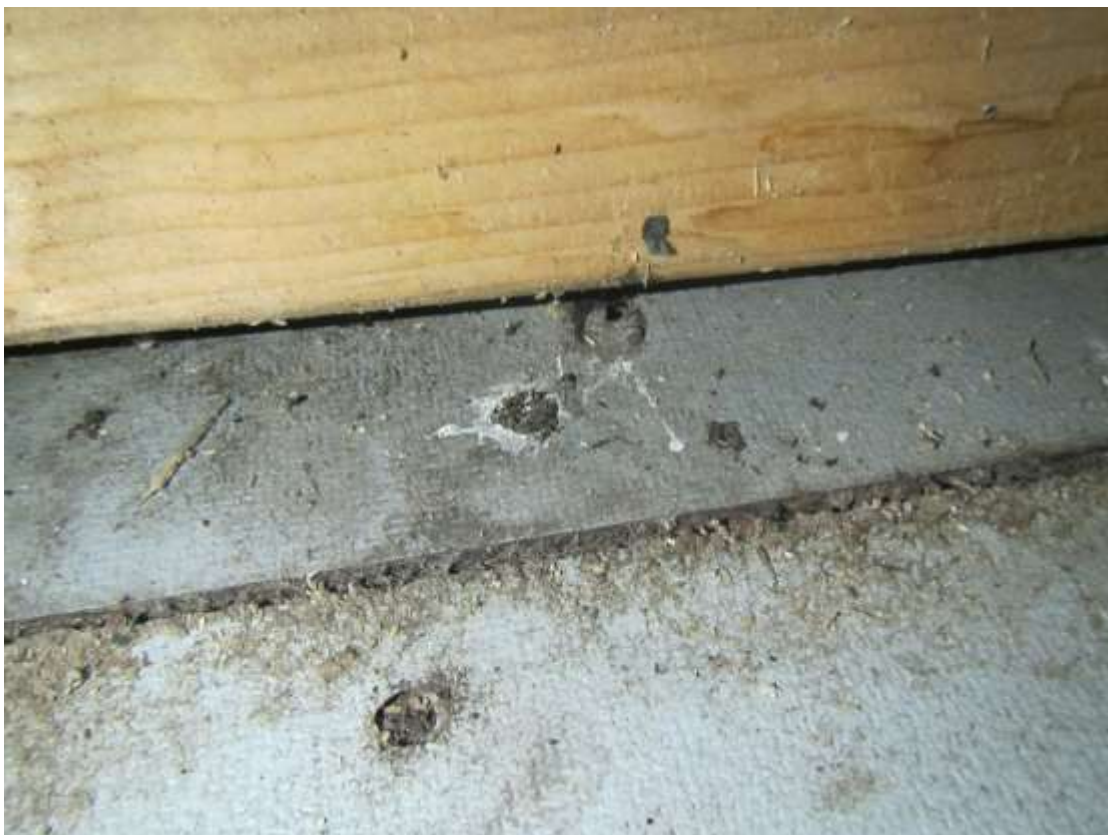
Anecdotal evidence suggests swallows *Hirundo rustica* use the partly constructed building during the summer. No evidence of nesting activity was observed within the building, however evidence of bird activity was evident in the form of a small number of scattered droppings (Photograph 12).

Photograph 12 – Bird droppings found within Building 1.

Due to the potential presence of breeding birds in Building 1, it is recommended that any demolition works and the initial construction works to seal the building (e.g. the installation of doors and windows) are to take place outside of the breeding bird season and should not be undertaken from March to August inclusive. If this is not possible, a breeding bird nest survey should be undertaken prior to the commencement of works by a suitably experienced ecologist and an ecological clerk of works appointed if considered necessary.

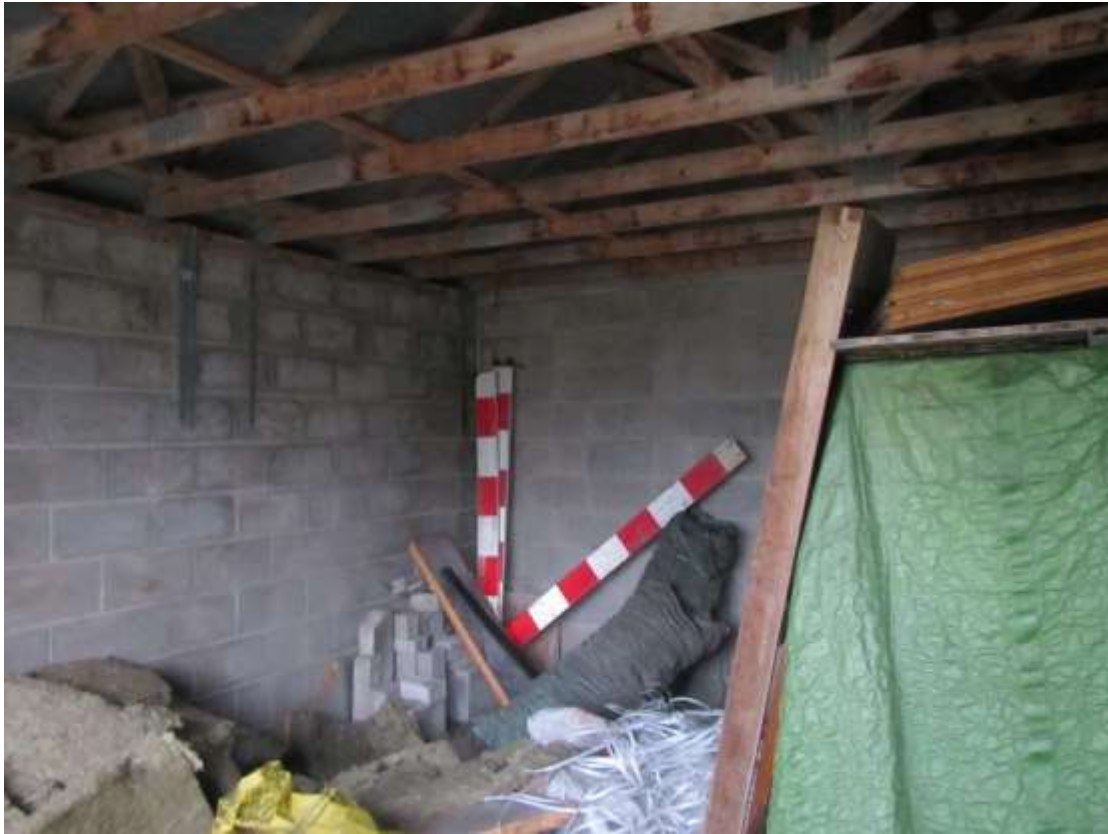
Internally within **Building 2**, the bare breezeblock walls are visible, and the underside of the roof is lined with breathable roofing membrane. The internal areas are cold and draughty and are well lit during the day. The internal areas of the building are in good condition and no cavities or crevices that would provide suitable PRFs were observed within the building. No evidence of nesting birds or roosting bats was observed.

Photograph 13 – Internal view of Building 2.

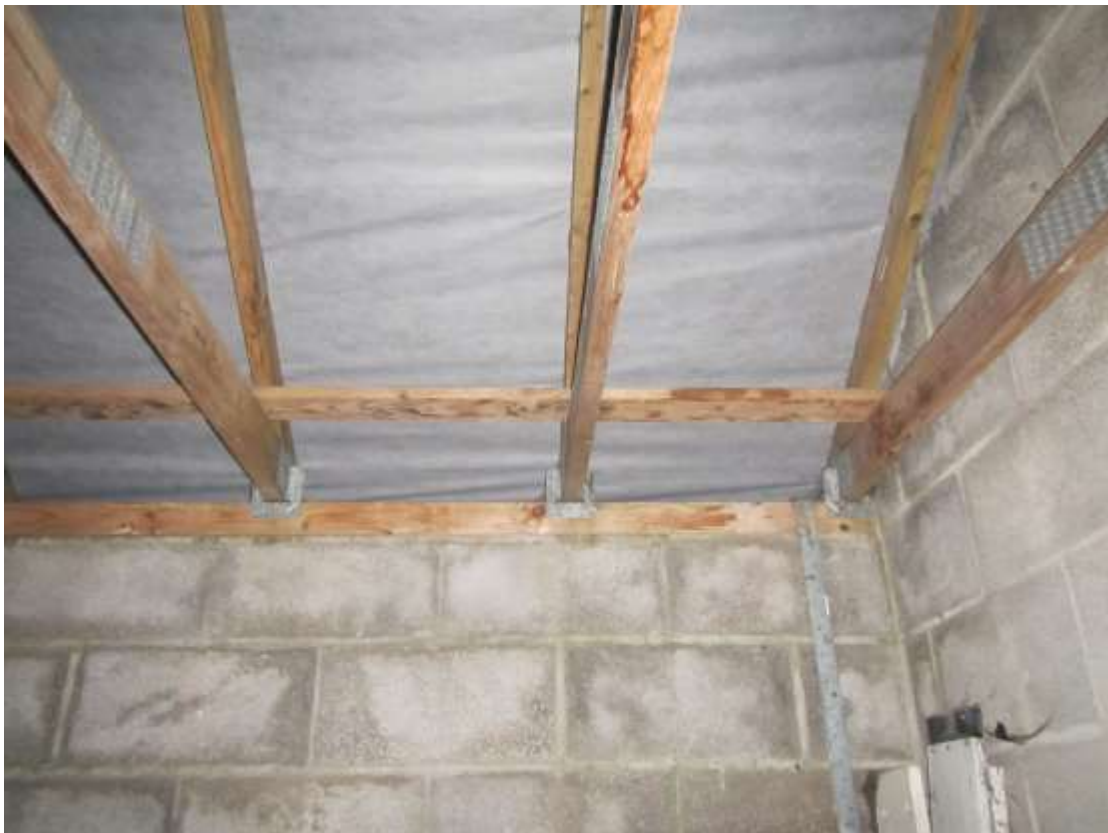
Photograph 14 – Showing the roof lining of Building 2.

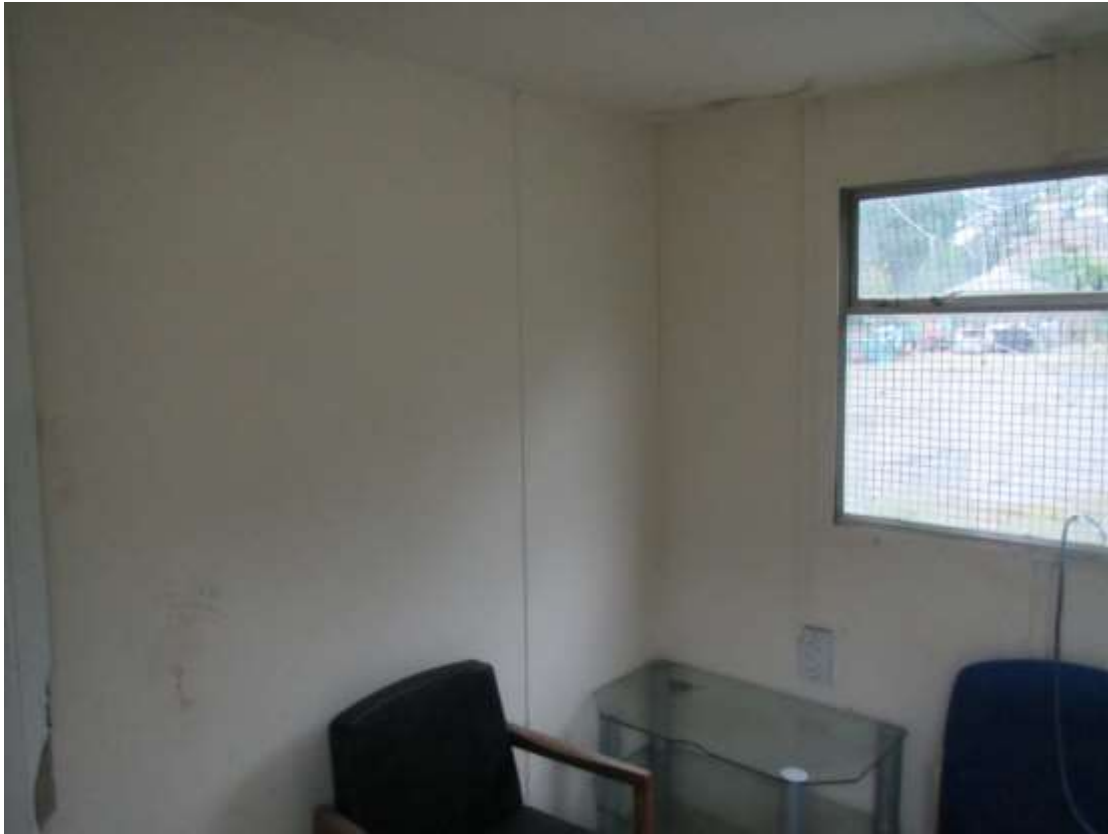
**Building 3** has no loft space and is not suitable to support roosting bats due to the lack of access points, lack of PRFs and high levels of light within the building. No evidence of nesting birds or roosting bats was observed within the building.

Photograph 15 – Inside of Building 3.
