# **Halsnead - land at rear of Cemetery**

Ground Investigation Report

21 June 2018

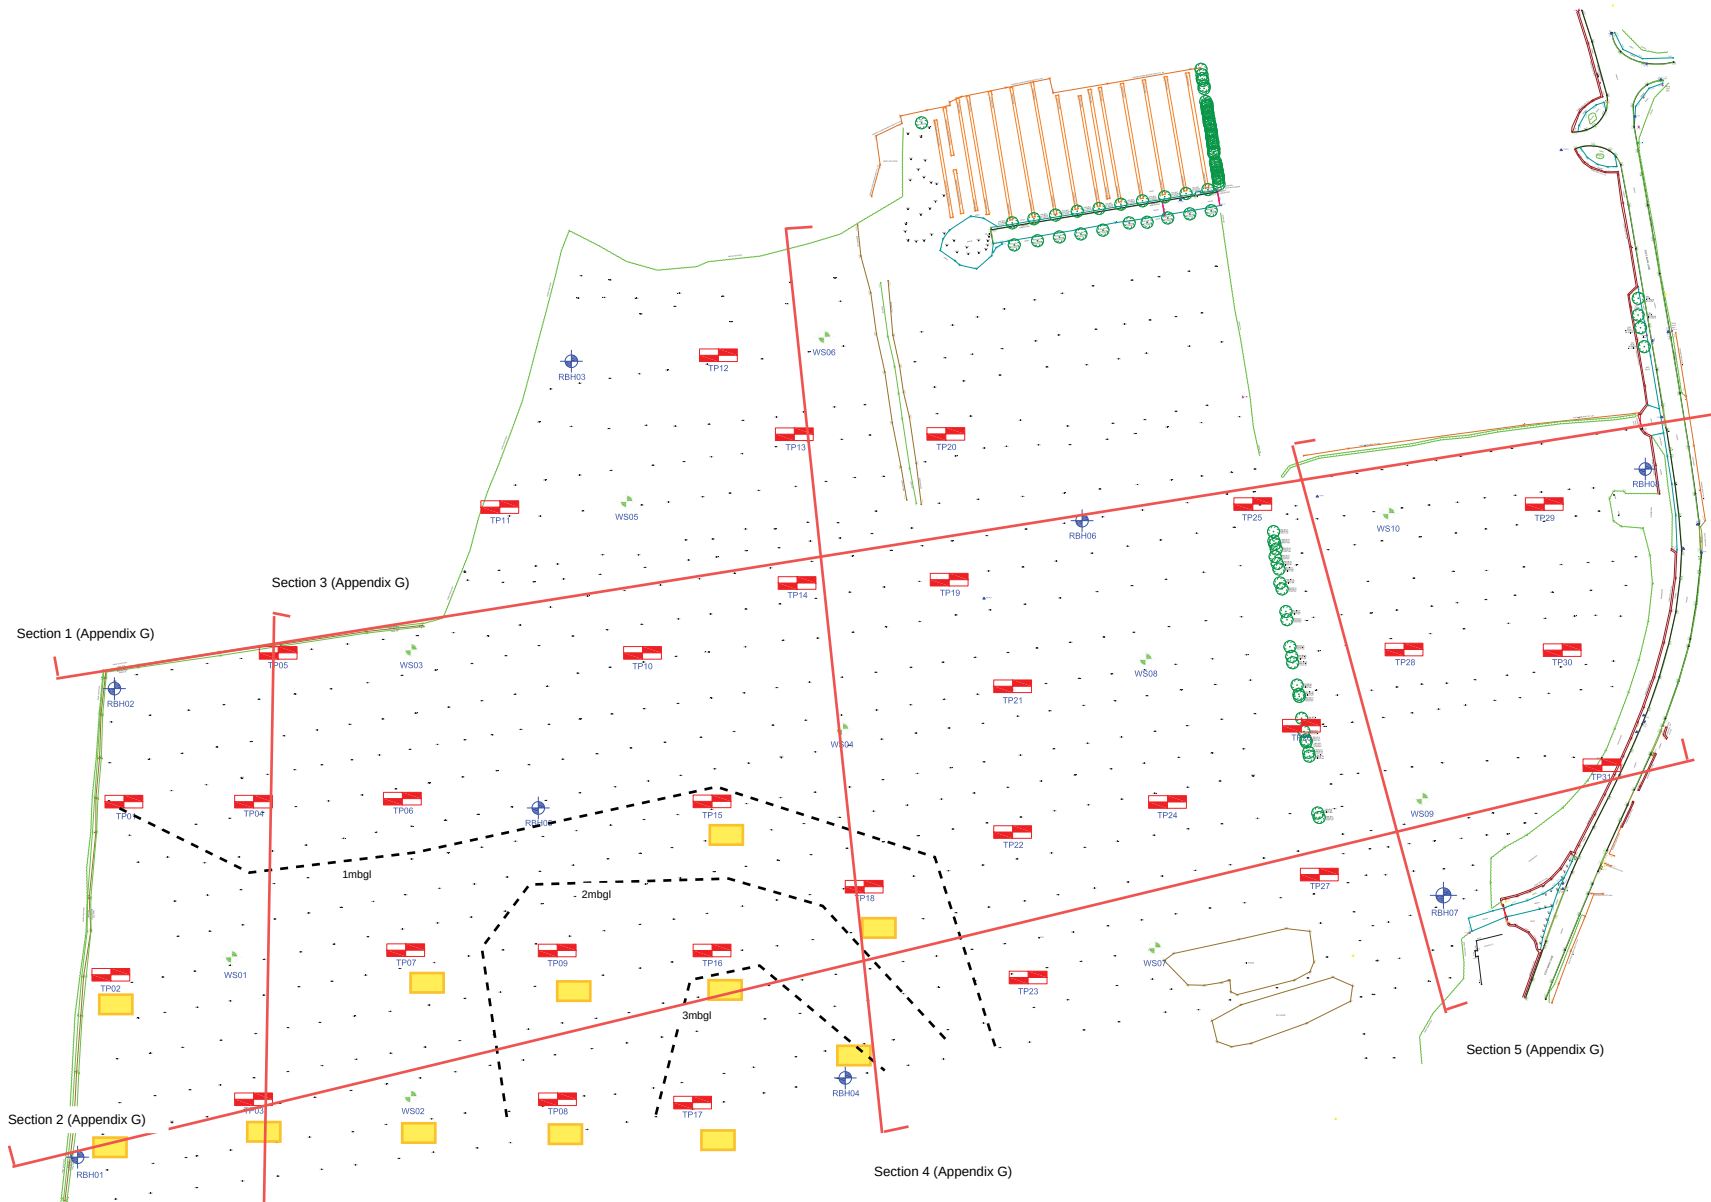
## **B. February 2018 GI Exploratory Hole Location Plan**

- Rotary Corred Borehole
- Windrowless Sample
- Machine excavated Trial Pit
- Glacial Till Deposits Encountered
- Completely Weathered Sandstone Contours (mbgl = metres below ground level)
- Cross-Section Lines

A summary of the ground conditions encountered is presented in Table 4.1 below. An exploratory hole location plan for the site is presented in Appendix B and geological cross sections in Appendix G. Exploratory hole logs are presented in CCG's factual report in Appendix H of this GIR.
