## STEWART MILNE HOMES

Halsnead Park, Whiston

Geo-environmental Assessment Report

LC/C3593/7018

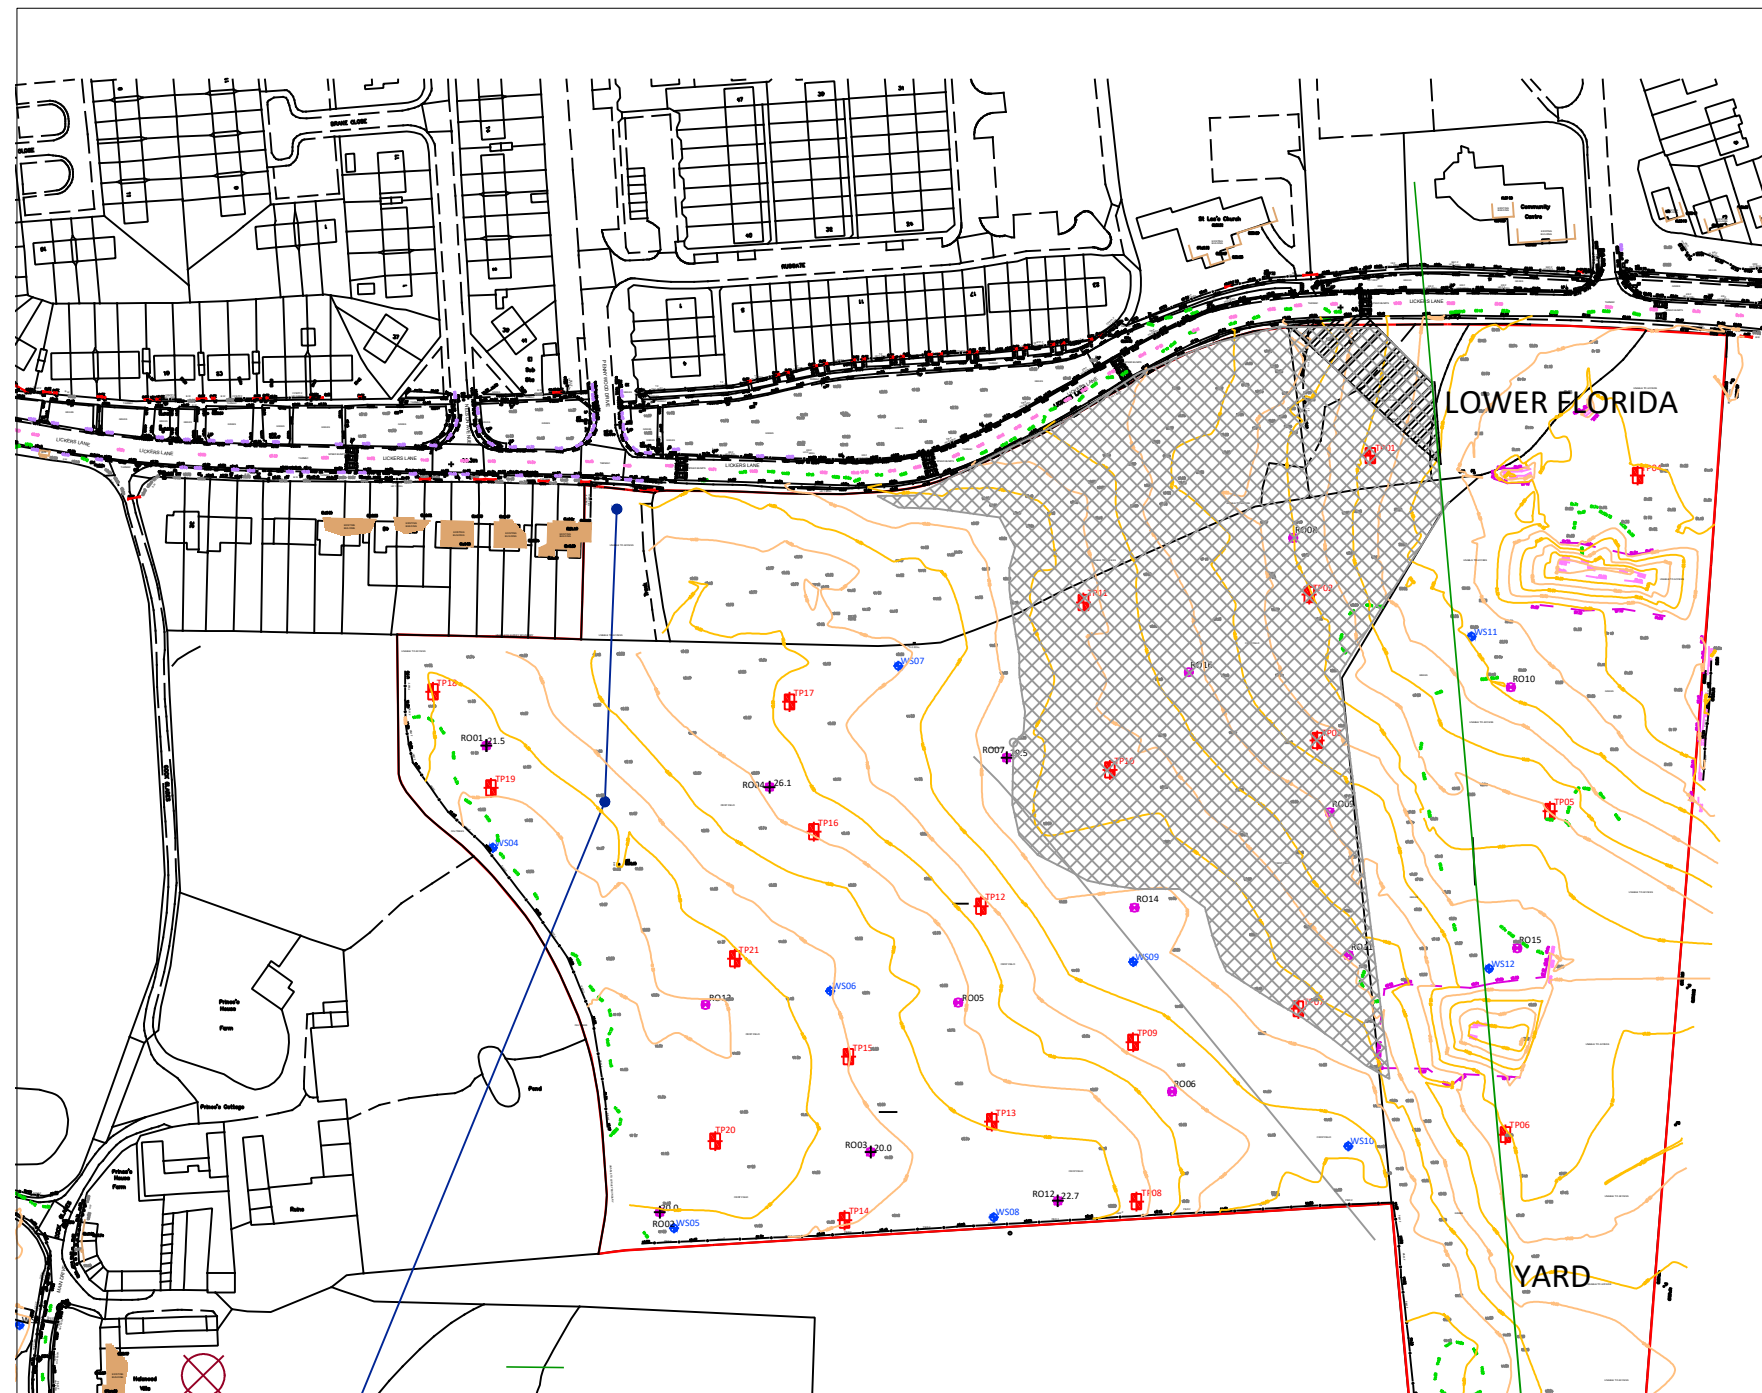
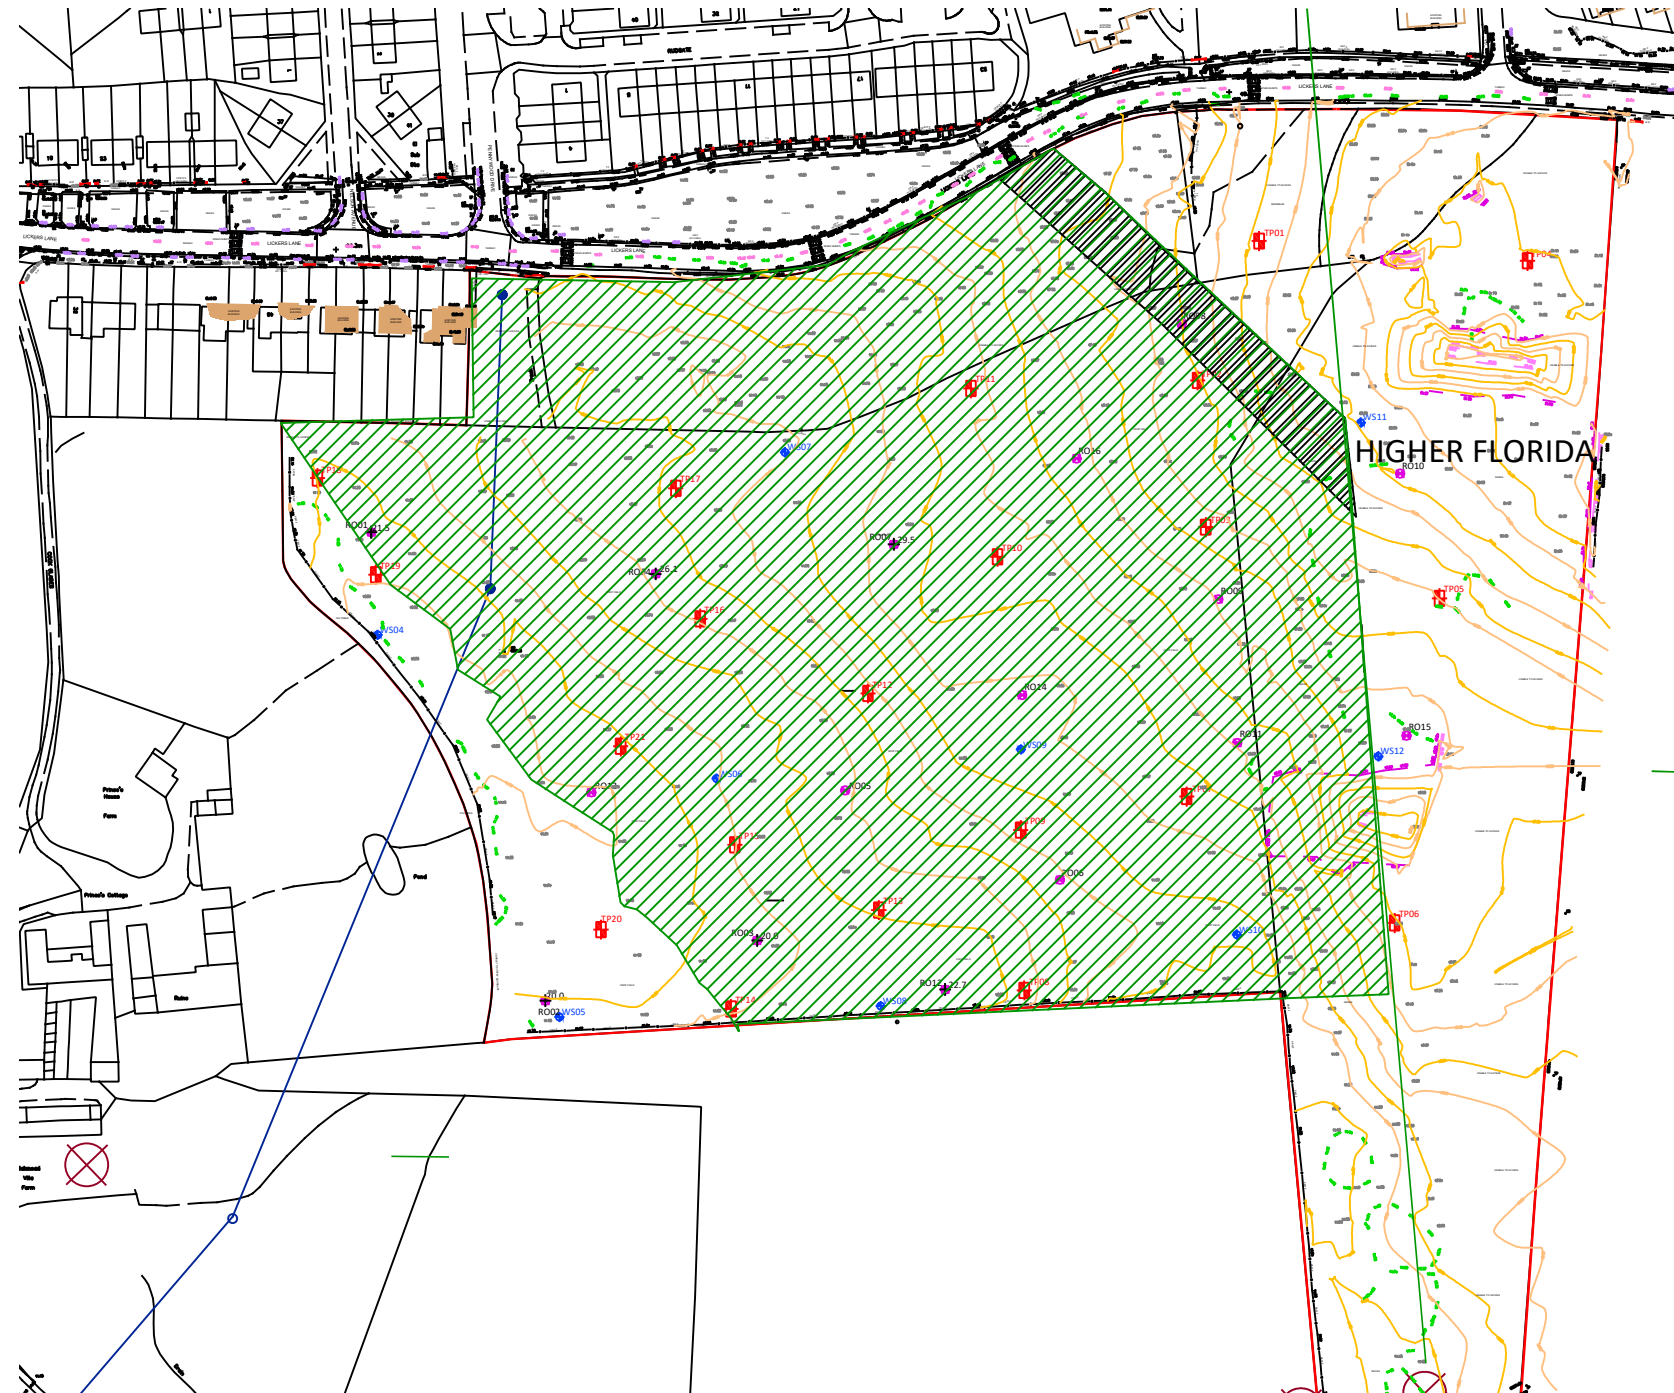
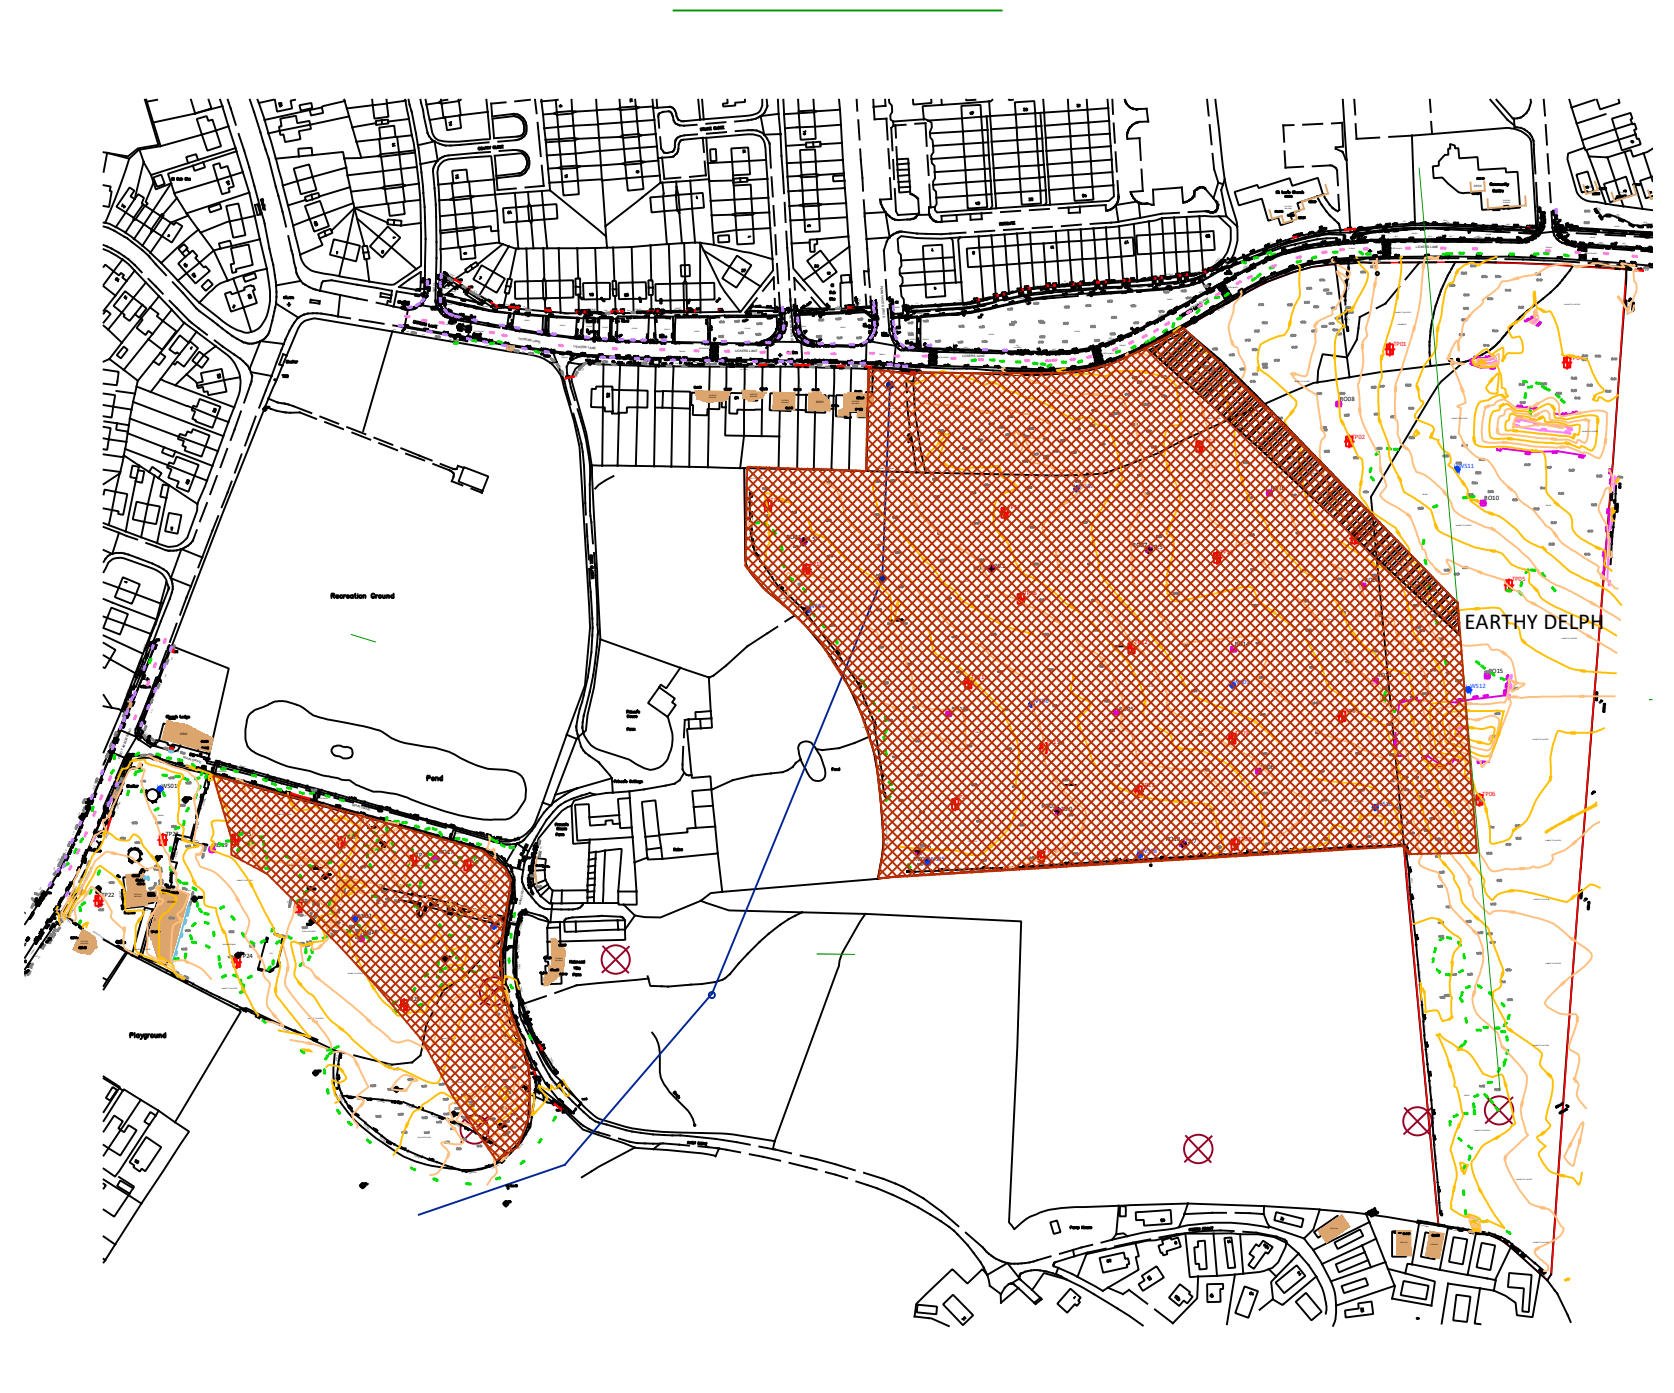
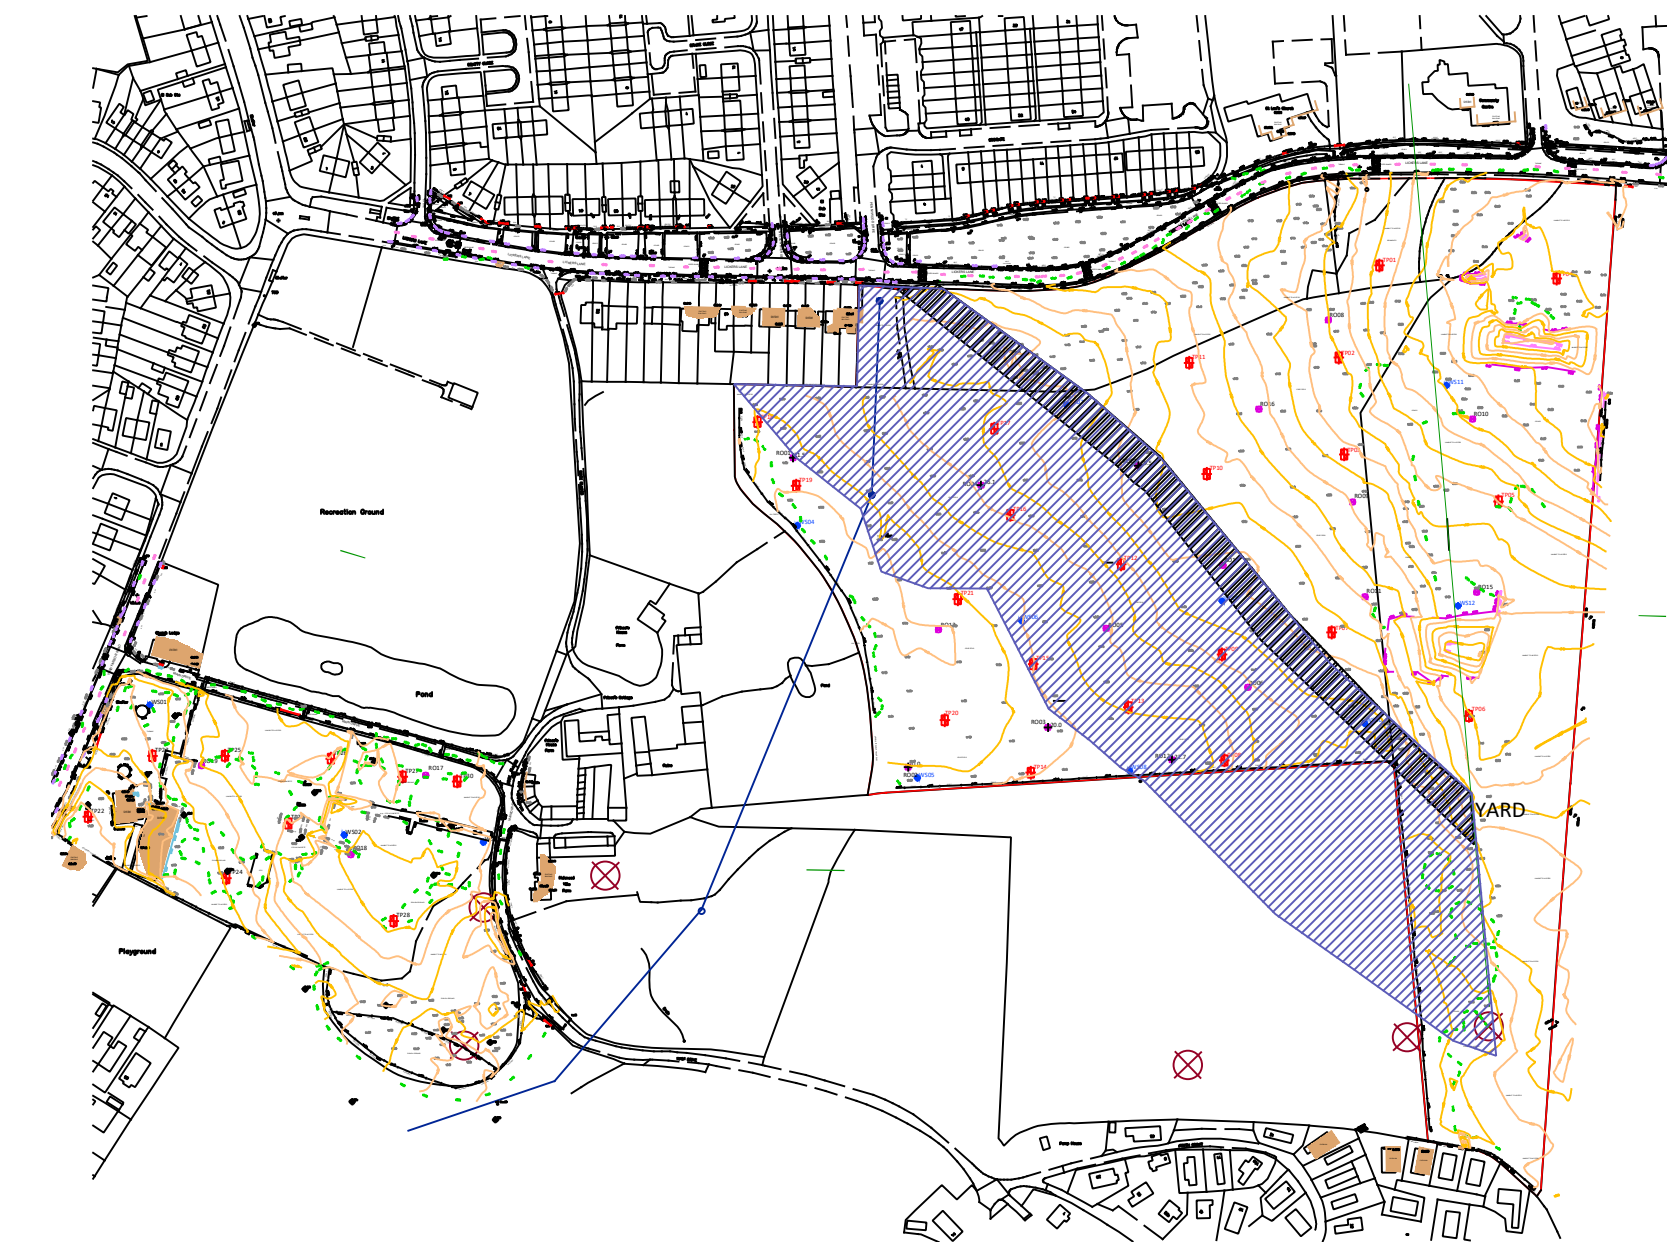
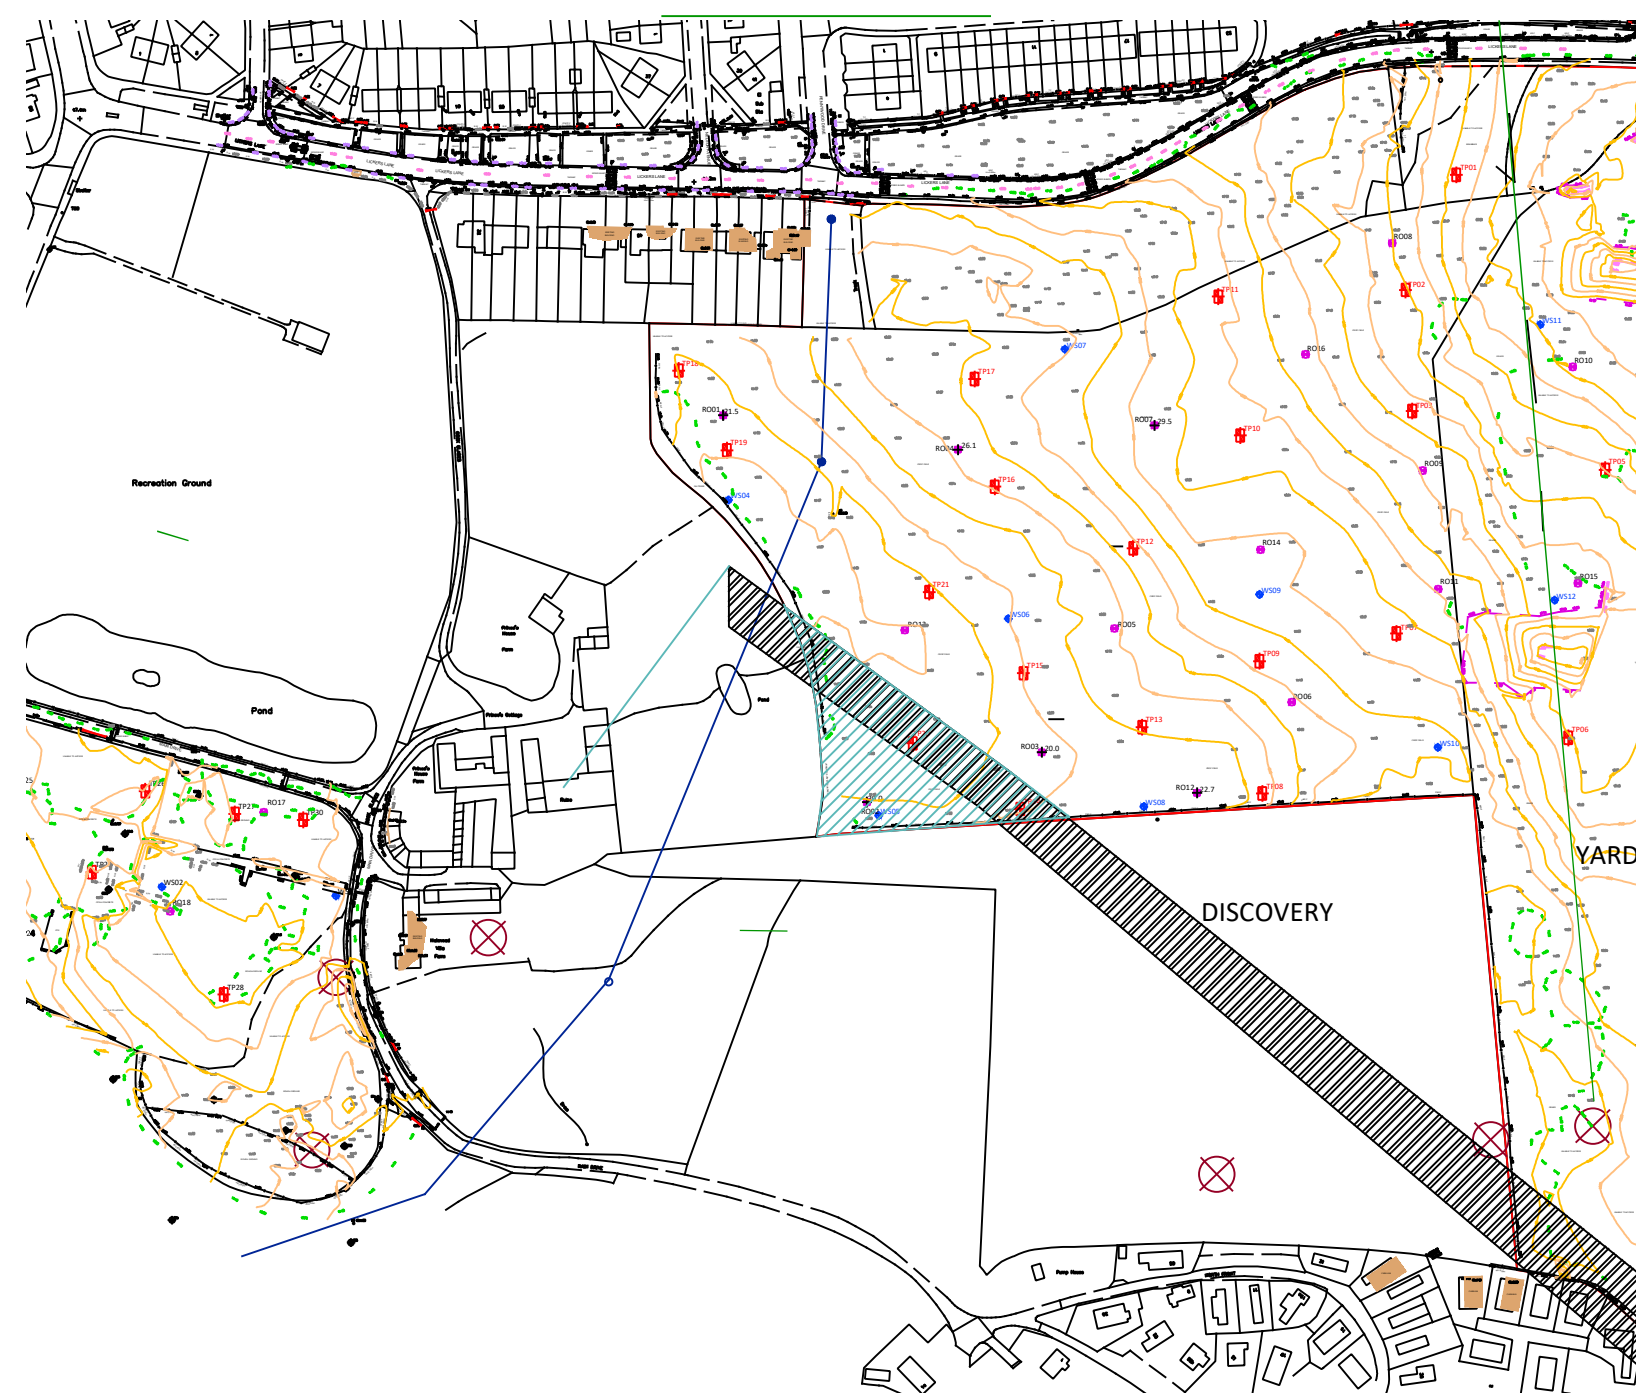
Zone of influence of each seam is shown as a worst case scenario based on maximum seam thickness and assuming all seams below are worked.

- 6.3.6 CIRIA SP32 “Construction over abandoned mine workings” indicates that a void will not migrate to the surface where there is more than ten times the seam thickness of rock cover. Up to this depth the void will begin to choke with rock from the roof (represented by broken ground). Beyond 10 times the seam thickness the rock will tend to arch and prevent upwards migration of the void.
- 6.3.7 Coal seams are present below the site and have been proven to be worked in places, with insufficient rock cover over the workings meaning there is potential for foundations of the proposed buildings potentially being affected by crown holing. The anticipated zone of influence at the surface for each of the seams is shown on the Coal Mining Influence Plan Drawing No. C3593/07.

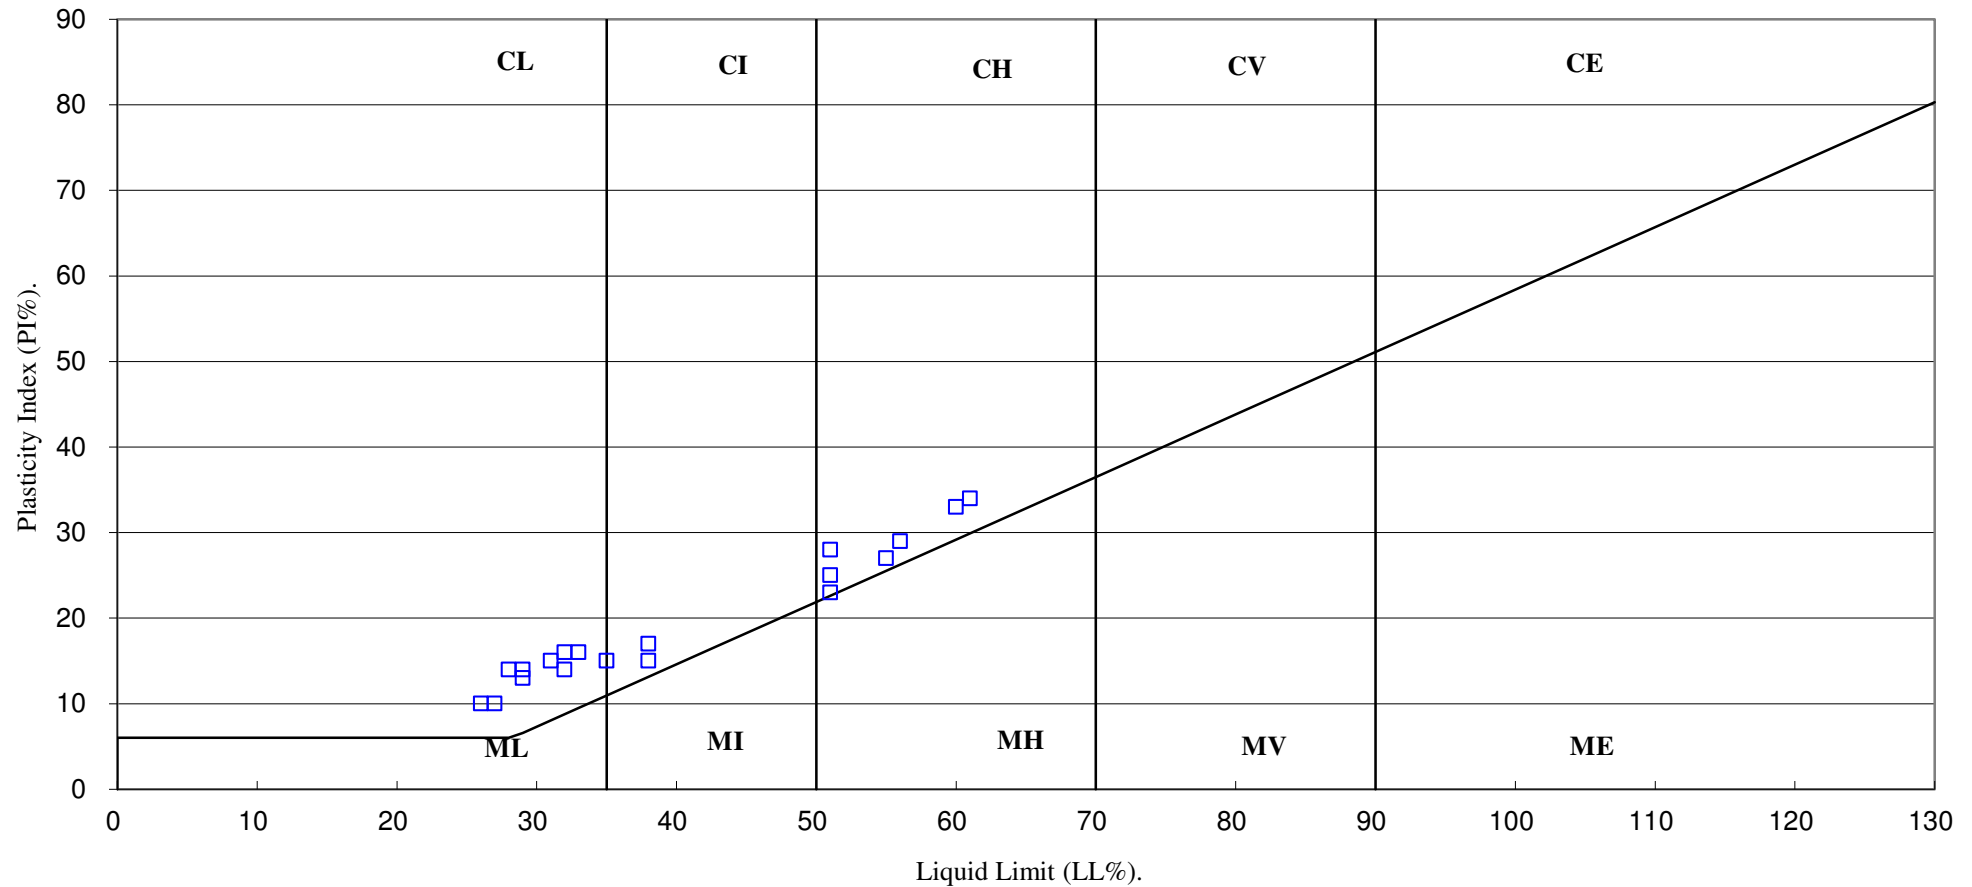
# PLASTICITY CHART FOR CASAGRANDE CLASSIFICATION.

(BS5930 :2015)

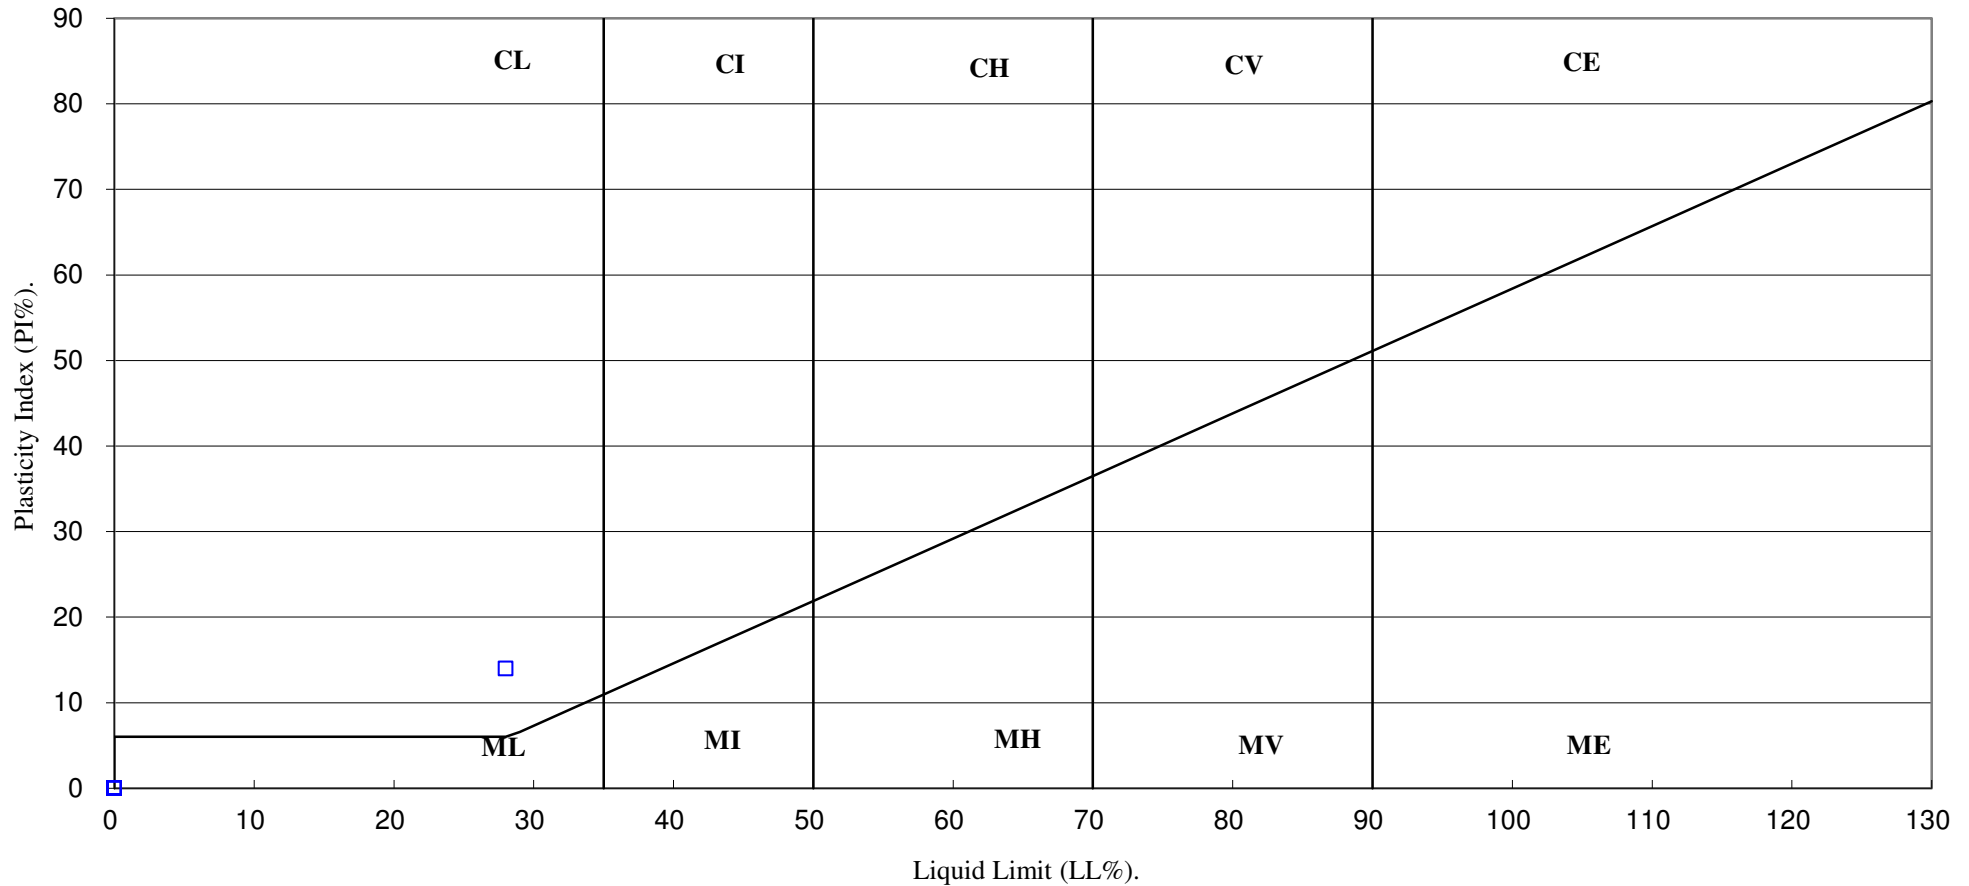
# PLASTICITY CHART FOR CASAGRANDE CLASSIFICATION.

(BS5930 :2015)
