## ARBORICULTURAL IMPACT ASSESSMENT

9 ASTER DRIVE  
KIRKBY  
KNOWSLEY  
L33 ISW

MARCH 2021

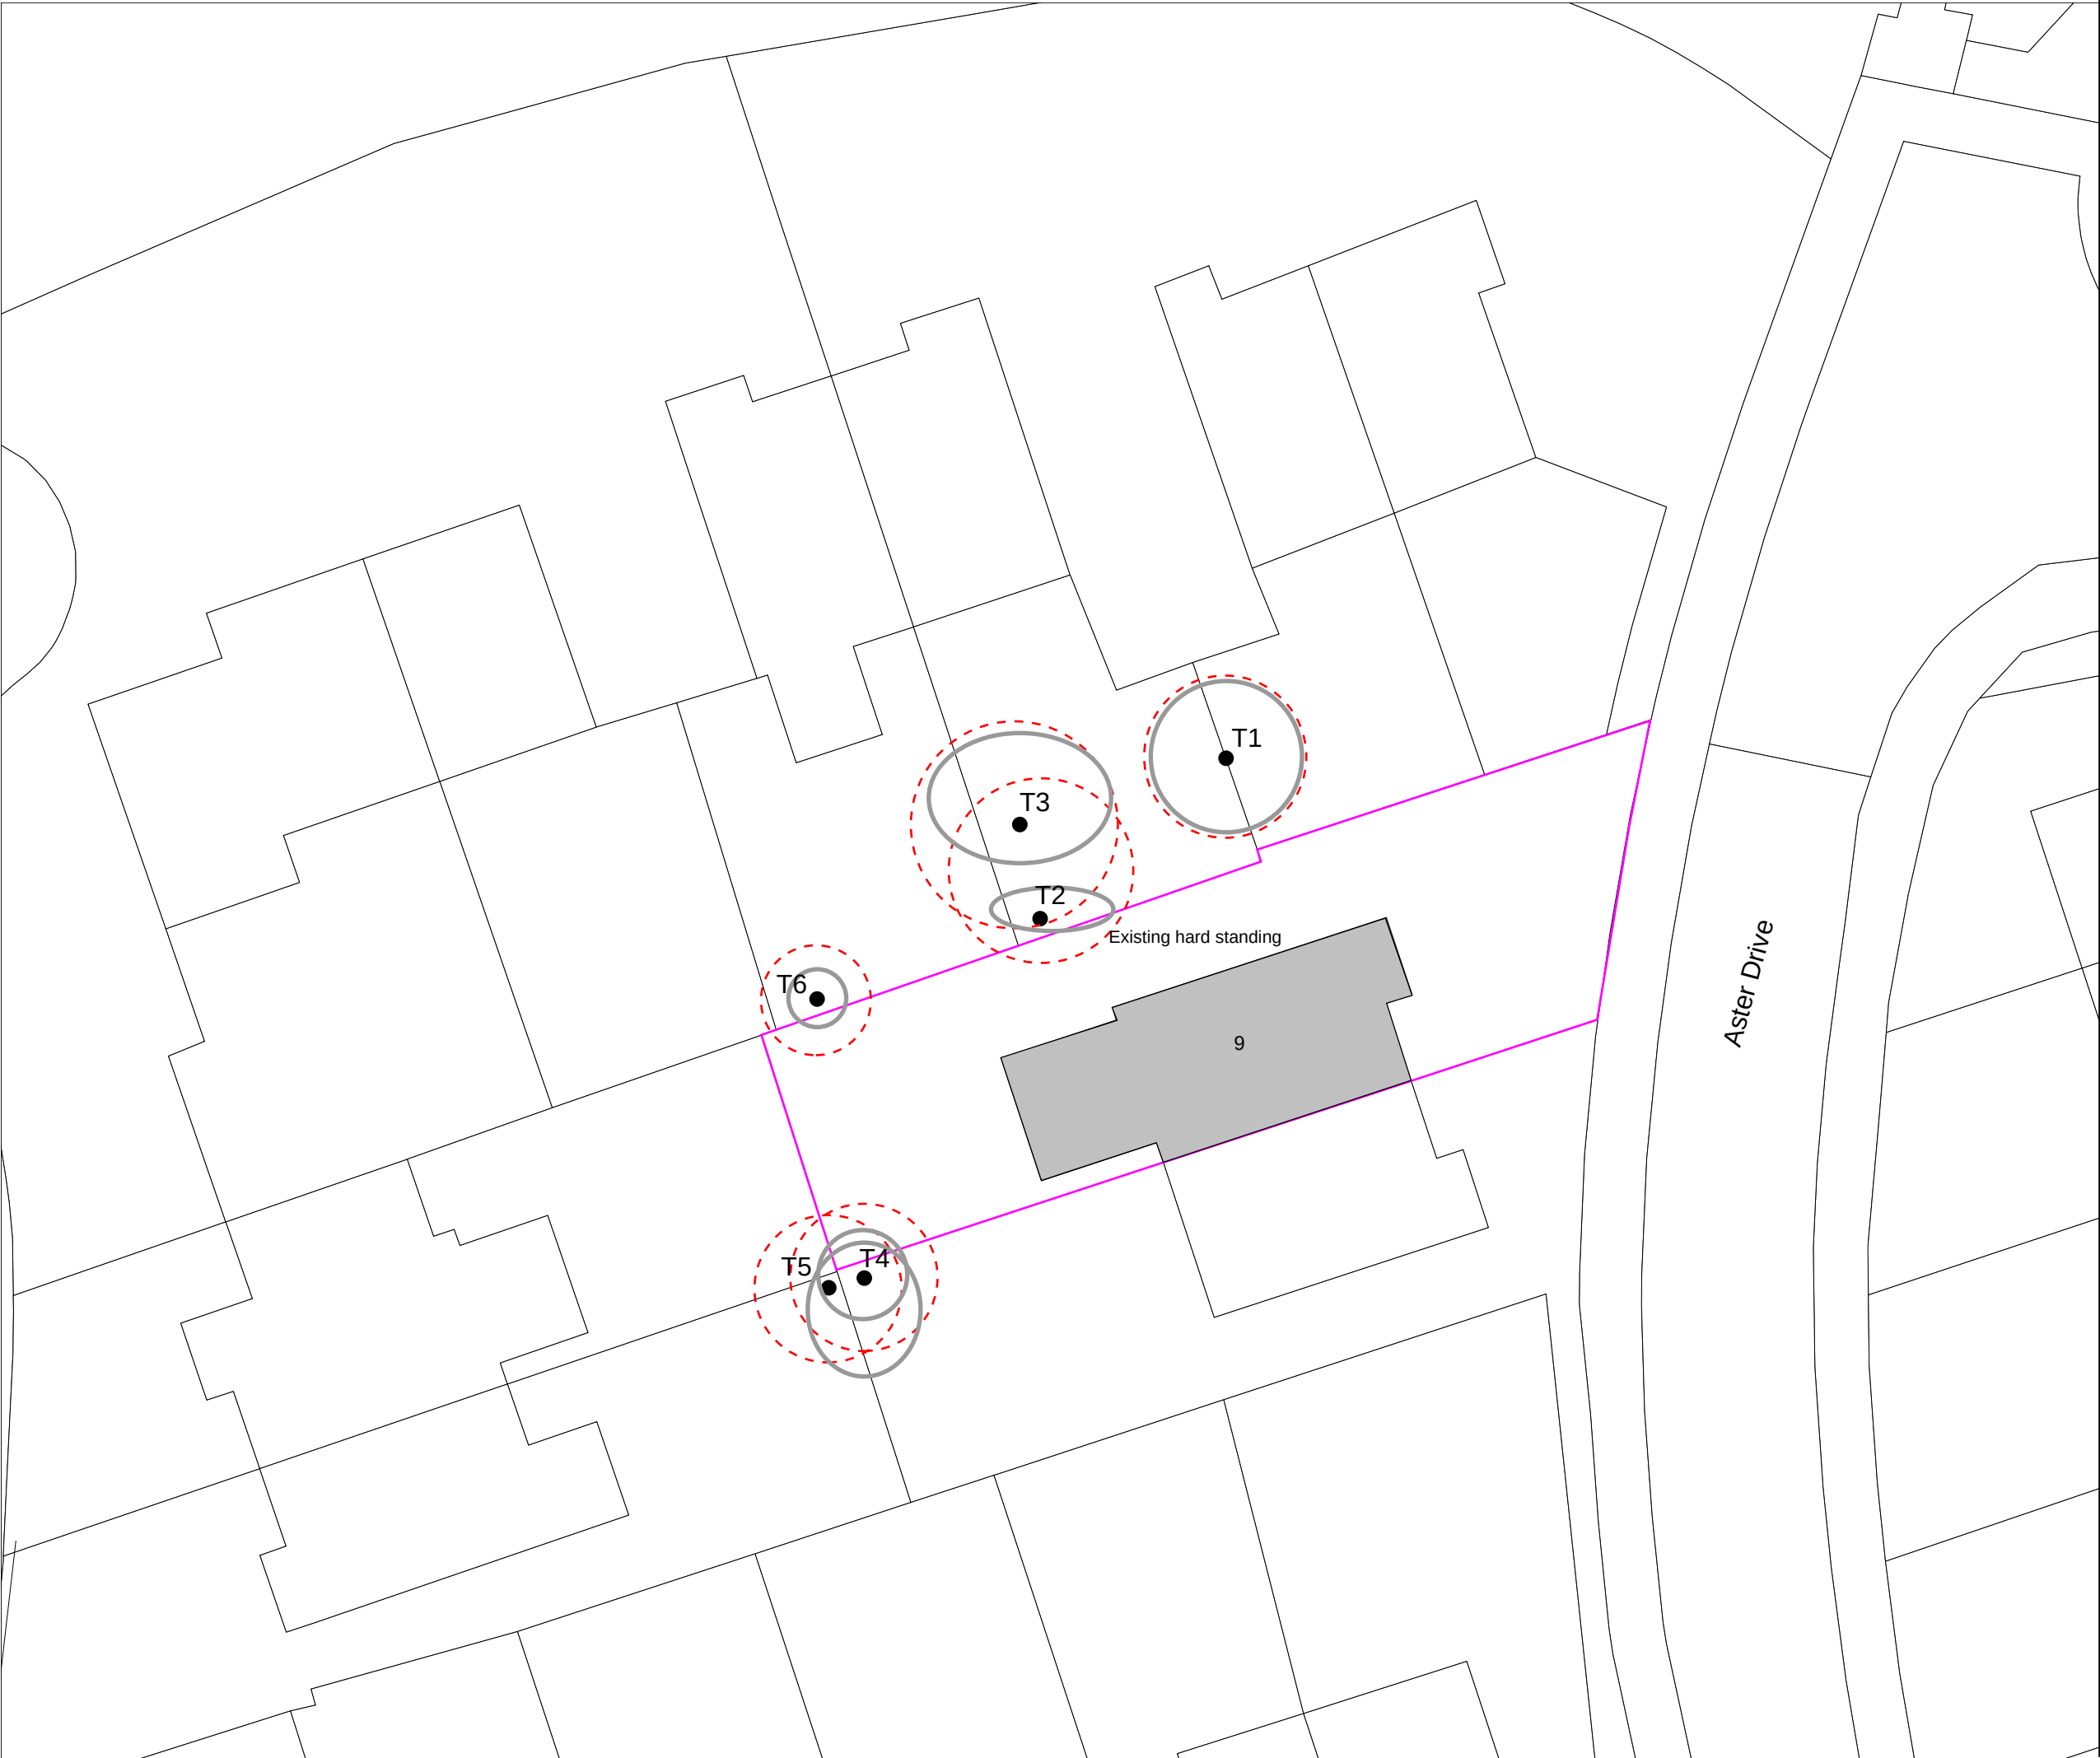
| Drawing Title:<br>BS5837 Plan | Drawing No:<br>21/00019/BSP | |

2.3 Where appropriate, canopy spread for each tree was recorded at four cardinal points in order to reproduce an accurate representation of the crown shape of the tree on the tree plan in Appendix 3.0.

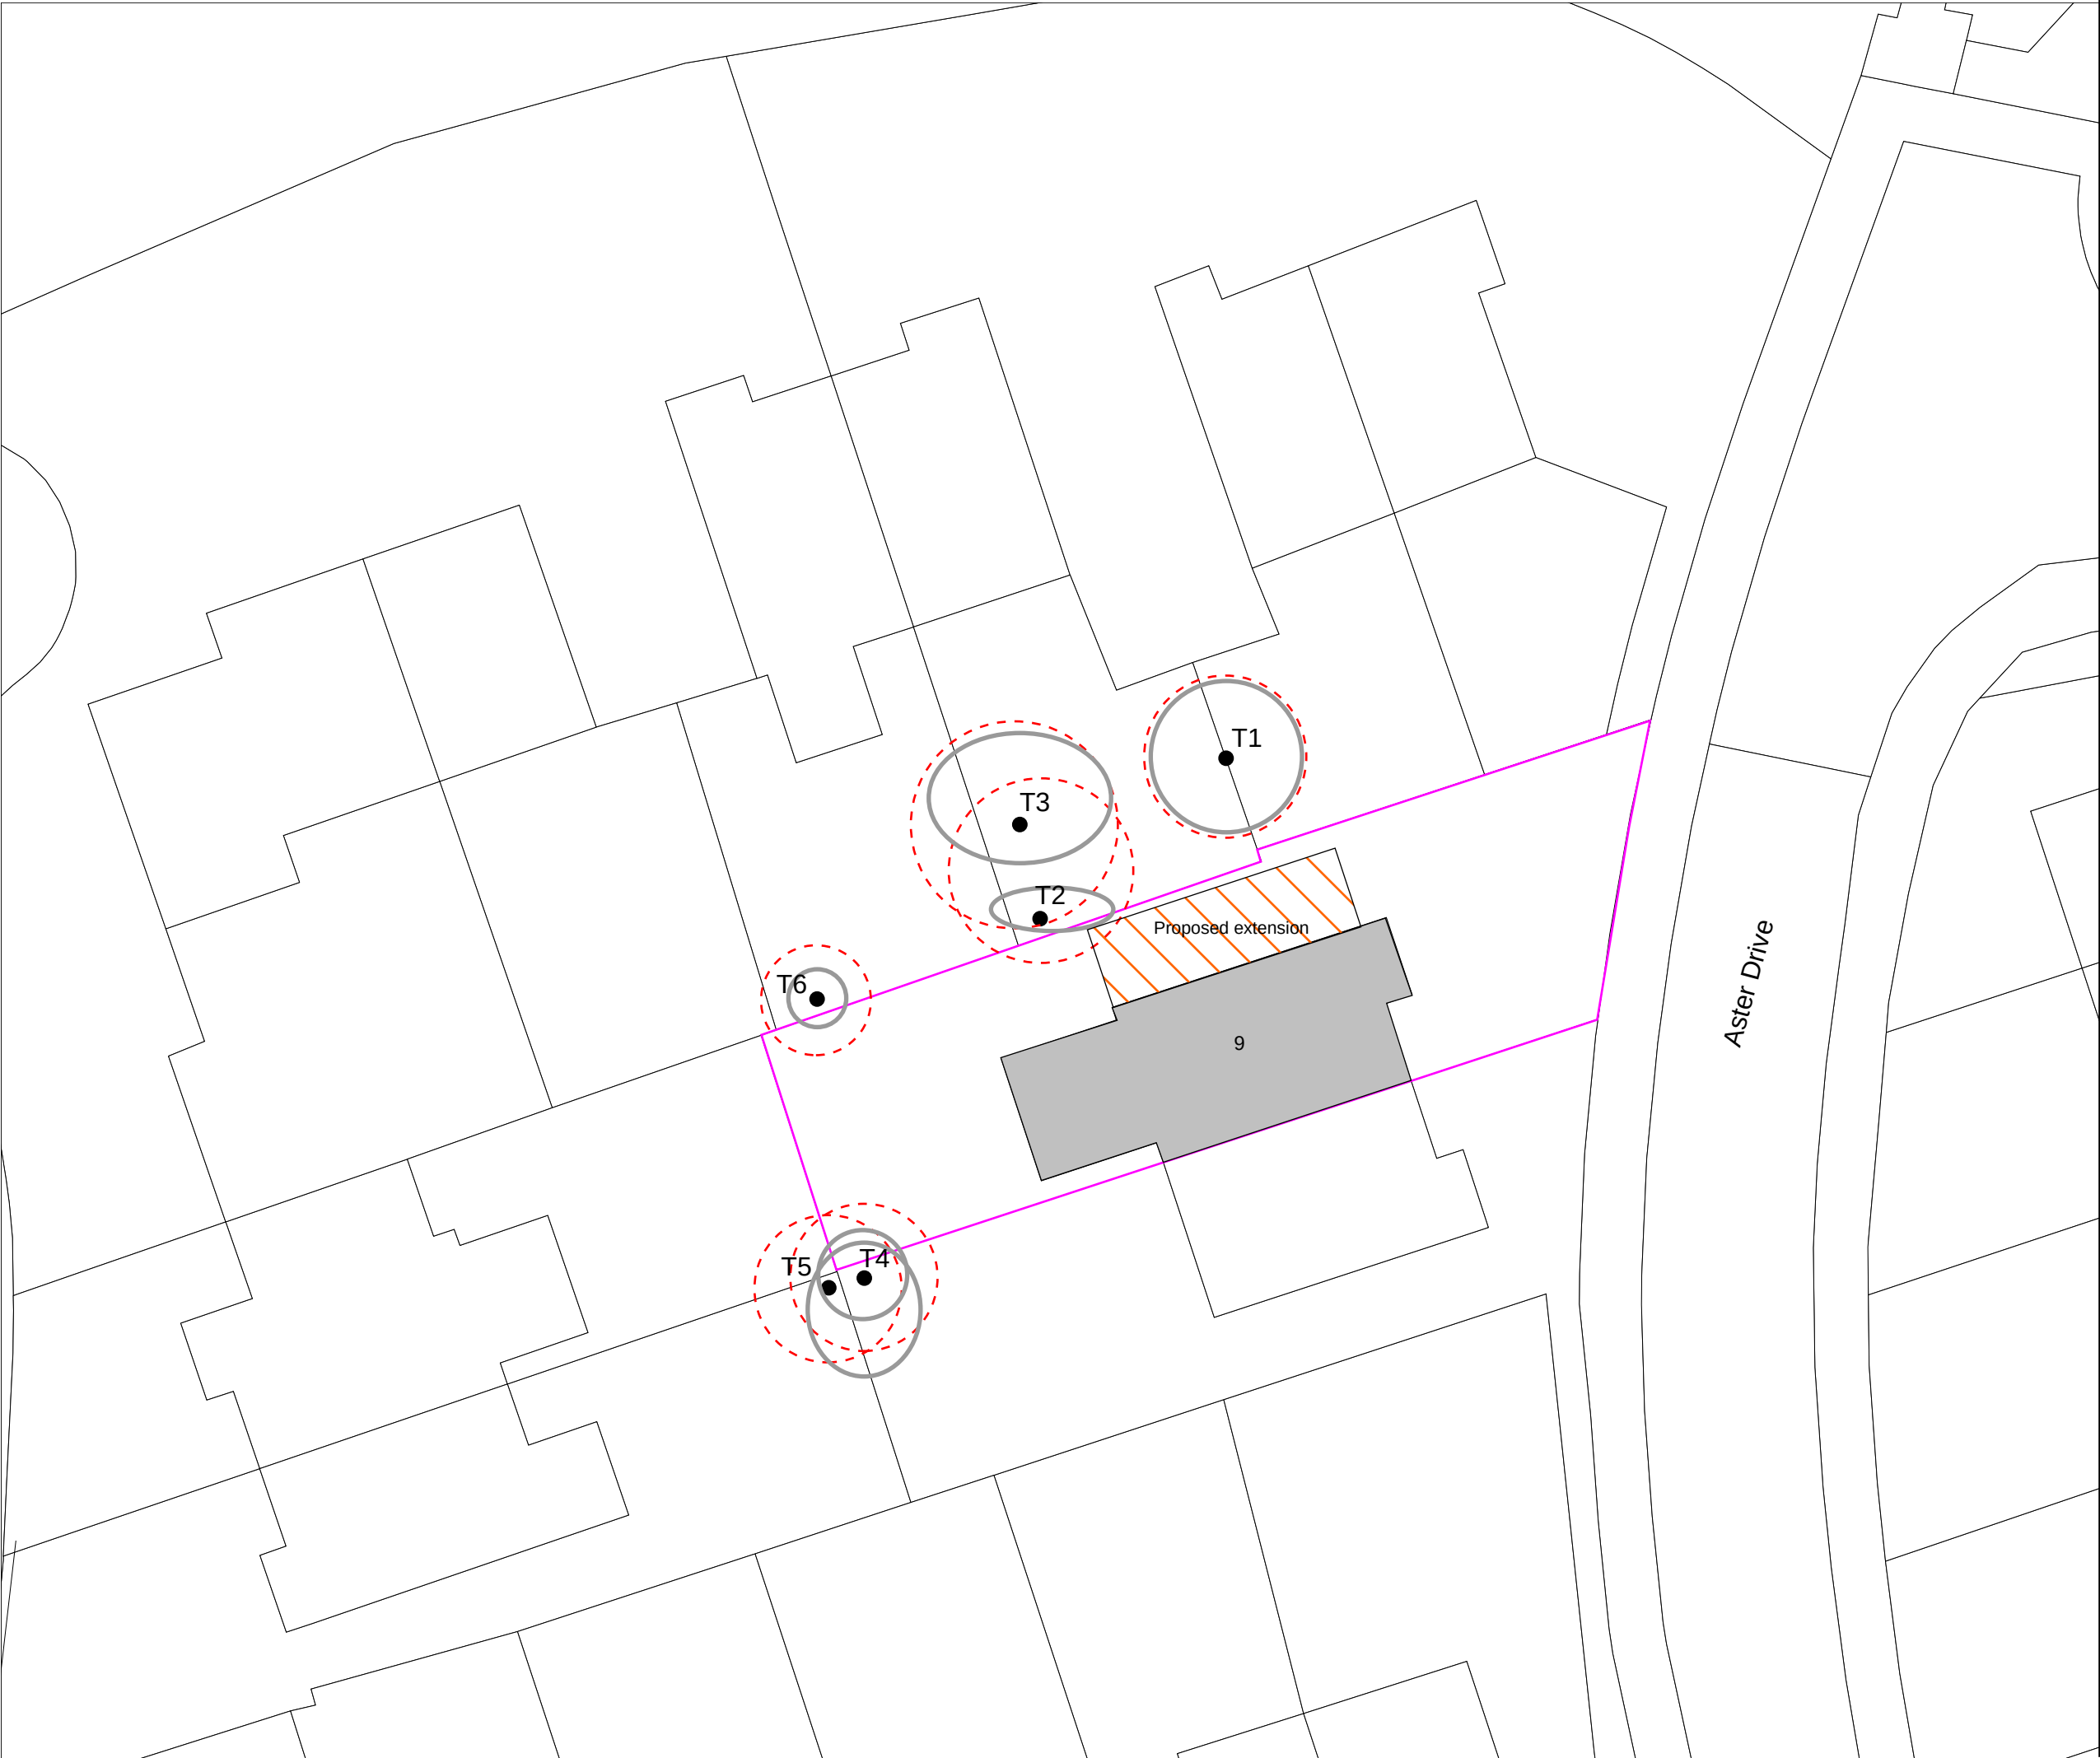
| Drawing Title:<br>AIA Plan | Drawing No:<br>21/00019/AIA | |

3.1 The site layout plan within Appendix 3.0 identifies the trees in relation to the proposed extension.

- 4.1 The tree categorisation method identifies the quality and value of the existing tree stock but it is not meant to be interpreted rigidly and is presented in order to form a balanced judgement on tree retention and removal.
- 4.2 As the scope of the proposed works and extent of the site are small-scale, it is not deemed appropriate to install tree protection fencing or ground protection measures. A precautionary method of working near trees is detailed in the accompanying Arboricultural Method Statement.
- 4.3 It is concluded that the proposed extension will not have an adverse impact on trees adjacent to the property.
