ACACIA Architects

#### PLANNING

Job: Grove Farm  
Client: Mr G. Pary  
Drawing Title: Existing Elevations  
Date: 14/09/2025  
Drawing no: 054 - 03 revision:  
Scale: 1: 100 @ A1

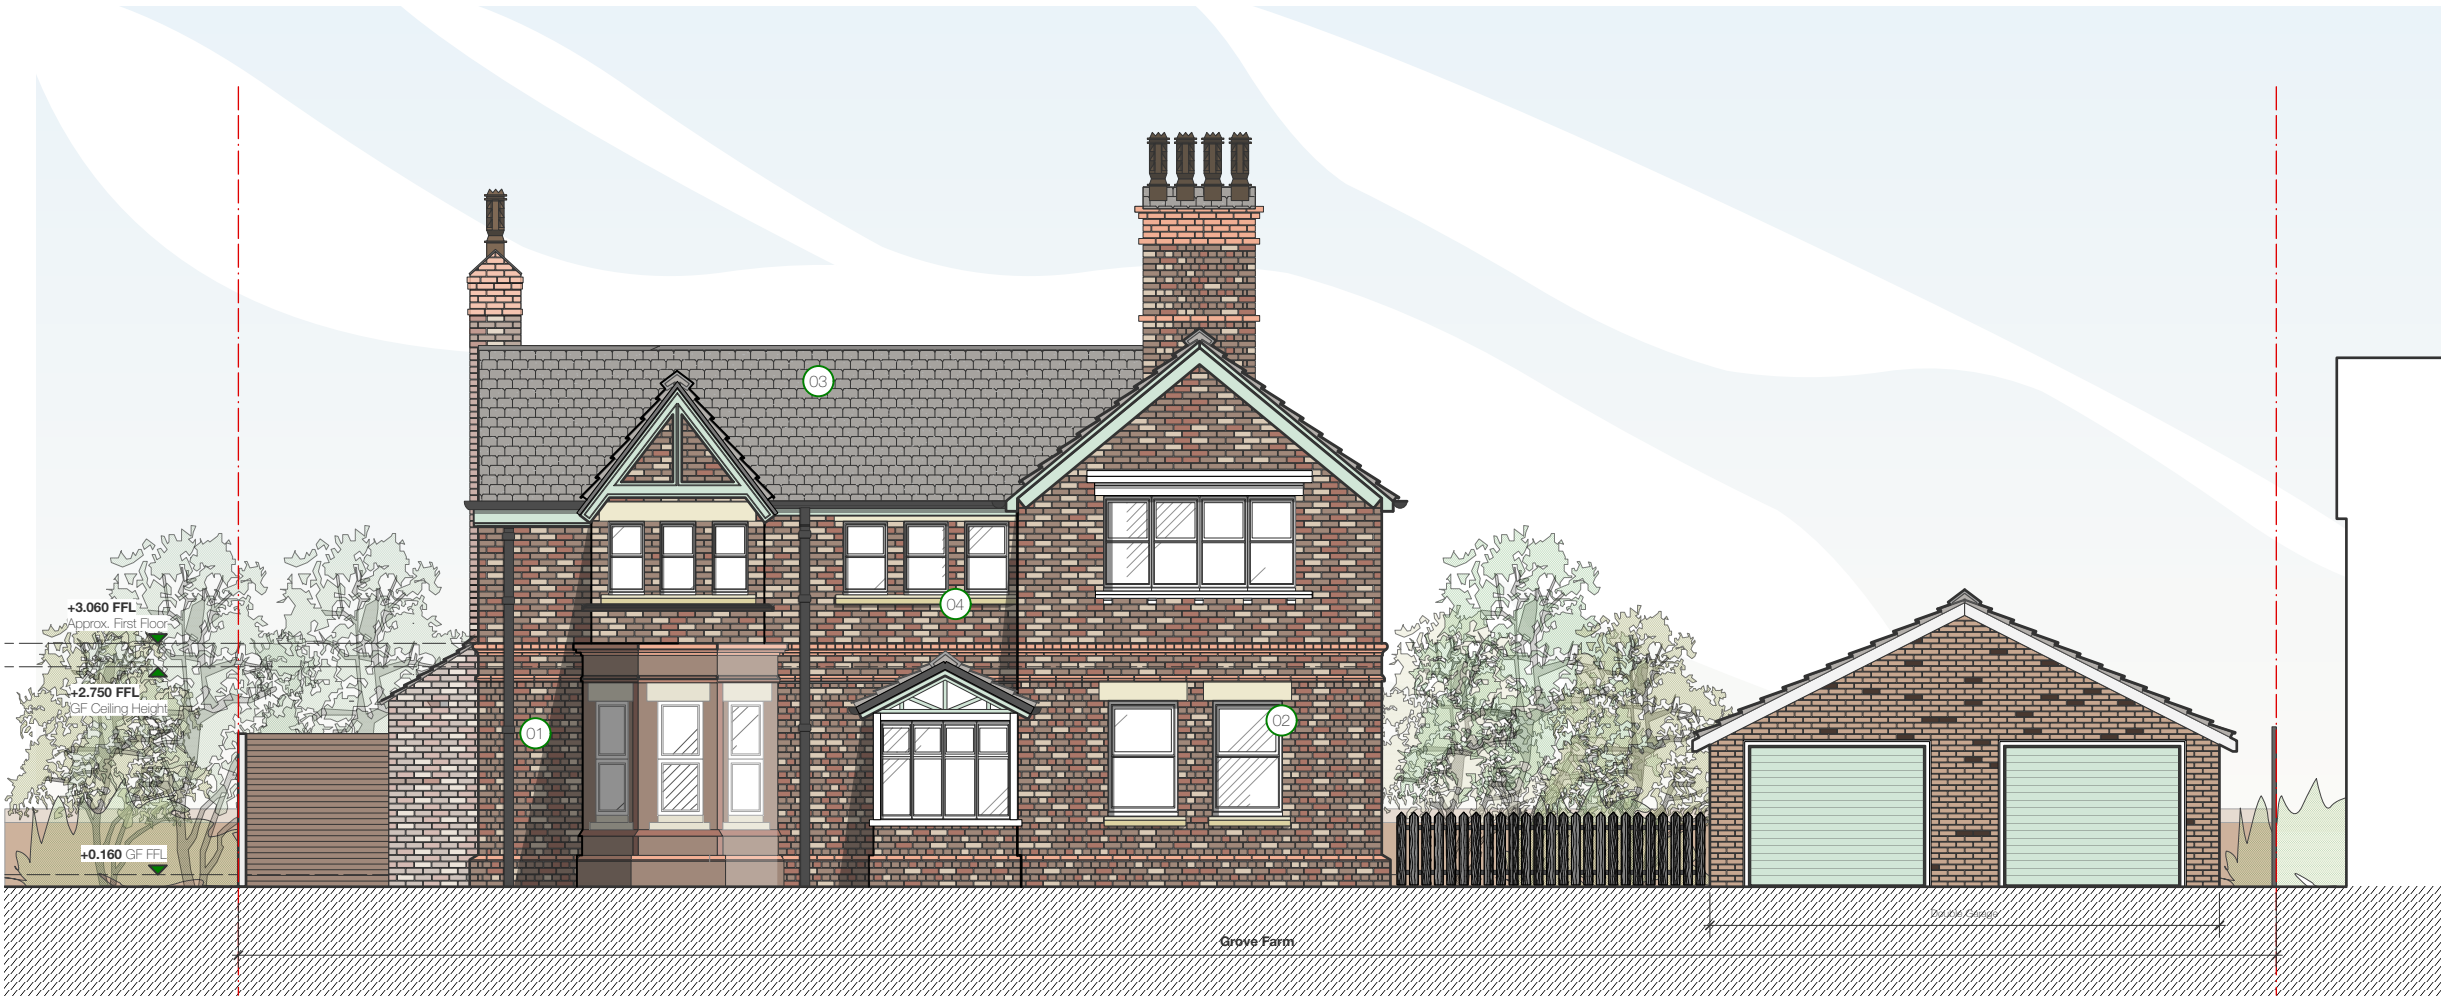
FRONT ELEVATION

1. Brickwork
2. Timber Frame Sash Window
3. Roof Tile
4. Feature Stone Head and Cill
