## Geo-Environmental Assessment

**Site 3, Image Business Park, Knowsley L33 7UF**

Issued: August 2021

Delta-Simons Project No: 19-0654.06

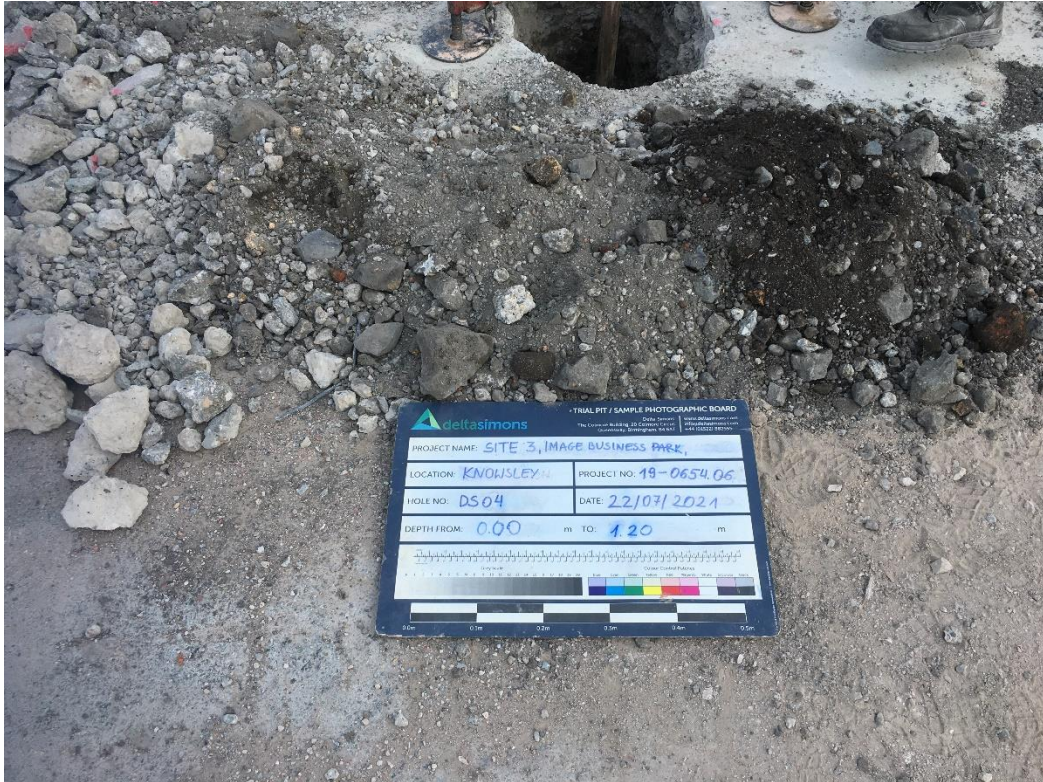
Photograph 35 – DS04 (0.00 – 1.20 m bgl)

No widespread significant visual or olfactory evidence of potential gross contamination of groundwater was observed during the investigation. A groundwater sample obtained from DS04 was noted to have an iridescent sheen and a slight hydrocarbon odour.

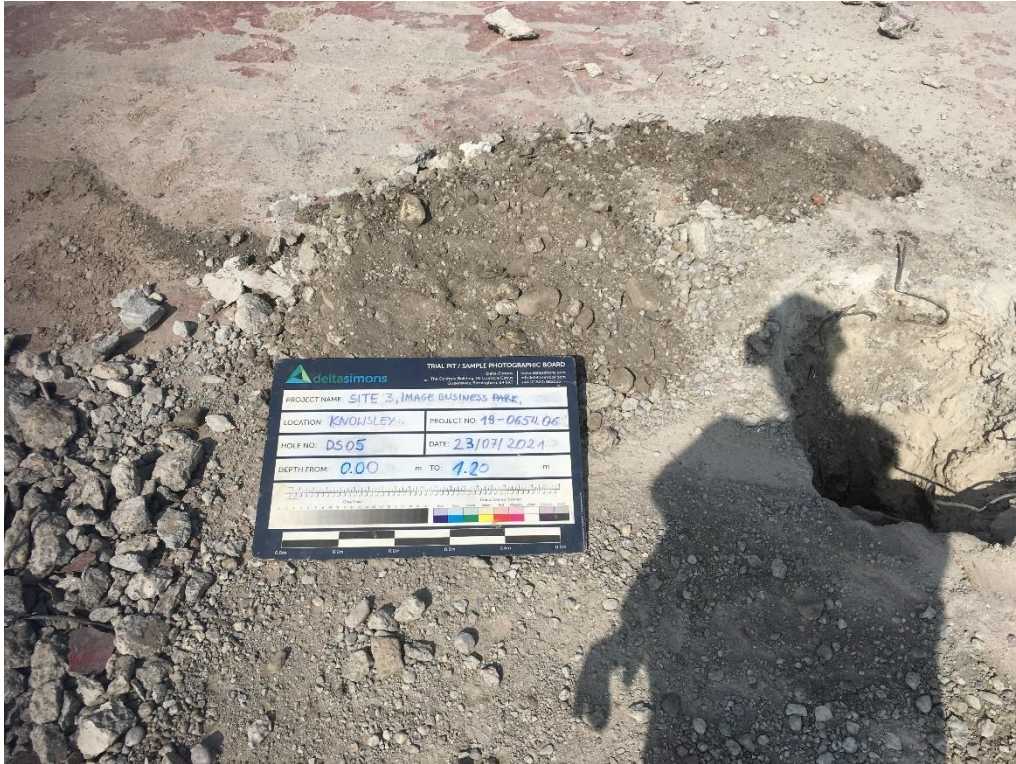
**Photograph 37 – DS05 (0.00 – 1.20 m bgl)**

- ▲ Borehole DS08 collapsed during drilling due to the presence of peat and was redrilled as location DS08A, approximately 1 m to the west.
- ▲ Boreholes DS05 and DS09 refused at relatively shallow depths (1.5 and 1.9 m bgl respectively) due to possible obstructions. A concrete obstruction was identified within borehole DS03 at 0.9 m bgl. This location was abandoned and reattempted as DS03A approximately 2 m to the west. Brick and concrete obstructions were also encountered in trial pits TP02, TP10 and TP11. As a result of these obstructions, ground conditions beneath these locations remain unknown.

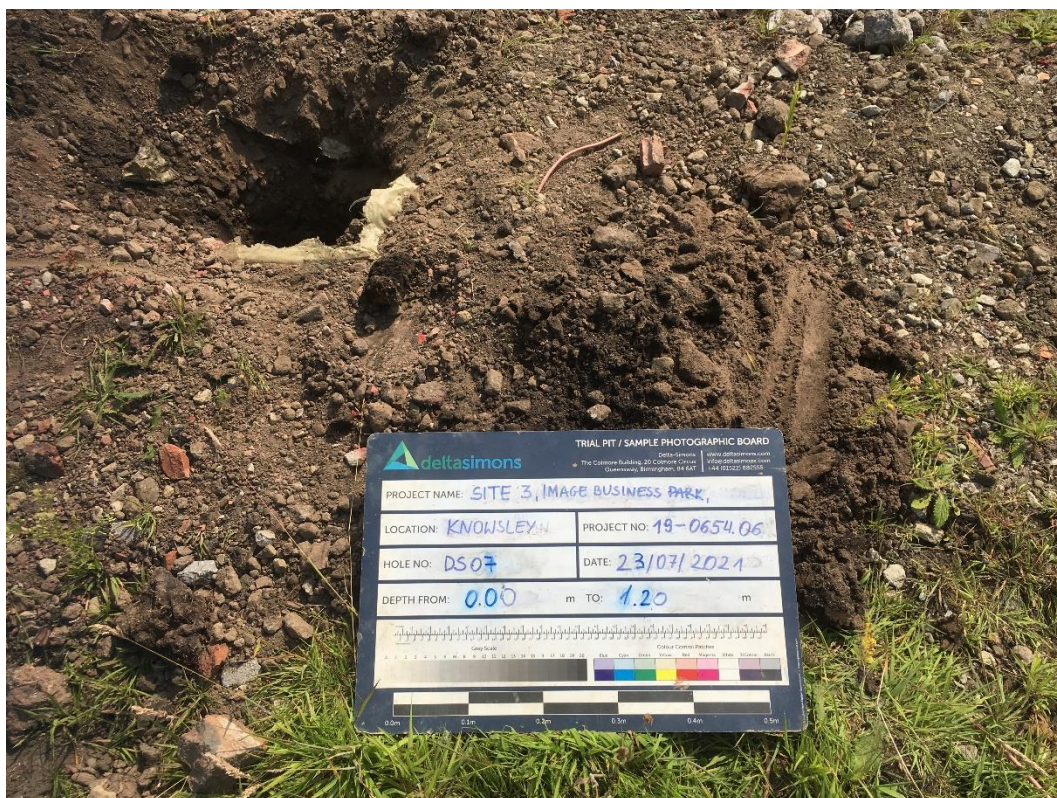
Photograph 40 – DS07 (0.00 – 1.20 m bgl)

Localised, relatively thin peat deposits were also encountered within TP06, DS07, DS08, DS10, TP12 and BH04, up to a maximum thickness of 0.5 m. Glacial Till was found to underlie these deposits and typically comprised firm becoming stiff (locally soft) slightly sandy slightly gravelly clay to depths of between 5.0 and 7.5 m bgl.

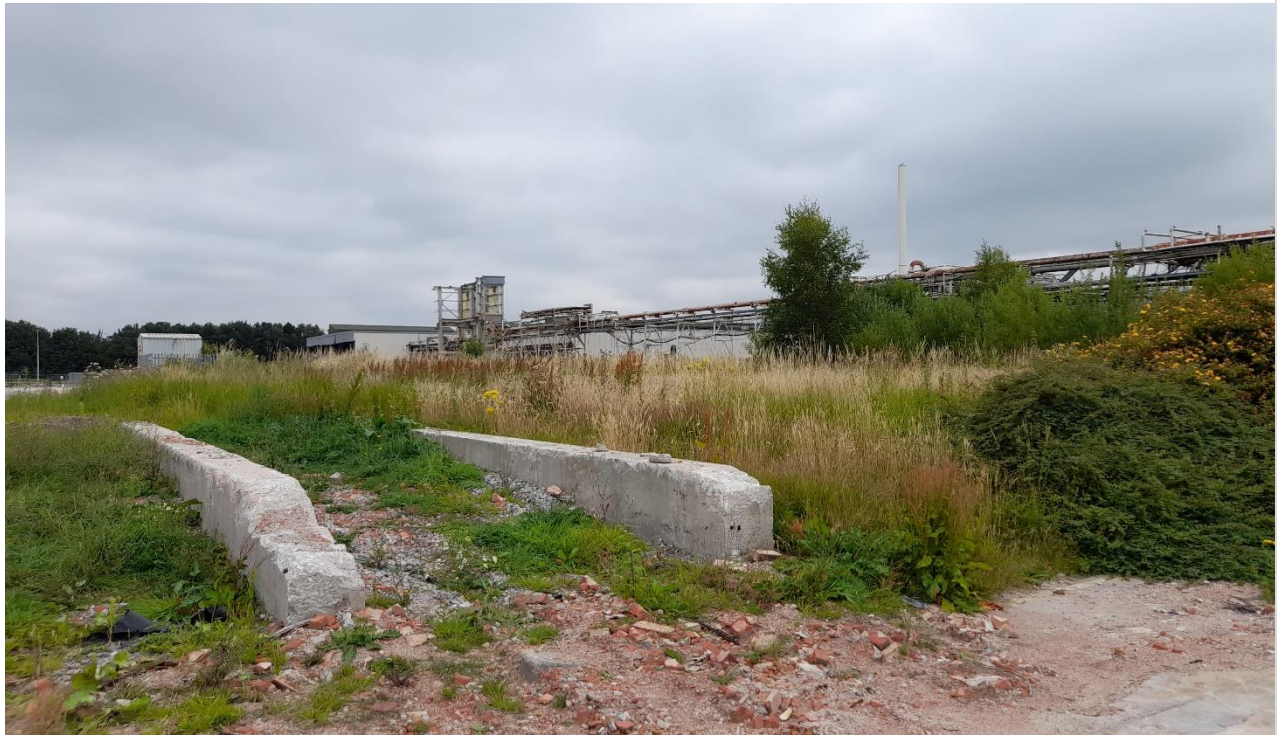
- ▲ It was not possible to investigate the central part of the Site due to the presence of dense vegetation and as such ground conditions beneath these areas remains unknown.

**Photograph 58 – Area of dense vegetation in the central western part of the Site**

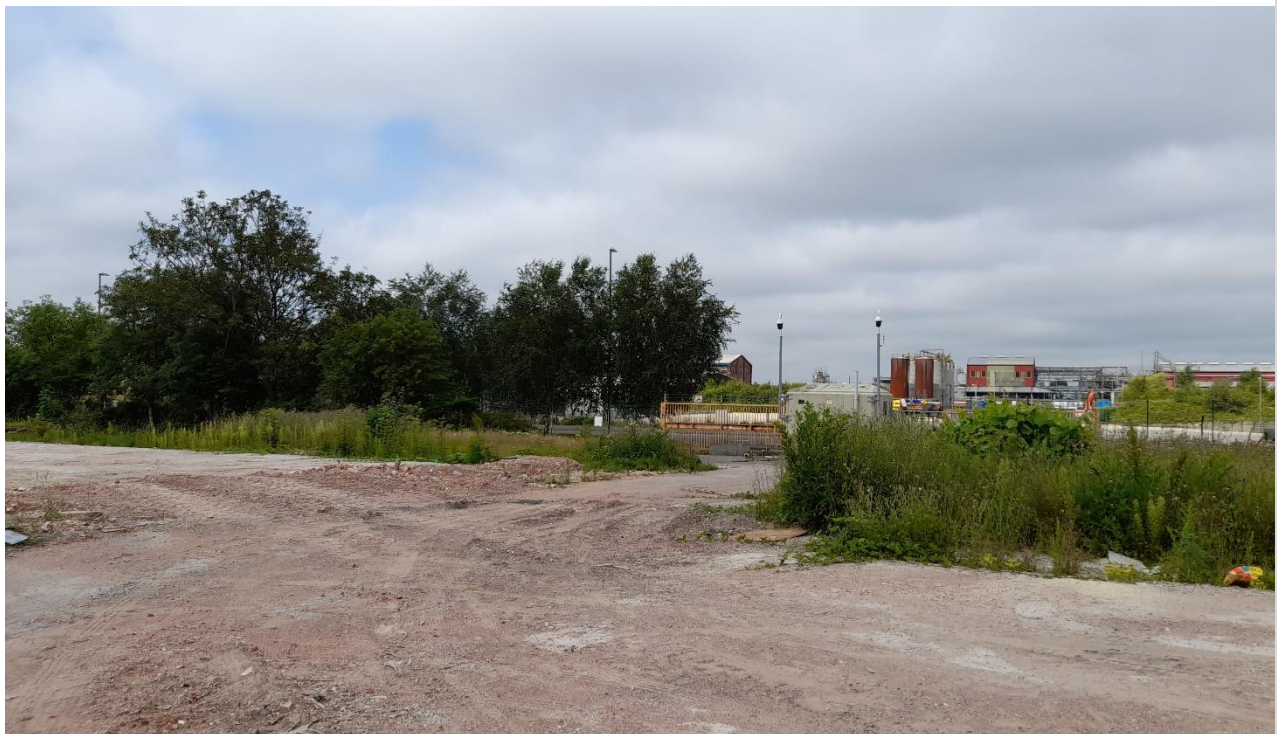
**Photograph 59 – Areas of dense vegetation in the central southern part of the Site**

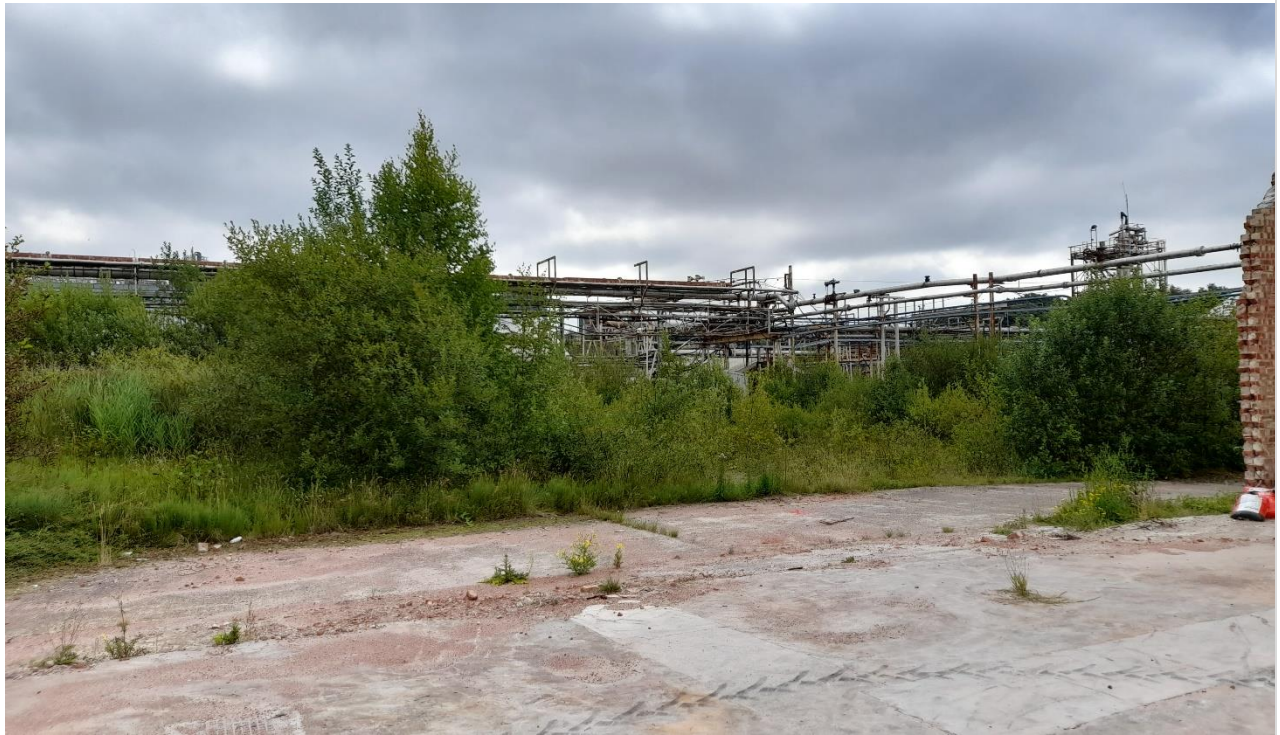
**Photograph 60 – Area of dense vegetation in the central eastern part of the Site**

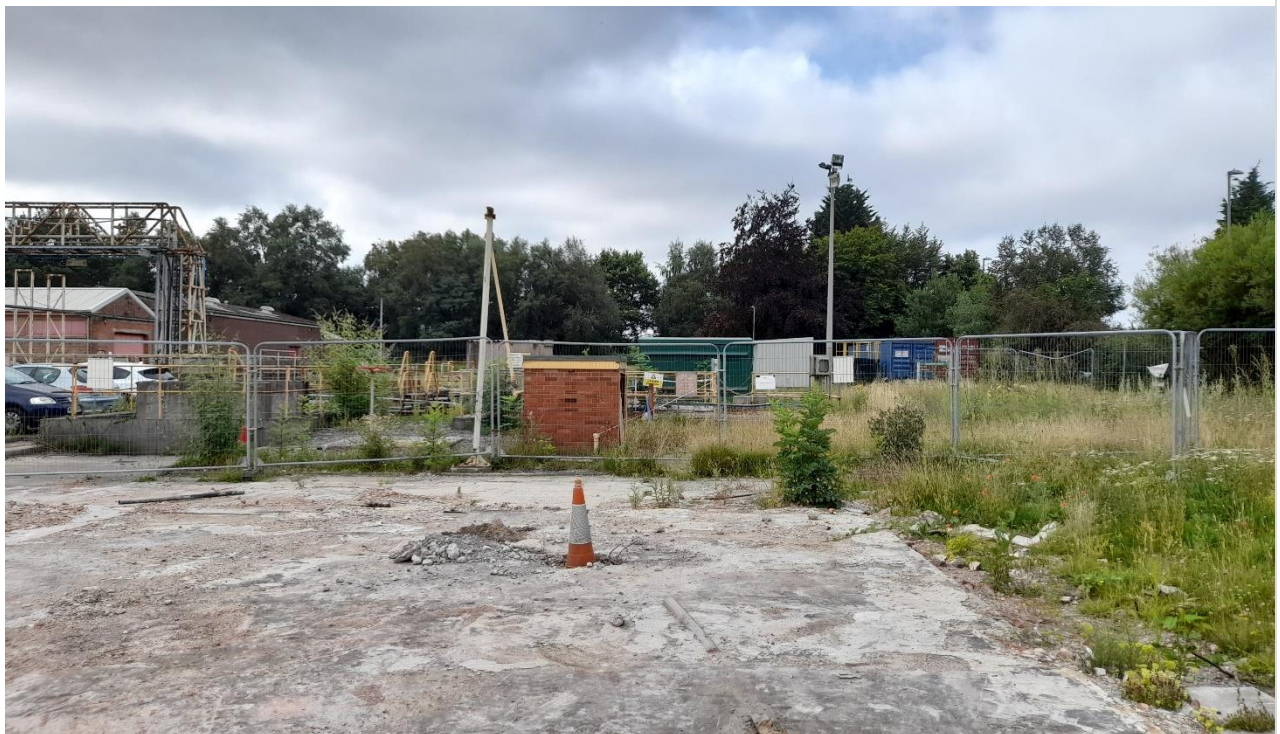
**Photograph 61 – Treatment tanks in the south-western corner (beyond fencing)**
