# PHASE I GEOENVIRONMENTAL SITE ASSESSMENT

| Site: | Wilson Road, Huyton |
| References: | 18-824-R1-1 |
| Client: | DJL Construction NW Ltd |

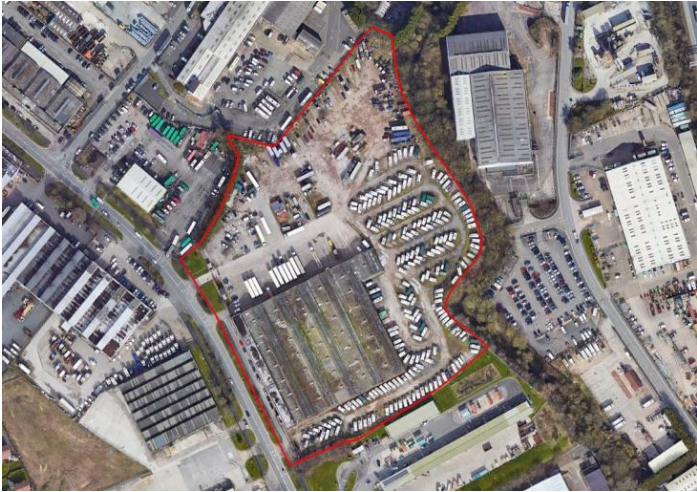
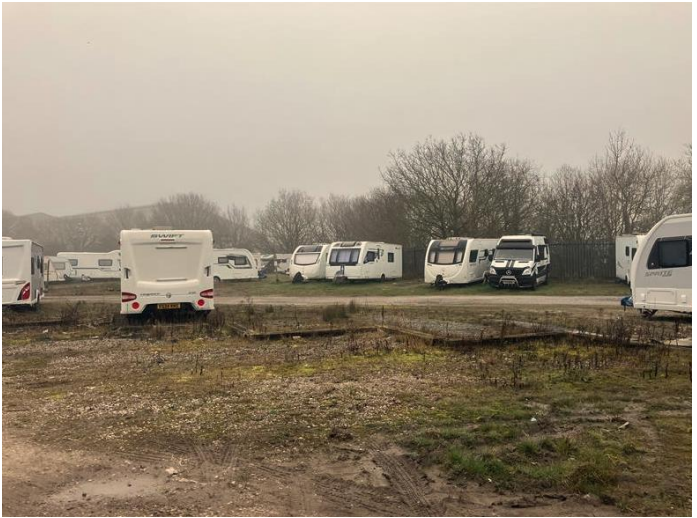
| FEATURE | DESCRIPTION | PHOTOGRAPHIC RECORD |
|---|---|---|
| Occupancy/Use | <p>The subject site is an irregular-shaped parcel of land located east of Liverpool and is currently occupied by John Mason International Movers and associated car and lorry parking.</p> <p>Site activities at John Mason International Movers include international shipping, packing, loading containers, service and collection.</p> <p>The northern area of the site is used for vehicle/HGV and equipment storage. The east and southeast of the site is currently used to store caravans.</p> | |

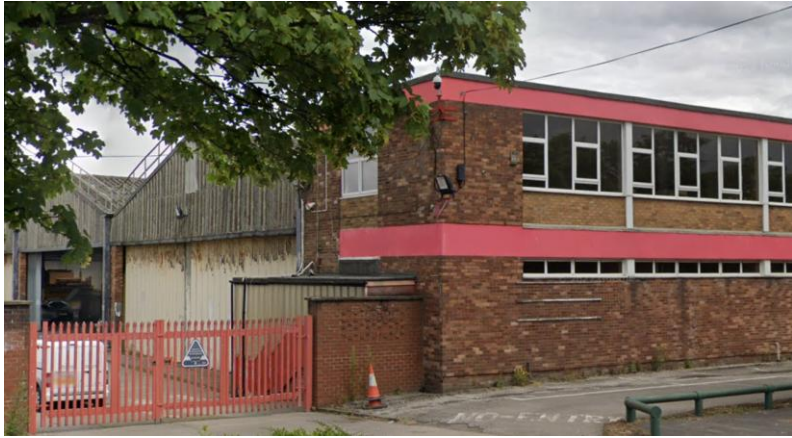
| FEATURE | DESCRIPTION | PHOTOGRAPHIC RECORD |
|---|---|---|
| Structures | <p>The site comprises a large steel-framed two-storey warehouse with a brick front along the western side of the building, situated in the south of the site. The remaining areas of the site are associated with car and lorry parking.</p> <p>An electricity substation is present in the west of the site. A further small brick building is present in the northwest.</p> | |

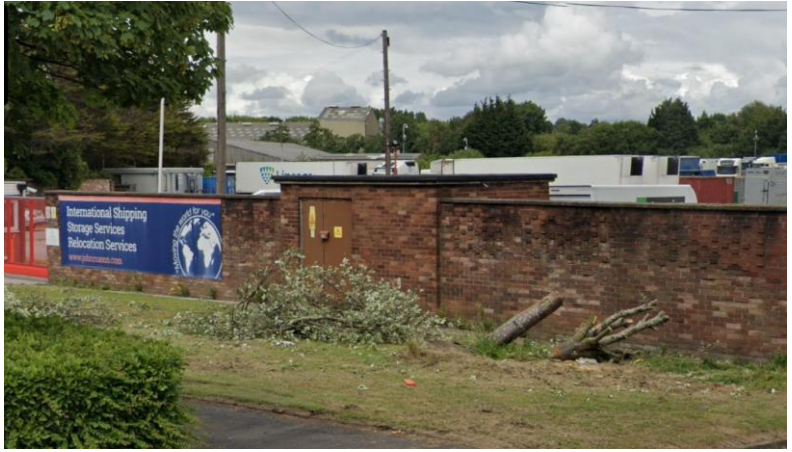
| FEATURE | DESCRIPTION | PHOTOGRAPHIC RECORD |
|---|---|---|
| Retaining Structures | <p>No retaining structures have been identified, however, there is a wall running north of the building for the remainder of the western site boundary.</p> | |

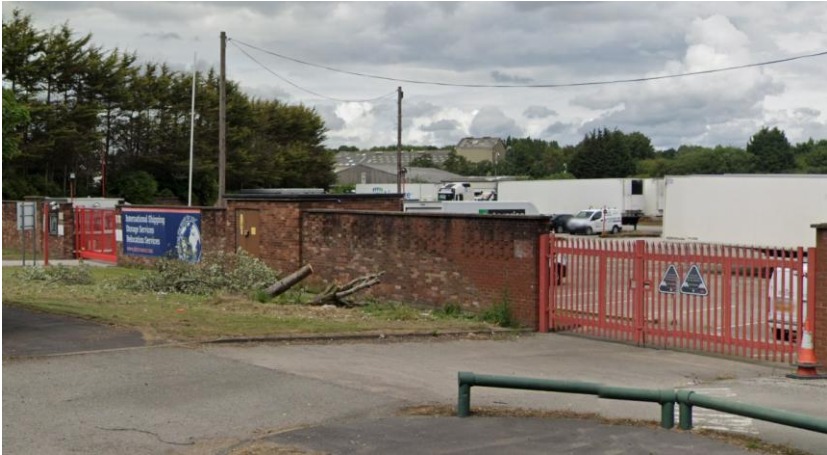
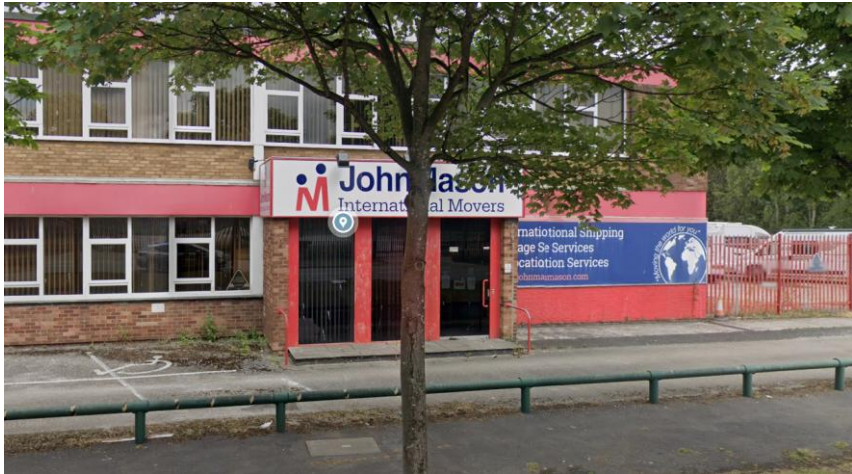
| FEATURE | DESCRIPTION | PHOTOGRAPHIC RECORD |
|---|---|---|
| <p><b>Access</b></p> | <p>Vehicle access can be gained from Wilson Road to the west of the site through double gates to the southwest corner of the building, to the northwest corner of the building and northwest site boundary.</p> <p>Pedestrian access can be gained off Wilson Road to the main entrance of the building located to the southwestern corner of the building and through a door in the wall to the west of the site.</p> | |

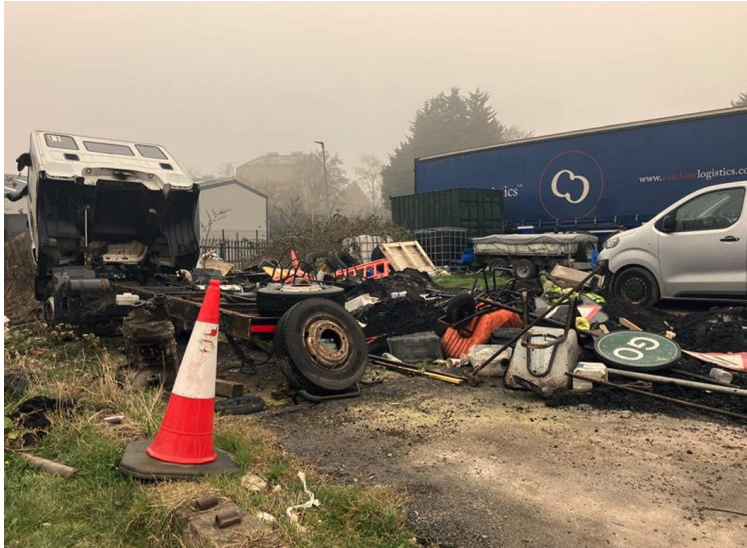
| FEATURE | DESCRIPTION | PHOTOGRAPHIC RECORD |
|---|---|---|
| <p><b>Waste Storage</b></p> | <p>Areas of the site appear to be rented out to organisations for material storage. Areas of waste material storage were noted.</p> | |

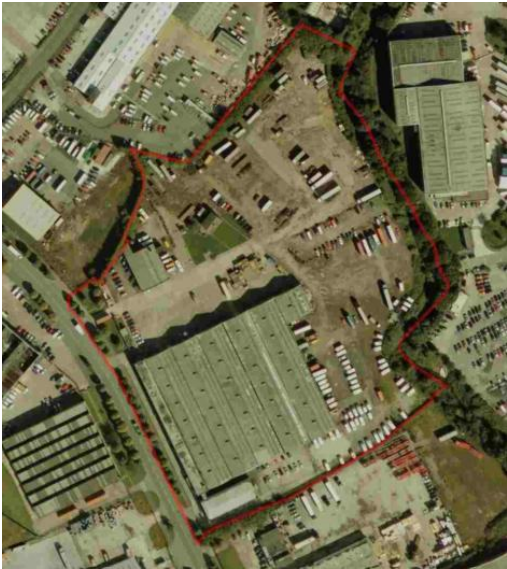
| MAP EDITION | DISCUSSION | MAP EXCERPT |
|---|---|---|
| <p>2005<br/>Google<br/>Imagery</p> | <p>The small structure to the southeast of the building is no longer present.</p> | |

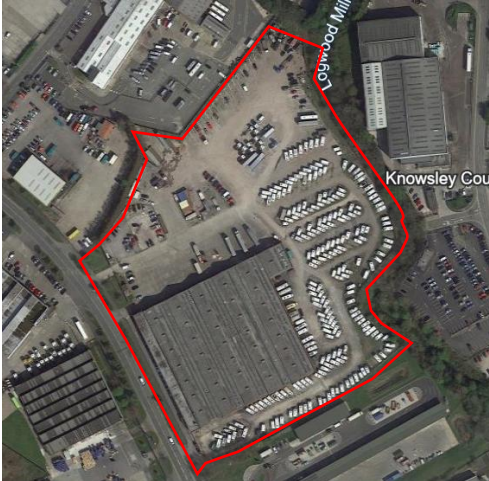
| MAP EDITION | DISCUSSION | MAP EXCERPT |
|---|---|---|
| <p>2015<br/>Google<br/>Imagery</p> | <p>The remaining structure to the south of the main warehouse is no longer present.</p> <p>The buildings in the north are no longer recorded.</p> | |

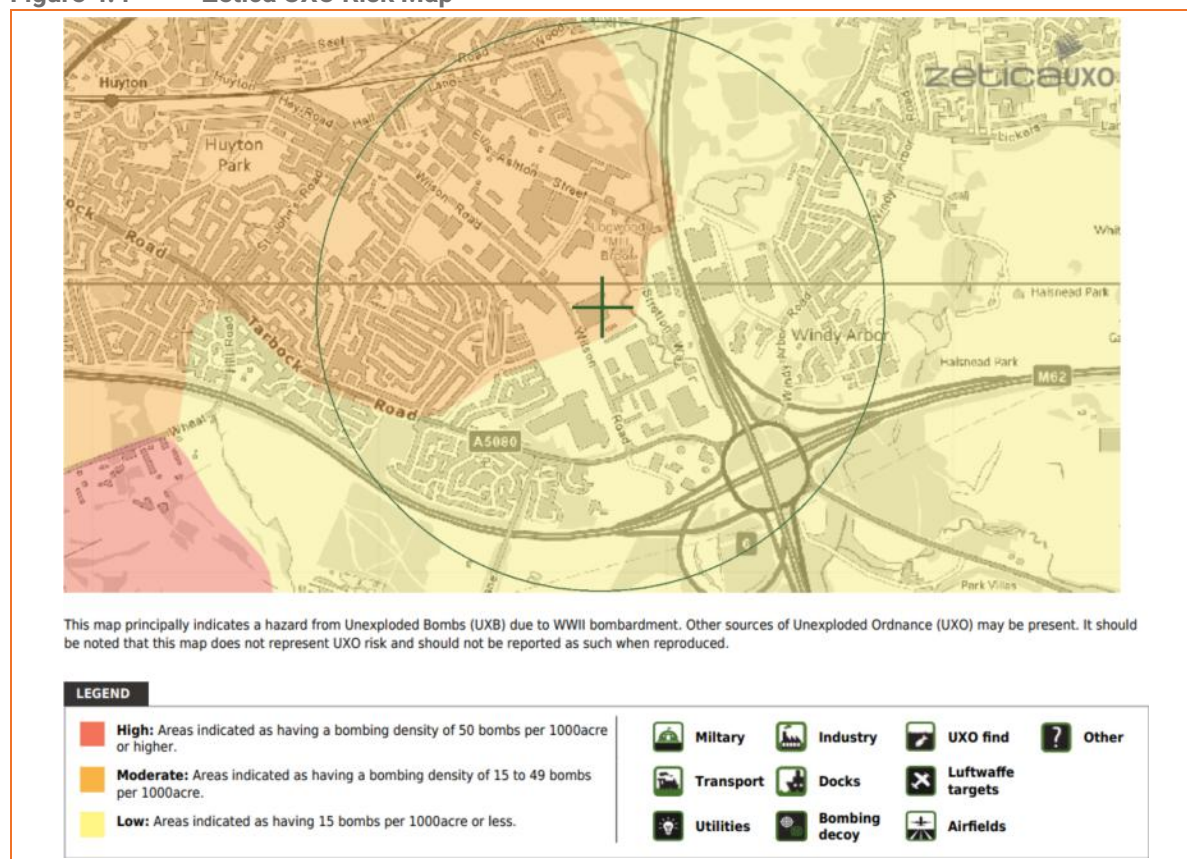
Figure 4.4 Zetica UXO Risk Map

Brimstone have completed a Stage 1 Preliminary UXO Risk Assessment (Ref: PRA-26-3004, dated 03/03/2026). The assessment indicates that there is no evidence of bomb damage occurring on site, however a Lancashire bomb plot records one incident of an unexploded AA shell at Huyton Quarry 600 m north of the site and it is possible that an unexploded British AA shell struck the site during WW2 and any such UXO could have penetrated the ground on site to shallow depths and remain in situ. The report suggests that further investigation and a Stage 2 Detailed Risk Assessment is not required. However, a UXO Safety Briefing is prudent to all personnel conducting groundworks. The PRA can be found attached in Appendix VII.

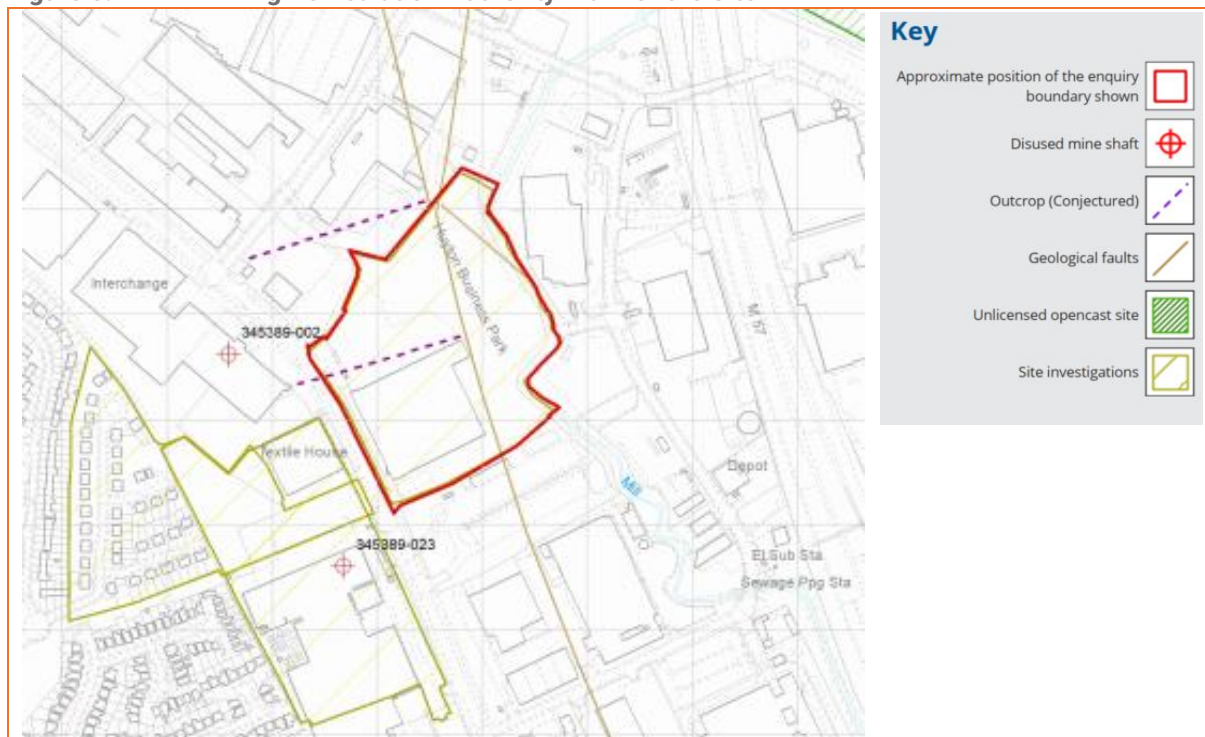
Figure 5.2 Mining Remediation Authority Plan for the Site

The Mining Remediation Authority plan referenced: MR-LARGE-PLOT-E3P-5QP-DSB-NUM-9JS shows the two faults within the site boundary and the coal sub-crop as illustrated in Figure 5.2.

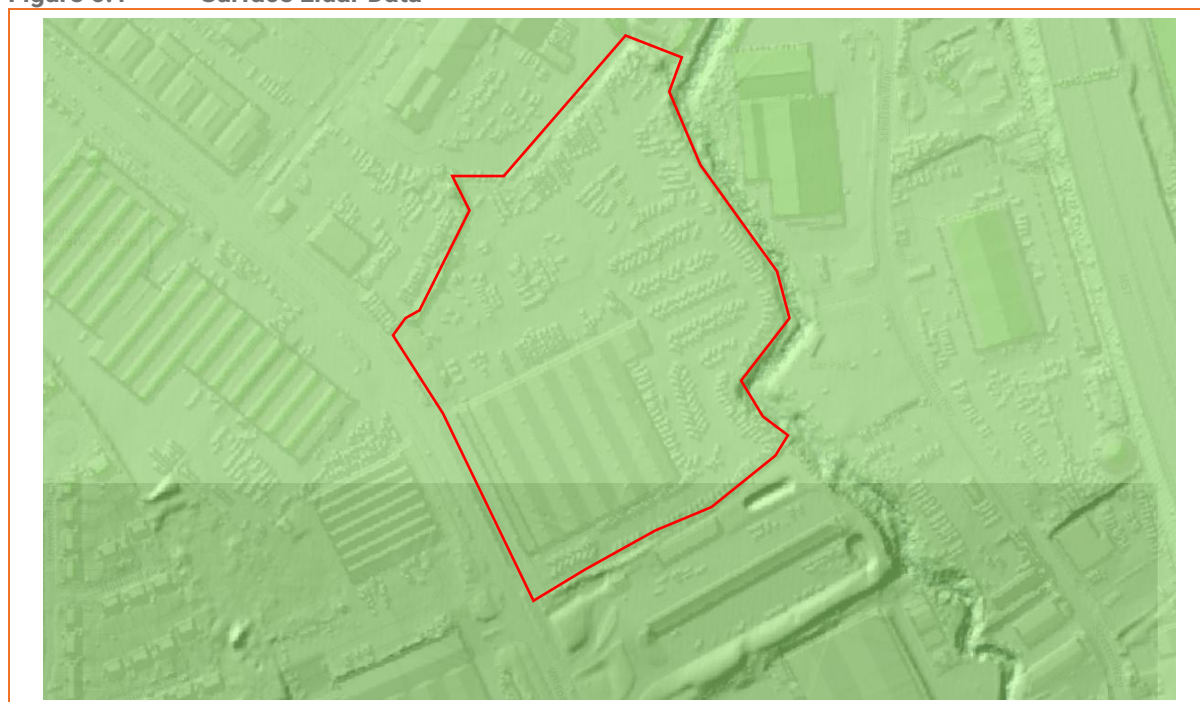
**Figure 6.1** Surface Lidar Data

It is likely that the site was historically levelled to form the current level development platform.
