## PHASE 2

# GEO-ENVIRONMENTAL REPORT

| job number | C3304/23/E/5028 | date | 07/08/23 |
| site address | Land off Fallows Way,<br>Whiston,<br>Prescott. | | |

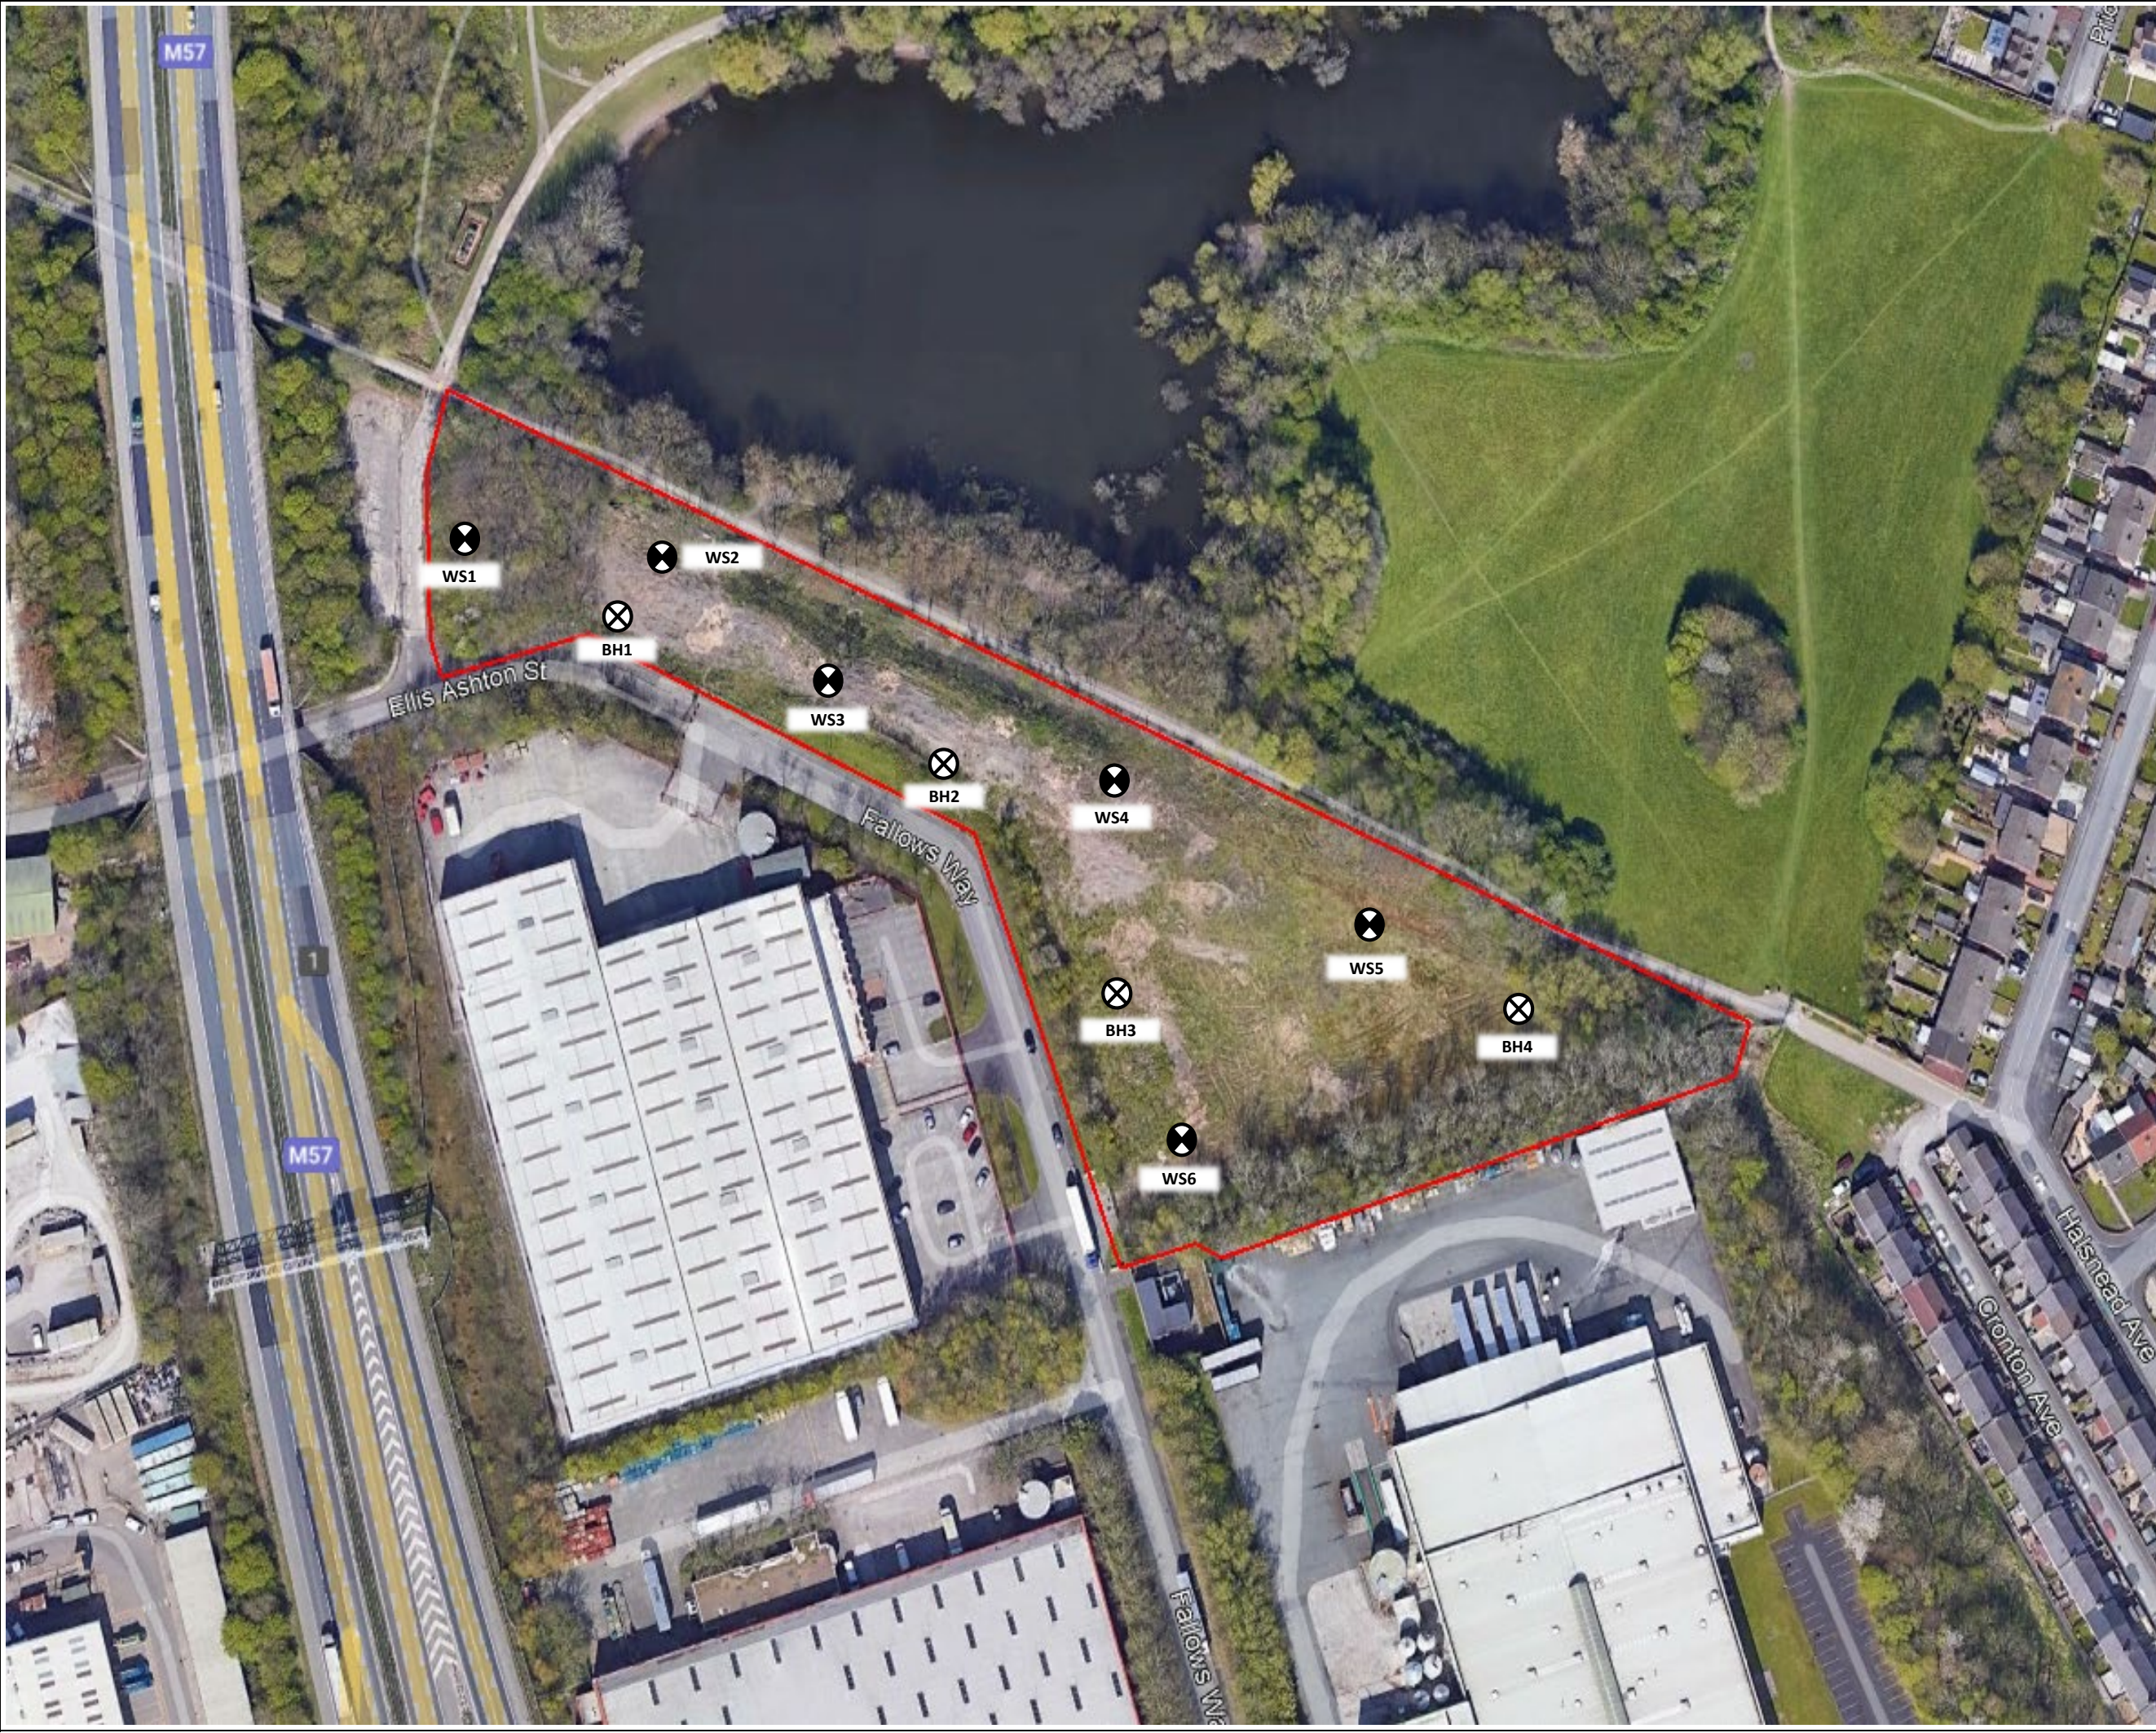
### Site Plan & Coal Authority License

**Notes:**  
Investigation positions approximated from site operative's notes.
