**CCG-C-23-14178**

**GROUND INVESTIGATION AT**

**HUYTON TOWN CENTRE**

**FACTUAL REPORT**

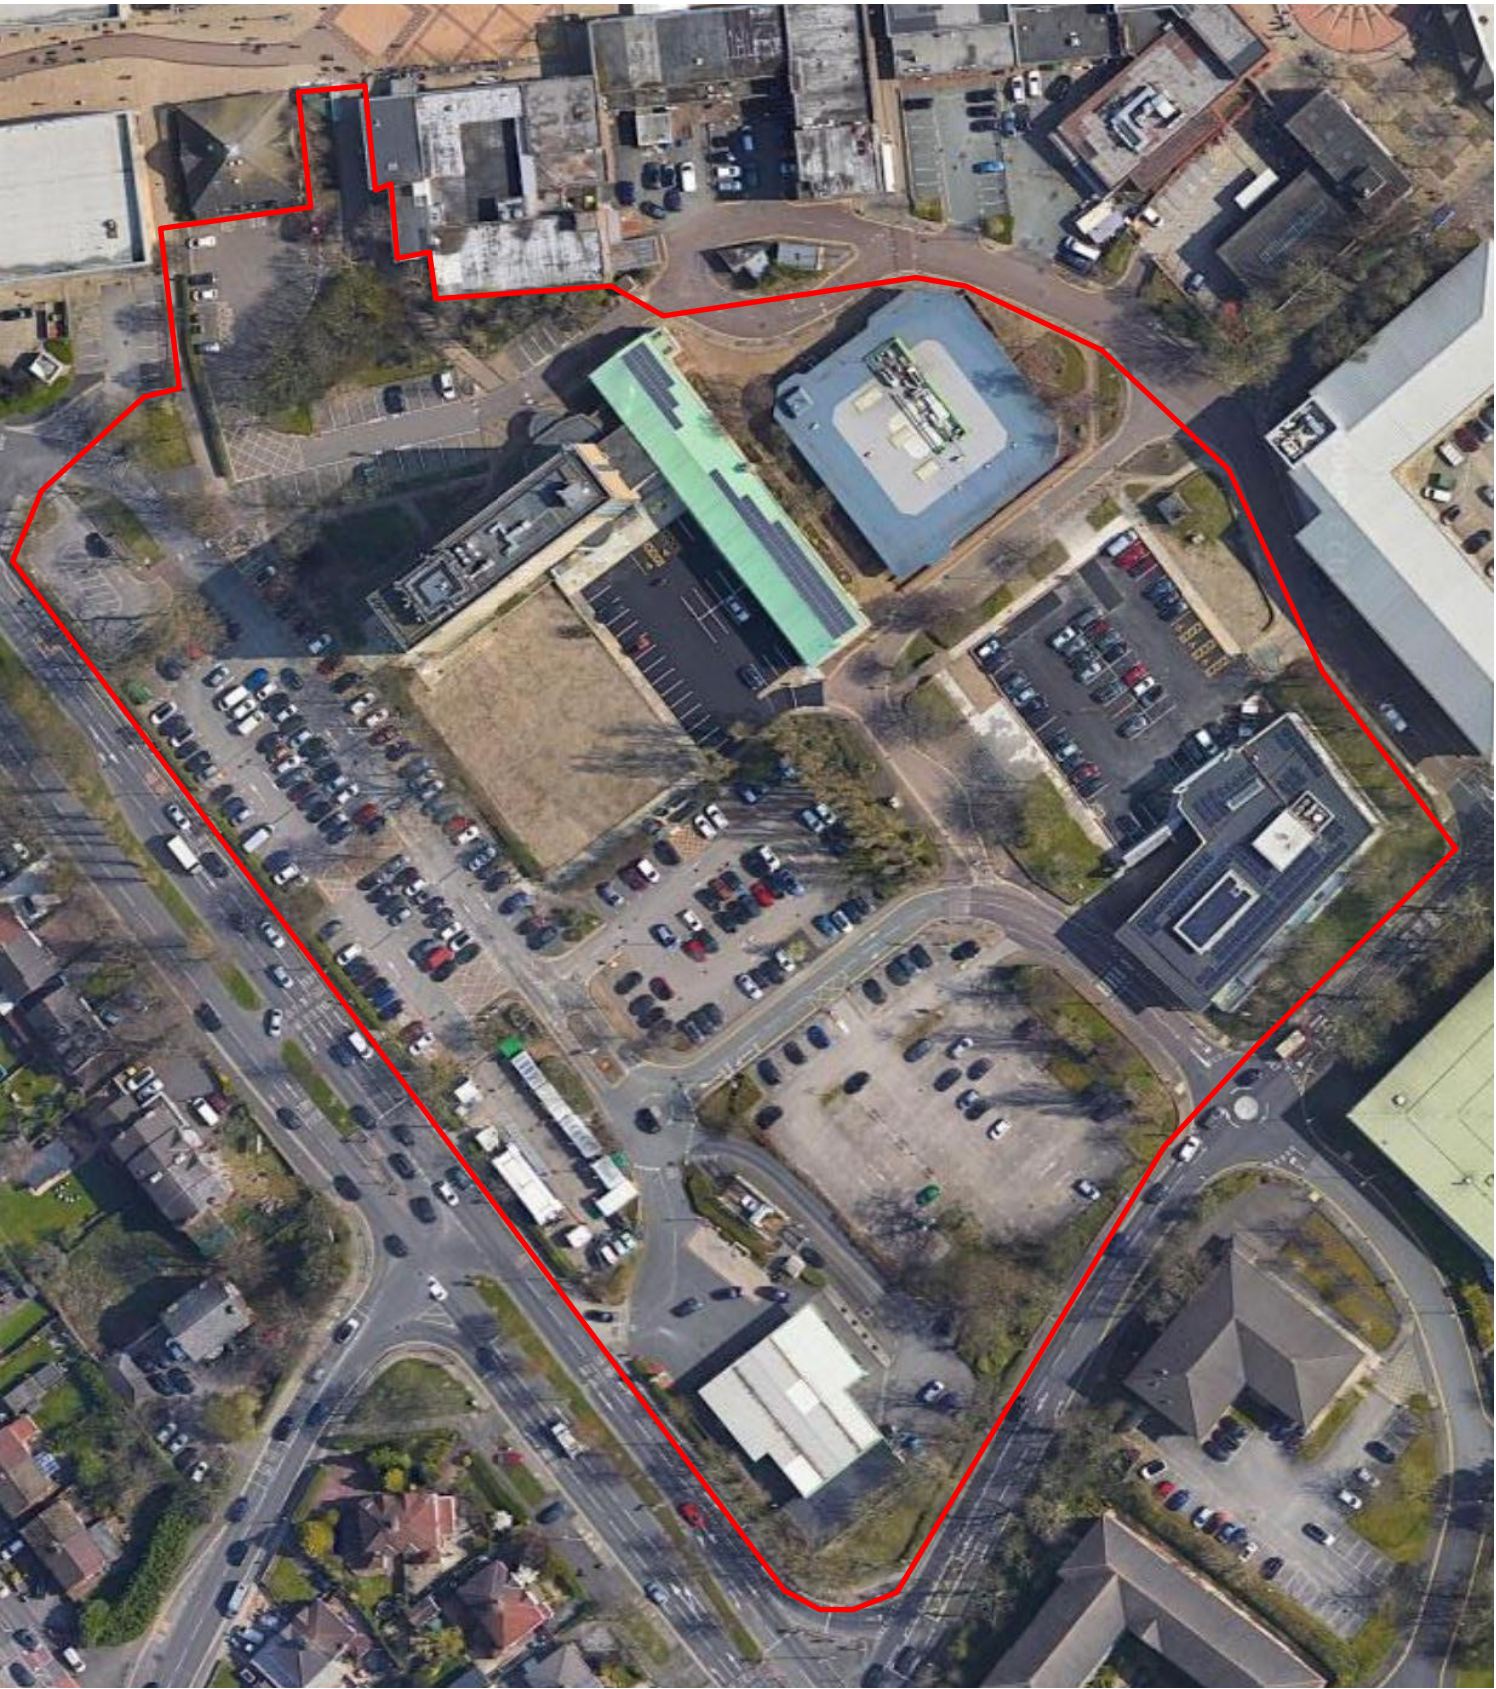
- CABLE PERCUSSION BOREHOLE
- DYNAMIC SAMPLING BOREHOLE
- DYNAMIC SAMPLING BOREHOLE & DYNAMIC CONE PENETROMETER TEST
- FOUNDATION INSPECTION PIT
- TRIAL PIT EXCAVATION
