Project St Michael's Place

Subject Phase I Preliminary Risk Assessment Cover Pages

Ref 051610-BHE-XX-XX-RP-GE-0001

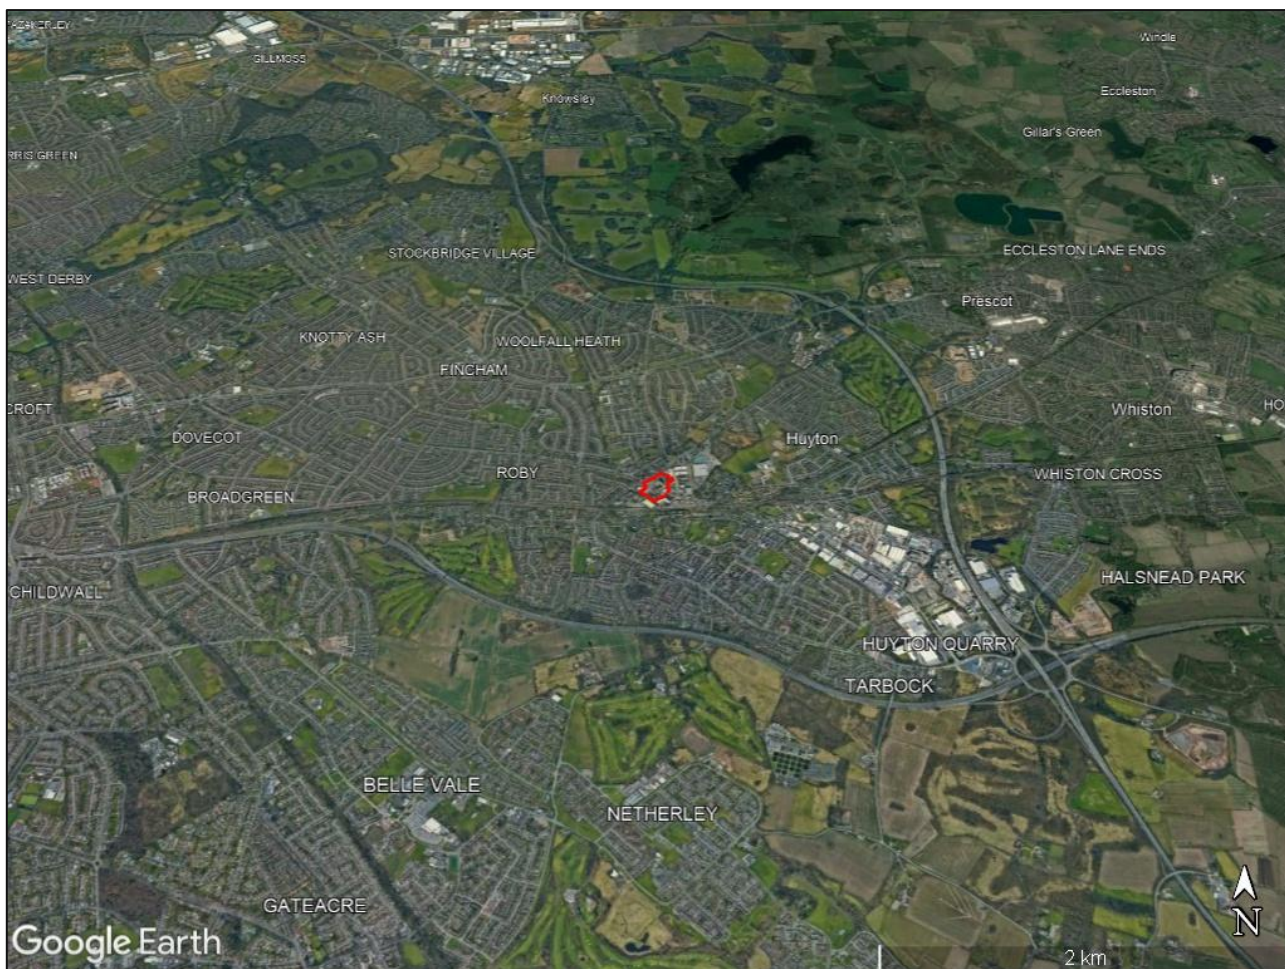
Figure 1—1: Site location plan. Source: Google Earth.

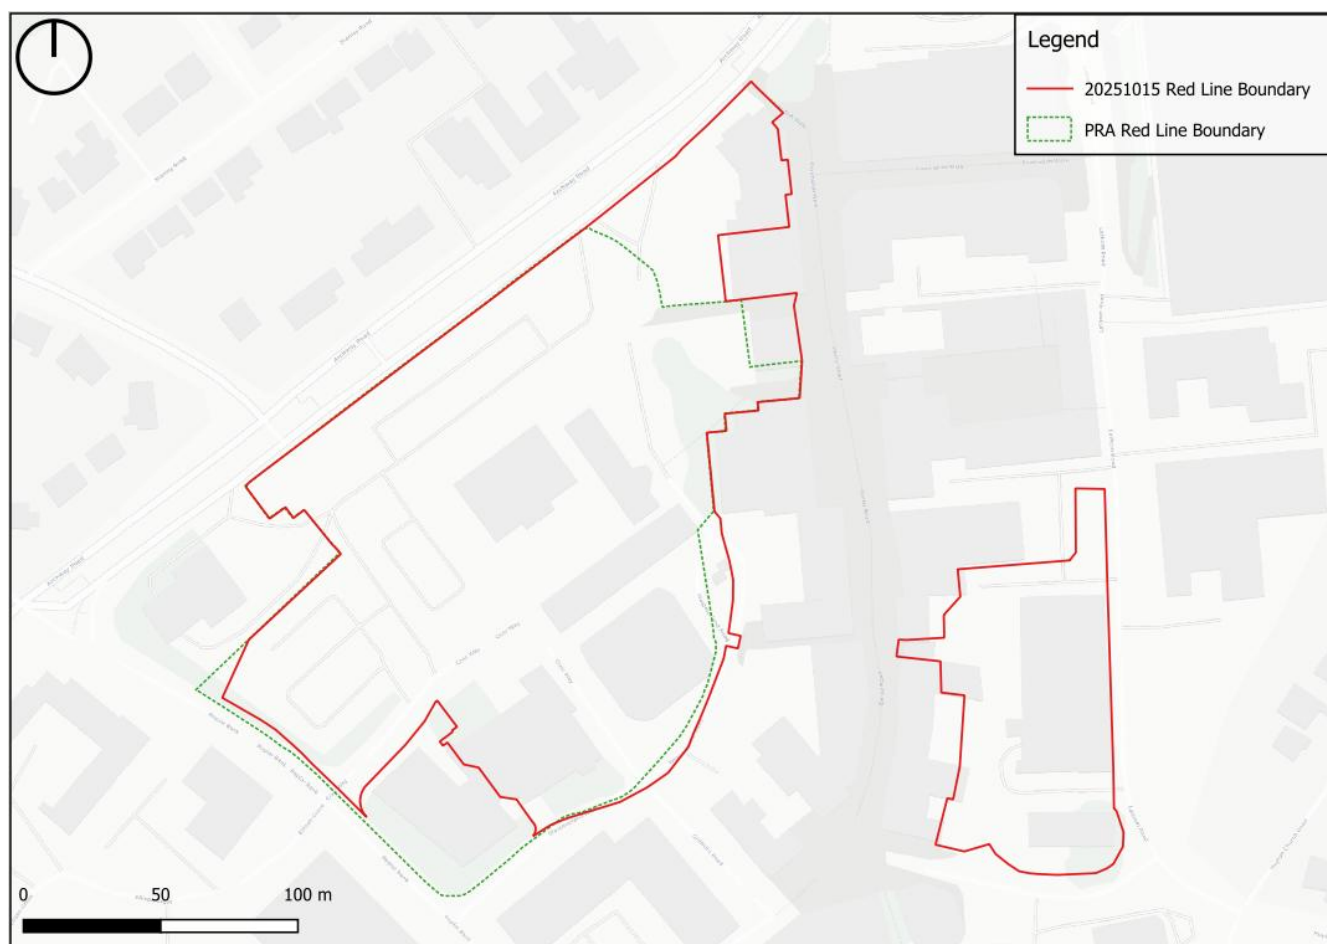
Figure 1—4: Comparison between current red line boundary and red line boundary in the Envirocheck report (green).

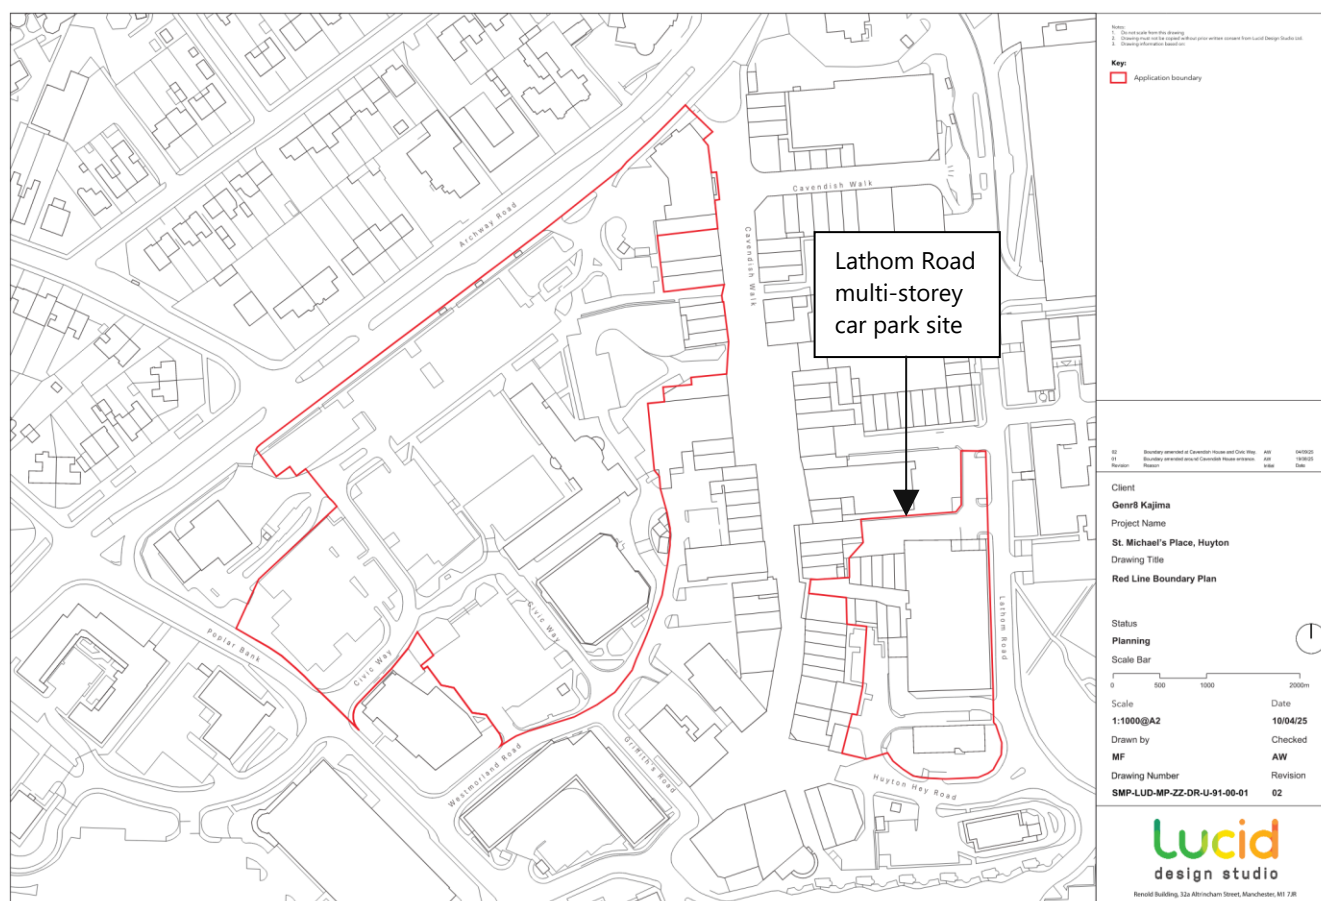
Figure 2—1: Red line boundary. Source: Lucid Design Studio, 15<sup>th</sup> October 2025.

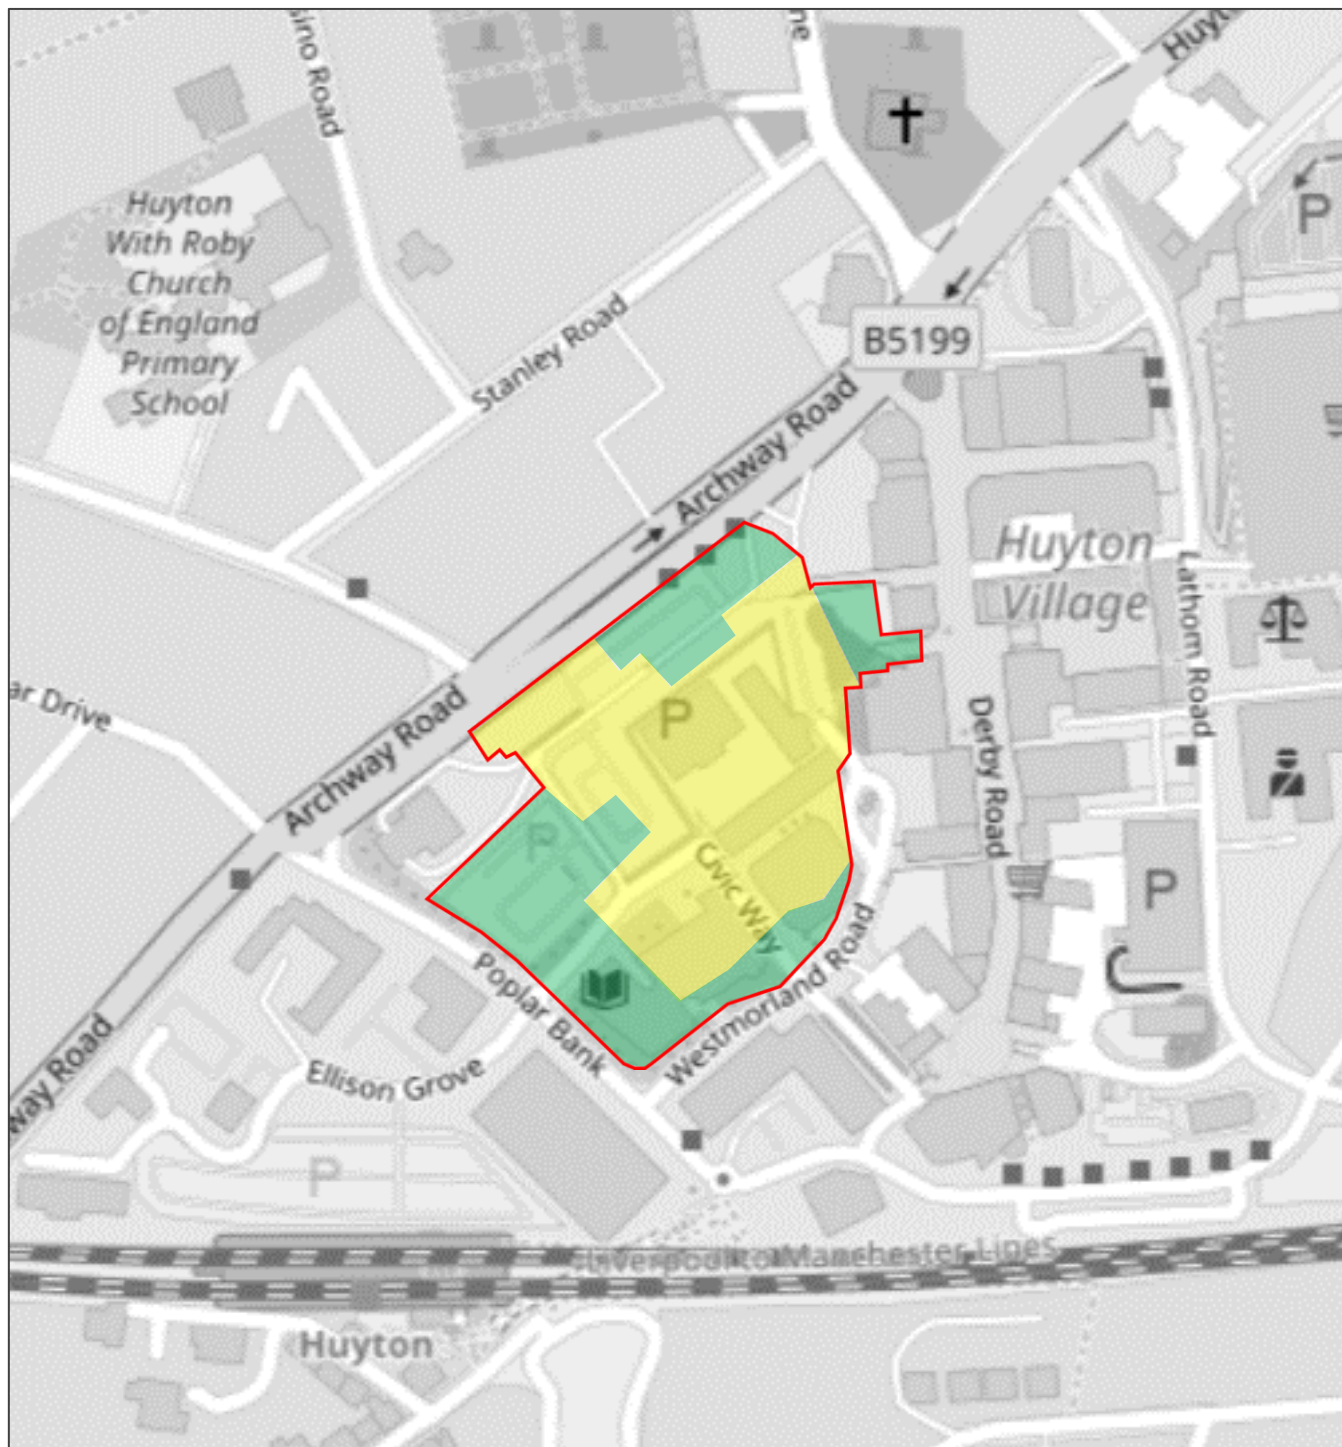
RISK MAP:

LOW risk from German UXBs and HAA shells

LOW-MODERATE risk from German UXBs and HAA shells

- In light of the abovementioned factors, the risk of encountering UXO on Site has been assessed to vary. Within locations of undamaged wartime structures, where wartime conditions are considered to be conducive to the obvious detection of UXBs, and adjacent well-kept garden areas, the risk has been assessed as **Low**. However, given the concentration of incidents in the wider study area, as the centre of the Site consisted of undeveloped ground, wherein conditions present could have feasibly resulted in a UXB strike falling unnoticed i.e. overgrown vegetation, a **Low-Moderate** risk of encountering UXO has been assessed. A 15m J-curve buffer has been included in the **Low-Moderate** zone.
