# Phase 2 Ground Investigation

Client: Lidl Great Britain  
Ltd

Telegraph Way, Kirkby

Report No: 1373.02.01

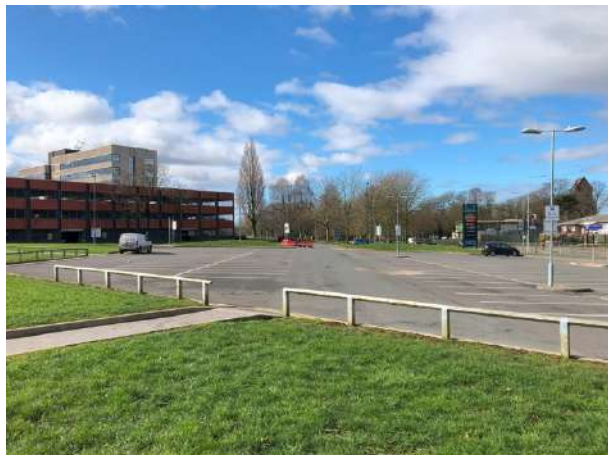
**Photo 1:** A view of the site towards the south-west with Telegraph Way in the distance.

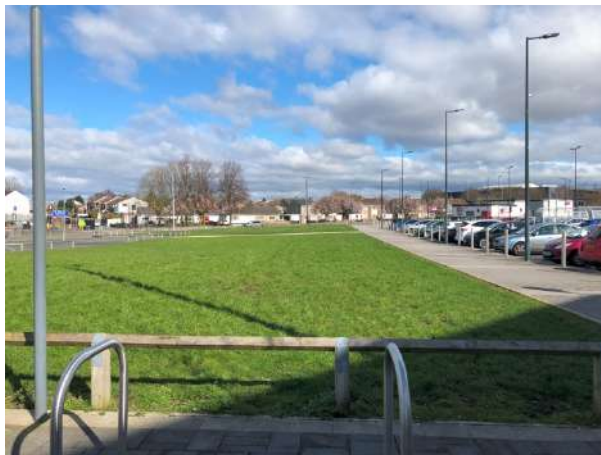
**Photo 2:** A view towards the north-east with areas of soft landscaping and the car park associated with Kirkby Retail Park to the right.

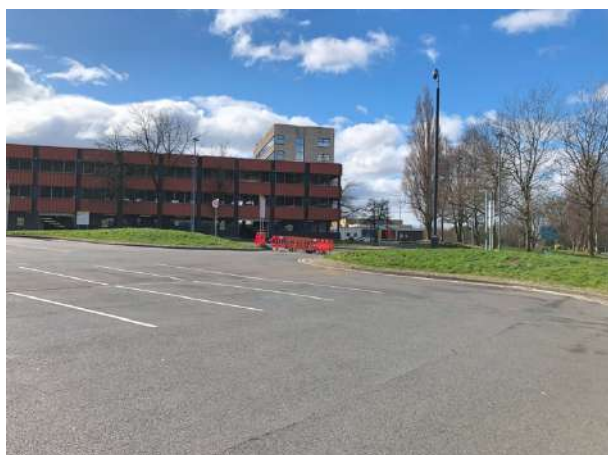
**Photo 3:** The western portion of the site showing the site access with two shallow bunds.

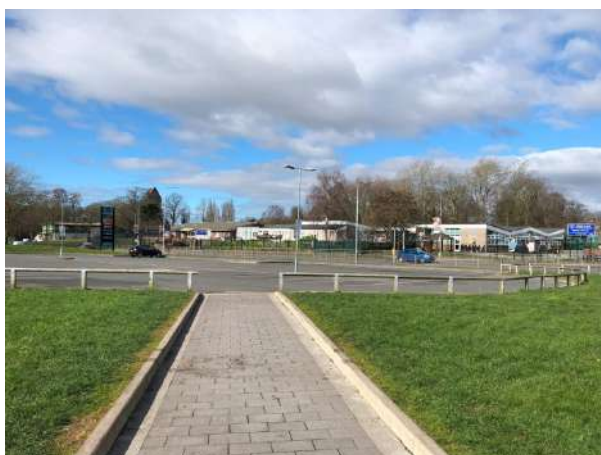
**Photo 4:** A view westwards, showing the car park, soft landscaping and footpath towards Kirkby Retail Park.
