# Preliminary Bat Roost Assessment Report

12 Church Street, Prescott

## Preliminary Bat Roost Assessment Report – 12 Church Street, Prescott

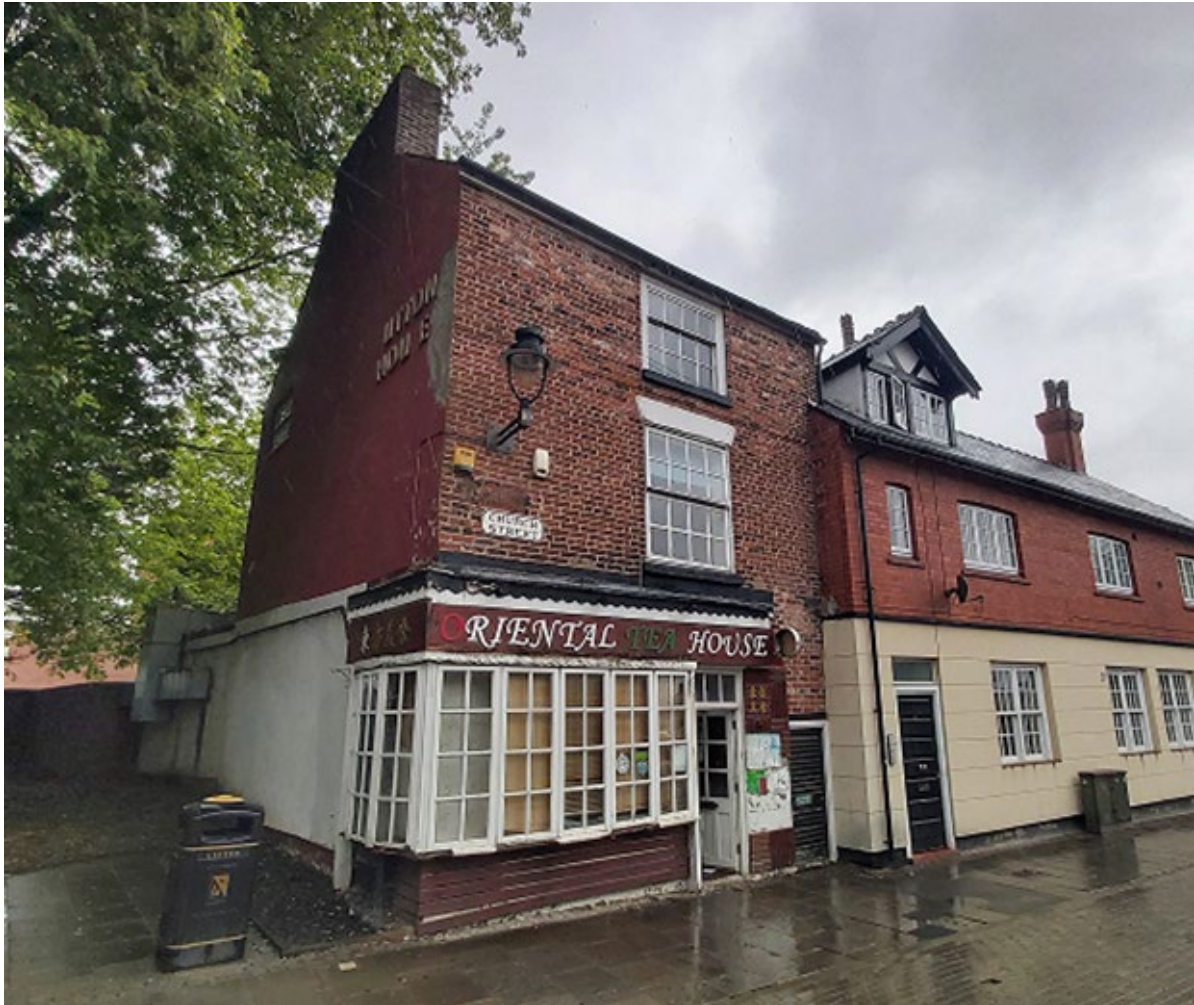
A view of the frontage of No.12 Church Street, Prescott.

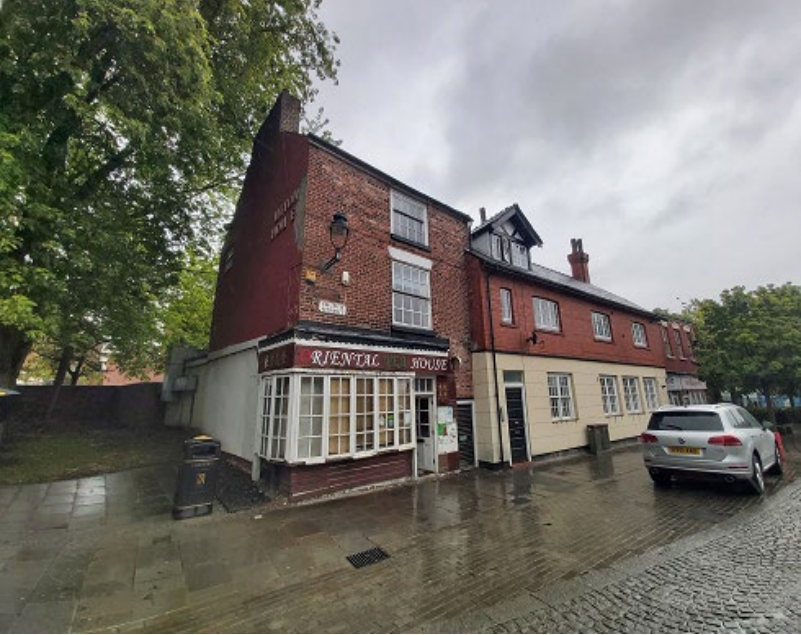
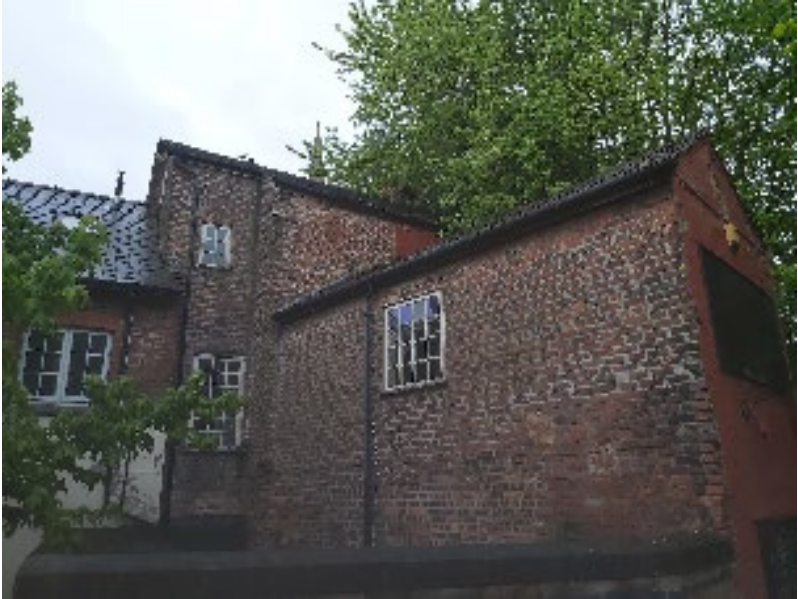
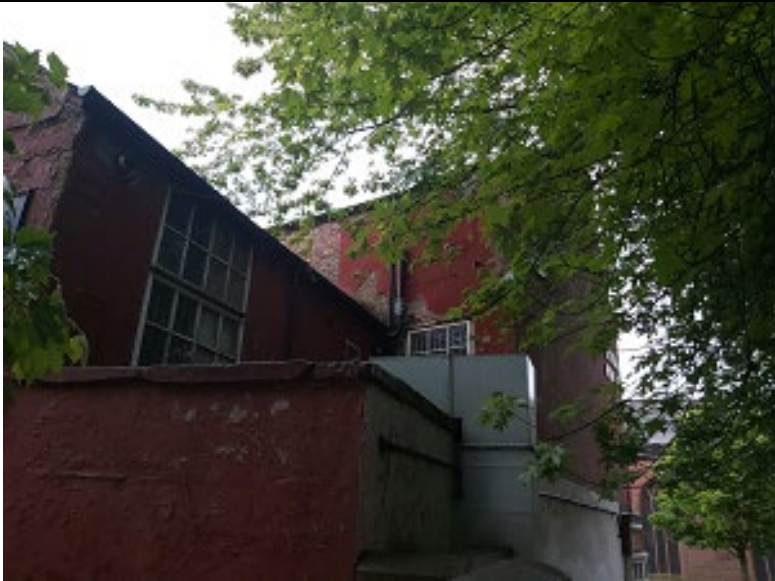
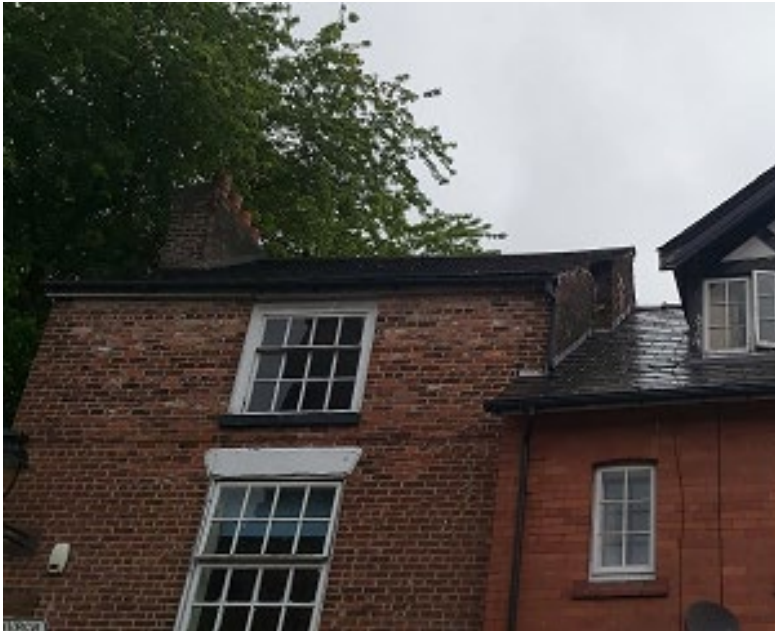
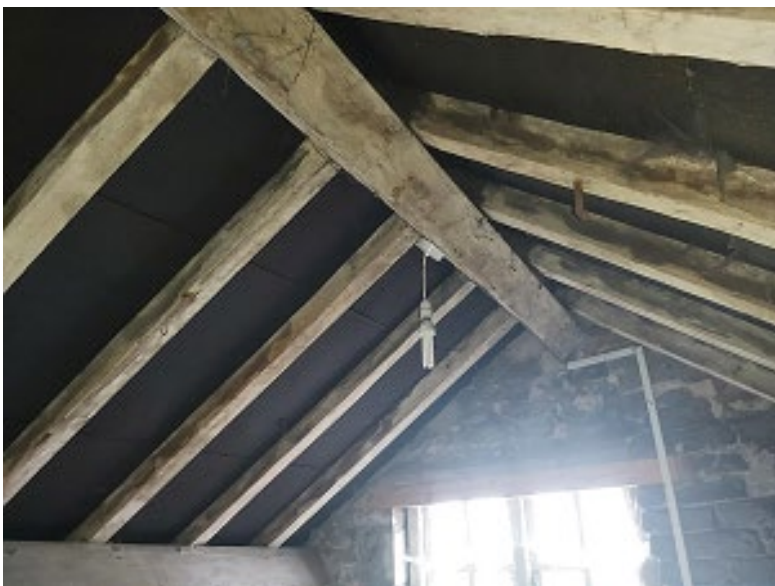
**Table.1 Building Inspection Results**

| Photo | Description |
|---|---|
| | <p>The exterior of the building is of brick construction. The roof is pitched with an outer layer of slate. There is a main roof with a void and a secondary roof on an extension to the north of the building (see Photo 2).</p> <p>There is one main roof void above the main building (Photos 5 &amp; 6). This is glazed to the eastern aspect and is therefore partially lit by daylight during the day. The western aspect is partially separated by a dividing wall so is therefore kept in darkness.</p> <p>The roof void is small but open internally (not cluttered) and the roof is underlined with bituminous felt.</p> <p>The ground floor and first floors house several rooms including former seating and kitchen areas of the former café, store</p> |

rooms, toilets, and living space to the upper levels. These rooms are glazed (allowing natural light during the day) and lack any notable internal potential roost features (PRFs).

The exterior of the roofing is generally in good condition but there are some lifted slates and natural gaps between slates, along with missing mortar at gable end roof edges which could potentially afford crevice dwelling bats access into the fabric of the roof (spaces between timber roof structure, felt and slates).

The external brick work and around window frames appear generally intact with no cavities observed that could be considered PRFs or allow access into the building.

Works must avoid all aspects of the roof structure and internal roof voids.

Any scaffolding to be erected should ensure any potential access points for bats are not obscured or blocked. This includes blocking of eaves, and roof edges at gable ends.

- Roofing works to take place during this period only.
- Traditional slate tiles and bituminous felt to be used (as per current materials).
- Naturally occurring gaps between slates (8-10mm sufficient) to be re-instated.
- Gaps along roof edges / eaves to be reinstated (8-10mm sufficient).
- Modern roofing membranes (i.e.; any plastic / non-bituminous felt) to be avoided.
- Ecologist to be consulted to confirm PRFs have been reinstated and correct materials used.

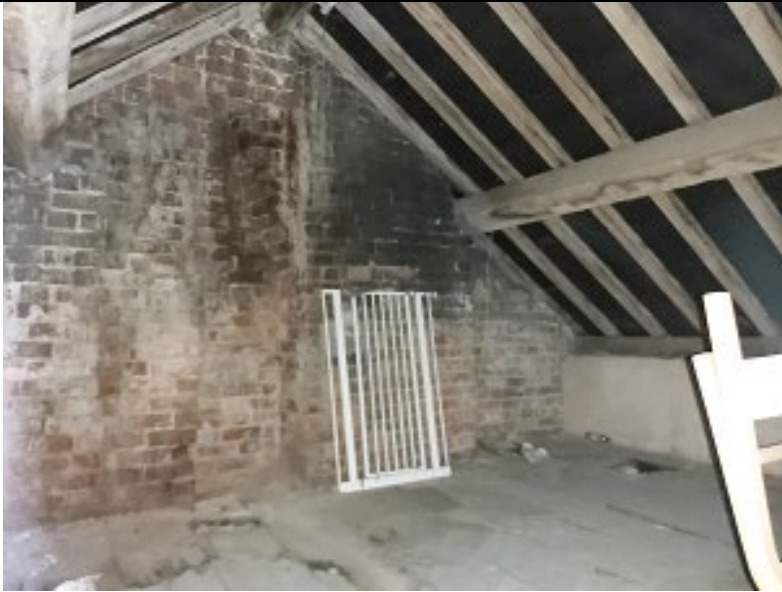
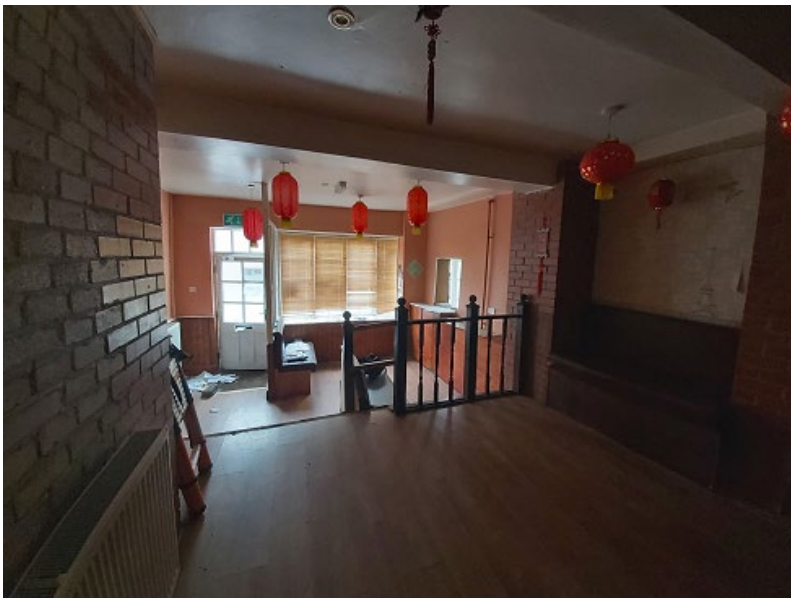
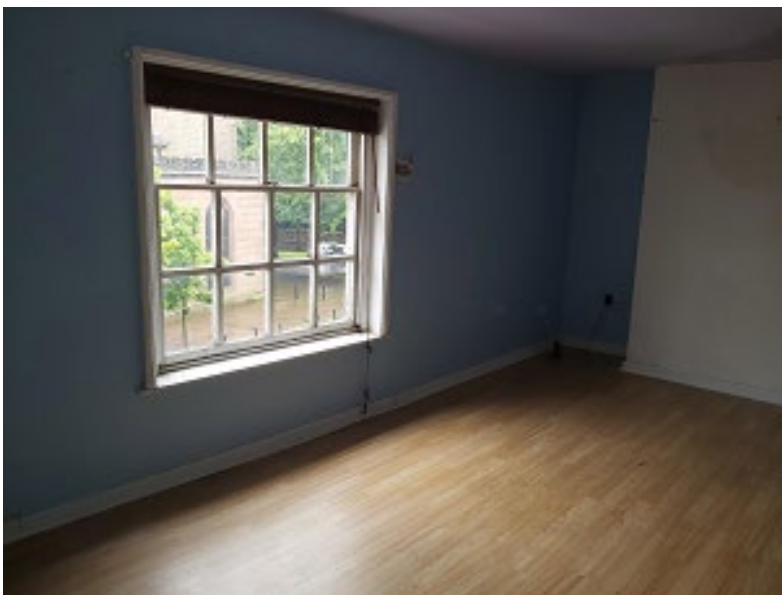
Small number of potential access points/roost features, with potential to support bat roosts (likely crevice dwelling species only) associated with external

roof fabric and roof voids.

The building is not considered suitable for hibernation roosts as the PRFs are associated with the roof top which would be exposed to sunlight (varying degrees) and therefore lead to unstable environmental conditions, not suited to hibernation.

No evidence of the presence of bats throughout the building (external or internal).

Low potential for supporting bat roosts. Roof section of the building only.
