Phase I Geoenvironmental Site Assessment  
East Hub, Knowsley

Reference: 15-354-R1-1  
Date: July 2022

# PHASE I GEOENVIRONMENTAL SITE ASSESSMENT

East Hub  
Knowsley Business Resource Centre  
Admin Road  
Liverpool  
L33 7TX

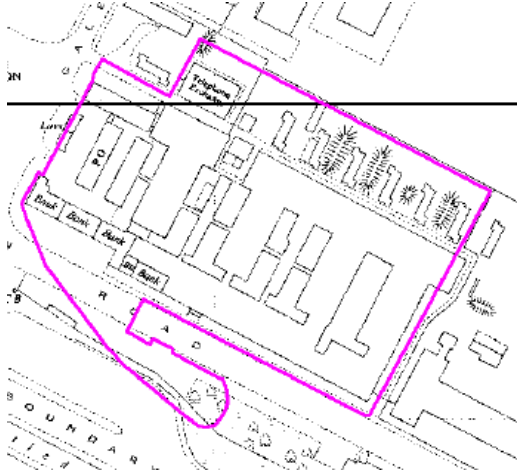
| MAP EDITION | HISTORICAL LAND USE | HISTORICAL MAP EXCERPT |
|---|---|---|
| <p><b>1959-1962</b><br/><b>1:2,500</b></p> | <p>A telephone exchange building is recorded to the northwest of the site. An earth mound is recorded to the north of the site.</p> <p>In the north-eastern sector of the site seven small identical structures are recorded parallel to each other, with earth mounds recorded between the structures. It is believed that these were blast mounds used to protect buildings from accidental explosions.</p> <p>A Post Office is recorded to the west of the site with two lavatory buildings recorded on the western boundary.</p> <p>Five buildings marked as banks are recorded to the southwest of the site.</p> <p>Across the remainder of the site, a large building with rectangular elements and interlinking corridors and open spaces is recorded.</p> <p>Admin Road bisects the south of the site and a small area of mature trees is recorded at the very south of the site.</p> | |

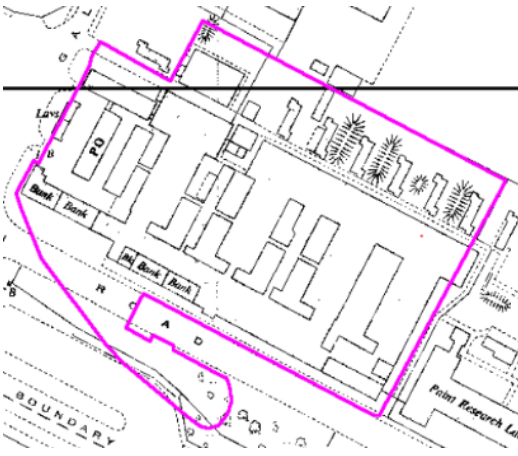
| MAP EDITION | HISTORICAL LAND USE | HISTORICAL MAP EXCERPT |
|---|---|---|
| <p><b>1965 – 1976</b><br/><b>1:1,250</b></p> | <p>Two small additional structures are recorded in the southeast corner of the site.</p> | |

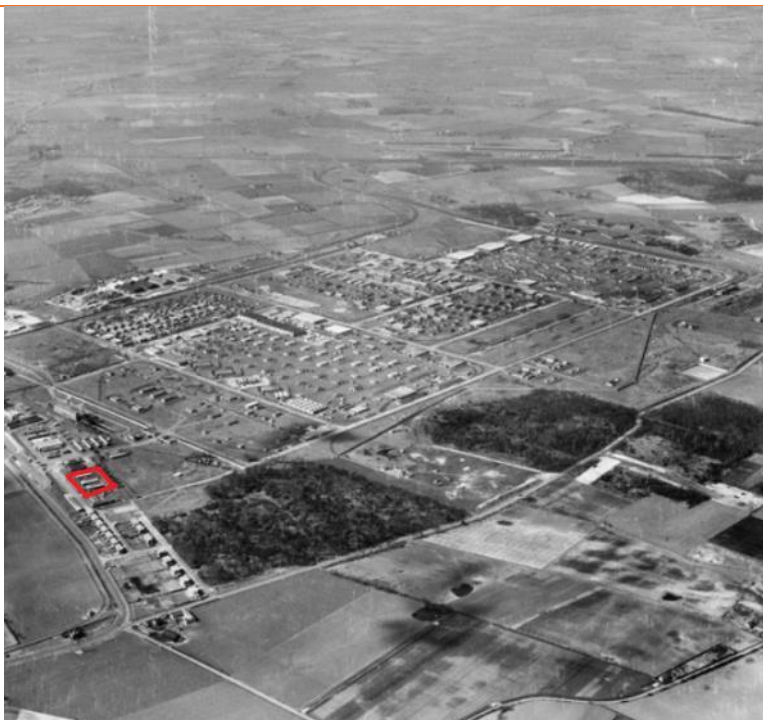
**PLATE 01 – BRITAIN  
FROM ABOVE 1947**

A web-based search of the subject site has recovered the following photograph, courtesy of Britain From Above:

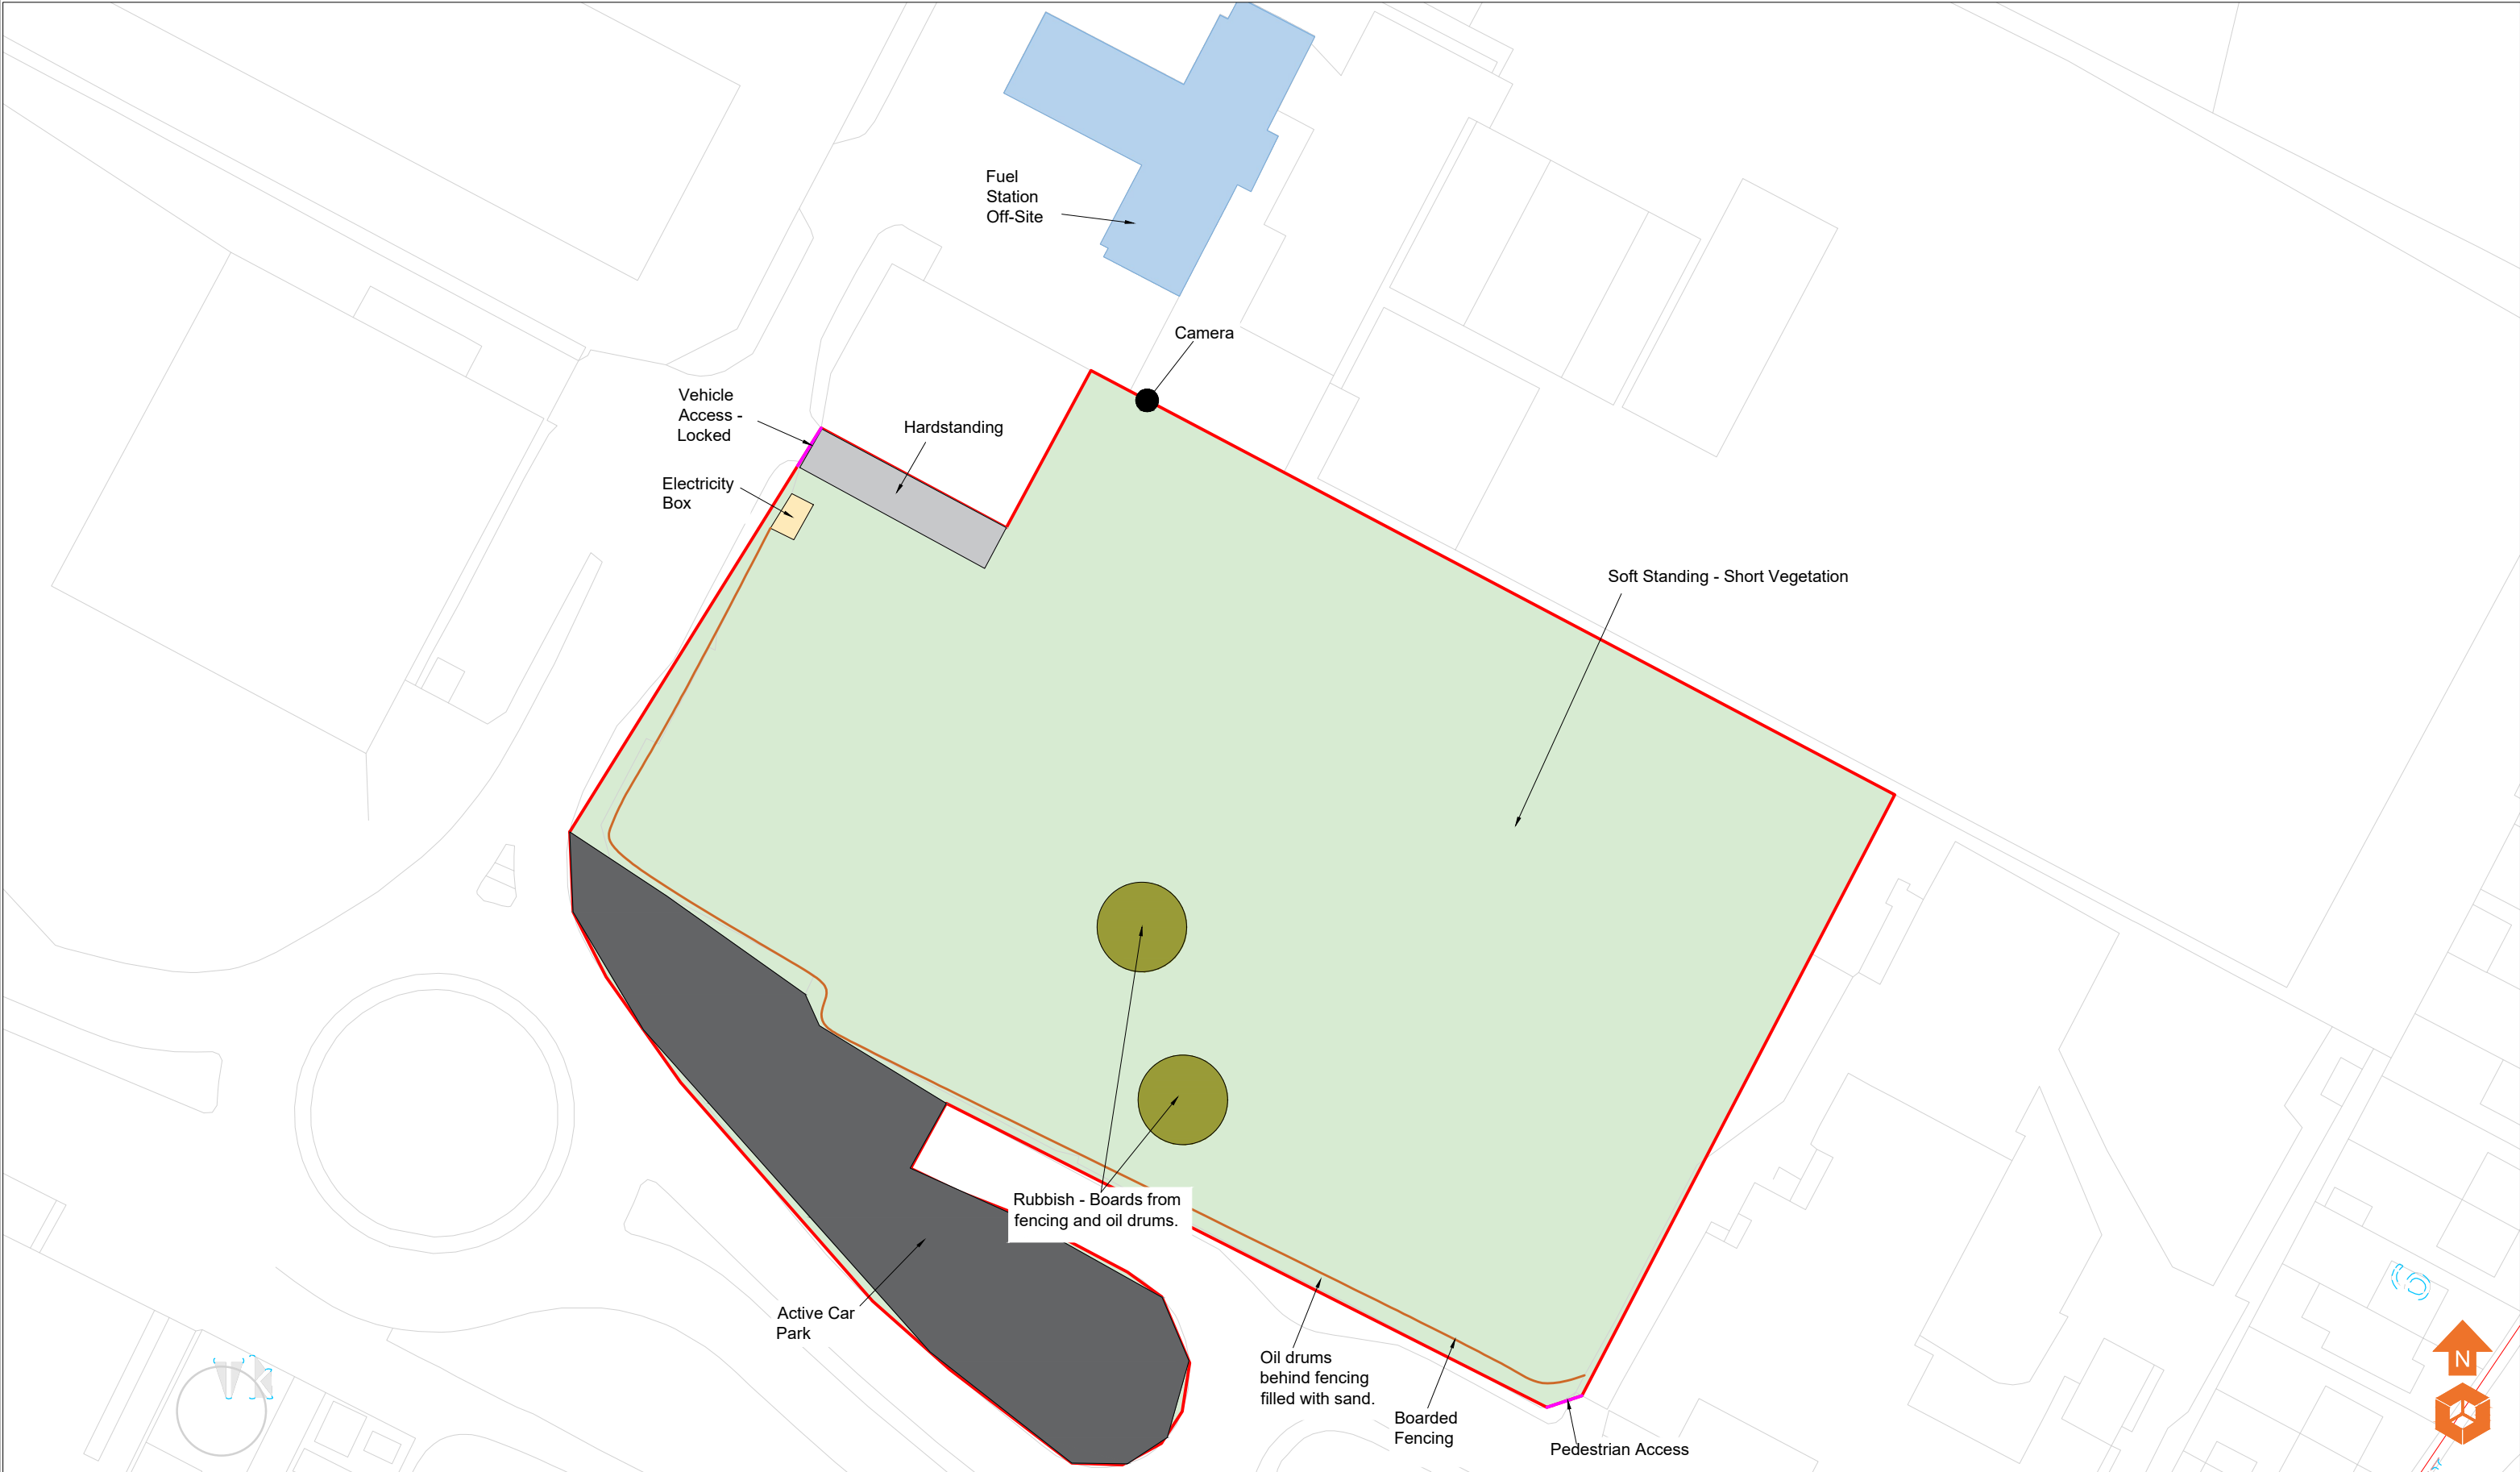
| <div>Site Features</div> <div><div></div> Soft Standing</div> <div><div></div> Active Car Park</div> <div><div></div> Hardstanding</div> <div><div></div> Electricity Box</div> <div><div></div> Camera</div> <div><div></div> Rubbish</div> <div><div></div> Access</div> <div><div></div> Fuel Station</div> |

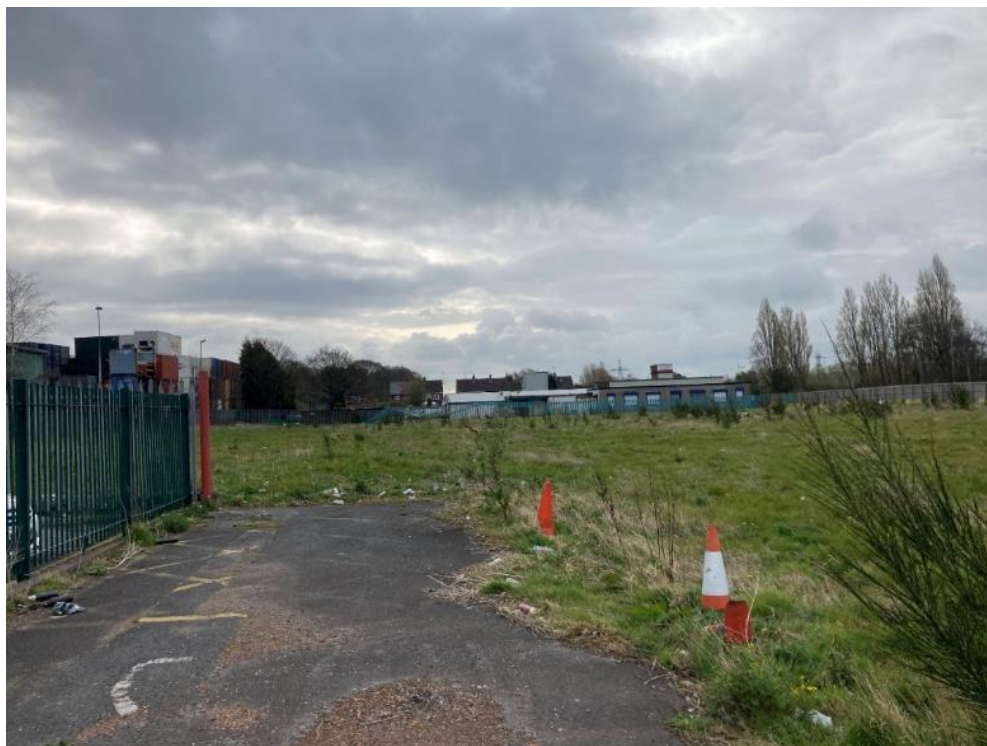
PLATE 2 HARDSTANDING IN NORTHWEST CORNER OF SITE FACING EAST

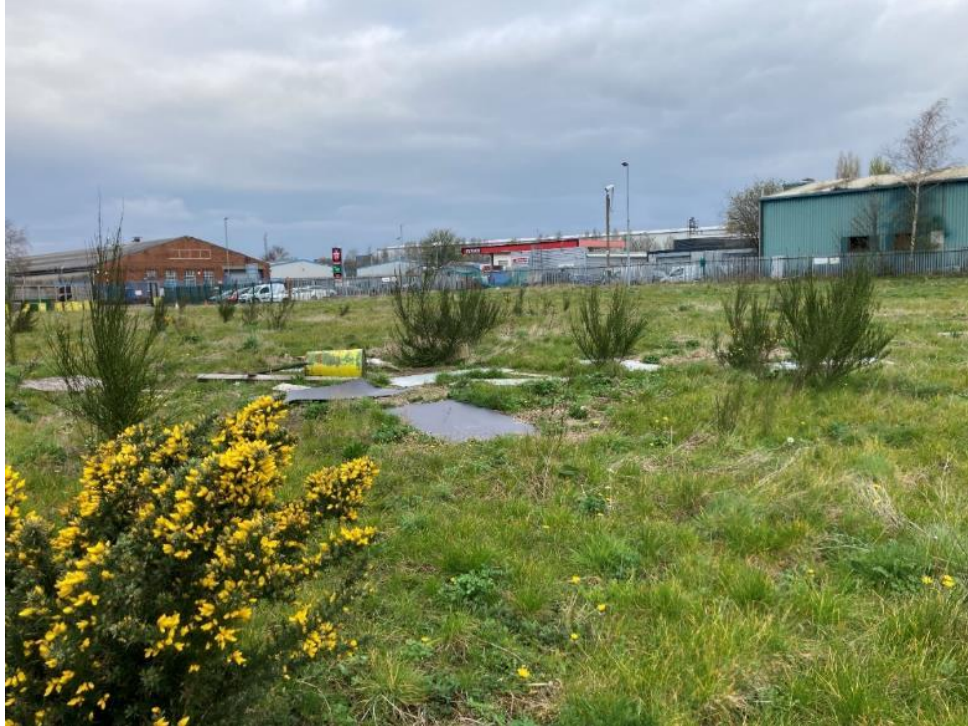
PLATE 3 SCRAP WOOD AND PLYWOOD IN THE CENTRAL AREA OF THE SITE

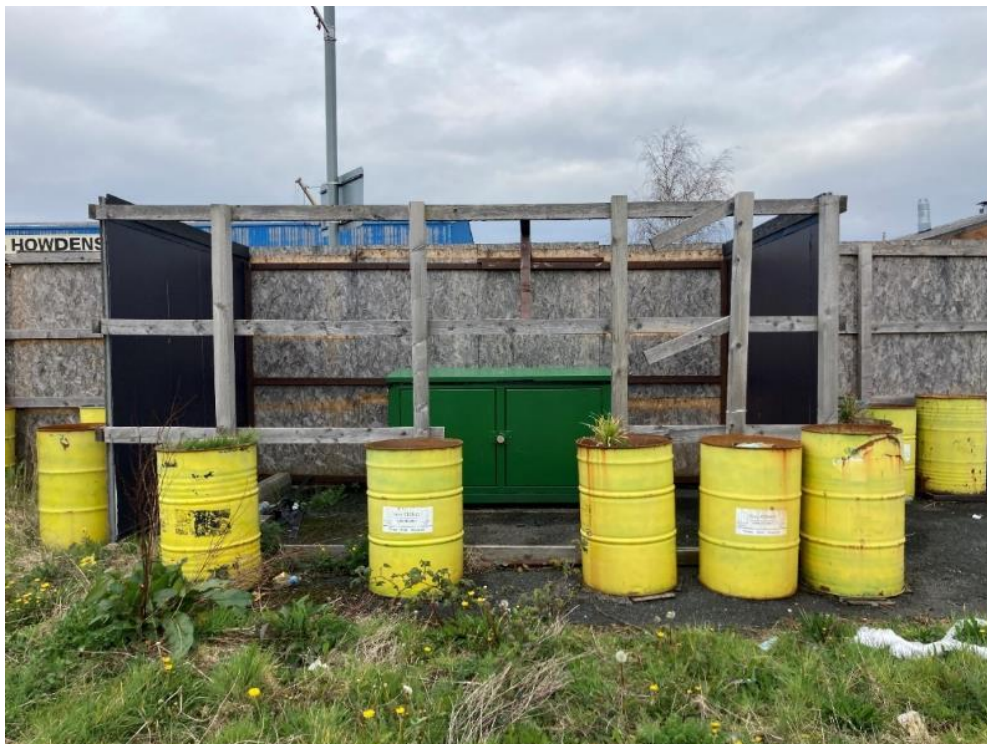
PLATE 4 ELECTRICITY BOX IN NORTH WEST CORNER OF SITE
