Phase I Geoenvironmental Site Assessment  
Land South of Lickers Lane, Whiston

Reference: 15-065-R1-1  
Date: November 2021

# PHASE I GEOENVIRONMENTAL SITE ASSESSMENT

Land south of Lickers Lane  
Whiston  
Prescot  
L35 3JE

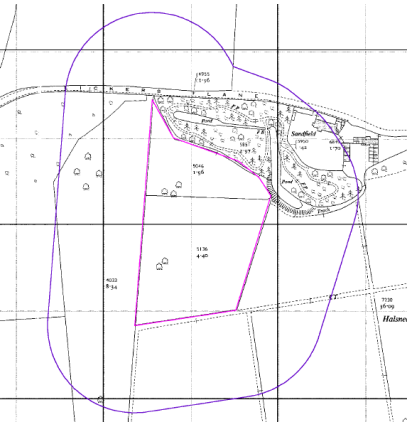
| <p><b>1959</b><br/><b>1:2,500</b></p> | <p>The saw-toothed field boundary has been removed, with a new field boundary being created in the northern sector of the site. The field boundary bisects the site east to west forming a larger paddock in the southern sector of the site.</p> <p>There are no other significant changes to the site.</p> | <p>This map shows the site boundary in 1959. The saw-toothed field boundary has been removed, and a new field boundary has been created in the northern sector. The new boundary bisects the site east to west, forming a larger paddock in the southern sector. The map includes various contour lines and spot heights.</p> |

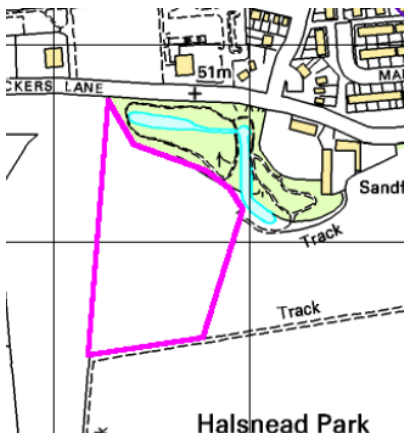
| <p><b>1999</b><br/><b>1:10,00</b></p> | <p>The field boundary in the northern sector of the site is no longer mapped.</p> <p>There are no other significant changes to the site.</p> | <p>The map shows Halsnead Park to the south of Lickers Lane. A pink boundary outlines the site. A track runs east-west through the park. A distance of 51m is marked between Lickers Lane and the track. The area is labeled 'Sand' and 'Track'.</p> |

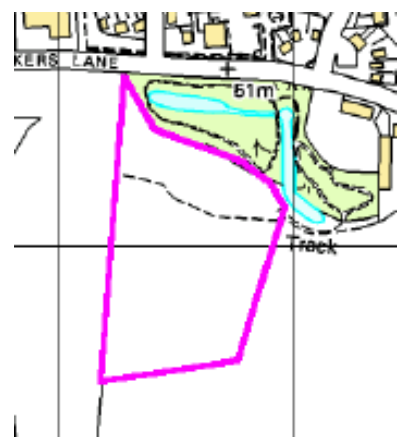
| <p><b>2006</b><br/><b>1:10,000</b></p> | <p>A path is mapped in the northern sector of the site bisecting the site from east to west.</p> <p>There are no other significant changes to the site.</p> | <p>The map shows Halsnead Park to the south of Lickers Lane. A pink boundary outlines the site. A path is mapped bisecting the site from east to west. A distance of 51m is marked between Lickers Lane and the path. The area is labeled 'Track'.</p> |

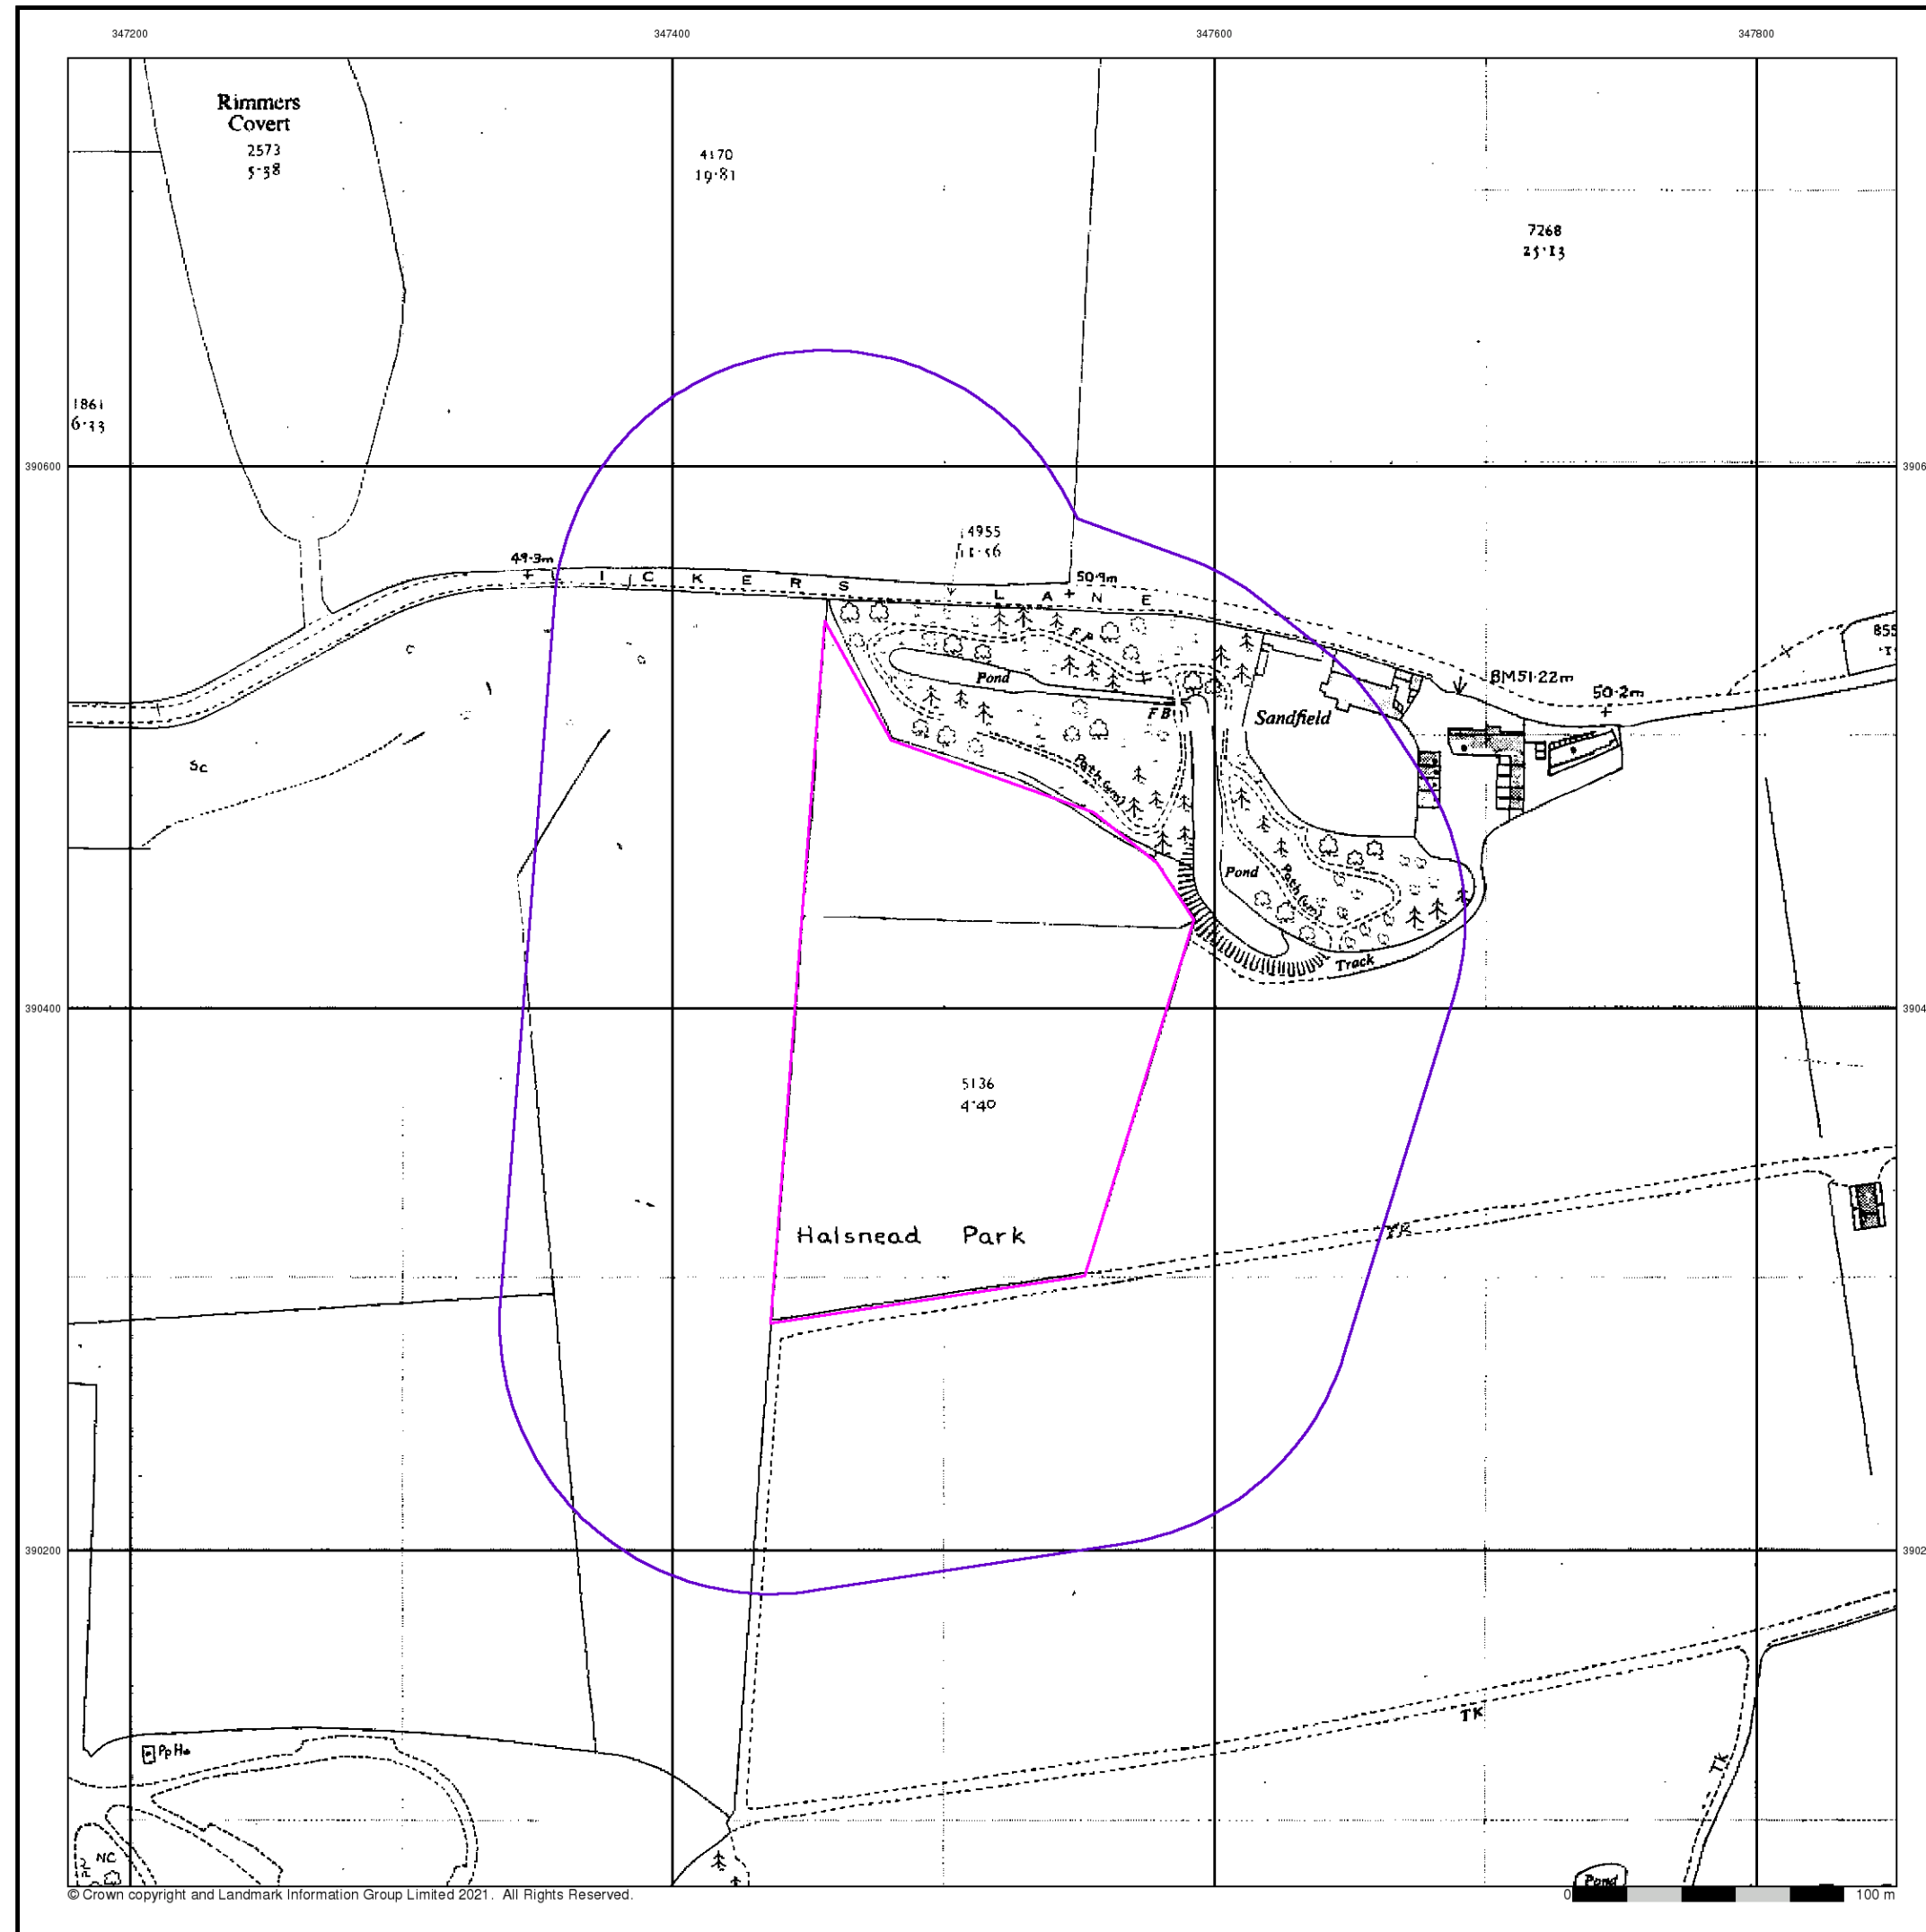
**Additional SIMs**  
**Published 1985**  
**Source map scale - 1:2,500**

The SIM cards (Ordnance Survey's 'Survey of Information on Microfilm') are further, minor editions of mapping which were produced and published in between the main editions as an area was updated. They date from 1947 to 1994, and contain detailed information on buildings, roads and land-use. These maps were produced at both 1:2,500 and 1:1,250 scales.
