# JLR Halewood, Eastlands

## Lighting Assessment - Part 1. Baseline Lighting Survey Report

Baseline conditions recorded to inform the Lighting Design for a new WIP and dispatch car park within the wider JLR site.

416.066699.00001

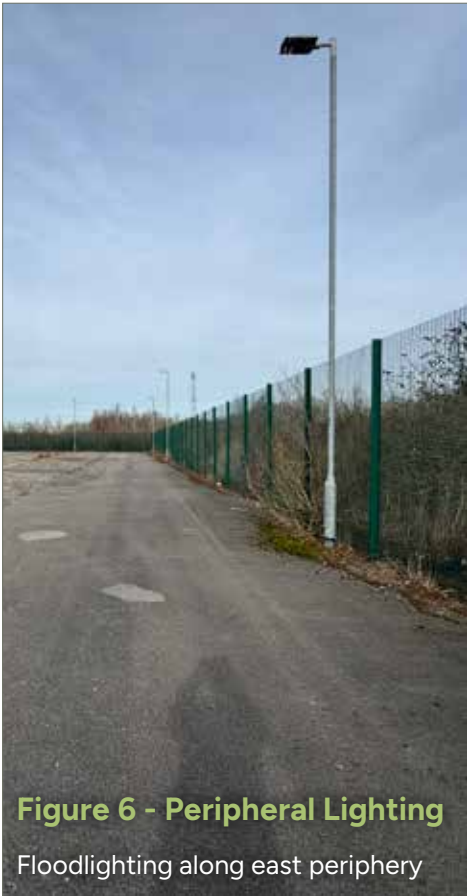
Figure 6 - Peripheral Lighting  
Floodlighting along east periphery

- 8-4 Higher readings were recorded at the periphery of the southern compound due to influence from existing floodlighting within the Site and to the south within the DHL Office compound.

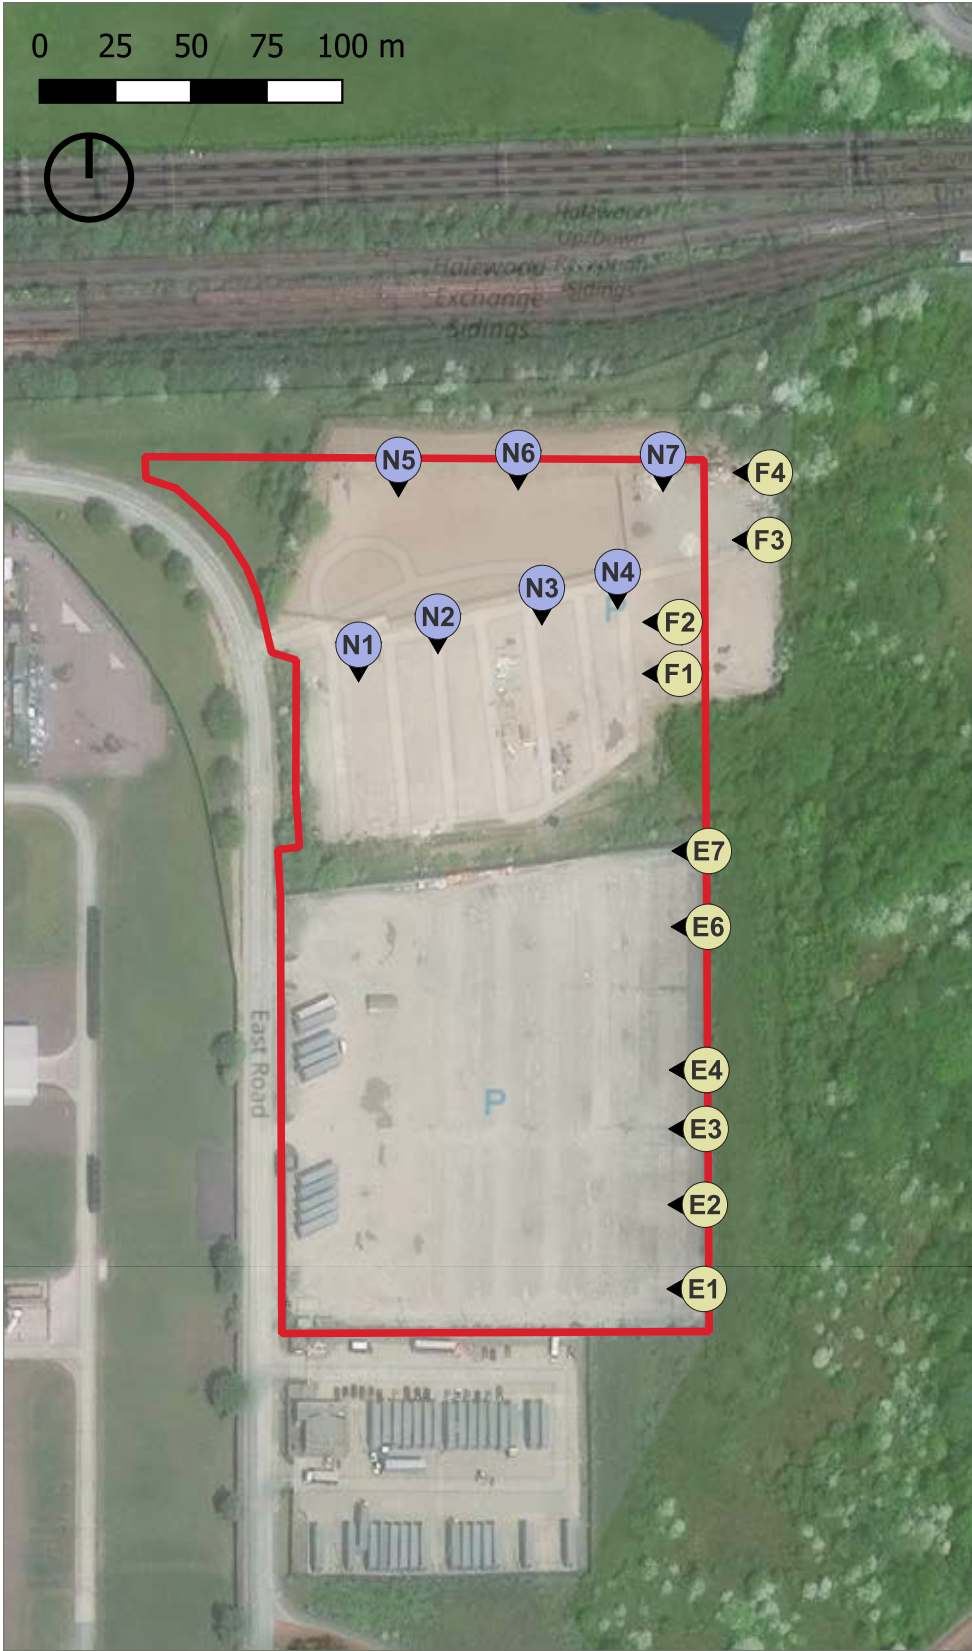
Figure 10 - Vertical Lux Survey Location Plan

- 8-3 The vertical measurements taken at the north and eastern boundary associated within the northern compound demonstrate low to negligible amounts of light received from the Site, with the shared boundaries to be below 0.5 lux.

Vertical Lux Level Survey Locations. Scale 1:2500 @ A3 - The licence for ESRI World Imagery: Esri, Maxar, GeoEye, Earthstar Geographics, CNES/Airbus DS, USDA, USGS, AeroGRID, IGN, and the GIS User Community

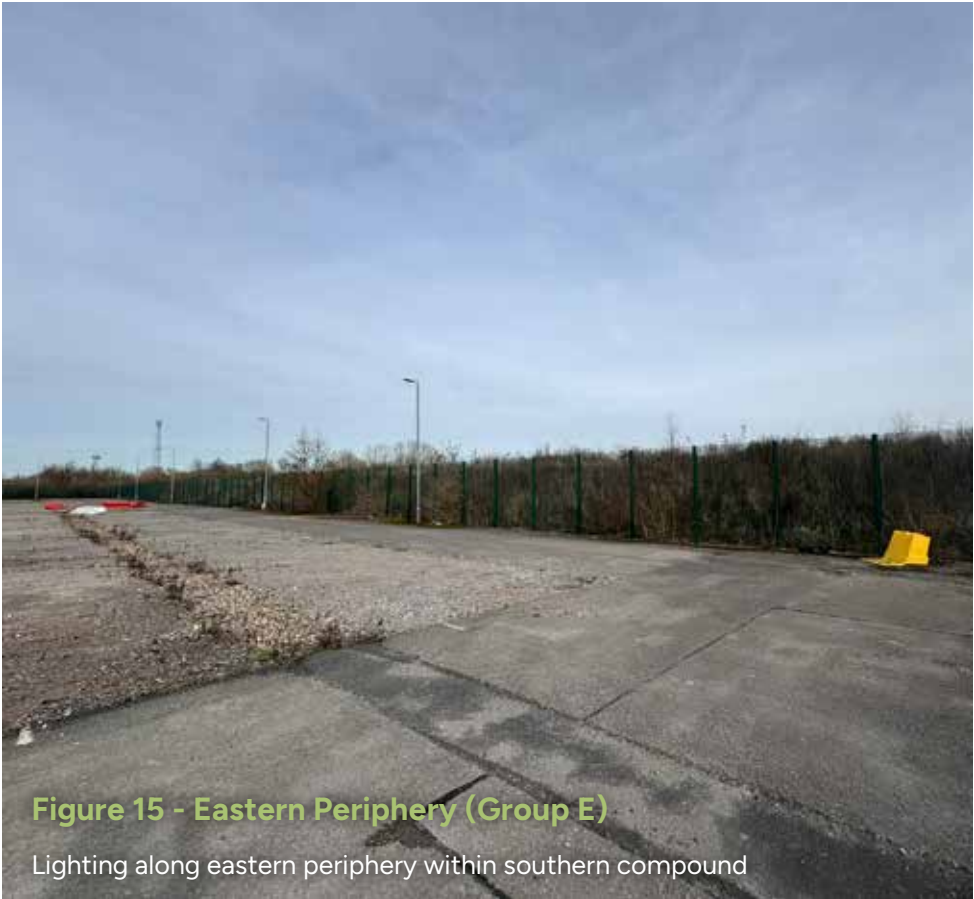
- 10-4 The vertical measurements taken along the eastern periphery within the southern compound indicate that the area of existing vegetation and stands of trees within 'Crab Tree Rough' are subject to minor adverse light pollution with peak 'hot spots' adjacent to peripheral floodlighting at the boundary.

**Figure 15 - Eastern Periphery (Group E)**  
Lighting along eastern periphery within southern compound

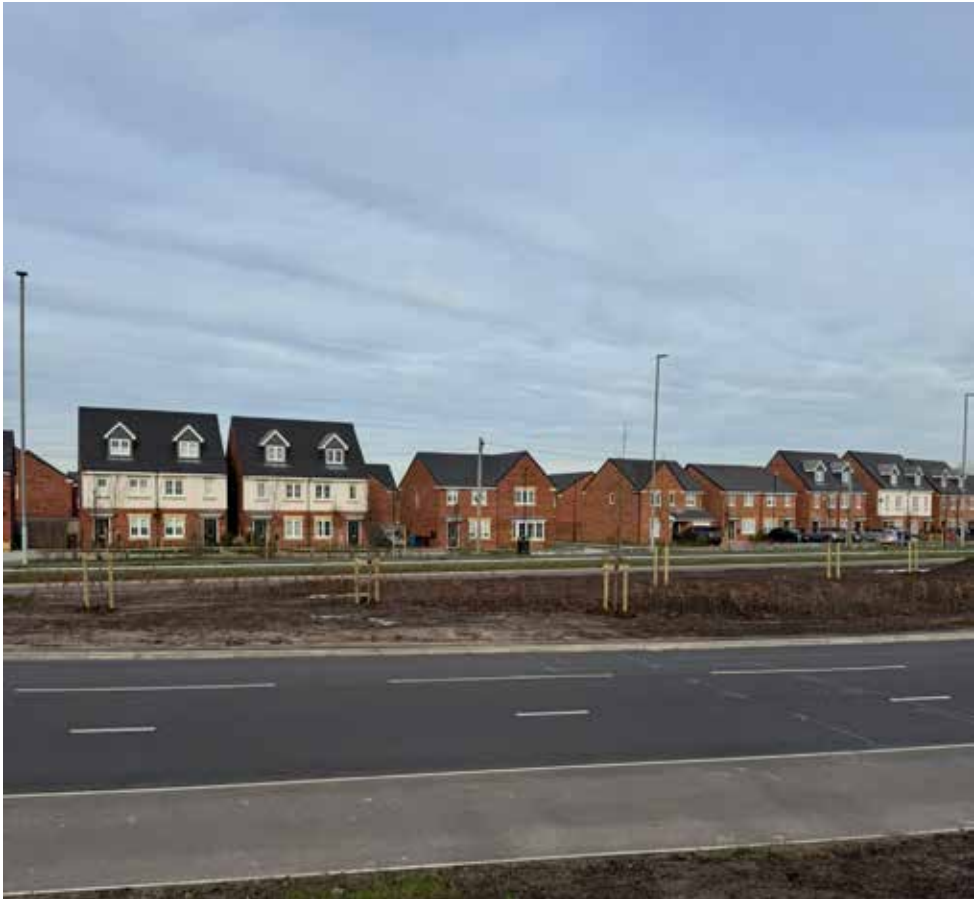
11 - Receptor 1

Crab Tree Rough (East)

- 11-1 Vegetation parcel of wood and scrub land at the eastern boundary of the Proposed Development Site.
- 11-2 The shared boundary within the southern compound is observed to be subject to minor adverse light pollution from existing peripheral floodlighting.
- 11-3 Light readings taken at the eastern boundary to the north indicate the area to be in 'contextual darkness' with measurements below 0.5 lux.
- 11-4 Care should be taken to preserve areas of 'contextual darkness' to allow light sensitive ecology to traverse through interconnected habitats.

- 15-2 When considering the addition of new lighting within the Proposed Development, care should be taken to preserve where possible areas of 'contextual darkness' at the east and northern boundaries for the benefit of light sensitive ecology.
