**PHASE 2: GROUND INVESTIGATION REPORT**  
**ALAN WOODS AND PARTNERS / VEOLIA**  
**HUYTON FOOD WASTE PROJECT**  
**ELLIS ASHTON STREET**  
**LIVERPOOL**  
**L36 6BJ**

**Project No: 24-787**

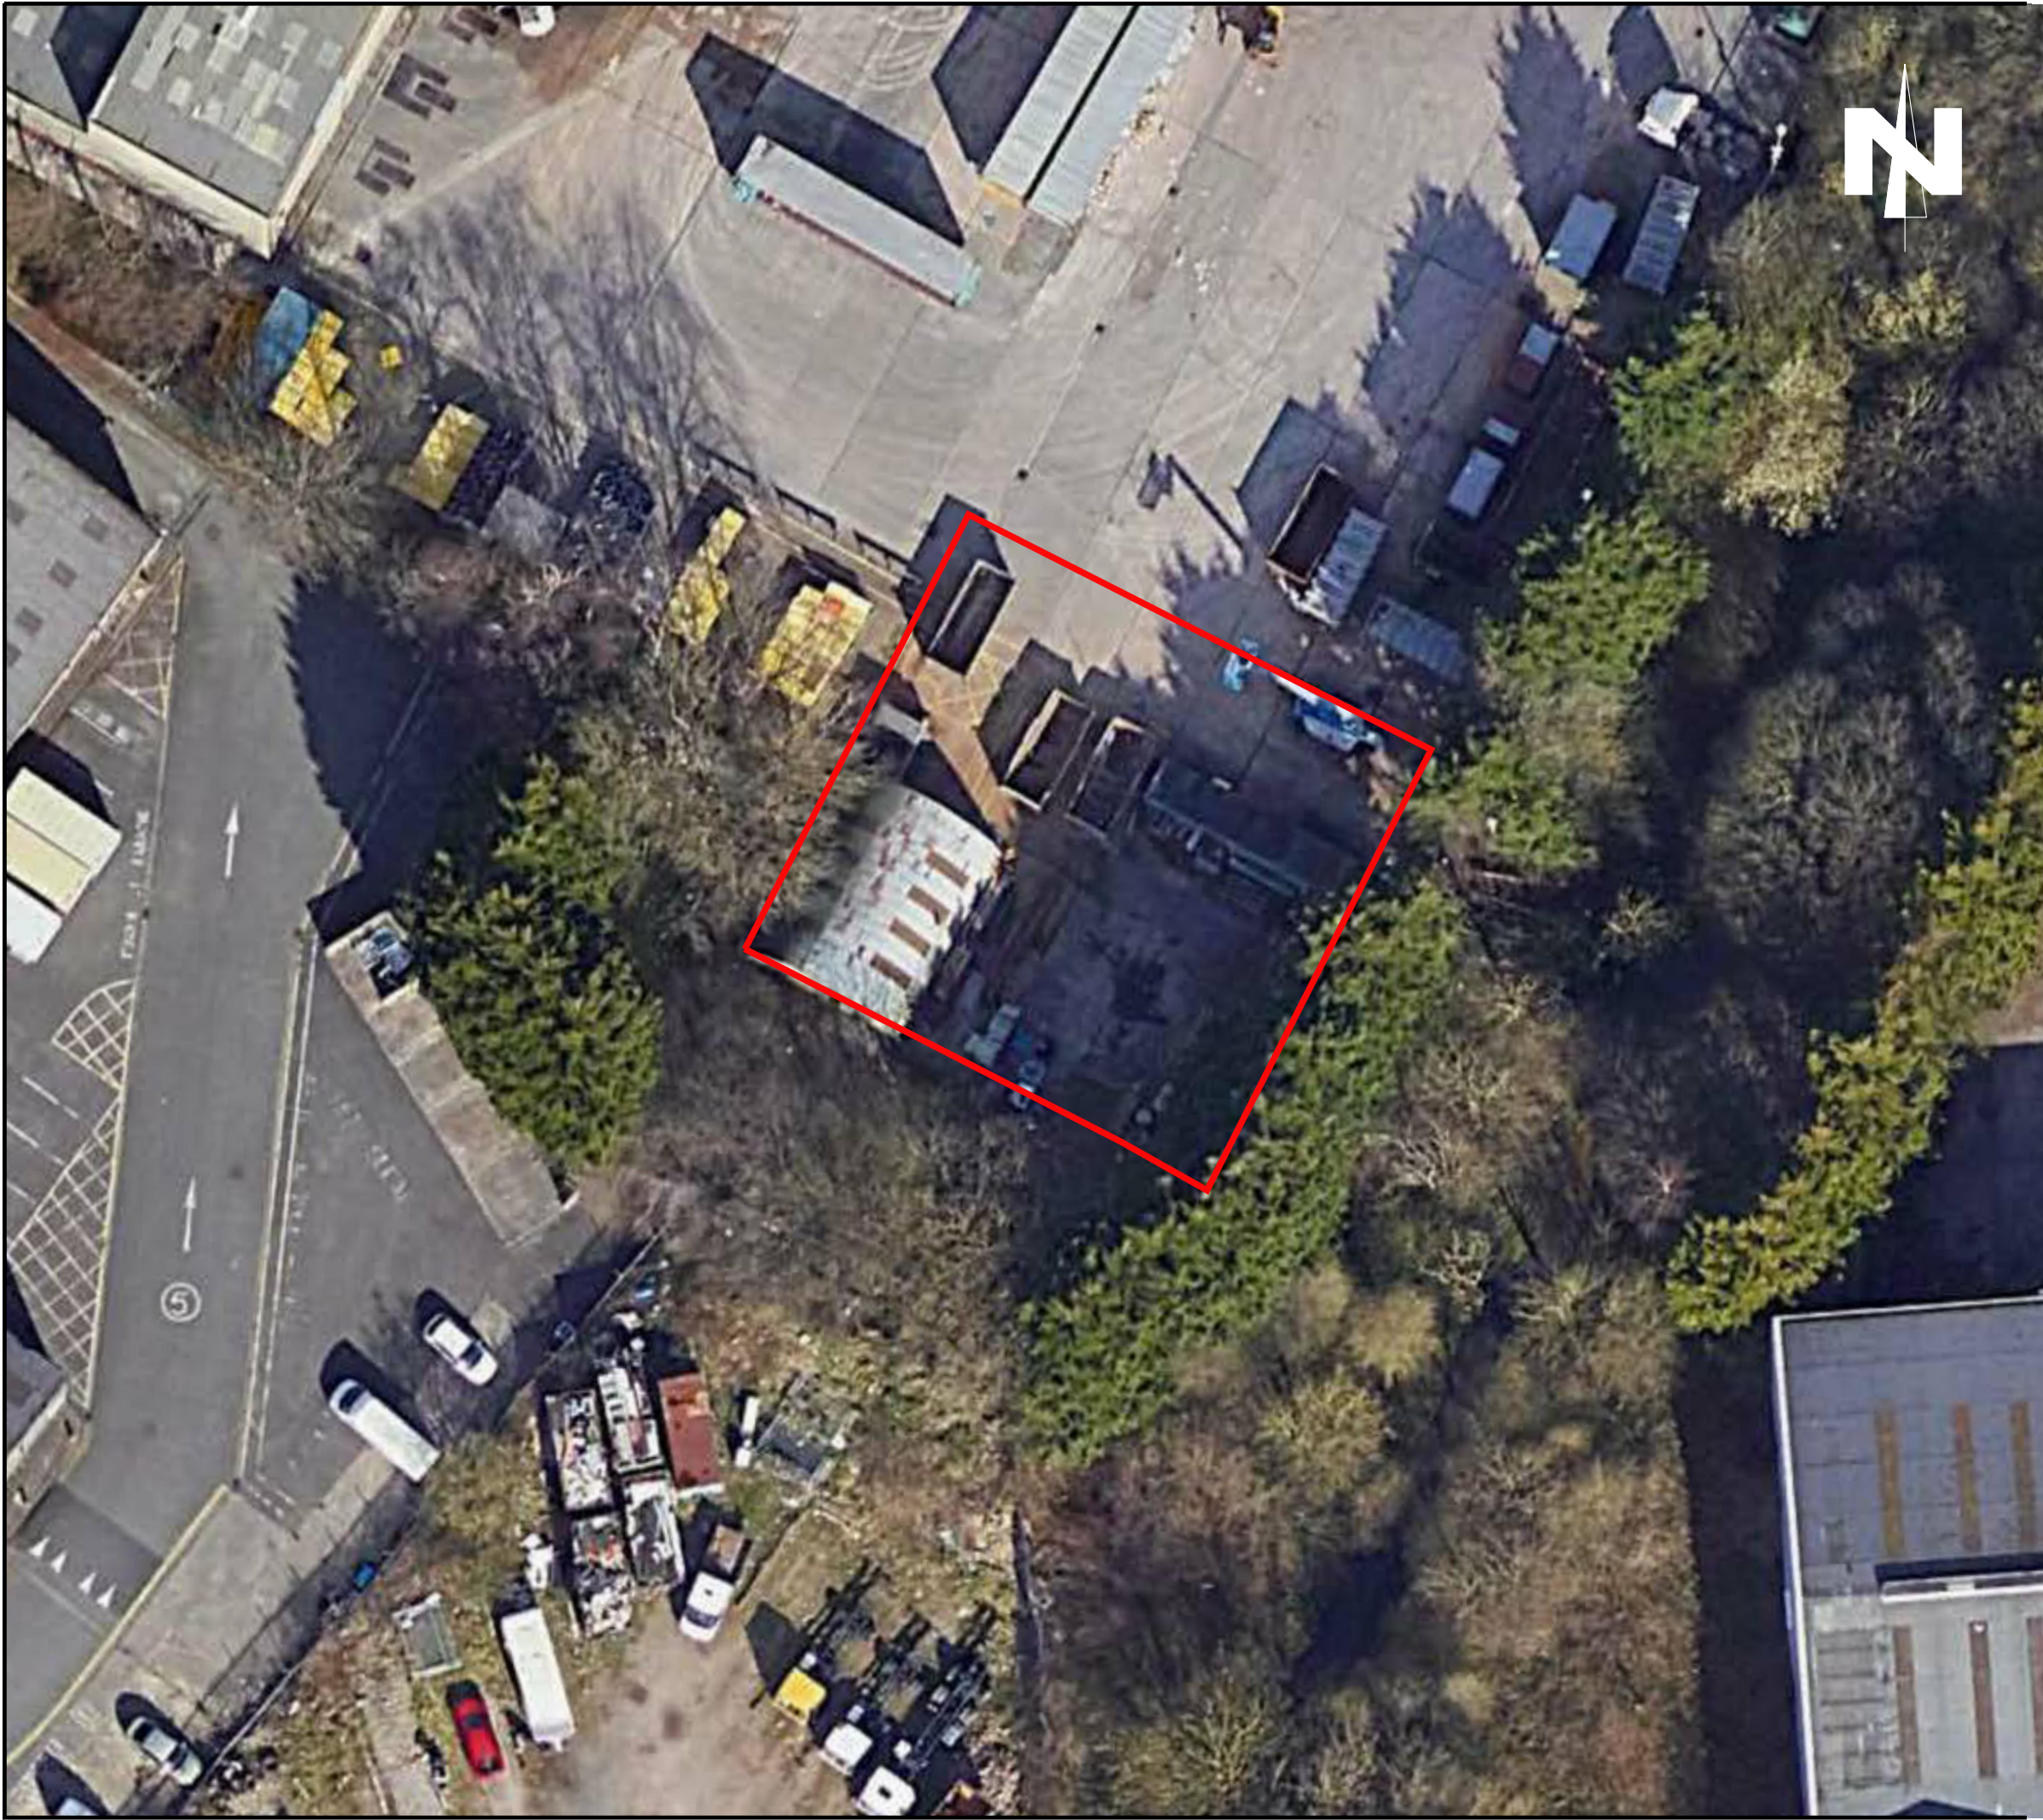
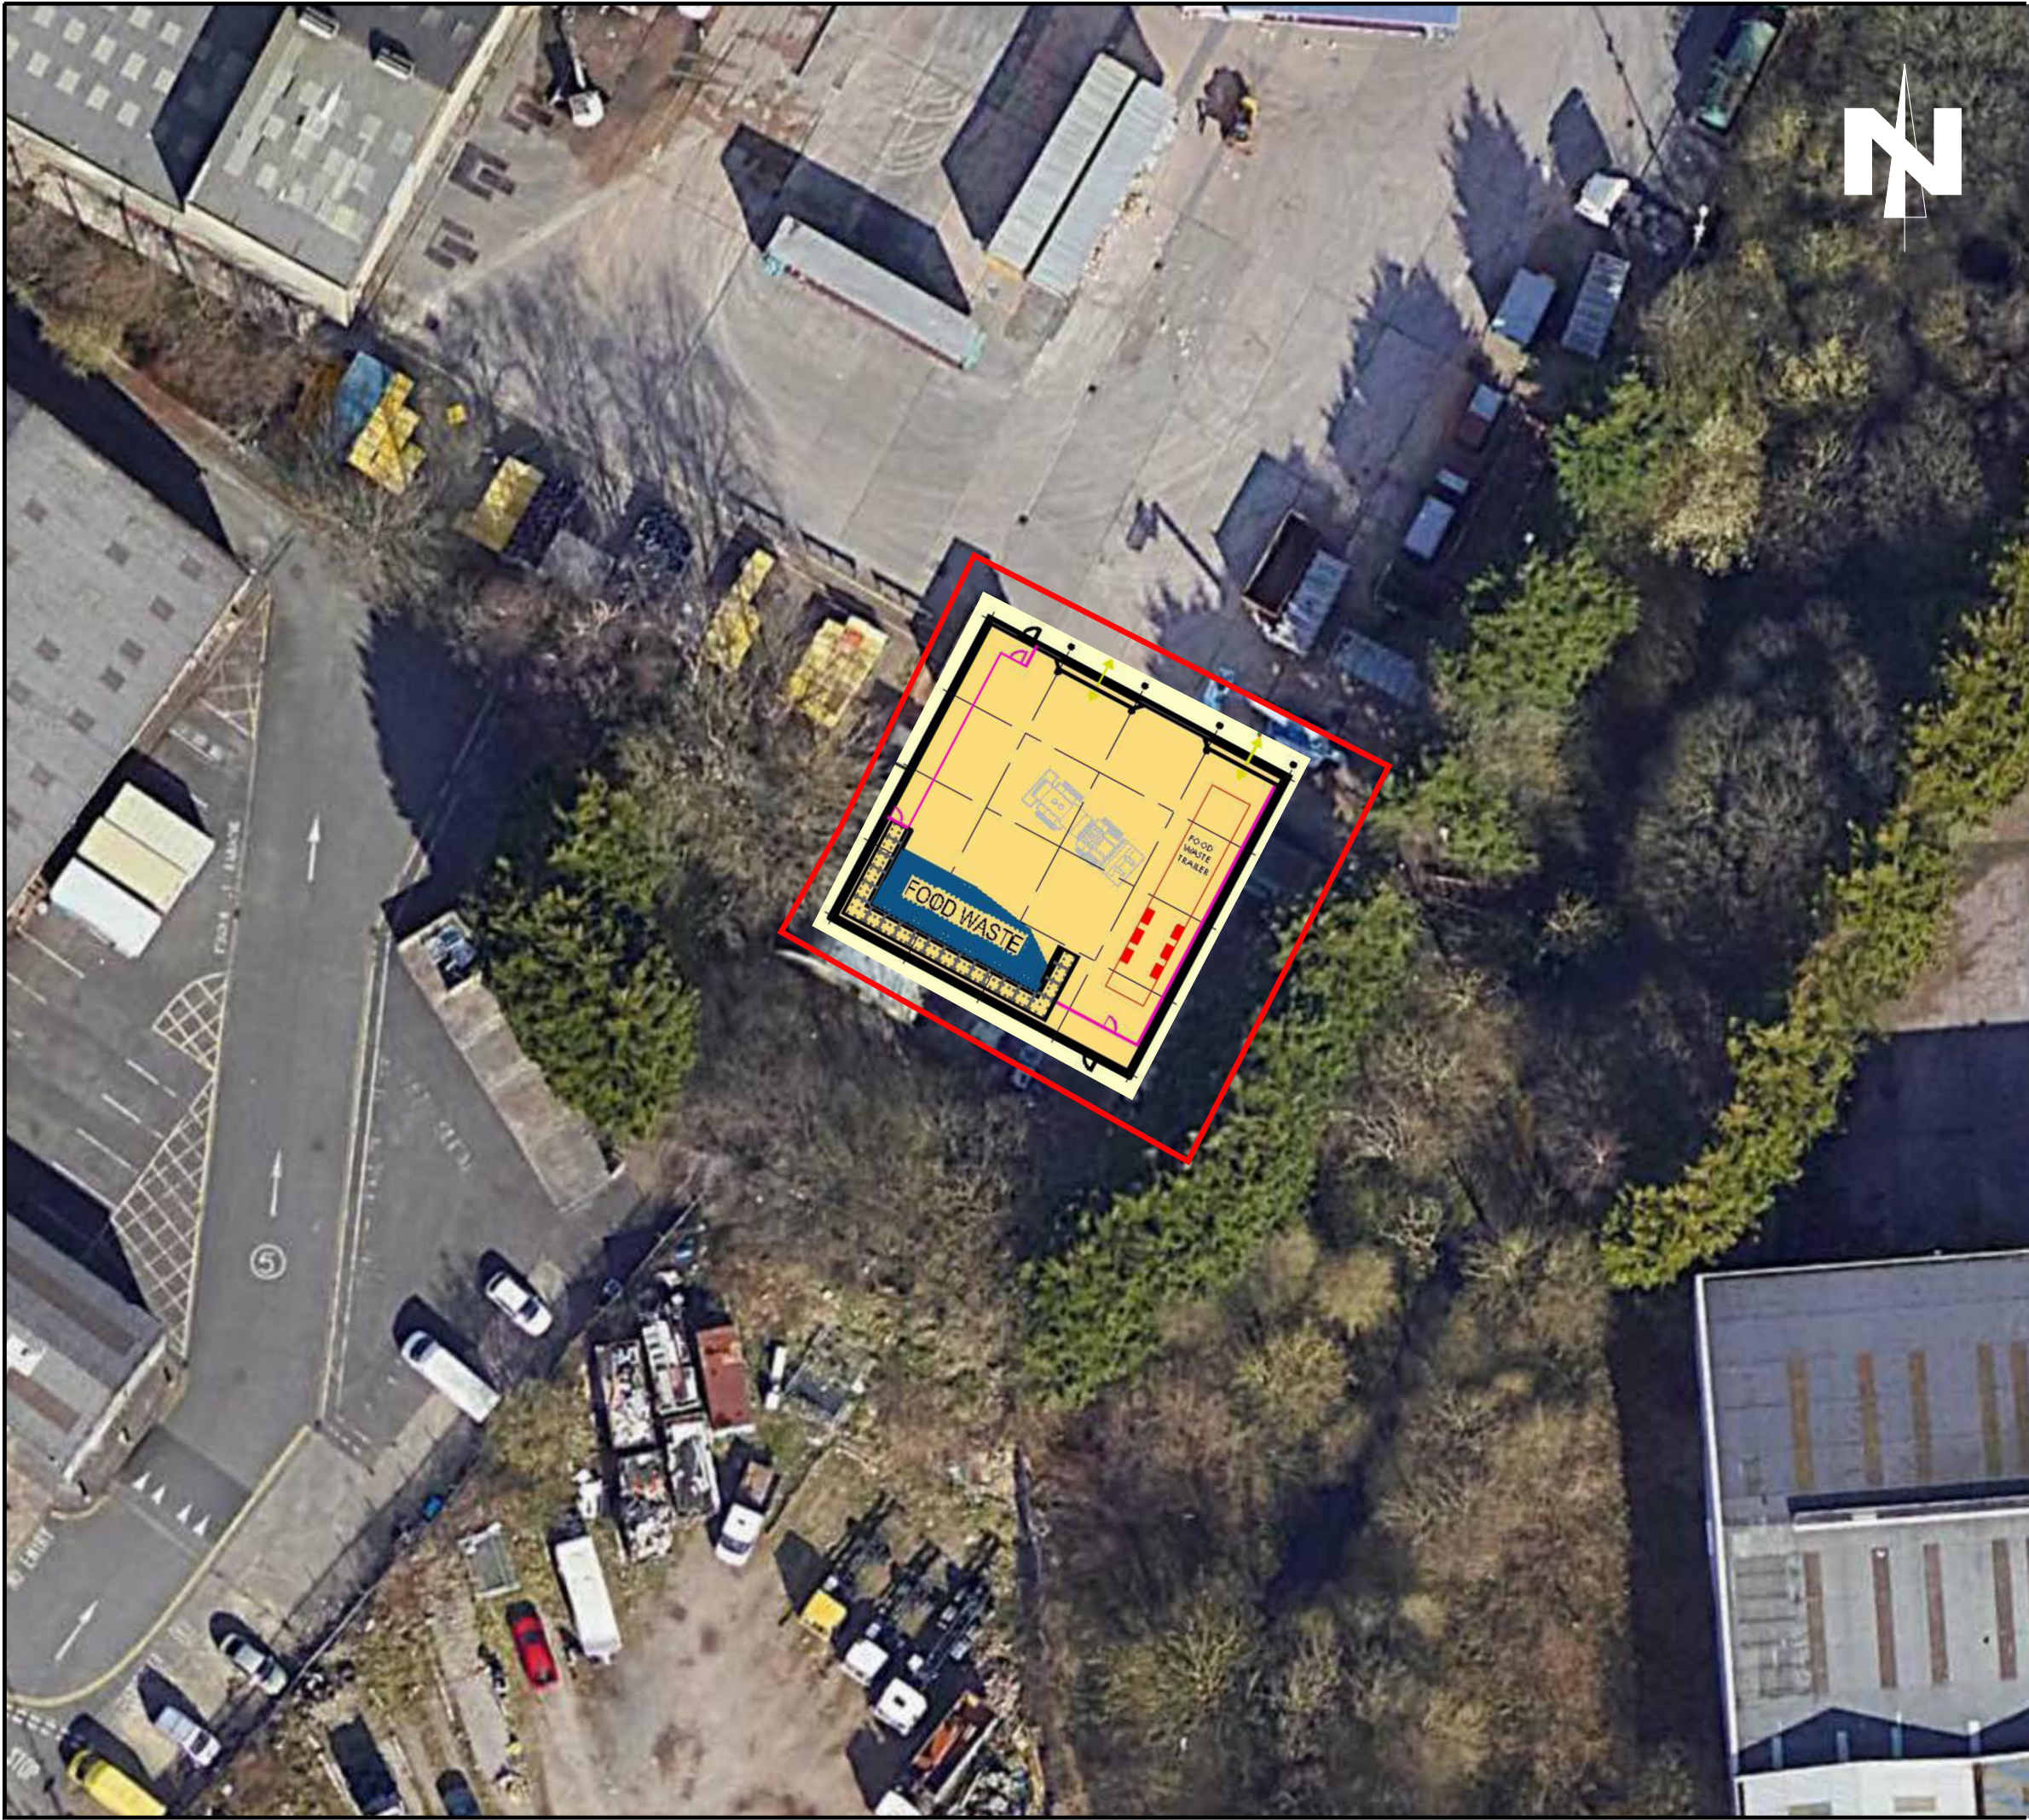
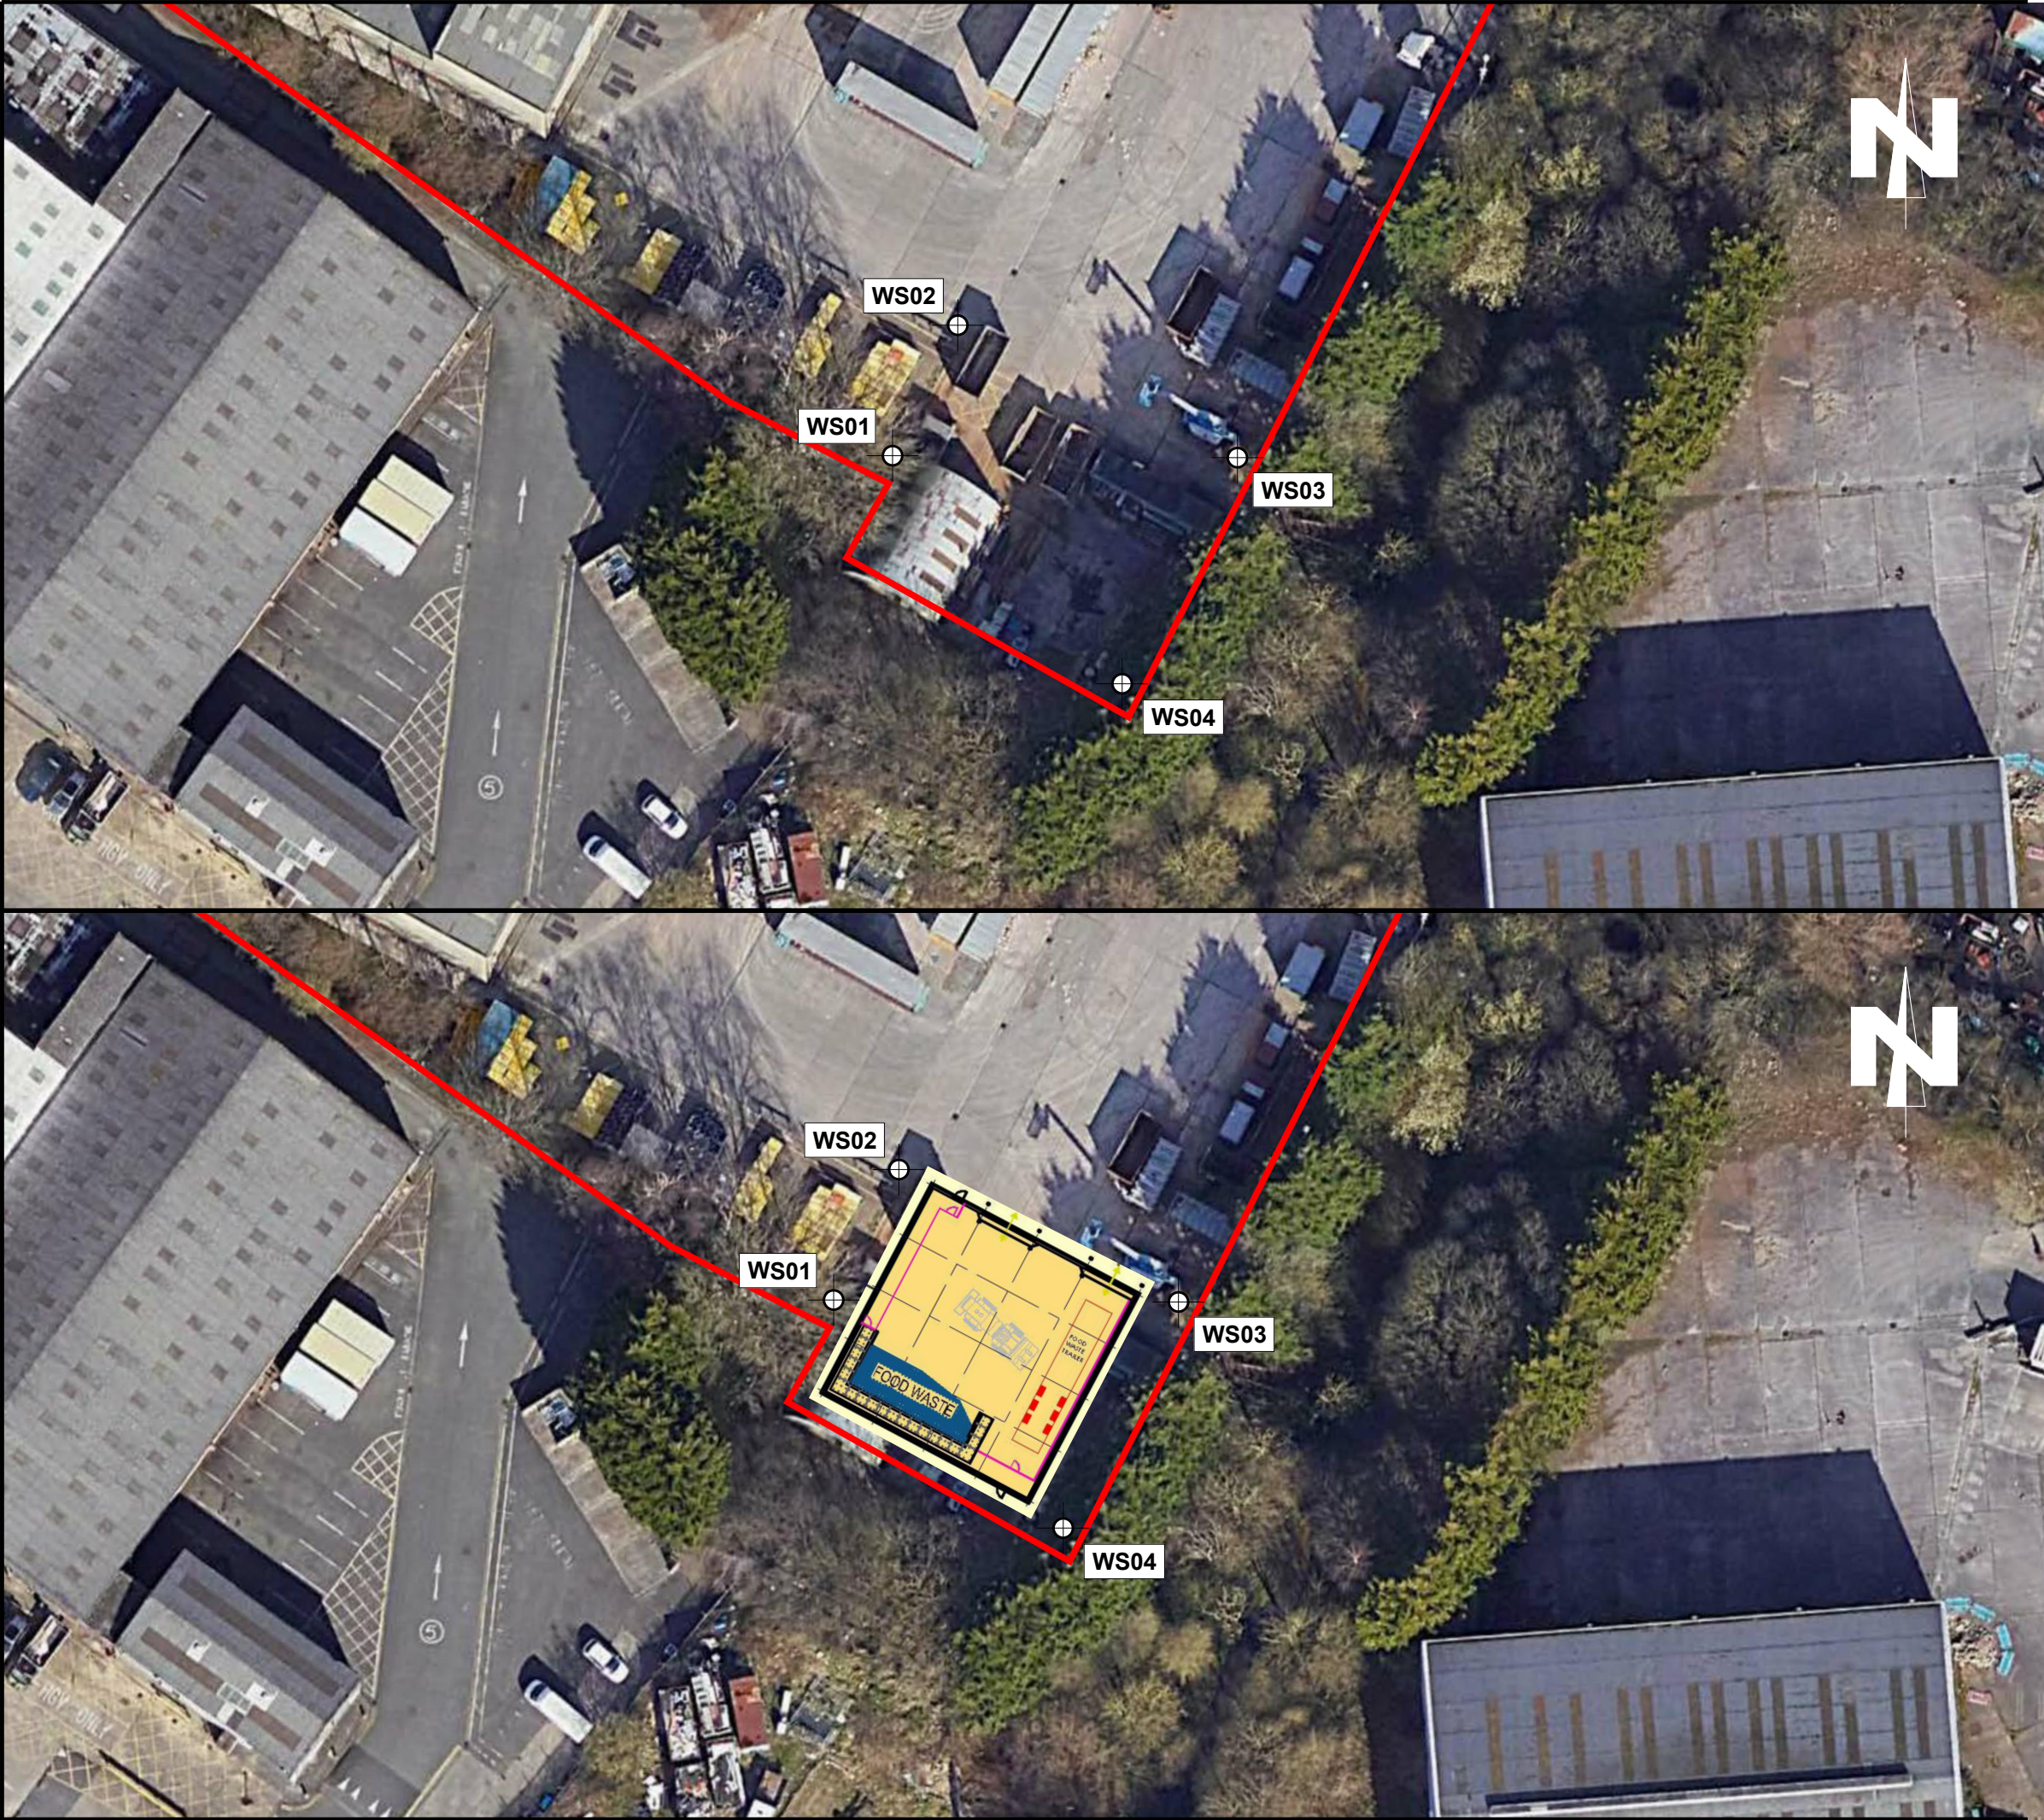
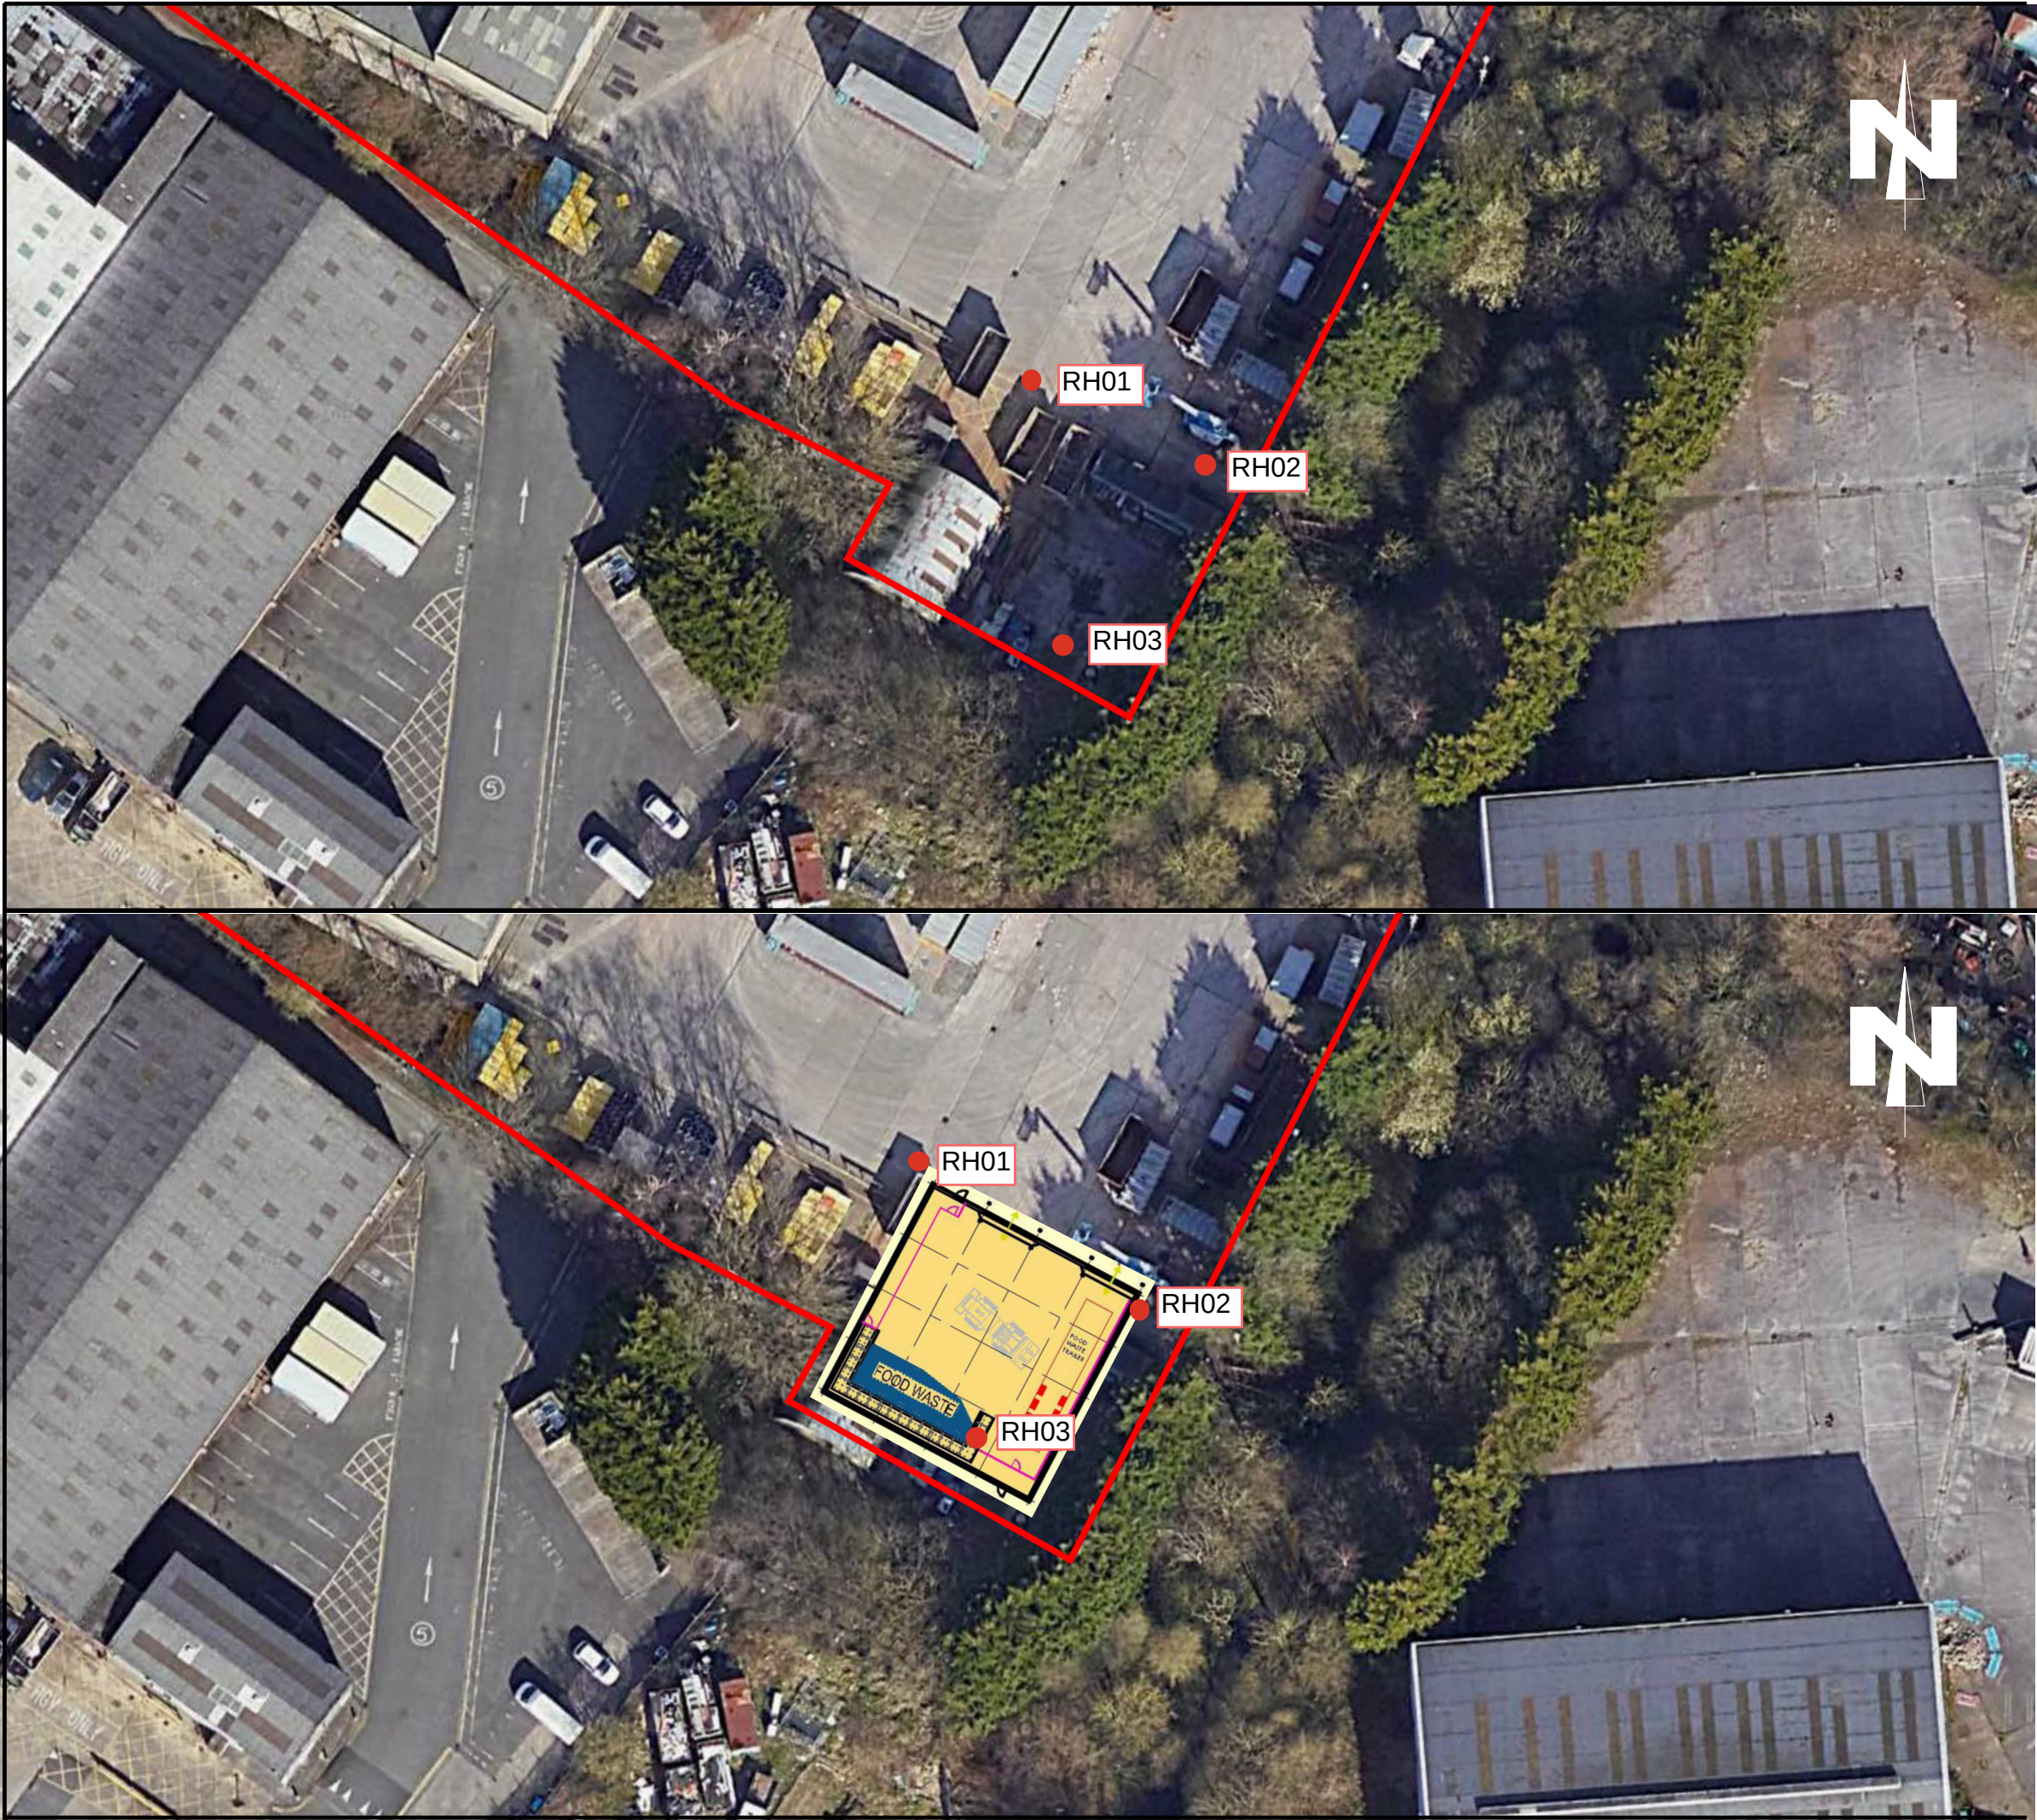
## **Exploratory Hole Location Plans**

The intrusive investigation works comprised 4 no. windowless sampling boreholes (WS01 to WS04) incorporating the installation of 3 no. combined gas and groundwater monitoring wells (WS01, WS03 & WS04) and 3 no. open hole rotary boreholes (RH01 to RH03). The positions of which can be seen on the Exploratory Hole Location Plan, a copy of which can be seen in Appendix II. It should be noted that this plan should be used for orientating purposes only, as the positions shown are approximate, and the plan is not to a standard scale.

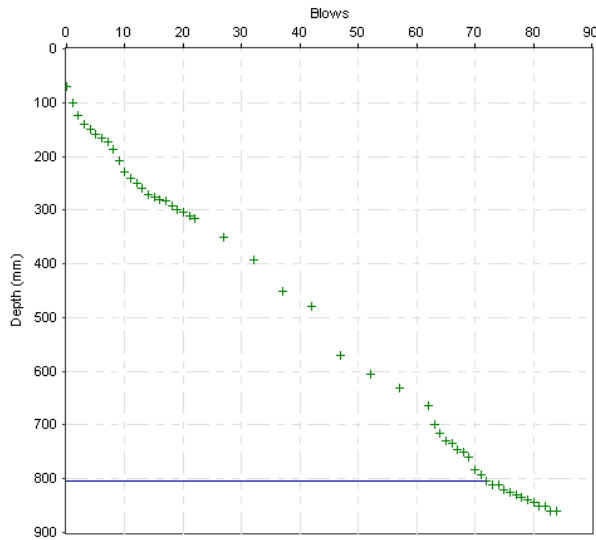
Layer Boundaries Chart

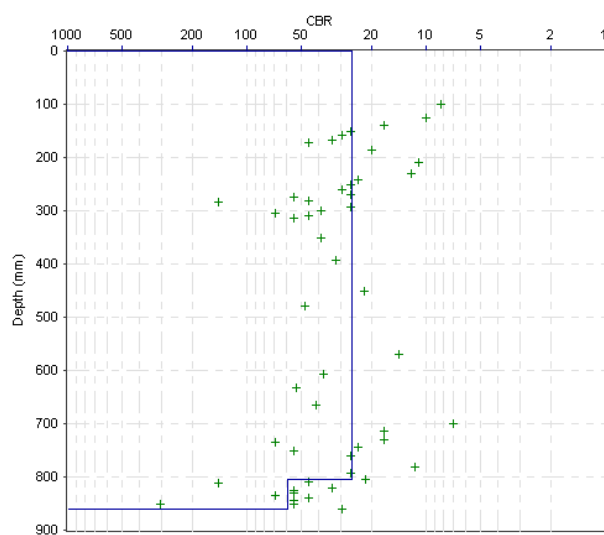
CBR Chart

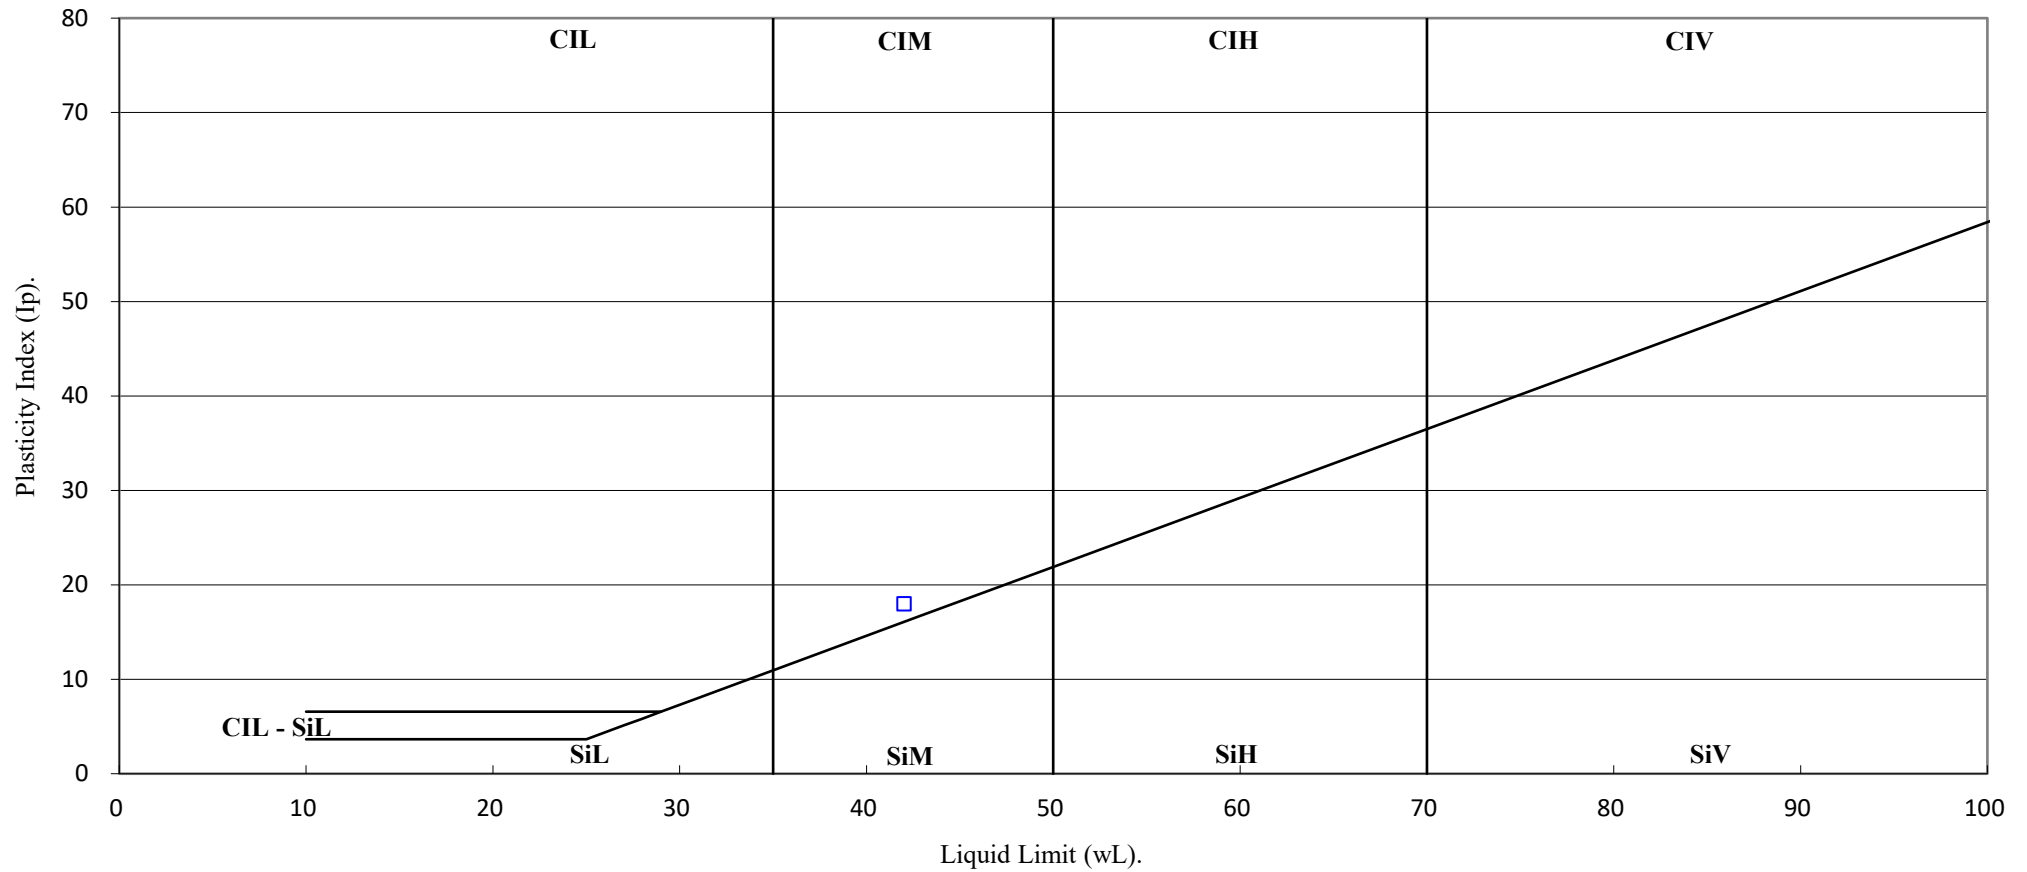
# PLASTICITY CHART

BS EN ISO 14688-2:2017 Clause 4.4

M/C = Moisture Content, LL = Liquid Limit, PL = Plastic Limit, Plastic PI = Plasticity Index, CH = Clay High

Therefore, the natural clay deposits tested are unlikely to undergo significant changes in volume, if large changes in their natural moisture content were to occur due to seasonal variations or the like.

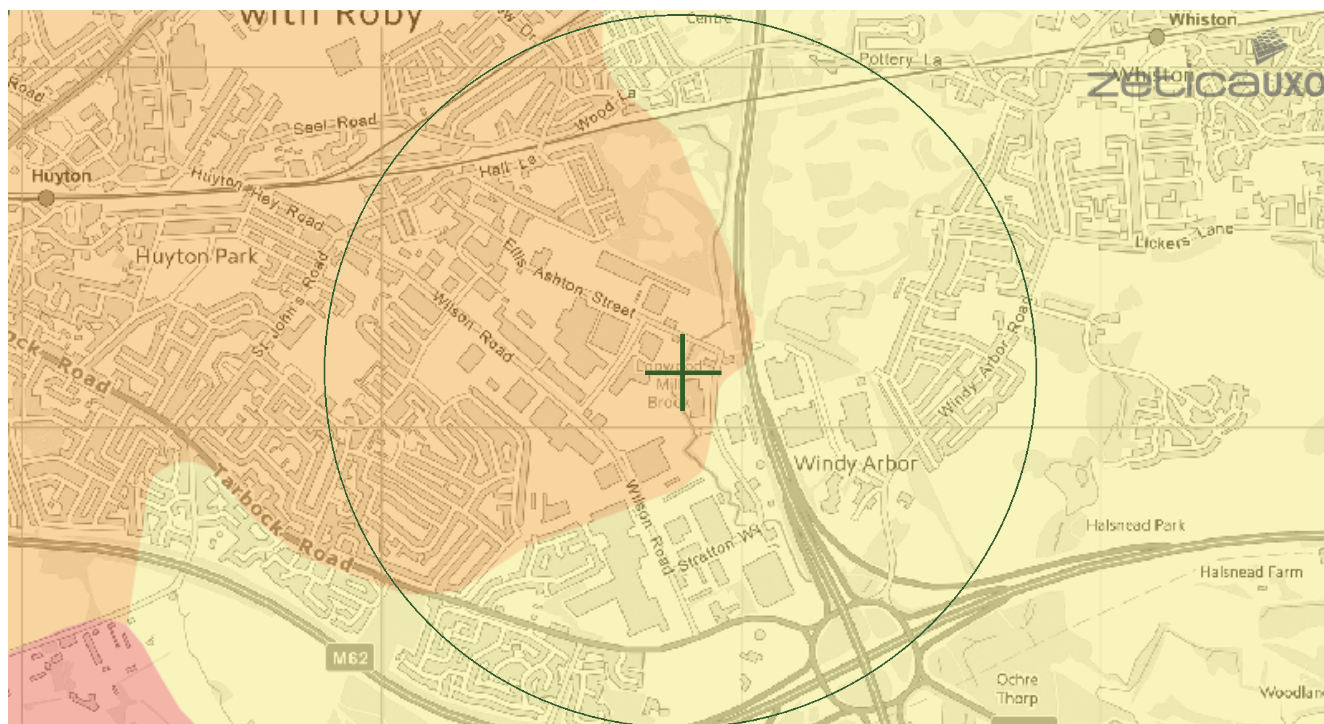
## SITE LOCATION

This map principally indicates a hazard from Unexploded Bombs (UXB) due to WWII bombardment. Other sources of Unexploded Ordnance (UXO) may be present. It should be noted that this map does not represent UXO risk and should not be reported as such when reproduced.

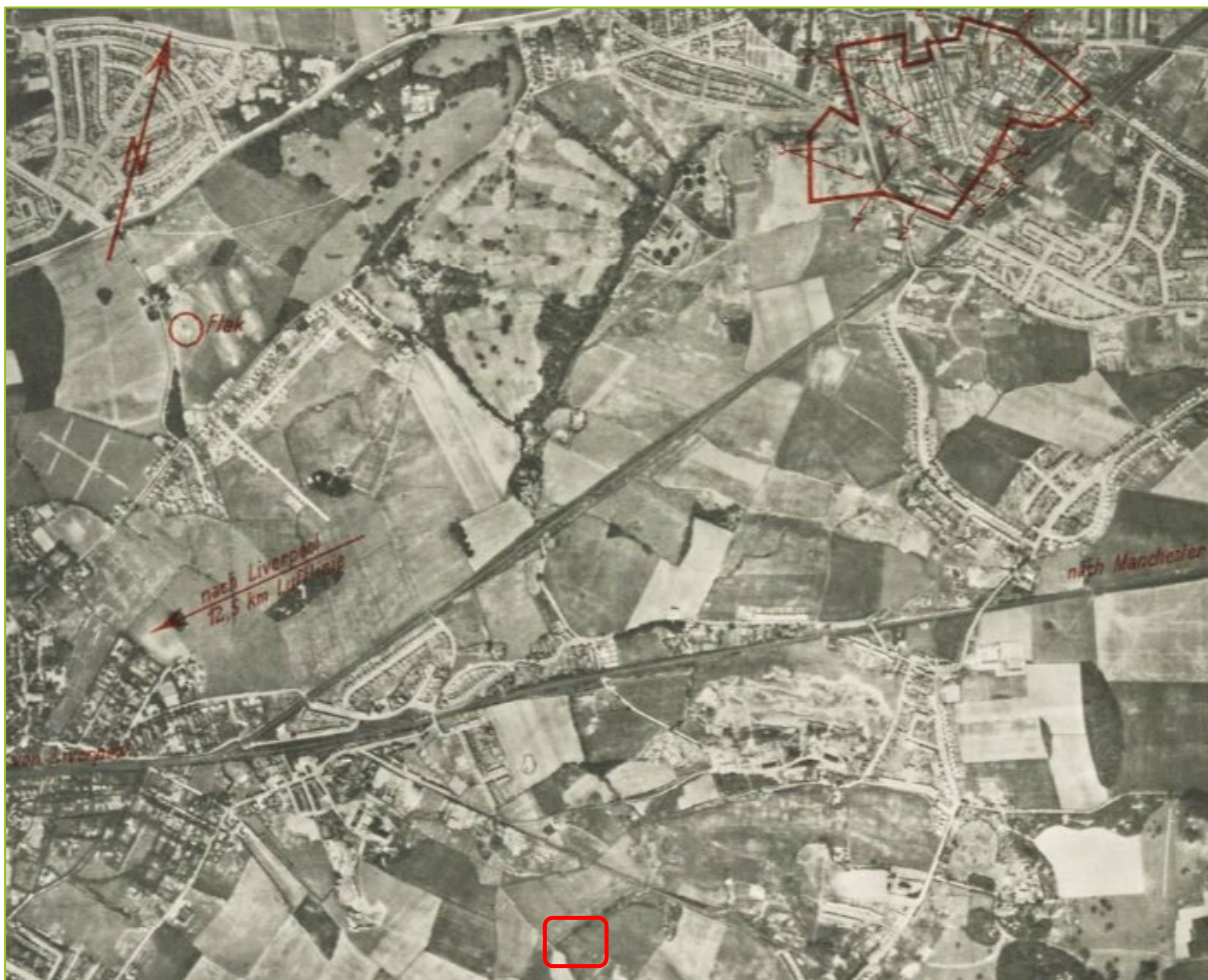
Luftwaffe target mapping denoting the cable works 2km to the north as a Luftwaffe target.

British Insulated Cables, a cable factory that was located approximately 2km north in Prescott, was recorded as a Luftwaffe target. The city of Liverpool, which was located approximately 5-10km to the west, was one of the most bombed cities in the country. Considering the importance of railway infrastructure to the war effort, the local train tracks, such as those that were located 250m to the north, may also have been targeted during Luftwaffe raids.

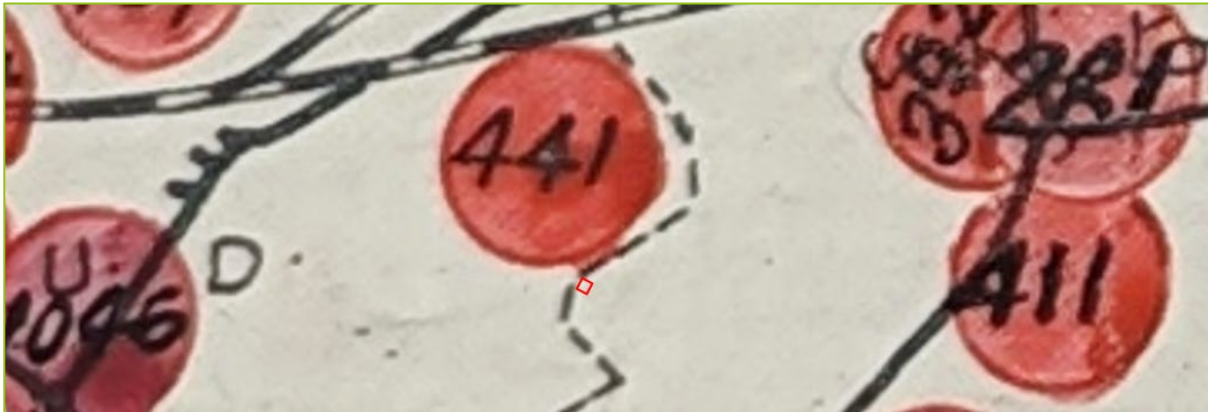
Incident no. 441 to the north of the site.

- No bombs were recorded on site between either period.
- An incident labelled number 441 was plotted to the north between 1939-41.
- Further incidents were plotted approximately 1km to the east and west between 1939-41. Another incident was plotted 1km north-east between 1942-45.

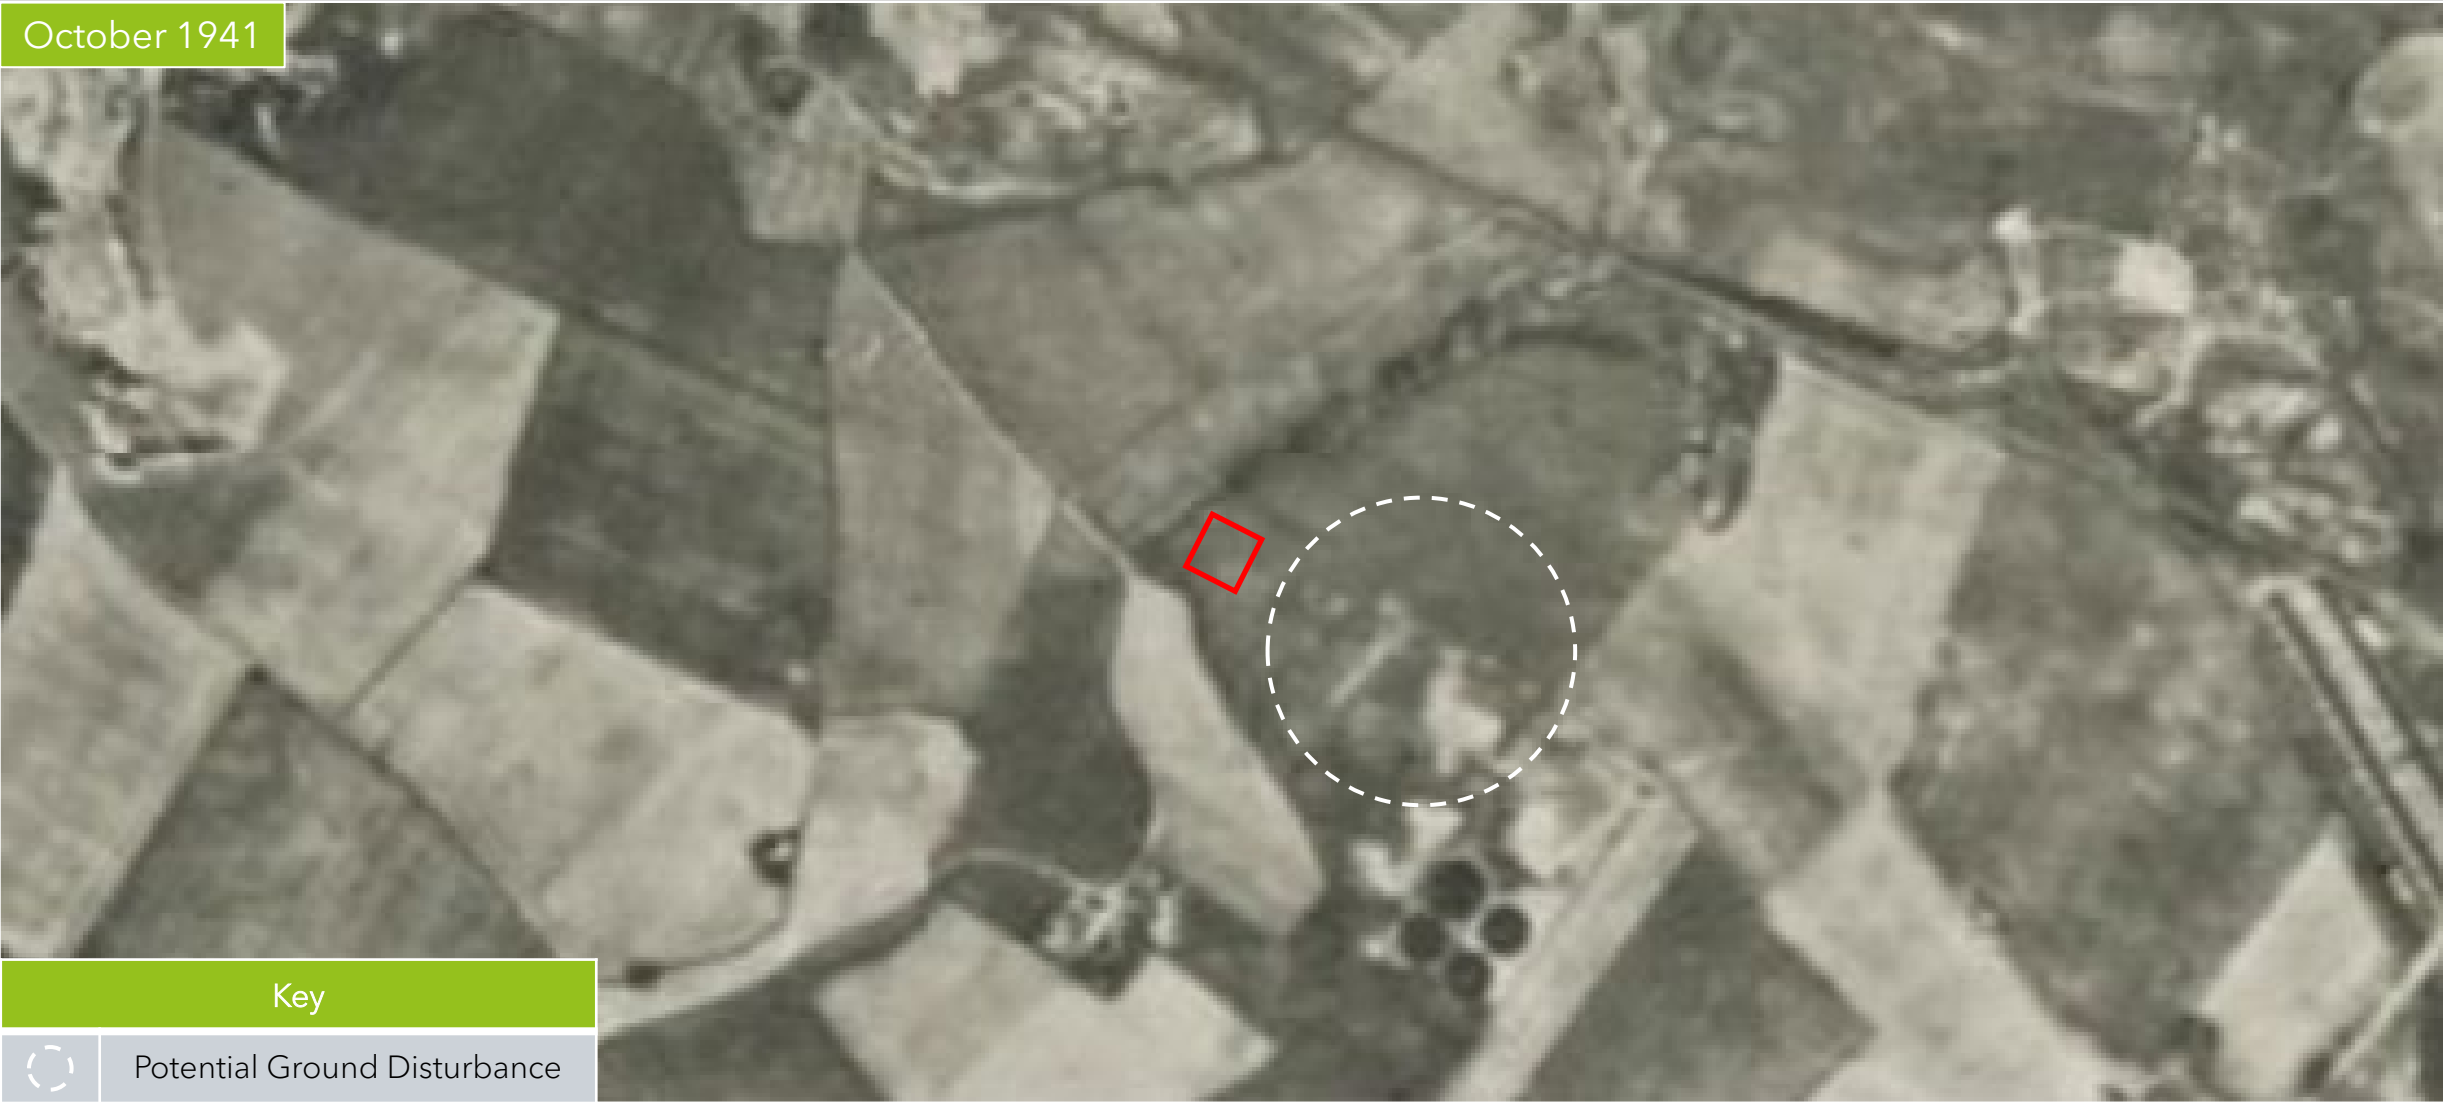
10<sup>th</sup> August 1945

Key

| | Potential Ground Disturbance |
