**PHASE 2: GROUND INVESTIGATION REPORT**  
**ALAN WOODS AND PARTNERS / VEOLIA**  
**HUYTON FOOD WASTE PROJECT**  
**ELLIS ASHTON STREET**  
**LIVERPOOL**  
**L36 6BJ**

**Project No: 24-787**

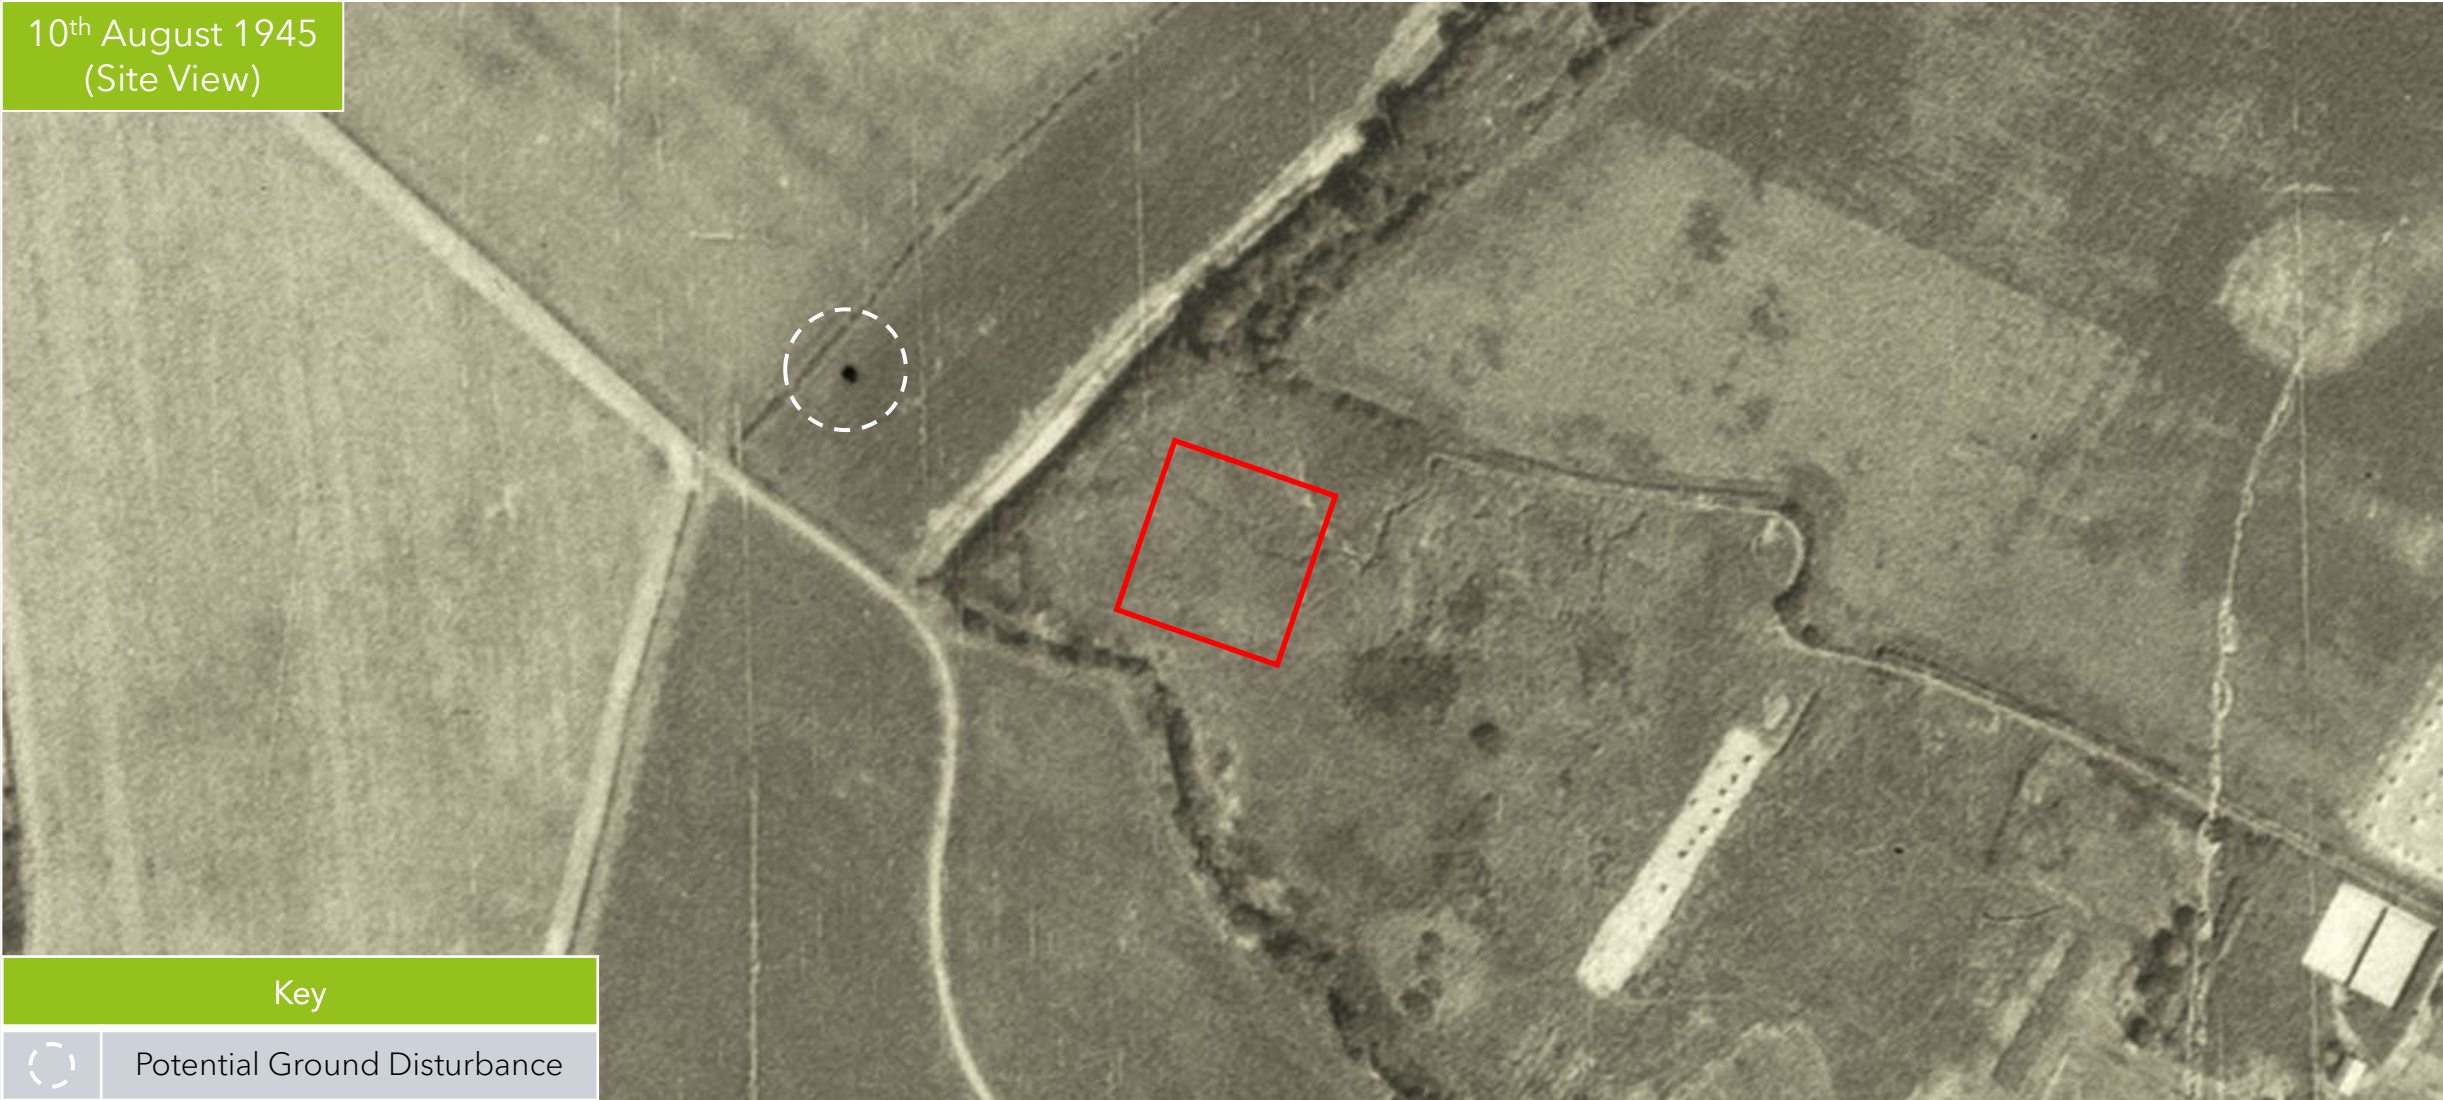
10<sup>th</sup> August 1945  
(Site View)

Key

Potential Ground Disturbance

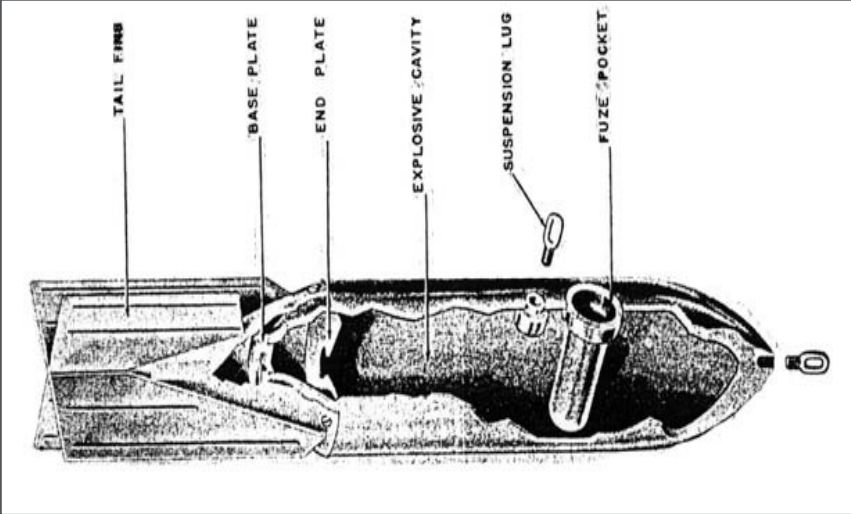
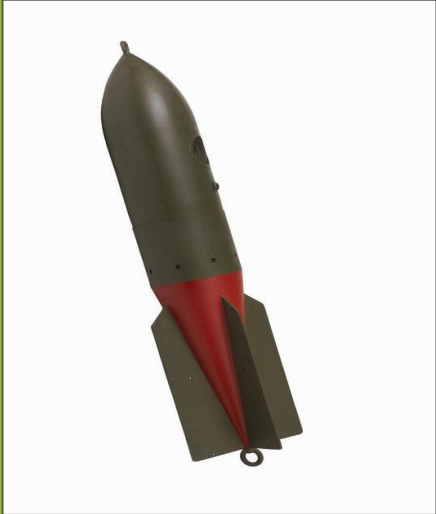
| 50kg HE Bomb | |
|---|---|
| Type of Fuze | Impact or electrical time delay |
| Notes | Most dropped bomb by weight over Britain. Useful against light targets. |

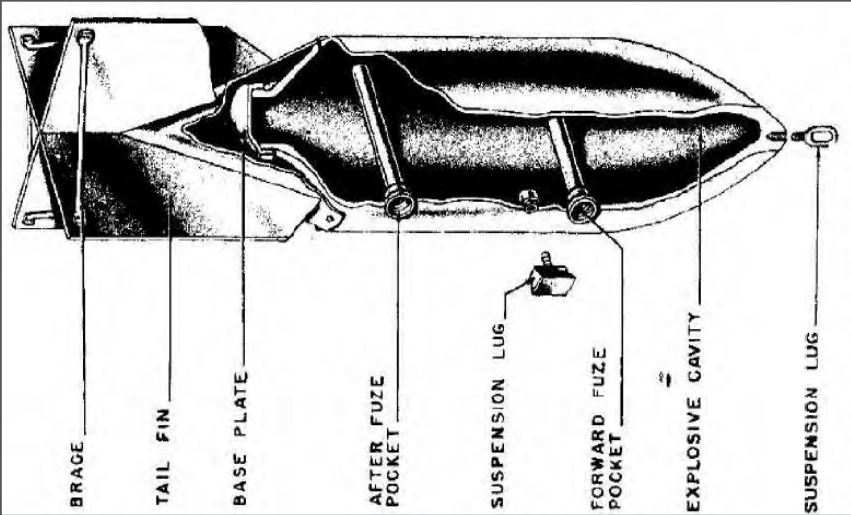
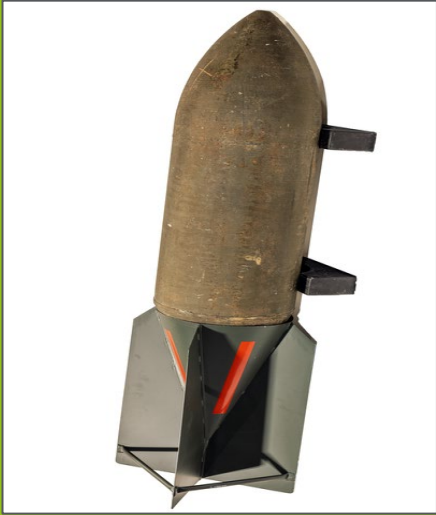
| 250kg HE Bomb | |

| 250kg HE Bomb | |
|---|---|
| Bomb Weight | 256kg |
| Type of Fuze | Impact or electrical time delay |
| Notes | Increased penetrative ability proved useful against sub-terranean targets. |

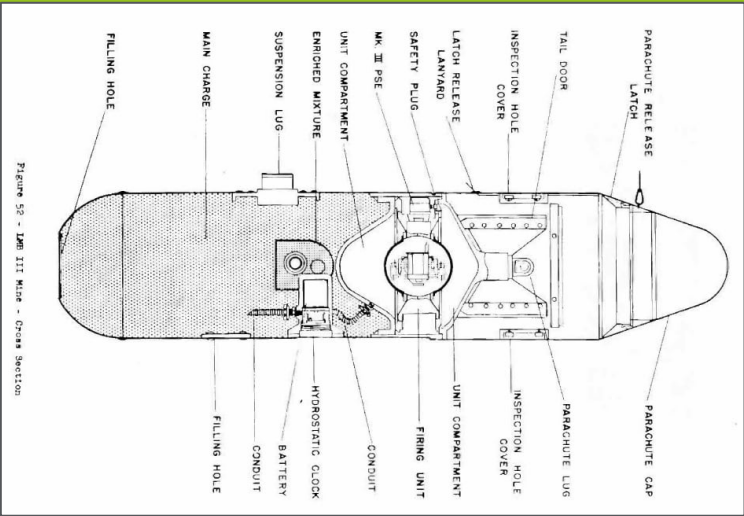
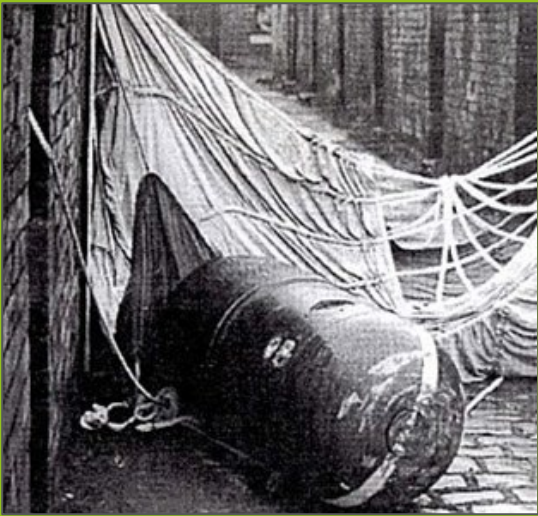
| Parachute Mine (Luftmine B) | |
|---|---|
| Type of Fuze | Impact or electrical time delay |
| Notes | Larger than Luftmine A (500kg). Descent retarded by parachute. |

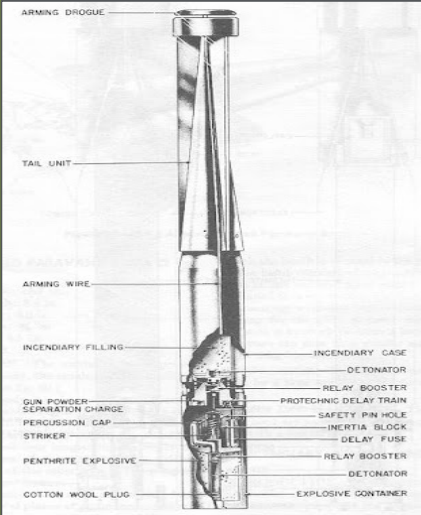
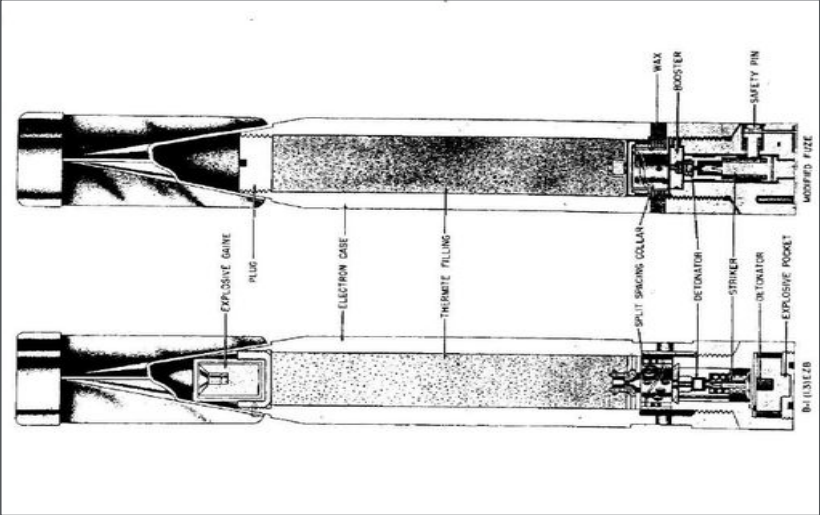
| 2kg Incendiary Bomb | |

| 2kg Incendiary Bomb | |
|---|---|
| Bomb Weight | 2.2kg |
| Type of Fuze | Electrical impact fuze |
| Notes | Dropped in container in batched of up to 372. Also had 1kg variant. |

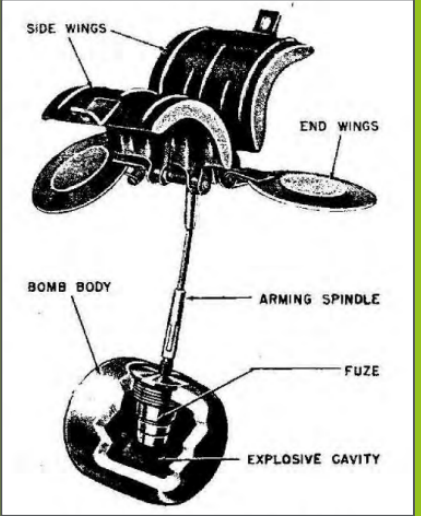
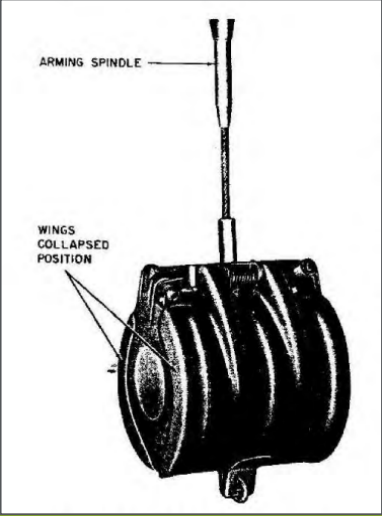
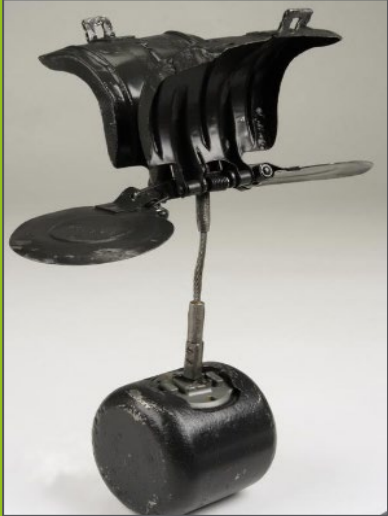
| SD2 AP Butterfly Bomb | |

| SD2 AP Butterfly Bomb | |
|---|---|
| Bomb Weight | 2kg |
| Type of Fuze | Time delay, anti-handling device |
| Notes | Fragmentation device. Bomb armed by wings as they spun on descent. |

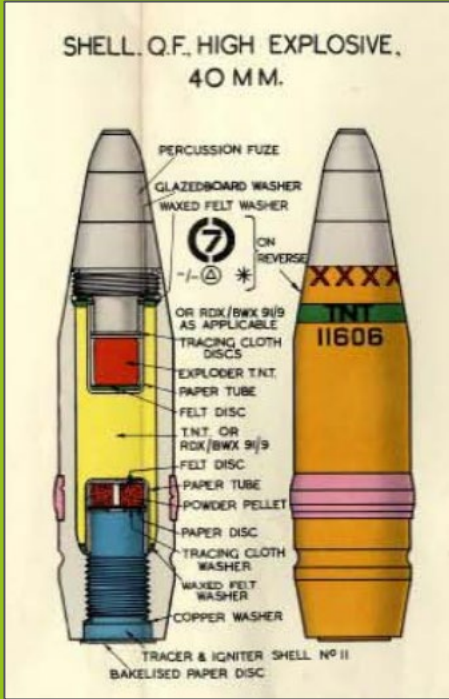
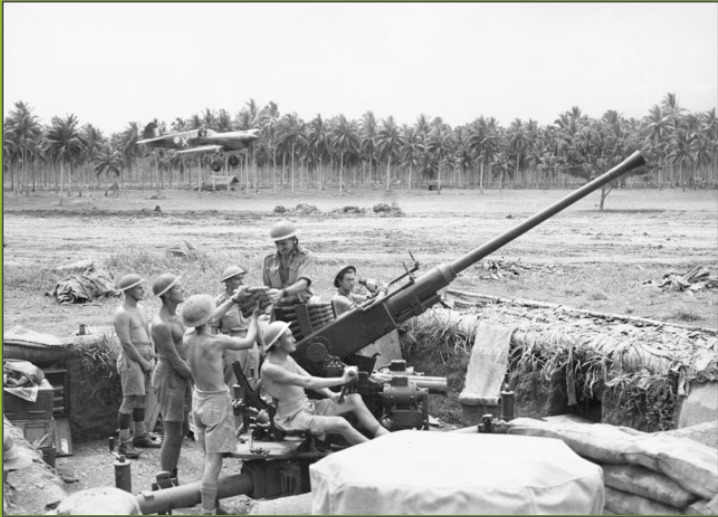
| 40mm Bofors Shell | |

| 40mm Bofors Shell | |
|---|---|
| Shell Weight | 0.84kg |
| Type of Fuze | Impact fuze |
| Notes | Both HE and armour piercing variants were utilised. |
