# HISTORIC BUILDING RECORDING

*Dye House & Outbuilding, Liverpool Road, Prescot, Merseyside*

ARS Report N°: 2022/118  
Oasis ID N°: archaeol5-509381

# Historic Building Recording: Dye House & Outbuilding, Liverpool Road, Prescot, Merseyside

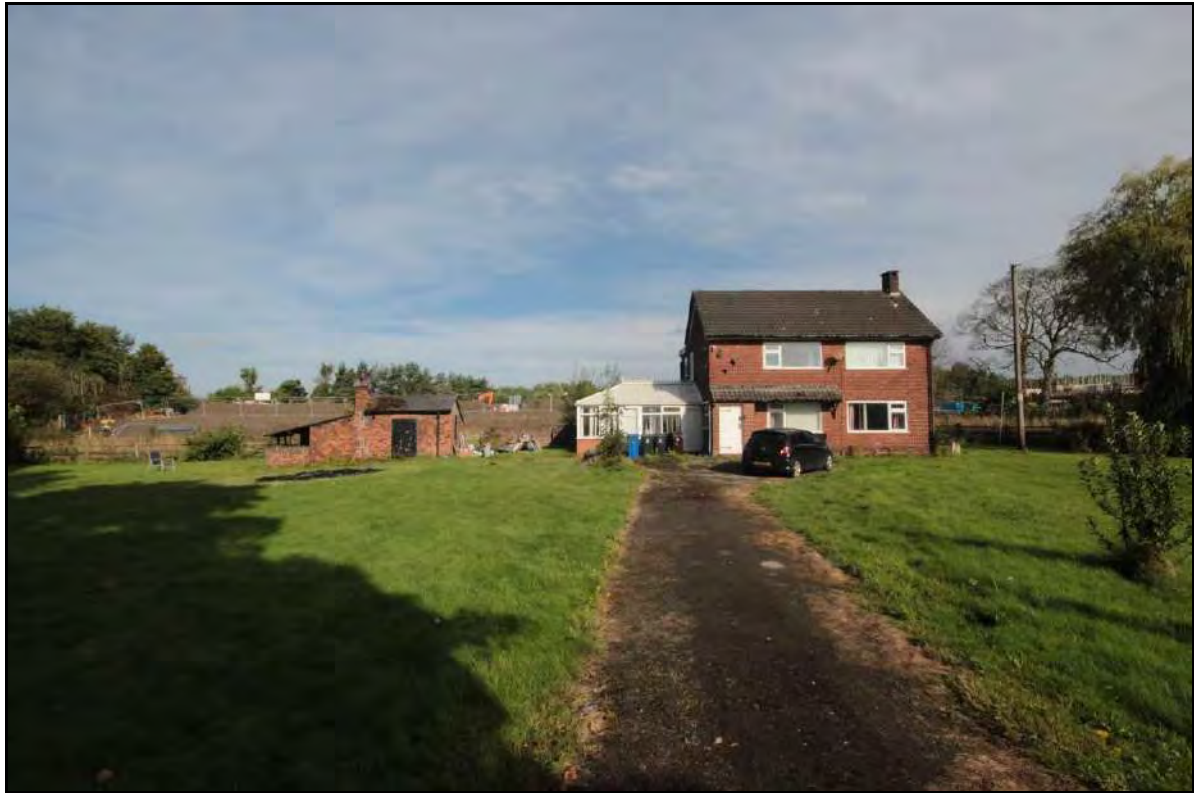
Photograph 4: View of the former Dye House and Outbuilding, situated within the northern extent of the site, taken facing north (File: HBR\_24)

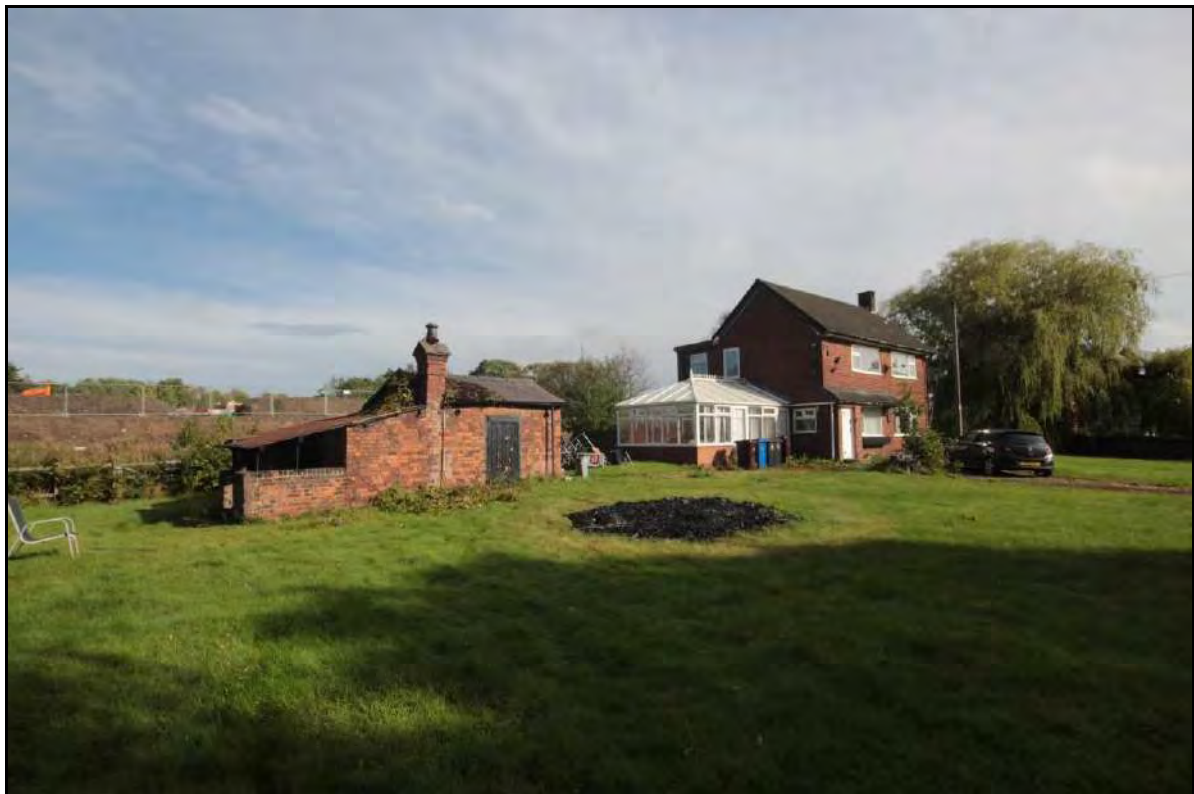
Photograph 5: View of the Dye House and Outbuilding, taken facing north-east from the western extent of the site (File: HBR\_23)

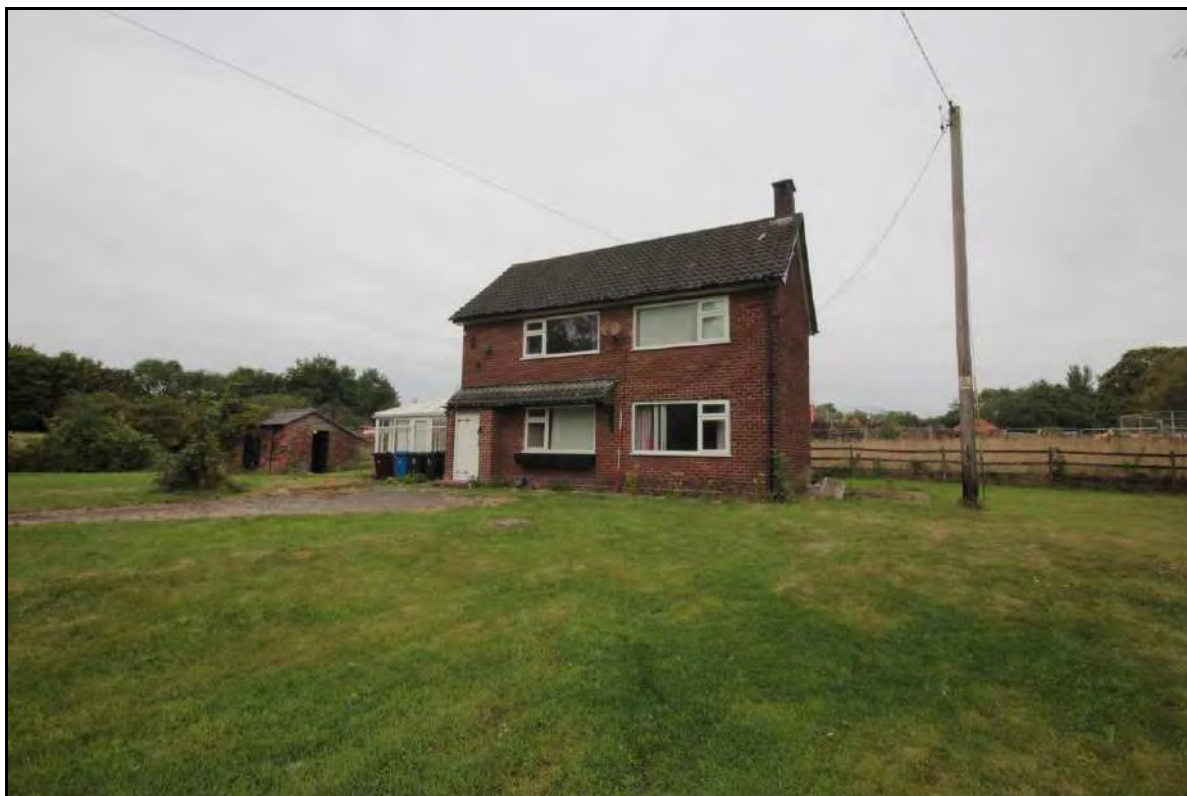
Photograph 13: Oblique view of the former Dye House, taken facing north-west with 2m scale (File: HBR\_12)

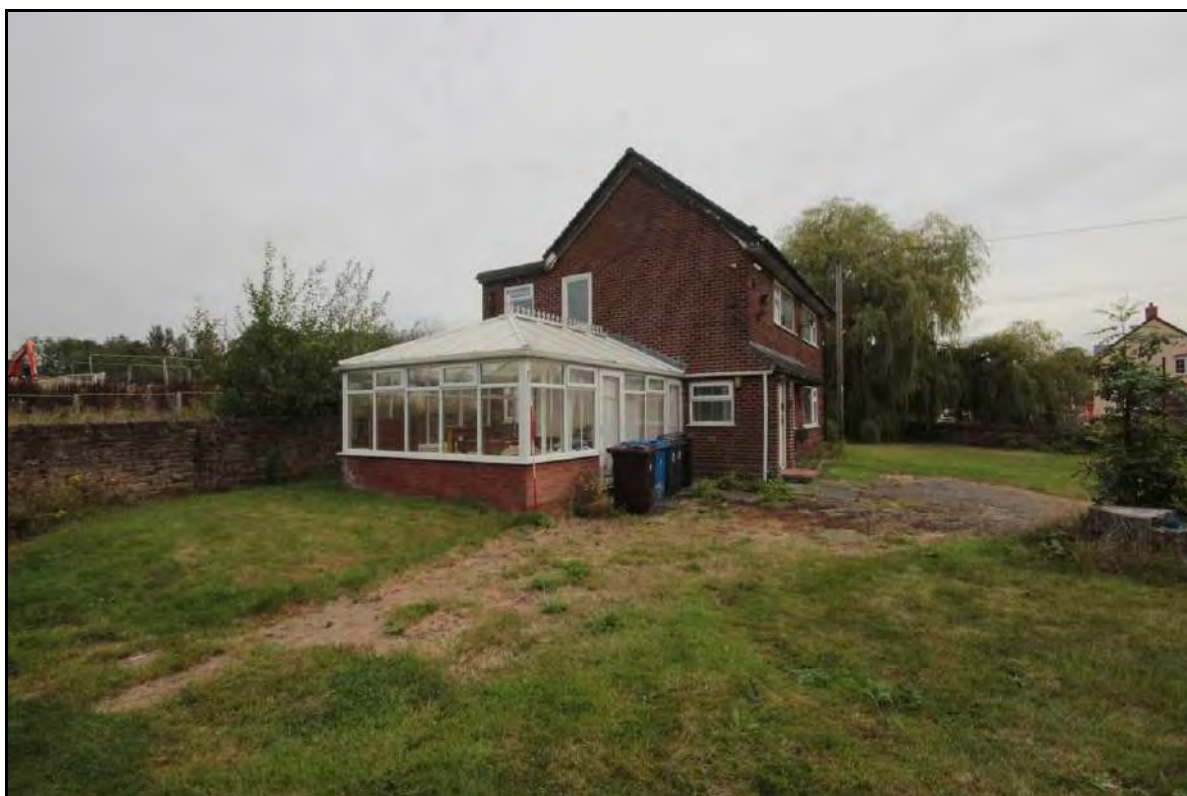
Photograph 14: View of the western extent of the former Dye House, taken with 2m scale facing north-east (File: HBR\_19)

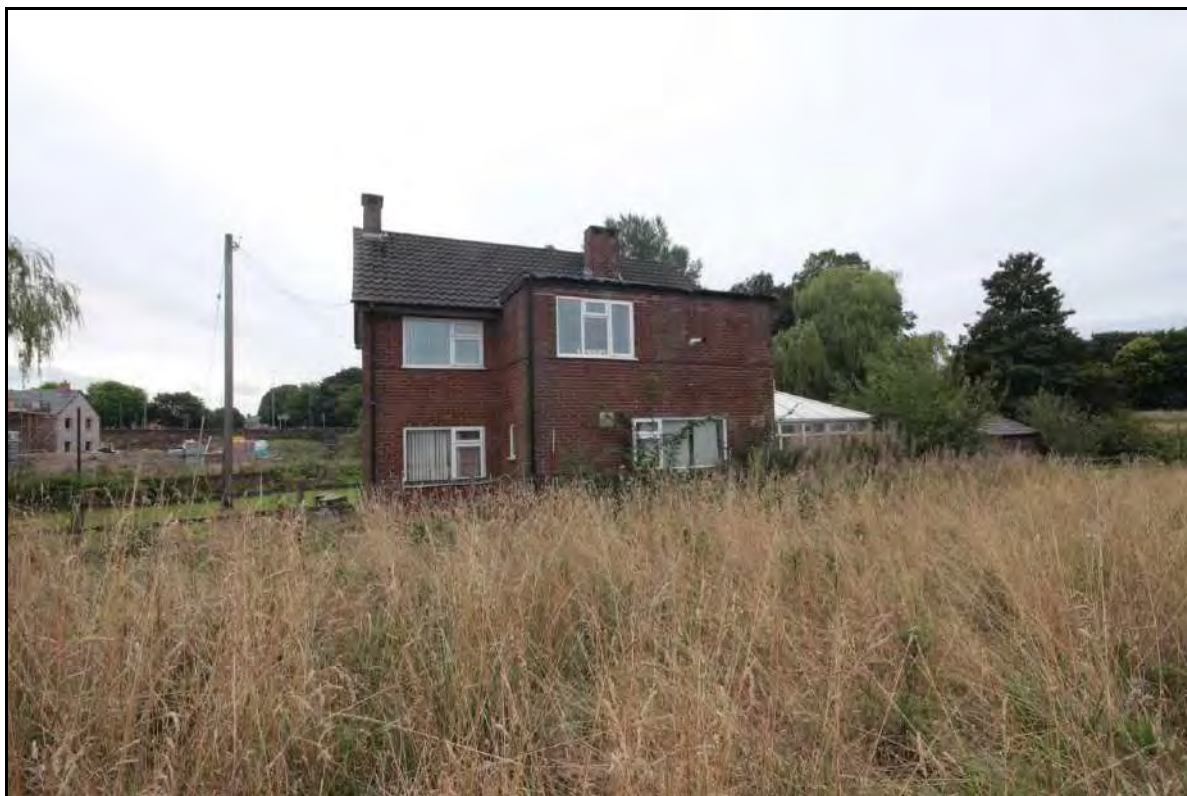
Photograph 15: View of the northern side of the former Dye House, taken facing south with 2m scale (File: HBR\_18)

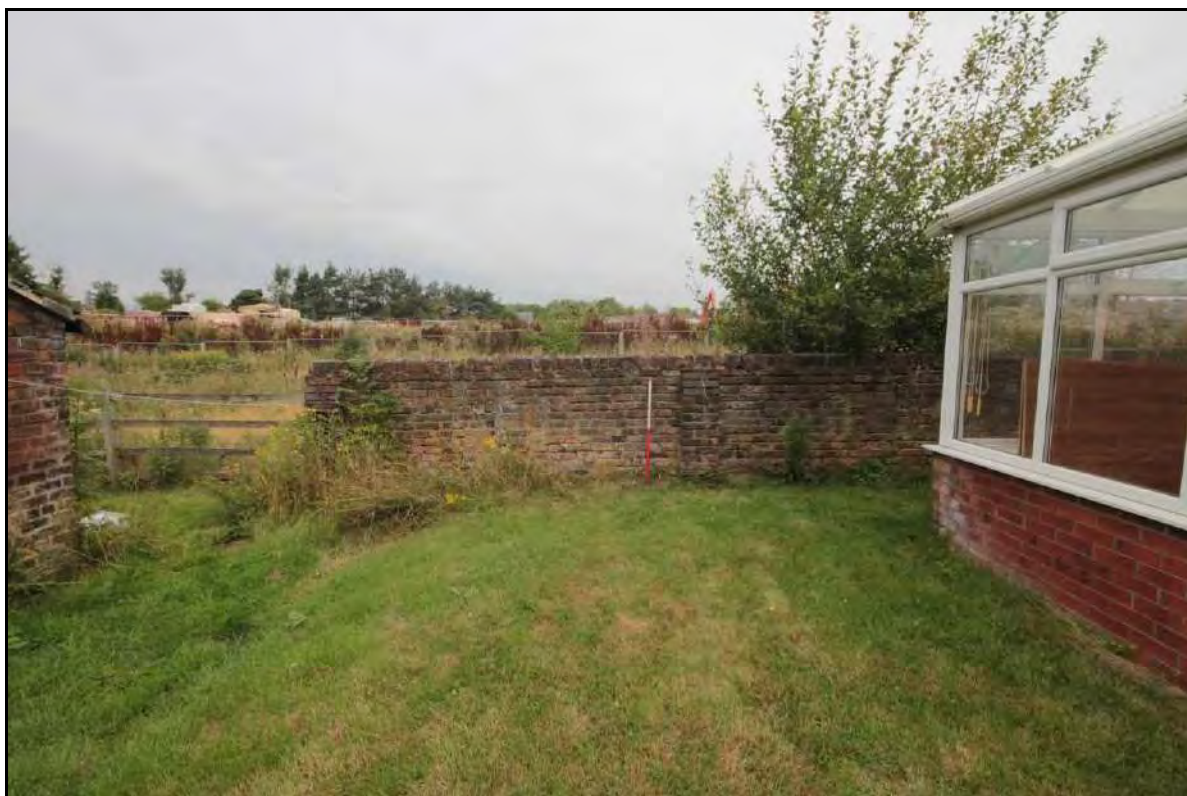
Photograph 16: View of the brick wall attached to the western side of the former Dye House, taken with 1m scale facing north (File: HBR\_21)

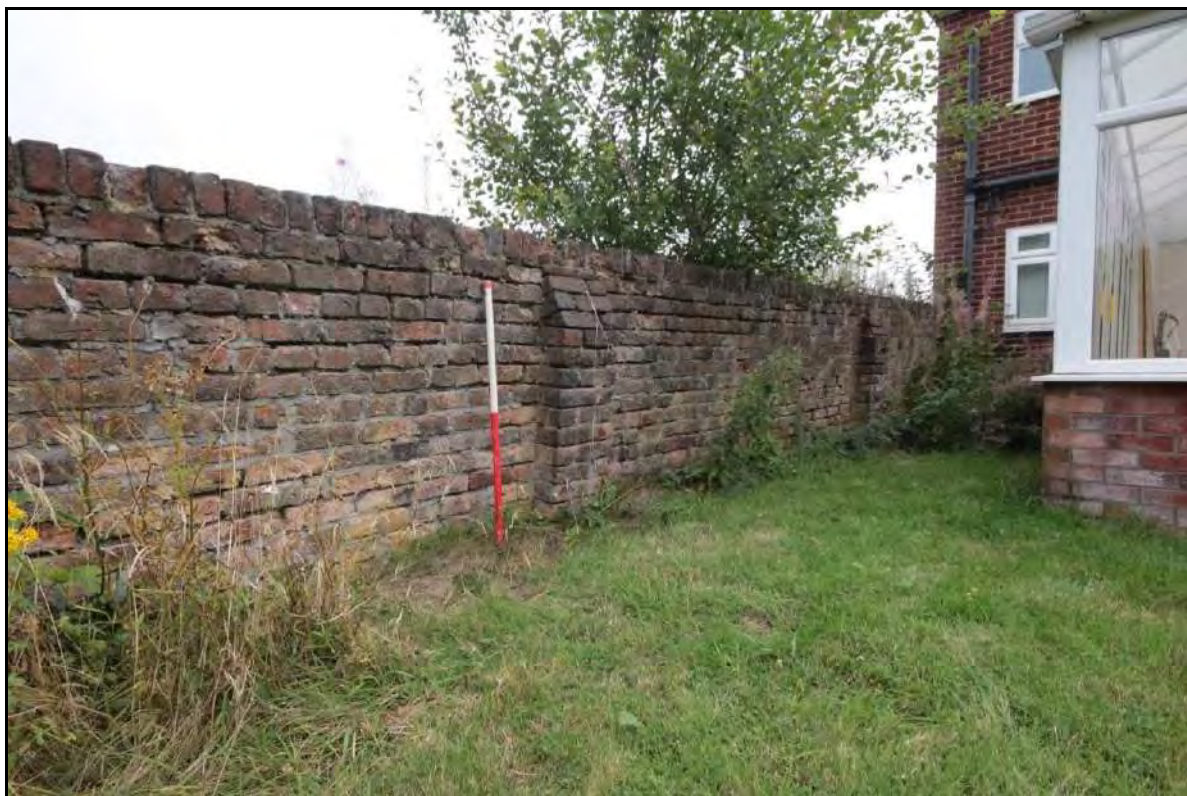
Photograph 17: Oblique view of the brick wall attached to the western side of the former Dye House, taken with 1m scale facing north-east (File: HBR\_22)

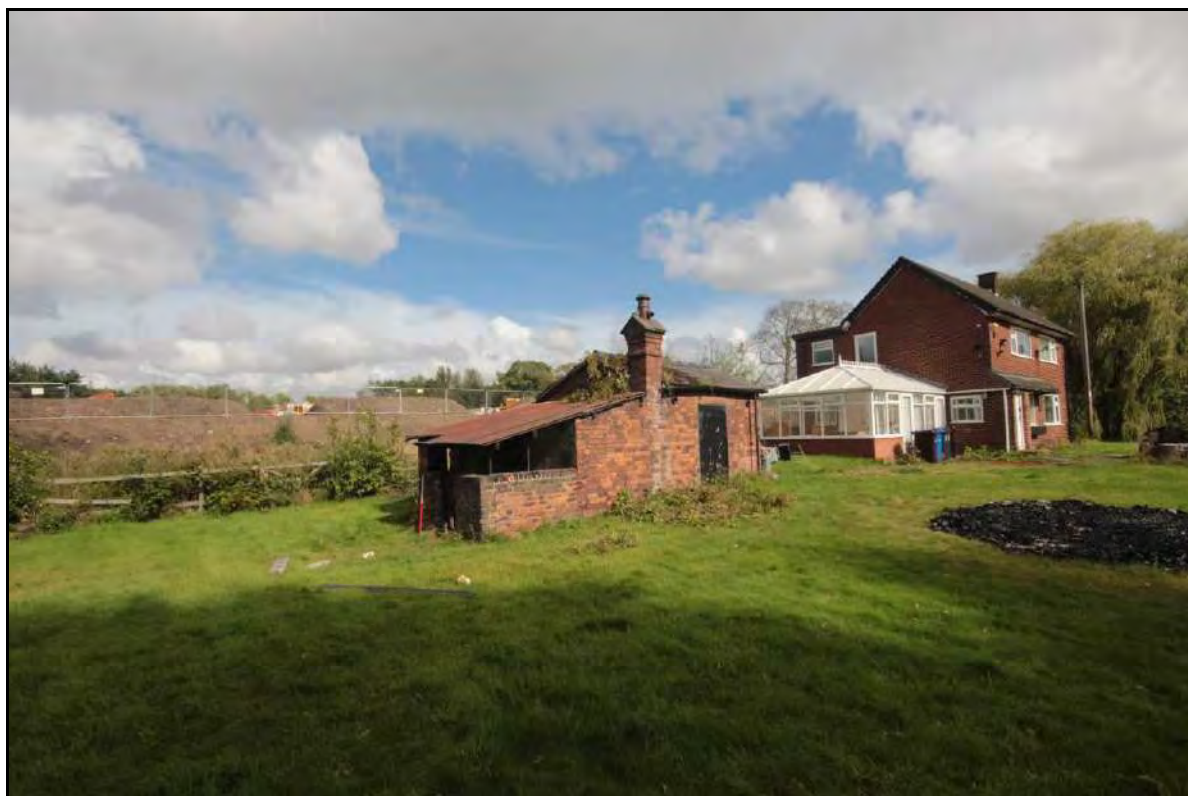
Photograph 24: View of the outbuilding from the south-west, taken with 1m scale facing north-east (File: HBR\_49)

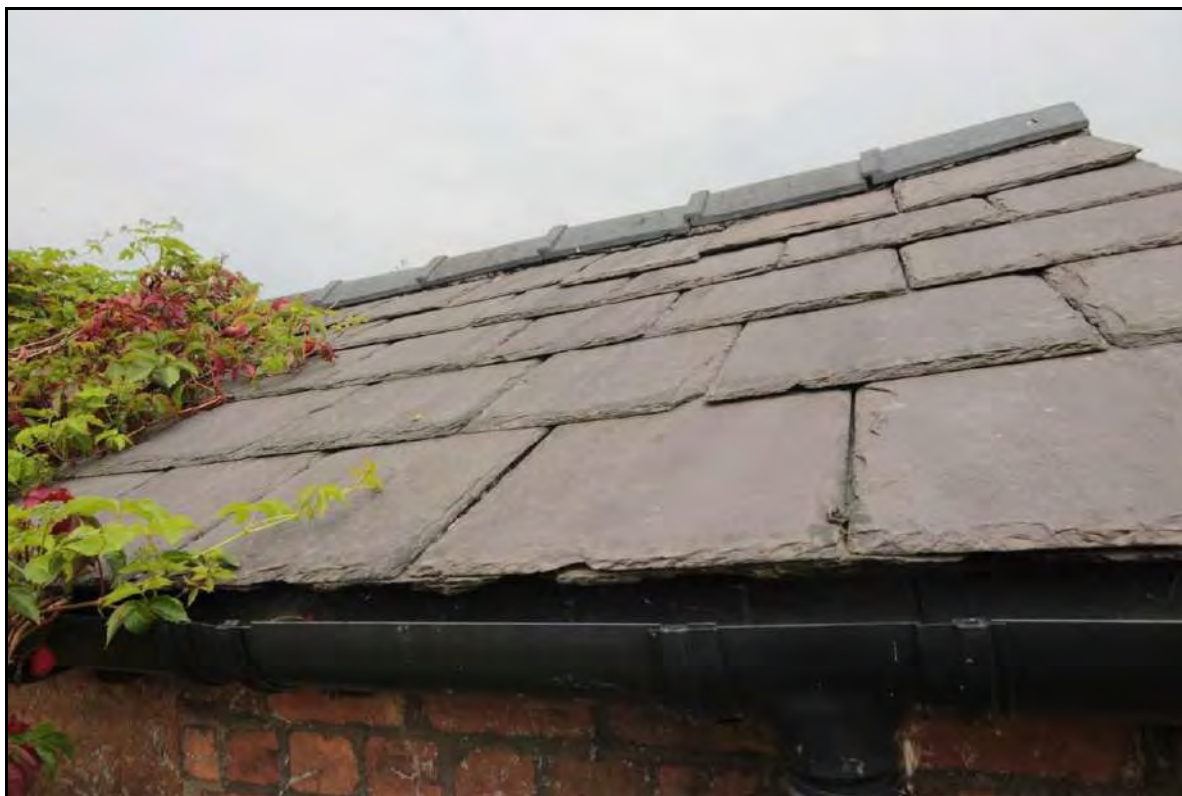
Photograph 25: View of the pitched slate roof of the outbuilding, taken facing north-west (File: HBR\_55)

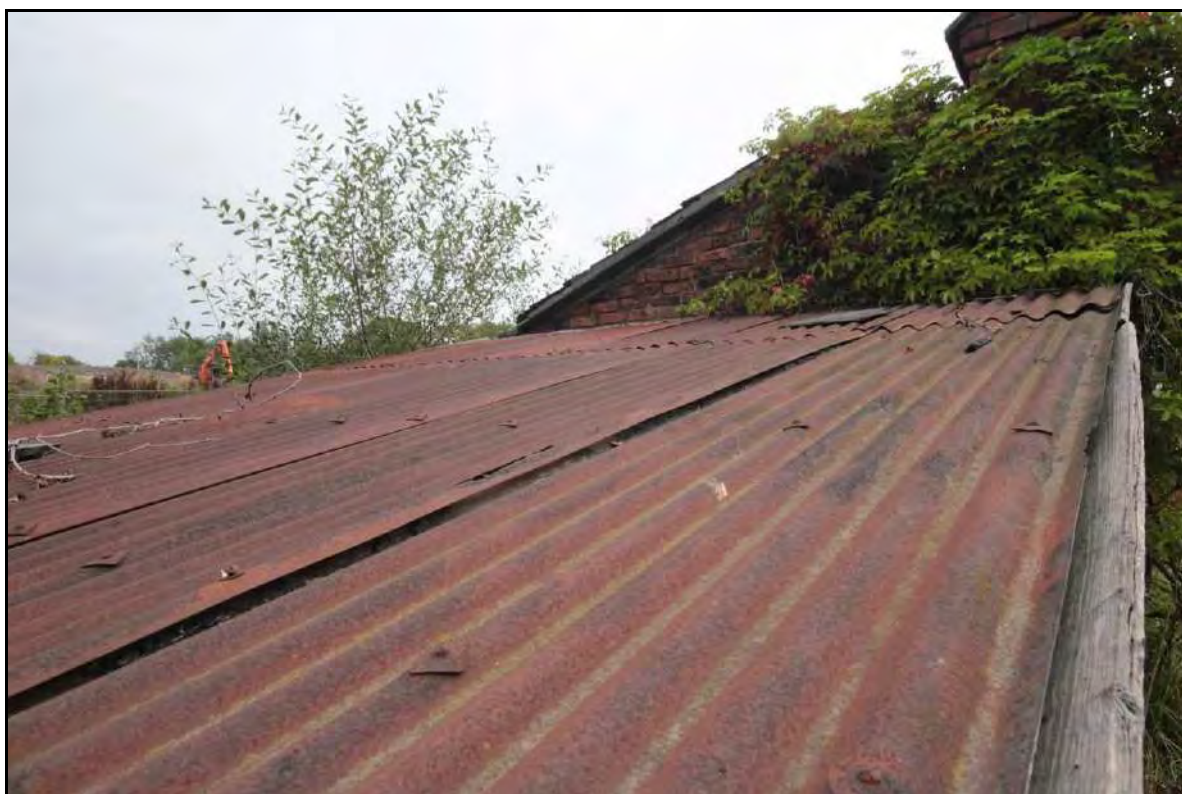
Photograph 26: View of the corrugated roofing sheets of the outbuilding's lean-to, taken facing north-east (File: HBR\_56)

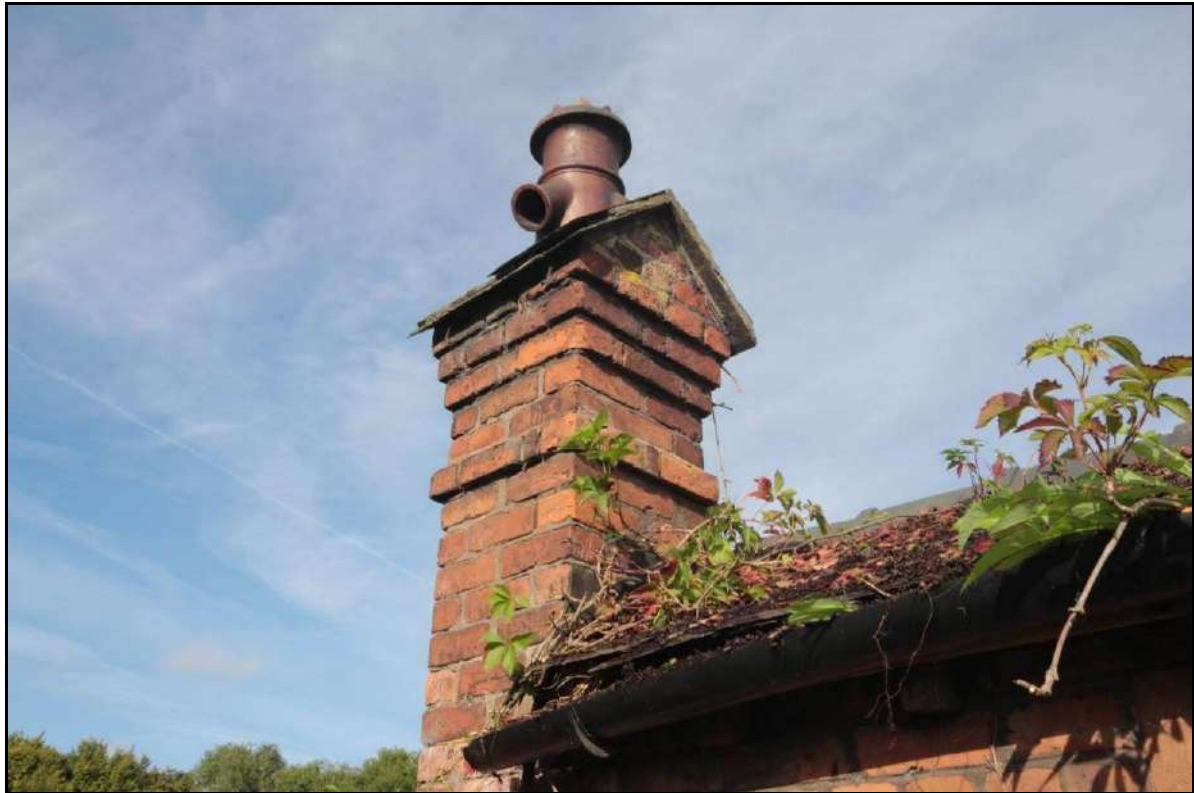
Photograph 27: View of the chimneystack of the outbuilding's pitched roof, taken facing north-west (File: HBR\_43)

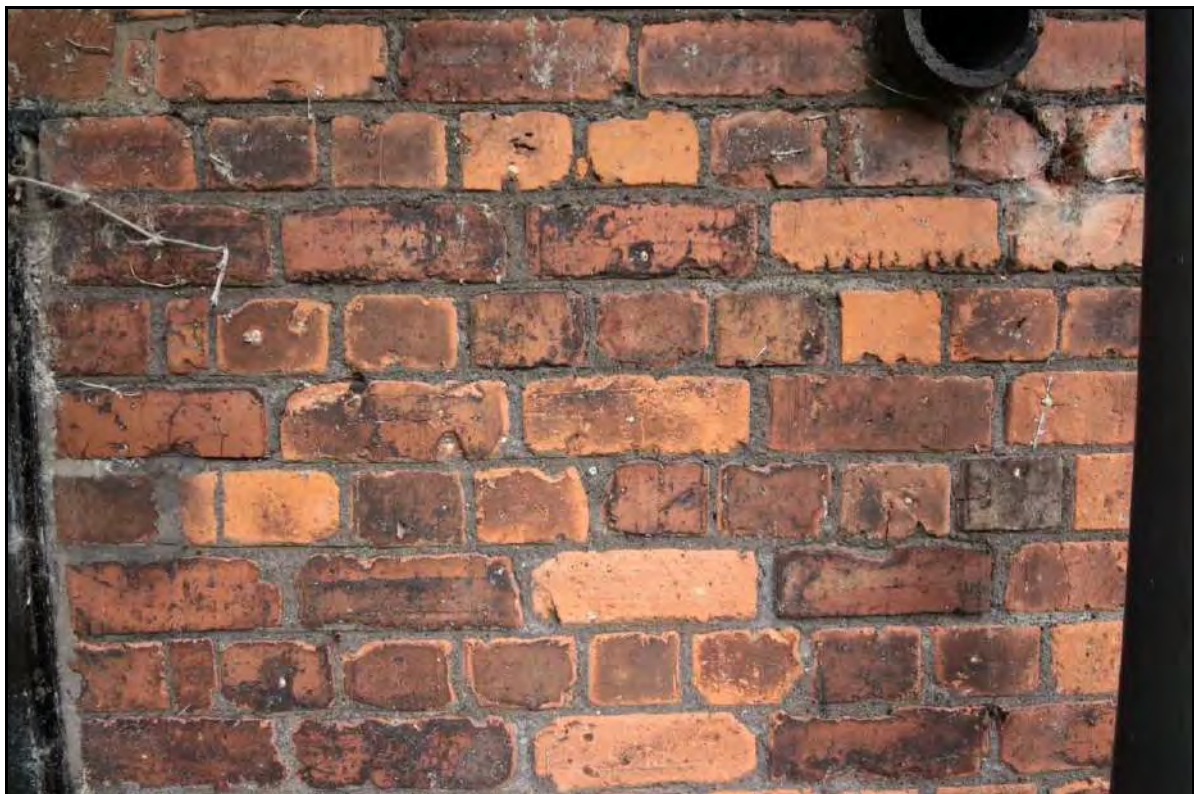
Photograph 28: View of the brick used in the southern and western walls of the outbuilding, taken facing north (File: HBR\_39)

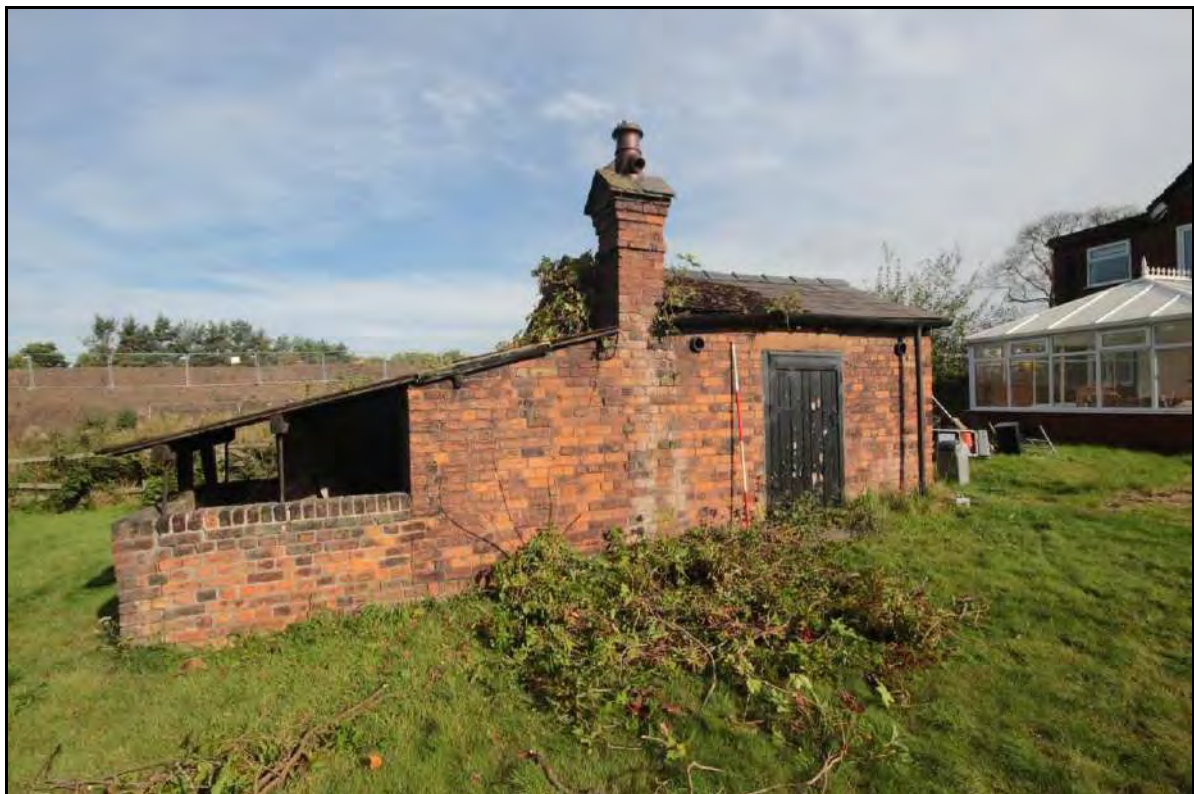
Photograph 30: Oblique view of the outbuilding's southern elevation, taken facing north-east with 2m scale (File: HBR\_37)

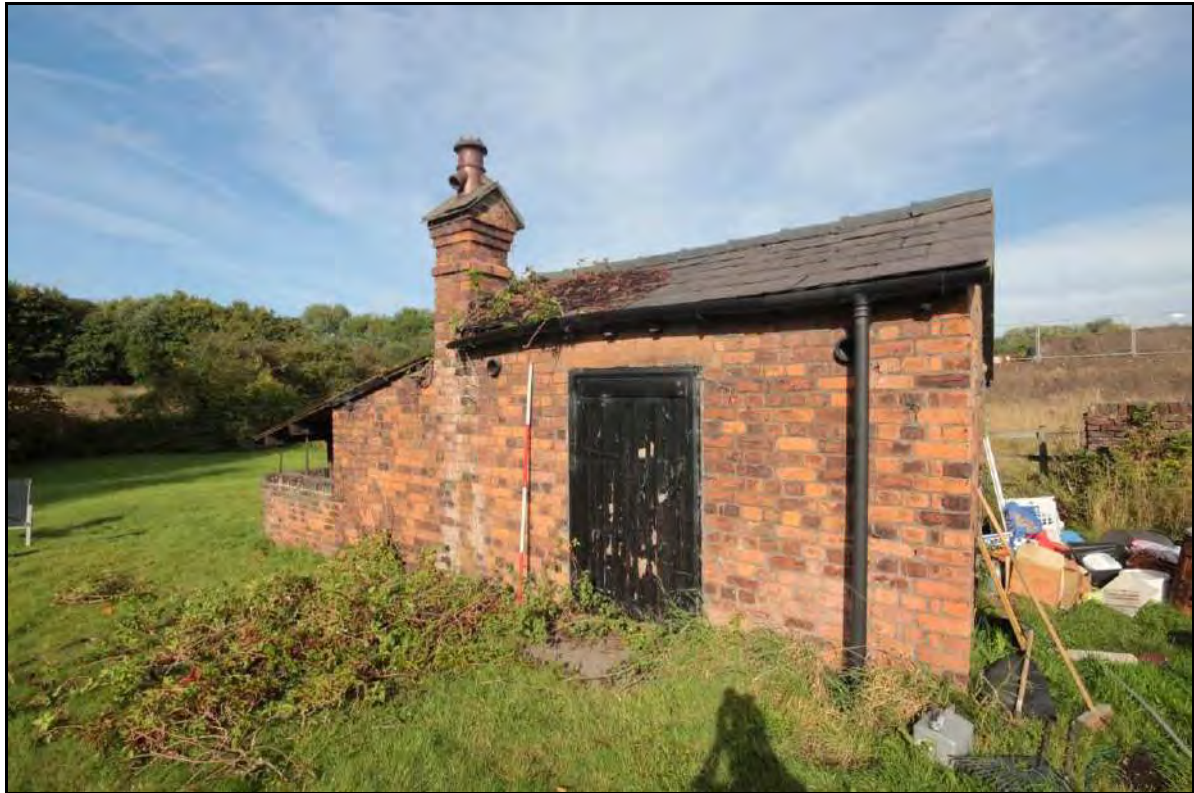
Photograph 31: Oblique view of the outbuilding's southern elevation, taken facing north-west with 2m scale (File: HBR\_38)

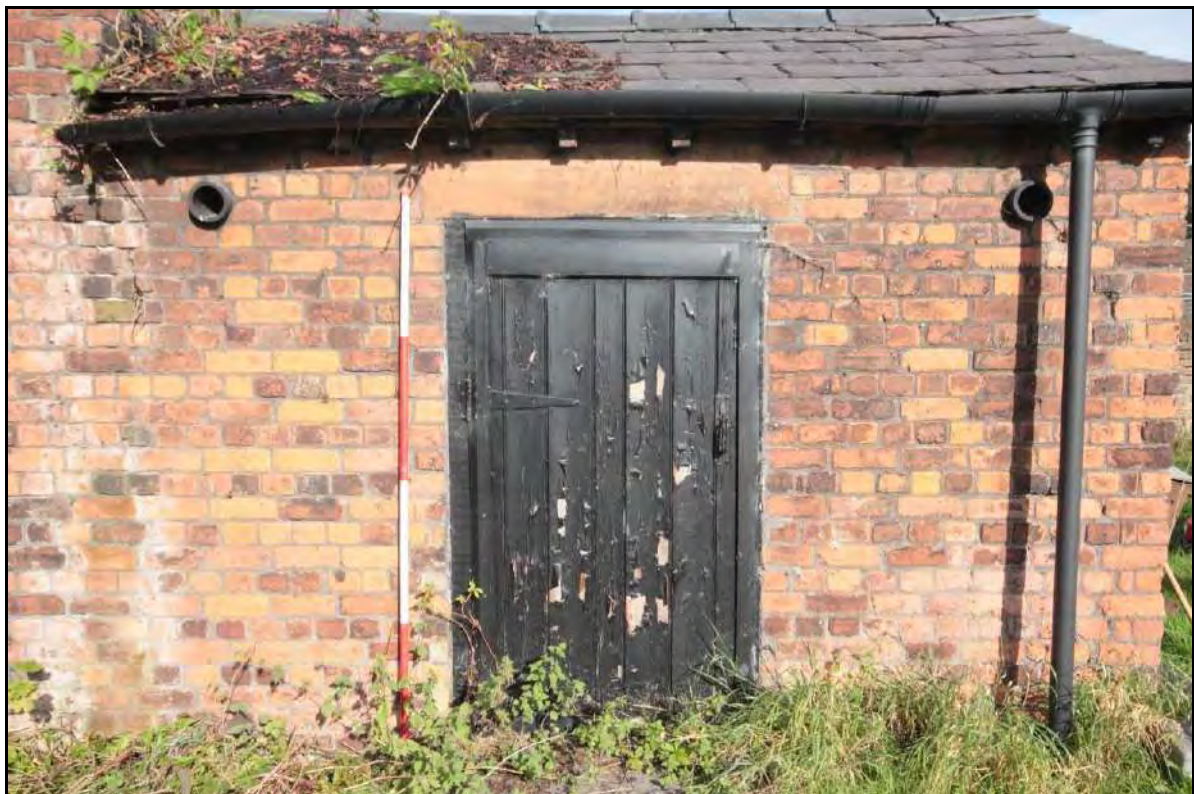
Photograph 32: View of the door flanked by vents on the southern elevation of the outbuilding, taken facing north with 2m scale (File: HBR\_40)

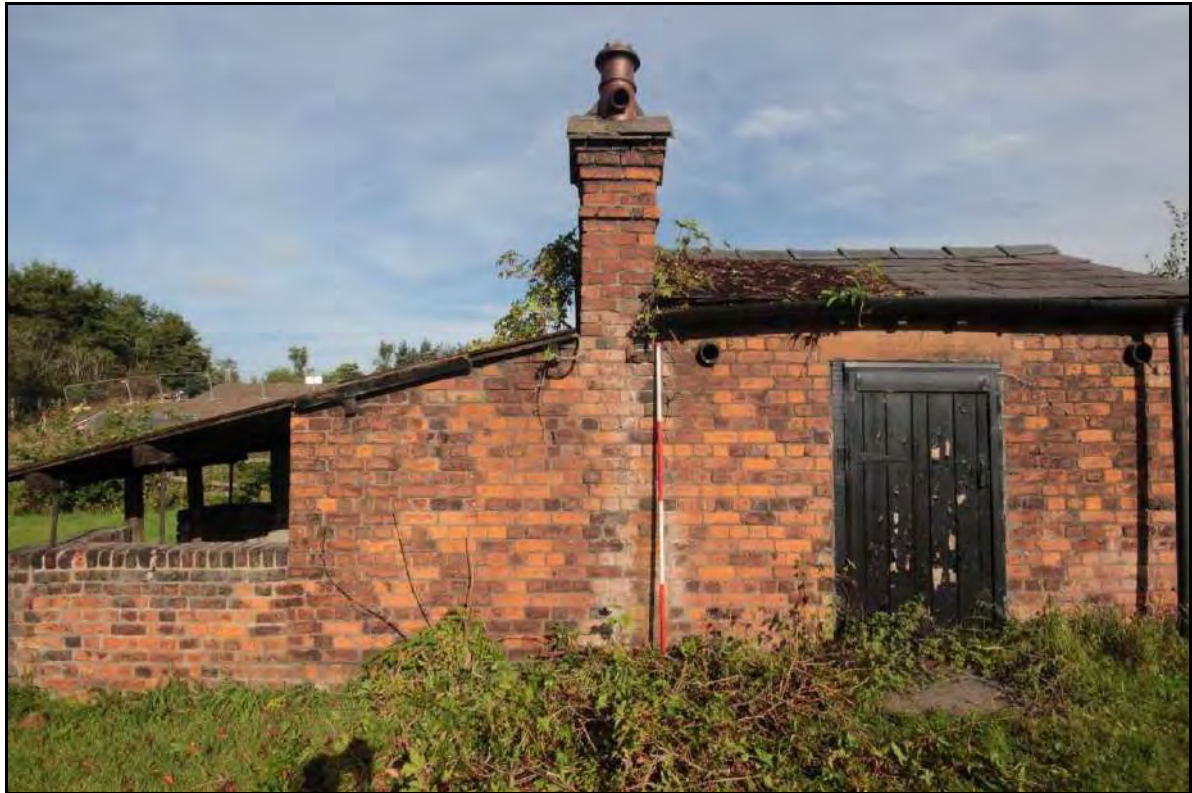
Photograph 33: View of the central extent of the outbuilding's southern elevation, taken facing north with 2m scale (File: HBR\_42)

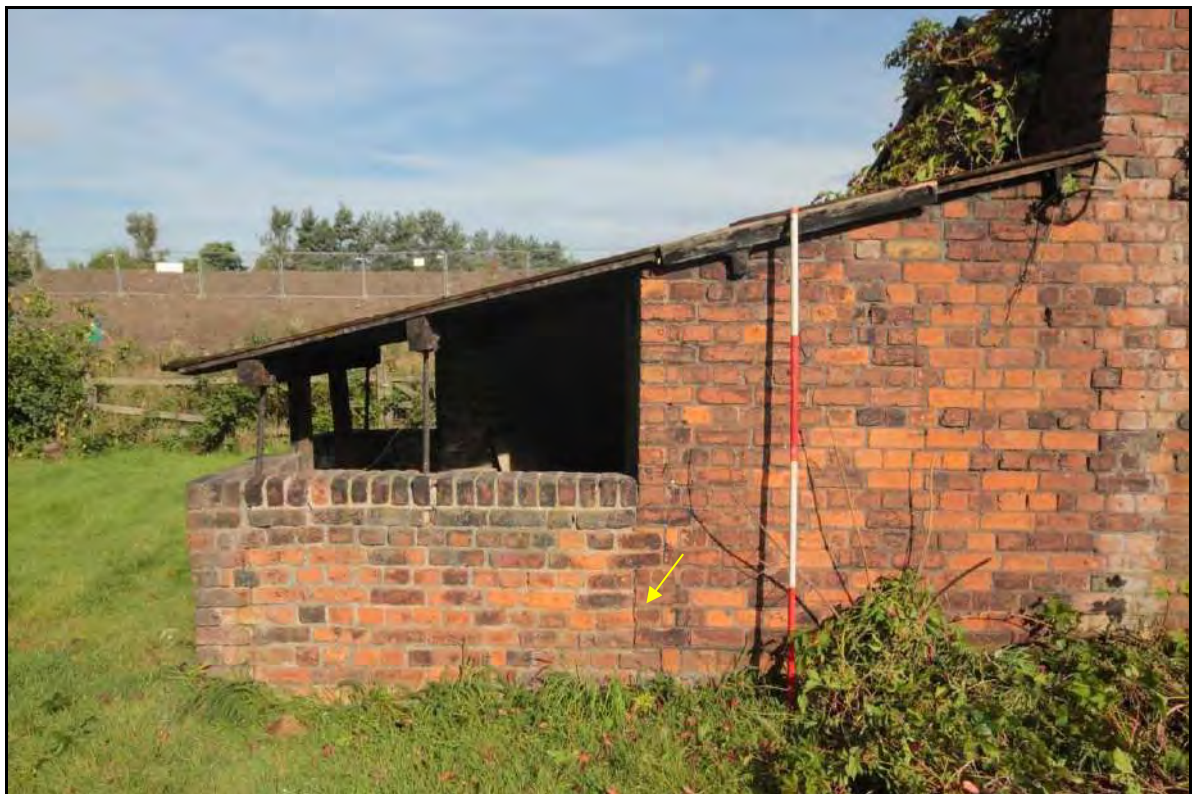
Photograph 34: View of the western end of the outbuilding's southern elevation, with straight joint of the low brick wall highlighted, which delineates its later phase. Taken with 2m scale facing north (File: HBR\_44)

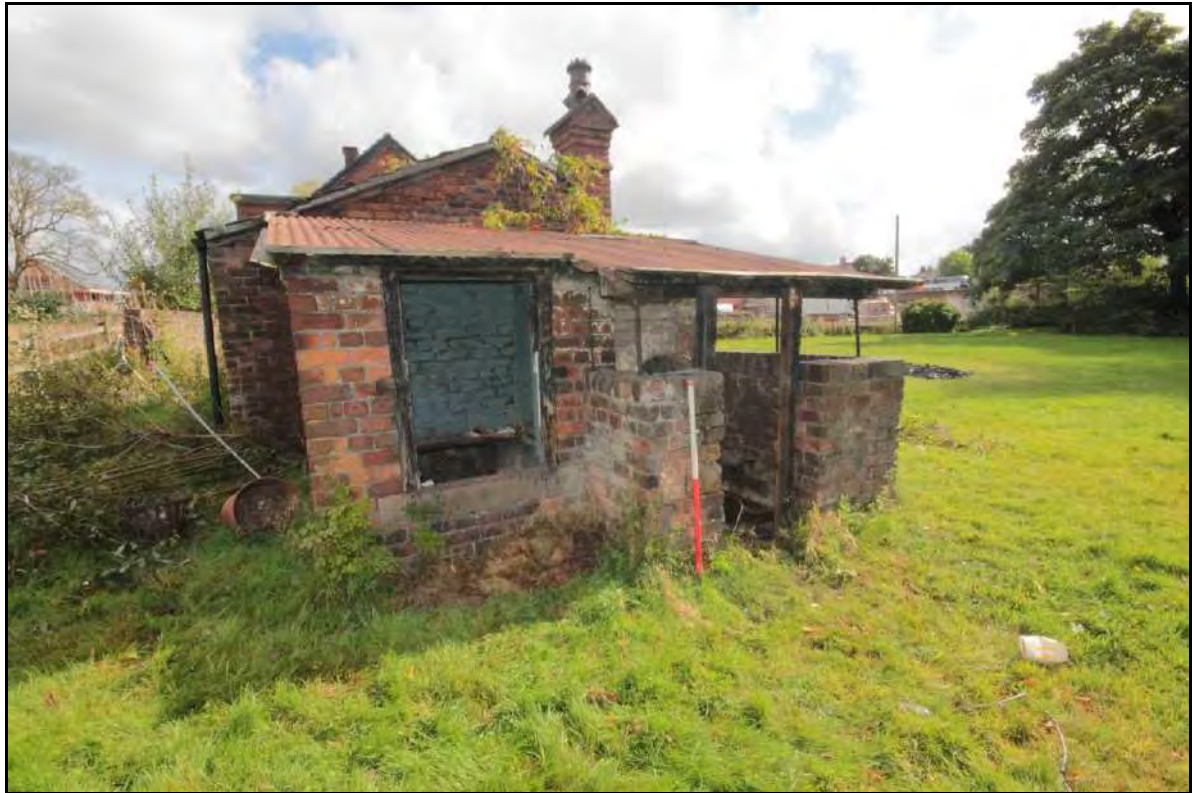
Photograph 35: Oblique view of the outbuilding's western elevation, taken with 1m scale facing south-east  
(File: HBR\_52)

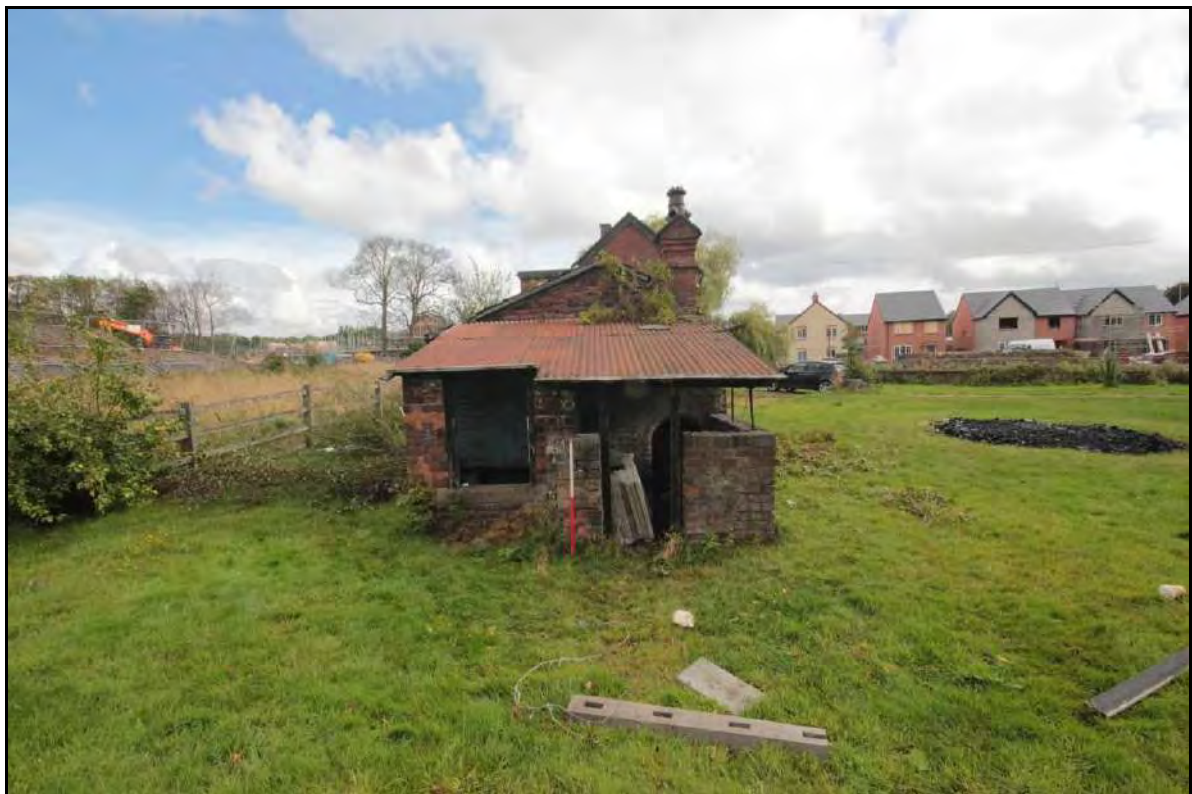
Photograph 36: Central view of the outbuilding's western elevation, taken facing east with 1m scale (File: HBR\_46)

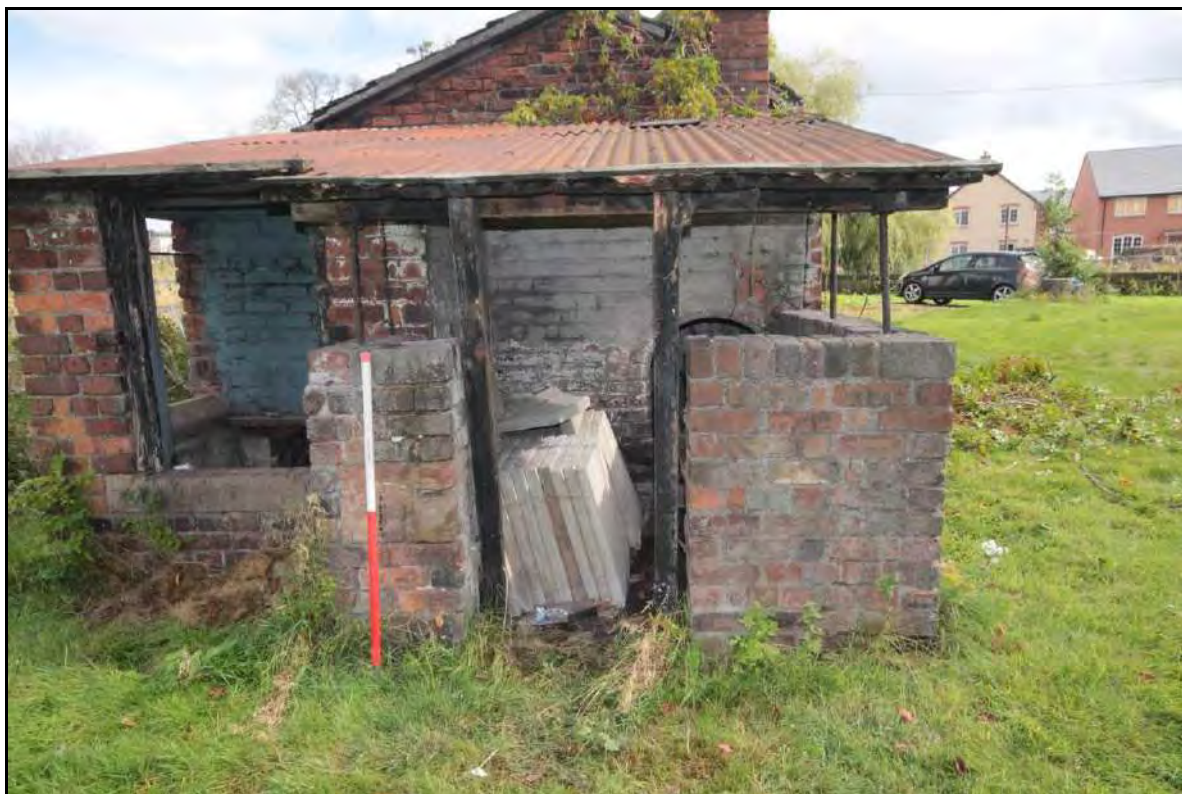
Photograph 37: View of the southern portion of the outbuilding's western elevation, taken with 1m scale facing east (File: HBR\_50)

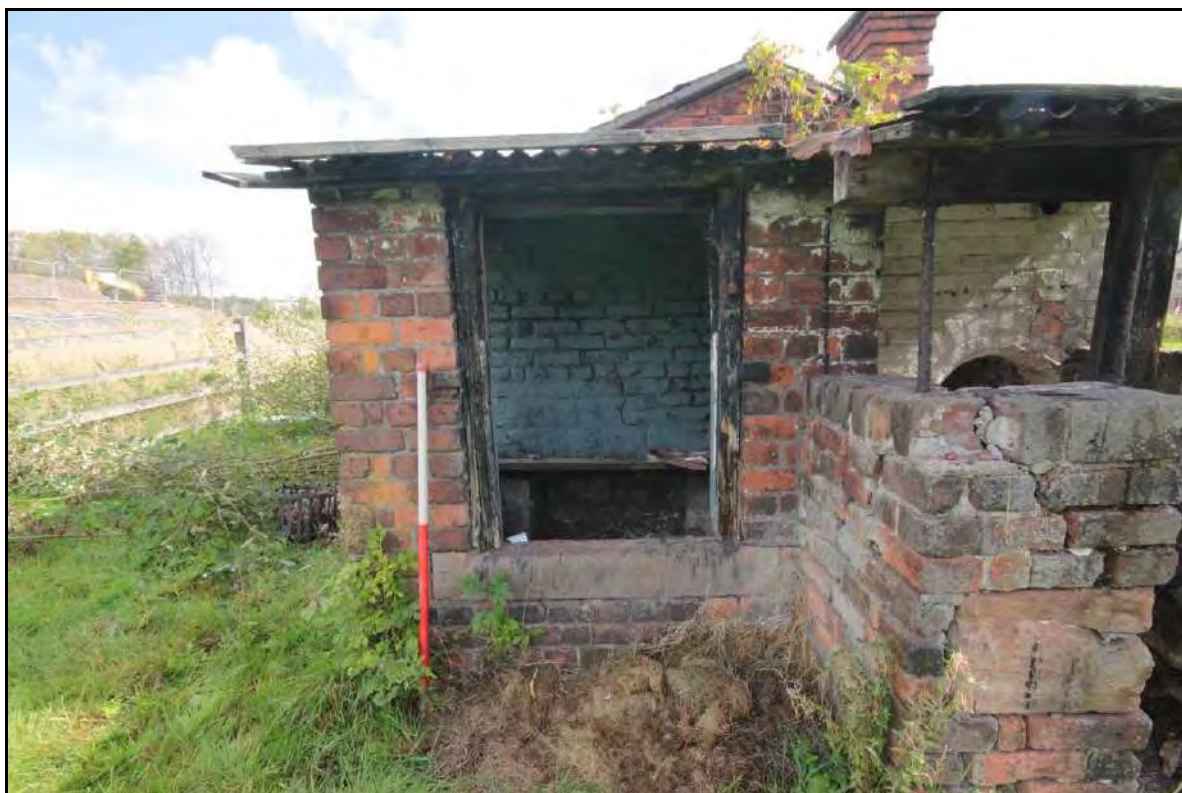
Photograph 38: View of the northern portion of the outbuilding's western elevation, taken facing east with 1m scale (File: HBR\_51)

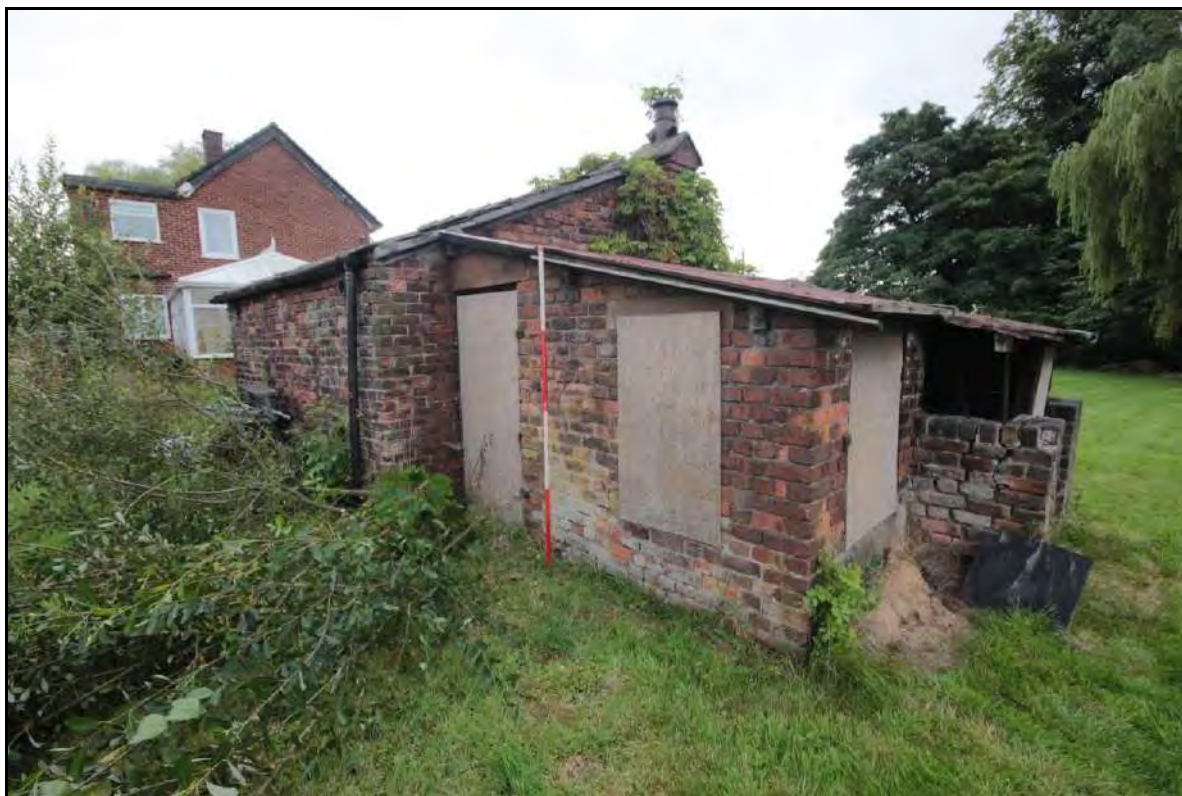
6.3.4 The northern elevation is roughly two bays in length, with the eastern bay comprising the core rectangular structure, projecting further outwards to the north (**Photographs 39 & 40**). The western extent features a rectangular aperture, with lintel and chamfered sill formed of ashlar sandstone blocks (**Photograph 41**). Adjacent to this to the east, there is a timber plank doorway with ashlar sandstone lintel, which has been constructed into the western wall of the pitched structure (**Photograph 42**). The eastern extent of the northern elevation is relatively plain of architectural features, with two circular ceramic vents (**Photograph 43**). Unlike the vents of the southern elevation, the brickwork surrounding these features shows signs of rebuilding, indicating that they represent later inserts (**Photograph 44**). This suggests that the brick of the northern elevation comprises earlier fabric, with the southern elevation comprising a later remodeling, with the vents added during this phase.

Photograph 39: Oblique view of the outbuilding's northern elevation, taken with 2m scale facing south-east  
(File: HBR\_58)

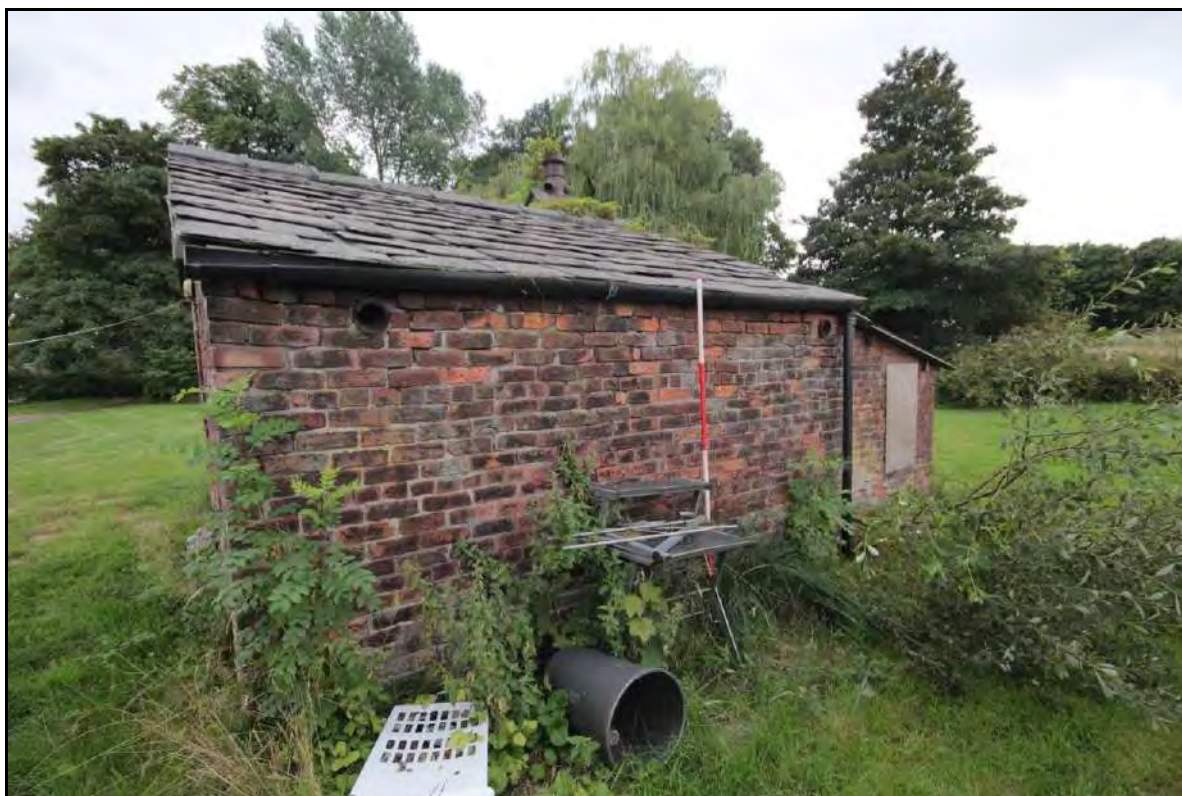
Photograph 40: Oblique view of the outbuilding's northern elevation, taken with 2m scale facing south-west  
(File: HBR\_65)
