# HISTORIC BUILDING RECORDING

*Dye House & Outbuilding, Liverpool Road, Prescot, Merseyside*

ARS Report N°: 2022/118  
Oasis ID N°: archaeol5-509381

# Historic Building Recording: Dye House & Outbuilding, Liverpool Road, Prescot, Merseyside

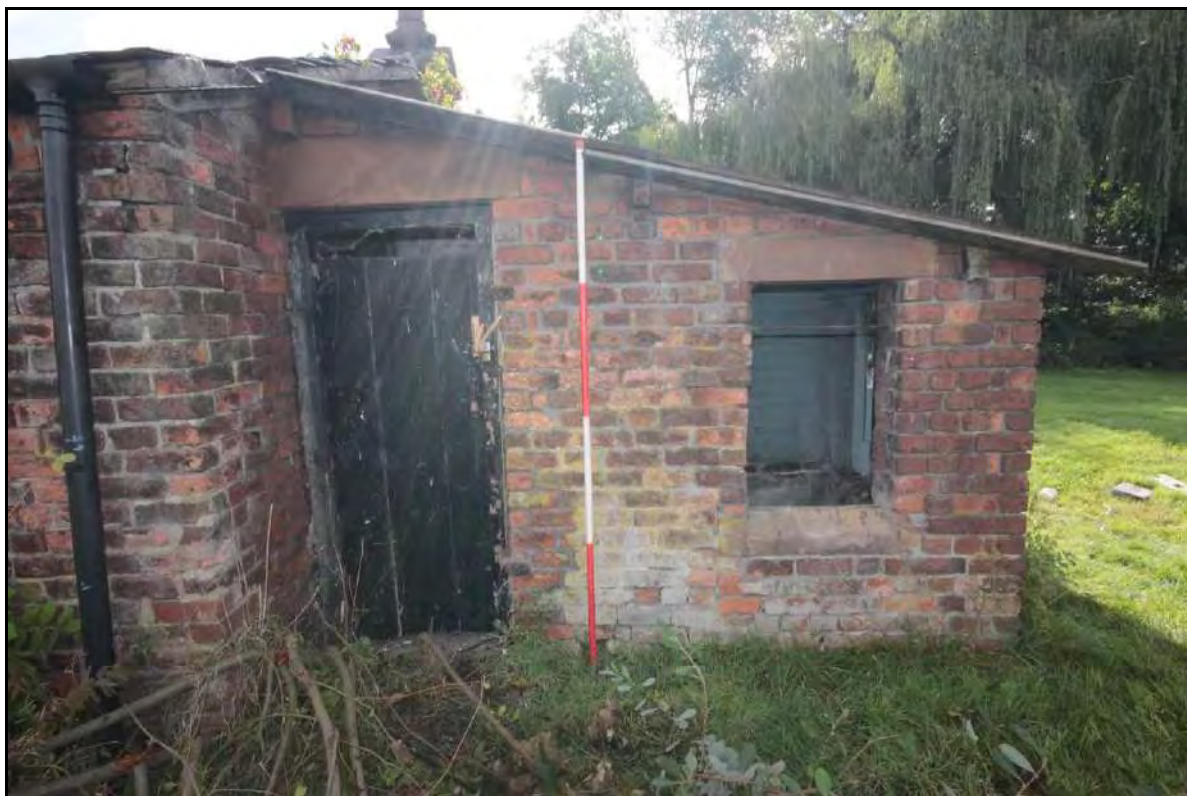
Photograph 41: View of the western extent of the outbuilding's northern elevation, taken with 2m scale facing south (File: HBR\_63)

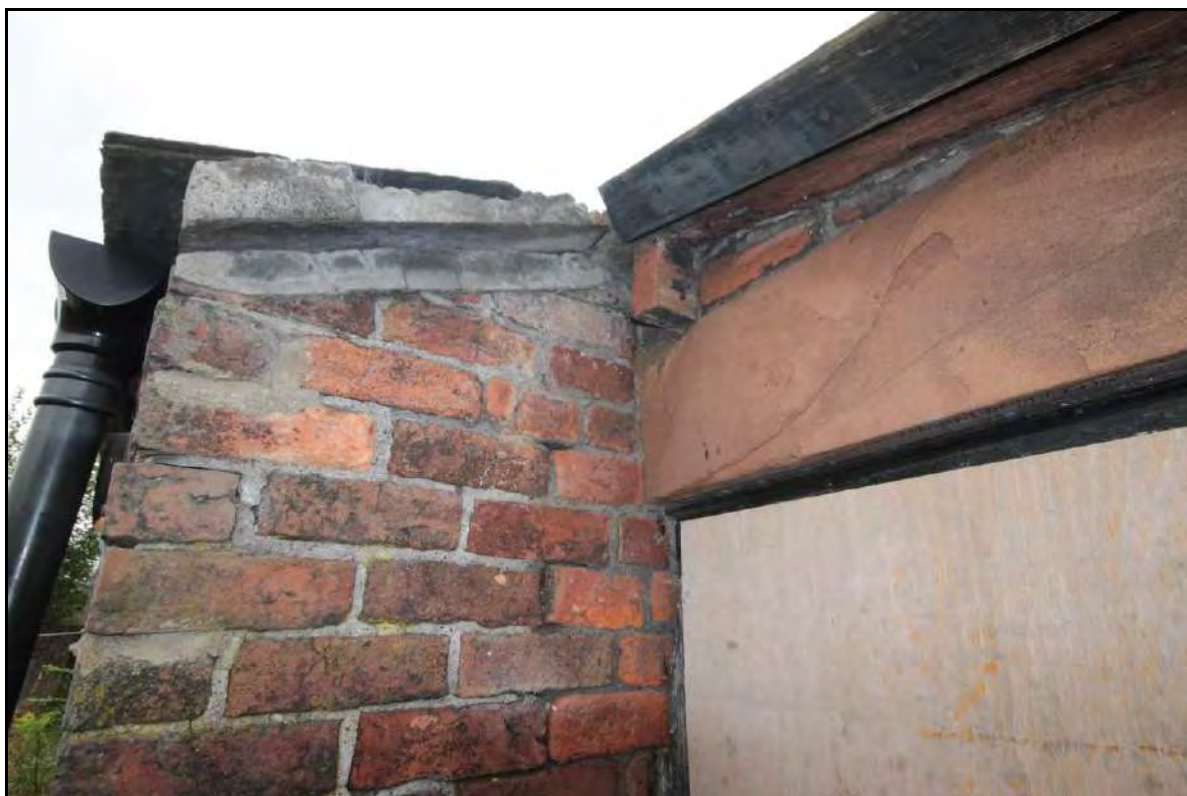
Photograph 42: View of the doorway lintel of the outbuilding's northern elevation, built into the pitched structure's western wall, taken facing south-east (File: HBR\_61)

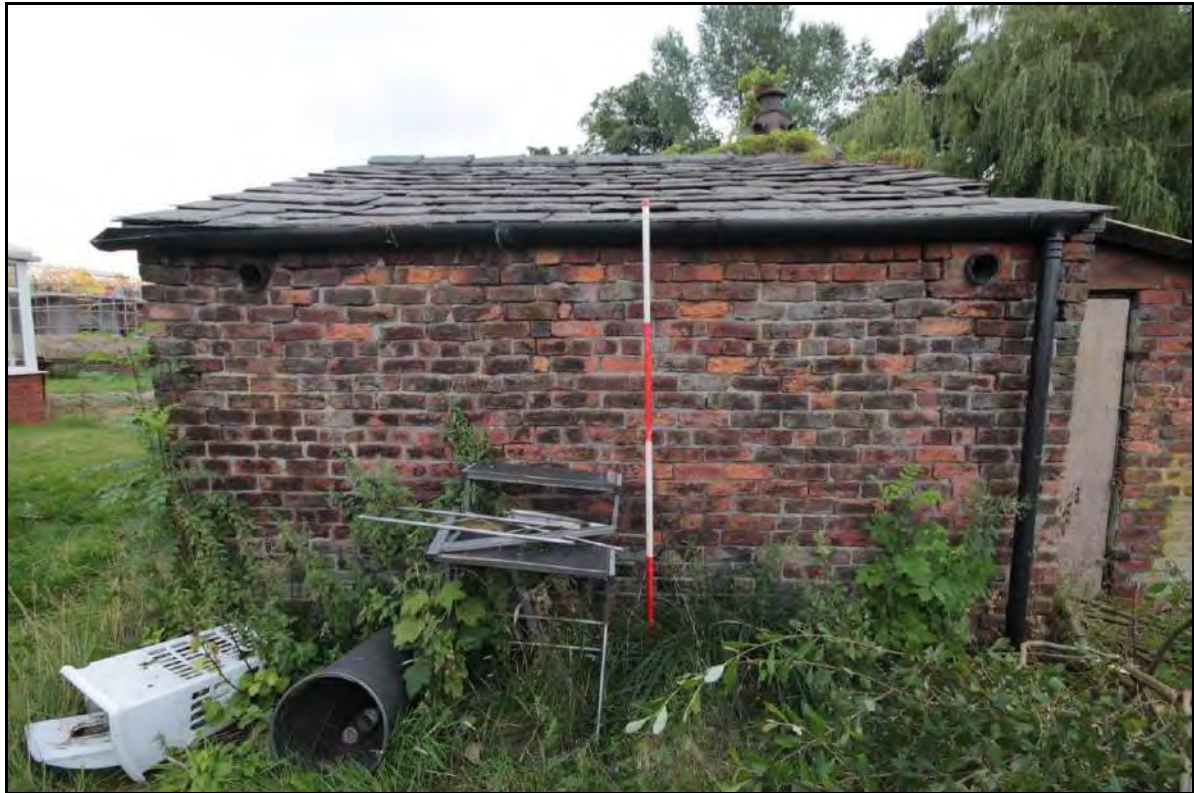
Photograph 43: View of the eastern extent of the outbuilding's northern elevation, taken facing south with 2m scale (File: HBR\_66)

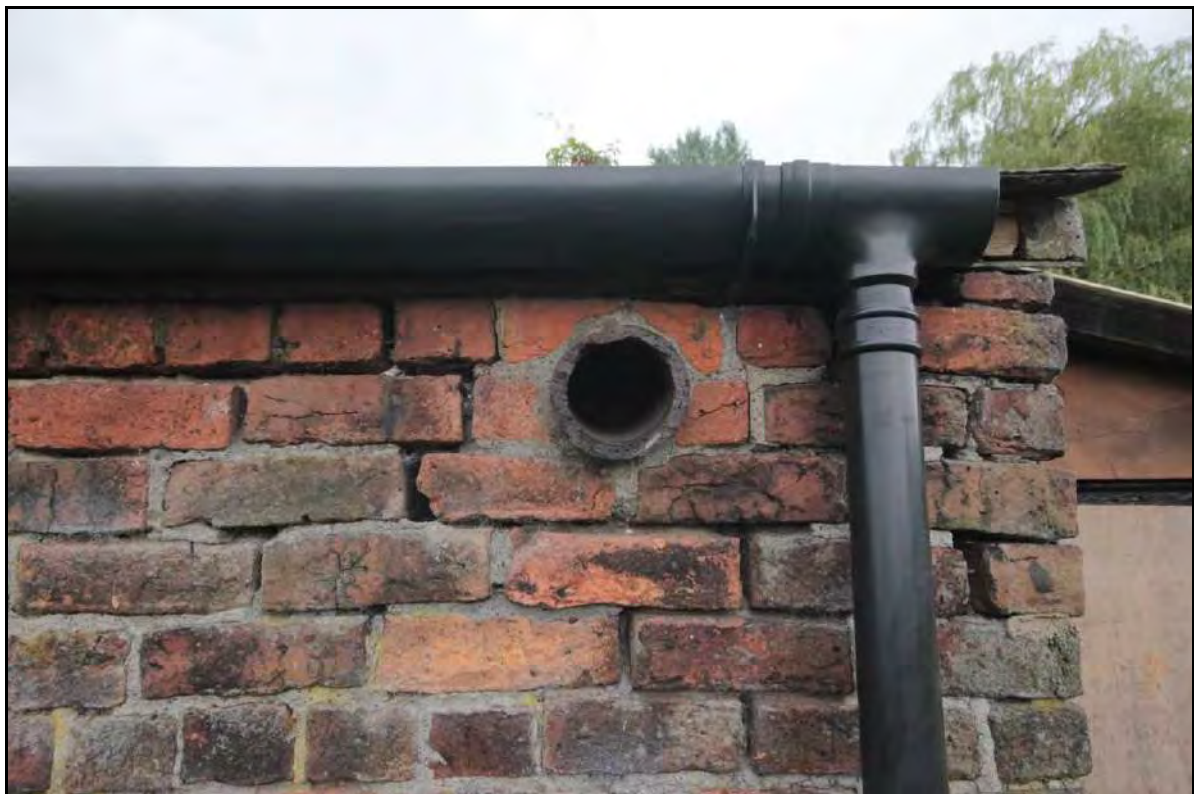
Photograph 44: View of one of the inserted vents of the outbuilding's northern elevation, taken facing south (File: HBR\_70)

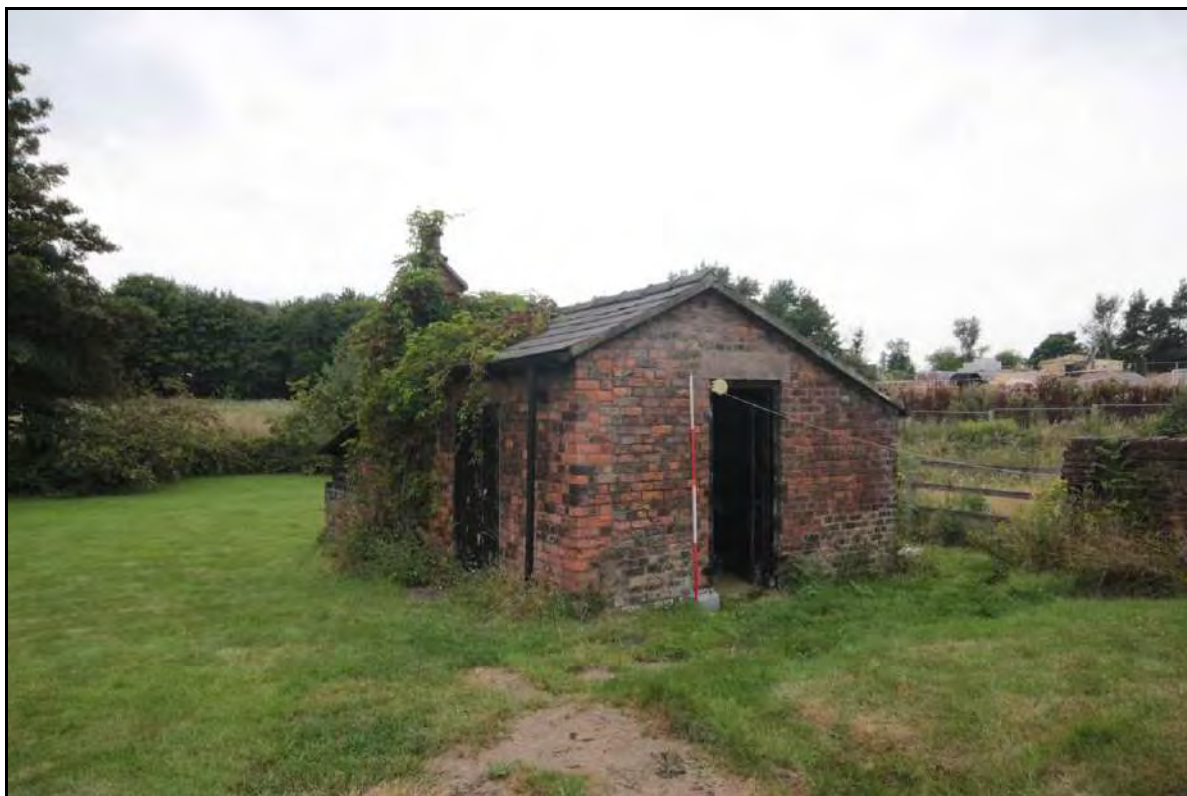
Photograph 45: Oblique view of the outbuilding's eastern elevation, taken facing north-west with 2m scale  
(File: HBR\_72)

6.3.5 The eastern elevation of the building comprises a gable end, and is roughly one bay in length (**Photographs 45 & 46**). The elevation demonstrates that the pitch of this structure extends further outwards to the north, suggesting it has seen a period of rebuilding. Within the centre of the elevation, there is a timber plank doorway with ashlar sandstone lintel (**Photograph 47**). The southern end of the elevation features straight joints, with varied brickwork (**Photograph 48**). This indicates that the southern elevation had likely been rebuilt, with the earlier brickwork of the eastern and northern elevations for the pitched structure, representing original fabric.

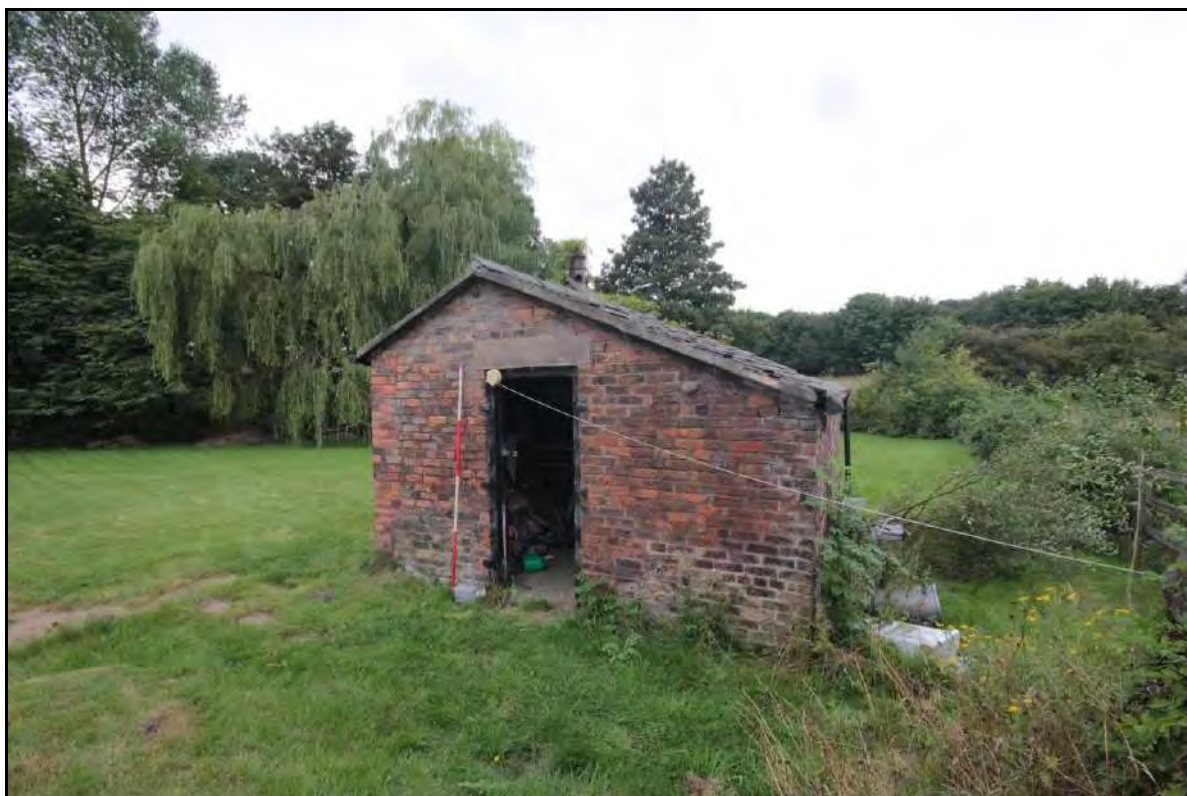
Photograph 46: Oblique view of the outbuilding's eastern elevation, taken facing south-west with 2m scale  
(File: HBR\_73)

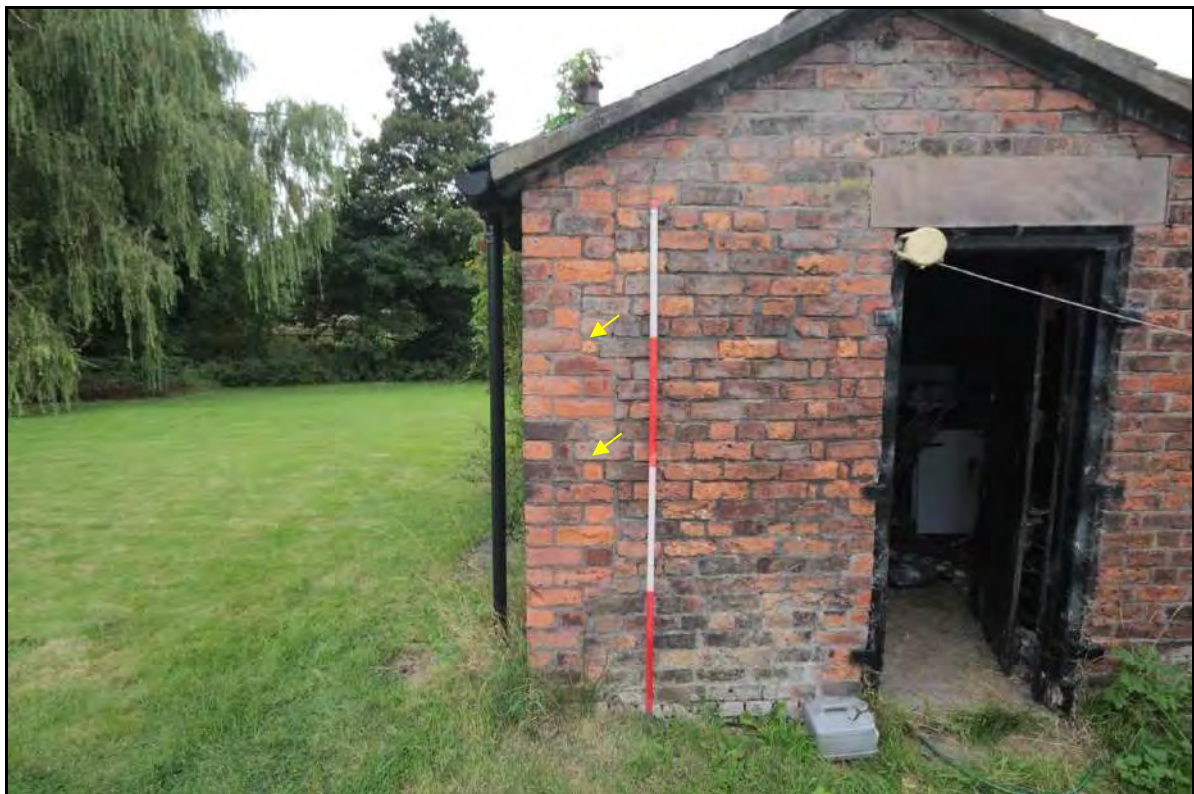
Photograph 48: View of the straight joints of the outbuilding's eastern elevation, delineating the two phases of brickwork. Taken facing west with 2m scale (File: HBR\_74)

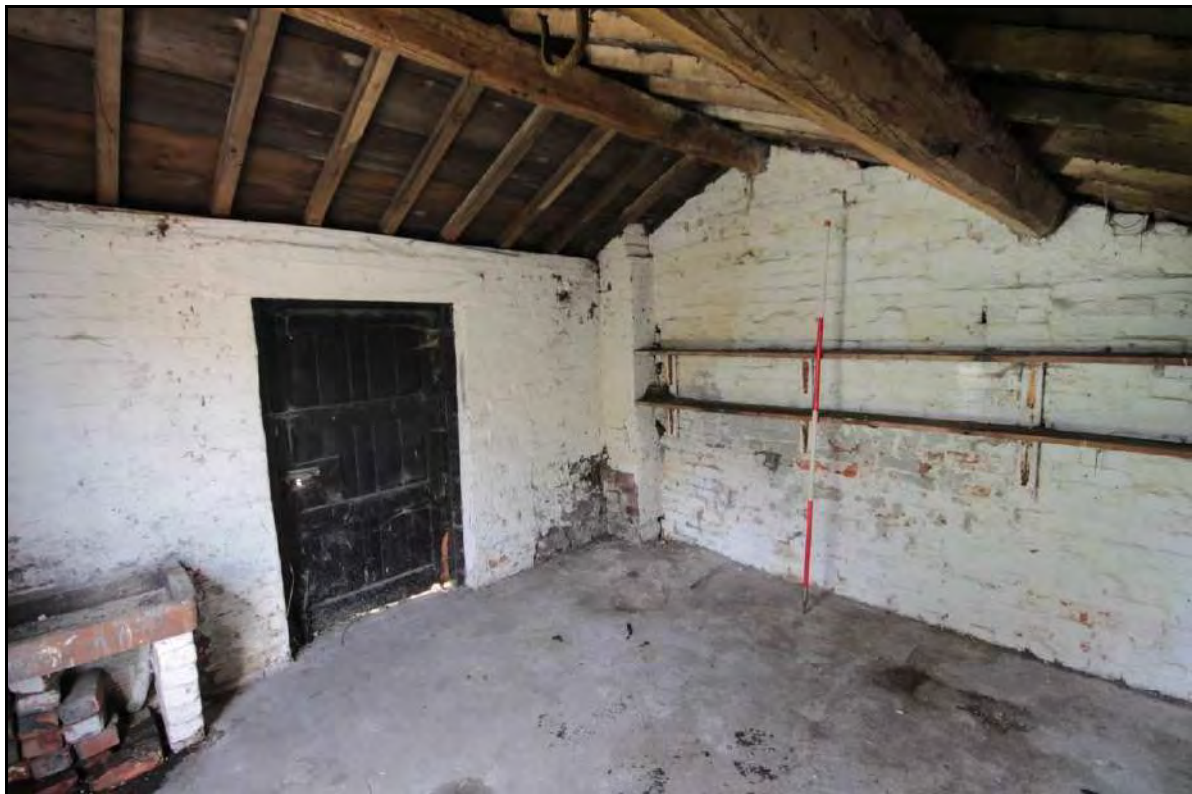
Photograph 49: General view to the south-west within Room 1, taken with 2m scale (File: HBR\_77)

6.4.1 The interior of the outbuilding is comprised of six main spaces (Rooms 1-6), and appears to have originated as a multi-functional building, comprising a main heated area, likely a wash house, earth closet privy, animal pen/accommodation and log store (**Figure 2, Appendix 1**). Room 1 comprises the eastern room of the space, which represents a small square space, roughly one bay in length and width (**Photograph 49**). The space is open to the roof structure, which comprises two purlins with chamfered edges, with machine cut rafter beams to the south and hand-sawn rafter beams to the east (**Photograph 50**). The northernmost purlin features a metal hook fixture, and the rafter beams support timber plank boarding above (**Photograph 51**). The flooring of the space is formed of concrete, and features the square outline of a former structure within the south-western corner, likely a wash copper boiler (**Photographs 52 & 53**). The walls of the space have been painted white.

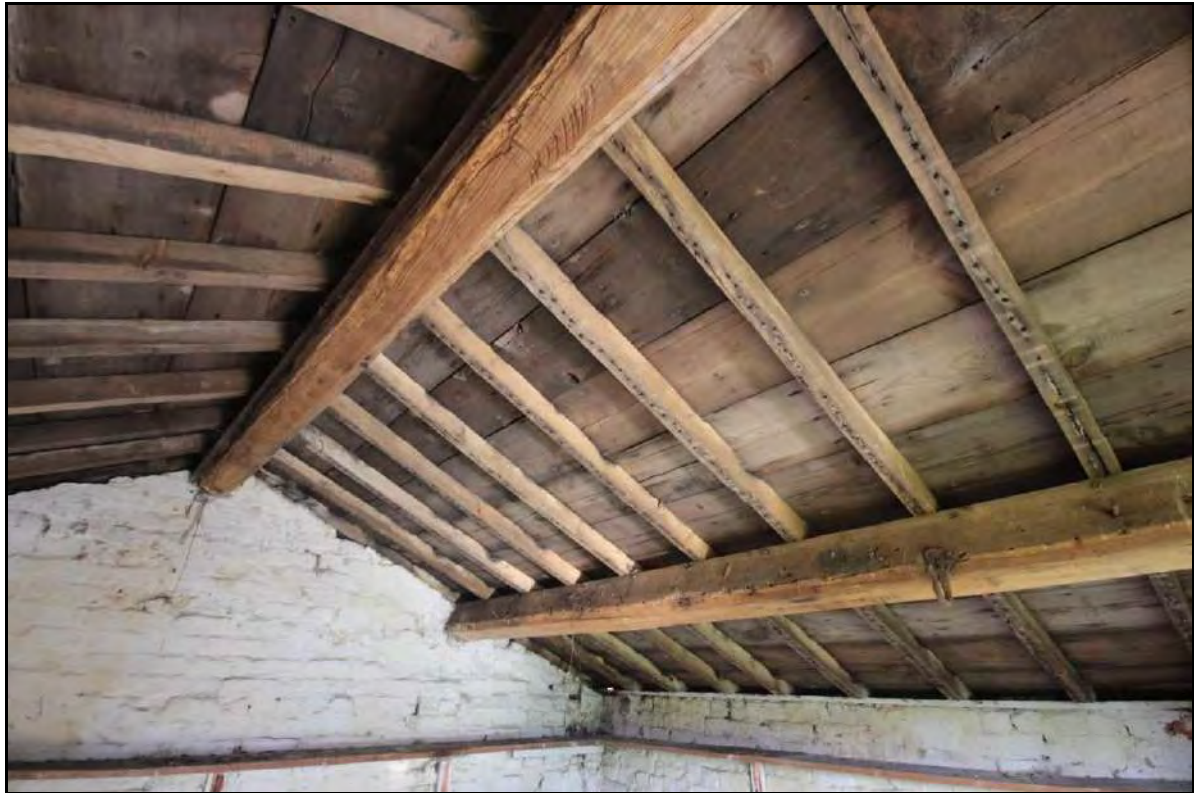
Photograph 50: View of the roof structure within Room 1, taken facing north-west (File: HBR\_79)

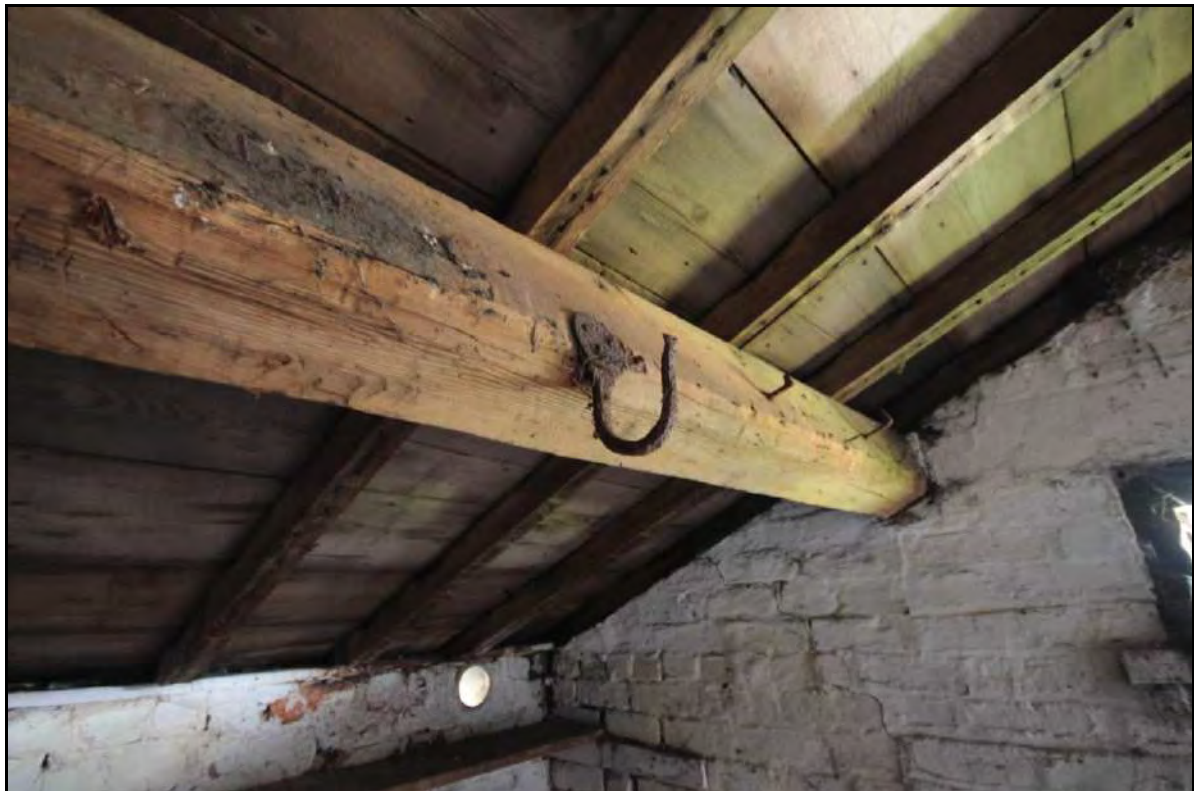
Photograph 51: View of the hook fixture on the northern purlin within Room 1, taken facing north-east (File: HBR\_87)

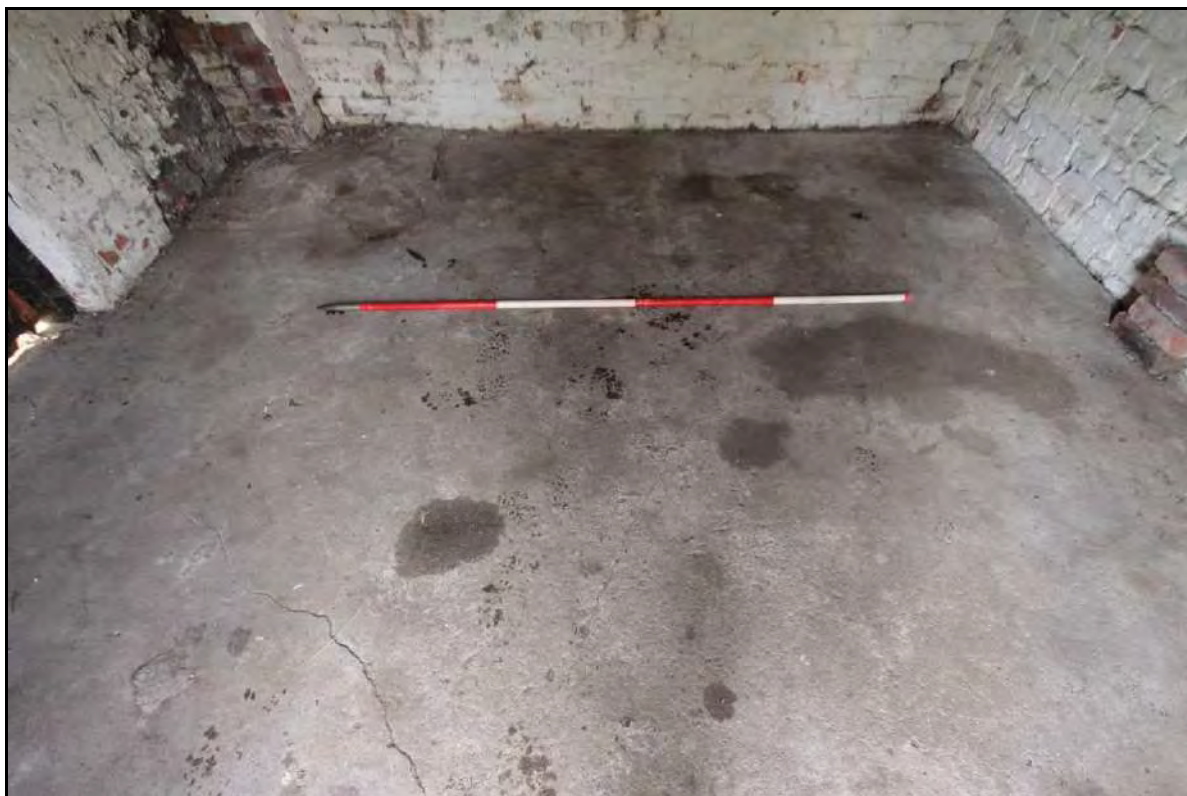
Photograph 52: View of the concrete flooring of Room 1, taken facing west with 2m scale (File: HBR\_78)

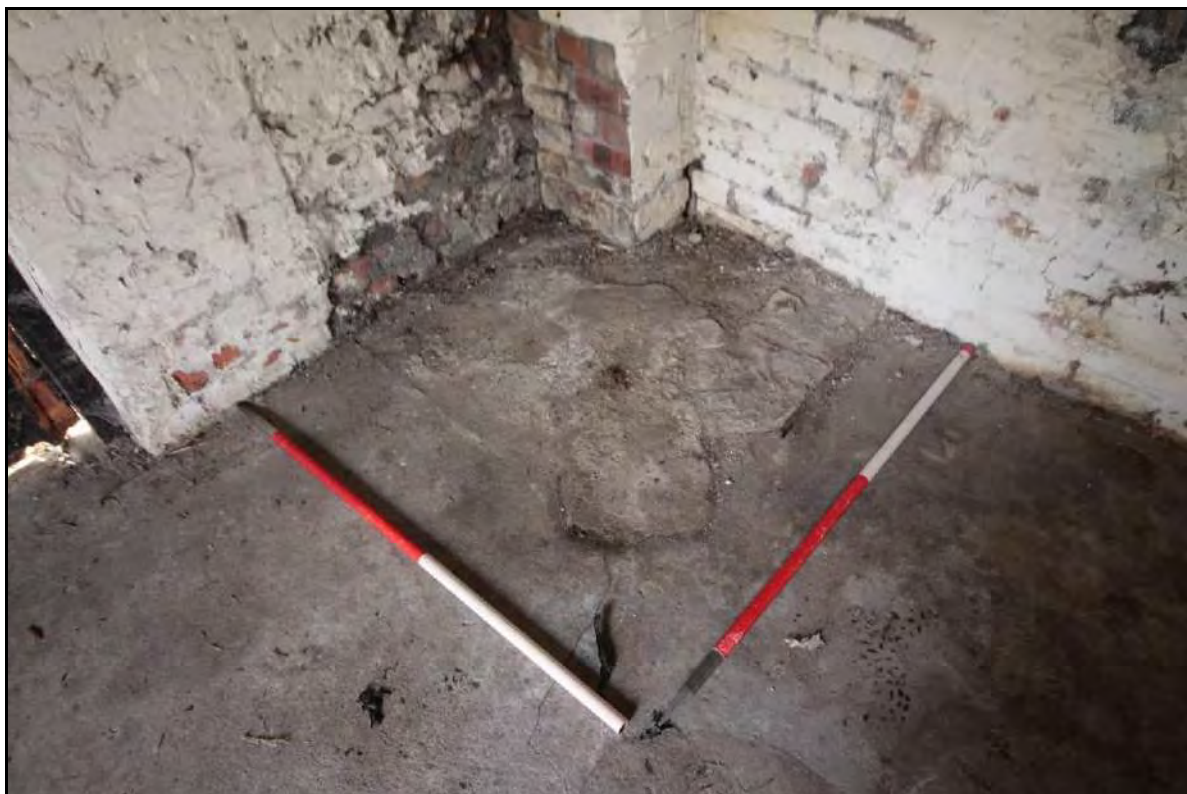
Photograph 53: View of the structural scarring where the wash copper stood within the south-western corner of Room 1's flooring, taken with 2 x 1m scale facing south-west (File: HBR\_80)

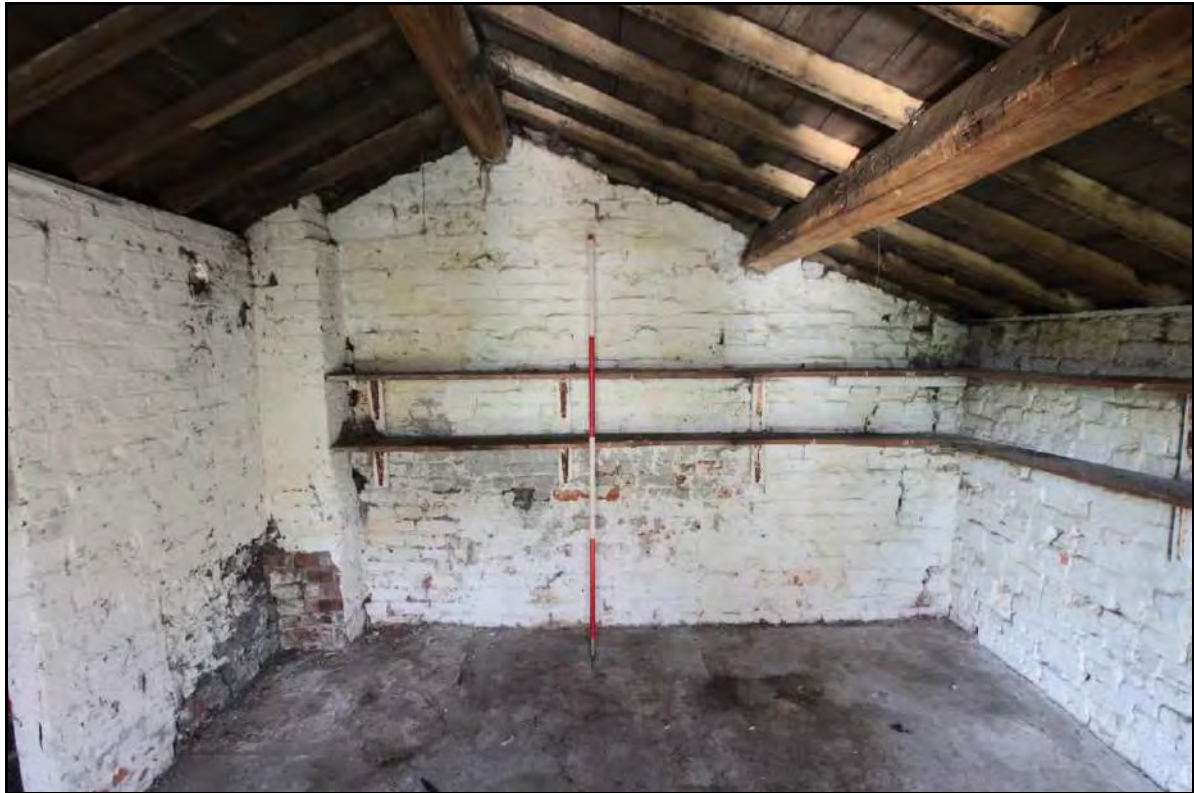
Photograph 54: View of Room 1's western wall, taken facing west with 2m scale (File: HBR\_81)

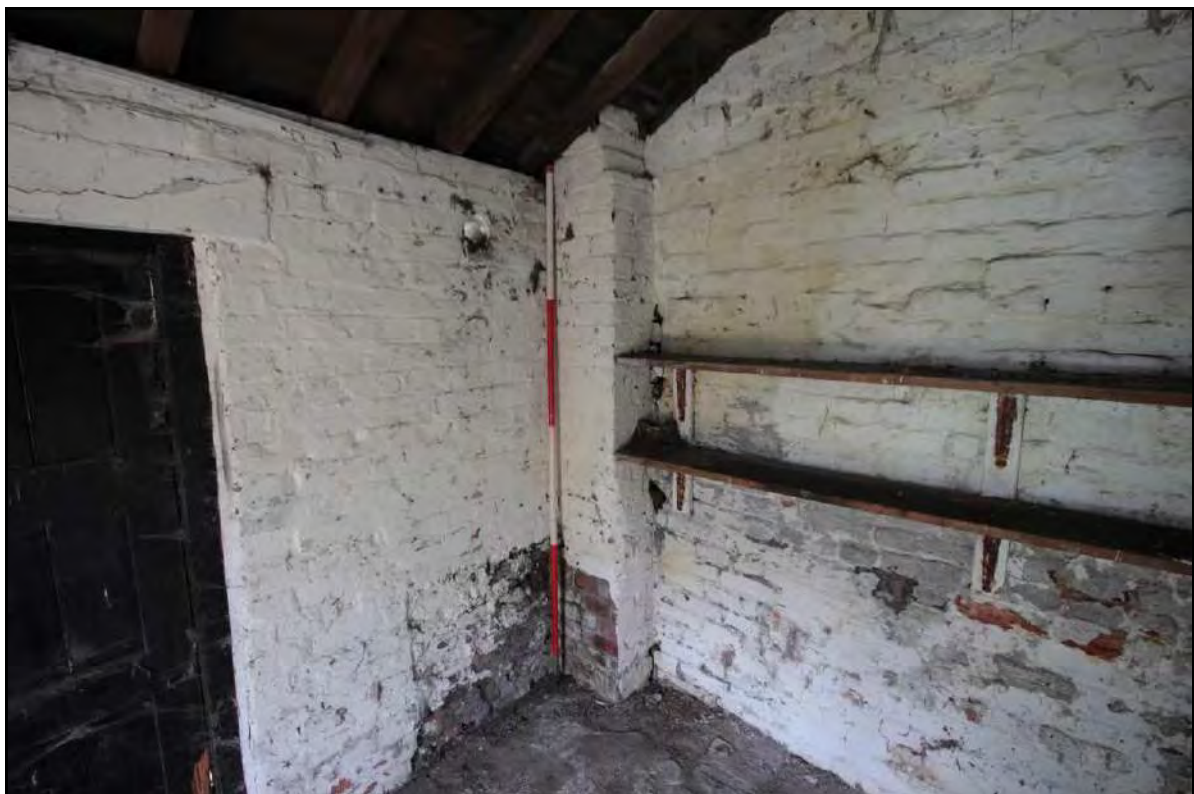
Photograph 55: View of the buildout within the south-western corner of Room 1, taken facing south-west with 2m scale (File: HBR\_82)

6.4.2 The western wall of Room 1 features a brick buildout in the southern corner, which is associated with the chimneystack (**Photographs 54 & 55**). This wall, and the northern wall, have modern timber shelving units fixed with brackets. The northern wall has two circular ceramic vent fixtures (**Photograph 56**). On the eastern wall, there is a central ledged timber plank door (**Photograph 57**). Within the south-eastern corner of the room, there is a small ceramic basin supported by brick piers, situated at c.0.5 meters in height (**Photograph 58**). The southern wall features a central ledged timber plank door, as well as the outline for the copper boiler (**Photograph 59**).

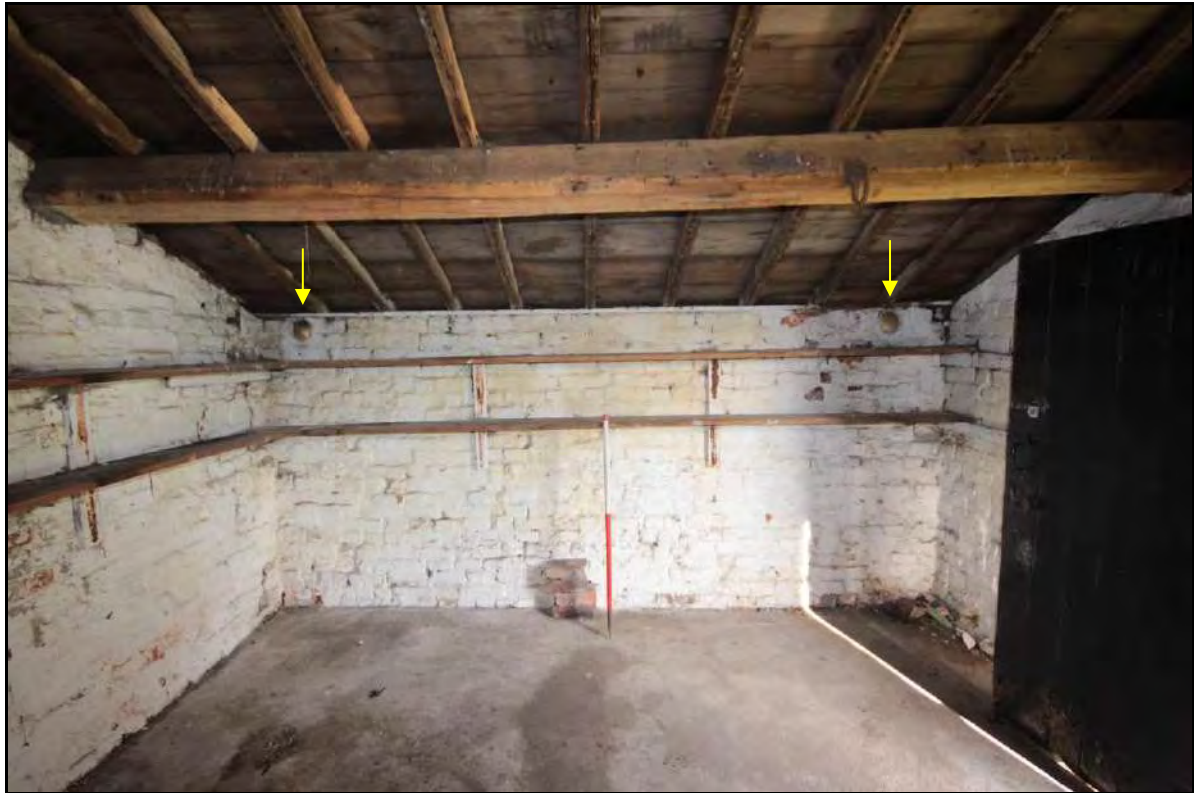
Photograph 56: View of the northern wall of Room 1, with vents highlighted, taken facing north with 1m scale (File: HBR\_83)

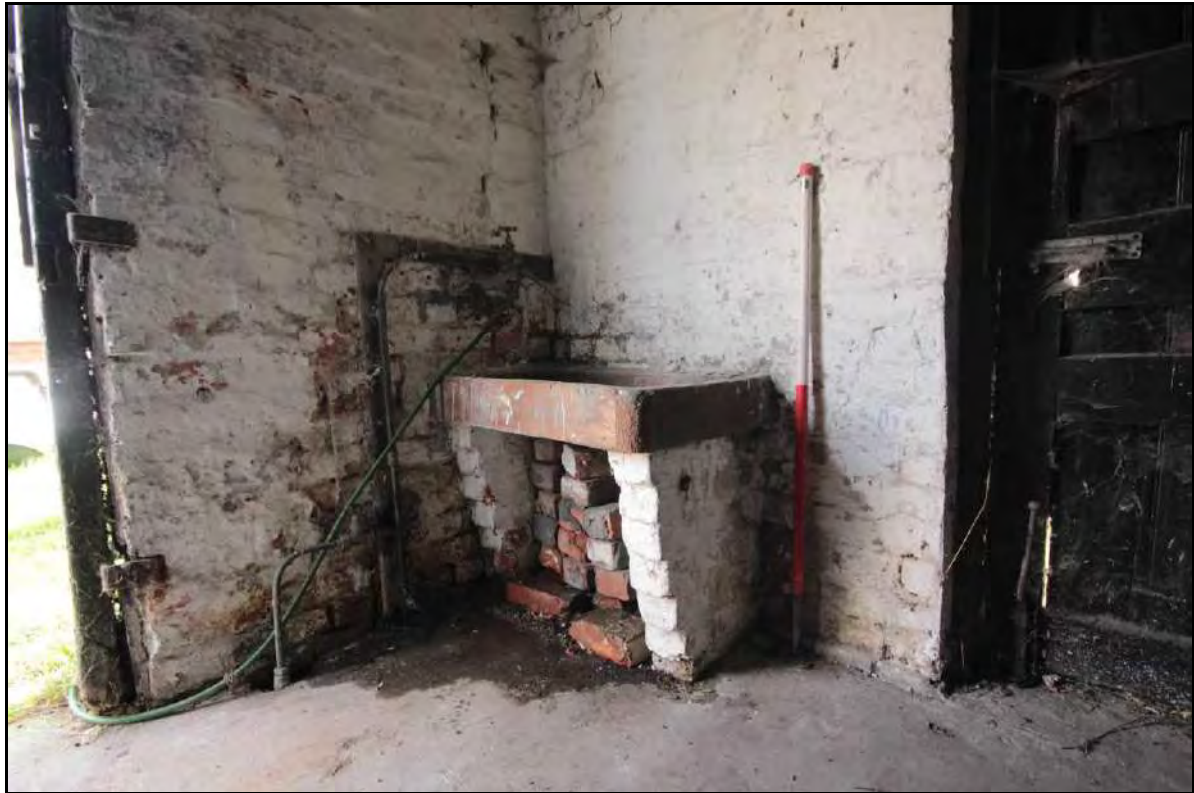
Photograph 58: View of the basin within the south-eastern corner of Room 1, taken facing south-east with 1m scale (File: HBR\_89)

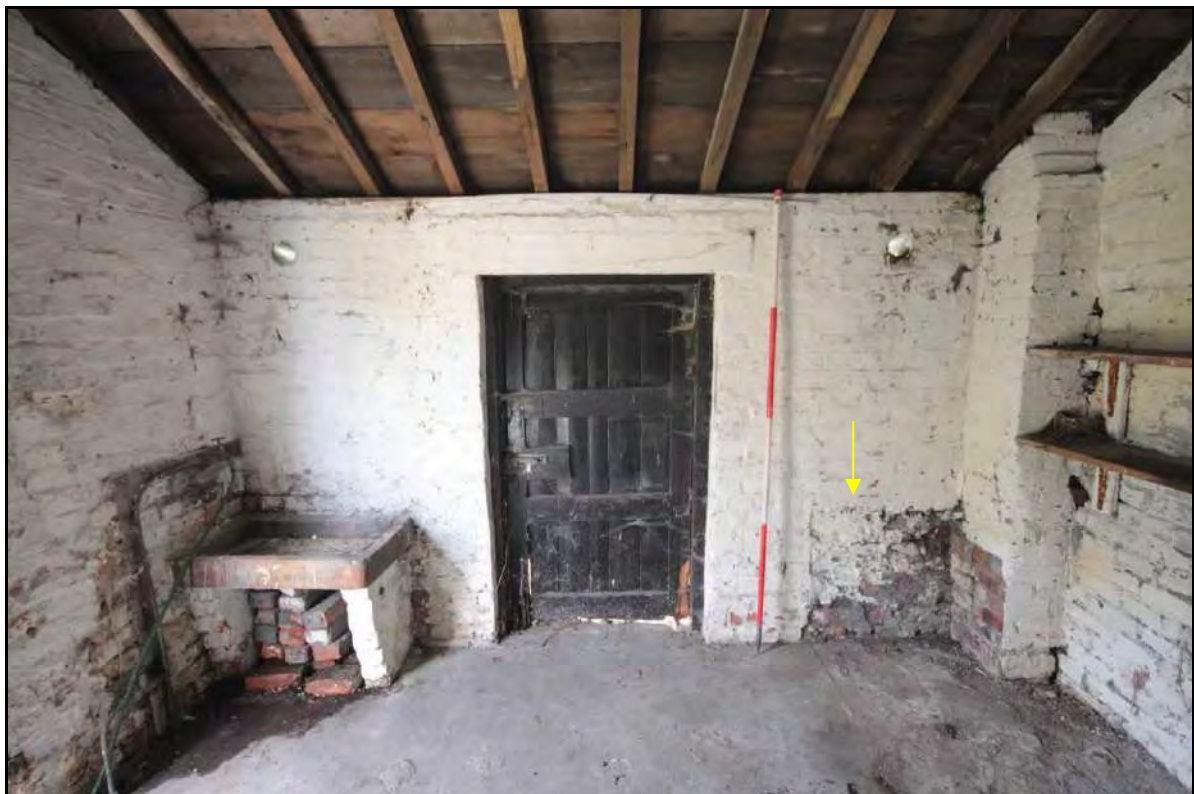
Photograph 59: View of the southern wall of Room 1, with scarring associated with an earlier brick structure highlighted. Taken facing south with 2m scale (File: HBR\_91)

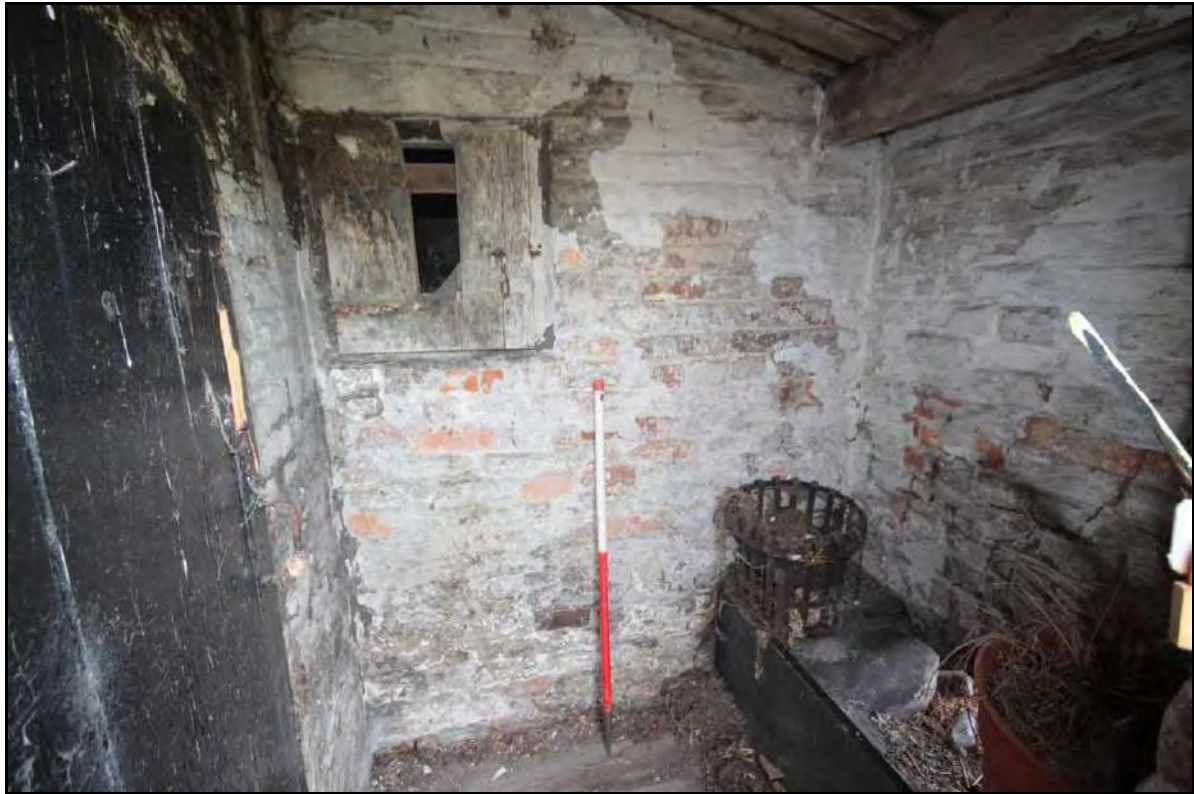
Photograph 60: General view into Room 2, taken with 1m scale facing south (File: HBR\_96)

6.4.3 Room 2 comprises a small square space, which functioned as a privy and represents part of the western lean-to structure (**Photograph 60**). The roof structure of this space is formed of two

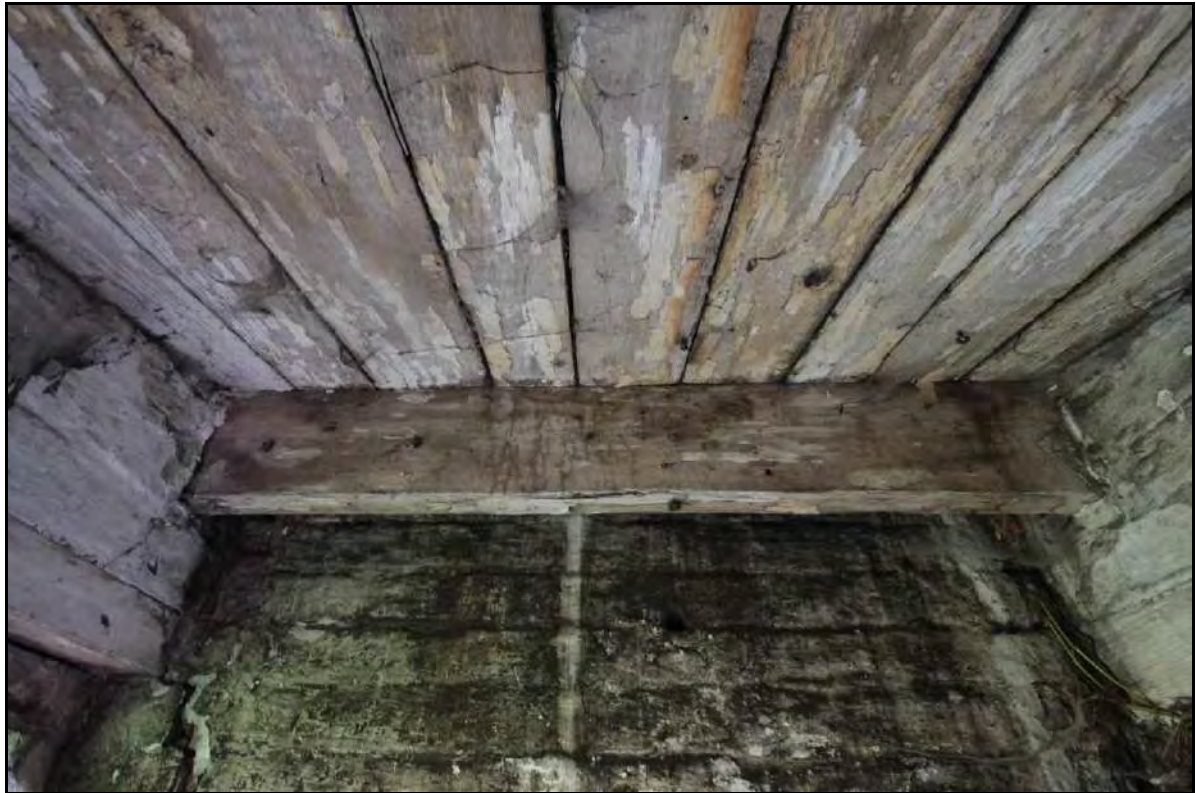
Photograph 61: View of the roof structure within Room 2, taken facing east (File: HBR\_97)

timber joists, supporting timber boards above (**Photograph 61**). The flooring is formed of concrete, with extant whitewash on the brick walls (**Photograph 62**).

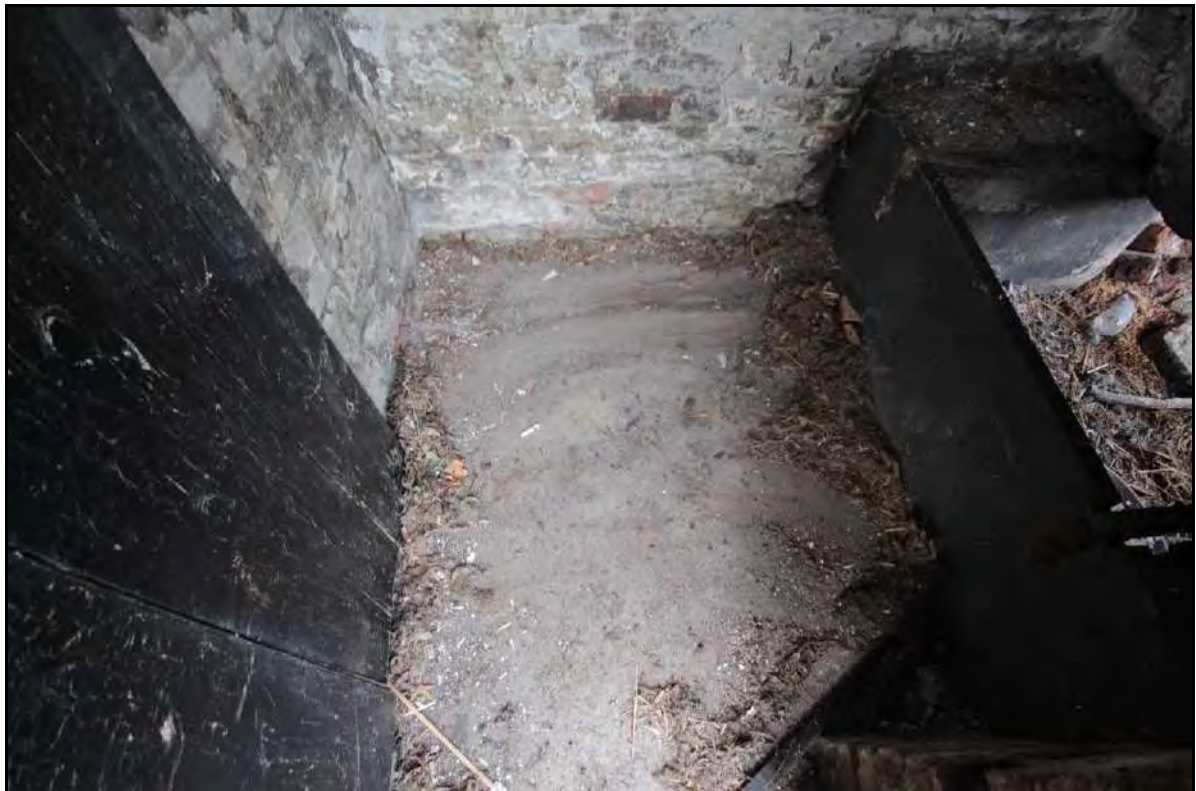
Photograph 62: View of the concrete flooring within Room 2, taken facing south (File: HBR\_99)

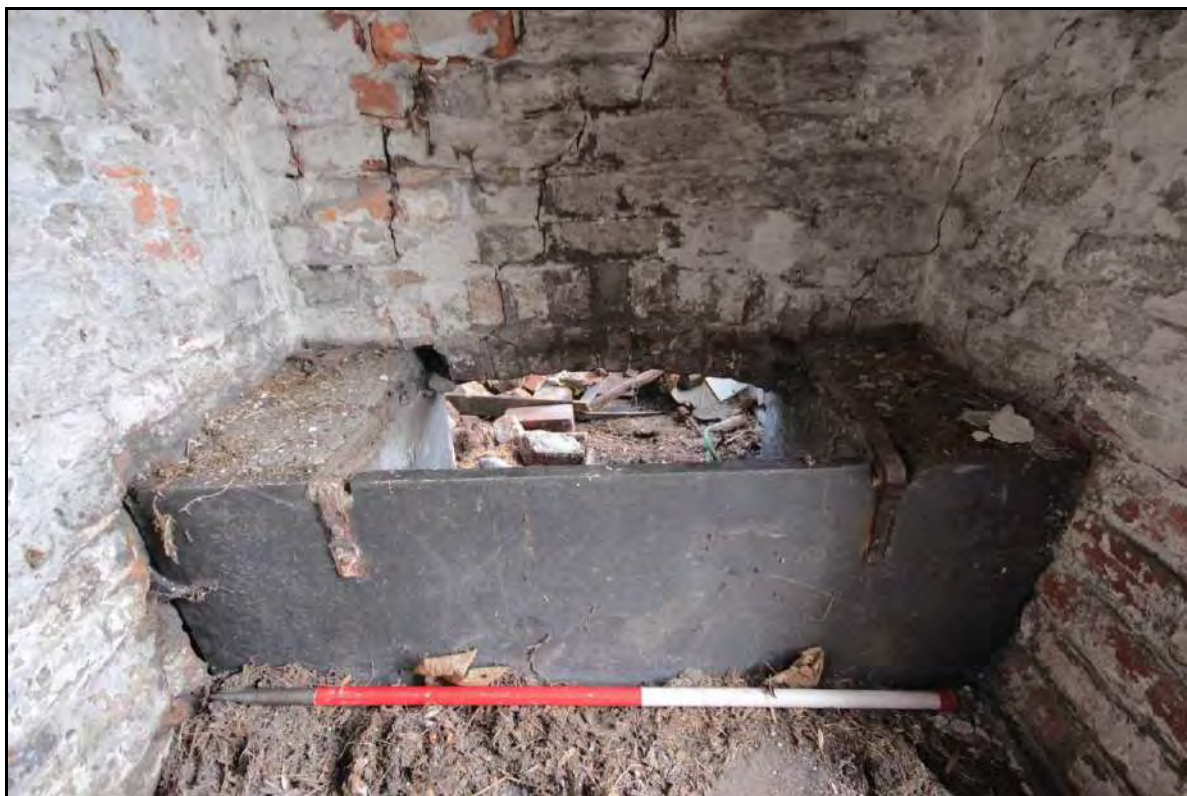
Photograph 64: View of the slate privy attached to the western wall of Room 2, taken with 1m scale facing west (File: HBR\_101)

6.4.4 The eastern extent of the space features a low slate structure, associated with the privy function (**Photograph 63**). This has a connection with Room 3 to the east, via an aperture on the eastern wall, with flat arch featuring brick stretcher voussoirs (**Photograph 64**). The southern wall of the space features the access doorway, formed of a ledged and braced timber plank door, with an internal timber lintel (**Photograph 65**). The northern wall features timber plank shutters at c.1.1 meters in height, with cast iron strap hinges, which provides a link with the small loft space of Room 6 (**Photographs 66 & 67**).

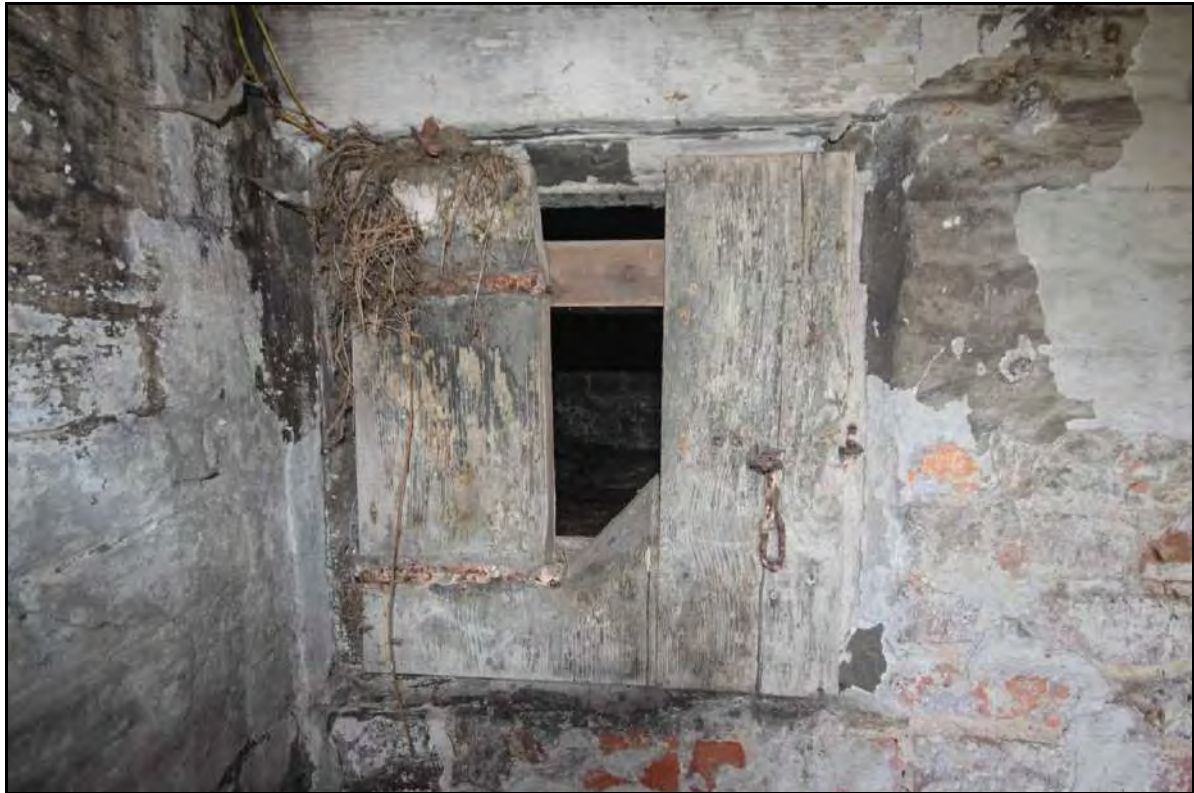
Photograph 67: View of the timber plank shutters on the southern wall of Room 2, taken facing south (File: HBR\_106)
