# HISTORIC BUILDING RECORDING

*Dye House & Outbuilding, Liverpool Road, Prescot, Merseyside*

ARS Report N°: 2022/118  
Oasis ID N°: archaeol5-509381

# Historic Building Recording: Dye House & Outbuilding, Liverpool Road, Prescot, Merseyside

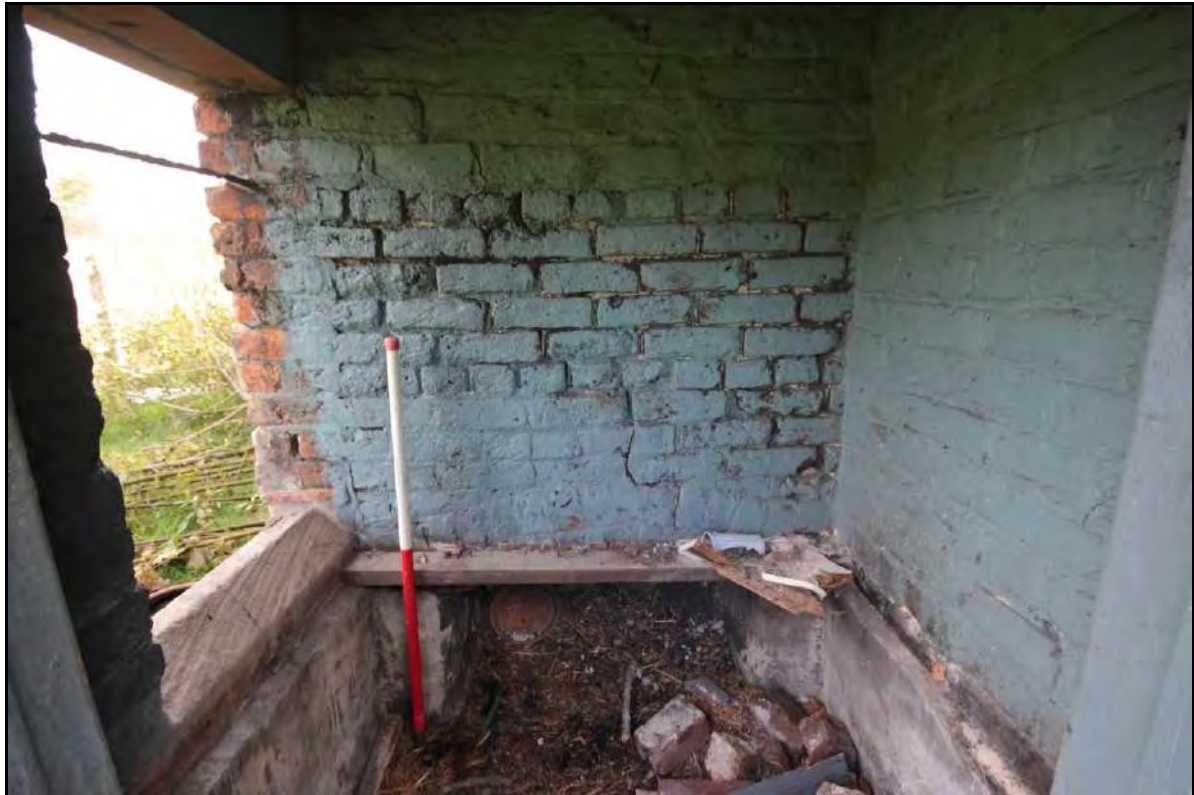
Photograph 68: View of the eastern wall of Room 3, taken with 1m scale facing east (File: HBR\_114)

6.4.5 Room 3 comprises a small square space forming the north-western room of the outbuilding (**Photograph 68**). The mono-pitched roof structure of the space is formed of timber boards (**Photograph 69**). The brick walls have been painted blue with cement plaster up to c.0.35 meters in height, and with the flooring formed of concrete. This space appears to have been built as ancillary to the privy, with a low aperture of c.0.7m in height on the eastern wall, linking with the privy of Room 2 (**Photograph 70**). The western and northern walls both feature rectangular apertures with lintels and chamfered sills formed of ashlar sandstone blocks (**Photographs 71 & 72**). The southern wall is plain of architectural features. (**Photograph 73**). This space likely housed the waste collected from the privy, which was an earth closet type toilet, with the apertures used for mucking out the space.

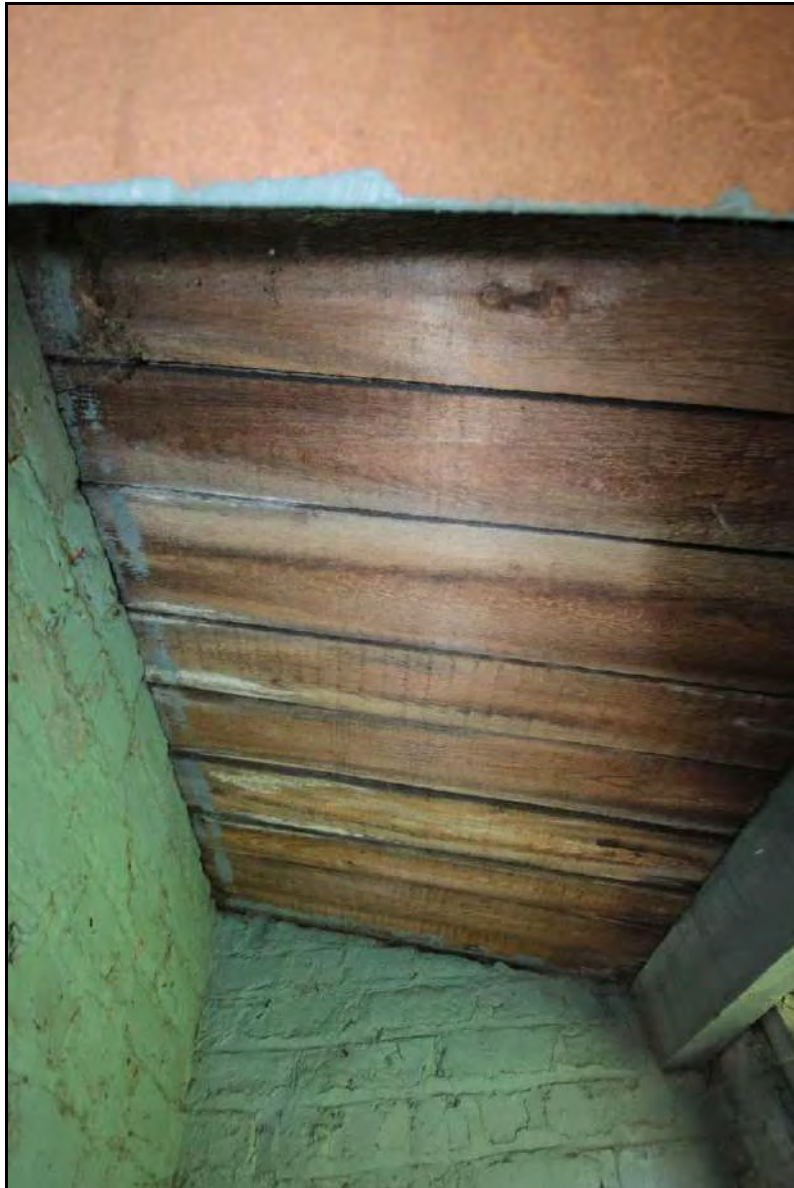
Photograph 69: View of Room 3's roof structure, taken facing south (File: HBR\_117)

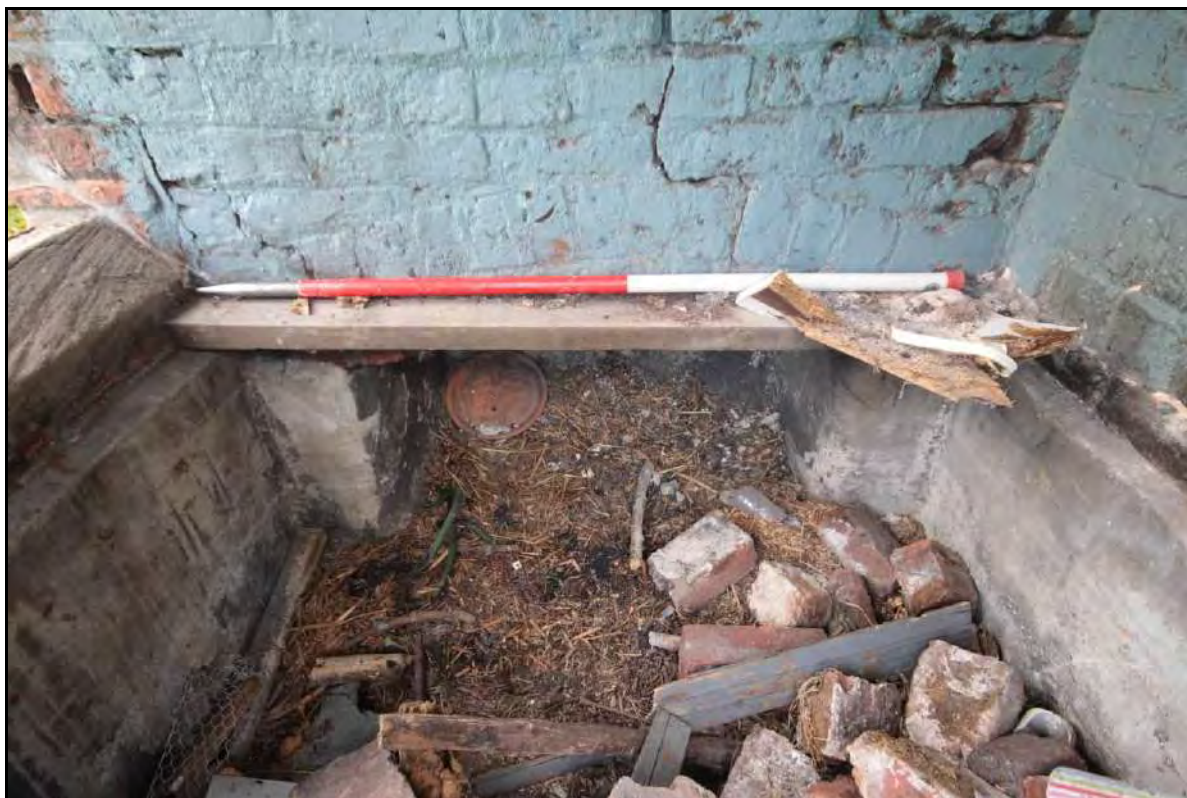
Photograph 70: View of the aperture connecting with the privy of Room 2, on the eastern wall of Room 3, taken with 1m scale facing east (File: HBR\_115)

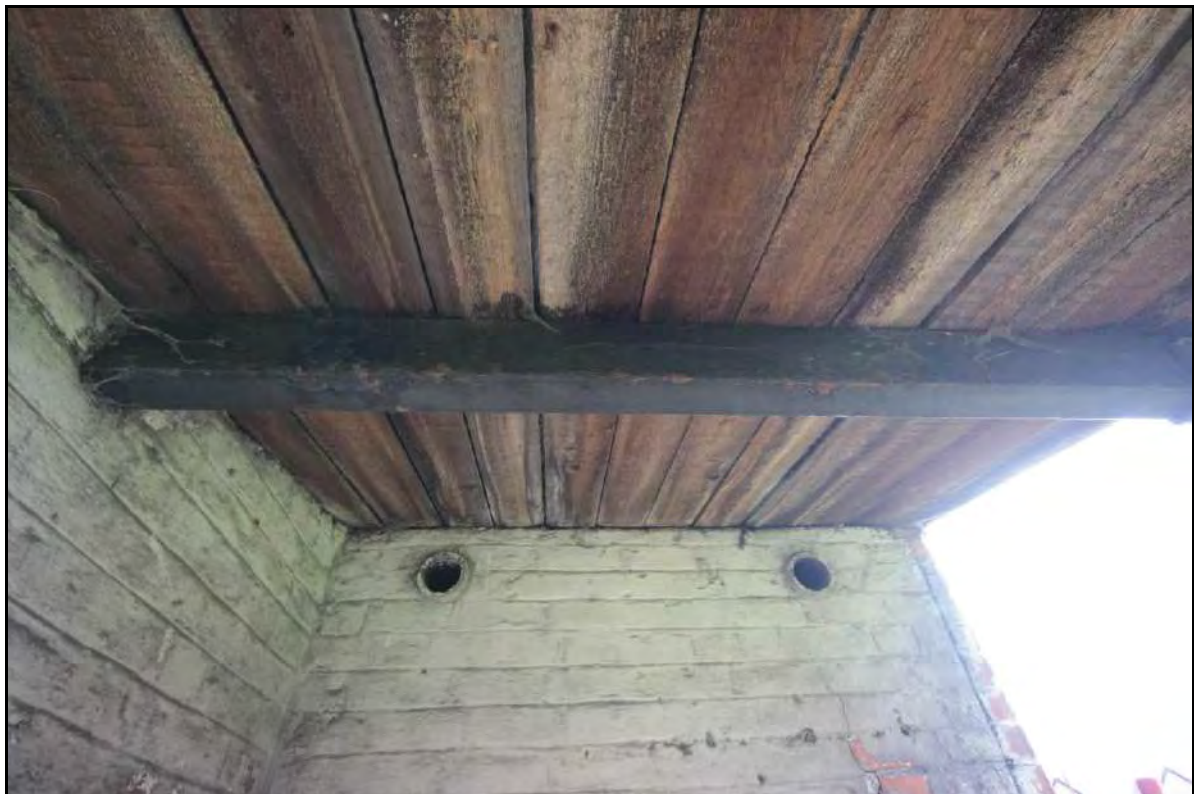
Photograph 75: View of Room 4's roof structure, taken facing east (File: HBR\_122)

6.4.6 Room 4 represents a small square space, roughly one bay in length and width, which forms the south-western portion of the structure (**Photograph 76**). The roof structure formed of timber joists supporting floorboards above, with iron bars fixed to the low brick walls (**Photograph 75**). The walls of the space feature extant whitewash, with the flooring formed of brick (**Photograph 76**). Within the south-western corner of the flooring, there is a small stone trough (**Photograph 77**). The western and southern walls of the space are formed of the later low brick walls, with an access point on the western wall (**Photographs 78 & 79**). The eastern wall features a small access doorway to Room 5, with a semi-circular archway formed of brick voussoirs (**Photographs 80 & 81**). This archway is situated at c.0.7m in height, suggesting it had represented an animal doorway. With the stone trough, it seems likely that this space, as well as Room 5 to the east, had functioned as a form of animal accommodation, likely as a small pig sty. On the upper portions of the eastern wall, there are two circular ceramic vents. The northern wall is plain of architectural features (**Photograph 82**).

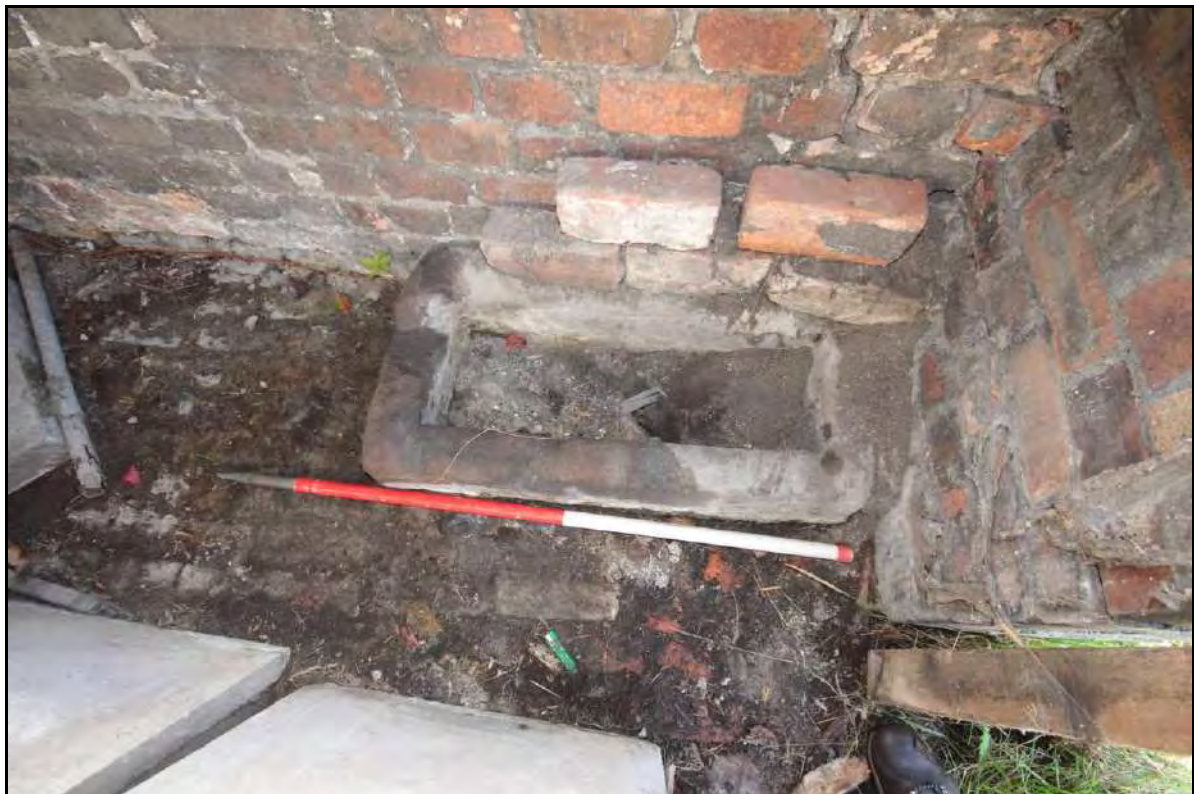
Photograph 77: View of the stone trough within the south-western corner of Room 4, taken with 1m scale facing south (File: HBR\_124)

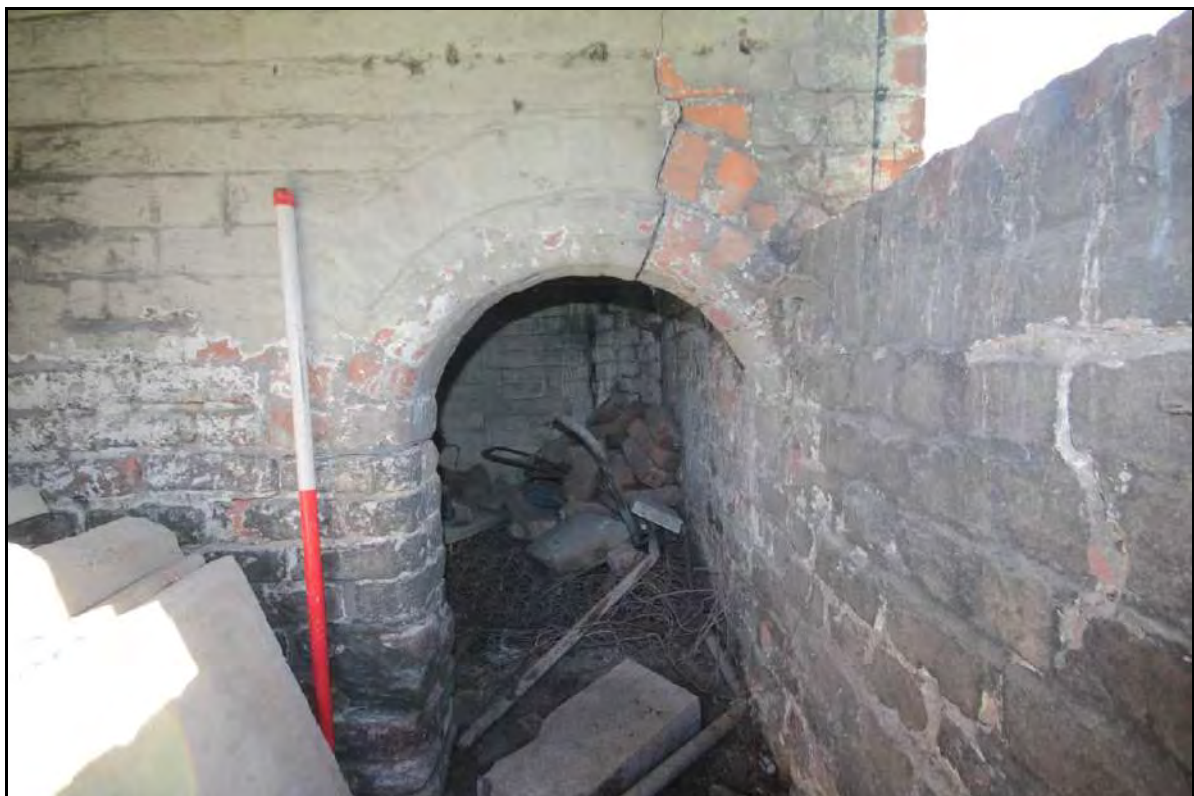
Photograph 81: View of the semi-circular arched aperture on the eastern wall of Room 4, taken with 1m scale facing east (File: HBR\_126)

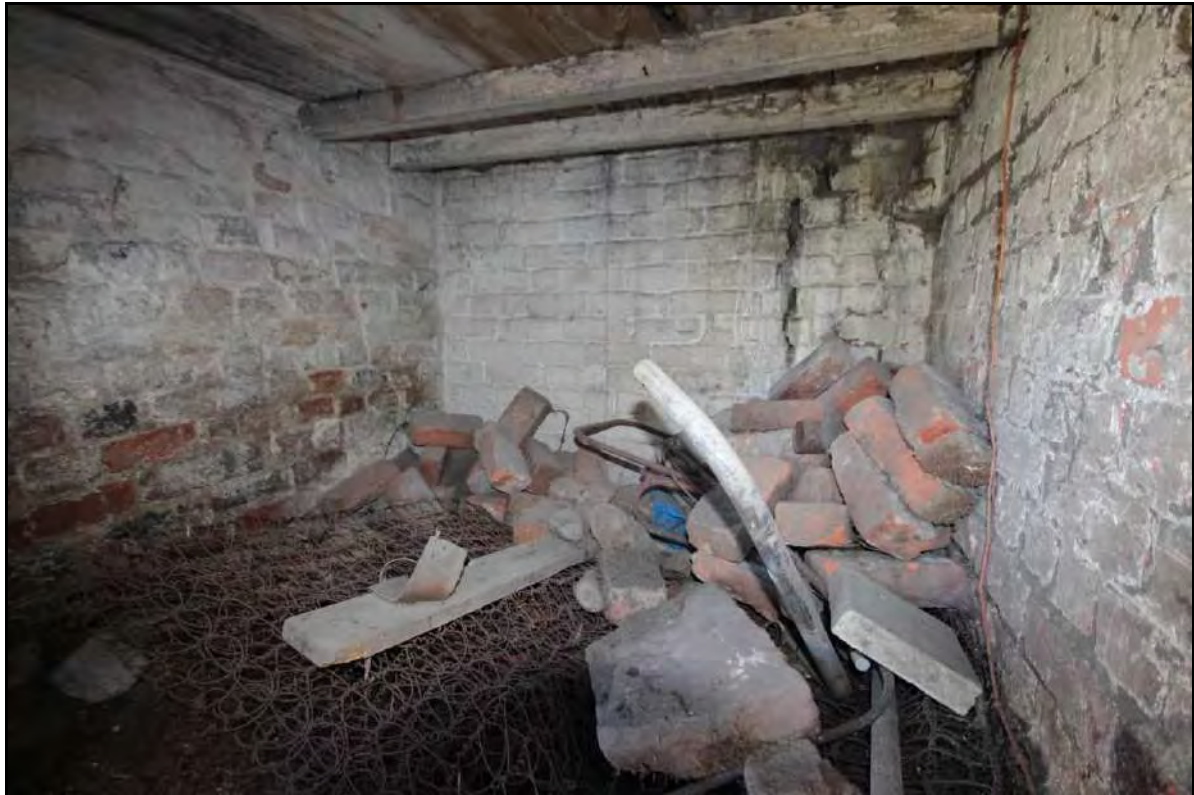
Photograph 83: General view to the east within Room 5 (File: HBR\_136)

6.4.7 Room 5 comprises a small space, roughly one bay in length and width, with a low ceiling height of c.1.1m (**Photograph 83**). This ceiling is formed of timber joists supporting timber floorboards associated with Room 6 above, with the flooring comprised of concrete (**Photograph 84**). The walls feature extant whitewash, and are relatively plain of architectural features (**Photographs 85-87**). On the western wall, there is the semi-circular archway with brick voussoirs (**Photographs 88 & 89**). This space formed part of the animal accommodation for the building, likely as a pig sty, along with Room 4.

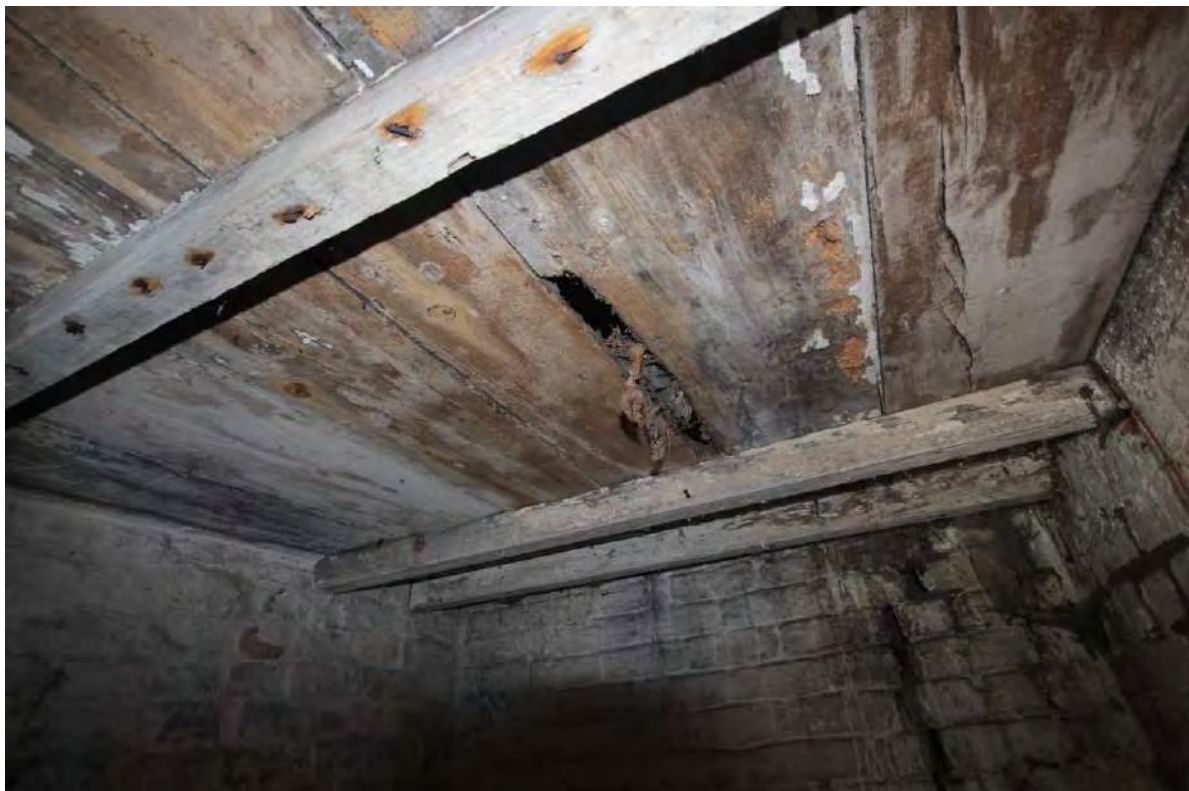
Photograph 84: View of the ceiling structure of Room 5, taken facing north-east (File: HBR\_139)

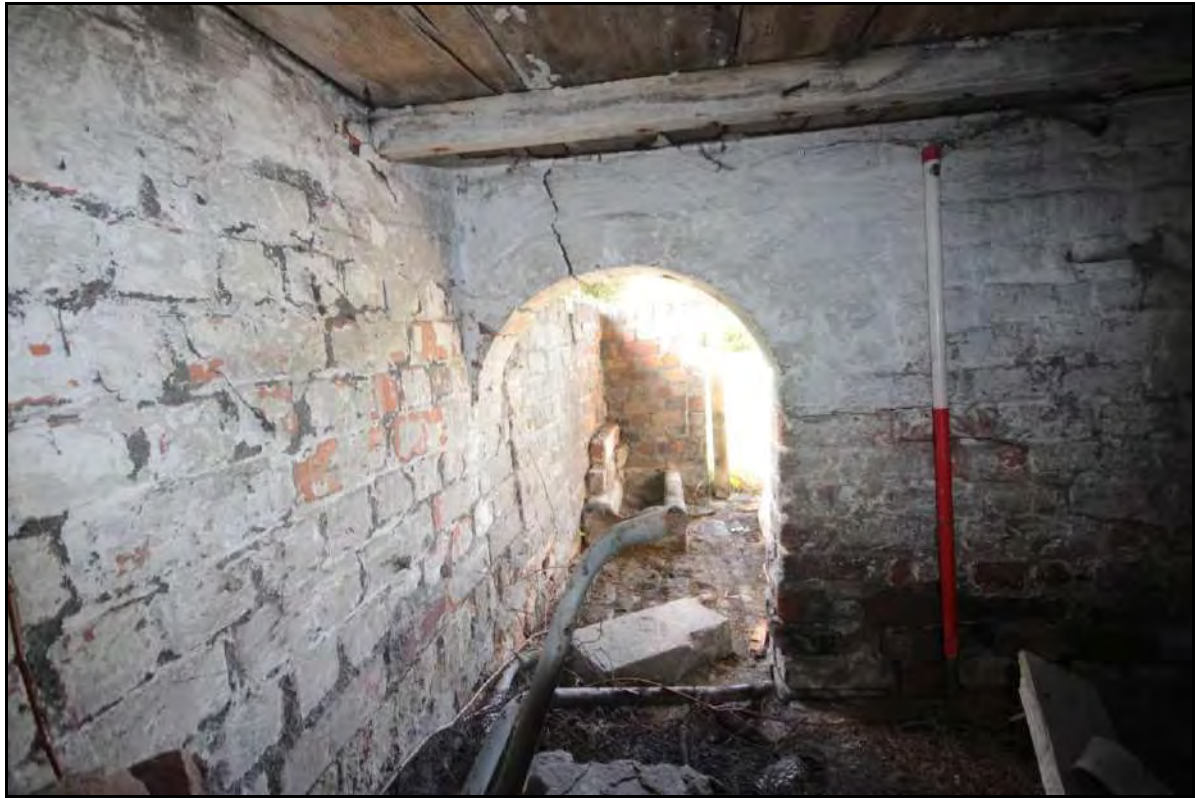
Photograph 89: View of the semi-circular archway on the western wall of Room 5, taken with 1m scale facing west (File: HBR\_134)

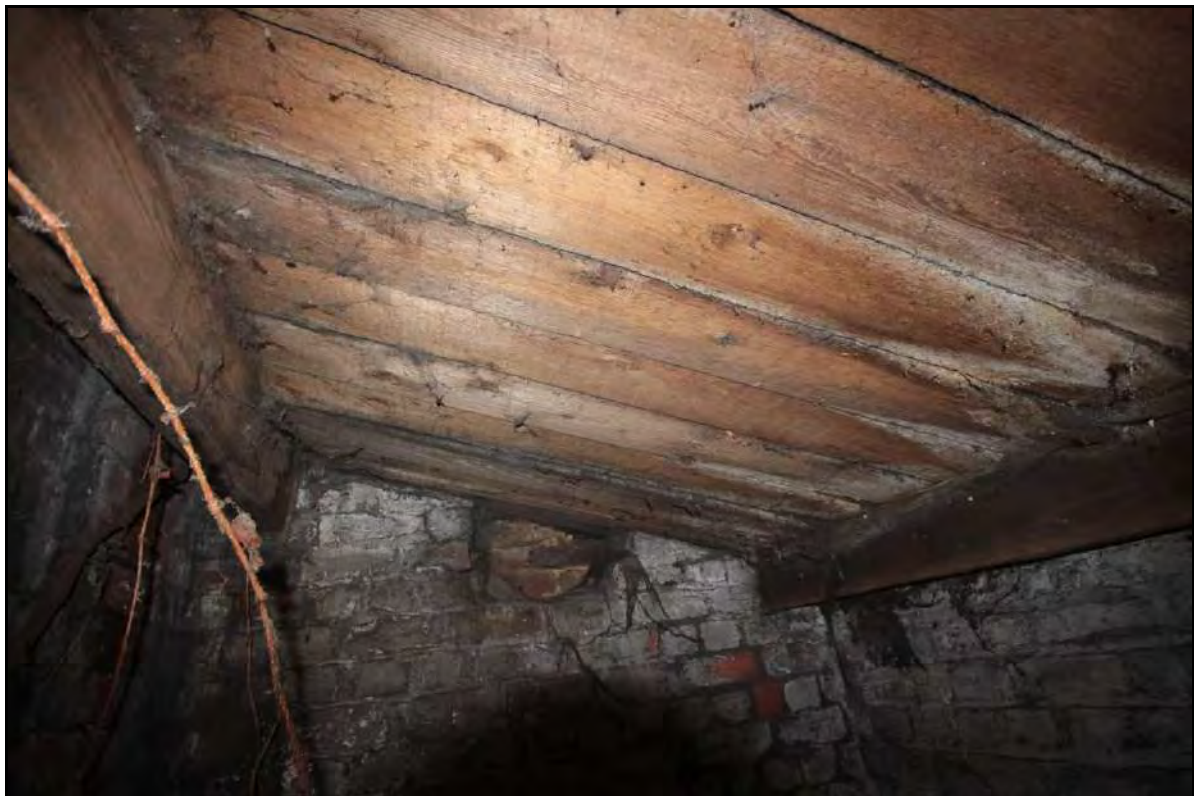
Photograph 91: View of the roof structure of Room 6, taken facing south (File: HBR\_108)

6.4.8 Room 6 forms a small square space, comprising a loft above Room 5, and accessed from the small timber shuttered aperture of Room 2. The roof structure of this space is mono-pitched, with two timber joists supporting timber boards above. The space features timber floorboards and has extant whitewash on the walls. The southern wall of the space features a blocked circular aperture, with two circular ceramic vents on the western wall. The northern wall features the timber shuttered aperture, with the eastern wall plain of architectural features. This space likely formed a log store.

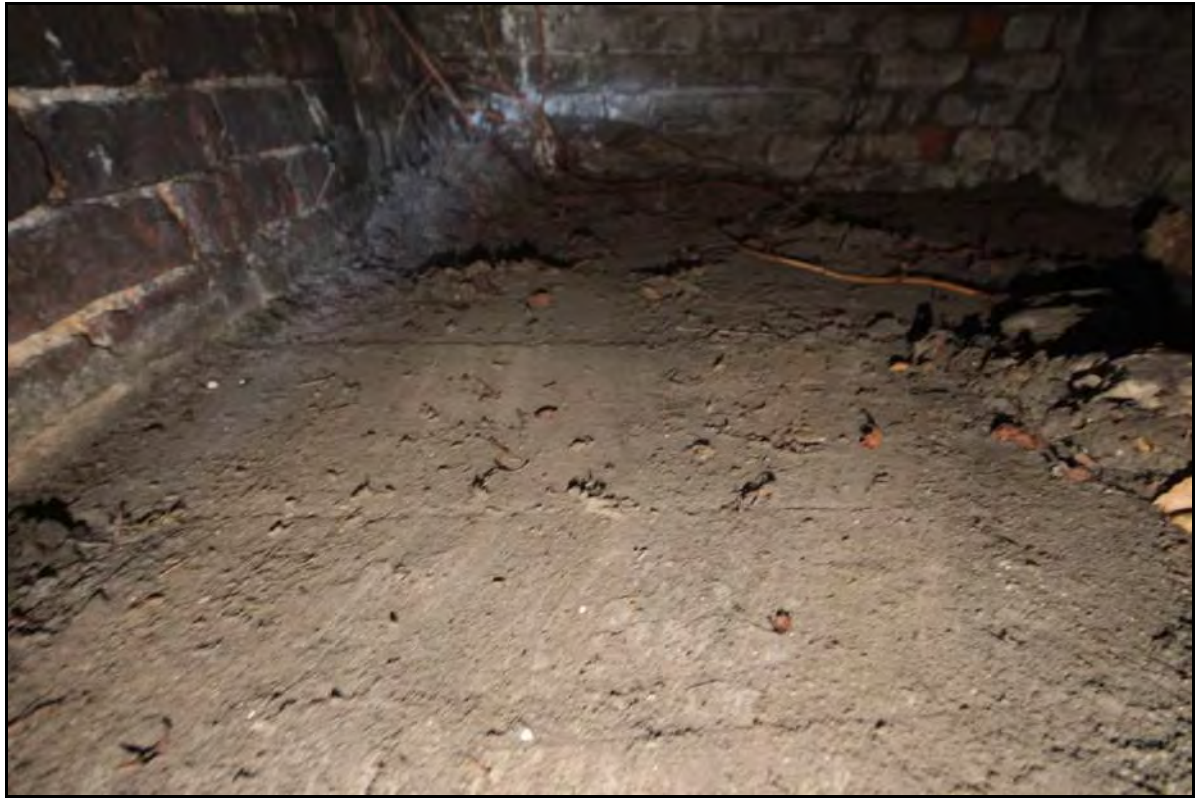
Photograph 92: View of the timber floorboards of Room 6, taken facing south (File: HBR\_109)

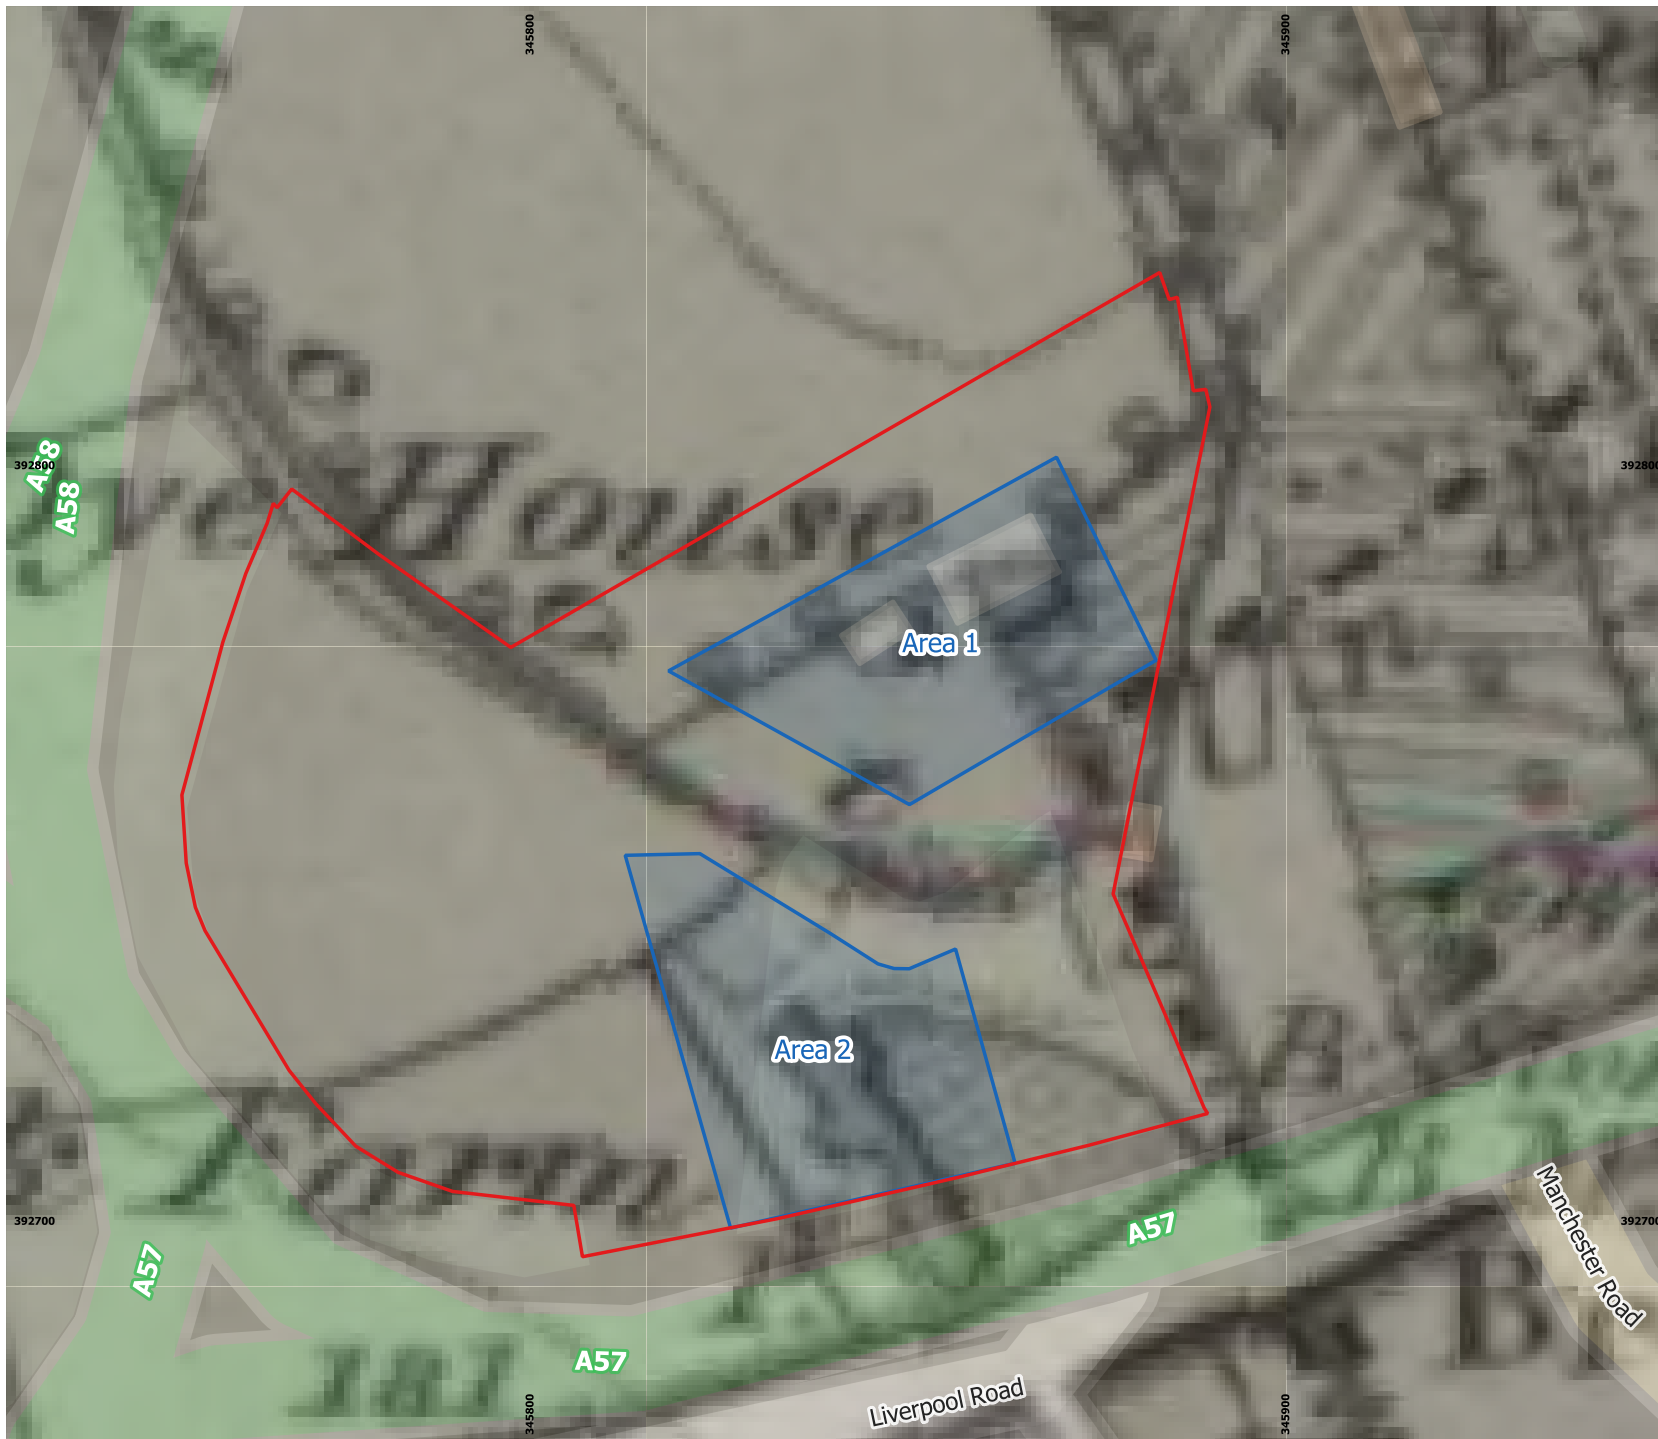
**Figure 2: Extent of Archaeological Excavation**

- Site Boundary
- Excavation Areas

1.2.1 The proposed development encompasses a total area of 1.14 ha and is located 500m west of Prescott town center (Figure 1; NGR SJ 45823 92744). The site presently consists of an open field flanked by two areas of woodland and a residential property called Dye House. The site is bisected from the north-west to south-east by Prescott Brook. To the north the site is bounded by the former Whitakers Garden Centre, now a development site and to the east lies an open field, to the south is Liverpool Road and to the west is the A58. The site is accessible from Liverpool Road via an access road to Dye House. The extent of the excavation comprises 0.3ha (Figure 2).

3.1.2 The maximum extent of the site subject to archaeological excavation is depicted on Figure 2, which comprises a total of 0.3ha. The strip will not extend beyond the limits of the archaeology once fully exposed. Area 1 is 0.15ha and lies north of Prescott Brook and focuses on the former dye works. Area 2 is also 0.15ha and lies to the south of the brook, targeted upon the former Brook Farmhouse.
