## HALSNEAD FARM

### PHASE 2 GROUND INVESTIGATION REPORT

**Curtins Ref:** 087052-CUR-XX-XX-T-GE-00003

Site Address: Halsnead Farm, Fox's Bank Lane, Whiston, L35 3SU

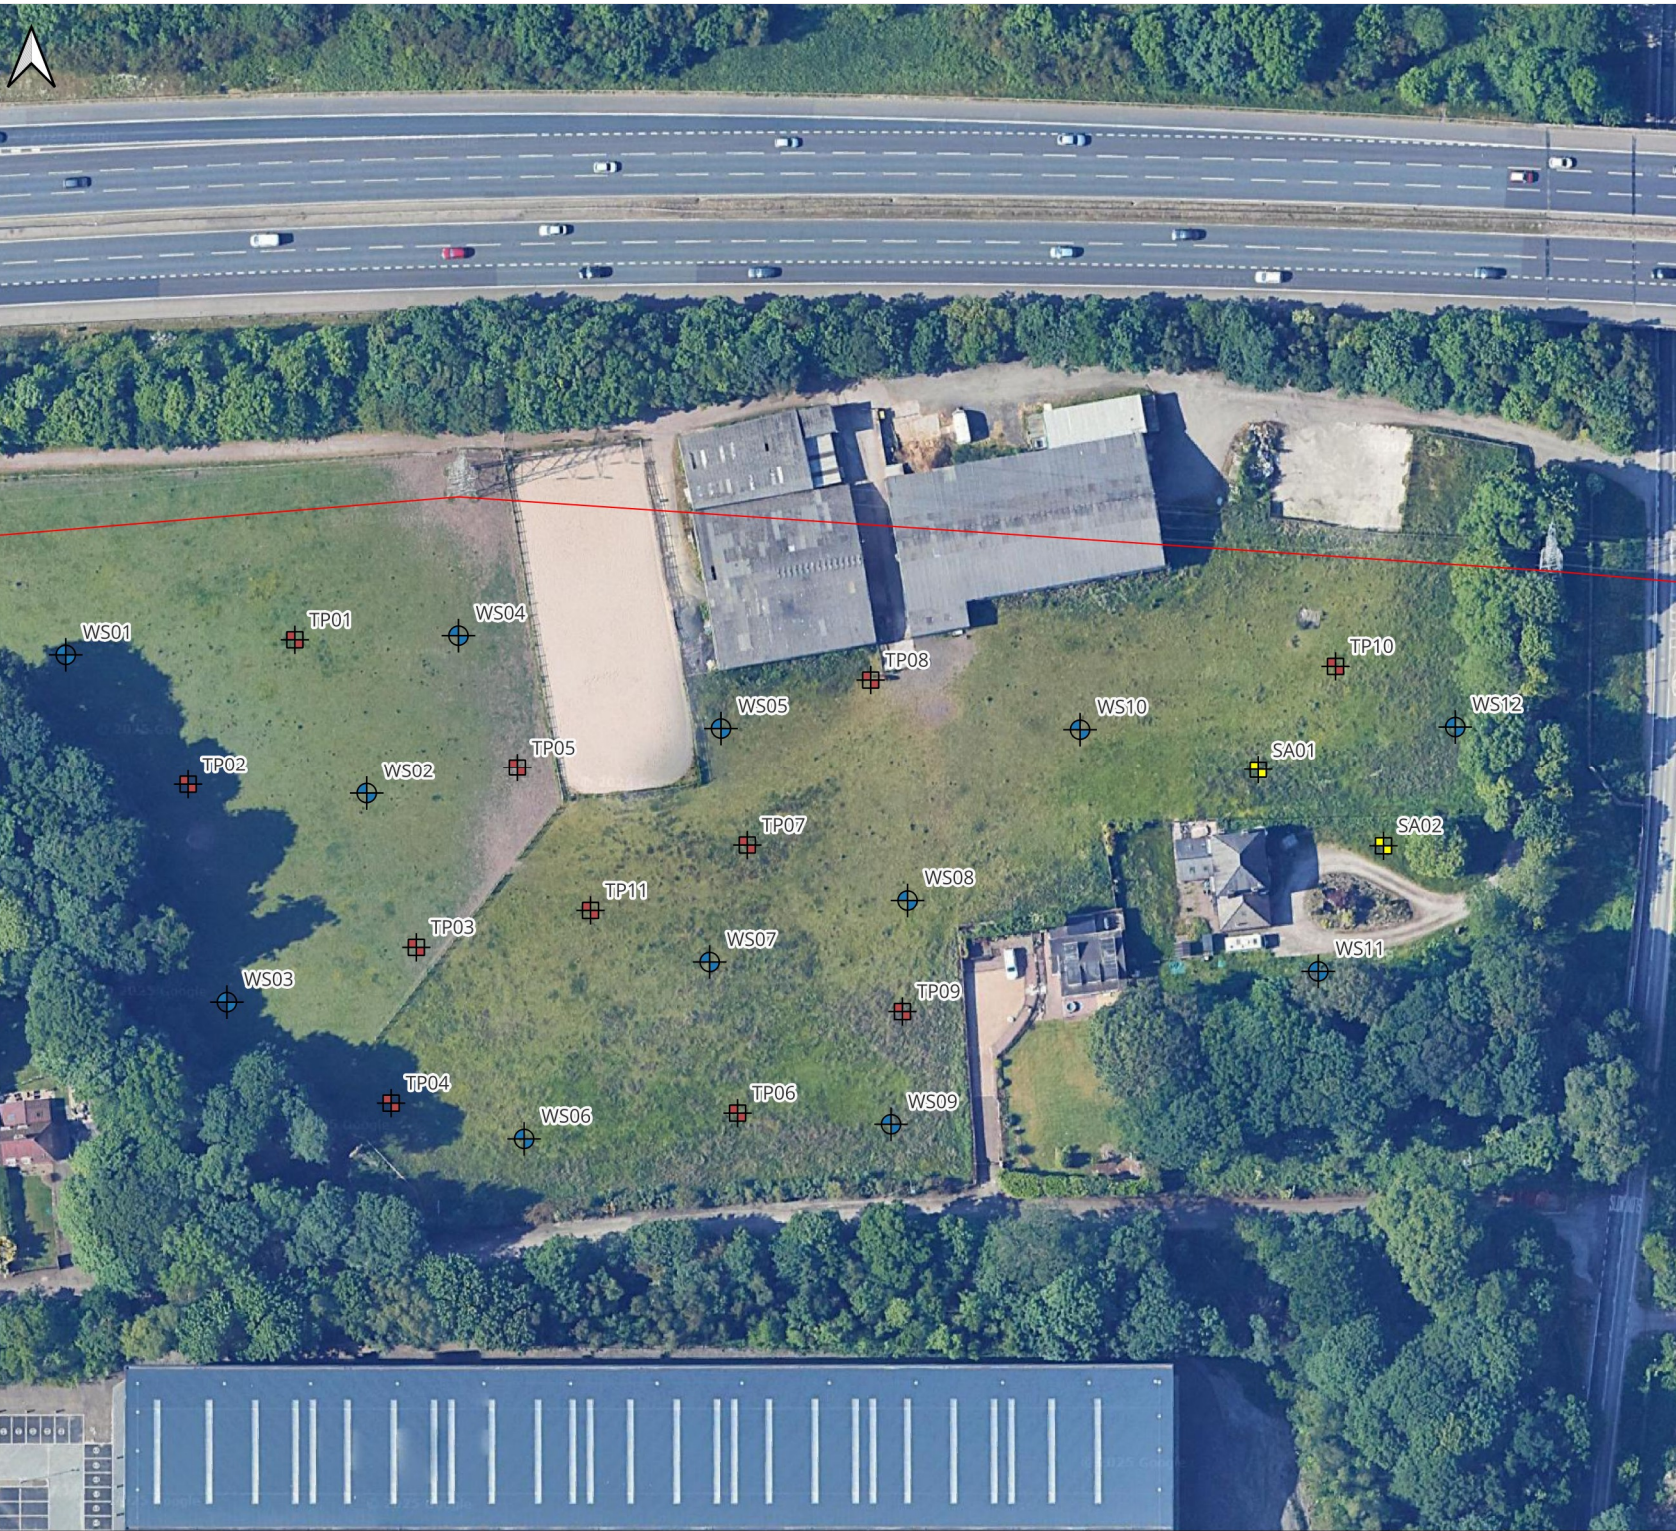
Borehole Locations

- SA
- TP
- WS
- Power Lines
