## Ground Investigation Report

Proposed Floodlit Artificial 3G Pitch

Knowsley MBC, Huyton

Document Title: Ground Investigation Report  
Document no.: STT-5625-R01 Rev A  
Date: July 2022  
Client: The Football Foundation

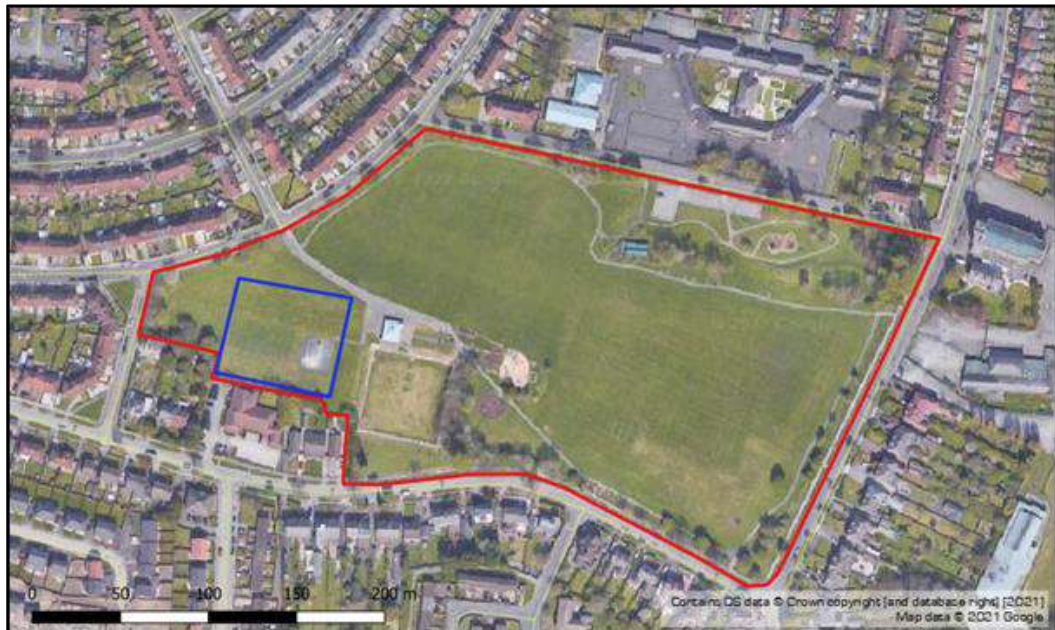
Figure 1-1: Aerial image and approximate site boundary

- 1.1.1 The proposed development is for construction of a 73m x 46m (9v9) 3G LED Floodlit Turf Pitch (FTP), including parking provision to the west and north. A site location plan is presented below.

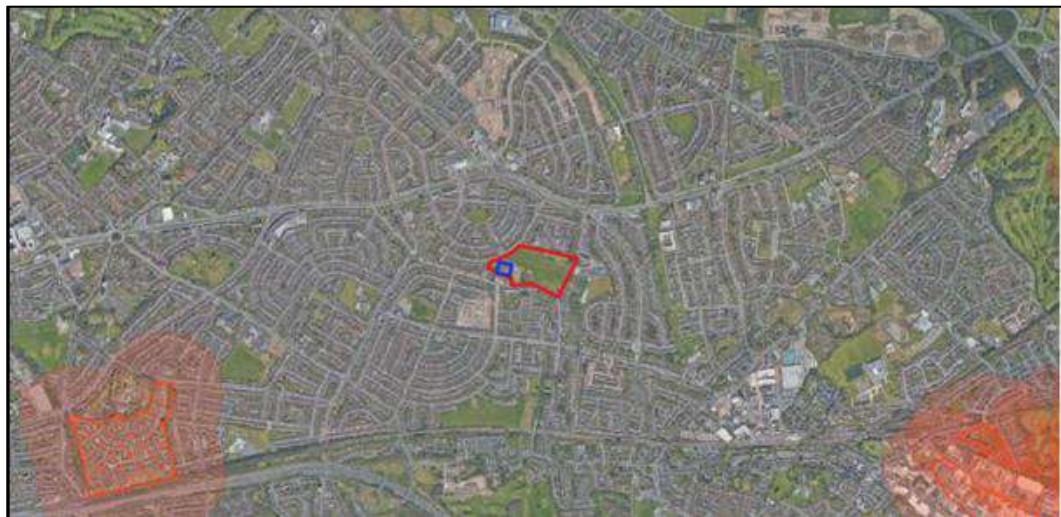
Figure 2-4: Historical and permitted landfills

- 2.5.1 Open-source Environment Agency landfill mapping data shows that the site does not lie within 250m of a permitted or historical landfill site (see Figure 2-5 below).
- 2.5.2 Based on the above and anticipated ground conditions on site, the risk from ground gases is considered low.

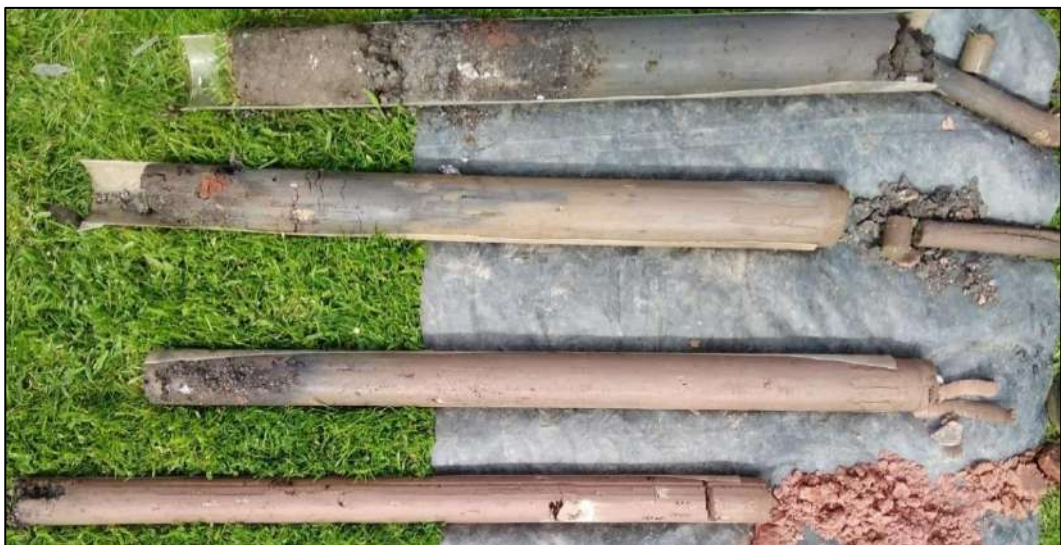
Figure 4-1: Photo of soil profile at WS102

- 4.1.1 Ground conditions comprised Topsoil overlying Made Ground within Devensian Till and/or Weathered Chester Formation recorded beneath.
- 4.1.2 Topsoil was observed between 0.1m and 0.5m in thickness across the site. Topsoil typically comprised grass onto dark brown gravelly sand with rootlets.

- 4.1.3 Made Ground was recorded beneath the Topsoil to depths between 0.7m and 1.3m across the site where proven. The Made Ground typically comprised black very gravelly medium to coarse sand and soft brown slightly gravelly slightly sandy clay beneath. Gravels comprised coal, flint, brick, concrete, glass, tile and sandstone. Towards the south of the proposed pitch development area, a thin layer of grey sandy gravel comprising of brick, concrete, sandstone and clinker-like material was also noted within the Made Ground (0.3m to 0.4m in thickness).

- 4.1.5 The Weathered Chester Formation was observed either beneath the Made Ground (north of proposed pitch area) or beneath the Devensian Till (south of proposed pitch area). The Weathered Chester Formation was recorded as a medium dense to dense reddish-brown sand with localised clay and silt inclusion and gravels of sandstone.

- 4.1.6 Photographs representing the typical ground conditions are presented below.

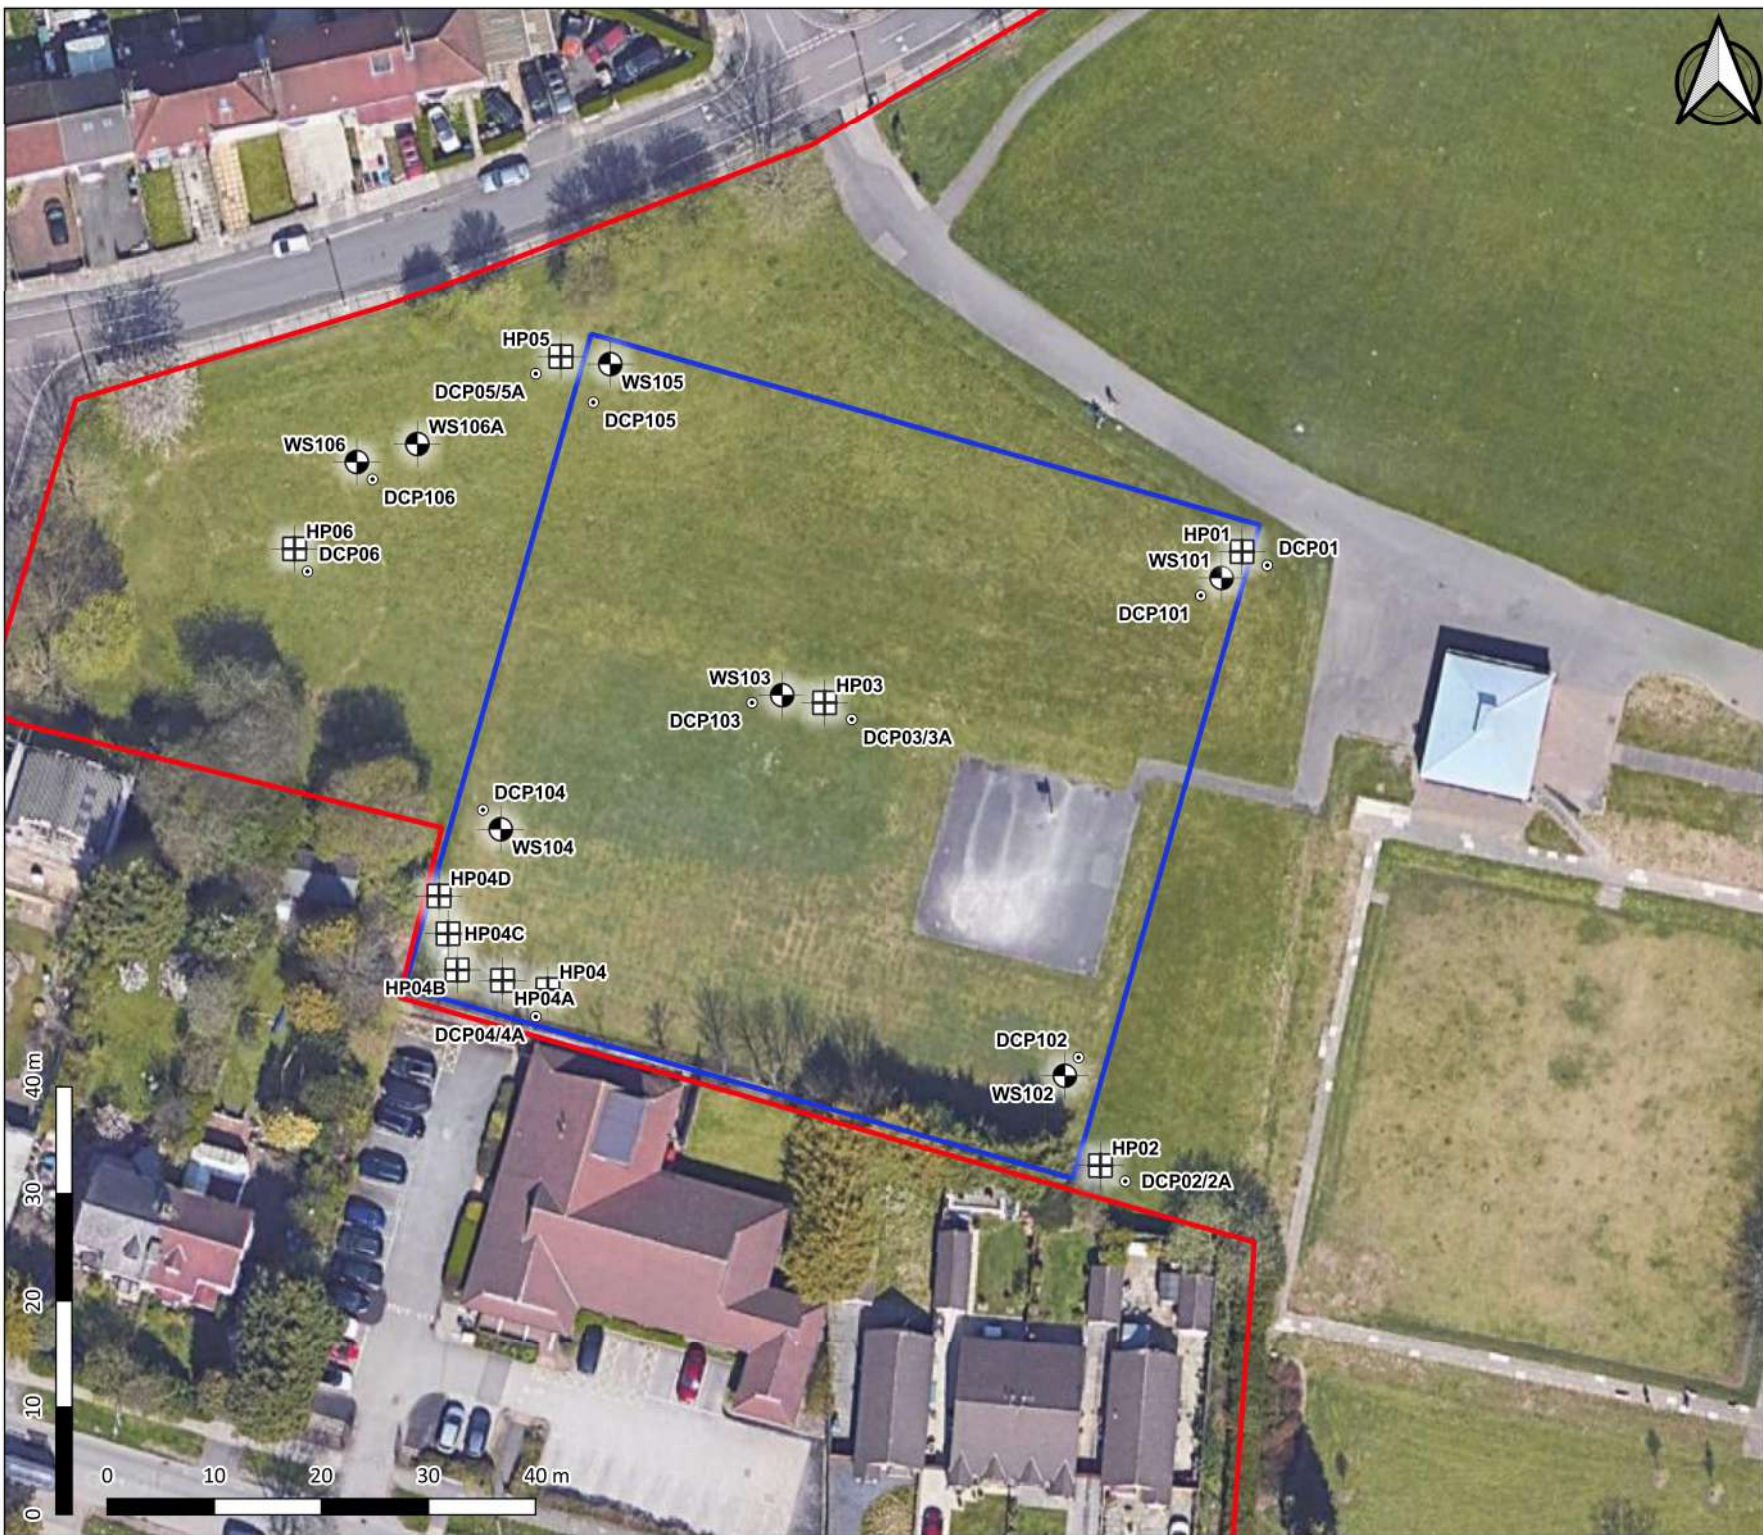
## Drawings

- Site Boundary
- Pitch Boundary
- Exploratory Locations — Hand Pit
- Exploratory Locations — WLS
- DCPs

- 7.3.1 We have determined CBR value for the proposed artificial pitch foundations based on existing ground levels using in-situ Dynamic Cone Penetrometer testing following the methodology defined by the Highways England Document CS229 Data for Pavement Assessment. The results are presented in Appendix C and the location of test positions are shown on Drawing 01.

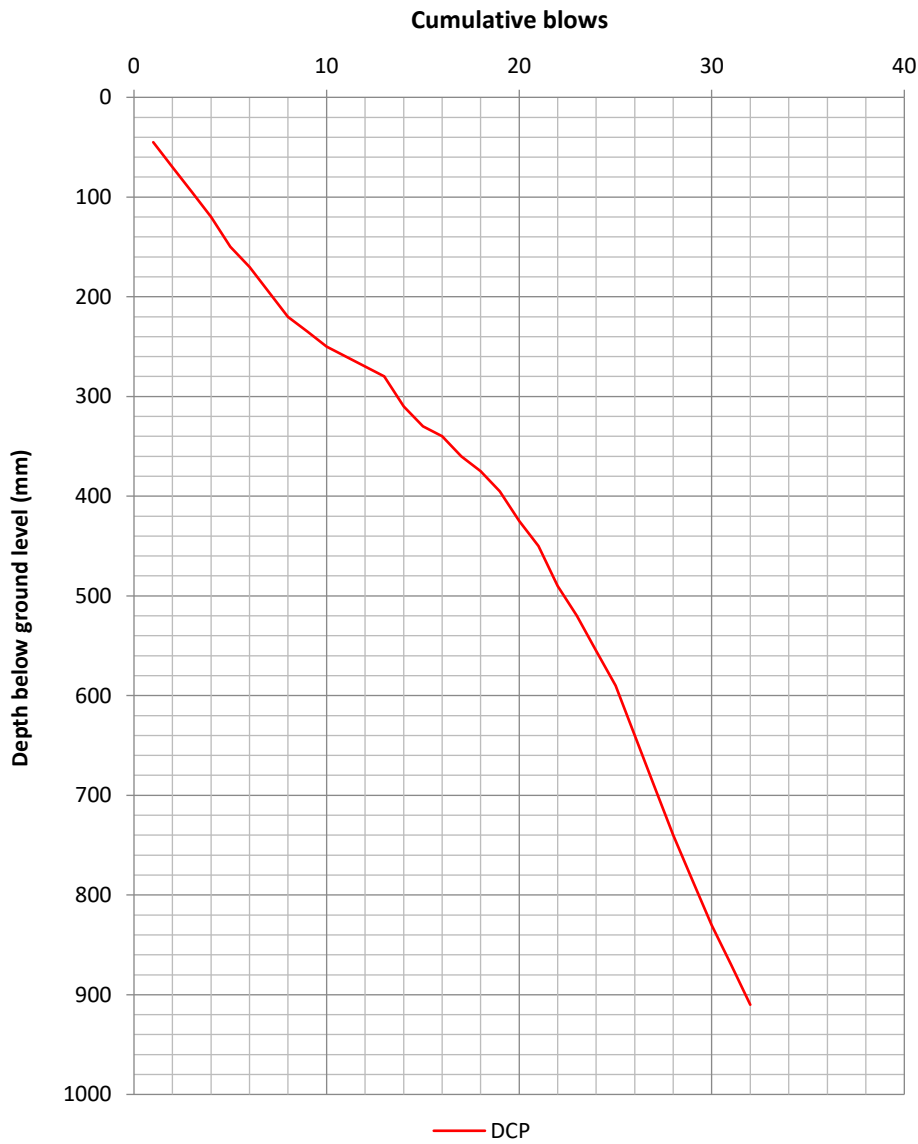
Plot showing number of blows against depth

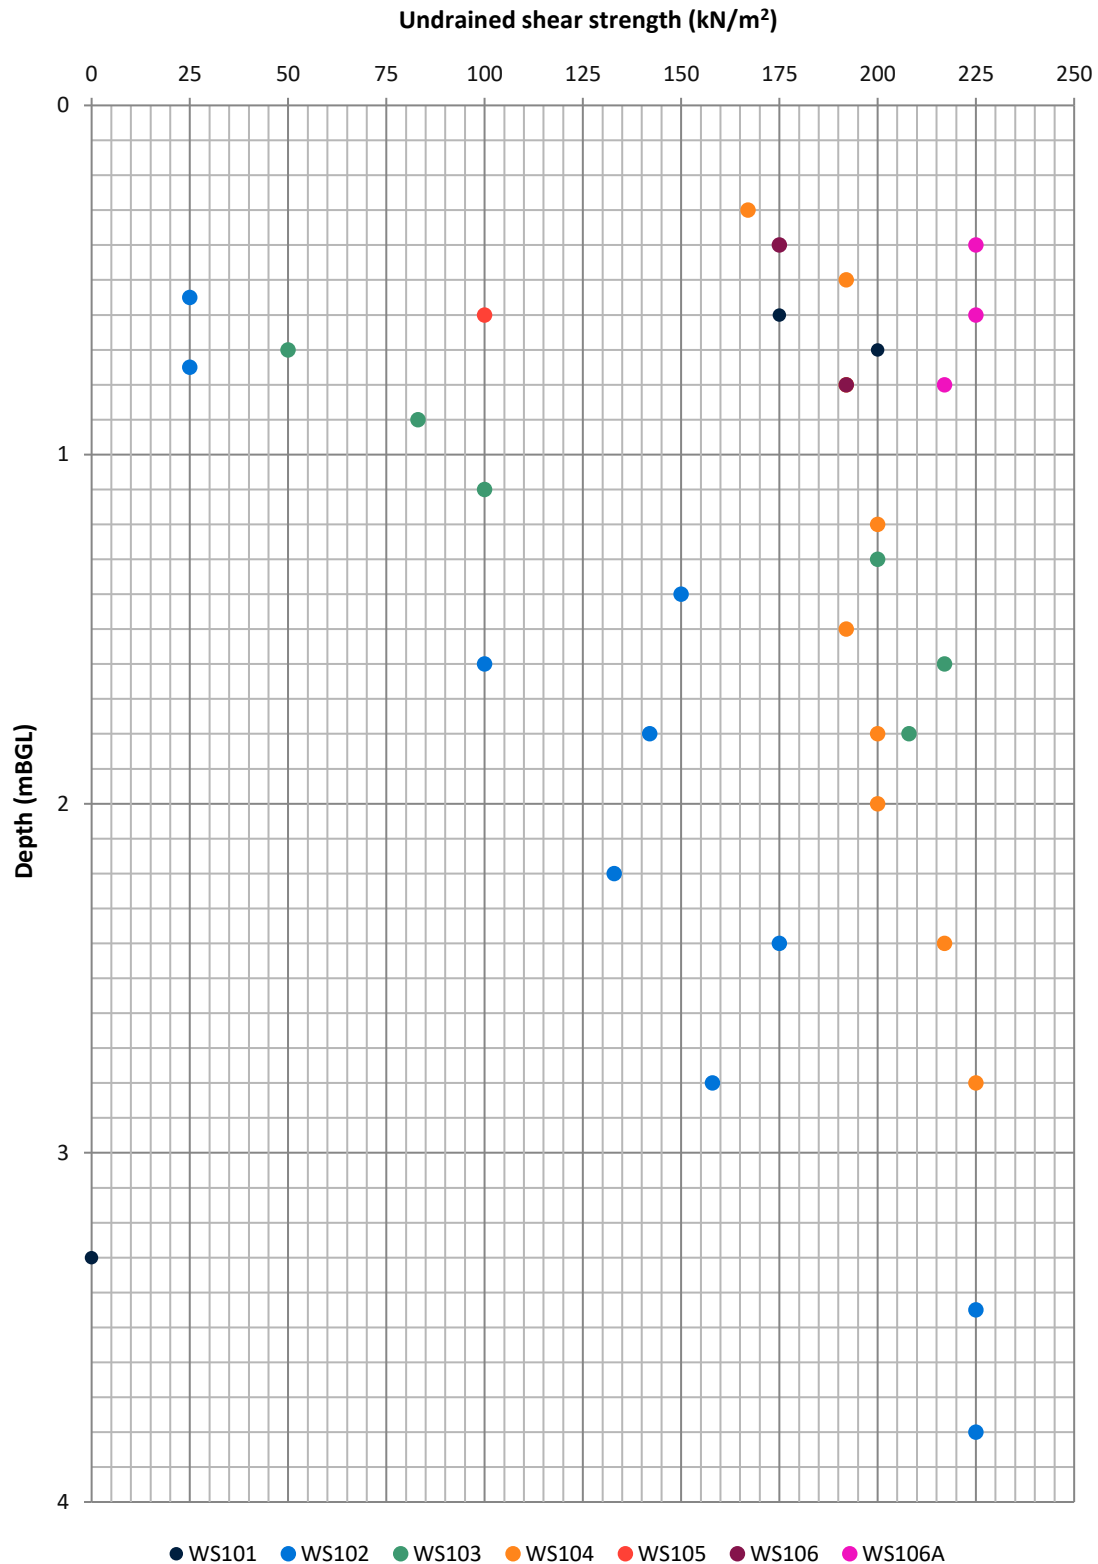
## Plot summarising Pocket Penetrometer results versus depth filtered by location

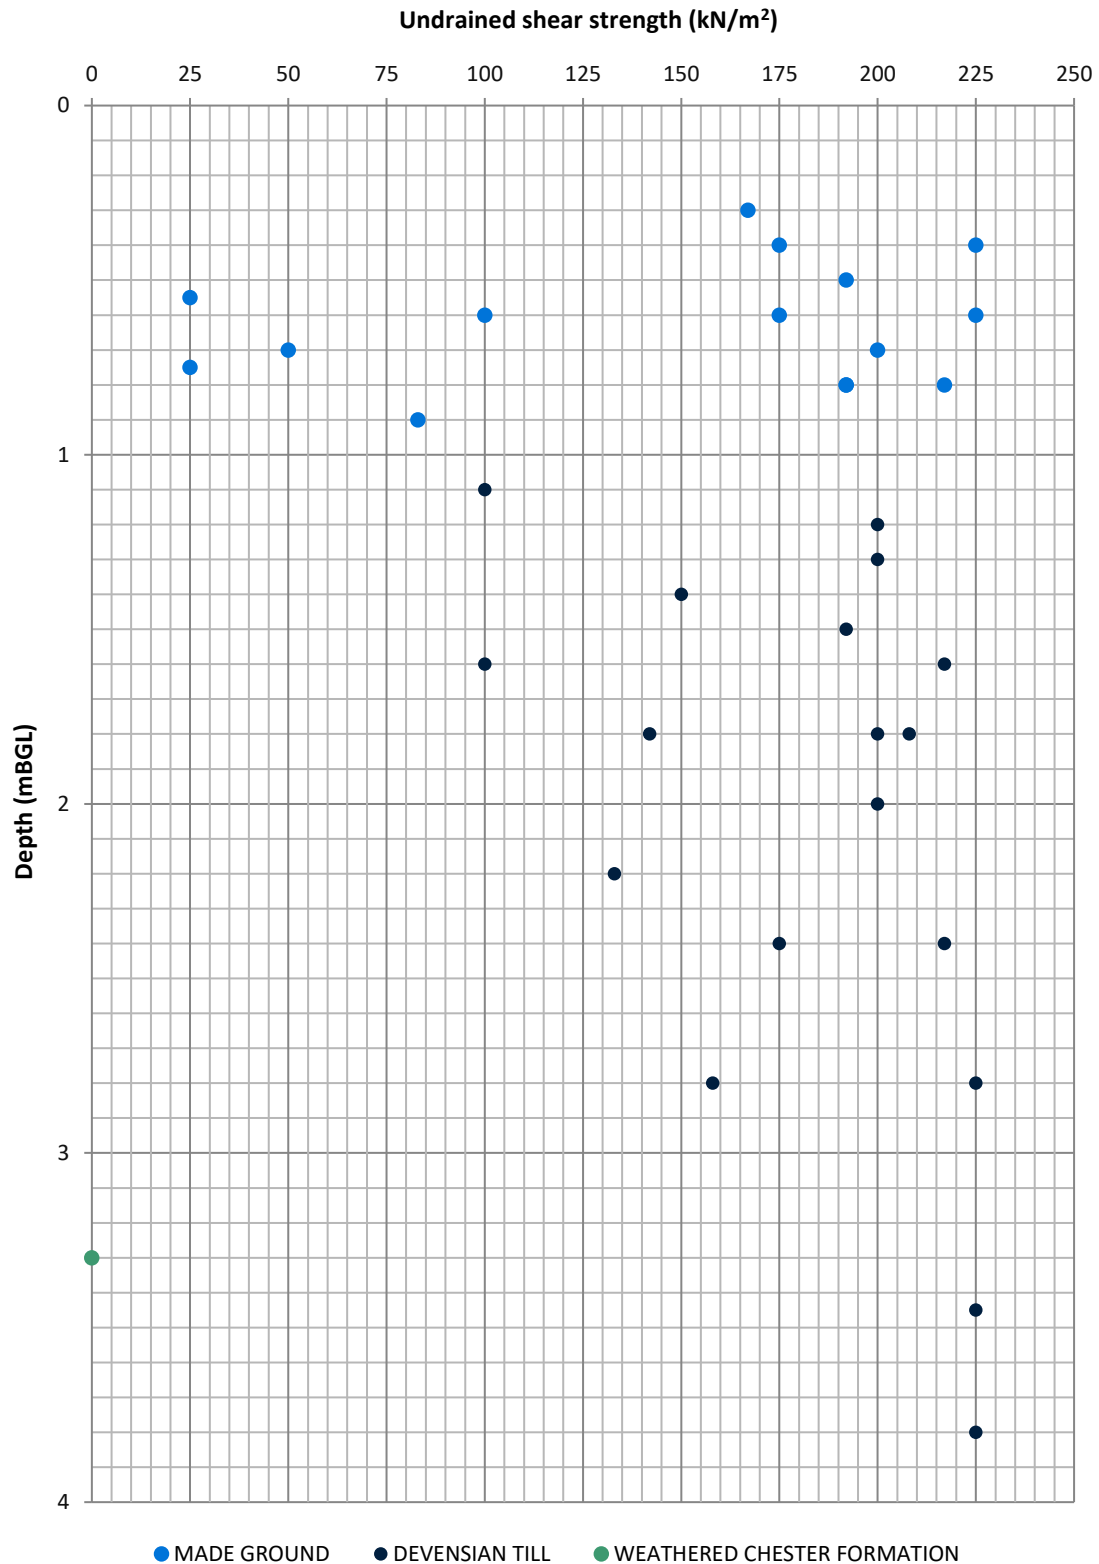
## Plot summarising Pocket Penetrometer results versus depth filtered by geology

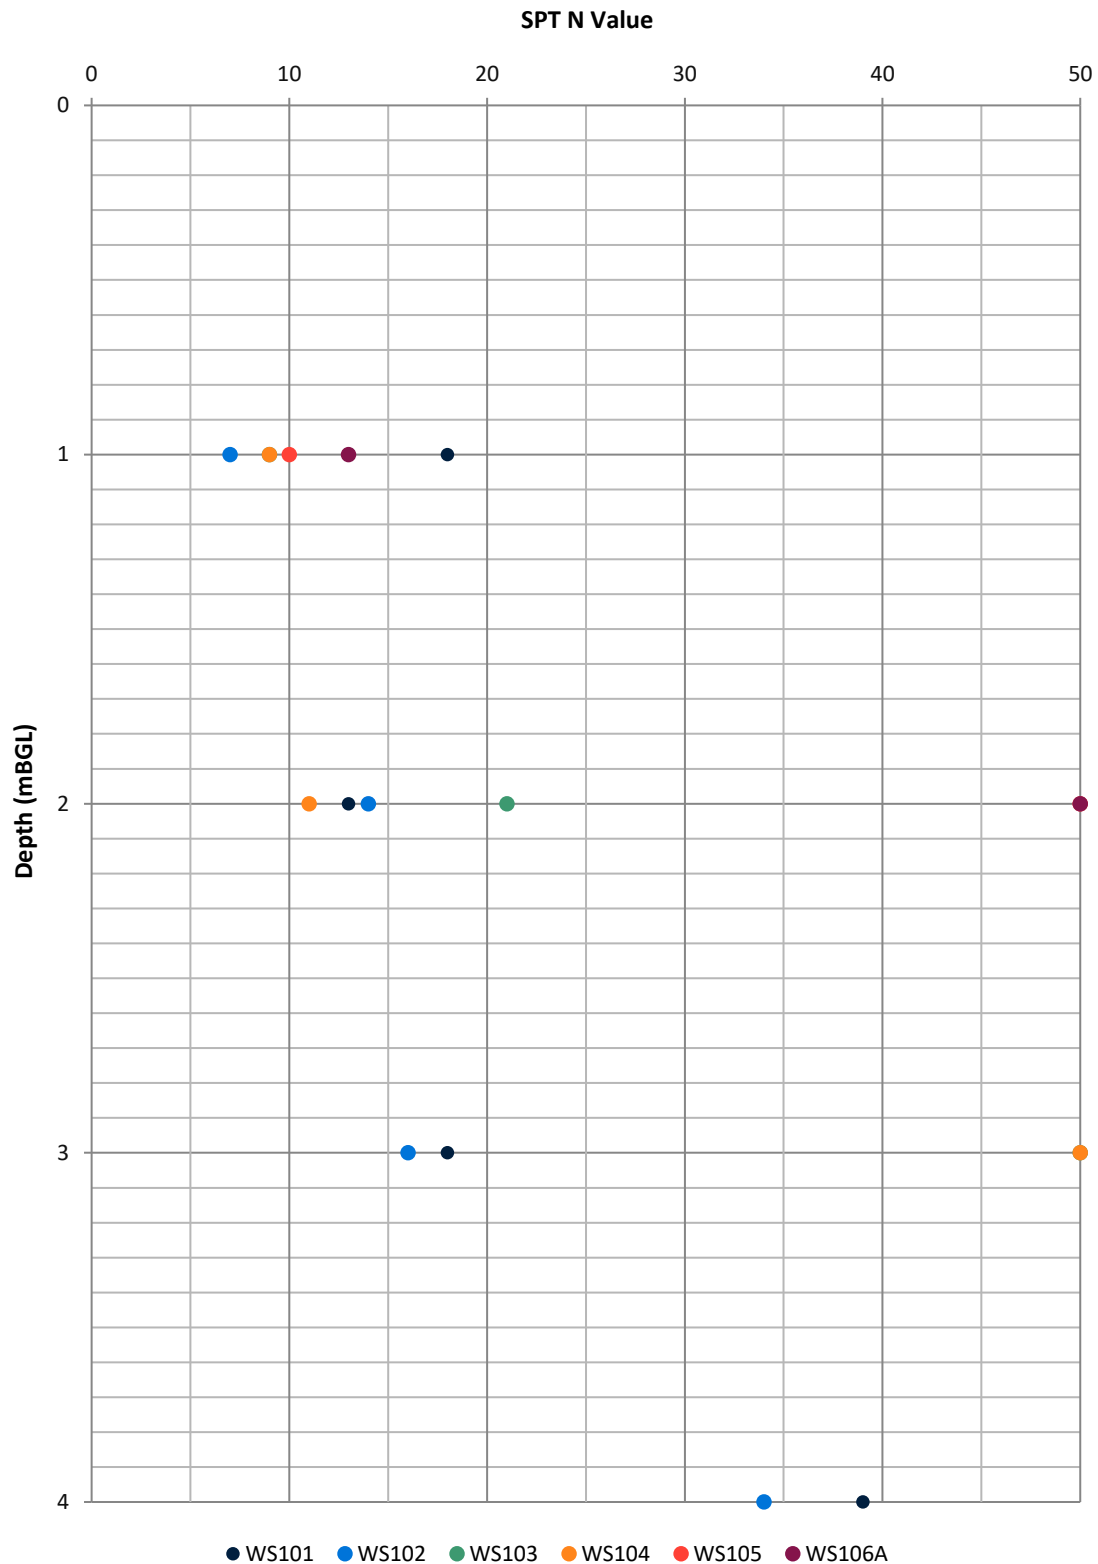
## Plot summarising Standard Penetration Test (SPT) results versus depth filtered by location

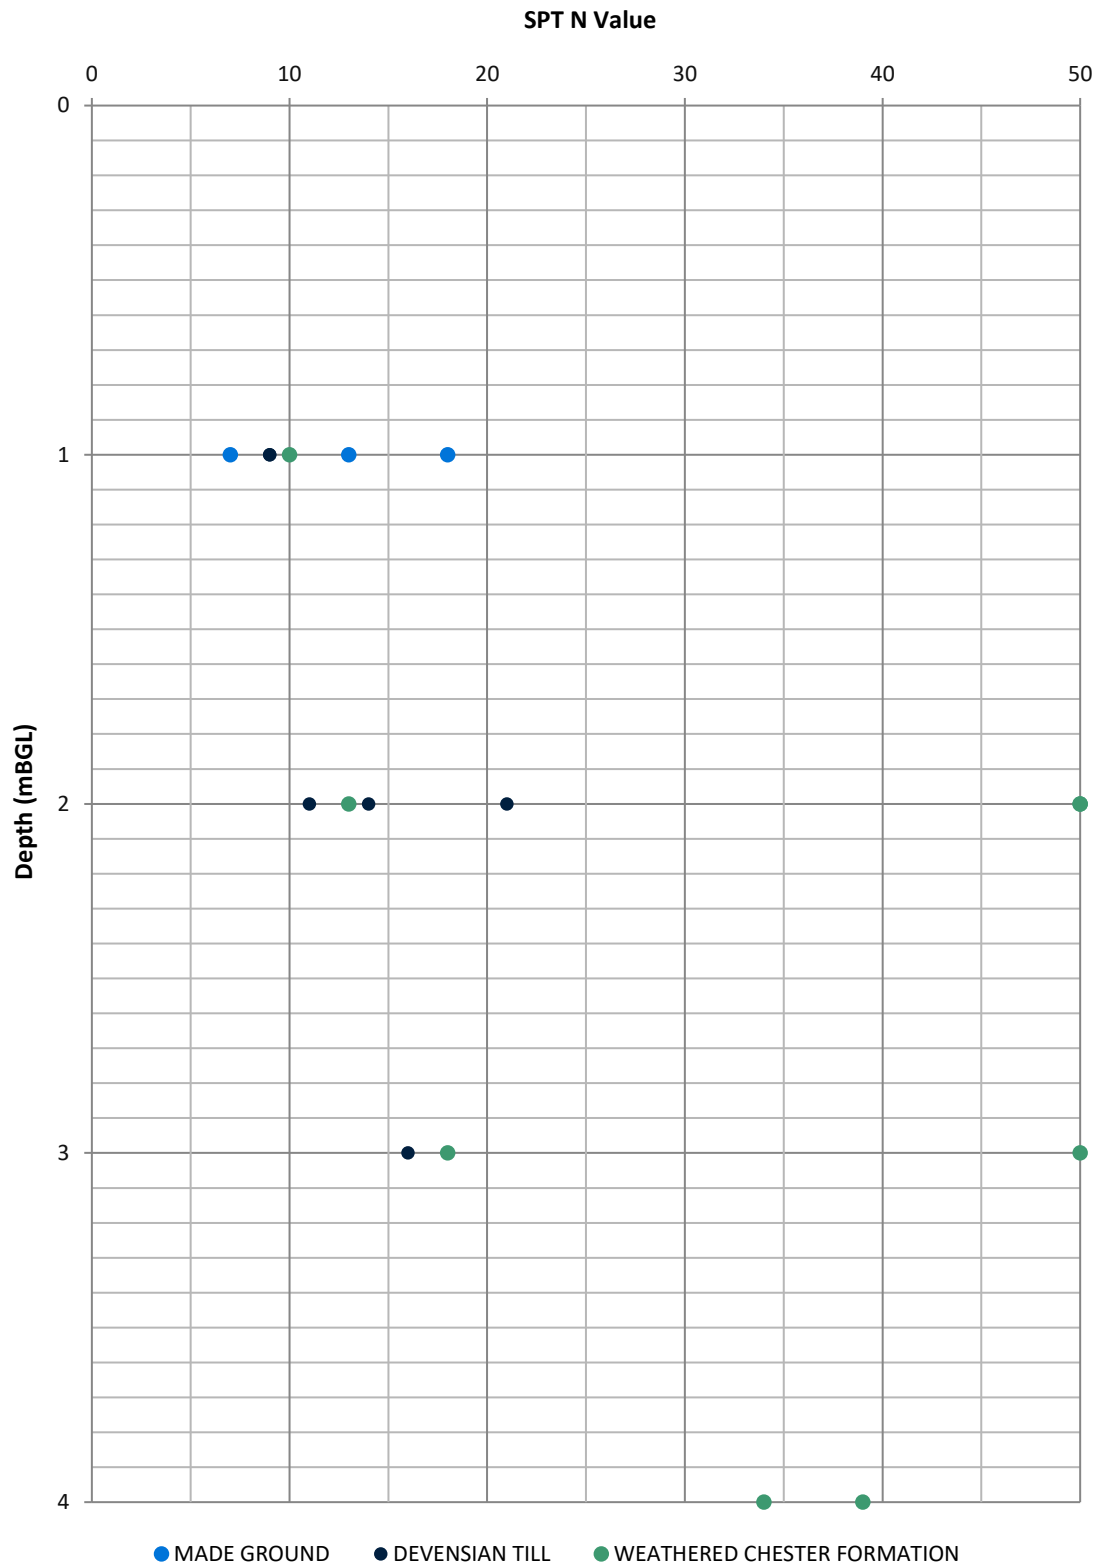
## Plot summarising Standard Penetration Test (SPT) results versus depth filtered by geology

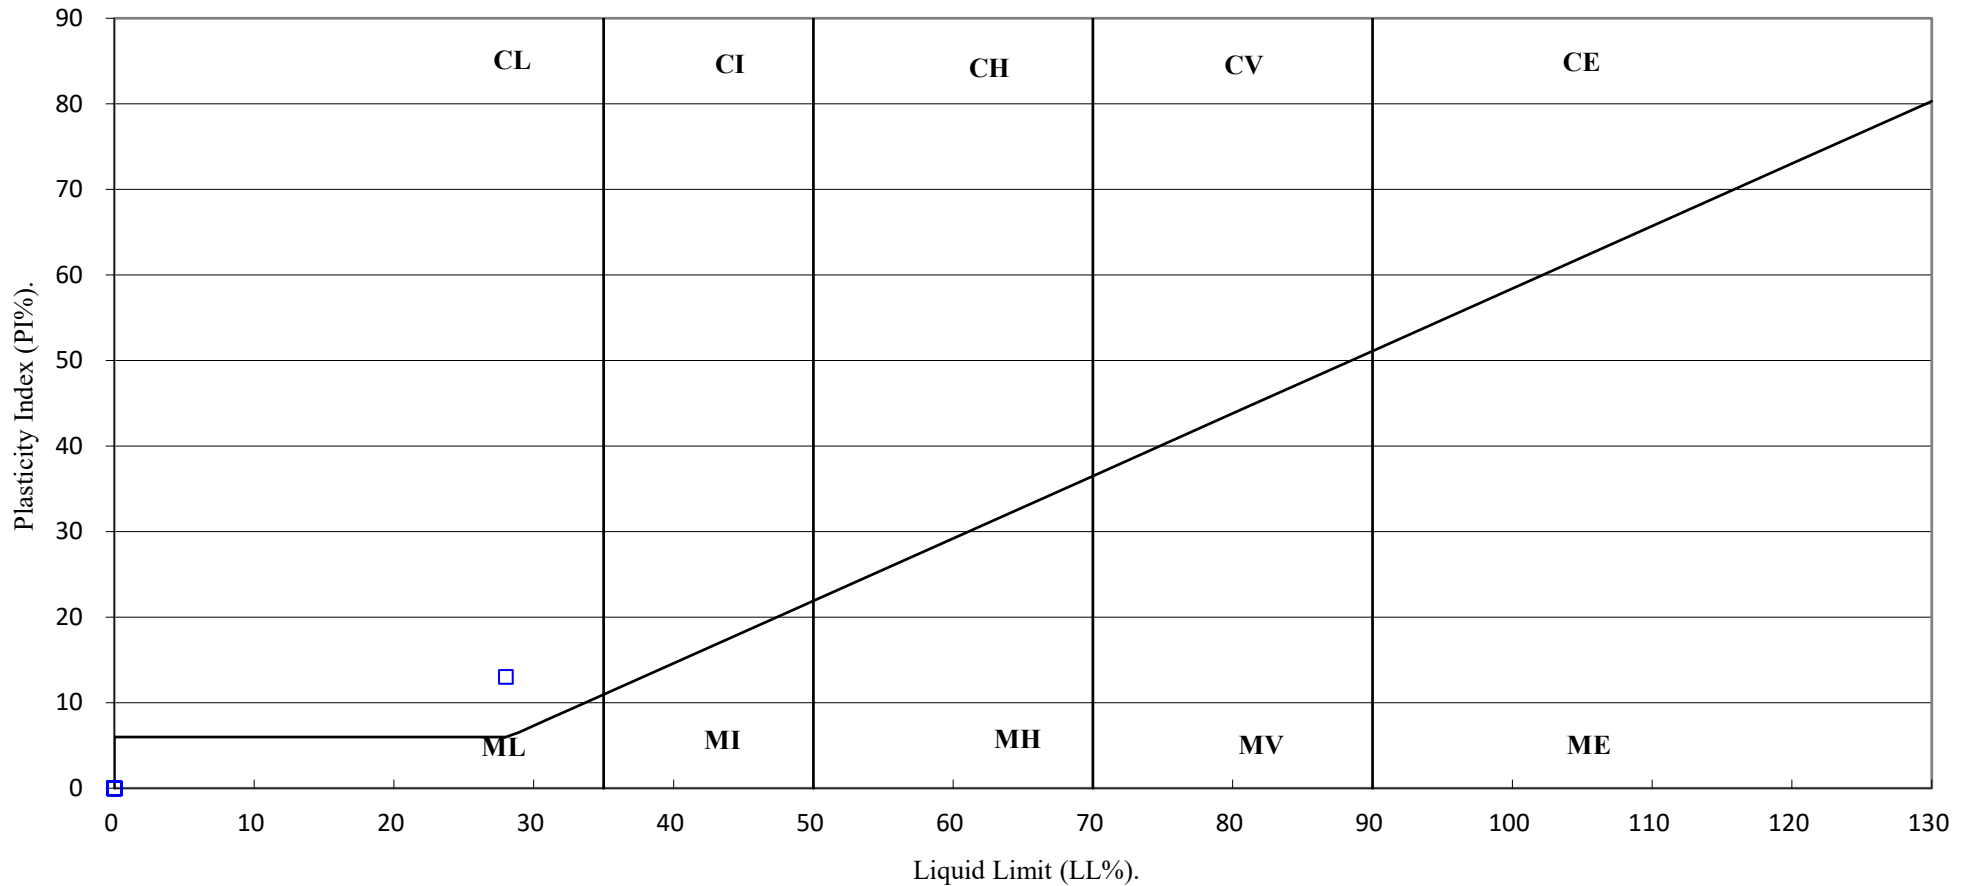
# PLASTICITY CHART FOR CASAGRANDE CLASSIFICATION.

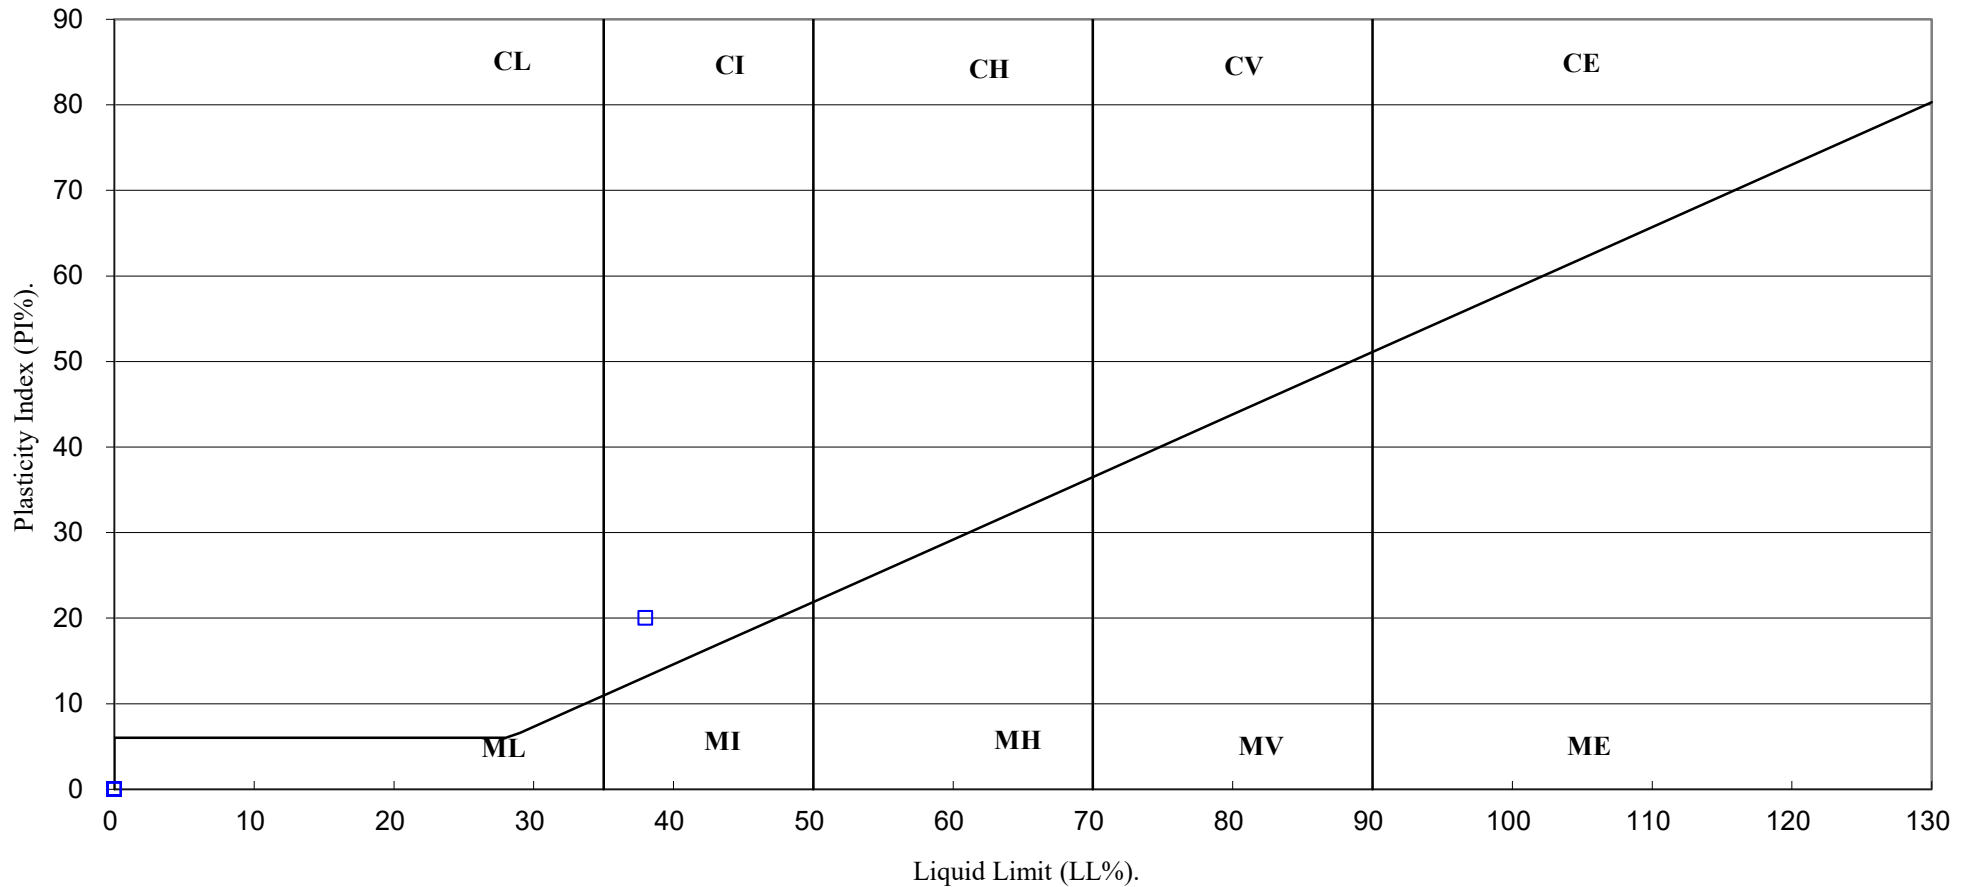
# PLASTICITY CHART FOR CASAGRANDE CLASSIFICATION.

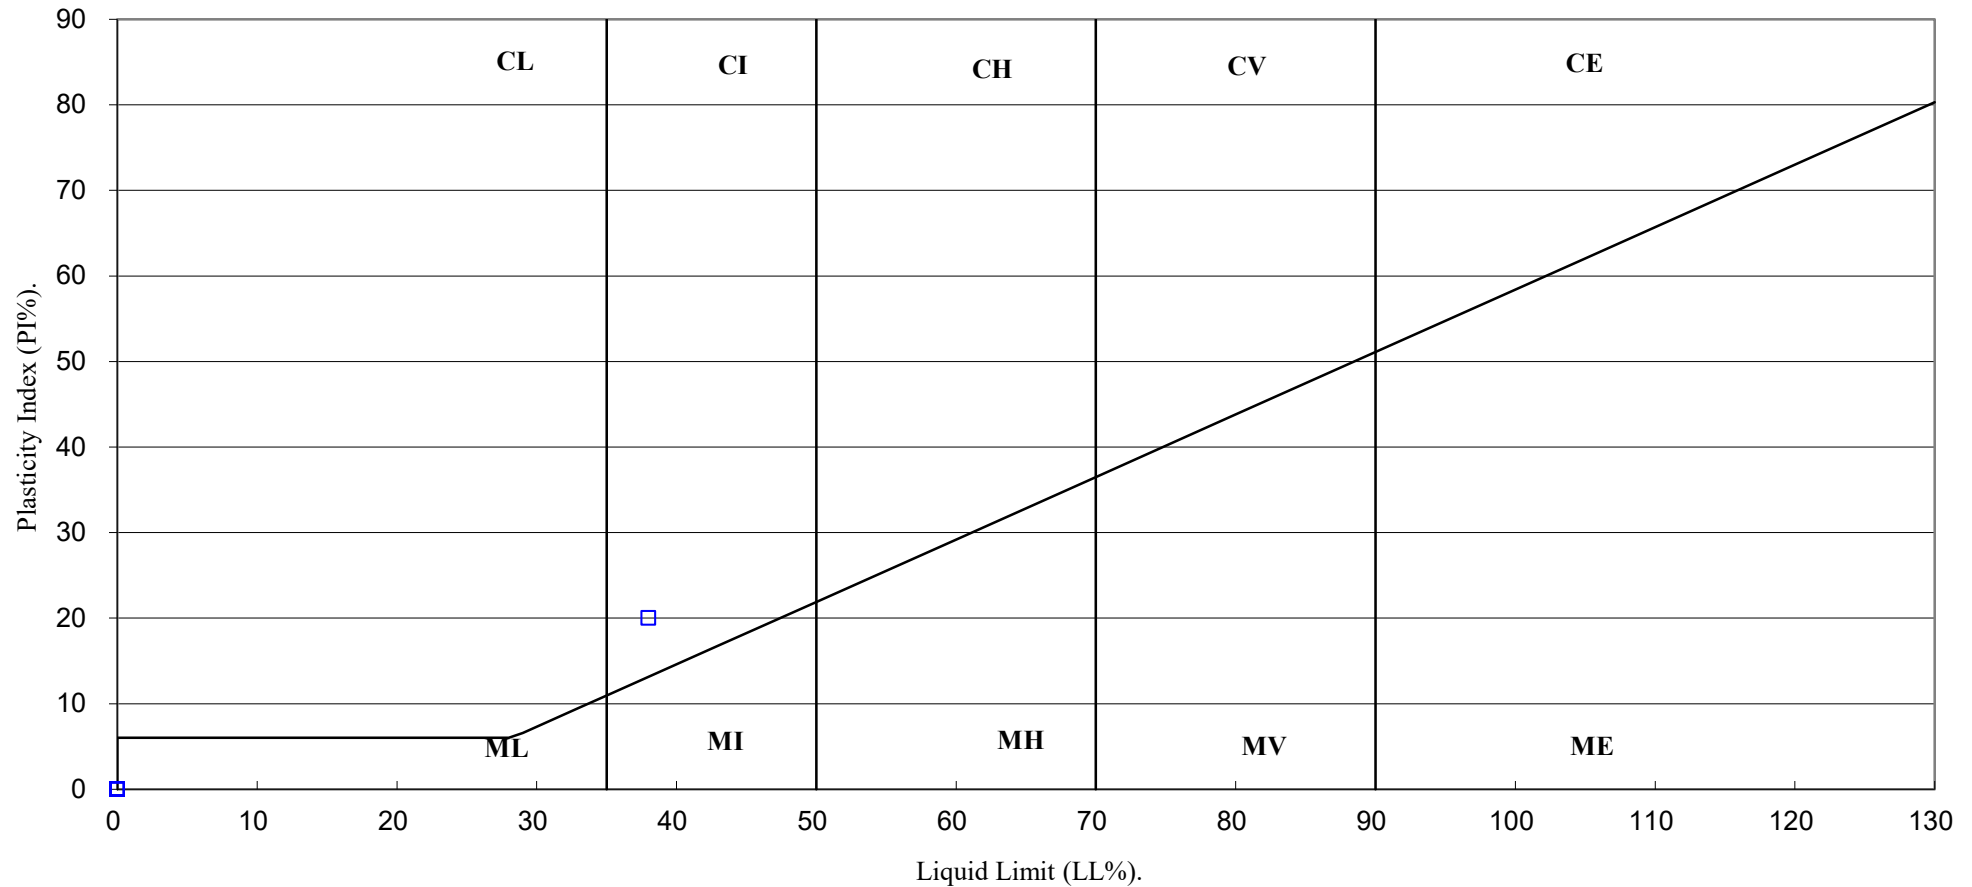
# PLASTICITY CHART FOR CASAGRANDE CLASSIFICATION.
