# Preliminary Bat Roost Assessment (PRA) Report

The Yorkon Building, Huyton.

Knowsley MBC

July 2021

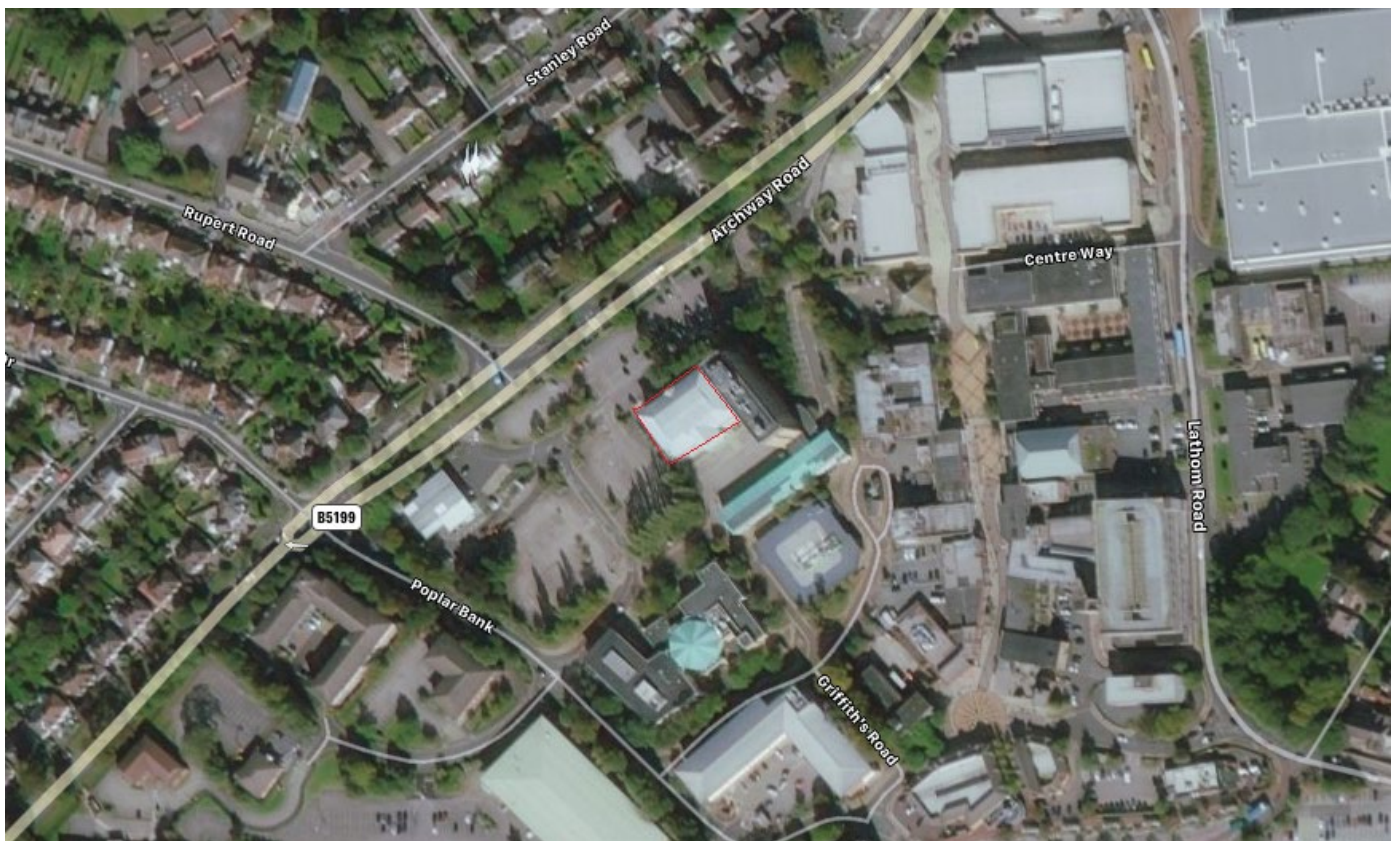
**Figure 1. Site (redline) and surrounding landscape character**

The site is located in Huyton village, Liverpool (Grid Reference: SJ 44173 90875) and consists of a large council office building (detached). The site is located in a highly urban area on the outskirts of Liverpool.

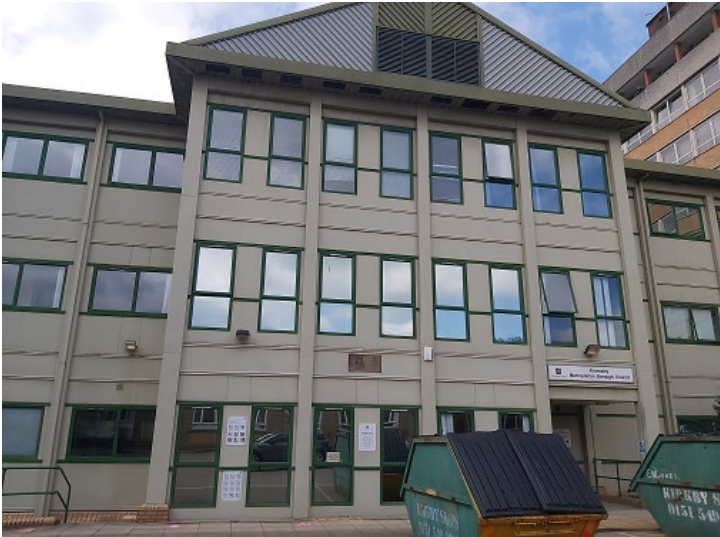
| Photo | Description |
|---|---|
| | <p>The <b>Yorkon Building</b> is of block construction with metal cladding overlain with no obvious access into the walls. There are grilled vents present to the exterior of the roof and walls.</p> <p>There is an enclosed roof void. Exposed metal beams are visible and the exterior of the roof is comprised of corrugate metal with no under layer. Floors are concrete block.</p> <p>There is no cellar or basement present.</p> |

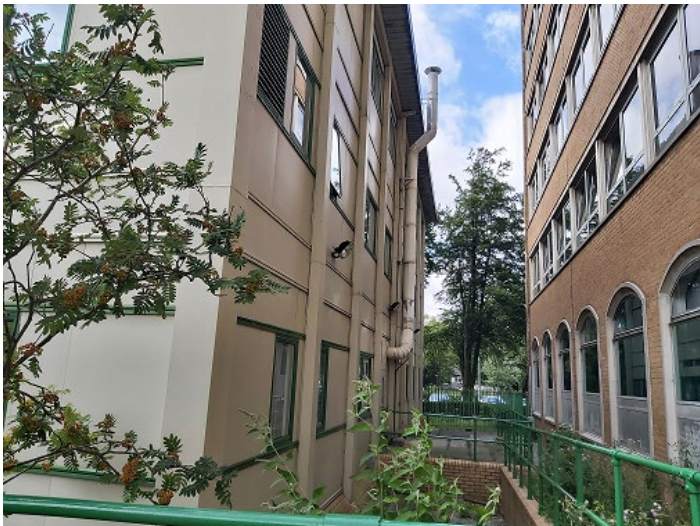
| Photo | Description |
|---|---|
| | <p>The building lacks features accessible by bat or any features suitable for supporting bat roosts.</p> <p>The materials used for construction are typically not well suited to supporting bat roosts.</p> |

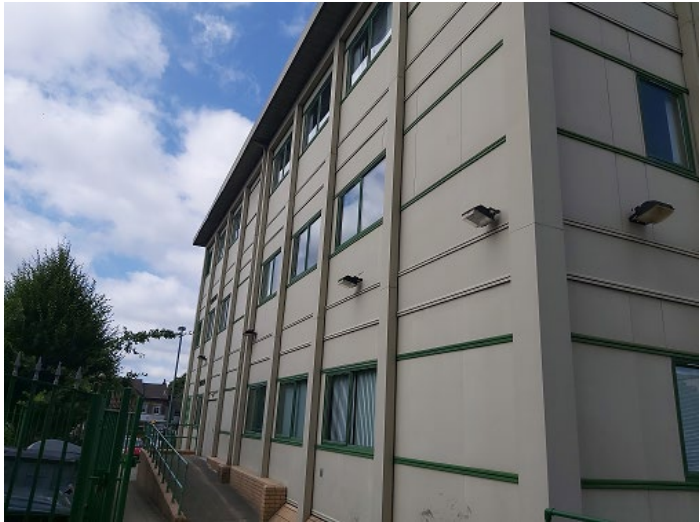
| Photo | Description |
|---|---|
| | <p><b>Potential Roost Features:</b></p> <p>No notable Potential Roost Features (PRFs) present. Construction materials present are typically not conducive to supporting bat roosts.</p> |

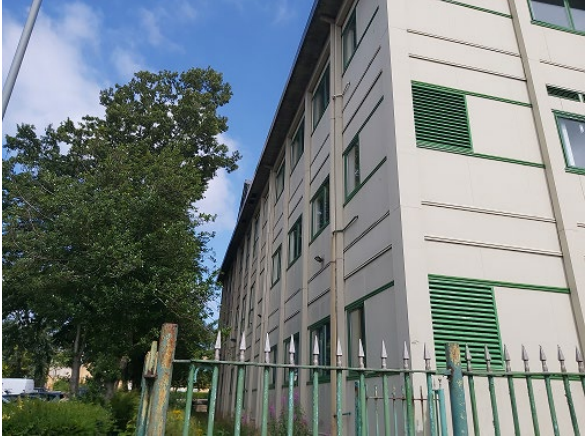
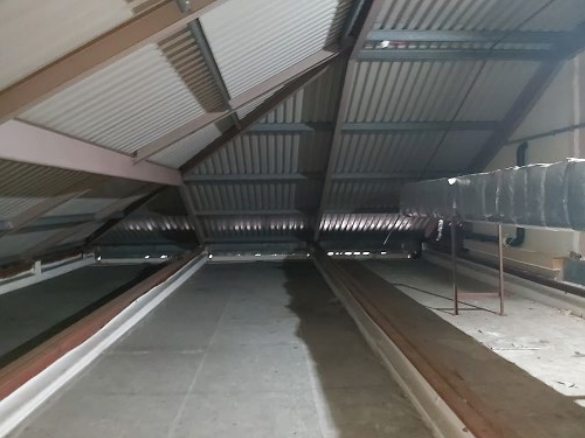
| <br> | <p><b>Evidence:</b></p> <p>None (external or internal).</p><br><p><b>Bat Roost Assessment:</b></p> <p><u>Negligible potential</u> for supporting bat roosts.</p><br><p>Note: No evidence of nesting birds was observed in association with the building.</p> |

The building proposed for demolition was assessed as being of ‘Negligible Potential’ for supporting bat roosts (Collin, J. (Ed), 2016) due to an absence of any evidence of bats and paucity of potential roost features (PRFs) for supporting bat roosts overall.

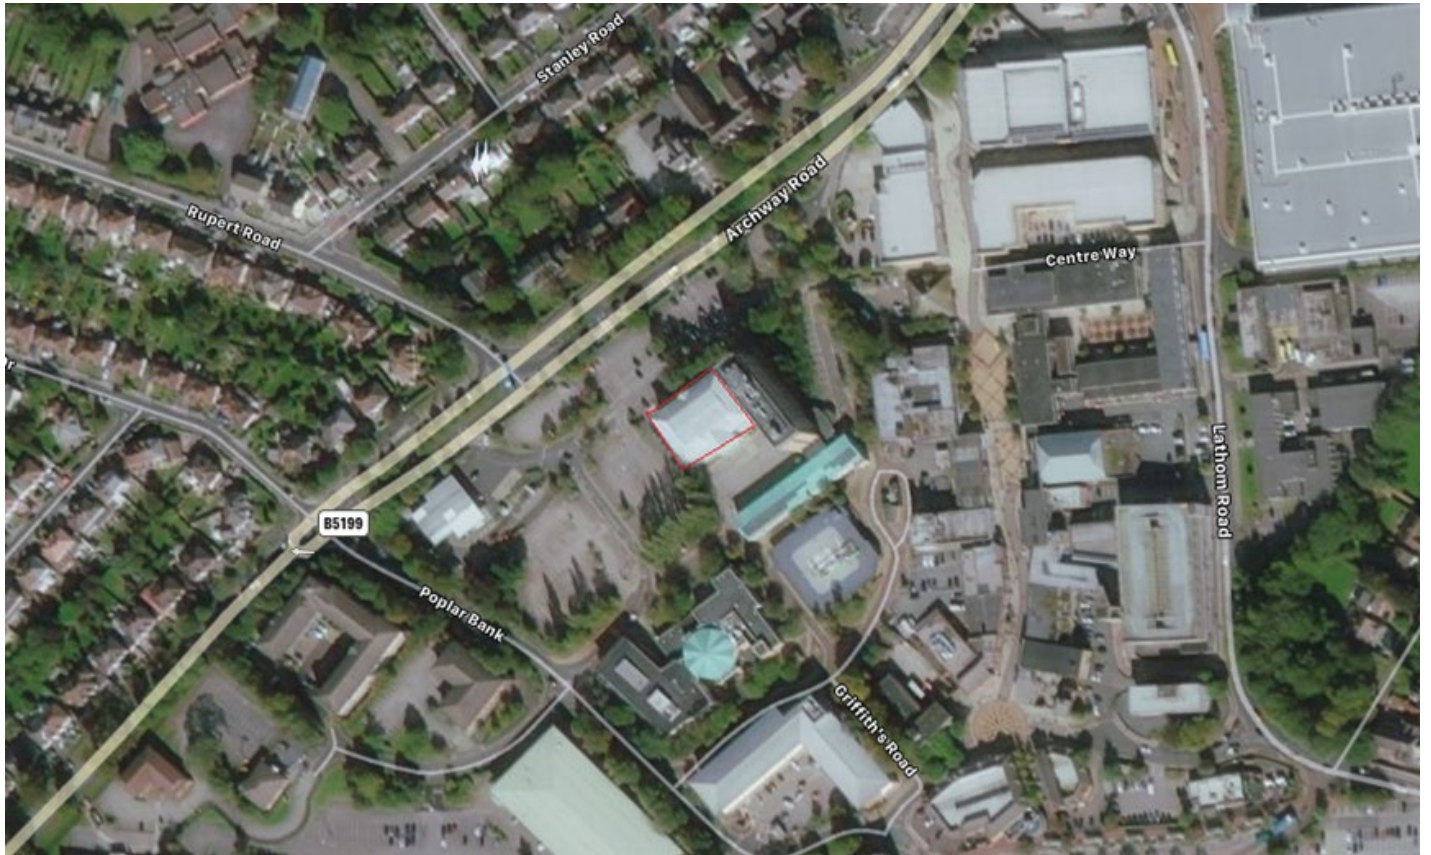
### APPENDIX 1 – EXISTING SITE LAYOUT

REDLINE = YORKON BUILDING
