**Huyton Town Centre Regeneration**  
CCTV Condition Report

Project Ref: TS-2645 Huyton Town Centre Regeneration CCTV  
Report\_303\_Issue01

**Dominic White – Tower Surveys CCTV Ltd**  
**23/05/2025**

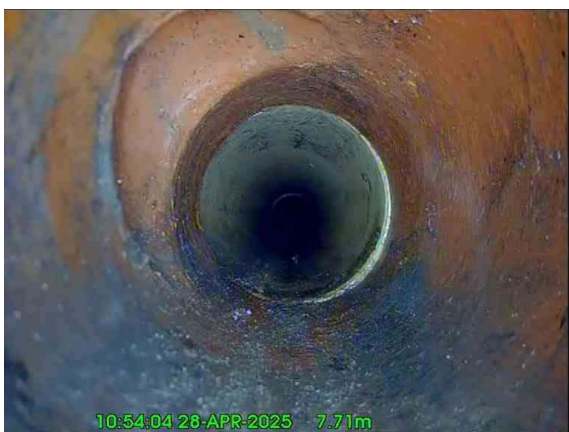
3, 00:00:44, 7.71 m  
Junction at 10 o'clock, 100mm dia

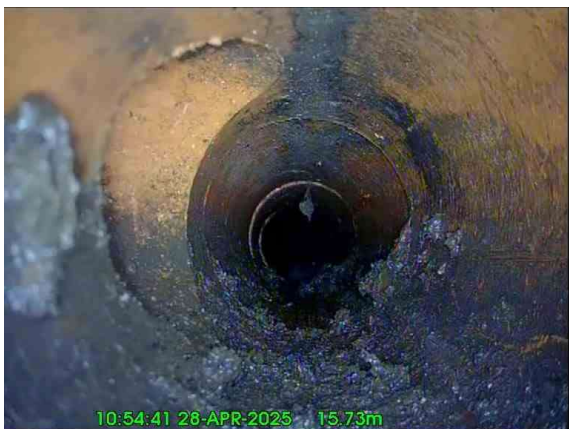
5, 00:01:21, 15.73 m  
Junction at 10 o'clock, 100mm dia

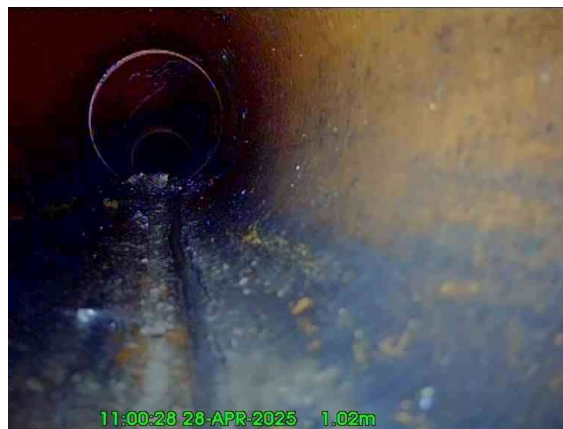
2, 00:00:21, 1.02 m  
Line deviates up

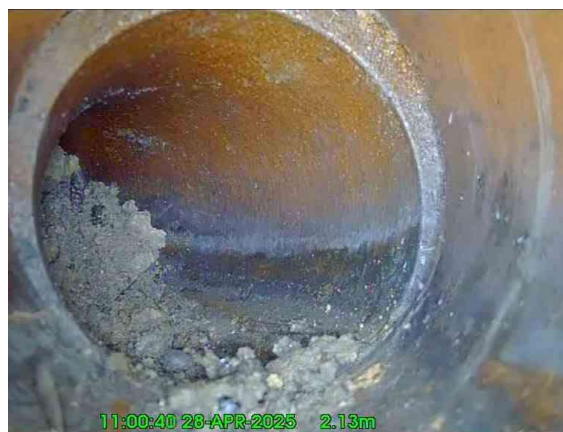
4, 00:00:33, 2.13 m  
Line deviates left

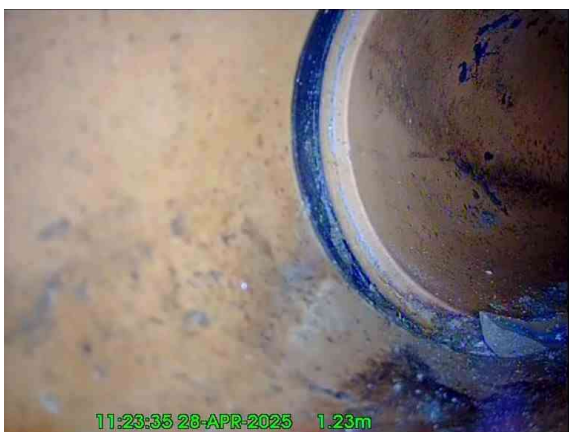
3, 00:00:19, 1.23 m  
Joint displaced, medium

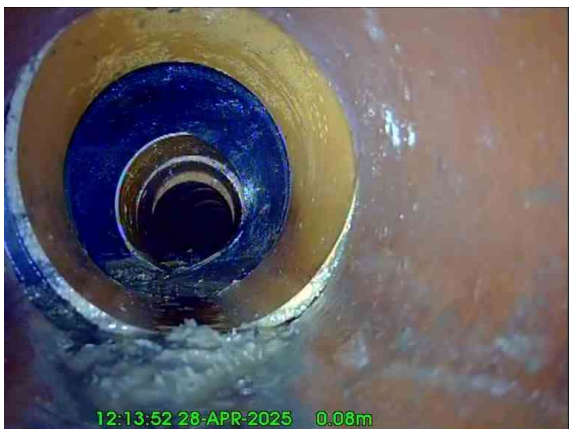
1, 00:00:02, 0.08 m  
Pipe material changes to polyvinyl chloride at this point

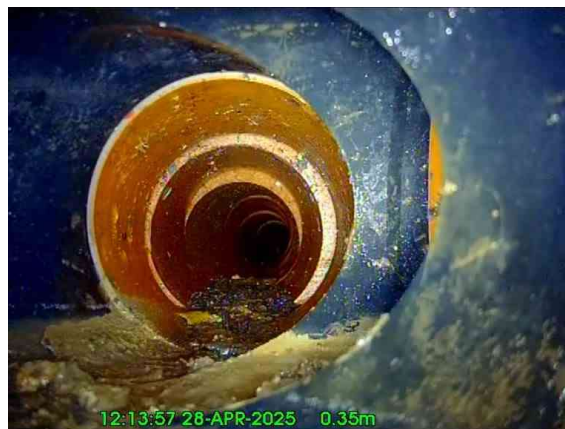
2, 00:00:12, 0.35 m  
Junction at 3 o'clock, 100mm dia

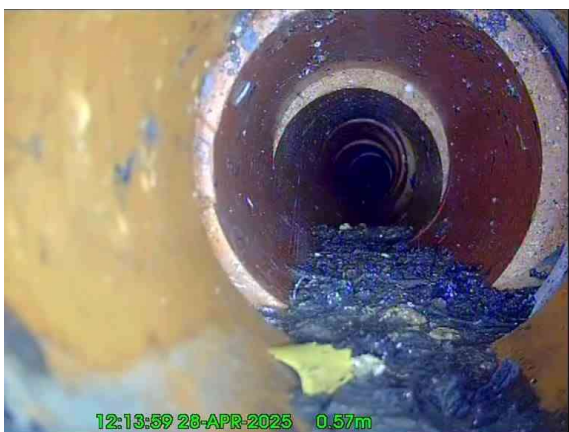
3, 00:00:14, 0.57 m  
Pipe material changes to vitrified clay at this point

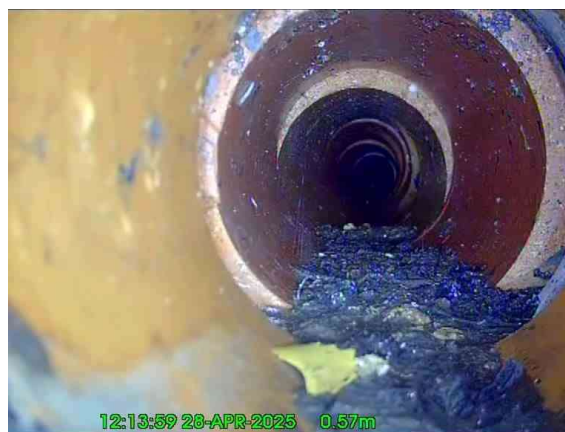
4, 00:00:14, 0.57 m  
Settled deposits, fine, 5% cross-sectional area loss

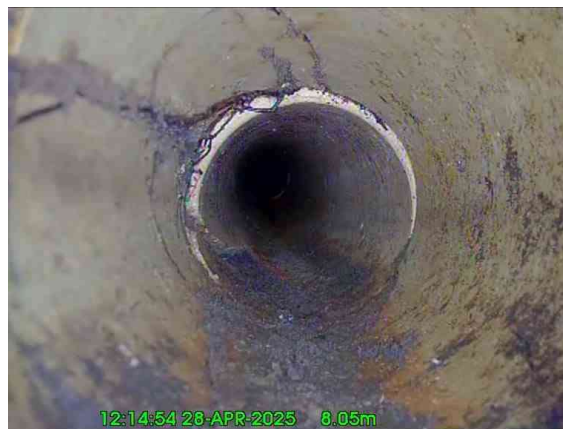
10, 00:01:09, 8.05 m  
Roots, fine at joint

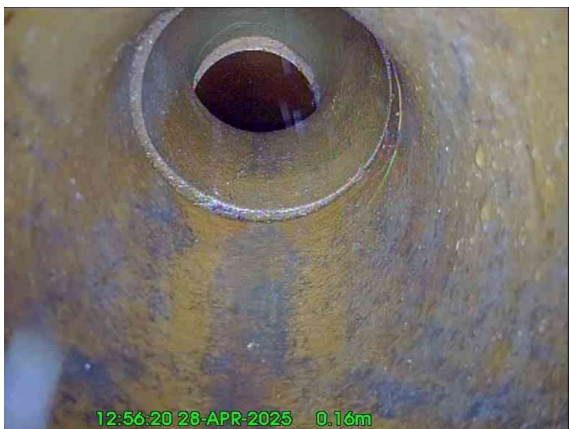
1, 00:00:05, 0.16 m  
Line deviates up

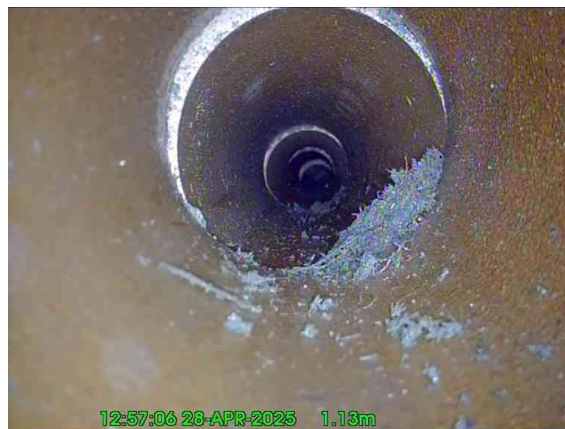
2, 00:00:51, 1.13 m  
Roots, mass at joint, 5% cross-sectional area loss

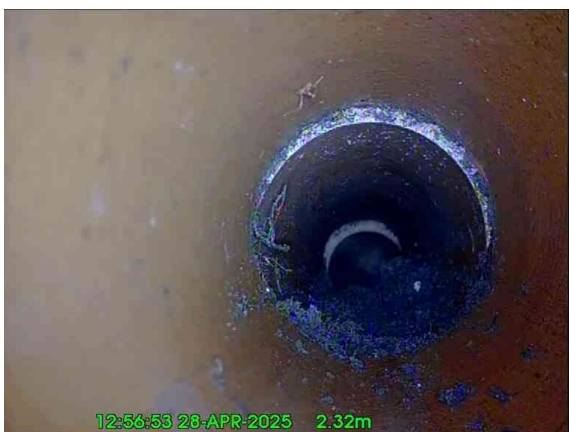
3, 00:00:38, 2.32 m  
Roots, mass at joint, 10% cross-sectional area loss

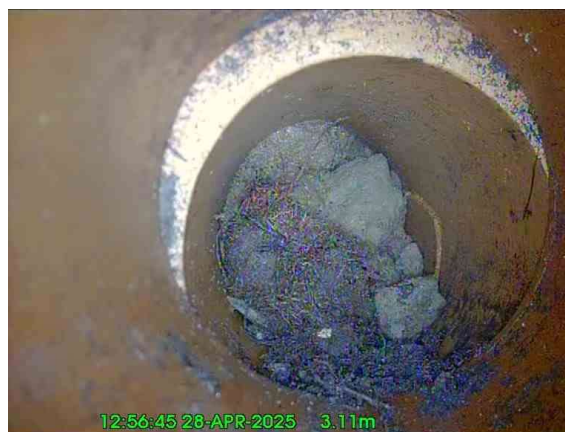
4, 00:00:30, 3.11 m  
Joint displaced, medium

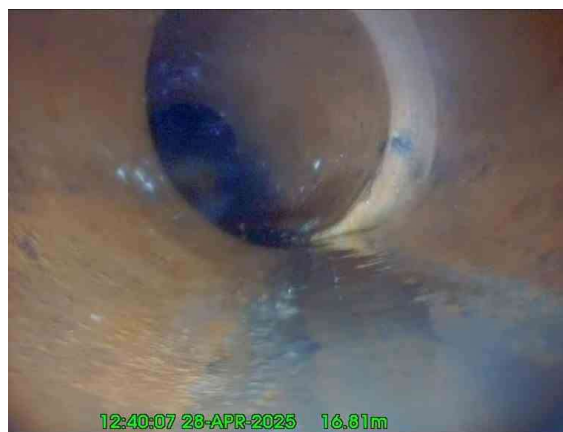
4, 00:01:17, 16.81 m  
Line deviates left

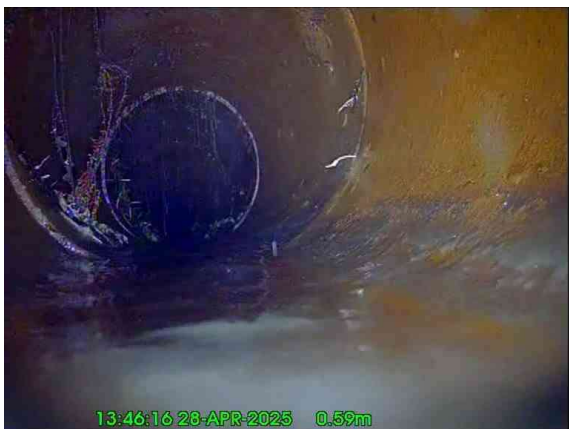
1, 00:00:07, 0.59 m  
Roots, mass at joint, 5% cross-sectional area loss, start

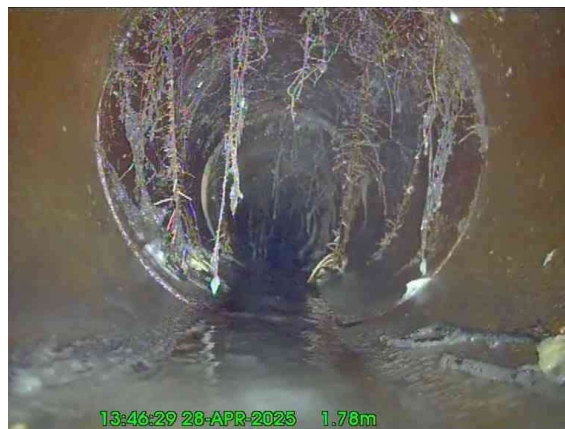
2, 00:00:20, 1.78 m  
Roots, mass at joint, 10% cross-sectional area loss, change

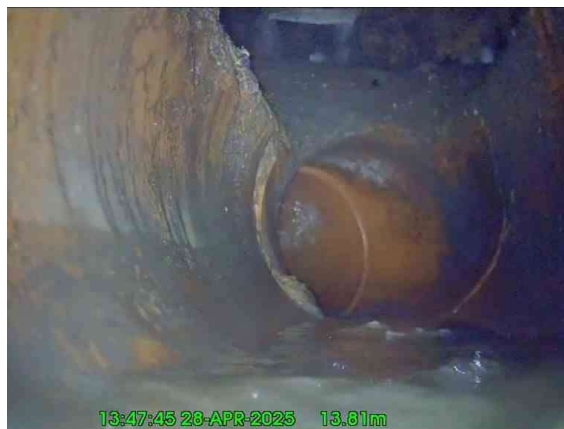
6, 00:01:37, 13.81 m  
Roots, mass at joint, 10% cross-sectional area loss, finish

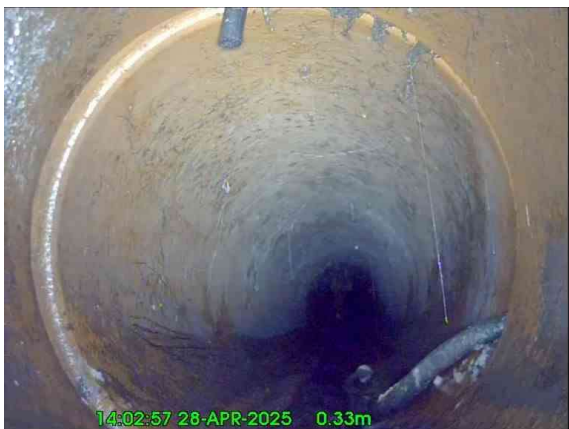
1, 00:00:06, 0.33 m  
Roots, tap at joint

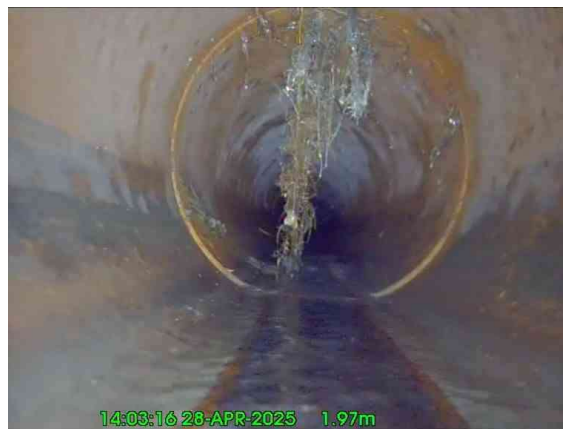
2, 00:00:25, 1.97 m  
Roots, mass at joint, 5% cross-sectional area loss

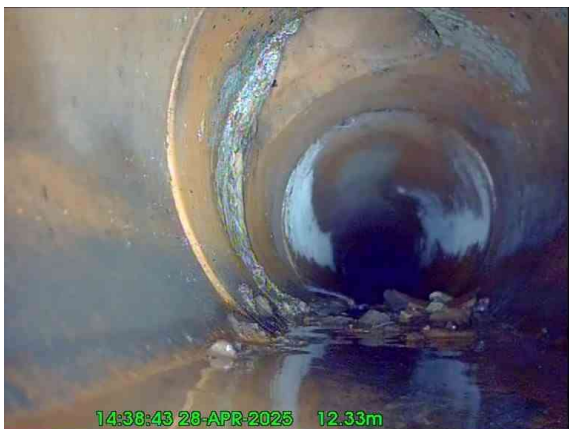
5, 00:01:09, 12.33 m  
Settled deposits, coarse, 5% cross-sectional area loss, start

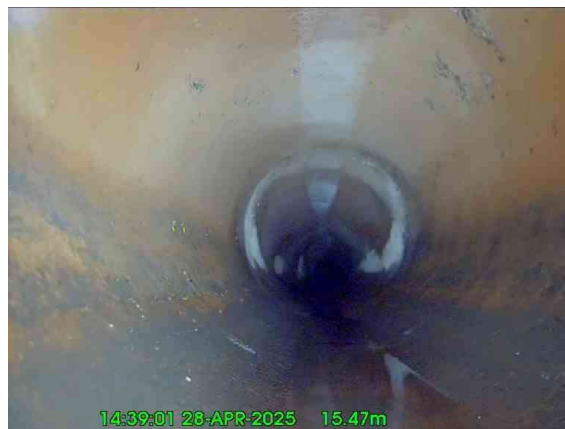
6, 00:01:27, 15.47 m  
Settled deposits, coarse, 5% cross-sectional area loss, finish

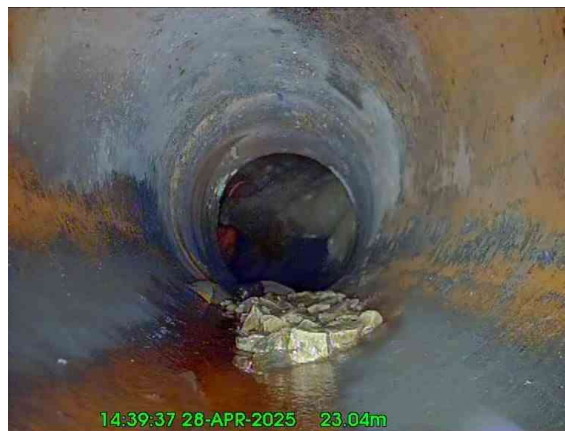
8, 00:02:03, 23.04 m  
Settled deposits, coarse, 5% cross-sectional area loss

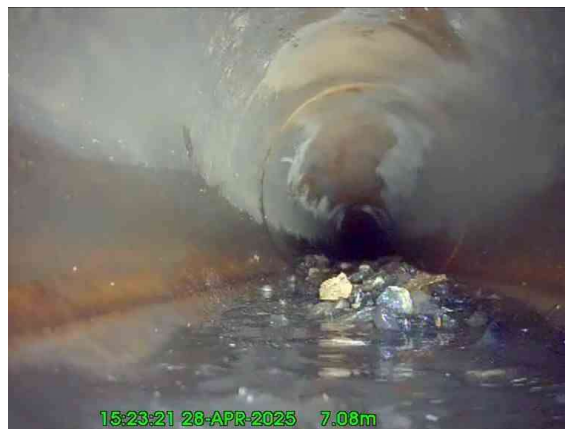
2, 00:05:12, 7.08 m  
Settled deposits, coarse, 5% cross-sectional area loss, start

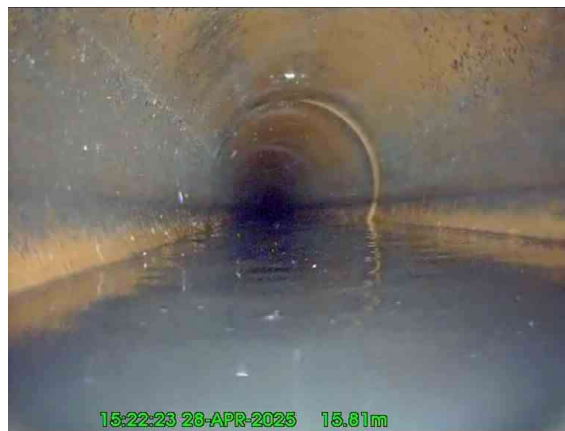
4, 00:04:14, 15.81 m  
Water level, 20% of the vertical dimension, Water standing in sewer

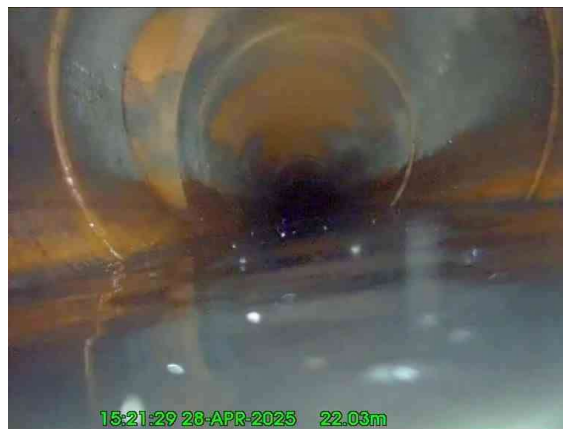
6, 00:03:20, 22.03 m  
Junction at 10 o'clock, 100mm dia, from MH18 X

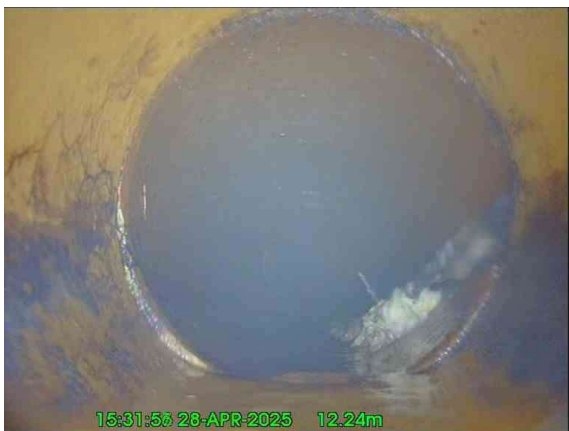
3, 00:00:52, 12.24 m  
Roots, mass at joint, 5% cross-sectional area loss

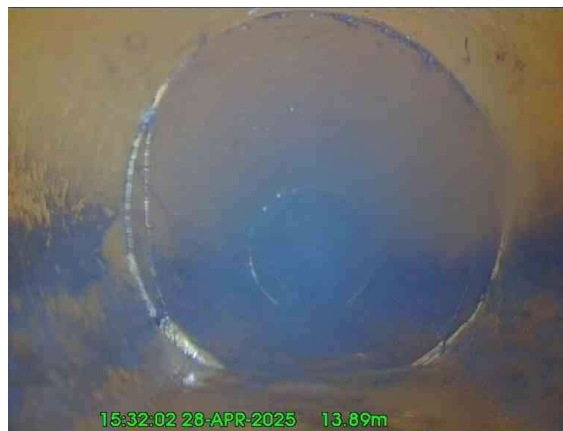
<table><tr><th>Position [m]</th><th>Code</th><th>Observation</th><th>MPEG</th><th>Photo</th><th>Grade</th></tr><tr><td>13.89</td><td>CCJ</td><td>Crack, circumferential at joint from 8 o'clock to 10 o'clock</td><td>00:01:03</td><td>4</td><td>2 / 2</td></tr></table>

4, 00:01:03, 13.89 m  
Crack, circumferential at joint from 8 o'clock to 10 o'clock

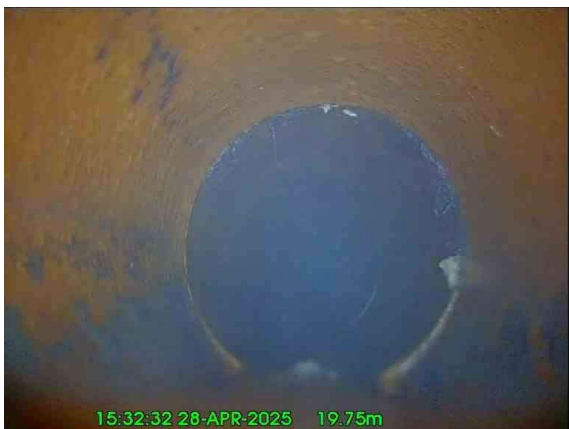
5, 00:01:33, 19.75 m  
Roots, mass at joint, 5% cross-sectional area loss, start

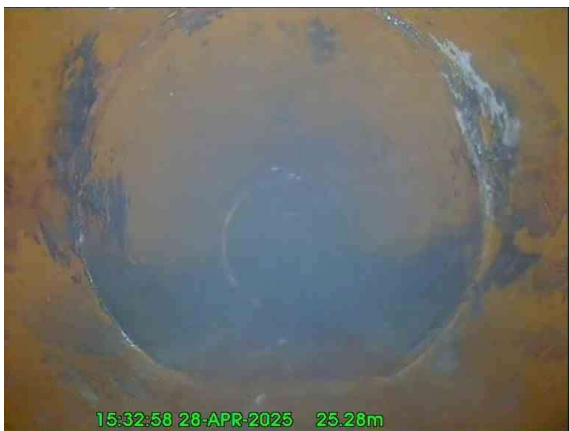
7, 00:01:59, 25.28 m  
Roots, mass at joint, 5% cross-sectional area loss, finish

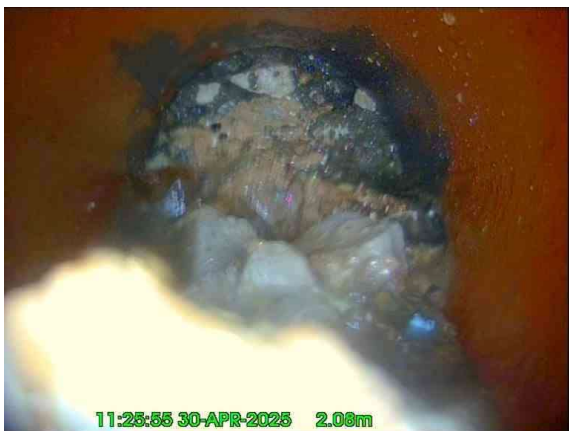
3, 00:00:23, 2.08 m  
Finish node, other special chamber, reference: Capped,  
Capped pipe reached

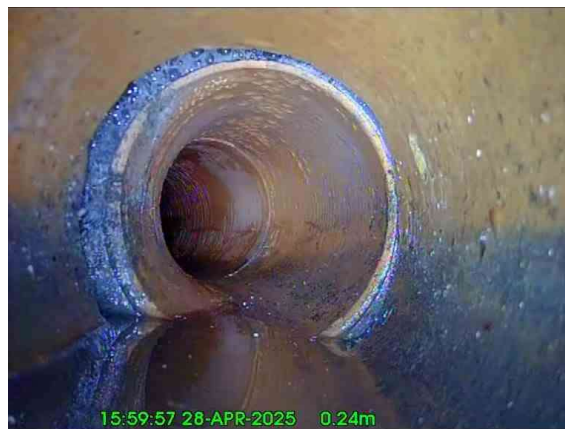
2, 00:00:05, 0.24 m  
Joint displaced, medium

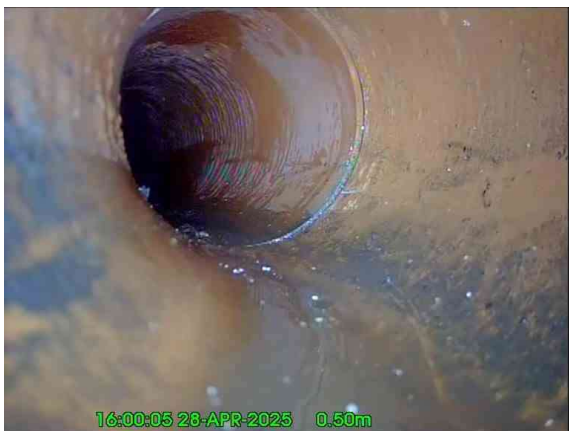
3, 00:00:13, 0.50 m  
Line deviates left

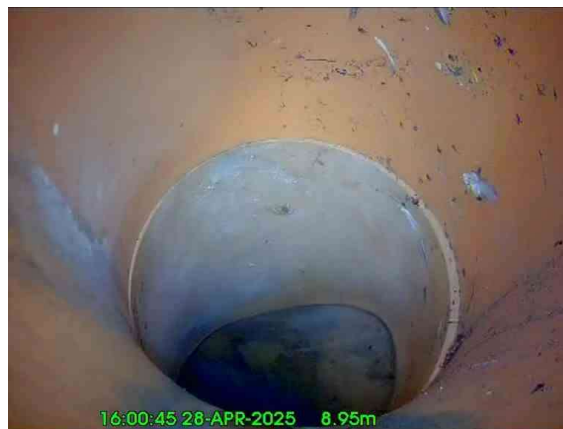
6, 00:00:53, 8.95 m  
Line deviates down

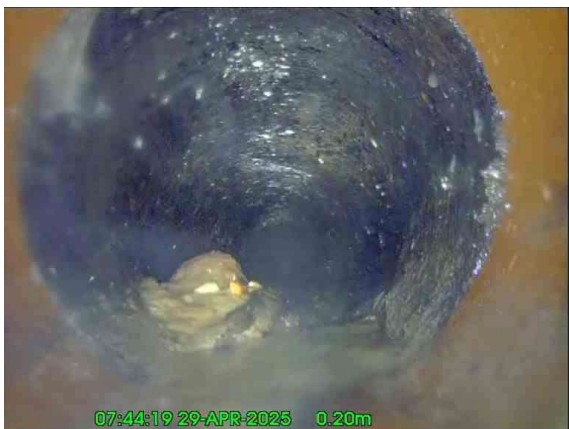
07:44:19 29-APR-2025 0.20m  
1, 00:00:06, 0.20 m  
Pipe material changes to pitch fibre at this point

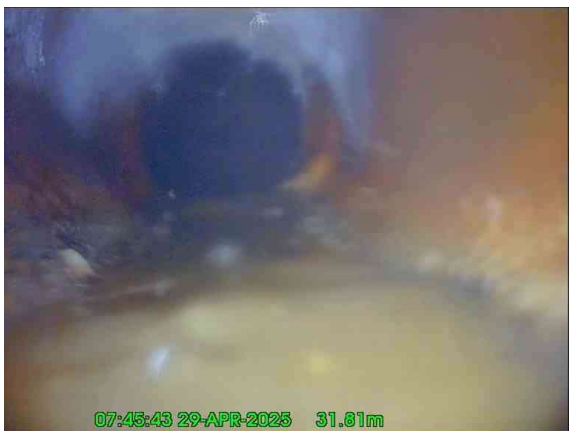
7, 00:01:31, 31.81 m  
Junction at 6 o'clock, 150mm dia, External Backdrop

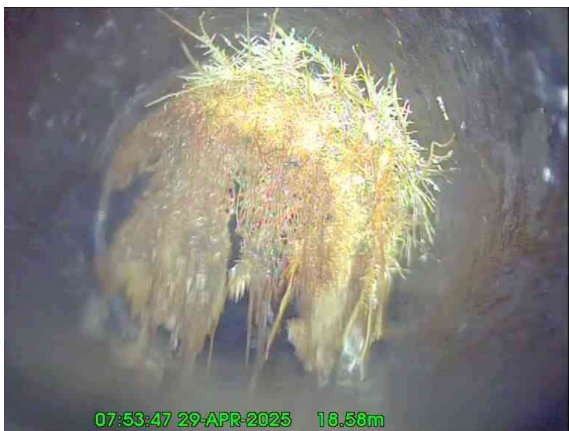
3, 00:01:21, 18.58 m  
Roots, mass at joint, 75% cross-sectional area loss

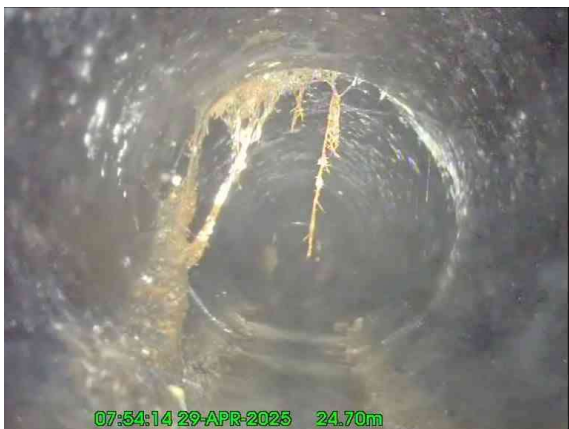
5, 00:01:48, 24.70 m  
Roots, mass at joint, 5% cross-sectional area loss

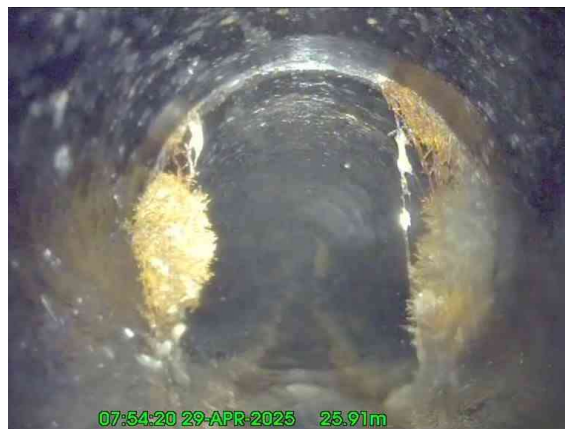
6, 00:01:55, 25.91 m  
Roots, mass at joint, 10% cross-sectional area loss

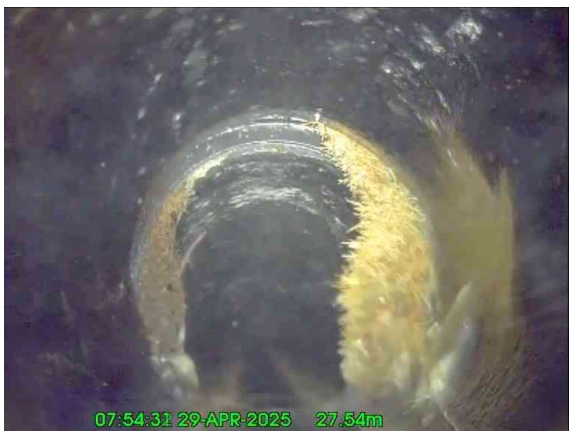
7, 00:02:06, 27.54 m  
Roots, mass at joint, 20% cross-sectional area loss

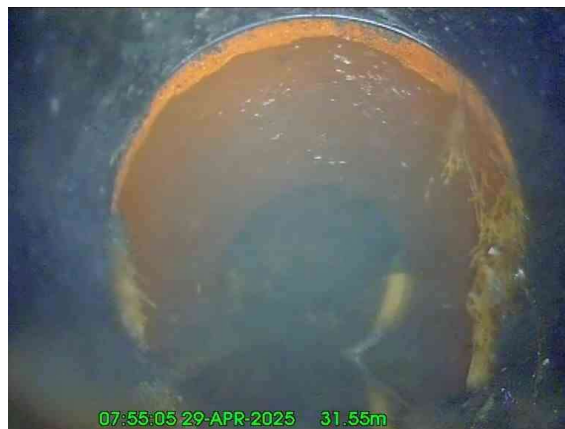
10, 00:02:40, 31.55 m  
Roots, mass at joint, 5% cross-sectional area loss

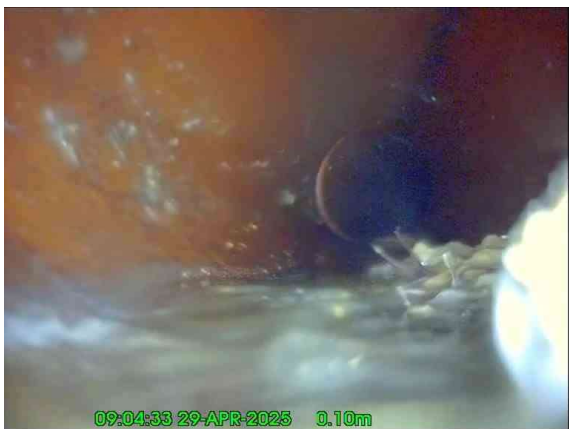
1, 00:02:45, 0.10 m  
Roots, mass at joint, 10% cross-sectional area loss

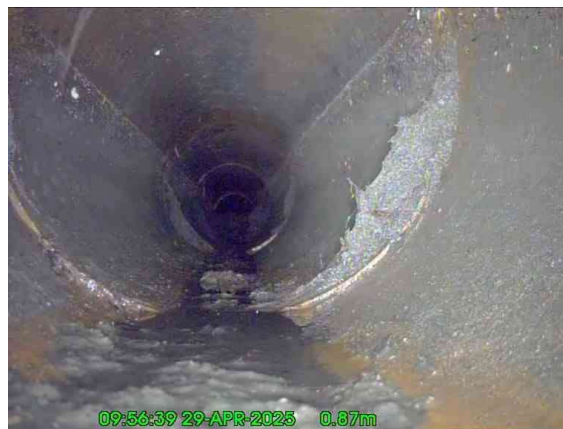
2, 00:00:10, 0.87 m  
Roots, mass at joint, 5% cross-sectional area loss

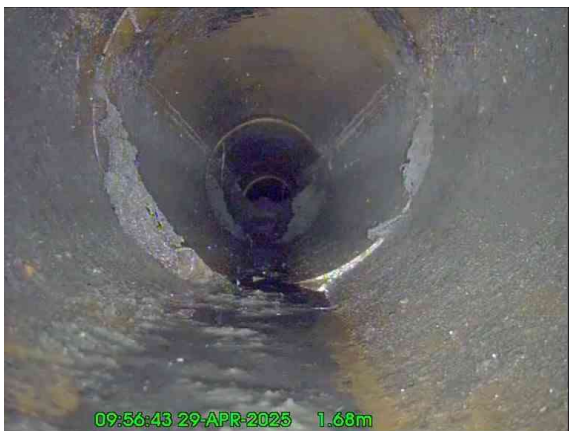
3, 00:00:14, 1.68 m  
Roots, mass at joint, 5% cross-sectional area loss

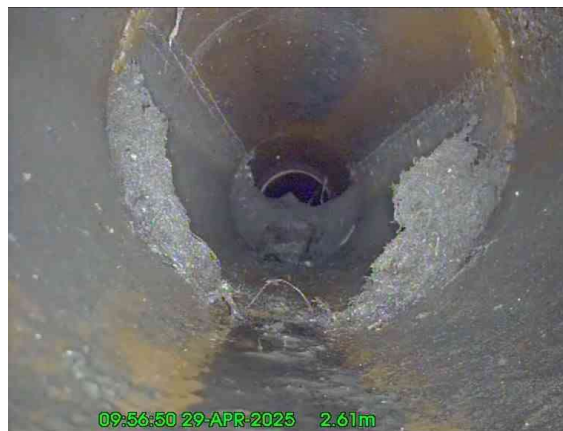
4, 00:00:21, 2.61 m  
Roots, mass at joint, 10% cross-sectional area loss

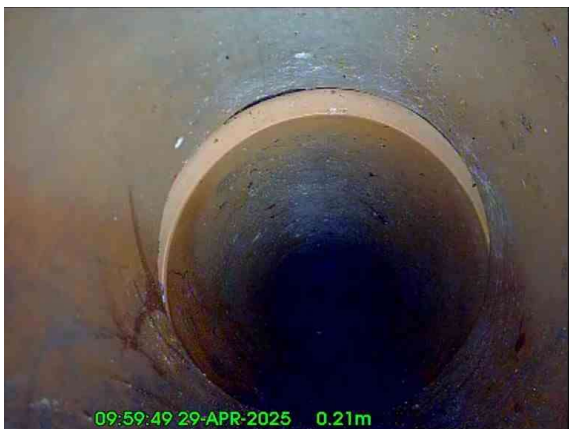
1, 00:00:06, 0.21 m  
Joint displaced, medium

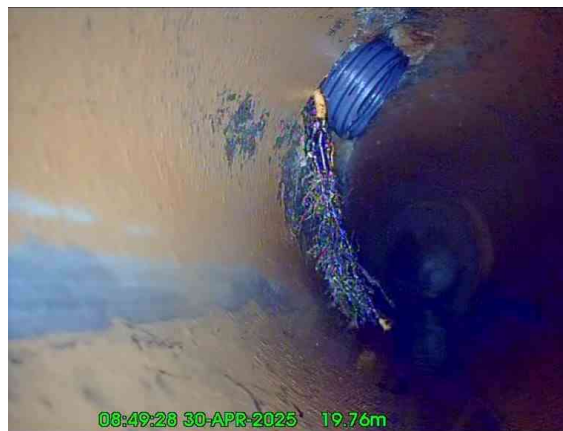
4, 00:01:24, 19.76 m  
Roots, mass, 5% cross-sectional area loss, Intruding via connection

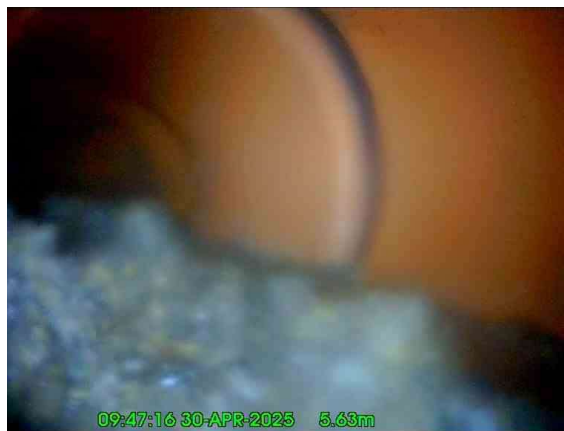
4, 00:02:18, 5.63 m  
Joint displaced, medium

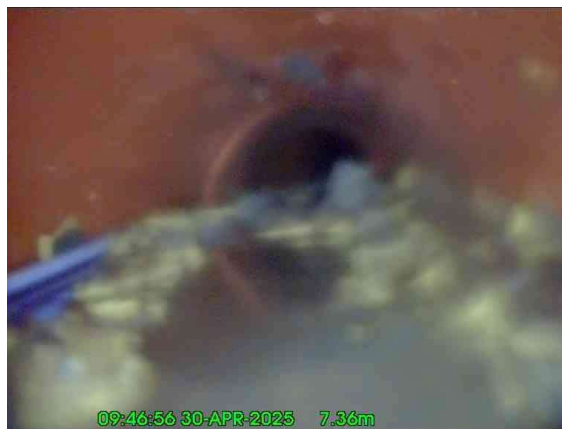
6, 00:01:58, 7.36 m  
Settled deposits, hard or compacted, 25% cross-sectional area loss, change, Solid set debris remained in sewer following jetting

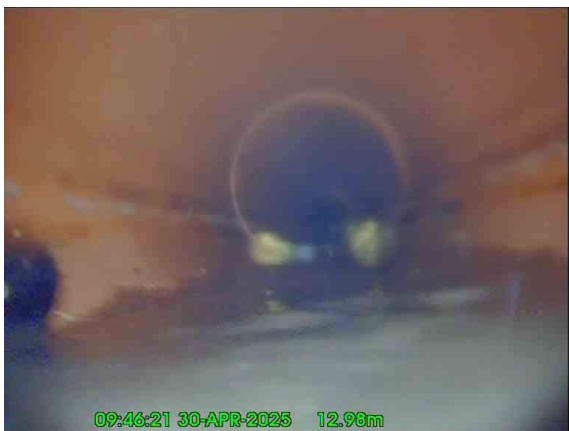
7, 00:01:23, 12.98 m  
Settled deposits, hard or compacted, 25% cross-sectional area loss, finish, Solid set debris remained in sewer following jetting

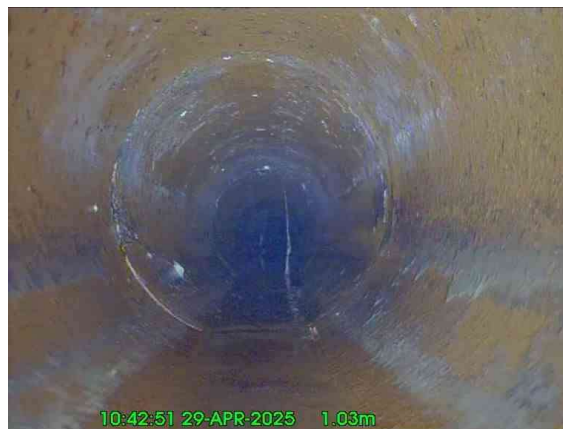
2, 00:00:08, 1.03 m  
Roots, fine at joint

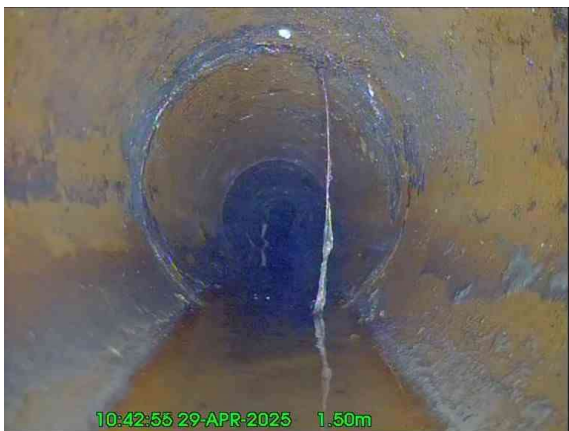
3, 00:00:13, 1.50 m  
Roots, fine at joint

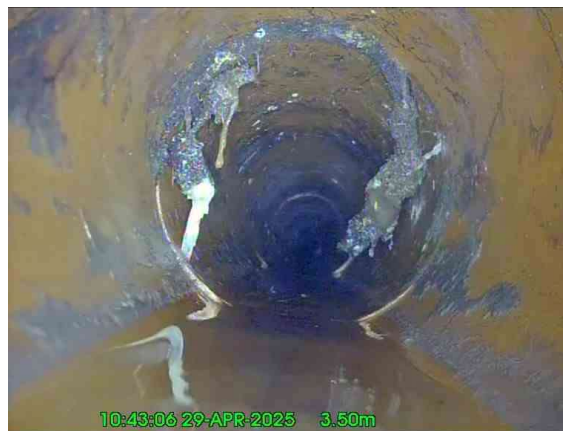
4, 00:00:24, 3.50 m  
Roots, mass at joint, 10% cross-sectional area loss

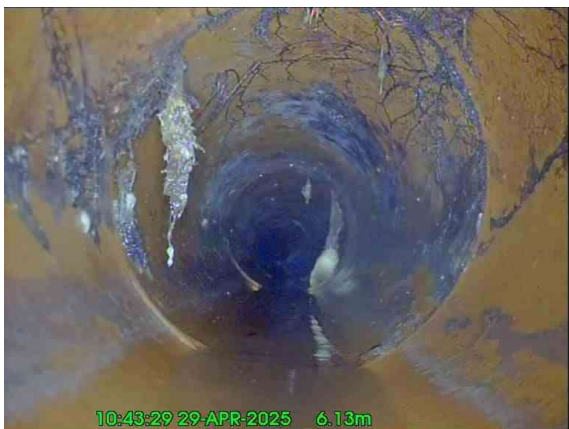
5, 00:00:47, 6.13 m  
Roots, mass at joint, 5% cross-sectional area loss

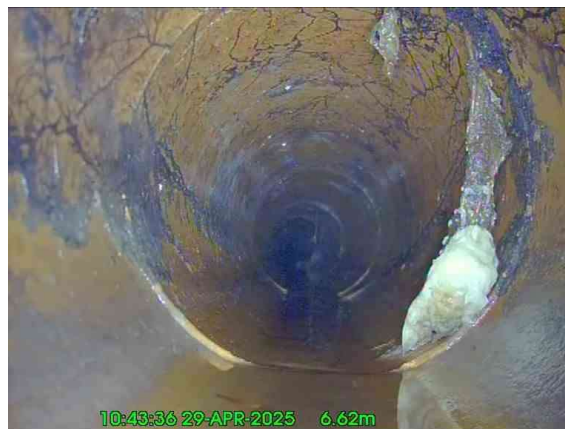
6, 00:00:54, 6.62 m  
Roots, mass at joint, 5% cross-sectional area loss

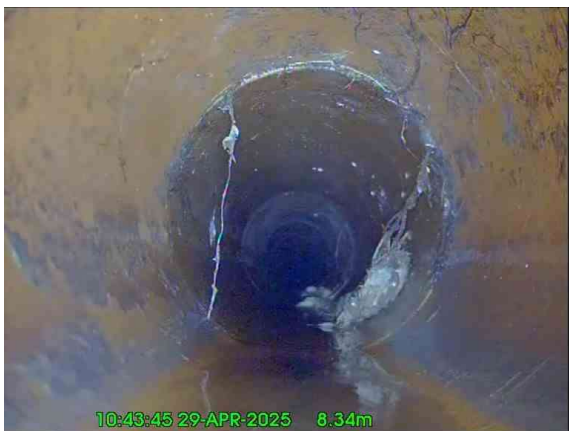
7, 00:01:03, 8.34 m  
Roots, mass at joint, 5% cross-sectional area loss

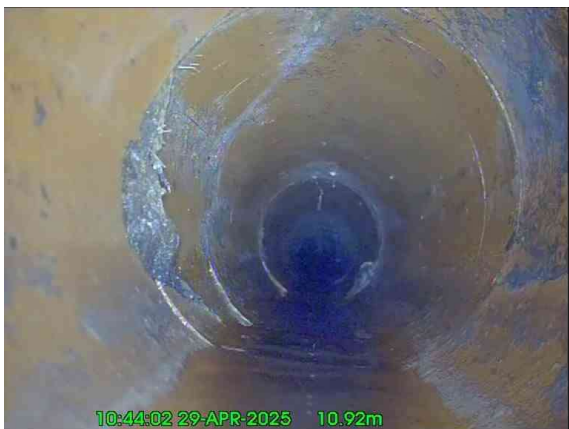
9, 00:01:20, 10.92 m  
Roots, mass at joint, 5% cross-sectional area loss

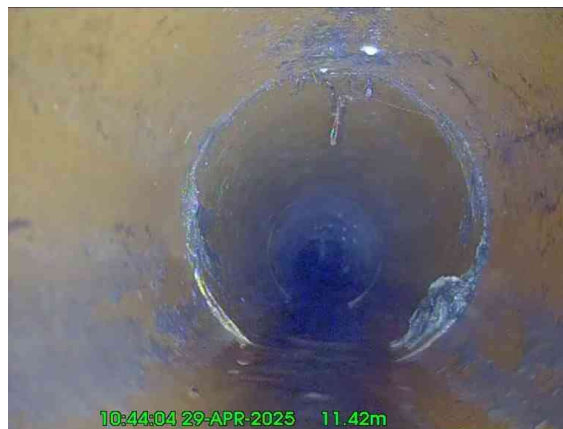
10, 00:01:22, 11.42 m  
Roots, mass at joint, 5% cross-sectional area loss

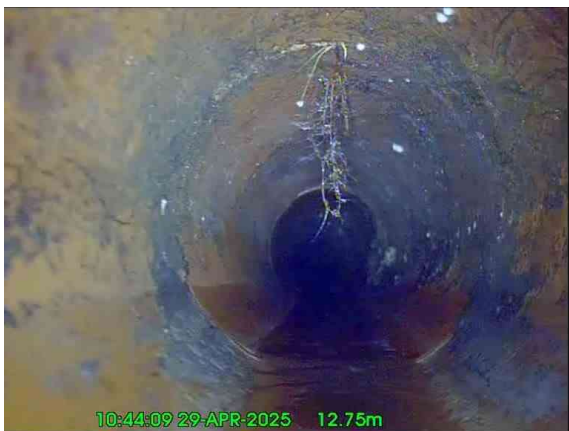
11, 00:01:27, 12.75 m  
Roots, fine at joint

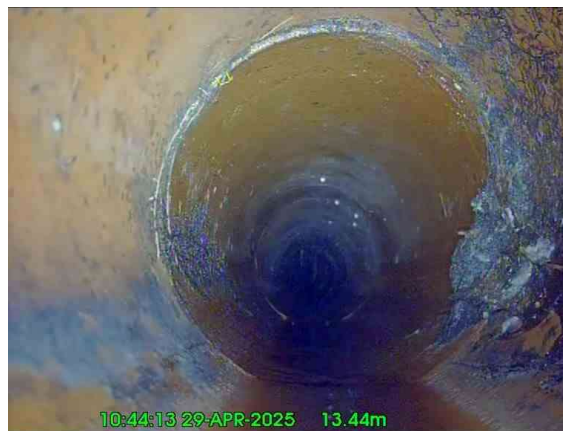
12, 00:01:31, 13.44 m  
Roots, mass at joint, 5% cross-sectional area loss

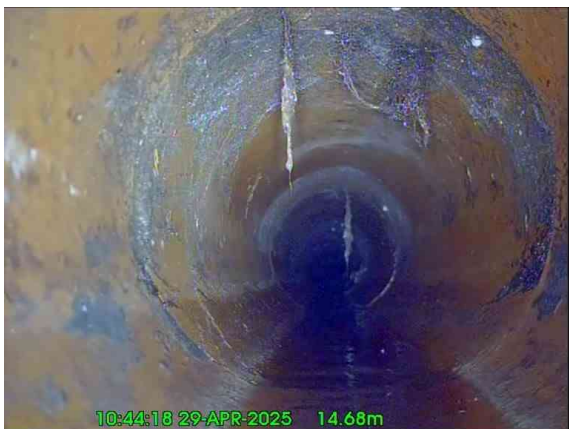
13, 00:01:36, 14.68 m  
Roots, fine at joint

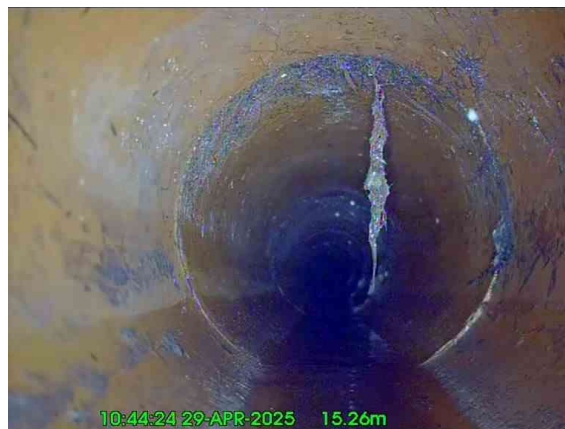
14, 00:01:42, 15.26 m  
Roots, fine at joint

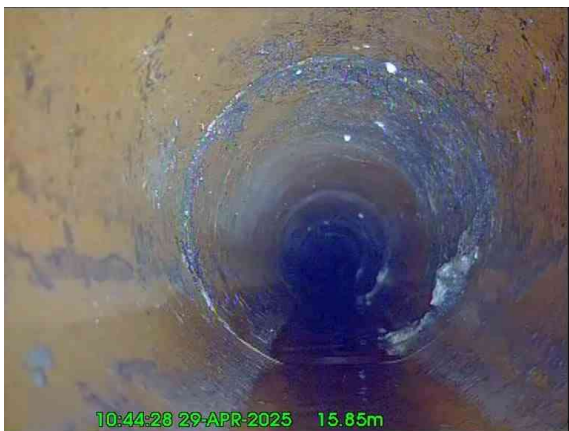
15, 00:01:46, 15.85 m  
Roots, mass at joint, 5% cross-sectional area loss

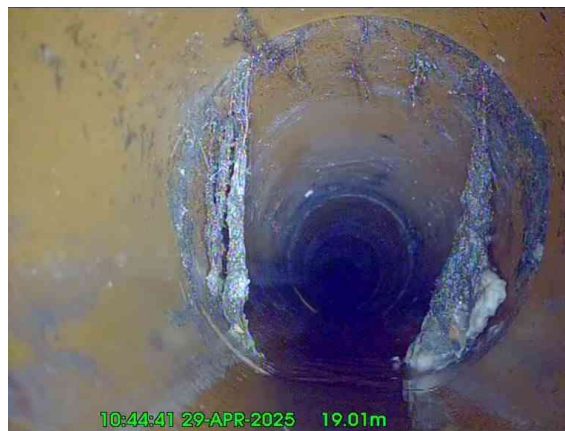
16, 00:01:59, 19.01 m  
Roots, mass at joint, 10% cross-sectional area loss

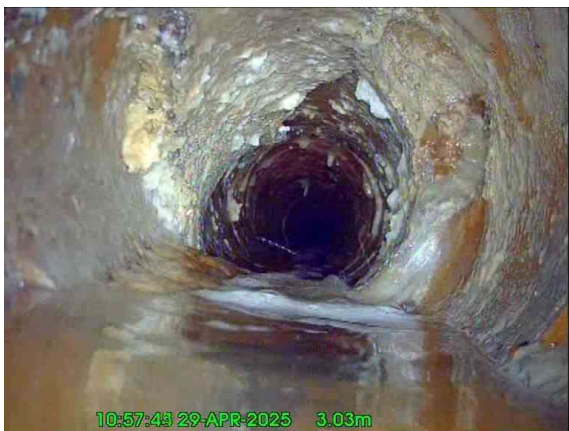
3, 00:00:26, 3.03 m  
Attached deposits, grease from 8 o'clock to 4 o'clock, 10% cross-sectional area loss

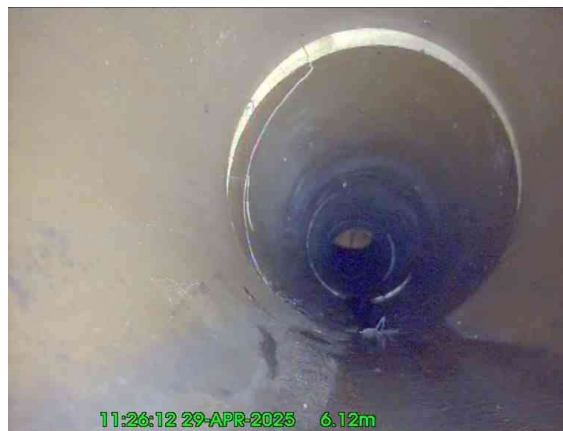
4, 00:00:30, 6.12 m  
Crack, circumferential at joint from 8 o'clock to 11 o'clock

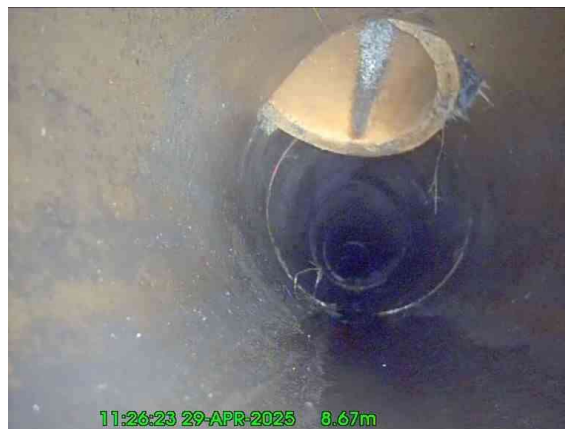
6, 00:00:41, 8.67 m  
Roots, fine, Intruding via connection

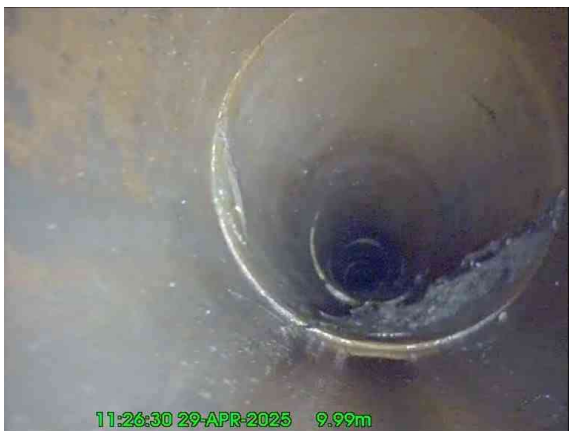
7, 00:00:48, 9.99 m  
Roots, mass at joint, 5% cross-sectional area loss

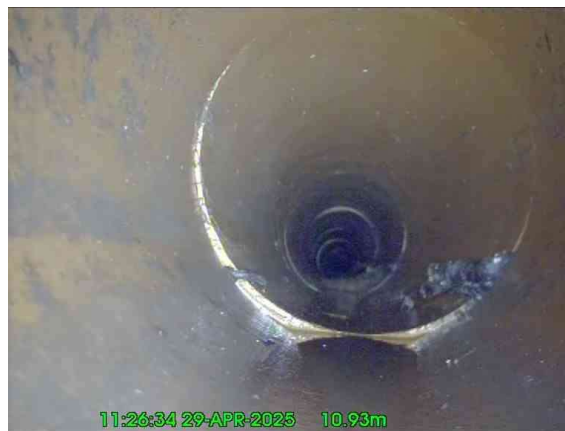
8, 00:00:52, 10.93 m  
Roots, tap at joint

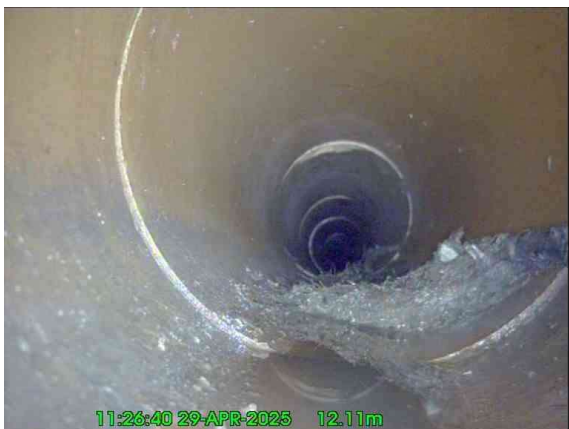
9, 00:00:57, 12.11 m  
Roots, mass at joint, 5% cross-sectional area loss

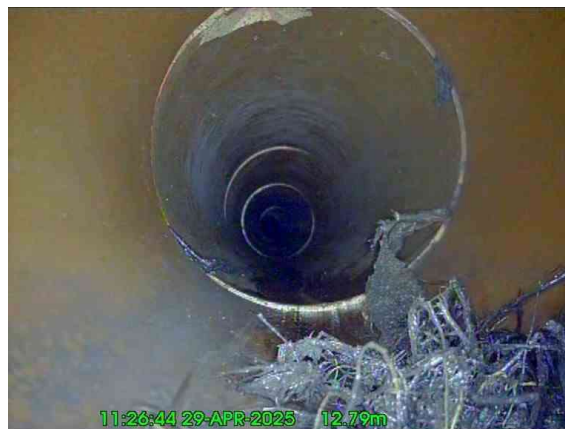
10, 00:01:01, 12.79 m  
Roots, mass at joint, 5% cross-sectional area loss

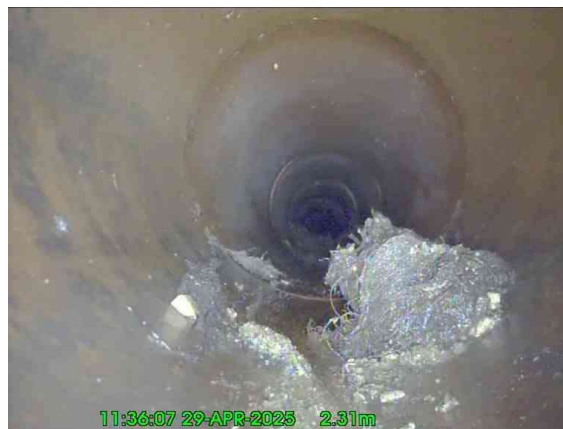
2, 00:03:09, 2.31 m  
Roots, mass at joint, 10% cross-sectional area loss, start

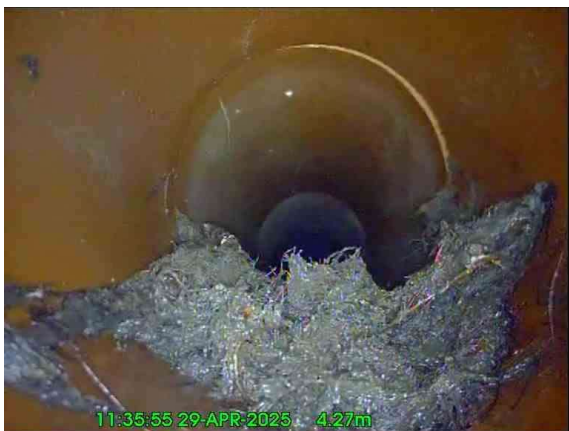
3, 00:02:57, 4.27 m  
Roots, mass at joint, 20% cross-sectional area loss, change

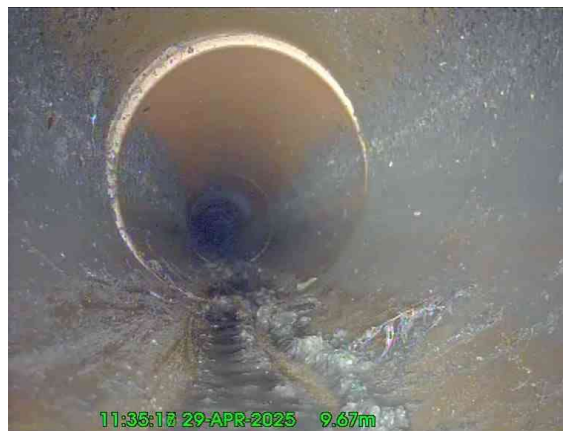
4, 00:02:19, 9.67 m  
Roots, mass at joint, 20% cross-sectional area loss, finish

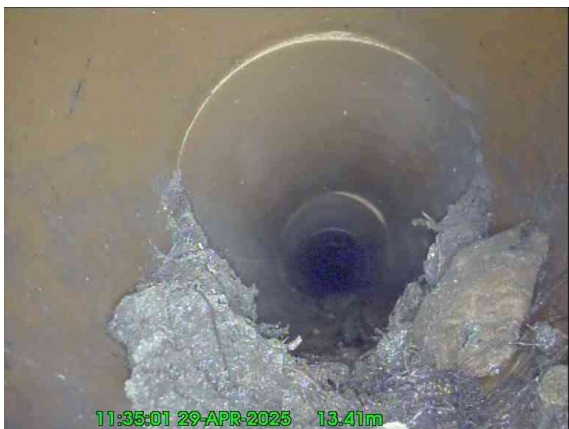
5, 00:02:02, 13.41 m  
Roots, mass at joint, 10% cross-sectional area loss

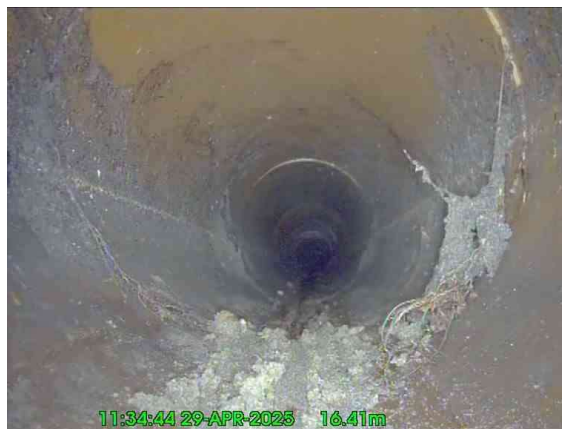
6, 00:01:45, 16.41 m  
Roots, fine at joint

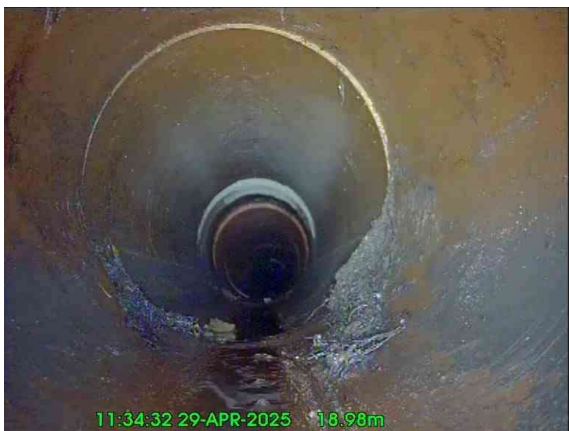
7, 00:01:33, 18.98 m  
Roots, mass at joint, 5% cross-sectional area loss

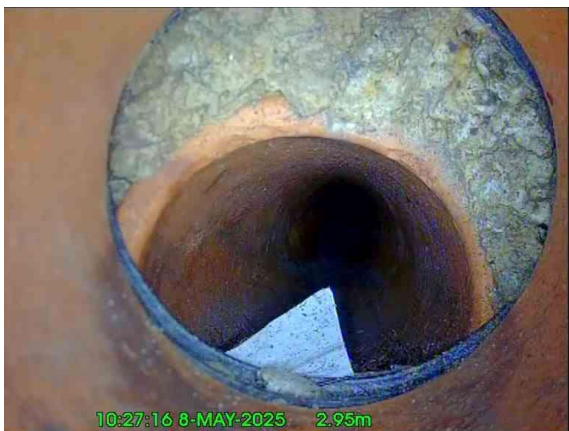
3, 00:00:14, 2.95 m  
Joint displaced, large

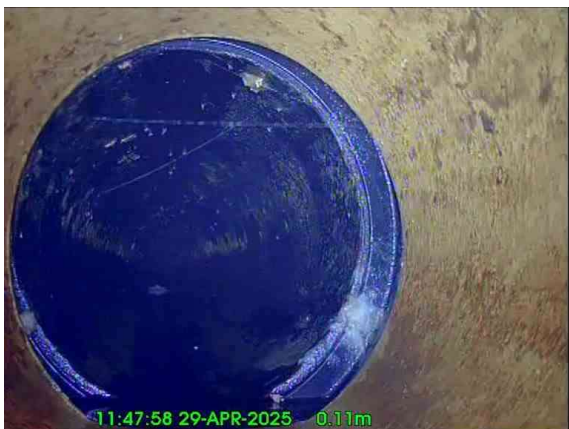
1, 00:00:06, 0.11 m  
Pipe material changes to pitch fibre at this point

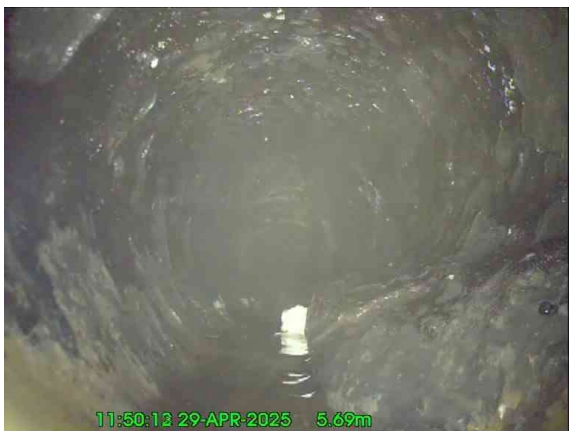
3, 00:02:21, 5.69 m  
Deformed sewer or drain, 5%

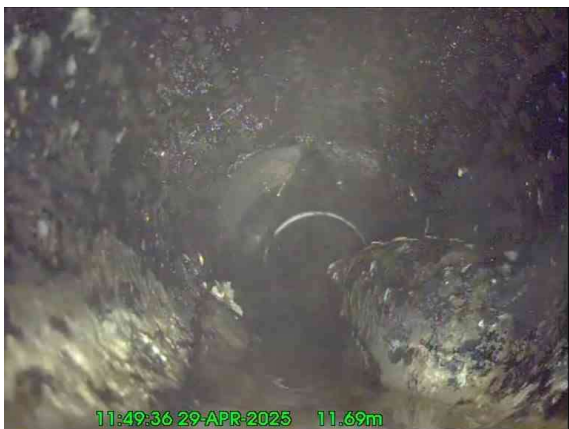
5, 00:01:44, 11.69 m  
Deformed sewer or drain, 20%

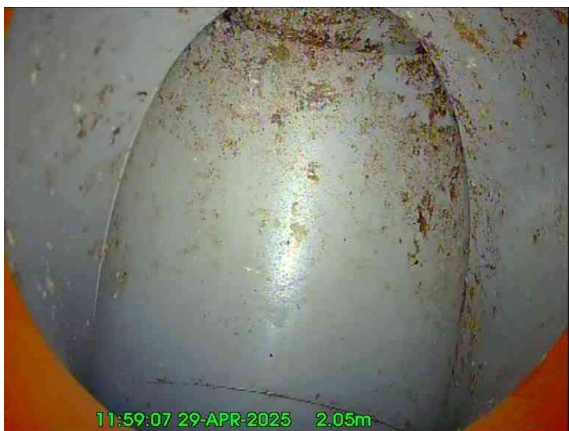
3, 00:00:20, 2.05 m  
Finish node, manhole, reference: MH30 reached, Internal Backdrop visible

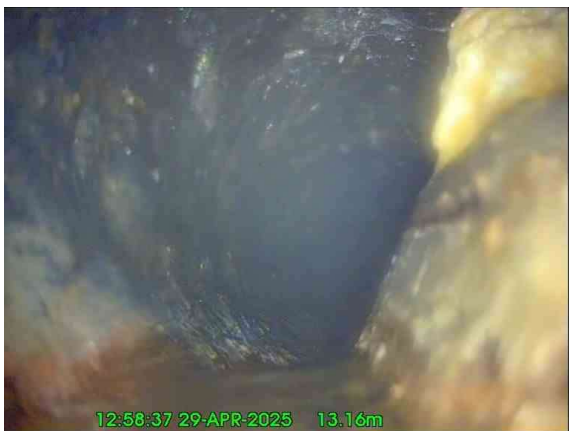
3, 00:02:29, 13.16 m  
Deformed sewer or drain, 25%

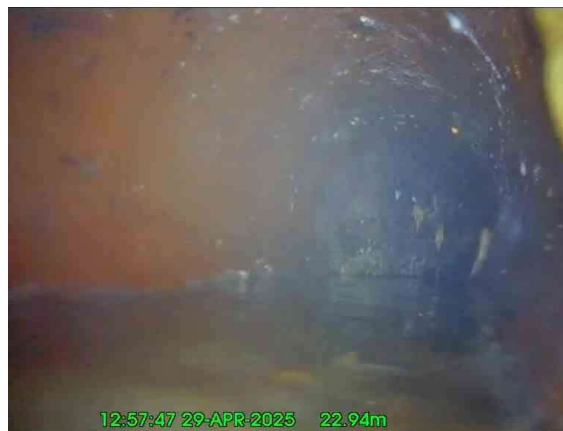
8, 00:01:39, 22.94 m  
Water level, 10% of the vertical dimension, Water standing in sewer due to mass roots at entry to MH20 UTL

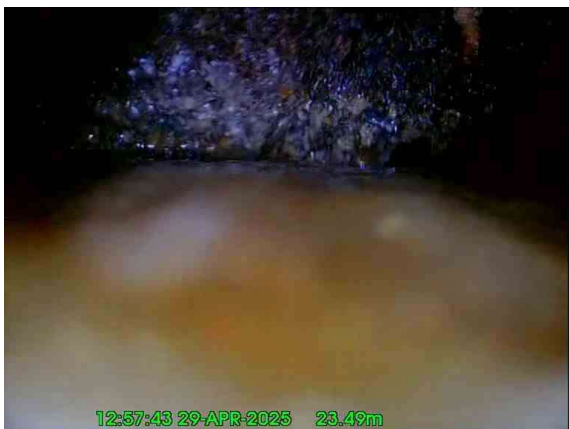
9, 00:01:34, 23.49 m  
Roots, mass, 75% cross-sectional area loss, At entry to MH20 UTL

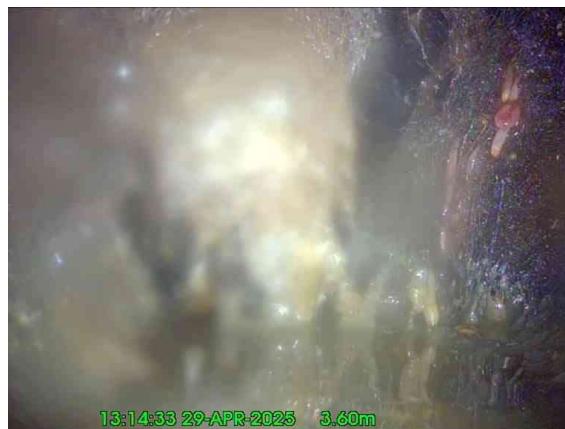
2, 00:01:58, 3.60 m  
Roots, mass at joint, 75% cross-sectional area loss

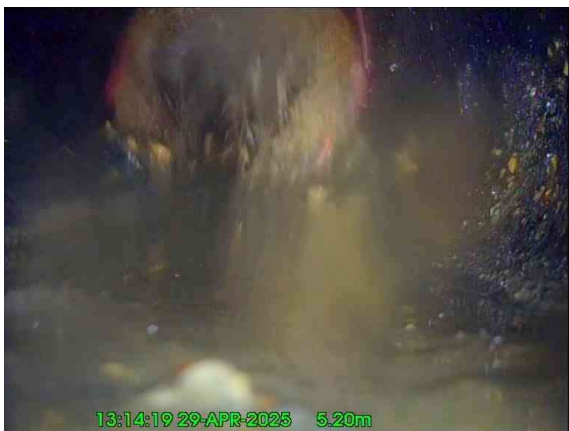
3, 00:01:44, 5.20 m  
Roots, mass at joint, 35% cross-sectional area loss
