**Huyton Town Centre Regeneration**  
CCTV Condition Report

Project Ref: TS-2645 Huyton Town Centre Regeneration CCTV  
Report\_303\_Issue01

**Dominic White – Tower Surveys CCTV Ltd**  
**23/05/2025**

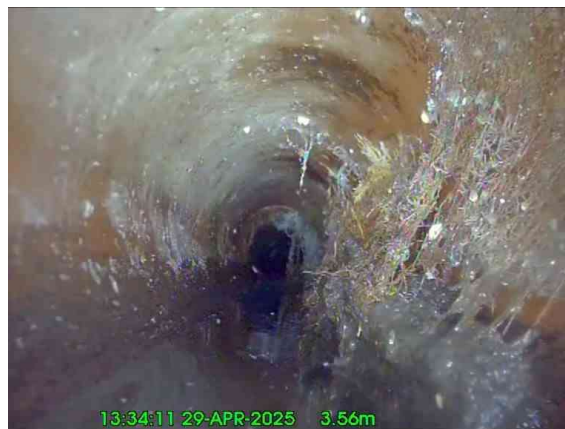
2, 00:00:25, 3.56 m  
Roots, mass at joint, 10% cross-sectional area loss, start

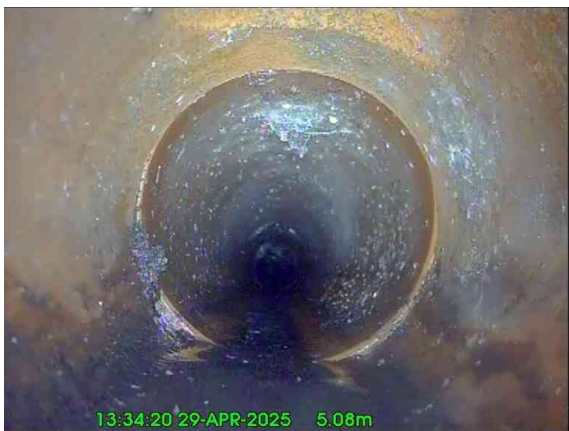
3, 00:00:34, 5.08 m  
Roots, mass at joint, 10% cross-sectional area loss, finish

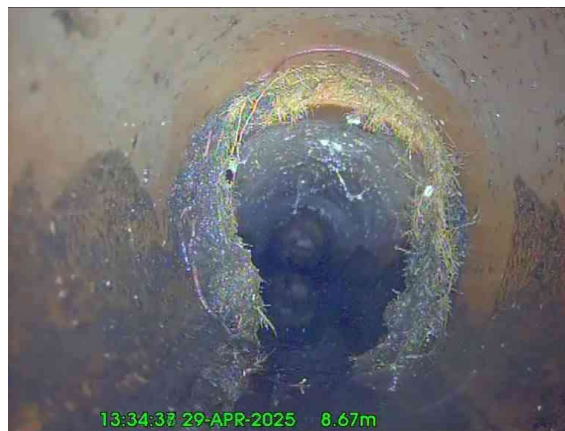
4, 00:00:52, 8.67 m  
Roots, mass at joint, 20% cross-sectional area loss

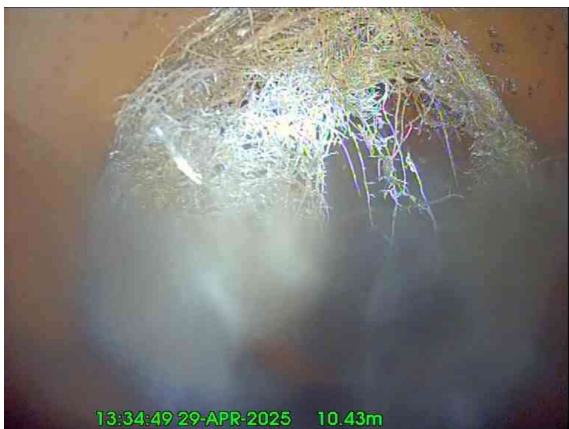
5, 00:01:04, 10.43 m  
Roots, mass at joint, 35% cross-sectional area loss

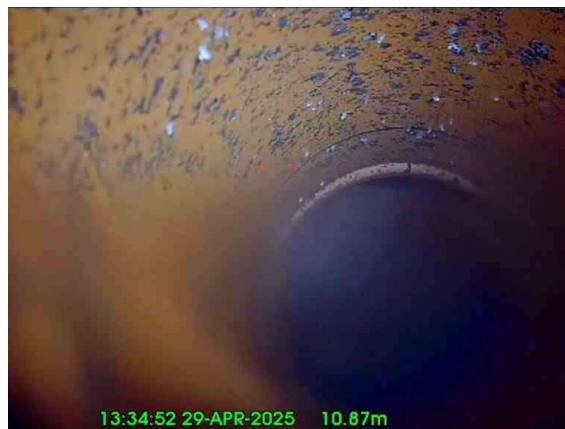
6, 00:01:07, 10.87 m  
Junction at 6 o'clock, 150mm dia, Internal Backdrop

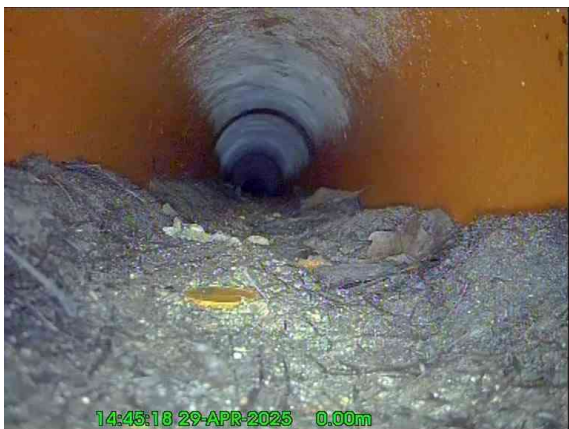
1, 00:00:03, 0.00 m  
Roots, mass, 20% cross-sectional area loss, start

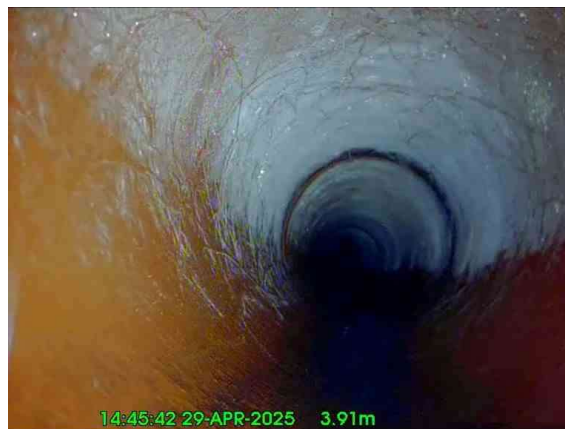
2, 00:00:27, 3.91 m  
Roots, mass, 20% cross-sectional area loss, finish

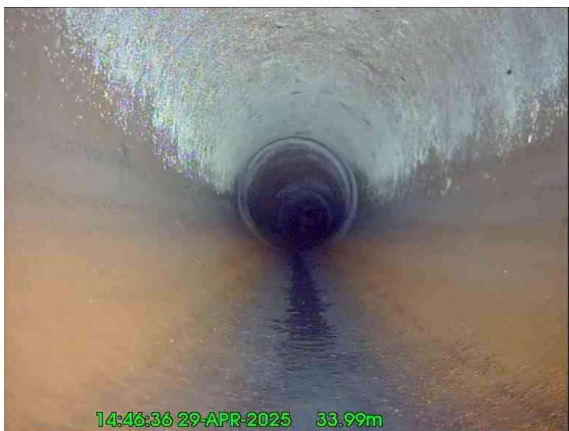
7, 00:01:22, 33.99 m  
Survey abandoned, Unable to push camera any further

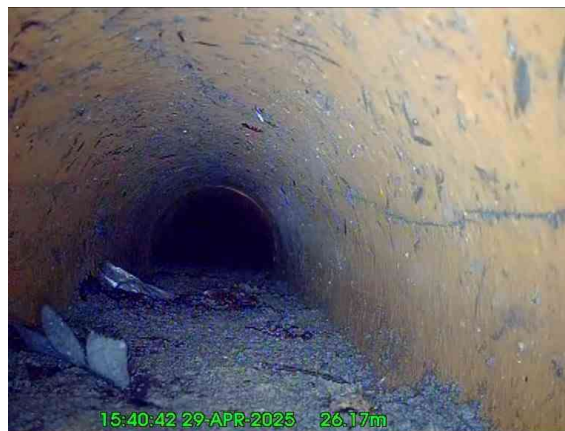
4, 00:02:12, 26.17 m  
Settled deposits, fine, 20% cross-sectional area loss

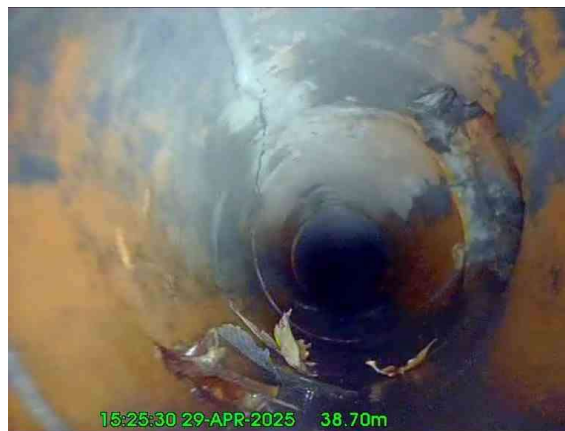
8, 00:03:03, 38.70 m  
Connection other than junction at 2 o'clock, 100mm dia

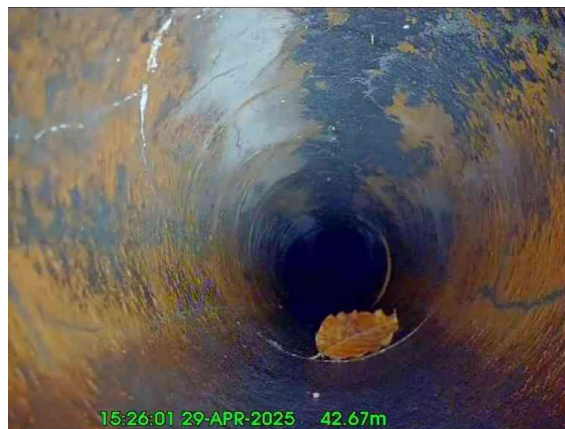
10, 00:03:34, 42.67 m  
Survey abandoned, Unable to push camera any further

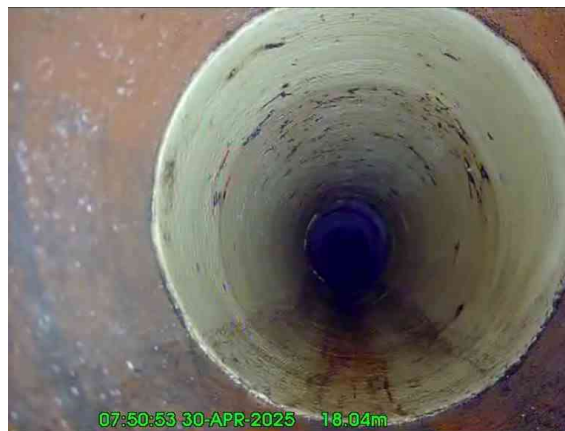
4, 00:00:54, 18.04 m  
Point repair, localised lining from 12 o'clock to 12 o'clock, start

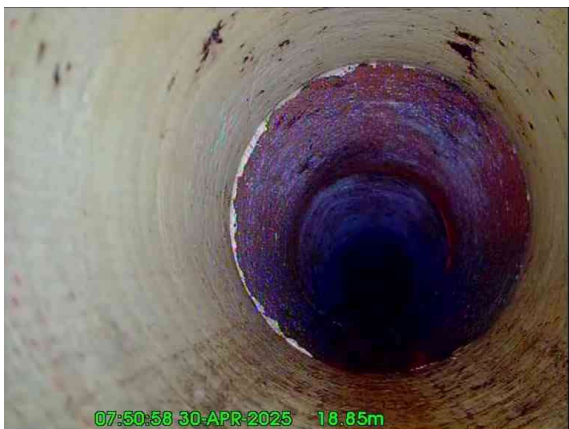
5, 00:00:59, 18.85 m  
Point repair, localised lining from 12 o'clock to 12 o'clock, finish

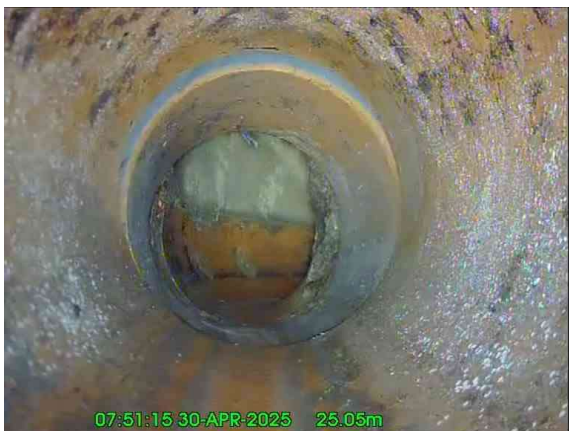
7, 00:01:17, 25.05 m  
Joint displaced, medium

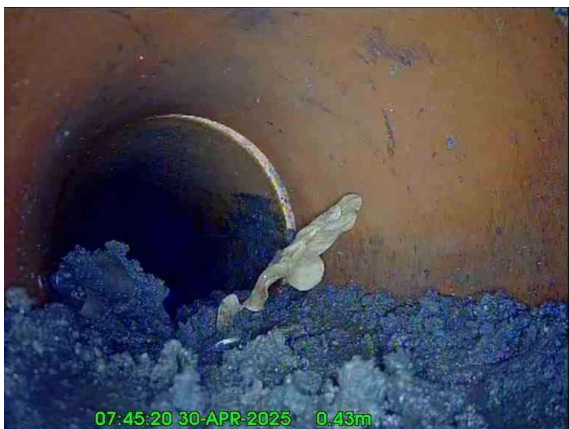
1, 00:00:04, 0.43 m  
Settled deposits, fine, 10% cross-sectional area loss, start

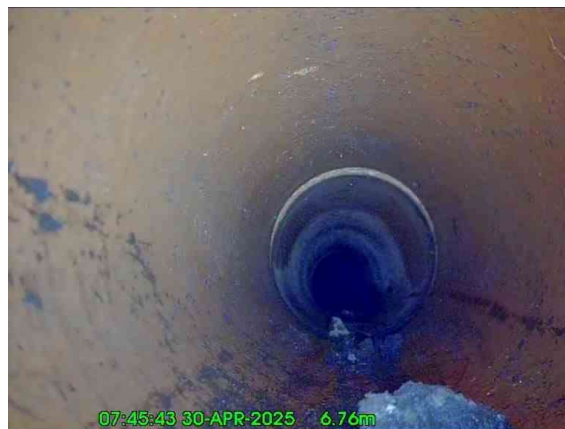
2, 00:00:27, 6.76 m  
Settled deposits, fine, 5% cross-sectional area loss, change

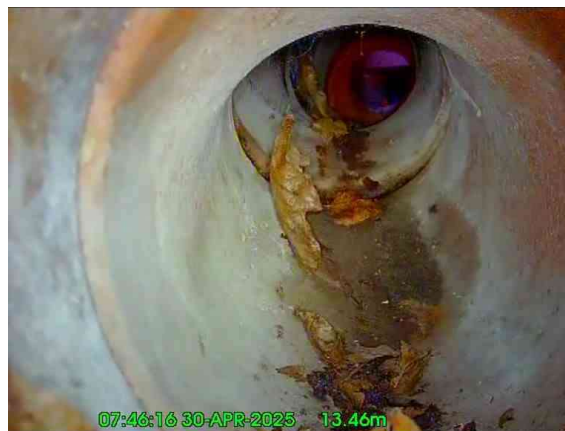
4, 00:01:00, 13.46 m  
Line deviates up

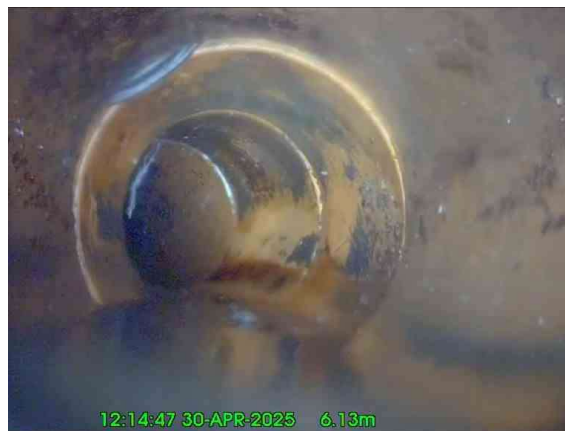
4, 00:00:32, 6.13 m  
Sealing ring intruding from 10 o'clock to 11 o'clock

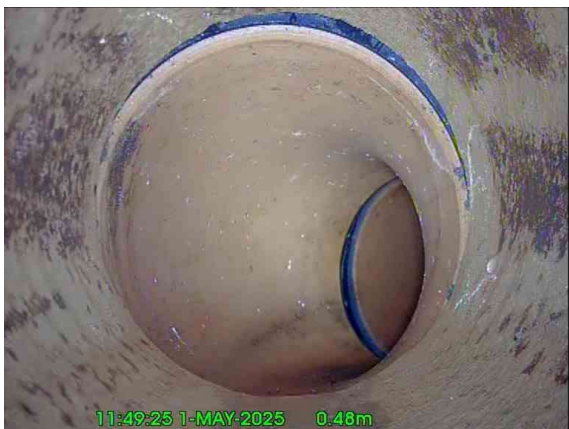
1, 00:00:10, 0.48 m  
Joint displaced, medium

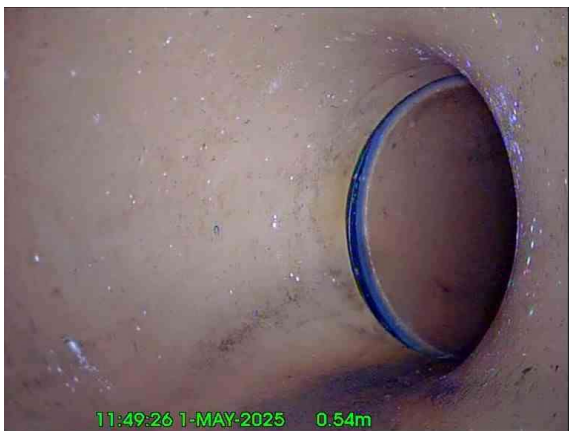
3, 00:00:11, 0.54 m  
Joint displaced, medium

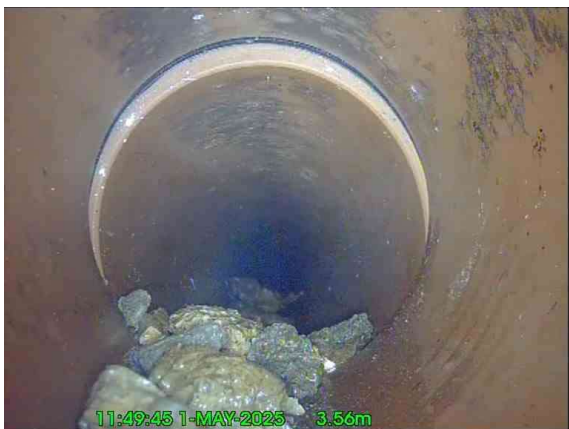
5, 00:00:30, 3.56 m  
Joint displaced, medium

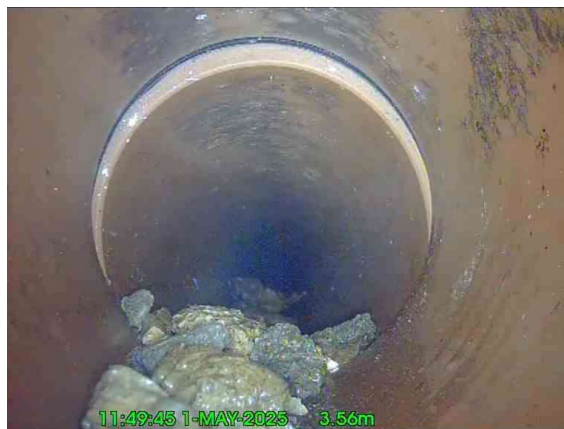
6, 00:00:30, 3.56 m  
Settled deposits, coarse, 5% cross-sectional area loss

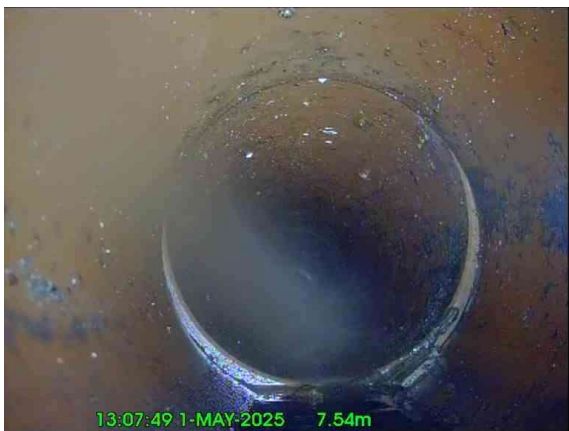
3, 00:00:42, 7.54 m  
Joint displaced, medium

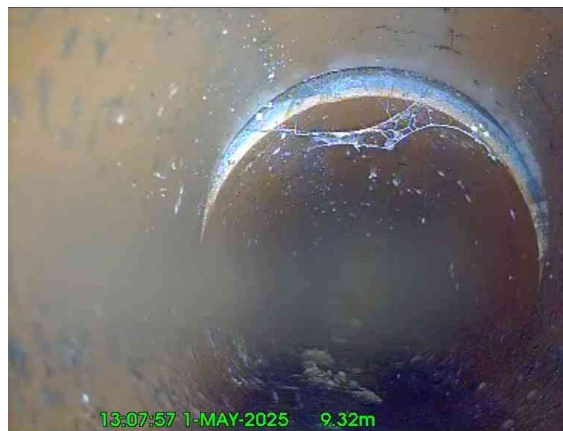
4, 00:00:50, 9.32 m  
Joint displaced, medium

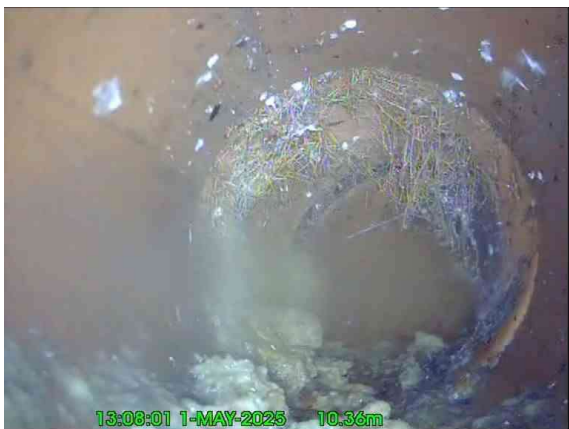
5, 00:00:54, 10.36 m  
Roots, mass at joint, 10% cross-sectional area loss

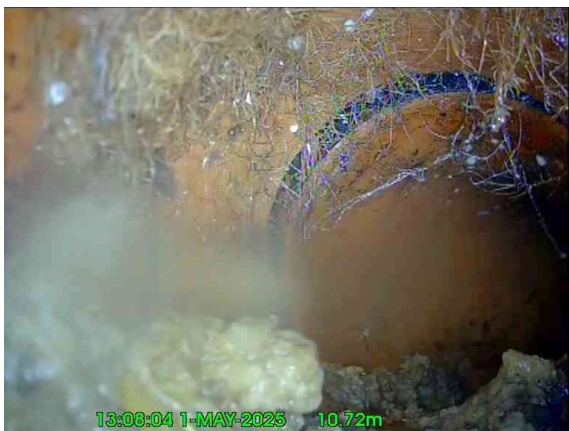
7, 00:00:57, 10.72 m  
Joint displaced, medium

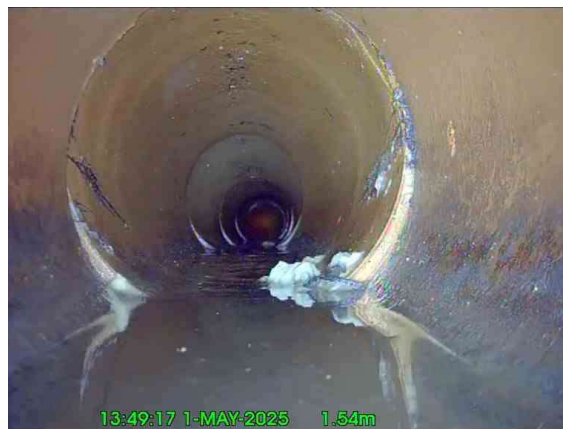
2, 00:00:17, 1.54 m  
Roots, fine at joint

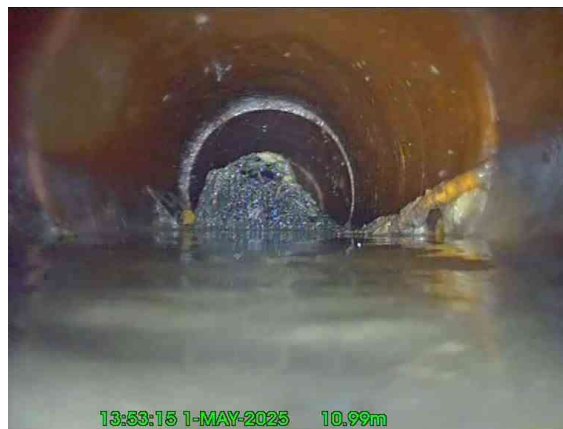
10, 00:02:12, 10.99 m  
Roots, tap at joint

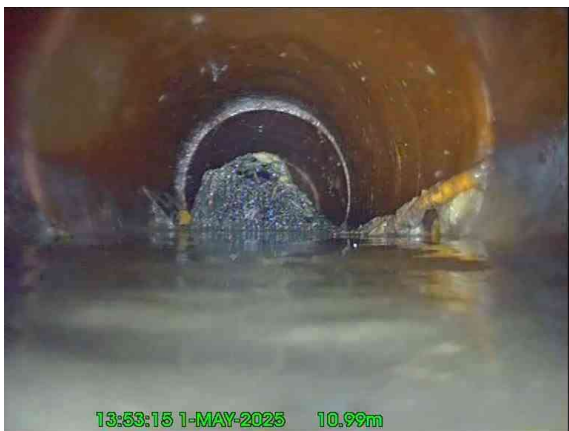
11, 00:02:12, 10.99 m  
Roots, mass at joint, 35% cross-sectional area loss

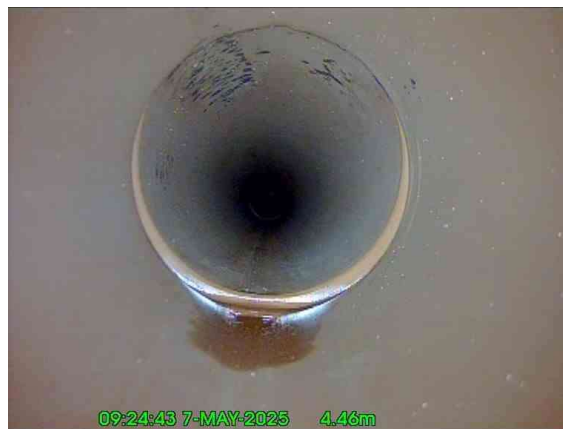
2, 00:00:19, 4.46 m  
Joint displaced, medium

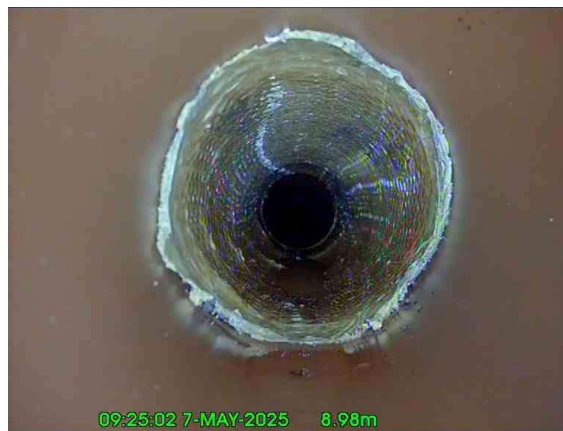
4, 00:00:38, 8.98 m  
Point repair, localised lining from 12 o'clock to 12 o'clock, start

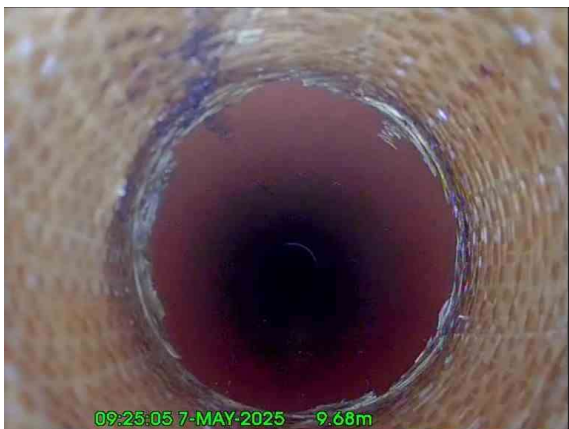
5, 00:00:41, 9.68 m  
Point repair, localised lining from 12 o'clock to 12 o'clock, finish

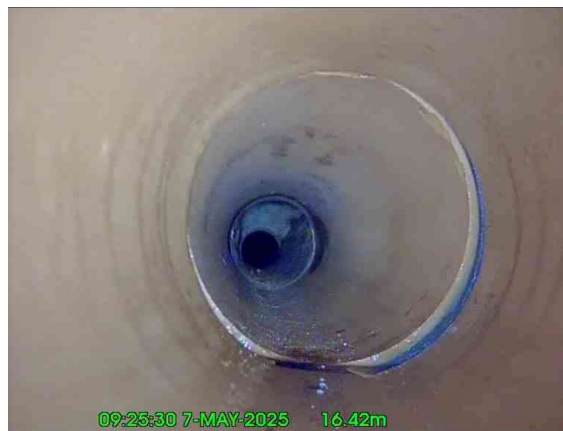
8, 00:01:06, 16.42 m  
Joint displaced, medium

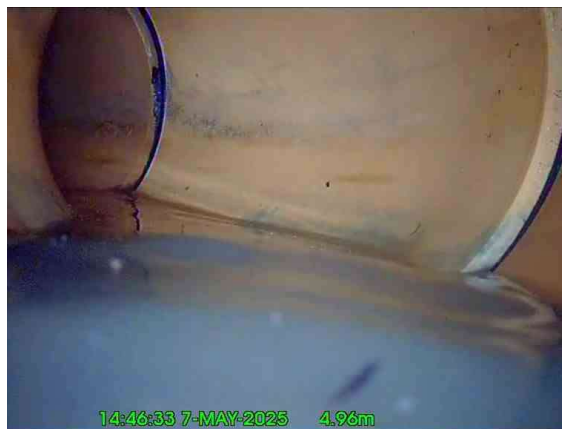
2, 00:00:26, 4.96 m  
Line deviates left

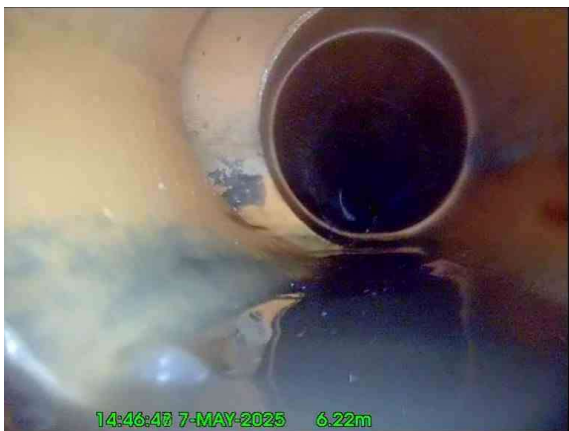
3, 00:00:41, 6.22 m  
Junction at 9 o'clock, 150mm dia

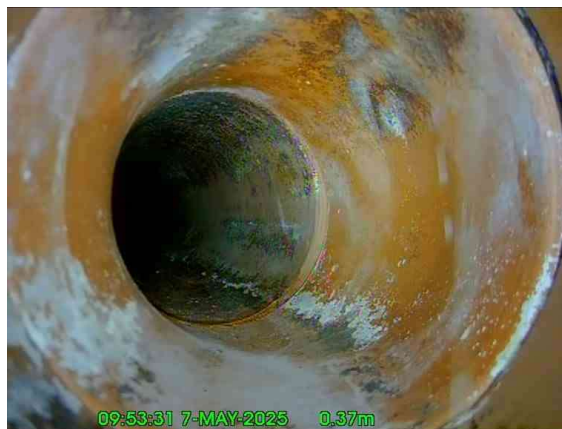
2, 00:00:10, 0.37 m  
Line deviates left

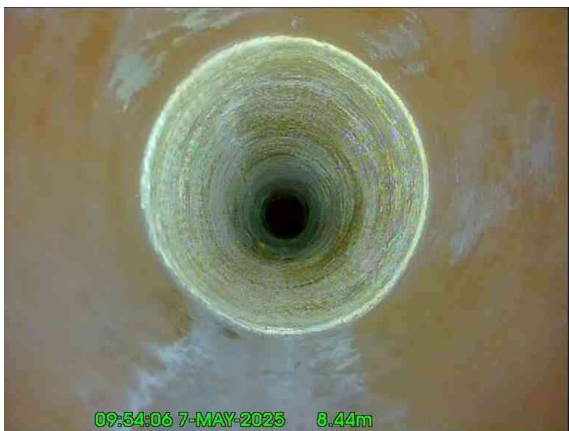
3, 00:00:46, 8.44 m  
Point repair, localised lining from 12 o'clock to 12 o'clock, start

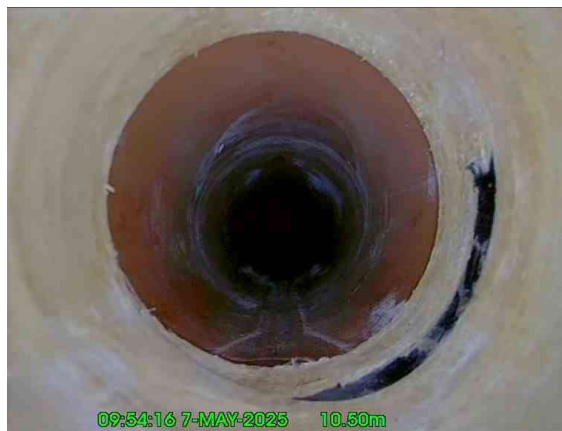
4, 00:00:56, 10.50 m  
Point repair, localised lining from 12 o'clock to 12 o'clock, finish

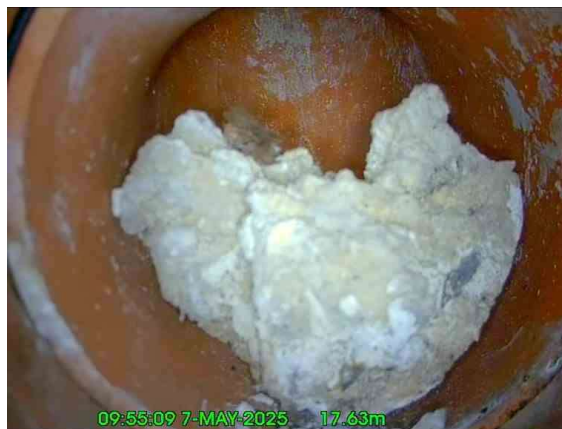
6, 00:01:48, 17.63 m  
Settled deposits, hard or compacted, 35% cross-sectional area loss, Unable to remove solid set debris via jetting

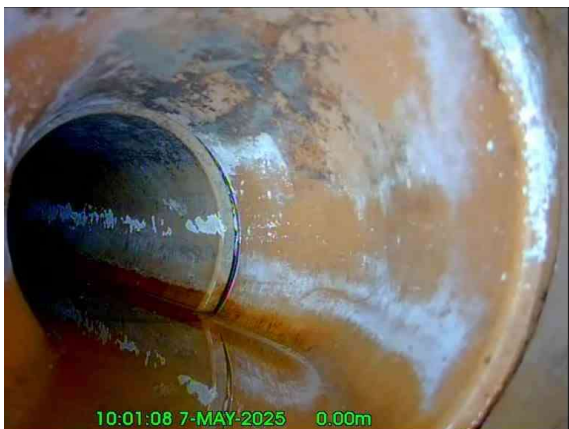
1, 00:00:01, 0.00 m  
Line deviates left

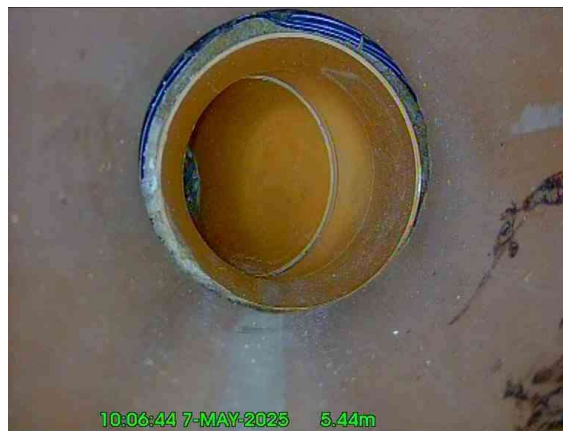
4, 00:00:36, 5.44 m  
Joint displaced, medium

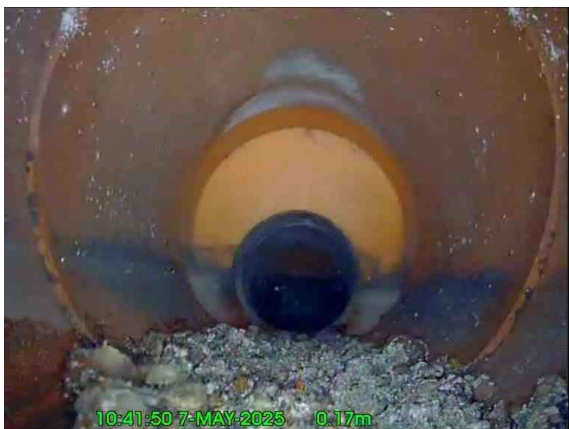
1, 00:00:05, 0.17 m  
Settled deposits, fine, 5% cross-sectional area loss

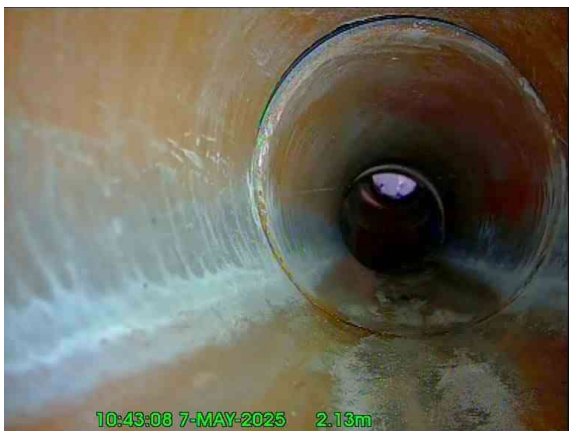
3, 00:00:20, 2.13 m  
Joint displaced, medium

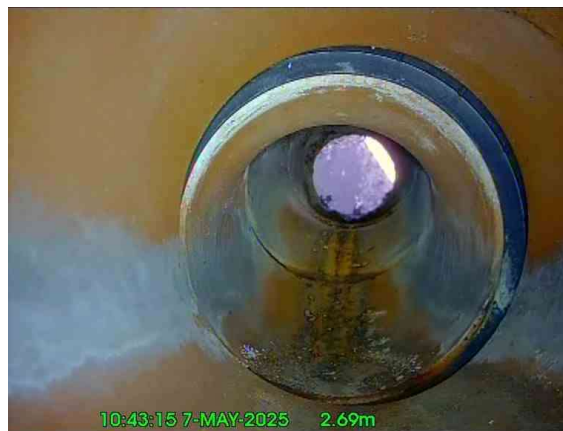
4, 00:00:27, 2.69 m  
Joint displaced, large

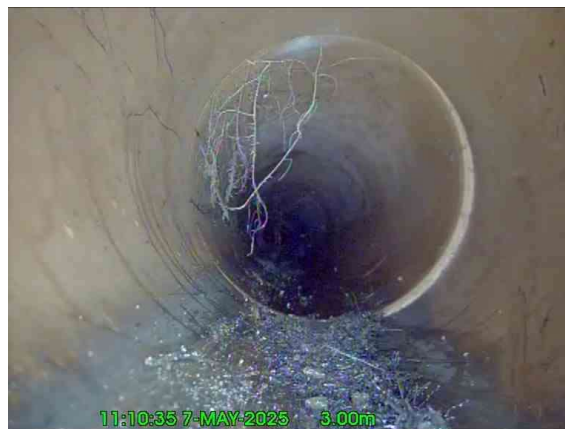
2, 00:00:20, 3.00 m  
Roots, mass at joint, 5% cross-sectional area loss

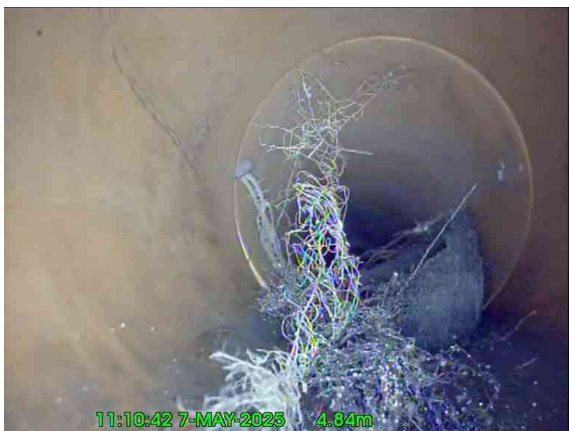
3, 00:00:27, 4.84 m  
Roots, mass at joint, 10% cross-sectional area loss

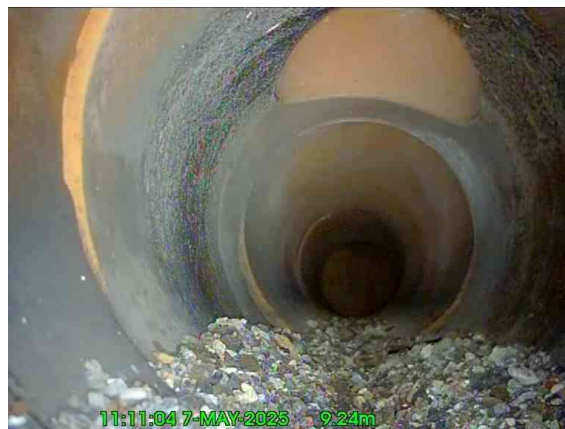
6, 00:00:49, 9.24 m  
Settled deposits, coarse, 5% cross-sectional area loss

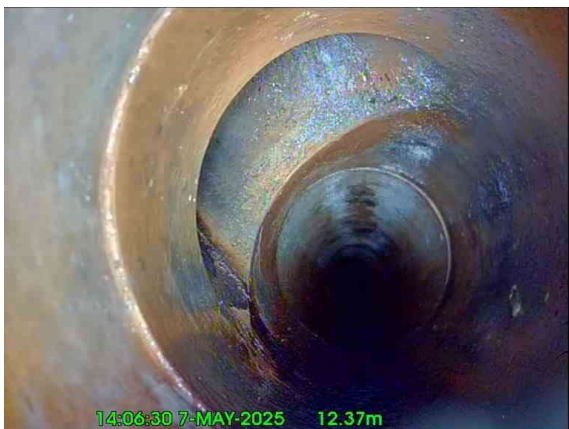
5, 00:00:46, 12.37 m  
Junction at 10 o'clock, 150mm dia, from Gully3 X

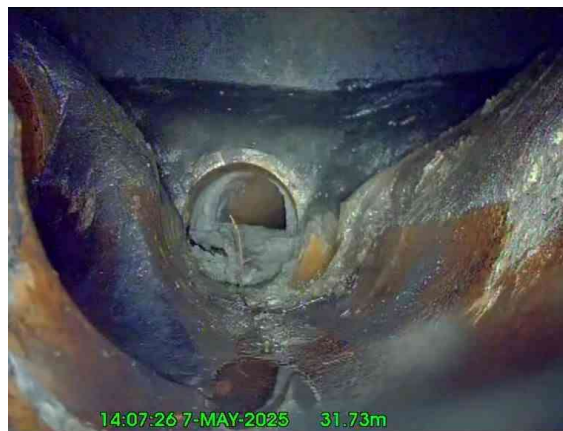
8, 00:01:42, 31.73 m  
Finish node, manhole, reference: MH60 UTL (MH Under Fence) reached

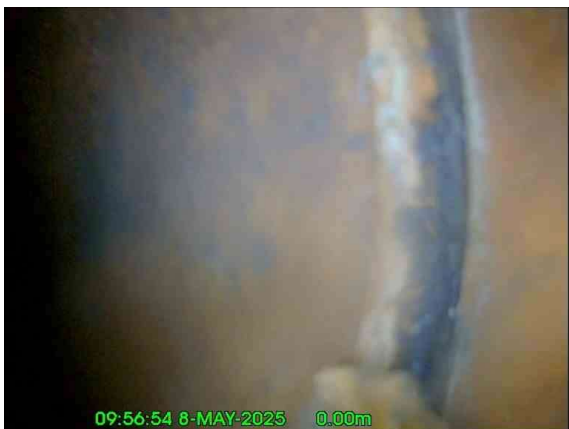
1, 00:00:02, 0.00 m  
Line deviates left

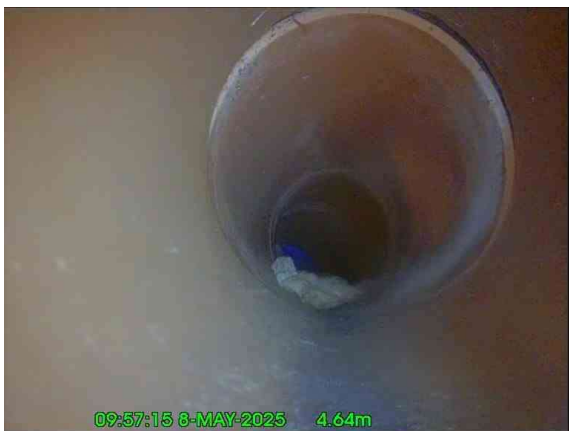
3, 00:00:22, 4.64 m  
Joint displaced, medium

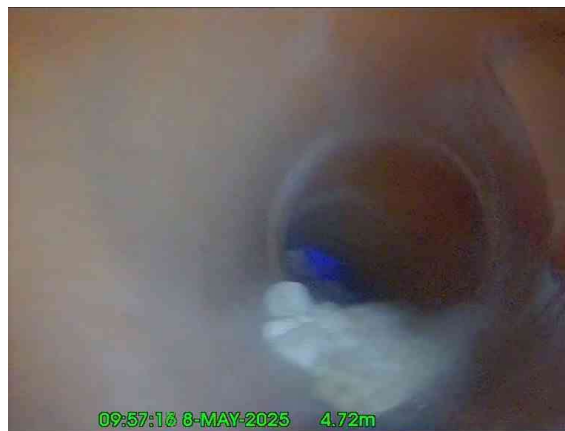
4, 00:00:23, 4.72 m  
Junction at 2 o'clock, 100mm dia

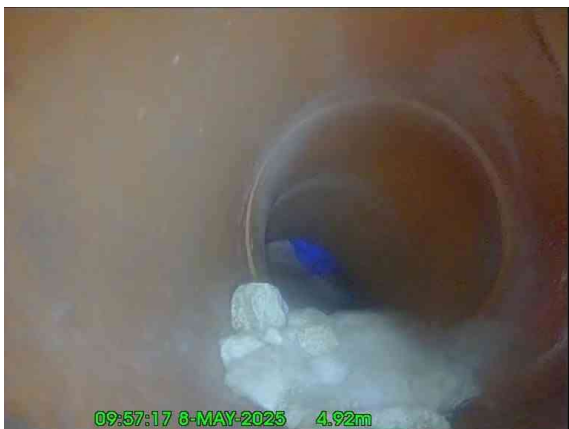
5, 00:00:23, 4.92 m  
Settled deposits, coarse, 10% cross-sectional area loss

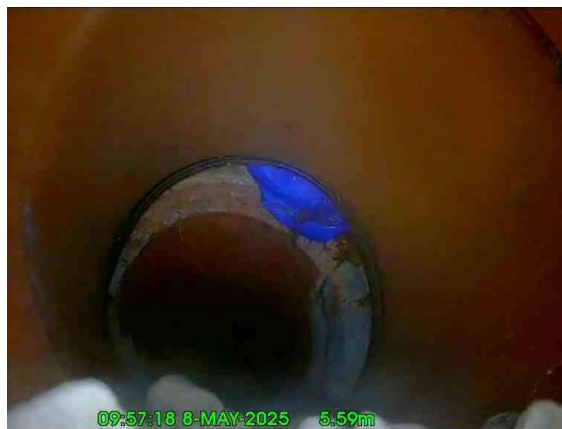
6, 00:00:24, 5.59 m  
Line deviates left

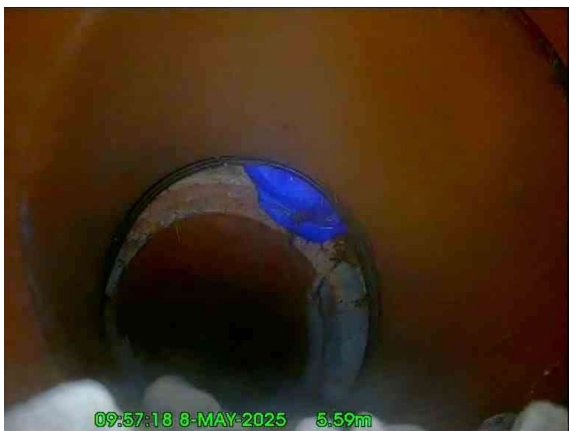
7, 00:00:24, 5.59 m  
Joint displaced, large

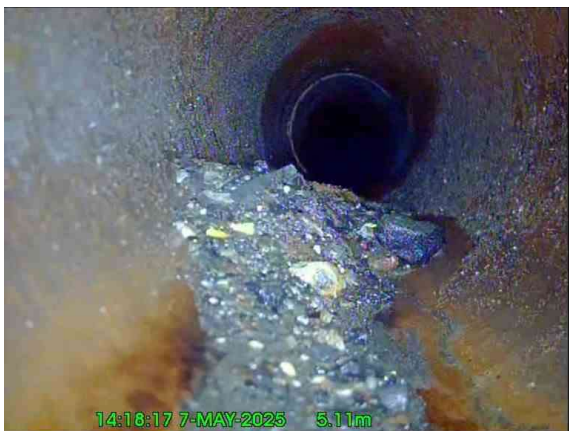
3, 00:00:31, 5.11 m  
Settled deposits, fine, 10% cross-sectional area loss

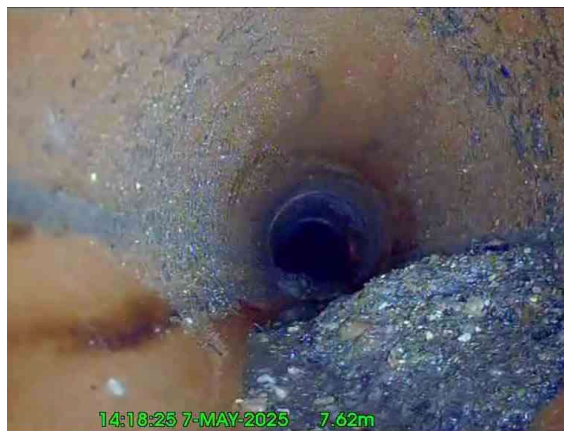
4, 00:00:38, 7.62 m  
Settled deposits, fine, 10% cross-sectional area loss, start

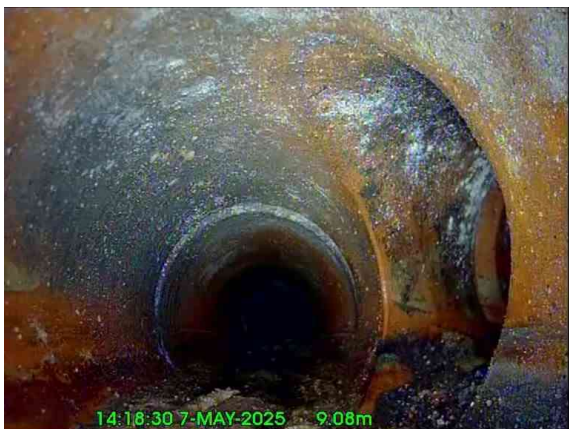
5, 00:00:44, 9.08 m  
Junction at 3 o'clock, 150mm dia

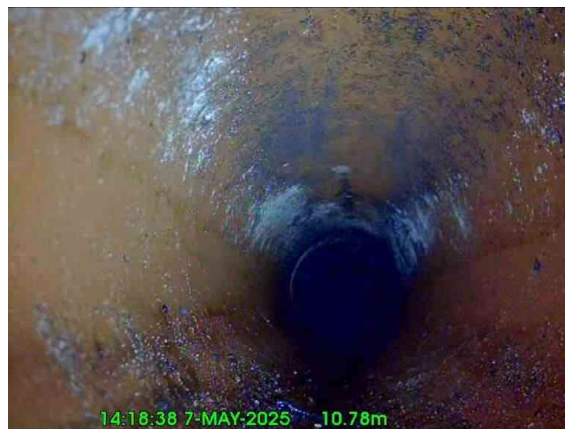
6, 00:00:52, 10.78 m  
Settled deposits, fine, 10% cross-sectional area loss, finish

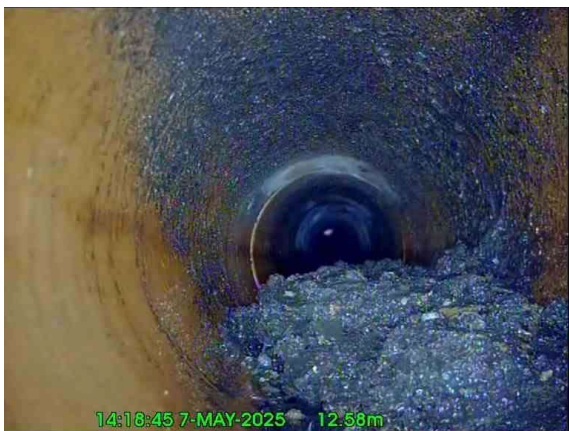
7, 00:01:00, 12.58 m  
Settled deposits, fine, 20% cross-sectional area loss

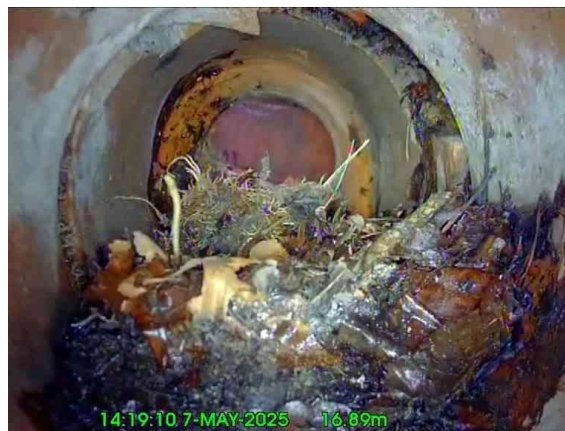
8, 00:01:25, 16.89 m  
Roots, mass at joint, 25% cross-sectional area loss, At entry to gully

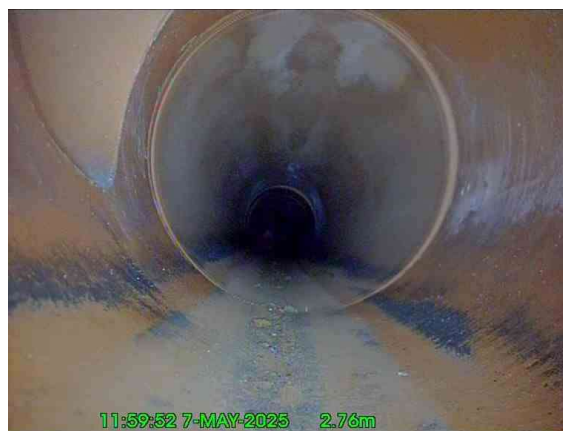
2, 00:00:17, 2.76 m  
Junction at 10 o'clock, 150mm dia

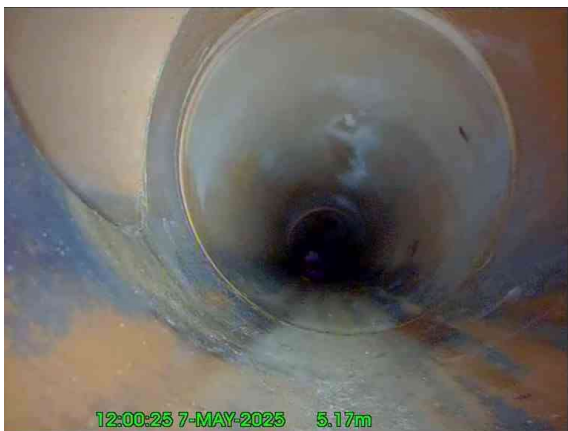
3, 00:00:50, 5.17 m  
Junction at 10 o'clock, 150mm dia

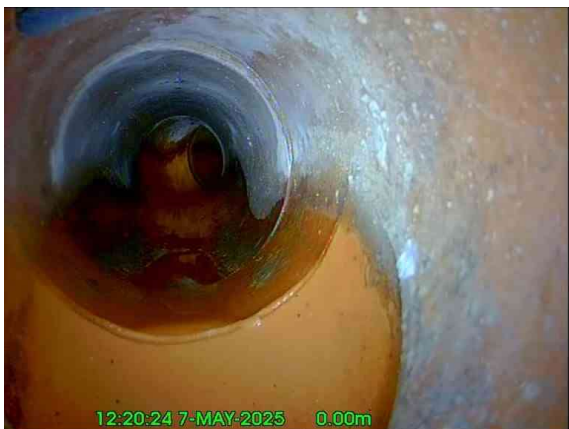
1, 00:00:02, 0.00 m  
Junction at 6 o'clock, 100mm dia, External Backdrop

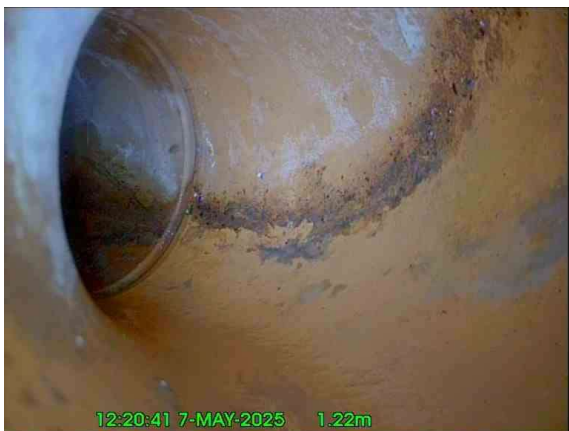
3, 00:00:15, 1.22 m  
Line deviates left

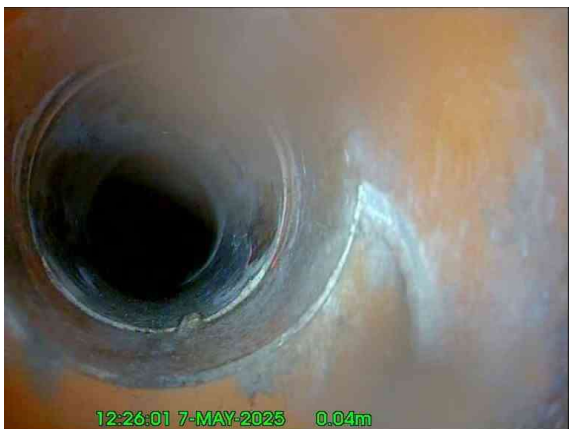
1, 00:00:08, 0.04 m  
Junction at 6 o'clock, 100mm dia, External Backdrop

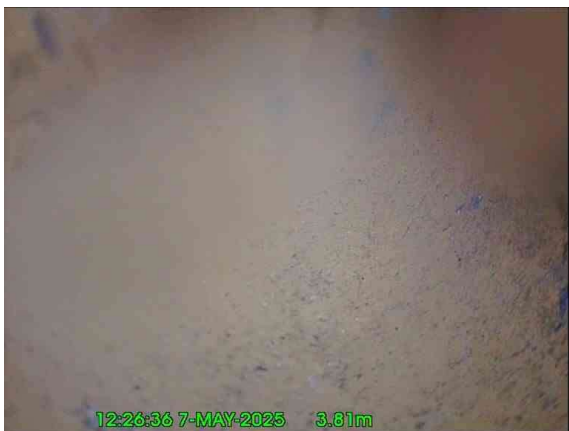
3, 00:00:44, 3.81 m  
Finish node, other special chamber, reference: Downpipe,  
Internal downpipe reached

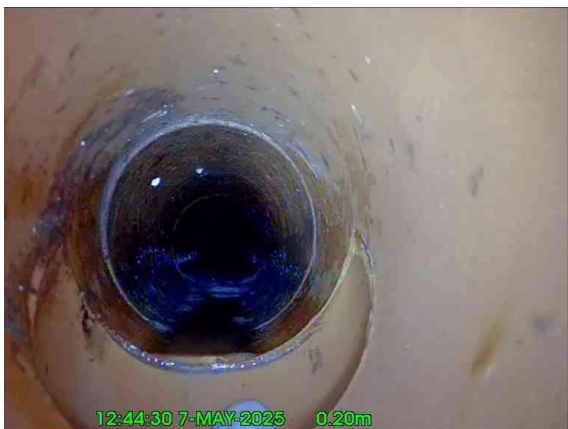
1, 00:00:08, 0.20 m  
Junction at 6 o'clock, 100mm dia, External Backdrop

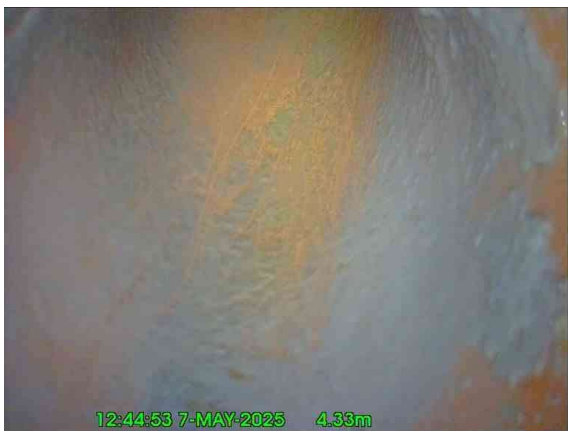
3, 00:00:32, 4.33 m  
Finish node, other special chamber, reference: Downpipe,  
Internal downpipe reached

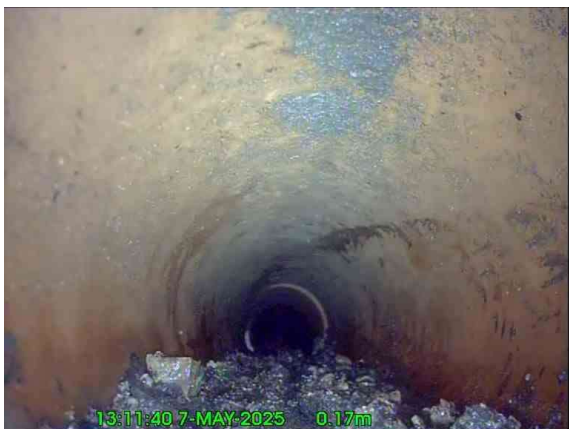
1, 00:00:55, 0.17 m  
Settled deposits, coarse, 10% cross-sectional area loss, start

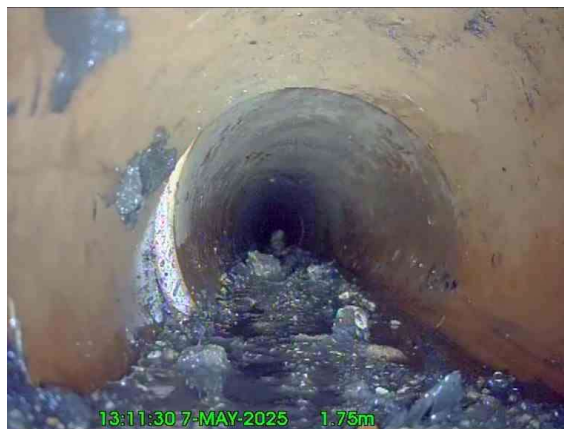
2, 00:00:45, 1.75 m  
Joint displaced, medium

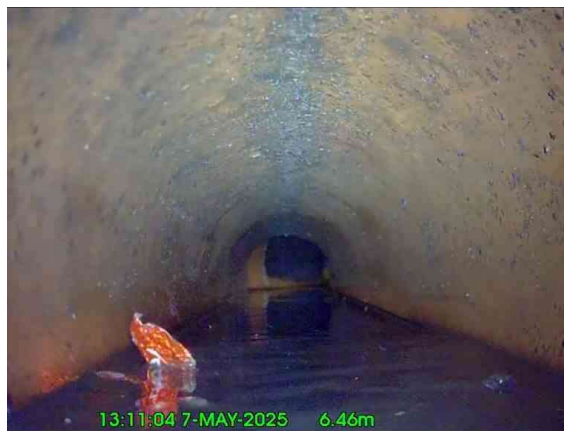
4, 00:00:19, 6.46 m  
Water level, 20% of the vertical dimension, Water standing in sewer

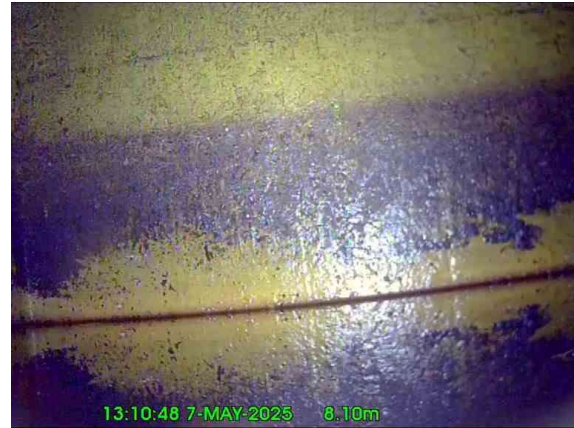
6, 00:00:02, 8.10 m  
Finish node, oil separator, reference: MH58 reached

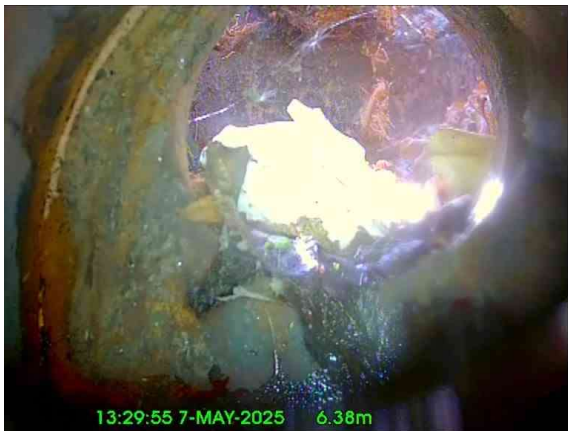
3, 00:00:53, 6.38 m  
Finish node, gully, reference: Gully reached

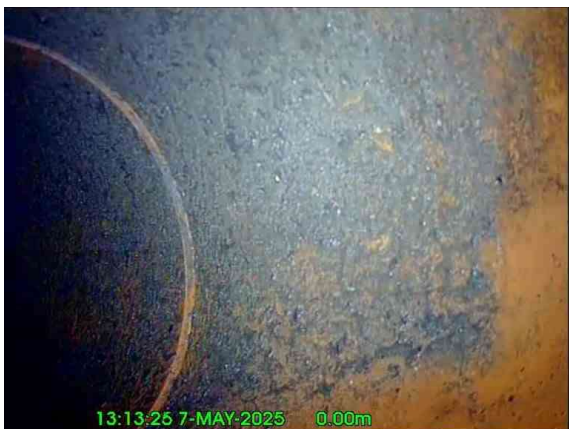
1, 00:00:06, 0.00 m  
Line deviates left

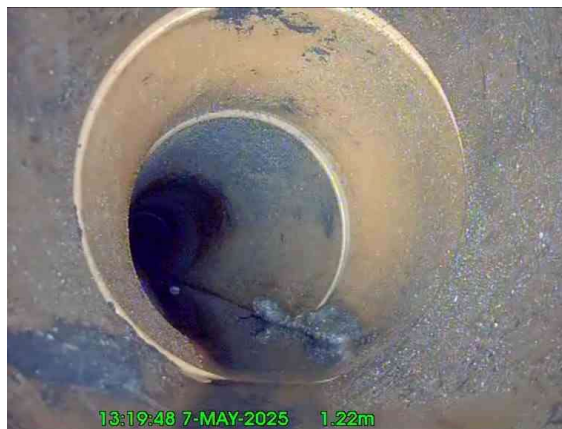
2, 00:00:07, 1.22 m  
Line deviates left

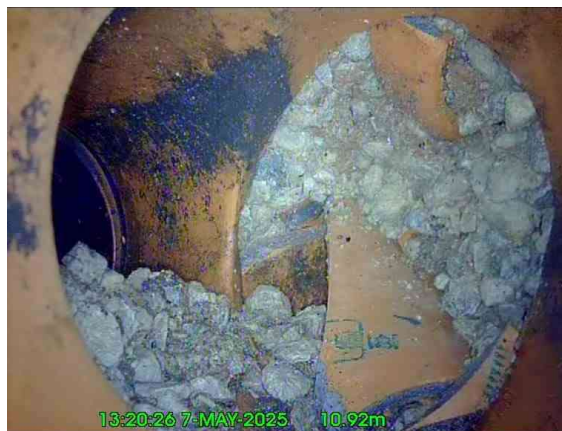
4, 00:00:44, 10.92 m  
Junction at 9 o'clock, 100mm dia

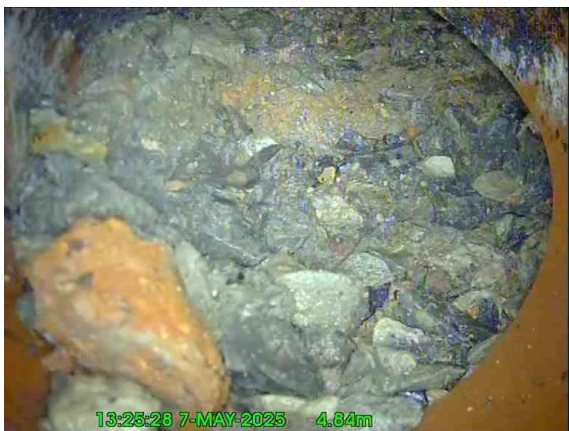
3, 00:00:33, 4.84 m  
Finish node, other special chamber, reference: Capped,  
Capped pipe reached

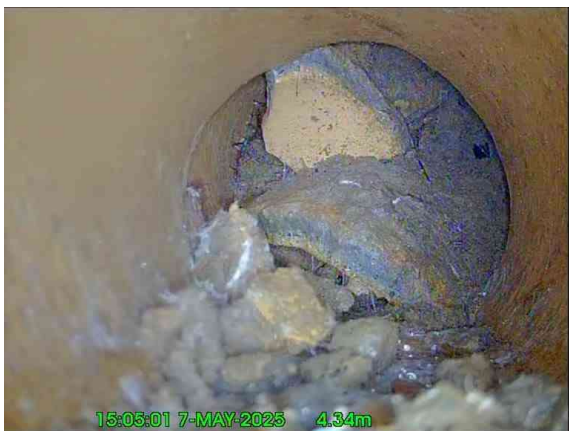
3, 00:00:24, 4.34 m  
Finish node, other special chamber, reference: Capped,  
Capped pipe reached

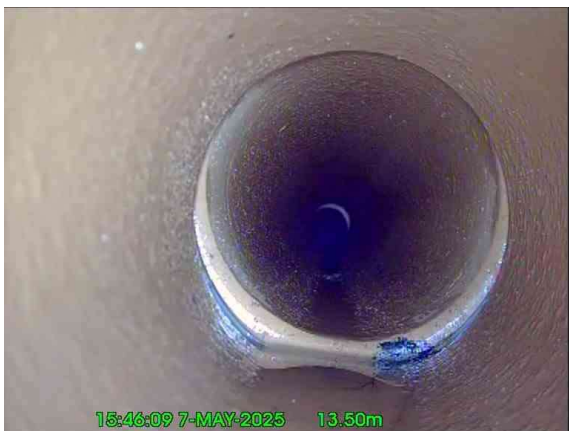
3, 00:01:00, 13.50 m  
Joint displaced, medium

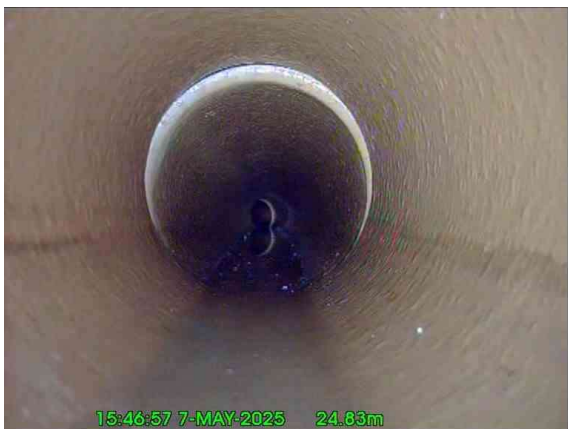
5, 00:01:46, 24.83 m  
Joint displaced, medium

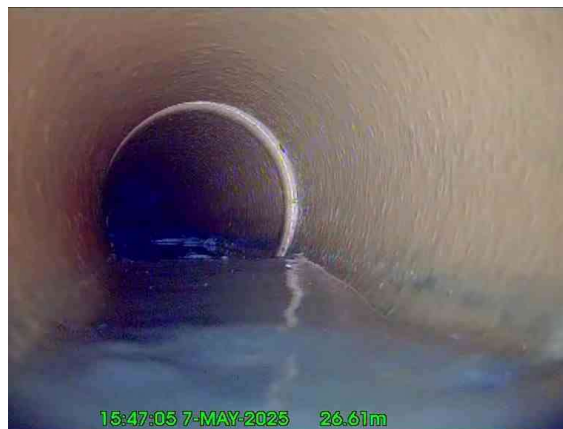
6, 00:01:55, 26.61 m  
Line deviates left

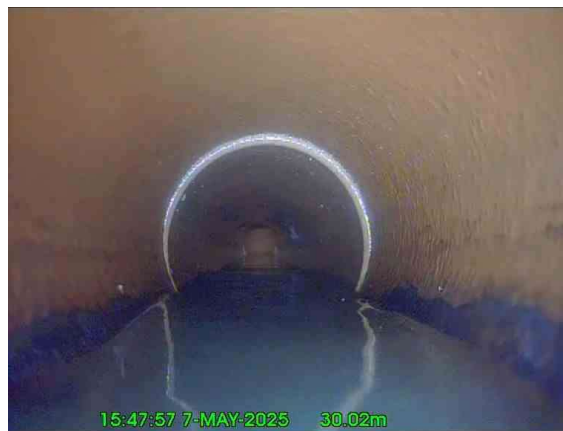
8, 00:02:47, 30.02 m  
Water level, 20% of the vertical dimension, Water standing in sewer

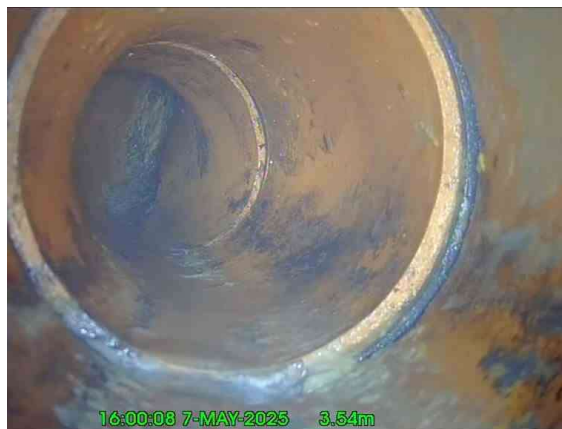
2, 00:00:28, 3.54 m  
Joint displaced, medium

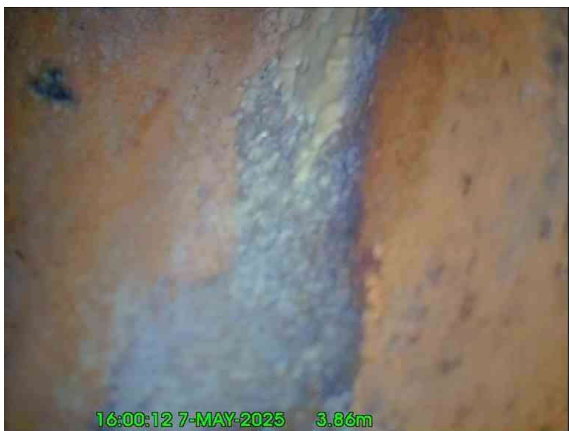
3, 00:00:32, 3.86 m  
Finish node, other special chamber, reference: Downpipe,  
Internal downpipe reached

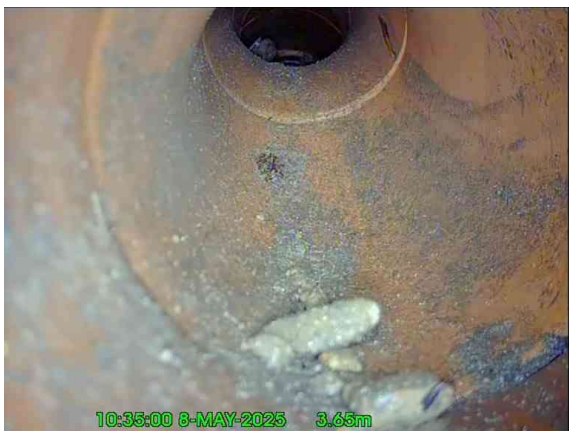
3, 00:00:21, 3.65 m  
Line deviates up

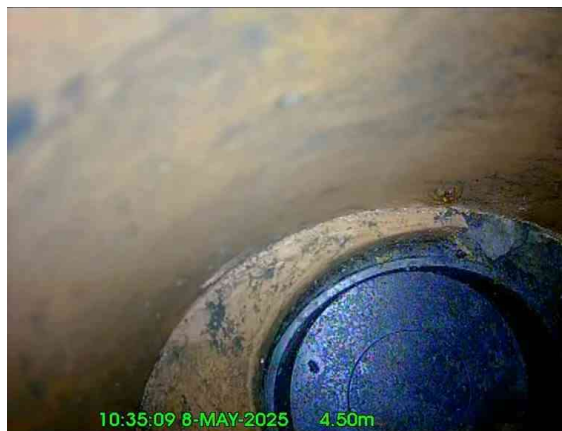
4, 00:00:29, 4.50 m  
Finish node, gully, reference: Buried Gly reached

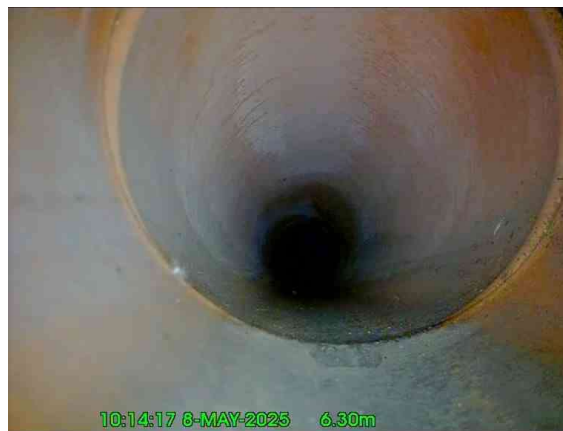
4, 00:00:25, 6.30 m  
Line deviates down
