**Huyton Town Centre Regeneration**  
CCTV Condition Report

Project Ref: TS-2645 Huyton Town Centre Regeneration CCTV  
Report\_303\_Issue01

**Dominic White – Tower Surveys CCTV Ltd**  
**23/05/2025**

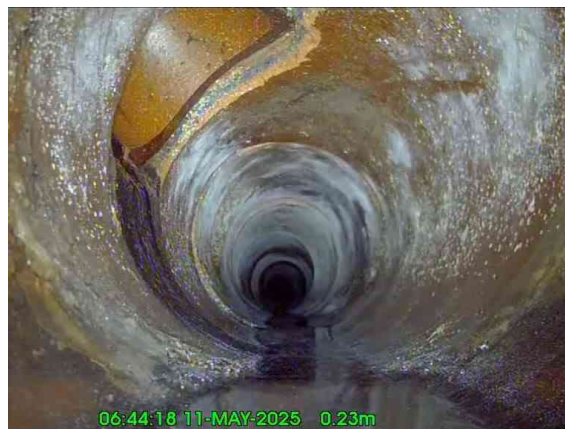
2, 00:00:06, 0.23 m  
Connection other than junction at 10 o'clock, 100mm dia

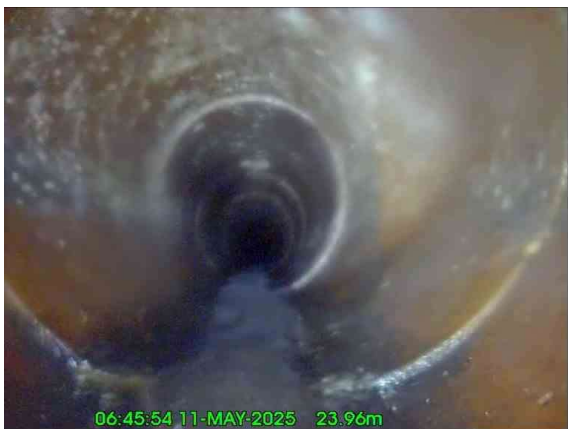
5, 00:01:43, 23.96 m  
Junction at 3 o'clock, 150mm dia

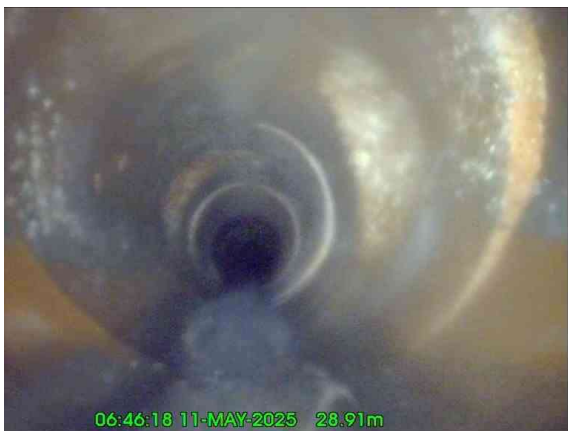
7, 00:02:06, 28.91 m  
Junction at 2 o'clock, 150mm dia

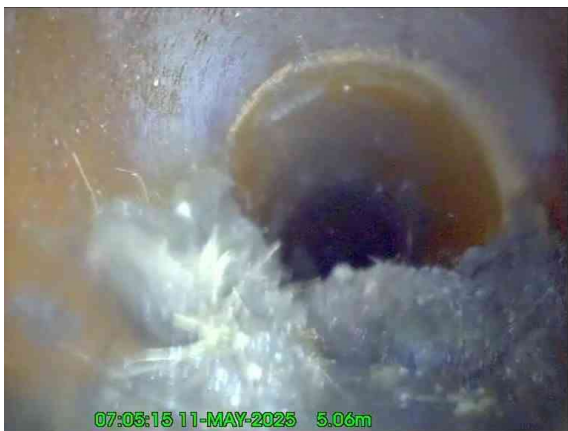
3, 00:00:22, 5.06 m  
Roots, mass at joint, 25% cross-sectional area loss

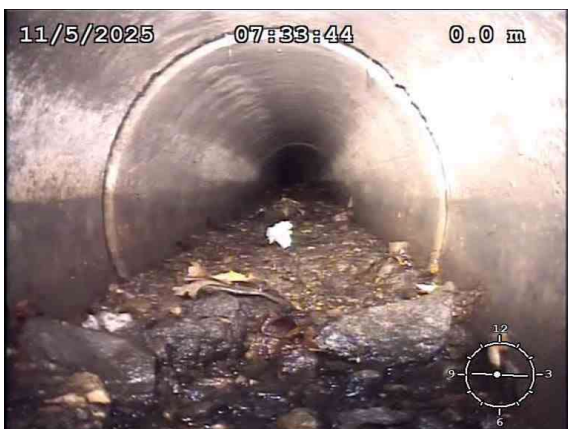
1, 00:00:01, 0.00 m  
Settled deposits, coarse, 20% cross-sectional area loss, start

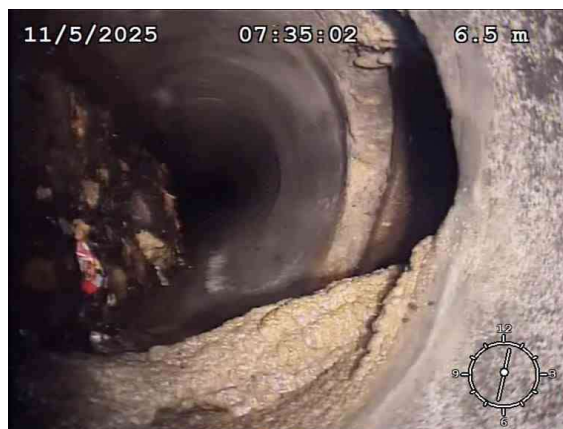
2, 00:01:19, 6.50 m  
Connection other than junction at 2 o'clock, 150mm dia

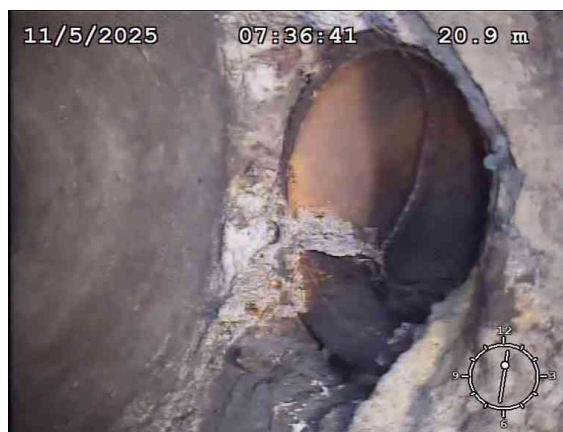
4, 00:02:58, 20.90 m  
Connection other than junction at 1 o'clock, 150mm dia

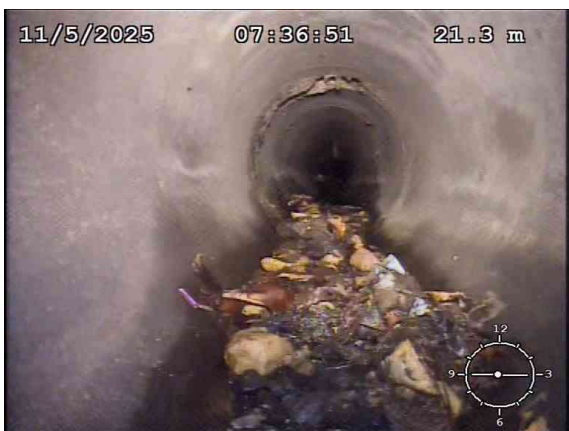
5, 00:03:08, 21.30 m  
Settled deposits, coarse, 10% cross-sectional area loss, start

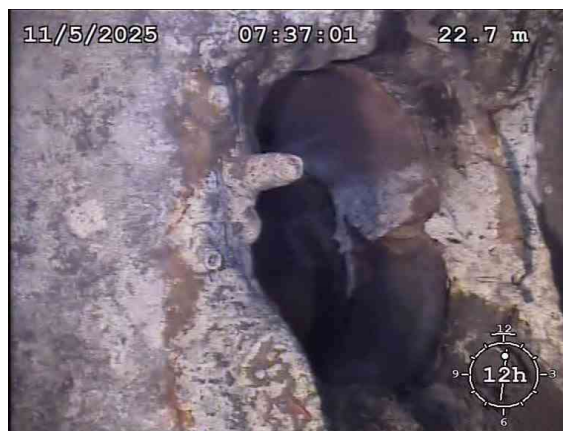
6, 00:03:18, 22.70 m  
Connection other than junction at 11 o'clock, 150mm dia

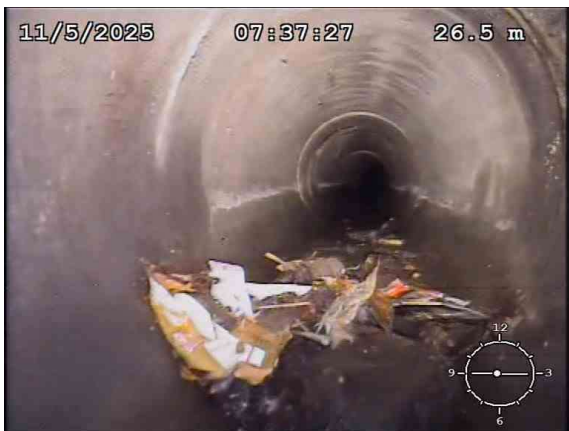
7, 00:03:44, 26.50 m  
Settled deposits, coarse, 5% cross-sectional area loss, start

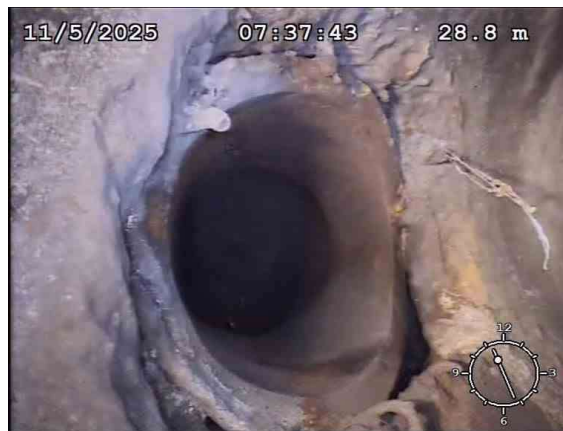
8, 00:04:00, 28.80 m  
Connection other than junction at 11 o'clock, 150mm dia

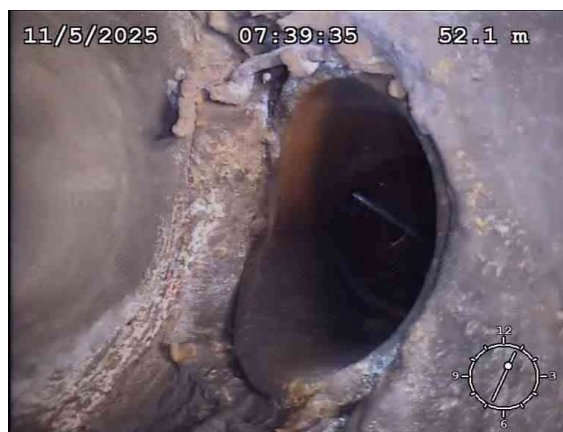
| Scale: | 1:392 | Position [m] | Code | Observation | MPEG | Photo | Grade |
|---|---|---|---|---|---|---|---|
| | | 52.10 | CN | Connection other than junction at 1 o'clock, 150mm dia | 00:05:52 | 12 | |

12, 00:05:52, 52.10 m  
Connection other than junction at 1 o'clock, 150mm dia

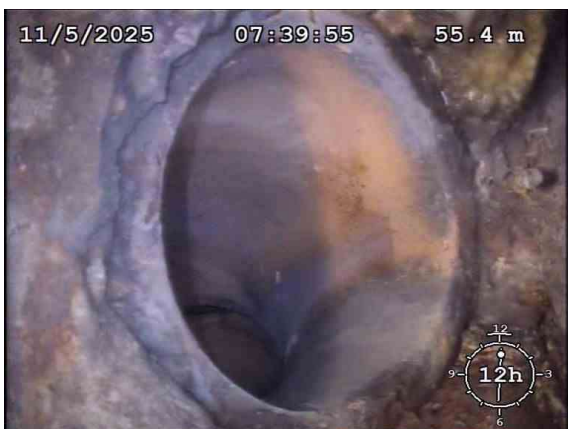
| Scale: | 1:392 | Position [m] | Code | Observation | MPEG | Photo | Grade |
|---|---|---|---|---|---|---|---|
| | | 55.40 | CN | Connection other than junction at 11 o'clock, 150mm dia | 00:06:12 | 13 | |

13, 00:06:12, 55.40 m  
Connection other than junction at 11 o'clock, 150mm dia

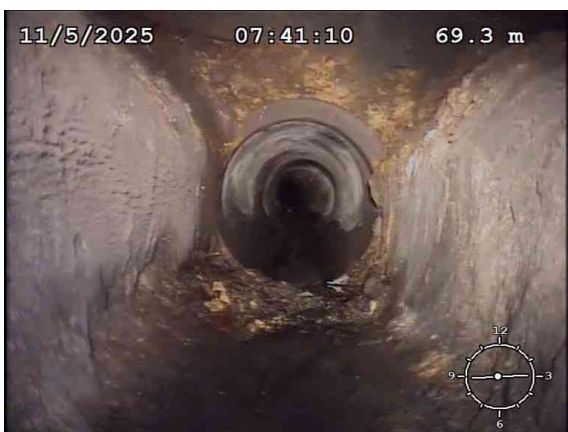
15, 00:07:27, 69.30 m  
Finish node, manhole, reference: MH67 UTL reached, UU MH  
Ref: 0802

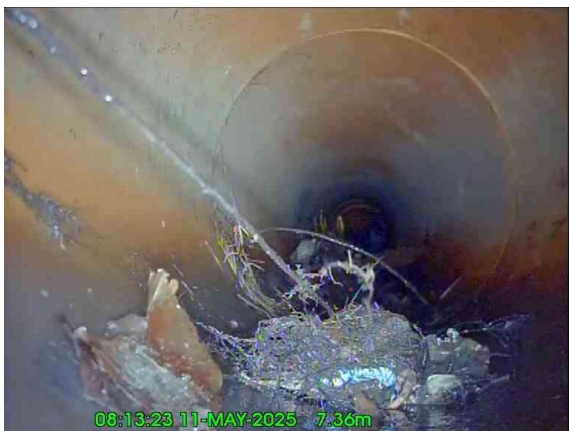
3, 00:01:49, 7.36 m  
Settled deposits, coarse, 5% cross-sectional area loss
