**Prescot Picture House**  
**8-14 Kemble Street, Prescot**

**Investigations into the condition of the historic ceiling and  
wall plasters within the main auditorium space**

**December 2022**

**M. WOMERSLEY**  
Historic Building Specialists

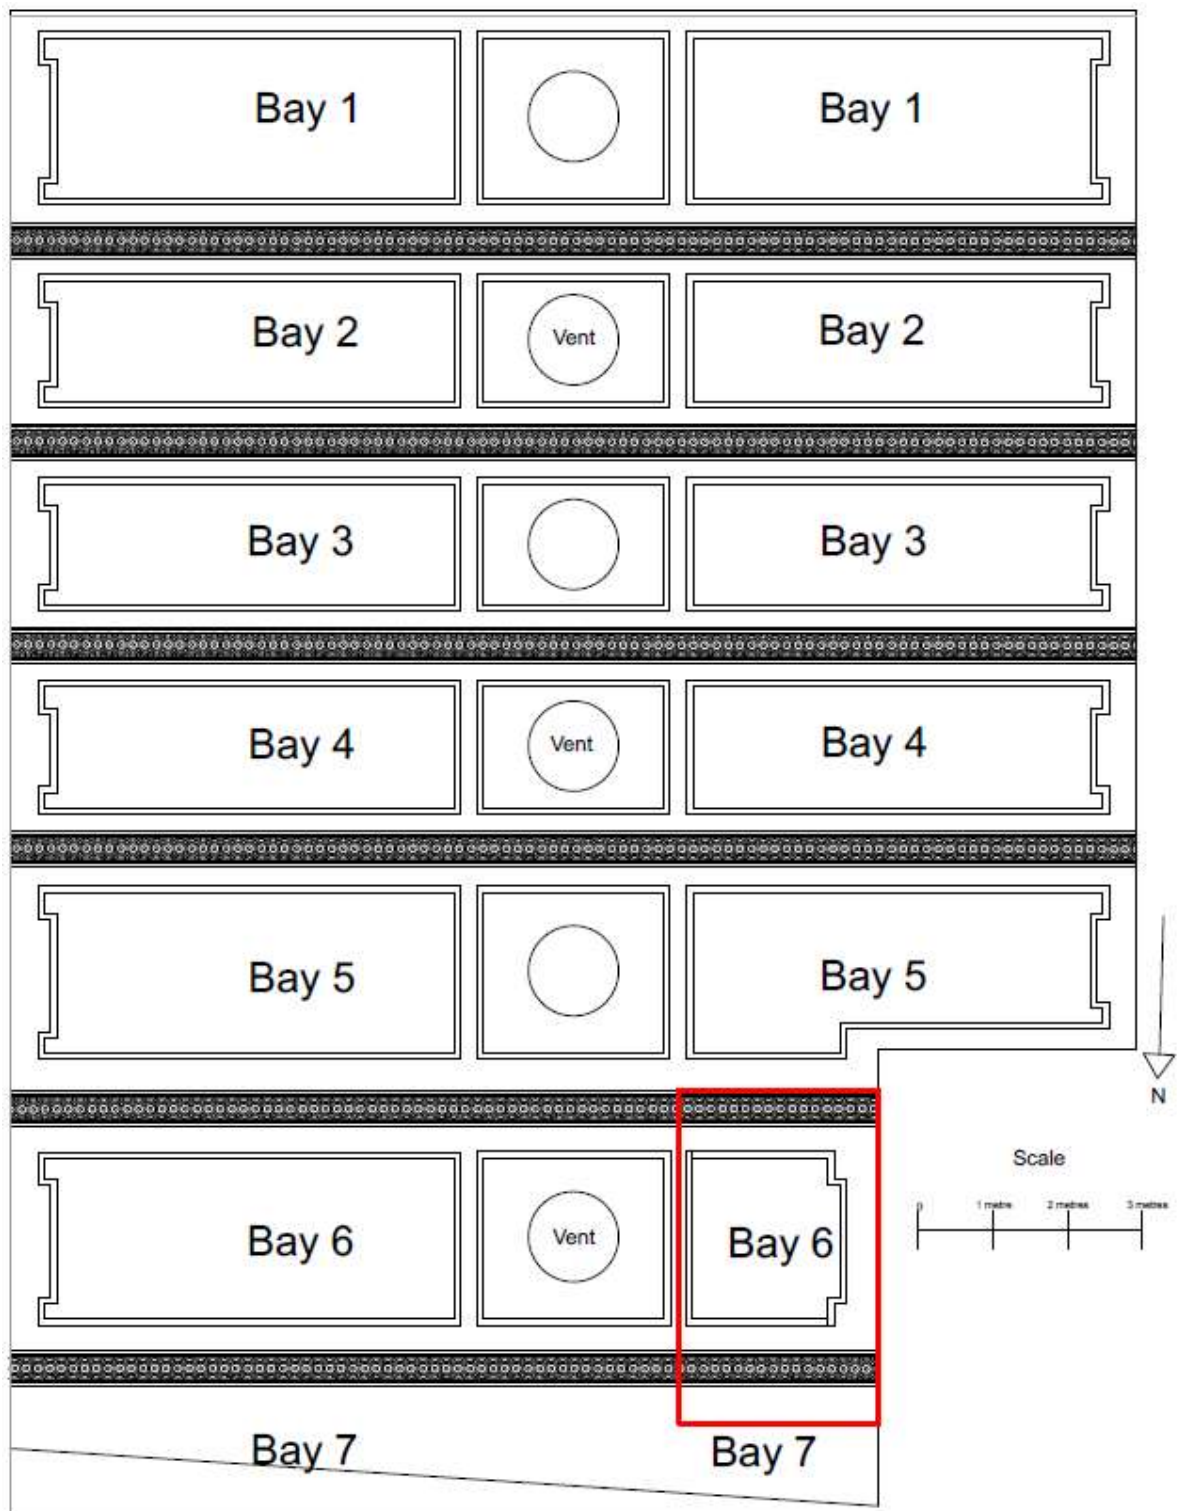
**Diagram 2: An opened out plan of the barrel vaulted ceiling, showing the bays, ribs, and panel moulds.**

In the first bay nearest the stage, see diagram 2 above, the ceiling is badly cracked where it meets the front of the proscenium arch; and parts of the first fibrous rib, between bay 1 and 2, are beginning to fall, see photos 28 & 29, and there is an impact damaged hole within the plain plaster contained by the central plaster wreath, which is itself in reasonable condition. Excessive water damaged ceiling and wall plasters can be found at the eastern end of this first bay, see photo 30. The first ceiling bay has suffered water and impact damage in the past and has been partly reskimmed or skimmed originally to create a more even arched plain plaster finish coat, but this is in part de-bonding, see photos 22 & 23:

Bay 3, like the previous two, is edged by a distorted and failing cornice, and has areas of debonding skim plaster, and an area of particular distress can be found in the centre of the western end of this bay, see photos 37 & 38. The plaster ventilation grill in the fourth bay is cracked and requires repair and wiring up, photos 39 & 40. The cornice on the western end of the 4<sup>th</sup> bay is almost completely decayed, and the rib between the 4<sup>th</sup> and 5<sup>th</sup> bay is badly cracked all along its edge, and there is an overturning cornice on the east wall, see photos 41 & 42.

In bay 6 the eastern third of the bay is distressed and the plaster has collapsed above its western end, because of rot in the supporting timbers, although the adjacent plaster ventilation grill is in reasonable condition, see photos 53, 54 and 55. The wall plasters are cracked and de-bonded and there are missing plaster wads, that should be holding the rib up between the 6<sup>th</sup> and 7<sup>th</sup> bay, see photos 56 and 57. Although evidence of missing and damaged wads can be seen above every rib on this ceiling, see photos 72-73.

| Activity | Budget Cost Estimate |
|---|---|
| As emergency works screw up and install plaster wads, and cut a plaster joint line, to allow the main contractor to take down and replace the rotten timberwork in the western half of the 6 <sup>th</sup> bay, as indicated by the red square on diagram 2. | £1,800 |
| As emergency works take down and replace the rotten timberwork in the western half of the bay, as indicated by the red square on diagram 2, and replace with new timber joists, to the same strength and dimensions of the existing. | My main contractor |

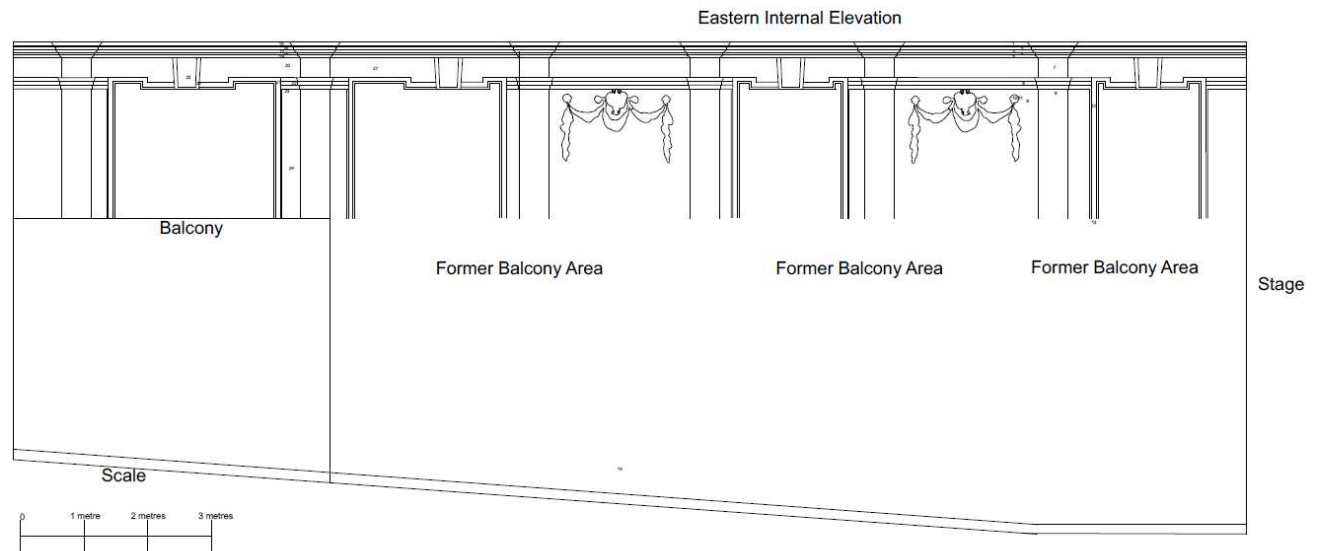
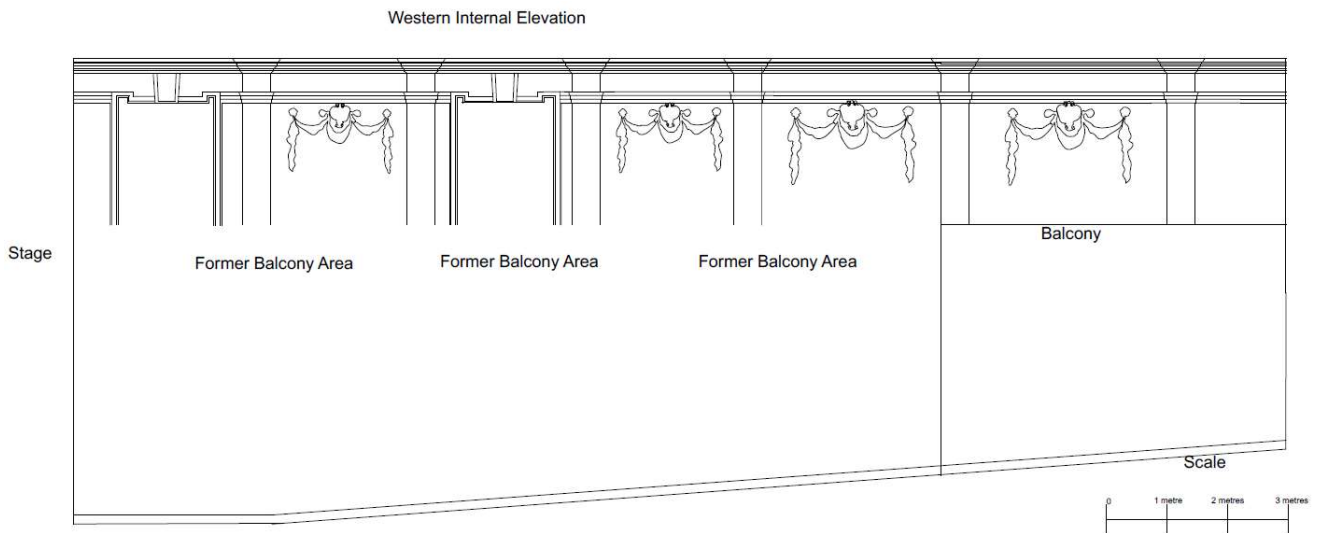
It is not clear if the skim below most of the cast panels was introduced later or at the time of insertion, especially as it runs behind applied mouldings. However, because of movement, damp, and weight on the boards, in many areas it is de-bonding, see photo 77. The wall plaster to both the east and west walls has significantly de-bonded, which is compromising the fibrous cast decorative swags, frieze bands, and window surrounds, see photo 79. Below the original cement-lime bound plasters, near the frieze band, are more modern plasters, applied pilasters and wooden vertical architraves, continuing the window surrounds, and modern gypsum over skim, which is debonding, see photo 80, in the areas previously below the balconies.

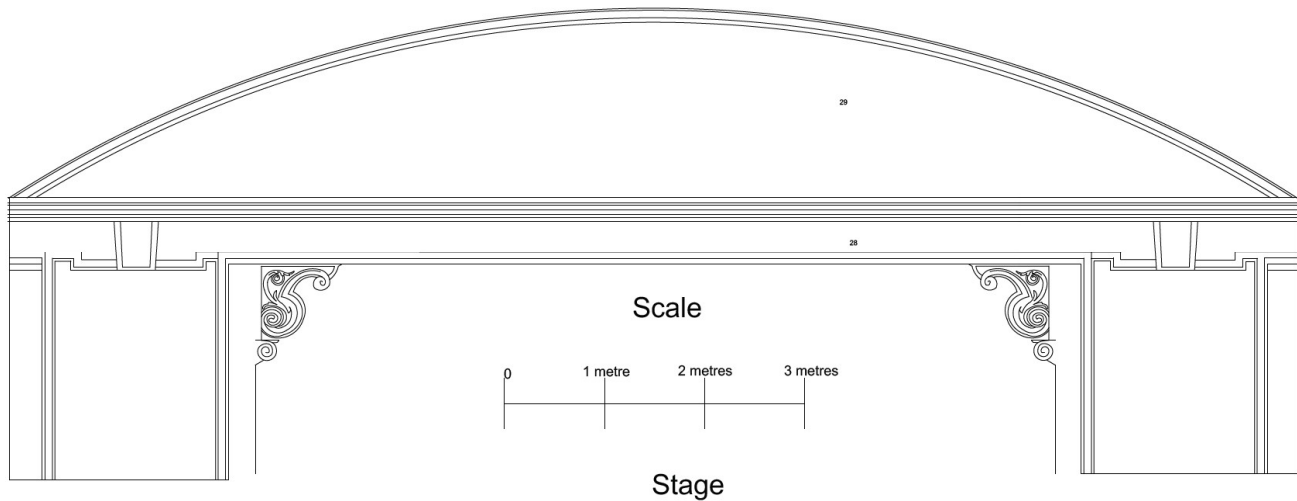
**Diagram 4: How the plasterwork in this area may have looked originally. The original plaster to the west and east ends has been lost below the freeze band.**

In contrast to the fibrous cast panel ceiling the enclosed proscenium arch and the proscenium beam below, carried by scroll console brackets, is created out of lath and lime plaster gauged with gypsum, see photo 10. This plaster needs conservation as does the vertical wall of the arch, as the plaster, in some areas, has only minimal supporting nibs, (but it is not deep enough to allow it to be secured back with sunken penny washers and screws), see photos 11 and 12. The projecting cornice, forming the springing point of this arch, is badly warped and deteriorated, see photo 13. Immediately below, the front of the proscenium beam is cracked, through the plaster on the lath, as is the soffit of the same beam, see photos 17-19.

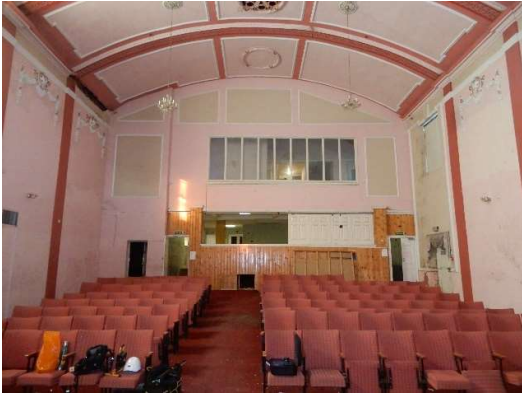
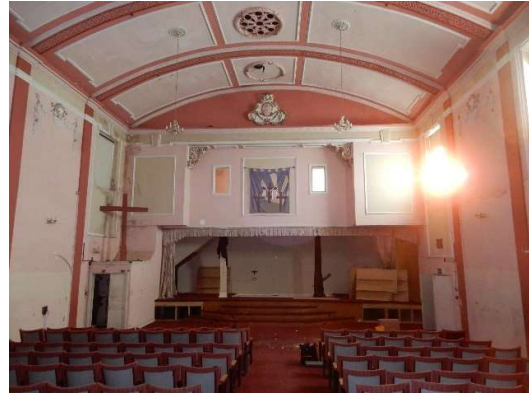
The barrel vaulted ceiling, see photos 1 & 2 below, has circular Guilloche patterned, principal ribs, edged with egg and dart decoration, that span the width of the ceiling, and it is further broken up by panel moulding. These together with circular ceiling wreaths and ventilation grills decorate the main auditorium space, part of which previously open beyond the more recent partition at the back. The whole fibrous plaster ceiling, is supported by lightweight fabricated iron trusses, see photos 3 and 4 below, which also support an earlier mechanical ventilation system.

Photos 1 & 2: The barrel vaulted ceiling, decorated with ribs and panel moulding, above the main auditorium space, with a previous open bay beyond the more recent partition at the back and the altered screen/stage area at the front.

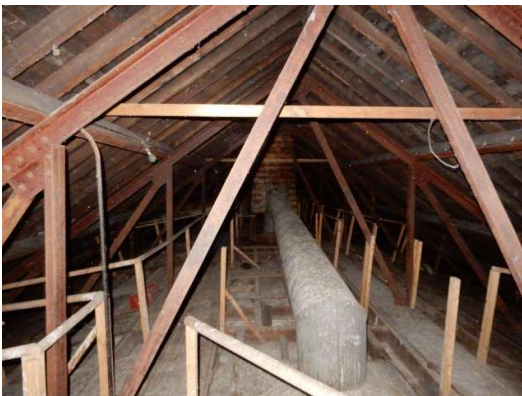
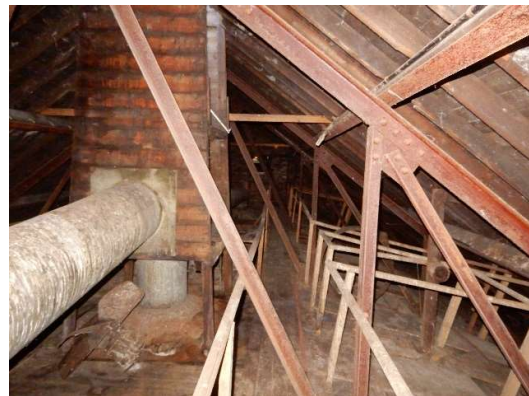
Photos 3 and 4: The ceiling is supported by lightweight fabricated wrought iron trusses, which also support an earlier mechanical ventilation system.

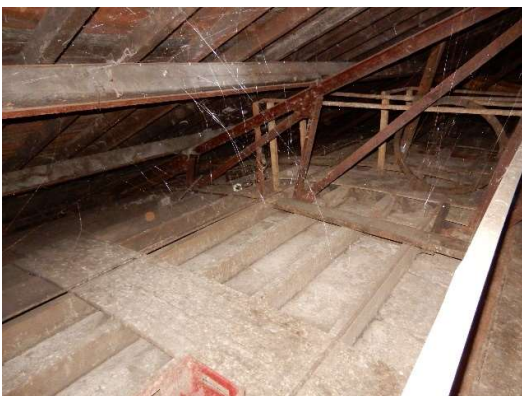
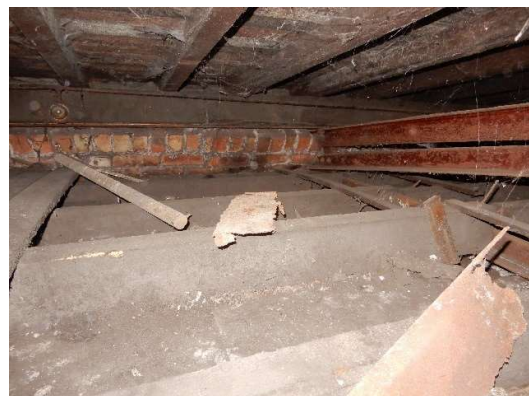
Running along the length of the ceiling and supported off the tie beams of the steel trusses are substantial ceiling joists, see photos 5 & 6. These ceiling joists sit upon the bottom member of the trusses and at both ends of the auditorium in pockets formed in the brickwork. Hung off the ceiling trusses are fibrous cast plain panels, which are just nailed on from below. The trusses also carry by unwired fibrous wads, the decorative ceiling ribs which hang directly below them, see photos 7 & 8. Whilst generally the ceiling joists are in good

Photos 5 & 6: Running along the length of the ceiling and supported off the tie beams of the steel trusses are substantial ceiling joists

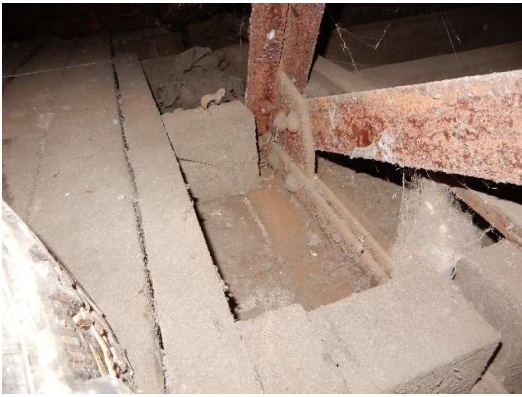
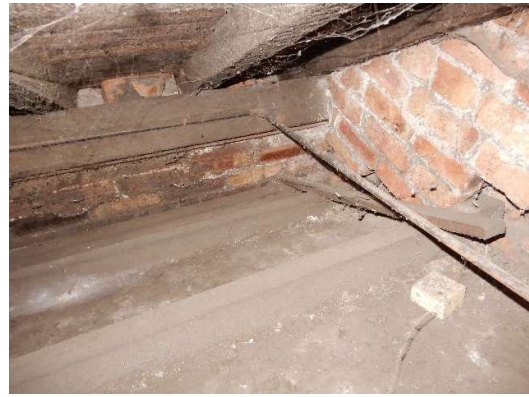
Photos 7 & 8: These ceiling joists sit upon the bottom member of the trusses, and at both ends of the auditorium in pockets formed in the brickwork. Hung off the ceiling trusses are fibrous cast plain panels, which are just nailed on from below. The trusses also carry by unwired fibrous wads, the decorative ceiling ribs which hang directly below them.

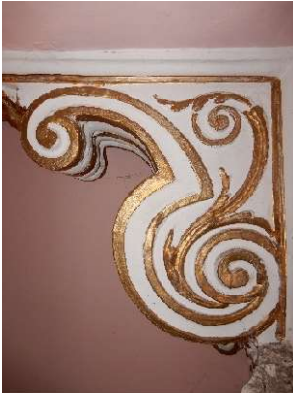
The scrolled corbel console brackets, both of which appear to have been fastened up 90 degrees in the wrong orientation, are hung through this soffit by wads that need replacing, with wire reinforced wads, see photos 20 & 21. Similarly, the central cartouche, rebranded by the previous church, is hung off the vertical timbers in the proscenium arch, and also needs new wires and wads installing and reinforcement with a blanket wad at the neck of the cast, as the top section is badly cracked and needs to be re-secured urgently, see photos 14, 15 & 16.

Photos 20 & 21: One of the scrolled corbel console brackets, both of which appear to have been fastened up 90 degrees in the wrong orientation; and the support from above the soffit of the proscenium beam.

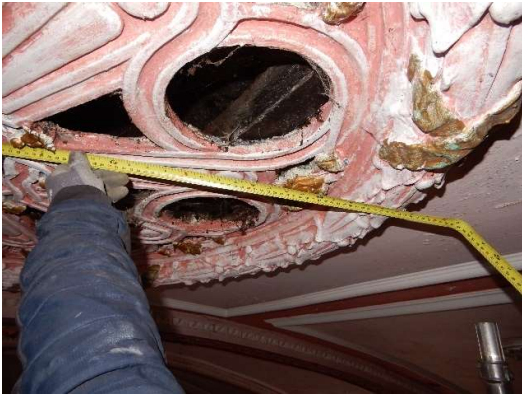
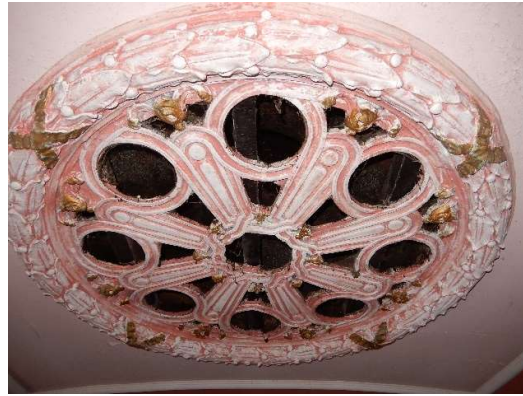
Photos 31 & 32: The plaster ventilation grill in the second bay.
