## **ARBORICULTURAL IMPACT ASSESSMENT REPORT**

**The Construction of an Extension to an  
Existing Dwelling House**

41 Longview Drive,  
Huyton L36 6EA

**Report Ref:**  
DTCL.310.AIA.2023

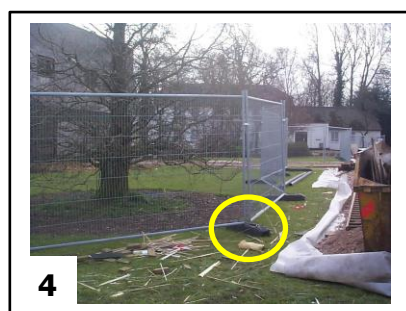
**Photo 4:** A view of protective fencing to protect a single tree. The ground block/base plate is shown by the yellow circle.
