# TREE HEALTH ASSESSMENT

Hey Park, Huyton

August 2022

Ref: 22/00043/THA

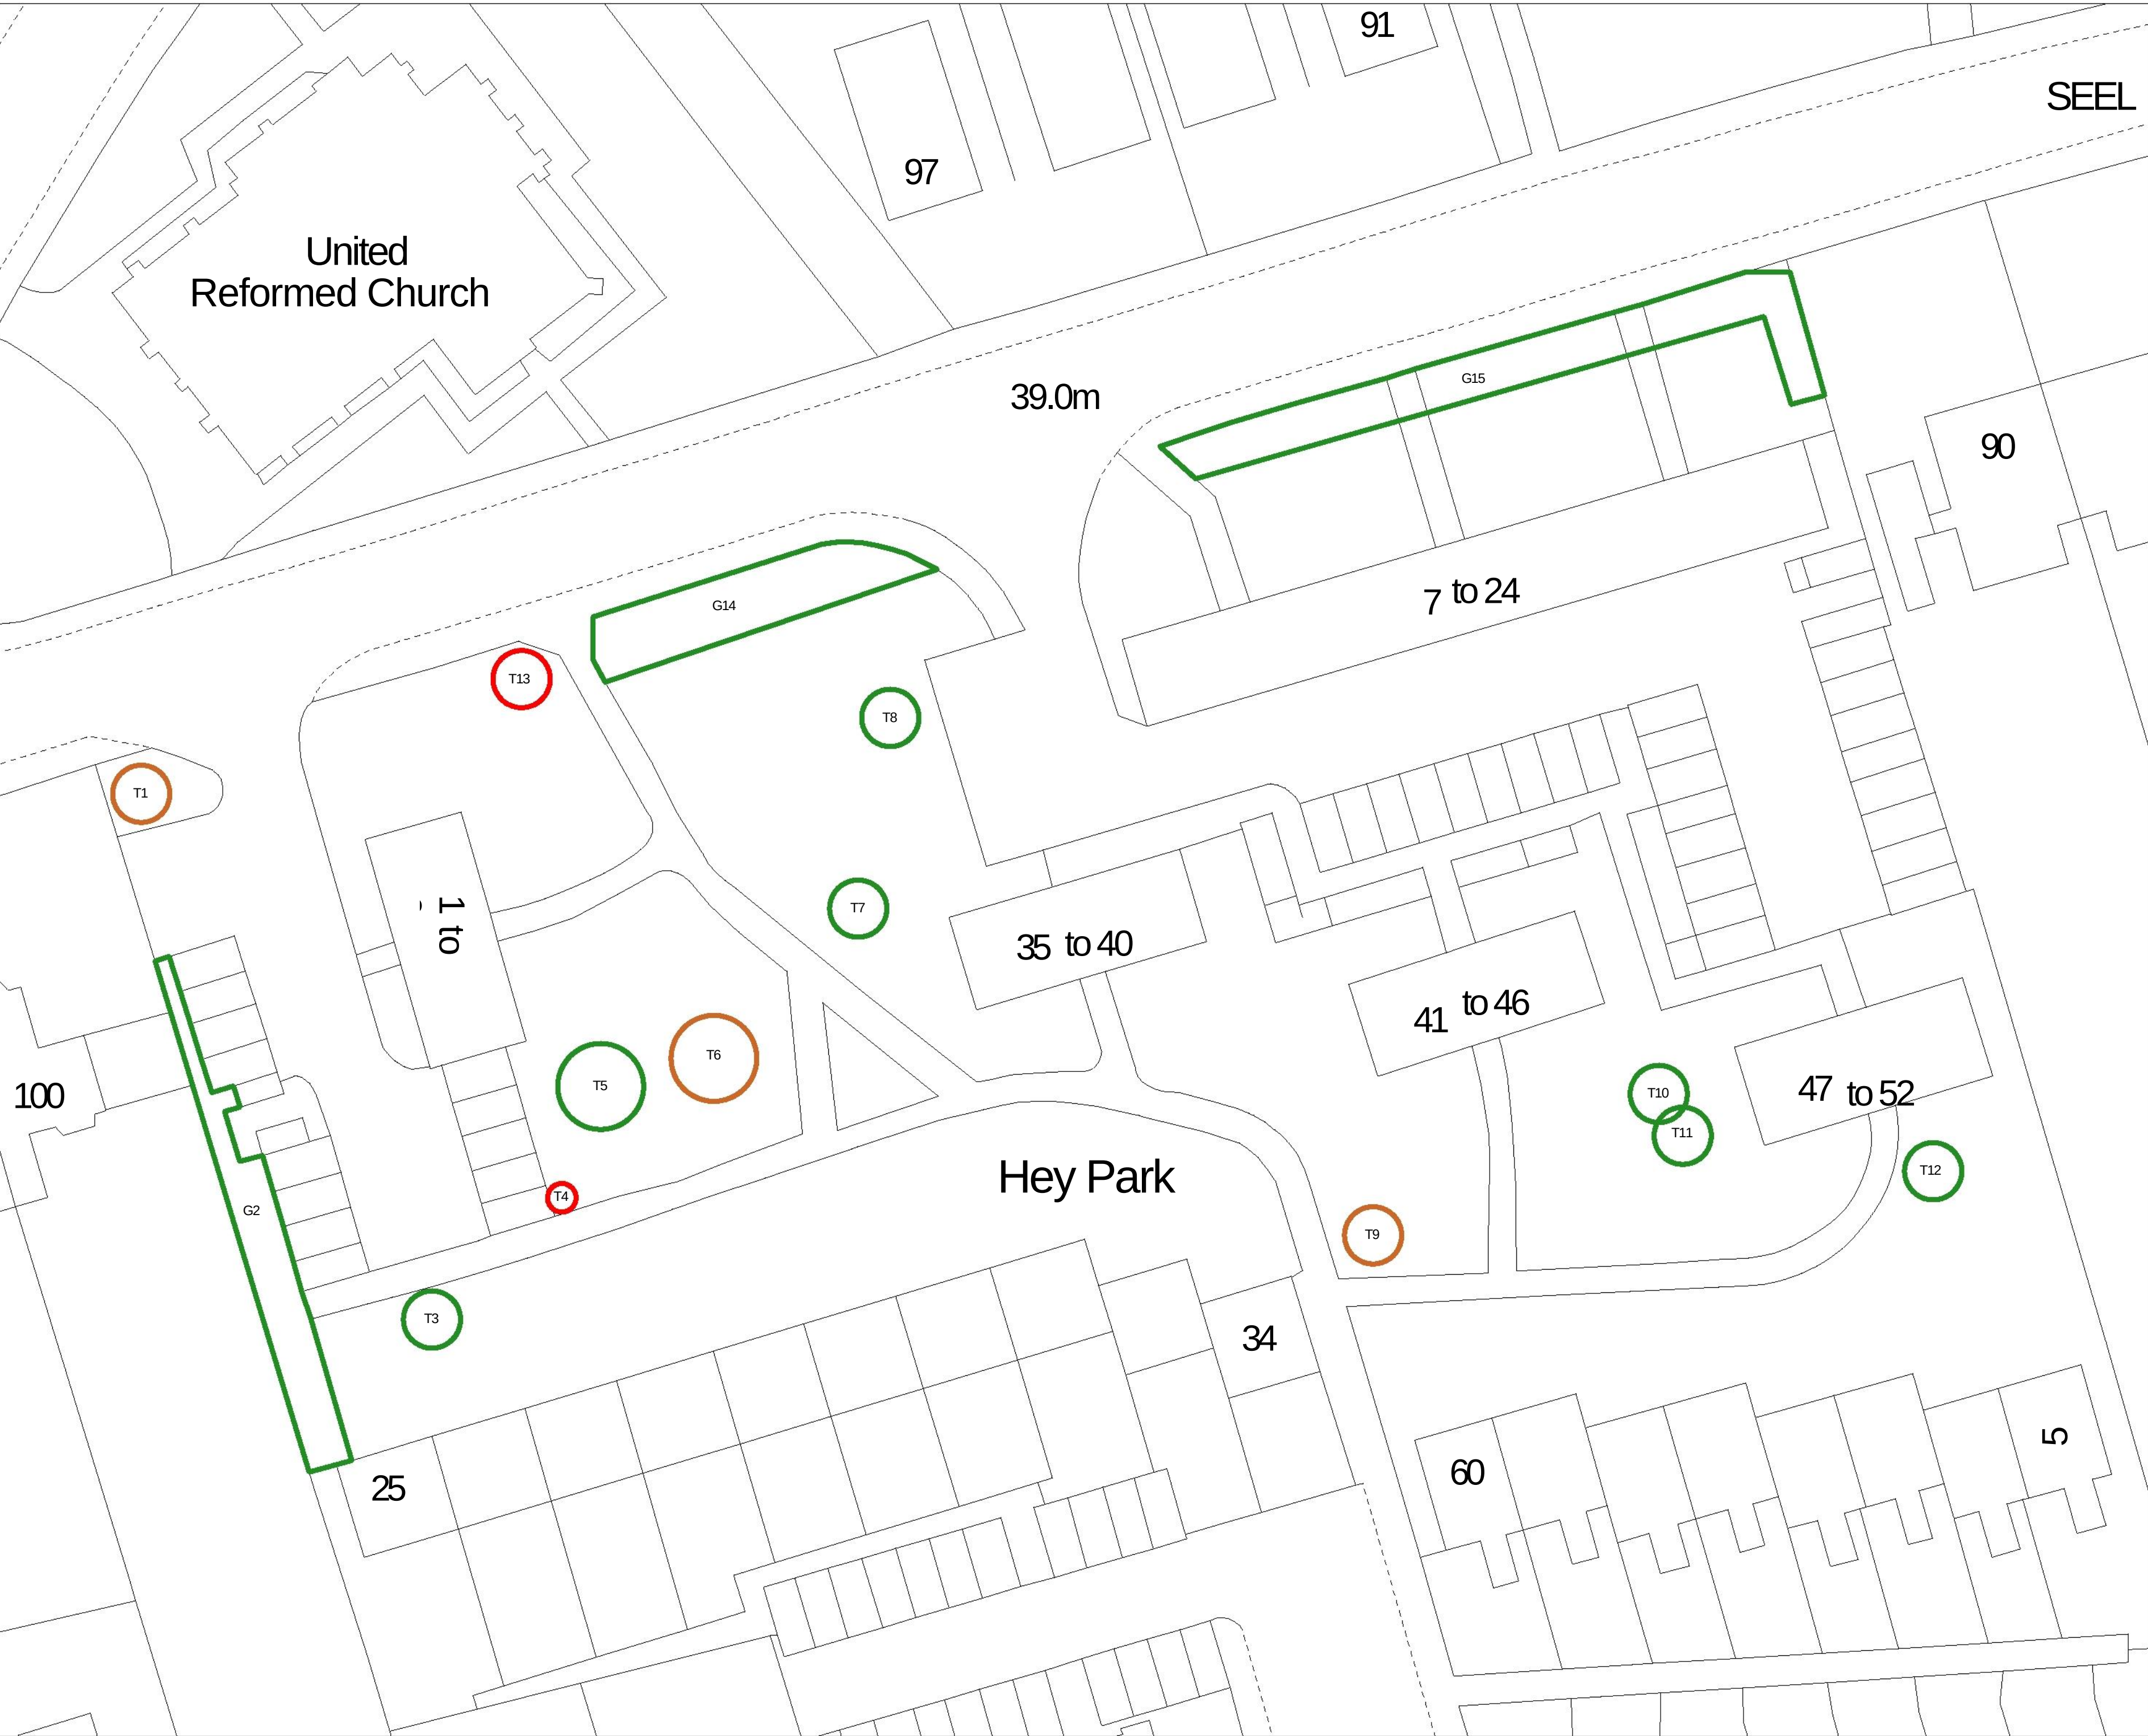
## **Appendix 2.0 Tree Location Plan**

| Tree No. | Species | Height (M) | Age | Condition Rating | Comments And Management Recommendations | Priority Rating |
|---|---|---|---|---|---|---|
| T13 | Horse Chestnut | 10. 1 - 15 | FM | Poor | Reasonable shape and form. Twin stemmed from 1m, union has no visible defects. Evidence of horse chestnut bleeding canker on both stems, active bleeds present. Minor deadwood in the crown.Fell. | 1 |
