MURRAY  
TREE CONSULTANCY

## TREE CONDITION ASSESSMENT

4-5 ALMOND CLOSE  
LIVERPOOL  
L26 1XL

September 2024

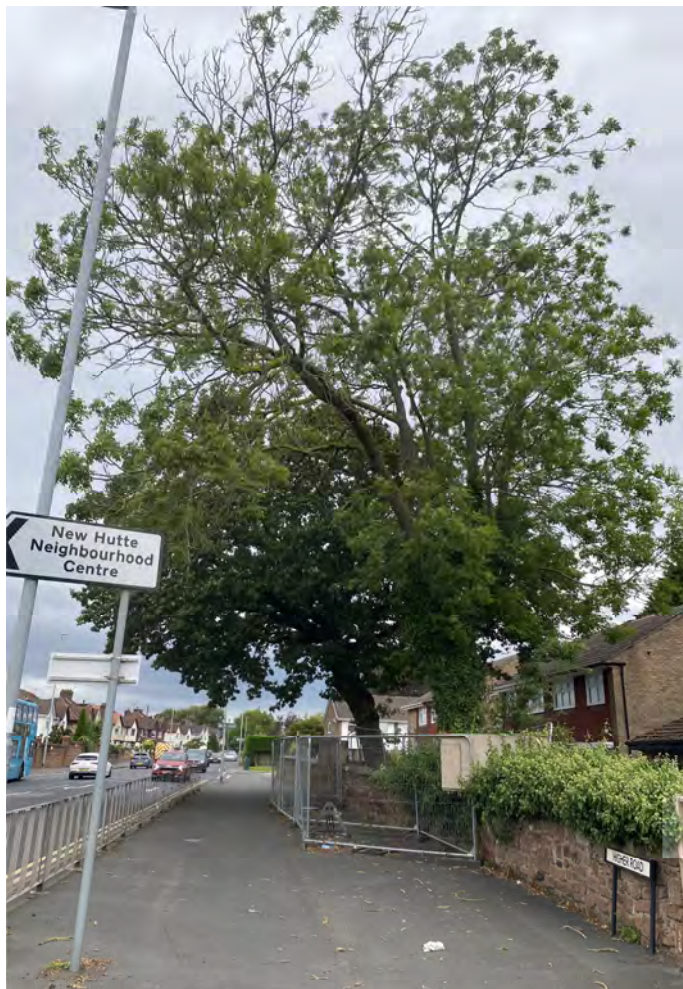
T2

- 2.2.3 The Ash (T2) is suffering with Ash Dieback and is difficult to say how it will affect this tree long term. This tree is also very unbalanced, which can be mostly attributed to a large southern limb that has been recommended for removal. This tree has also be recommended to be reduced by approximately 1-2m in order to remove dead branch tips and promote healthy growth. The Ivy also need stripping from around the base and removing form the wall.

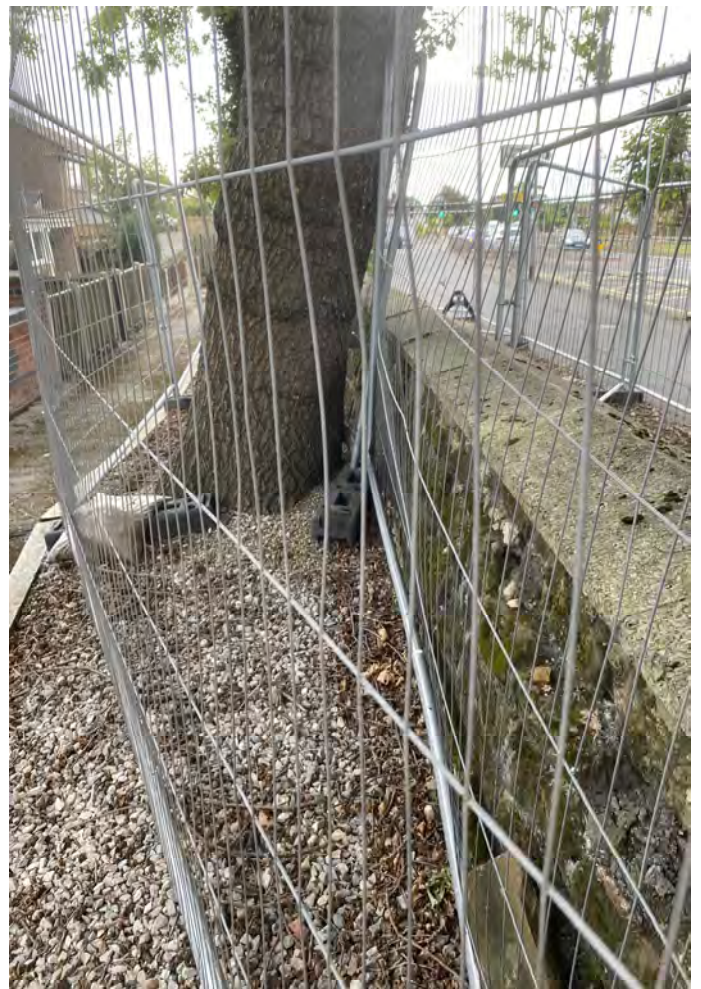
T1

- 2.2.1 The Oak tree (T1) is in good condition for its age, species and location although it has not received much maintenance in recent years. The crown is very unbalanced and has low foliage over the highway with some deadwood present. It has been previously pruned on the housing side adding to the balance issues. The only evidence of surface roots are within the internal footpath, which has been repaired but needs uncovering again and attending to. The crown also requires pruning to address the balance issues and prune low foliage away from passing vehicles as well as removing any significant deadwood.

- 2.2.2 It is recommended that the crown be reduced and re-shaped, pruning mostly on the southern side in order to create a more balanced tree. The pruning should broadly be as illustrated within the photograph below. Pruning approximately 1-2m from the house side, 3-4m from the highway side also creating a 5.5m height clearance and approximately 1m from the top. Any significant deadwood should be removed at the same time.
