## STRUCTURAL ENGINEERS REPORT

C15403

Huyton Cricket Club Pavillion  
Huyton Lane, Knowsley  
Liverpool L36 7XD

13 June 2025

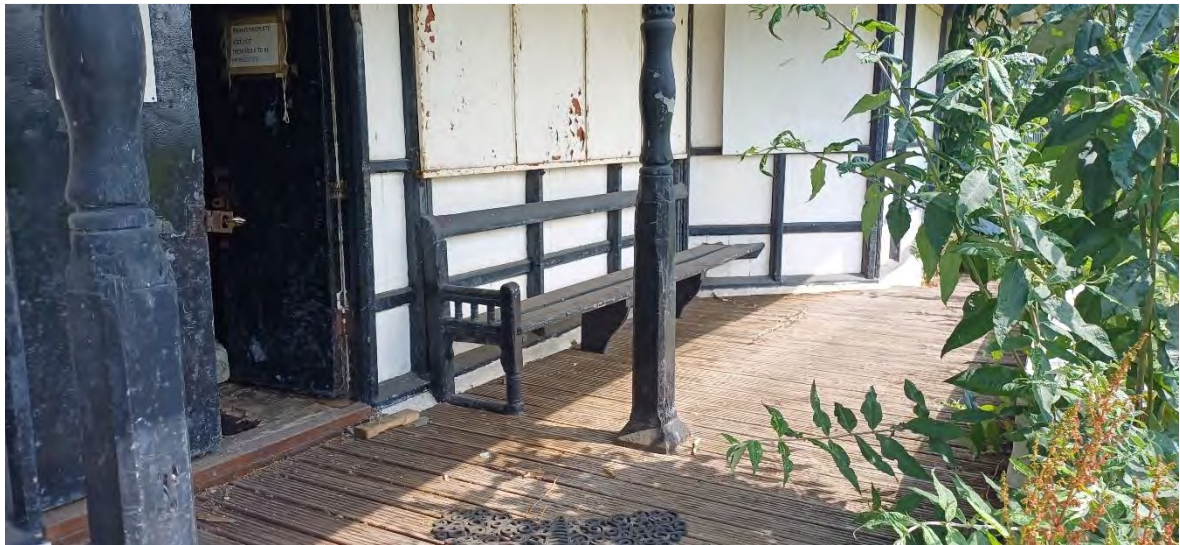
*Figure 4 – Base of post & fixed benching*

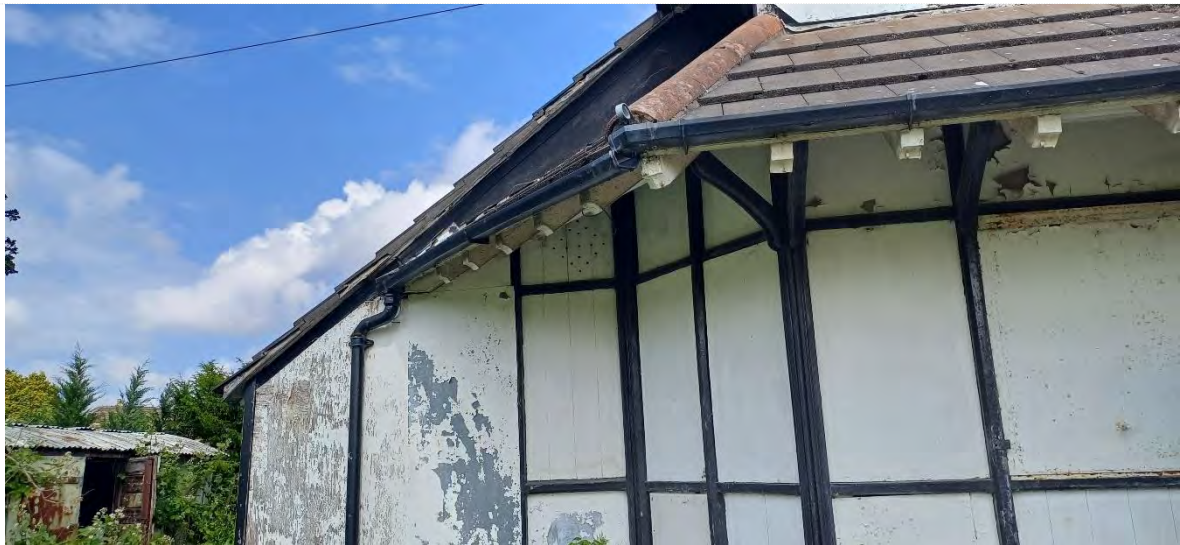
*Figure 8 – Left corner to front*

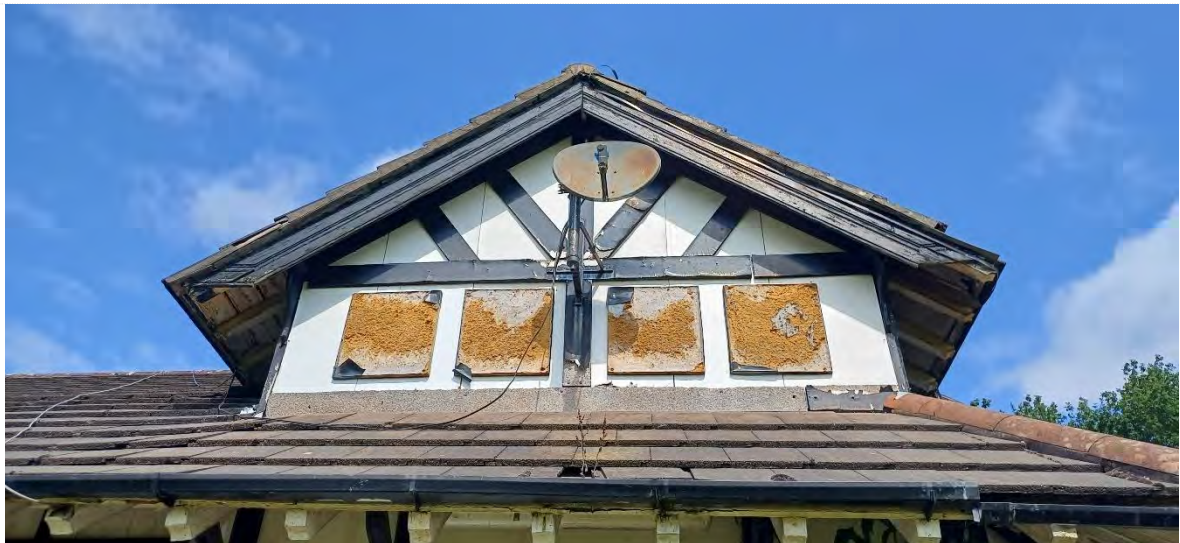
*Figure 16 – Right dormer*

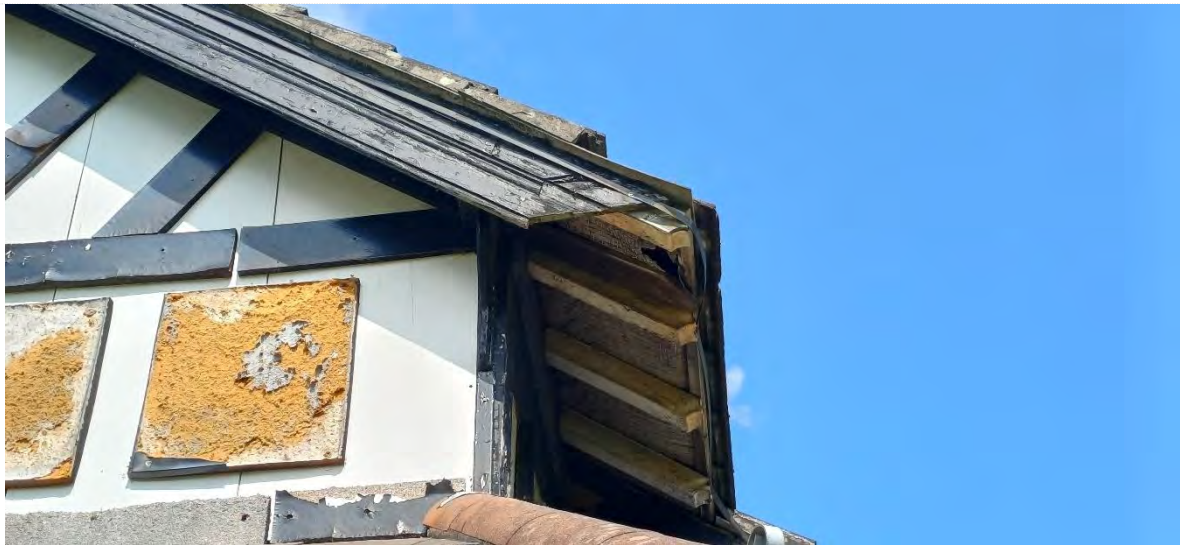
*Figure 18 – Roofing felt, right side of right dormer*

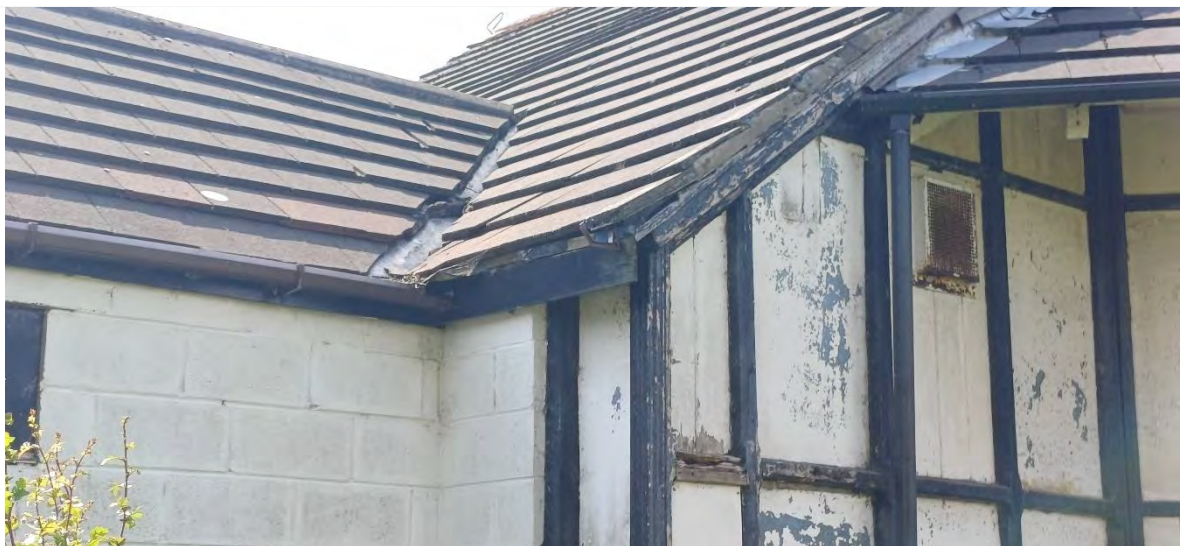
*Figure 24 – Missing guttering, right side, rear*

1. Rainwater goods – these are missing or incomplete around the building
2. Flashing details – some repairs have been made but generally new flashing is required to the gables, dormers and possibly the valleys
3. The roof tiles are dislodged or missing, with felt in some areas and not in others – hopefully this could be addressed by re-roofing with appropriate materials
4. We noted that stained glass windows are damaged where boarded over
5. Connect drainage to a formal system

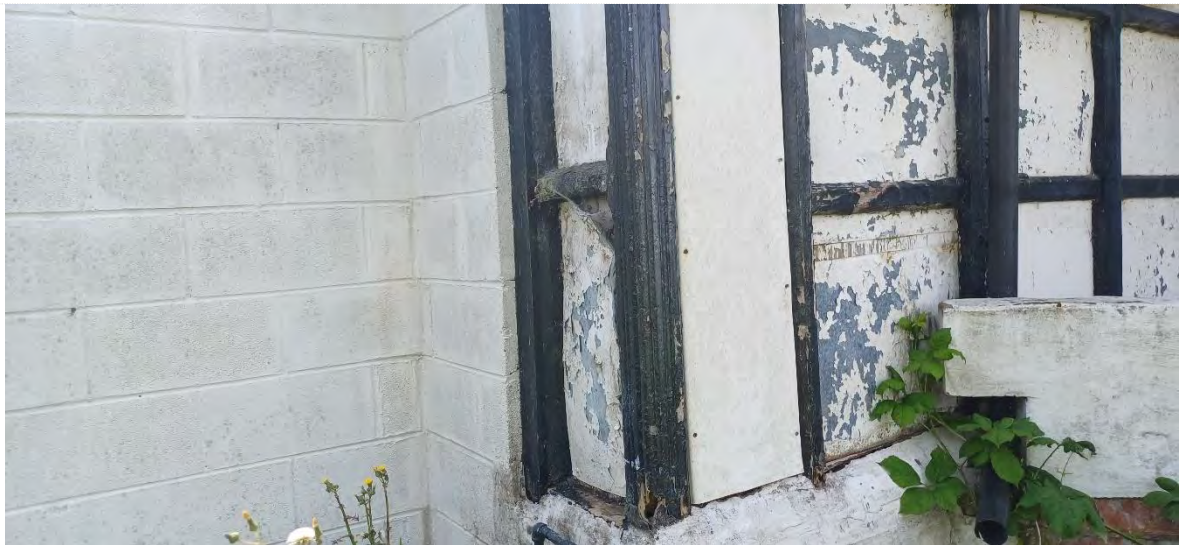
*Figure 26 – Paneling, right side, rear*

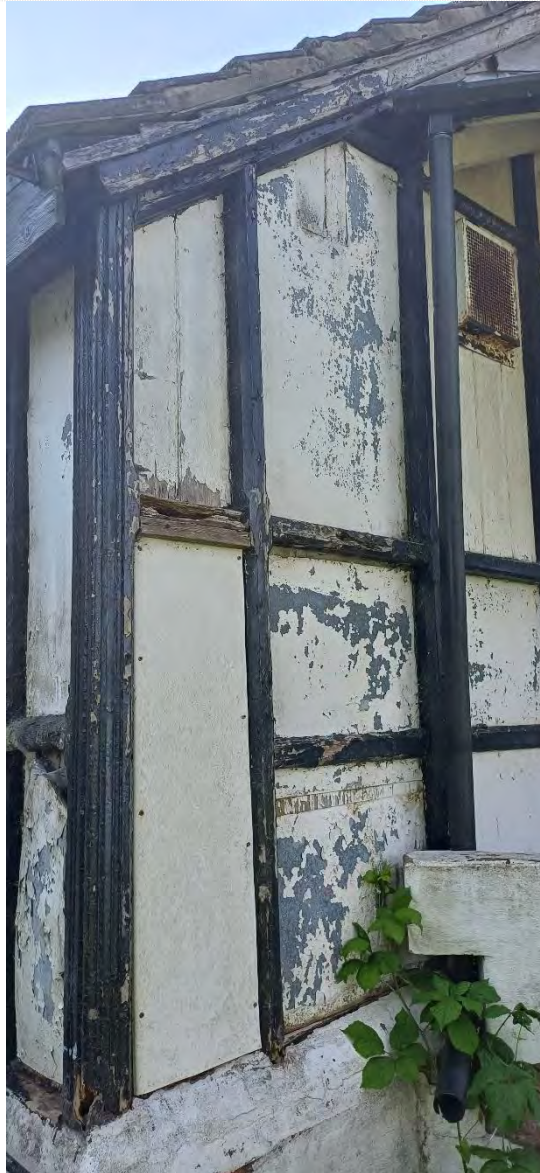
*Figure 27 – Rotten timber, right side, rear*

1. Carry out a dimensional survey of the structural members – this is likely to need a contractor to open-up and make areas safe
2. Replace all damaged and rotting panels to the elevations with new T&G to match existing
3. Replace affected vertical and horizontal timbers to the front, rear and sides
4. Rebuild the front retaining wall
5. Replace the suspended ground floor structure
6. Provide suitable beams over the kitchen opening

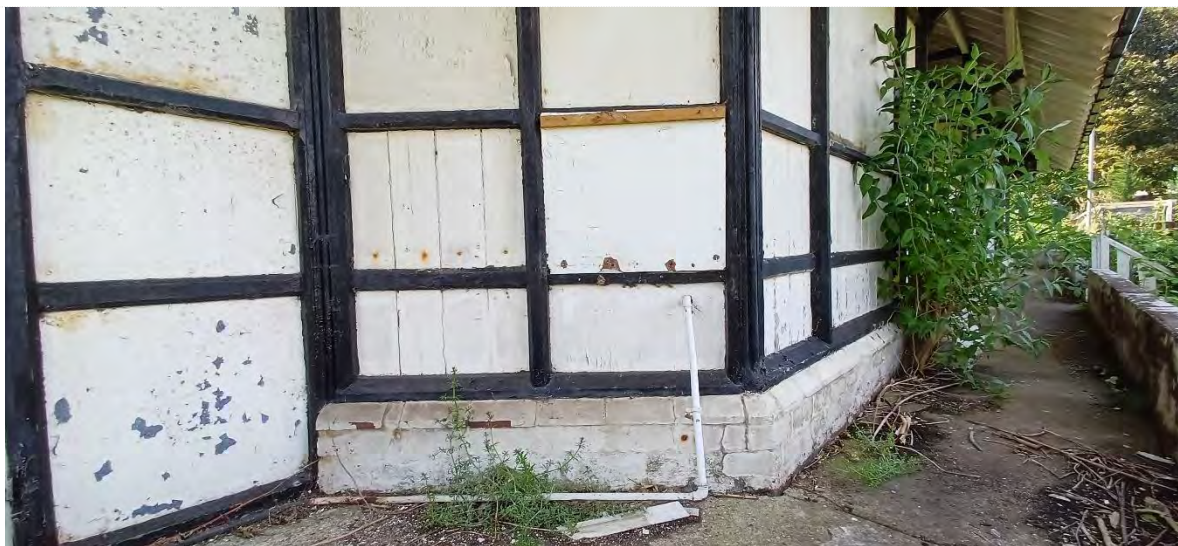
*Figure 29 – Timber boarding, paneling & dwarf wall*

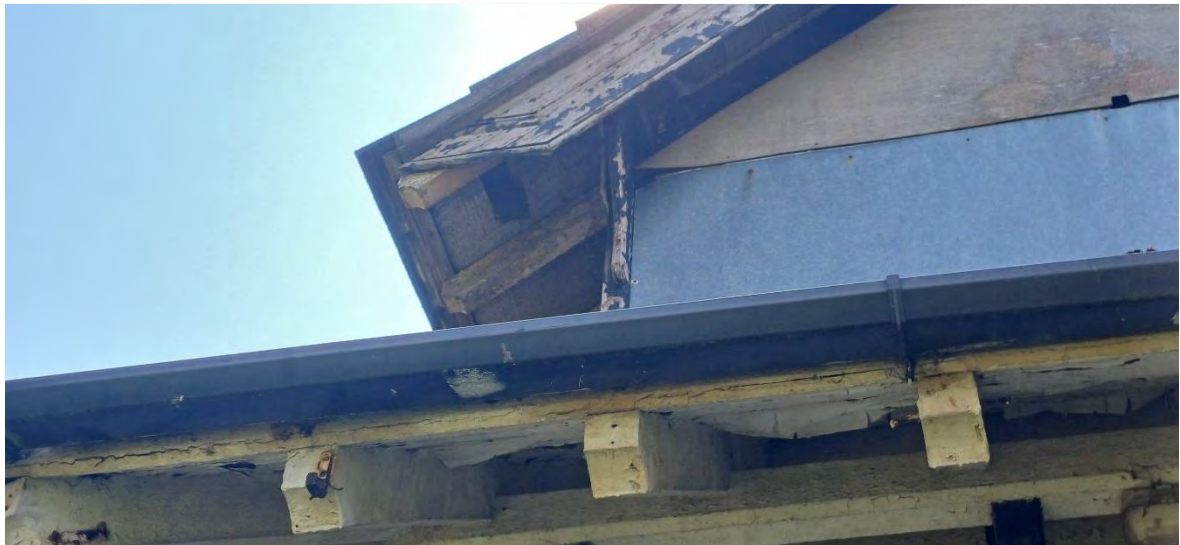
*Figure 31 – Felt to roof, rear right dormer*

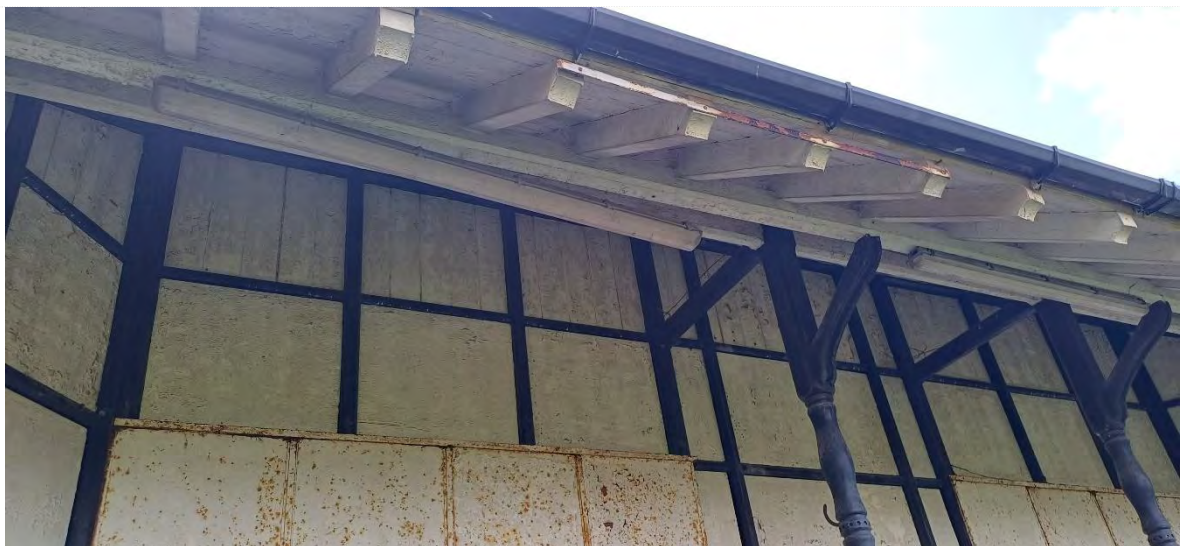
*Figure 33 – Eaves & lighting to veranda*

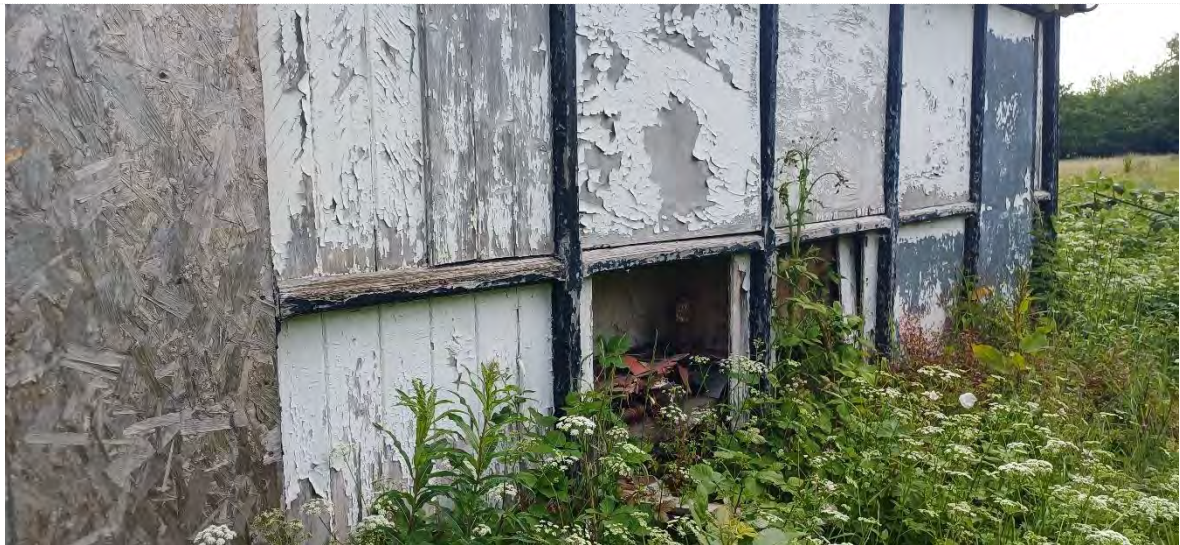
*Figure 46 – Openings, left elevation*

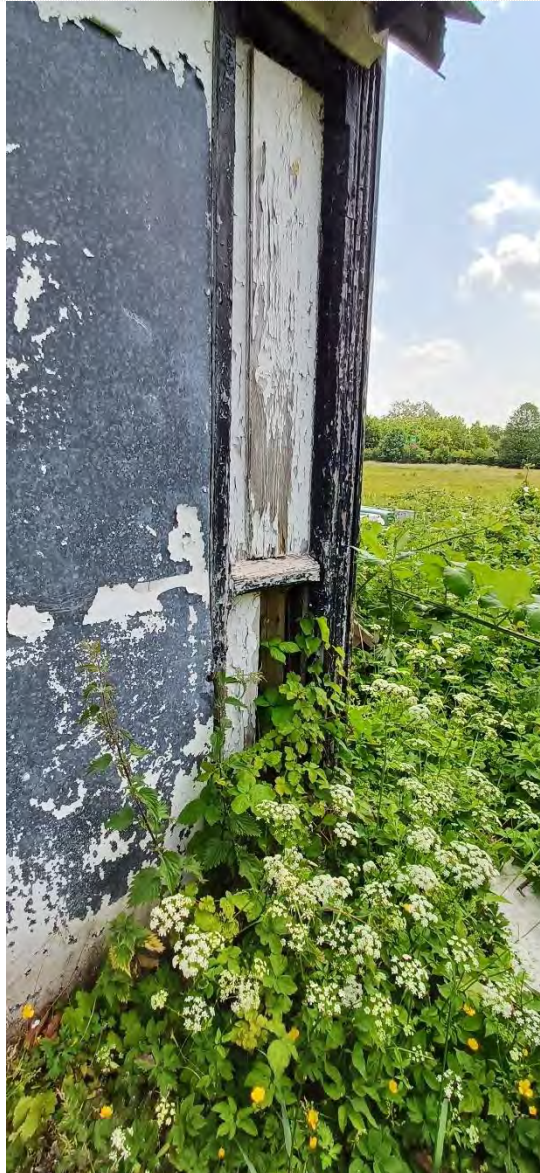
*Figure 48 – Front left corner*

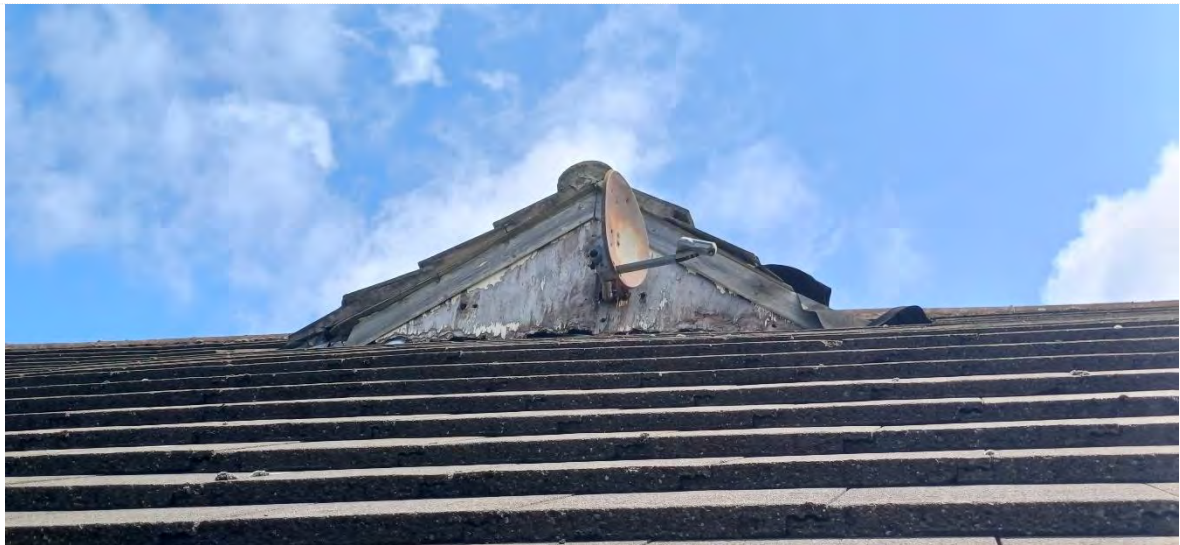
*Figure 50 – Cladding to roof*

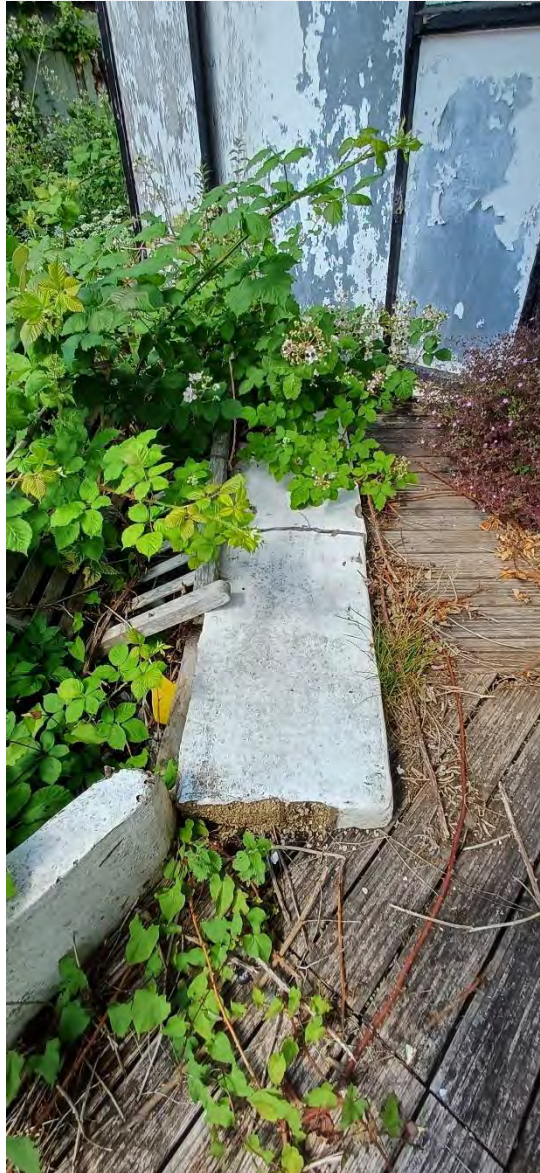
*Figure 51 – Collapsed retaining wall front left*

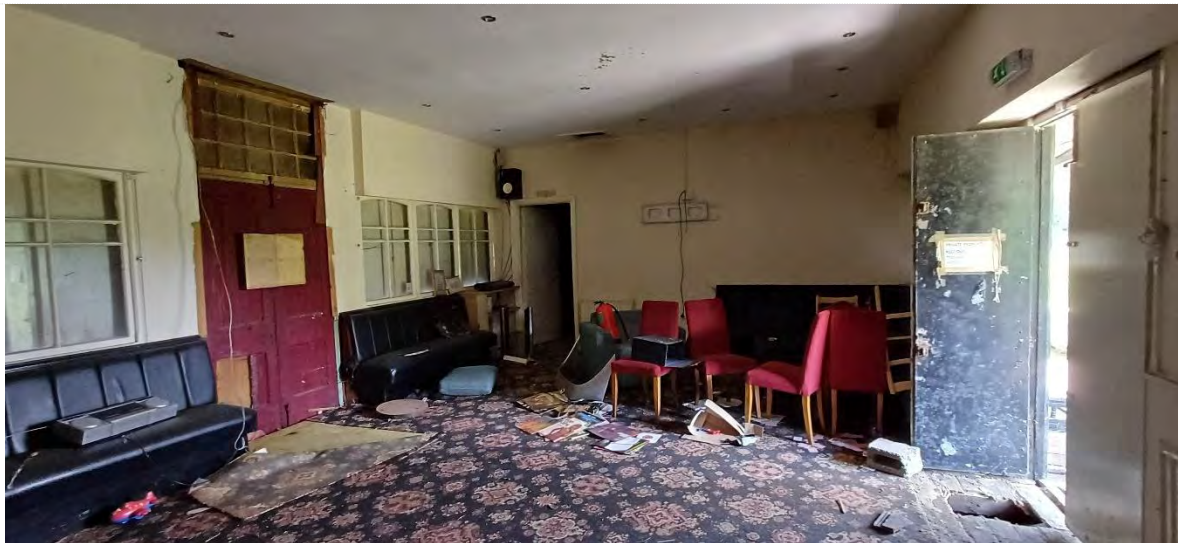
*Figure 55 – Main, central room looking right*

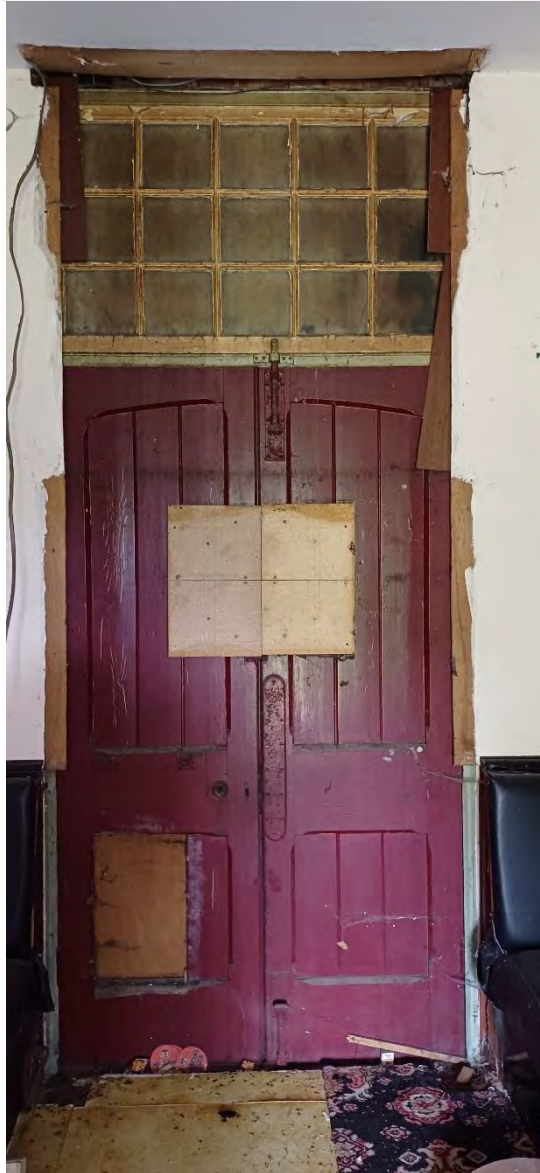
*Figure 57 – Central doors, rear wall*

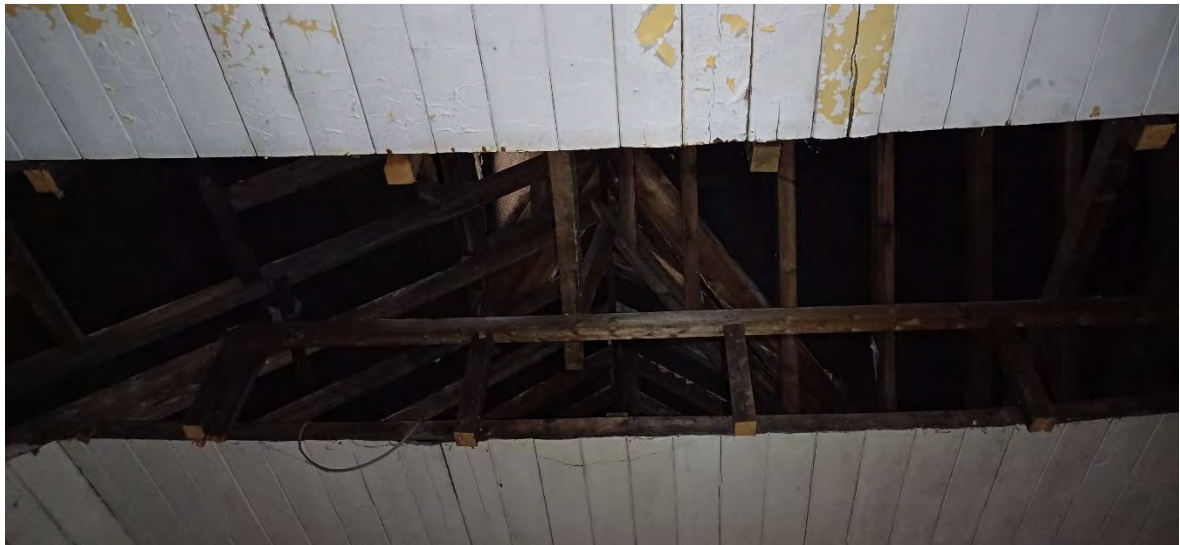
*Figure 59 – Roof structure over right hand room*

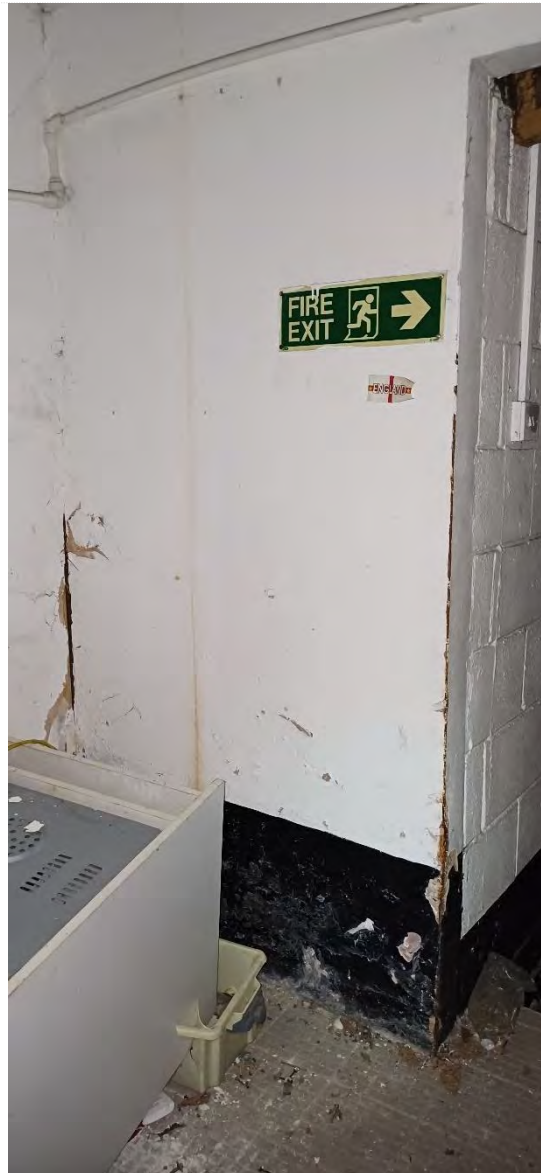
*Figure 71 – Rear of right wall toilets*

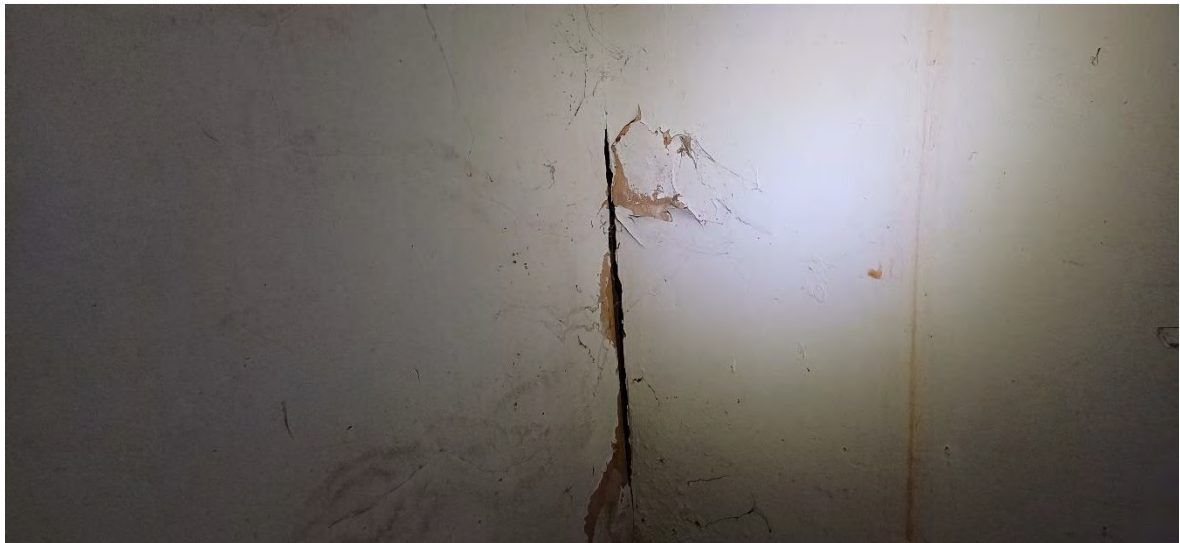
*Figure 73 – Rear right corner, toilets*

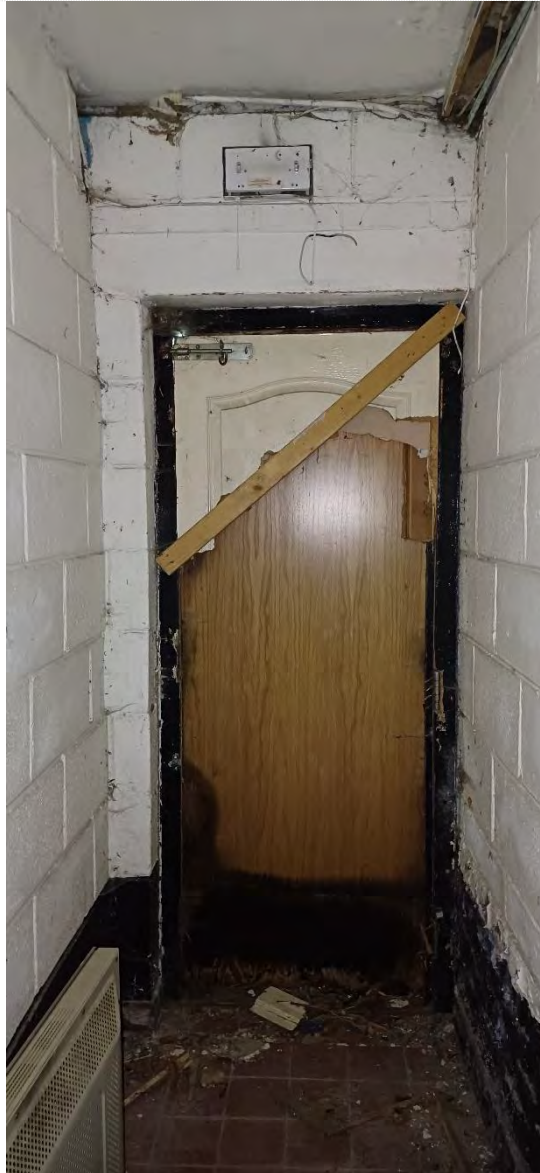
*Figure 75 – Door to front wall*

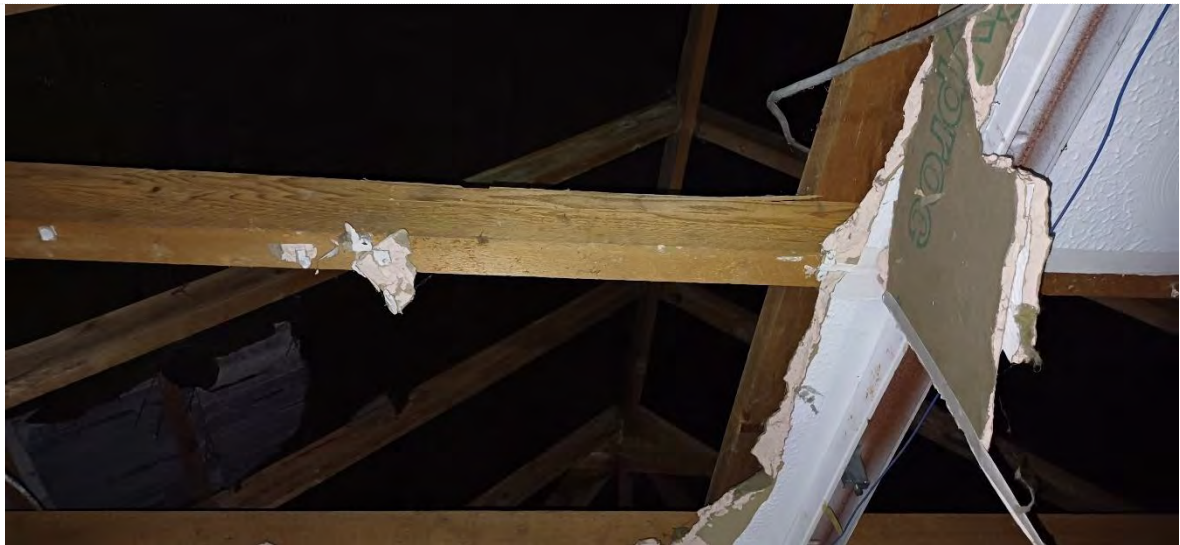
*Figure 77 – Roof structure, right toilet room*

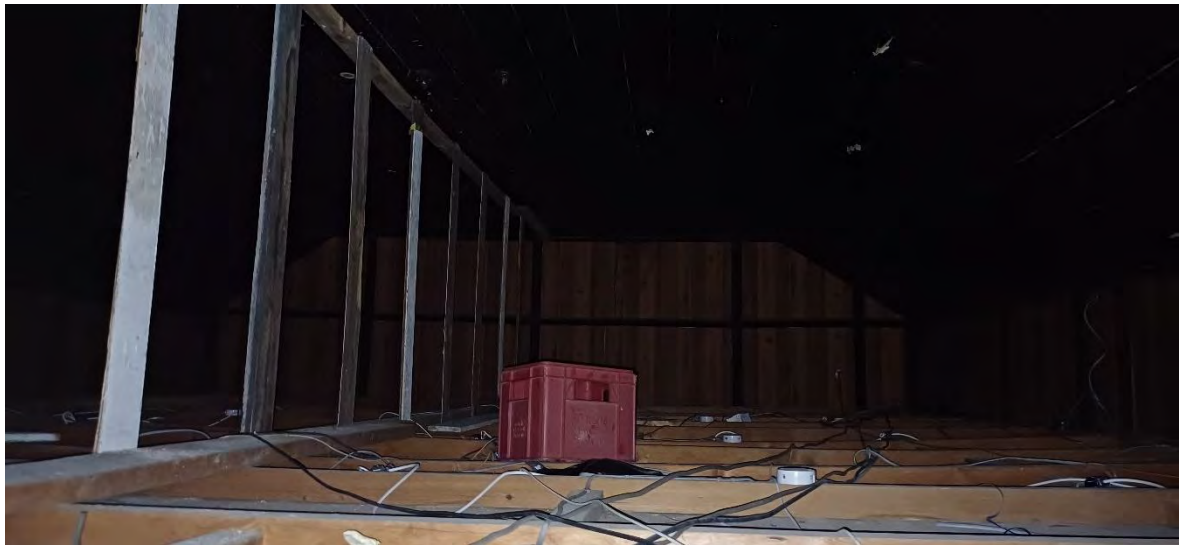
*Figure 89 – Roof void over kitchen*

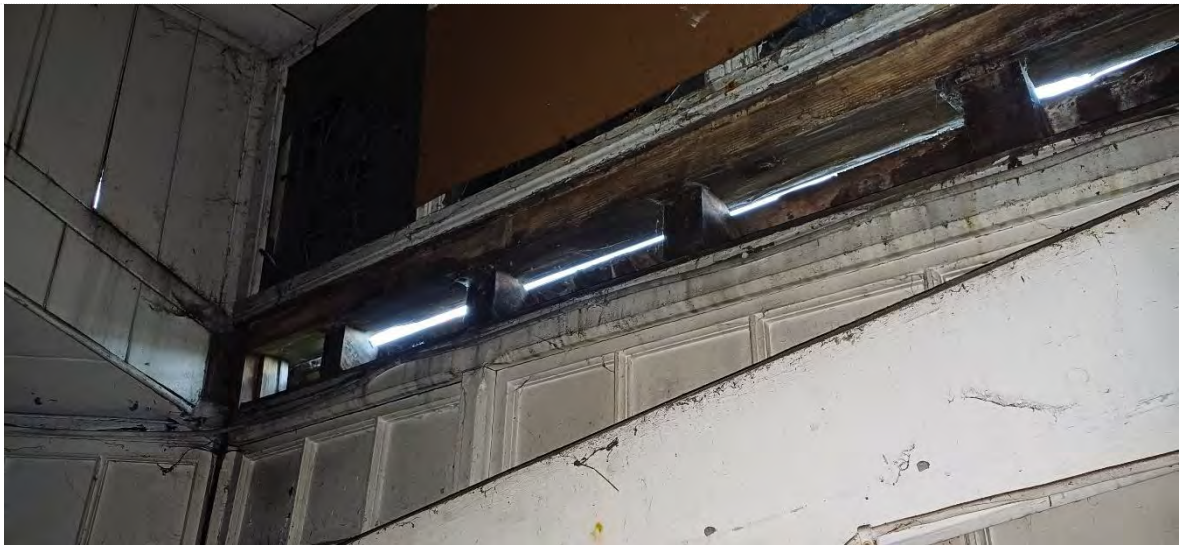
*Figure 91 – Rear wall to bar*

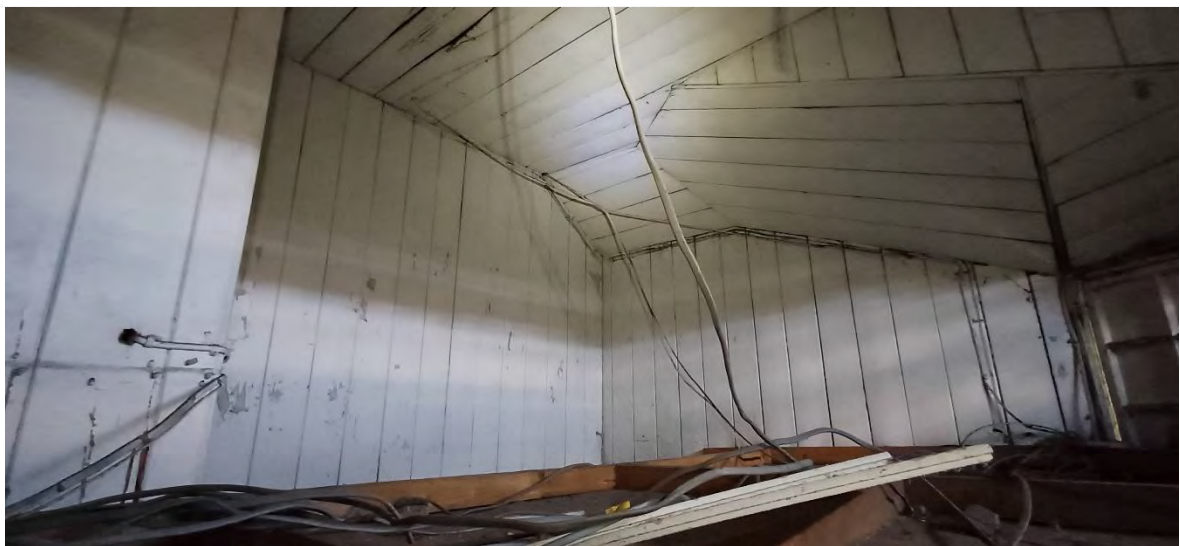
*Figure 93 – Roof/ceiling boarding, rear of bar*

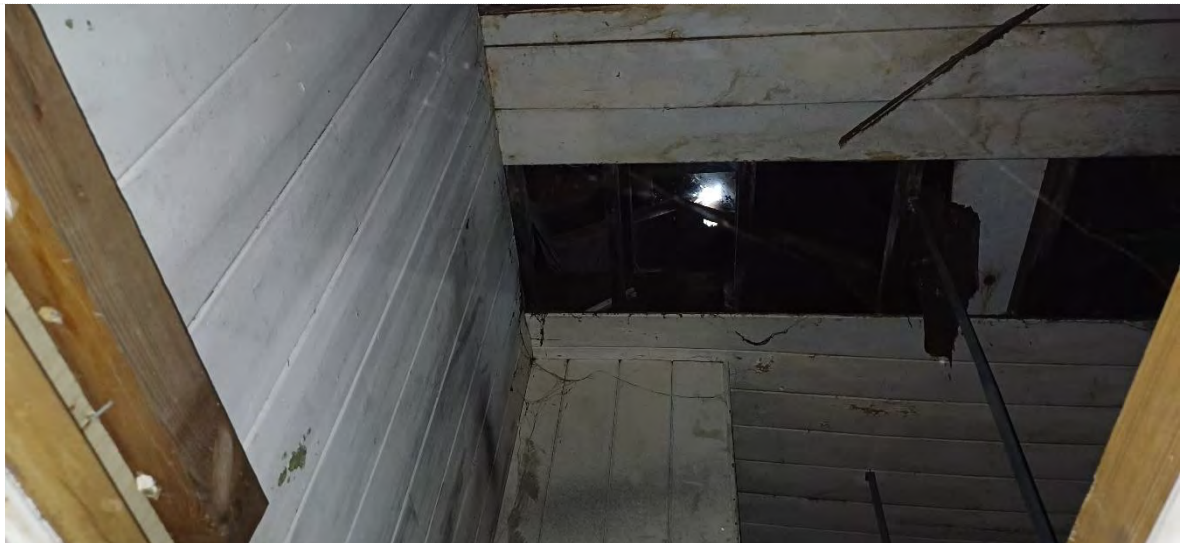
*Figure 97 – Roof over toilets*
