SF3422 Earlsfield Park

ARBORICULTURAL SURVEY REPORT | BS 5837:2012

June Revision A 2023

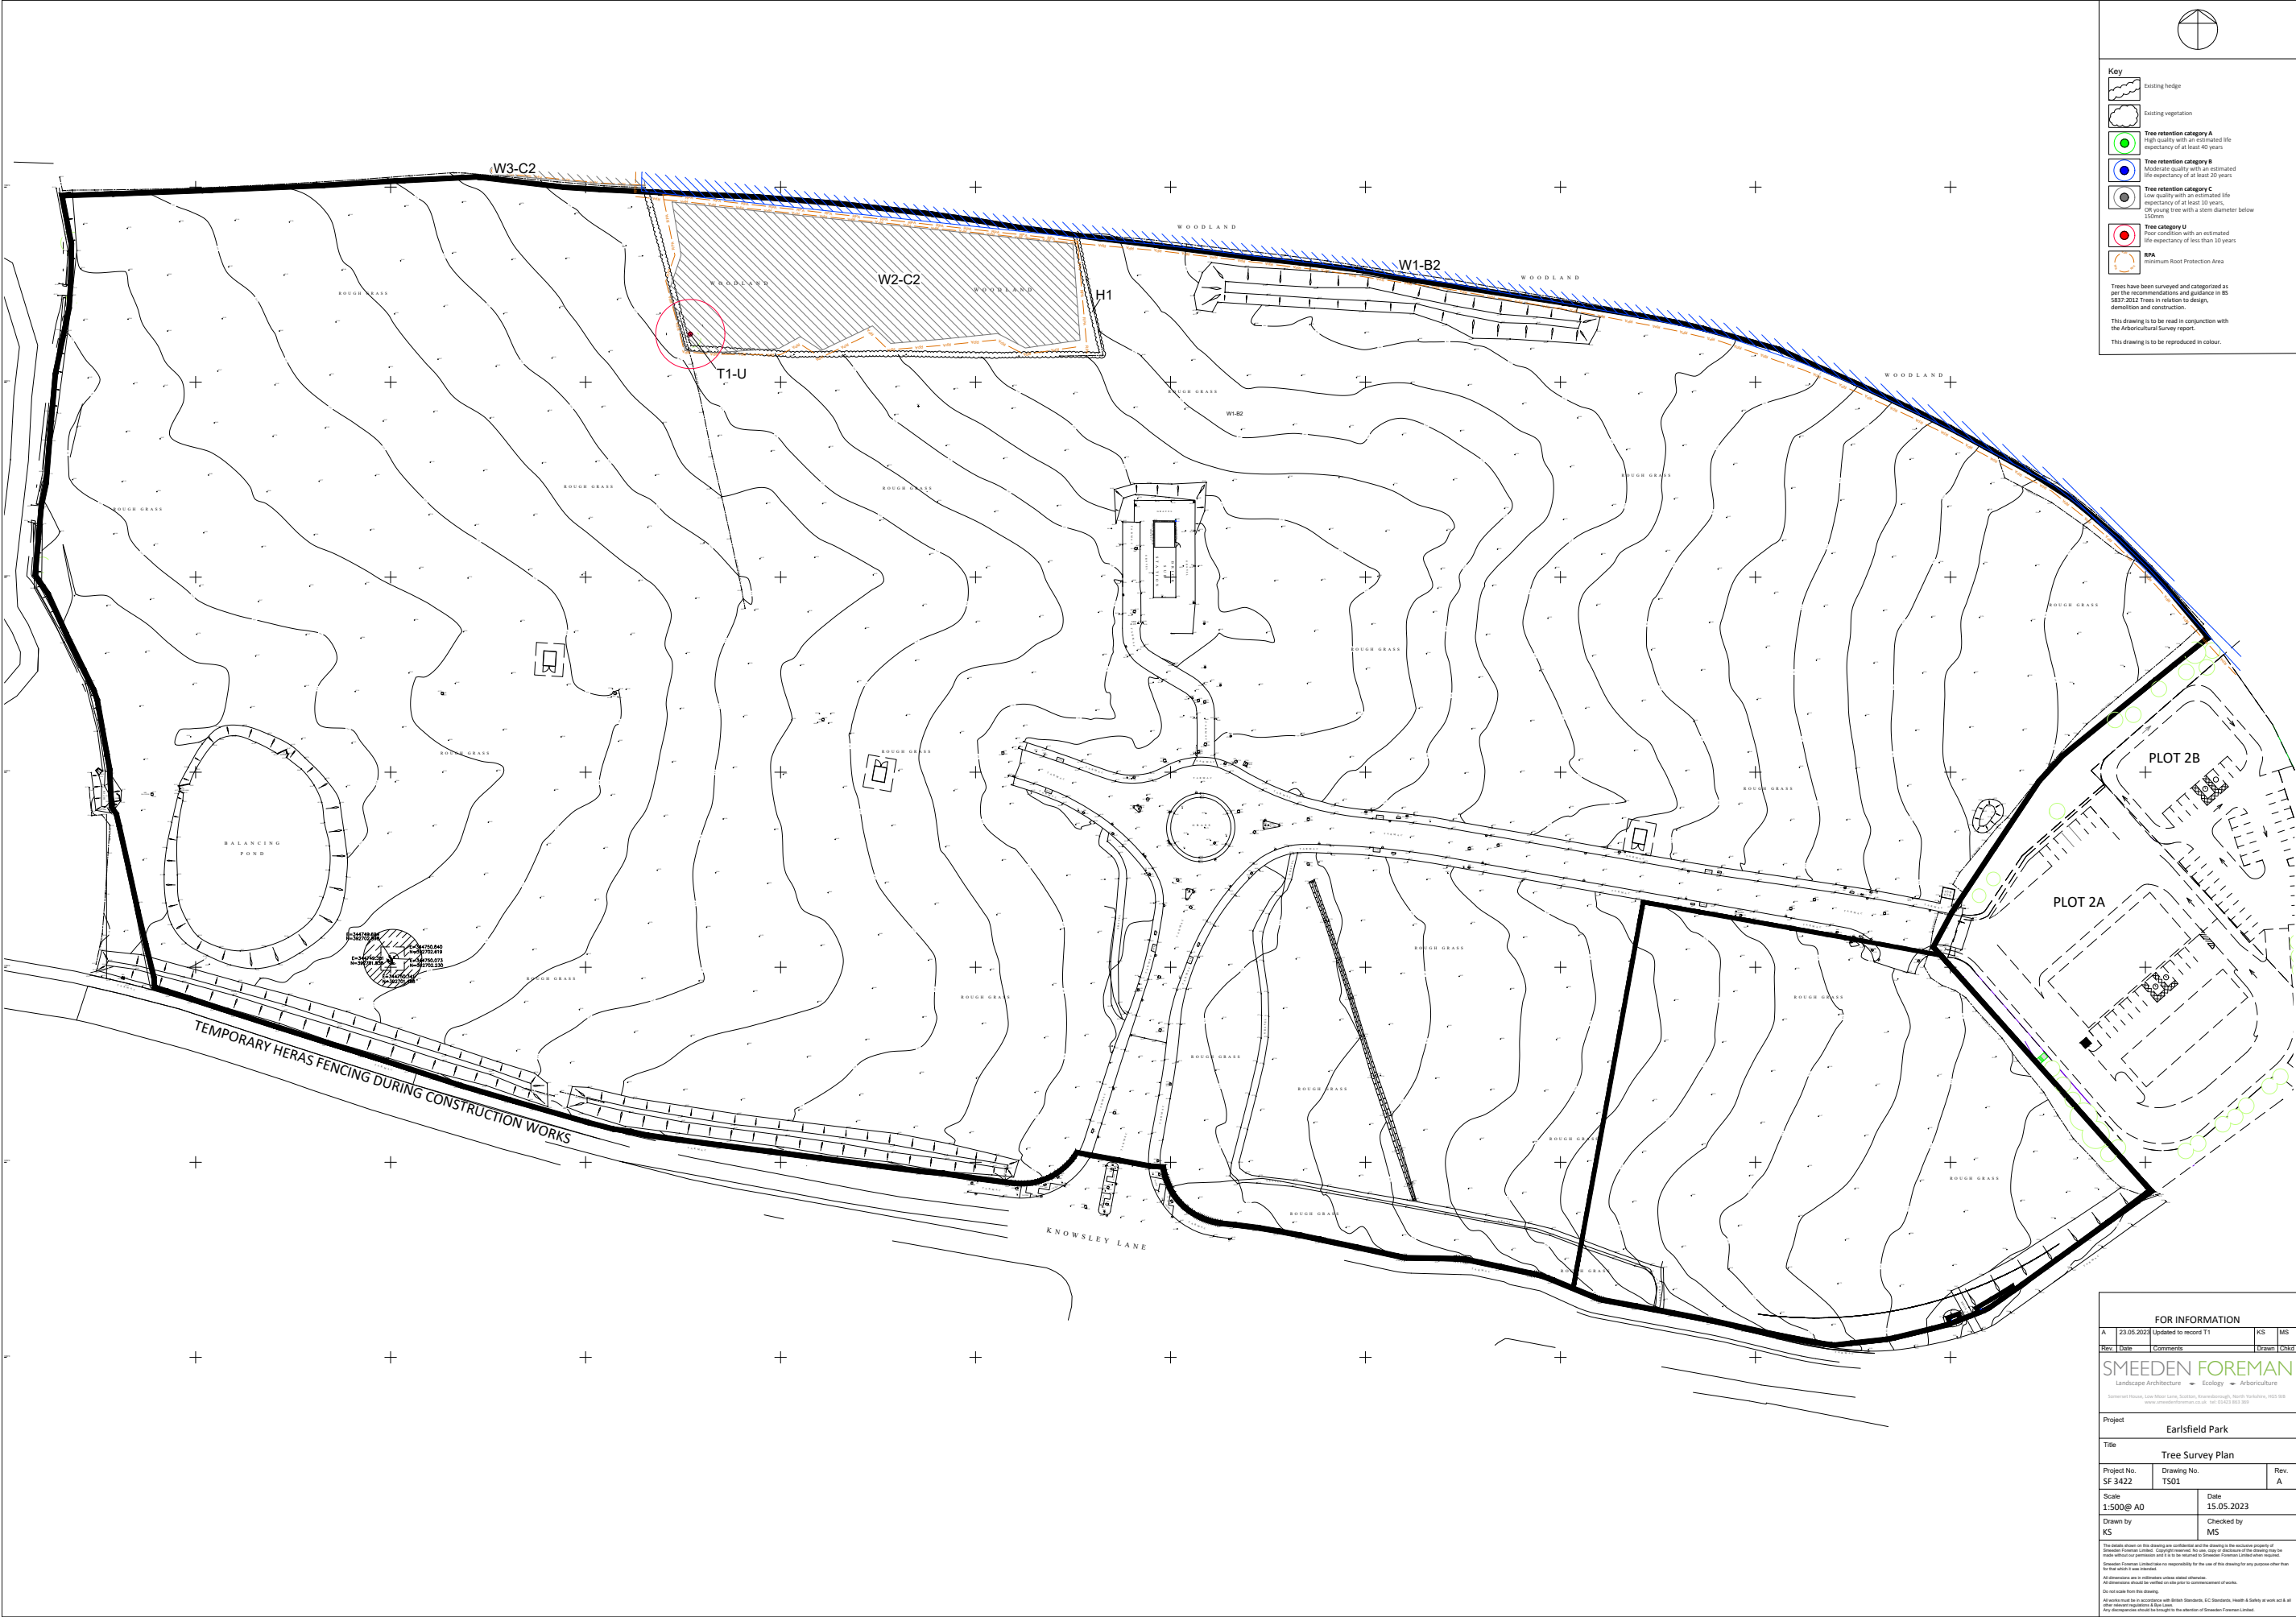
SF3422 TS01 Rev A Tree Survey Plan

- 5.3 The tree constraints drawing (SF3422 TS01) plots the location and extent of the tree below ground through application of the calculation provided in section 4.6 of the BS5837:2012 Trees in relation to design demolition and construction – Recommendations.

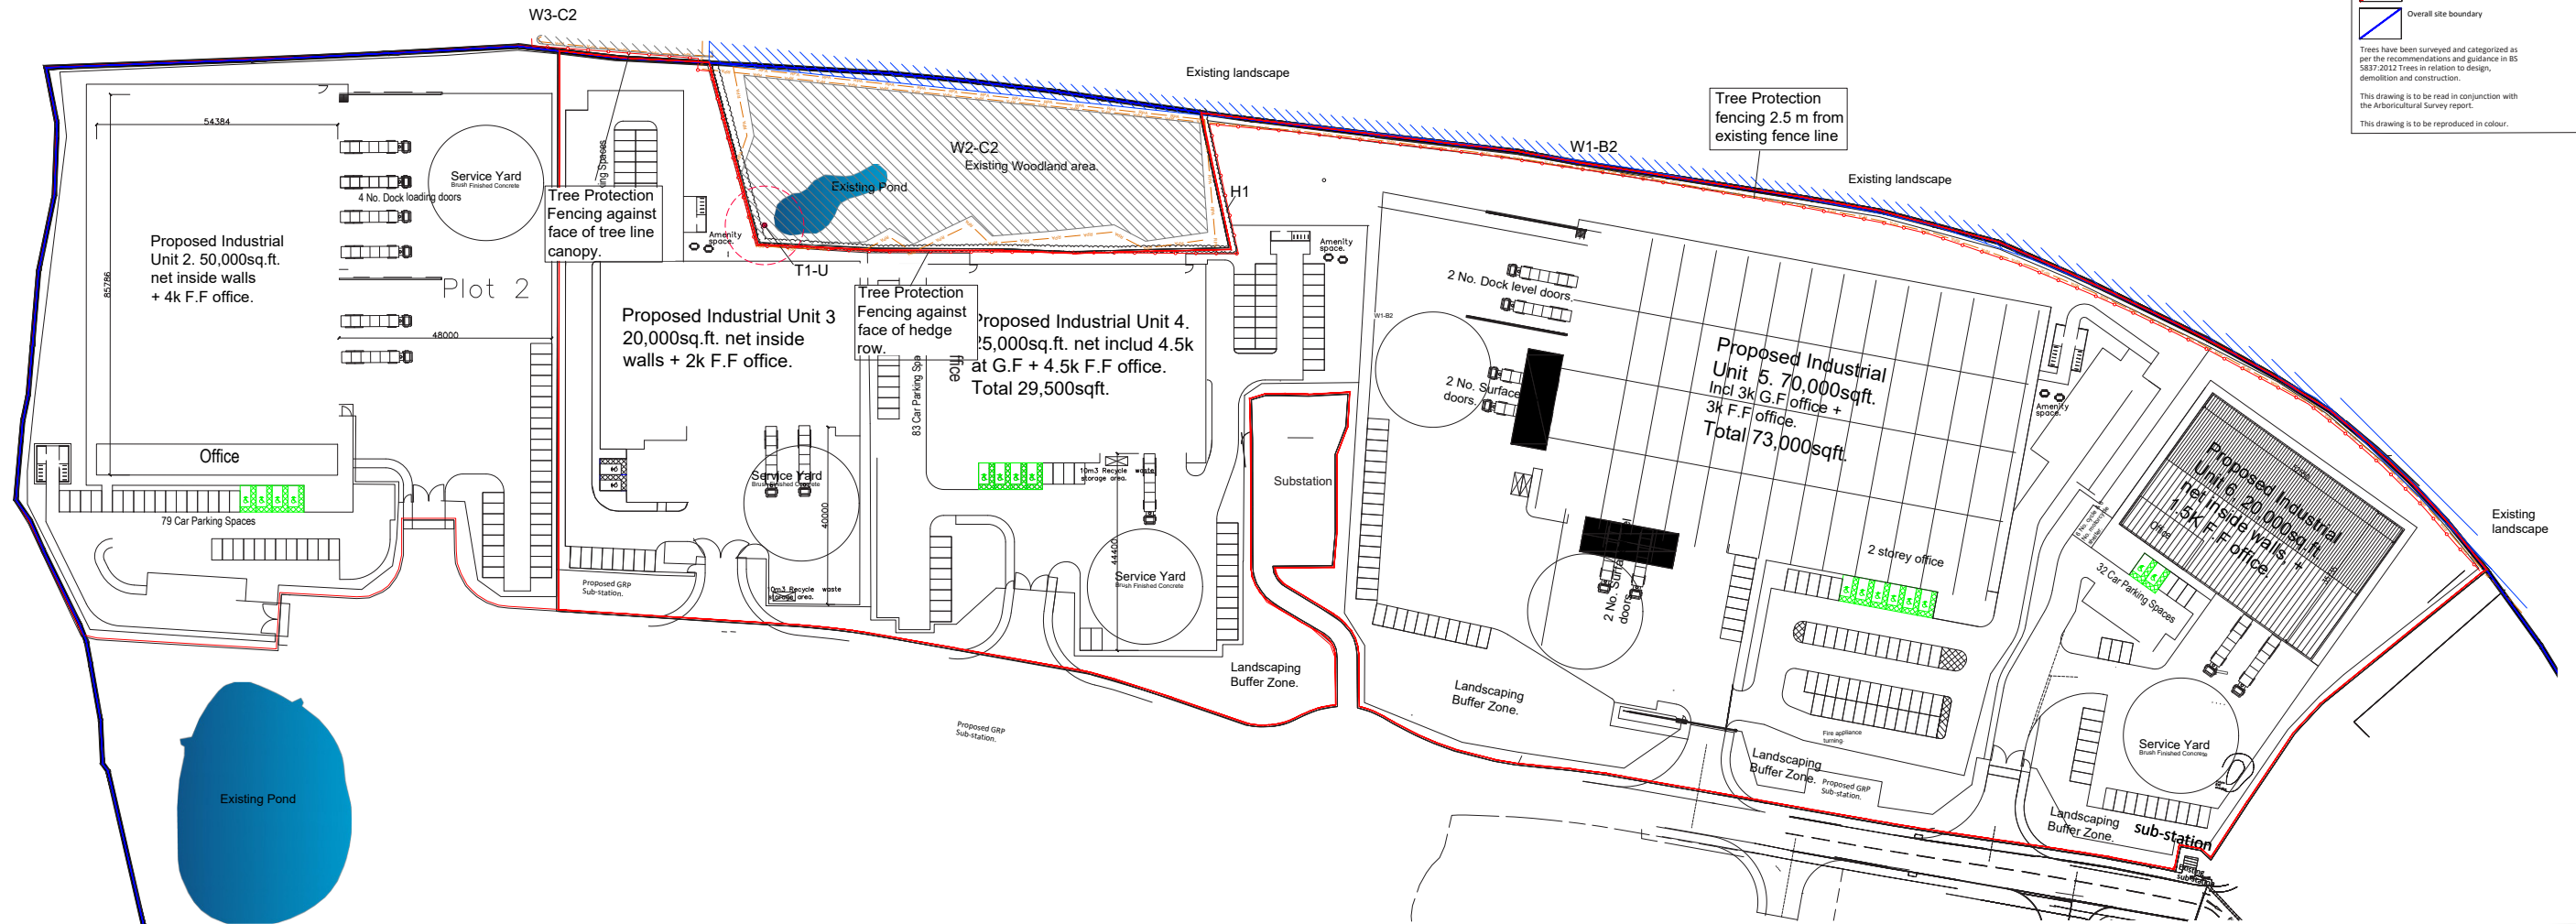
SF3422 AIA01 Rev A  
Arboricultural Impact Assessment Plan

- 6.1 The proposed development produced by Building Management Services Ltd. has been assessed in relation to the existing trees on drawing SF3422 AIA01 (Appendix C).
- 6.1.2 T1 was found to be in danger of failure due to the presence of ash die-back and a large cavity on the stem which is in excess of an expectable threshold for such a defect (see figure 2). It is therefore recommended for removal.
