## **STRUCTURAL ENGINEERS REPORT**

### **Addendum report**

Wayside  
Pexhill  
Cronton  
Wirral

19-AC-3748a

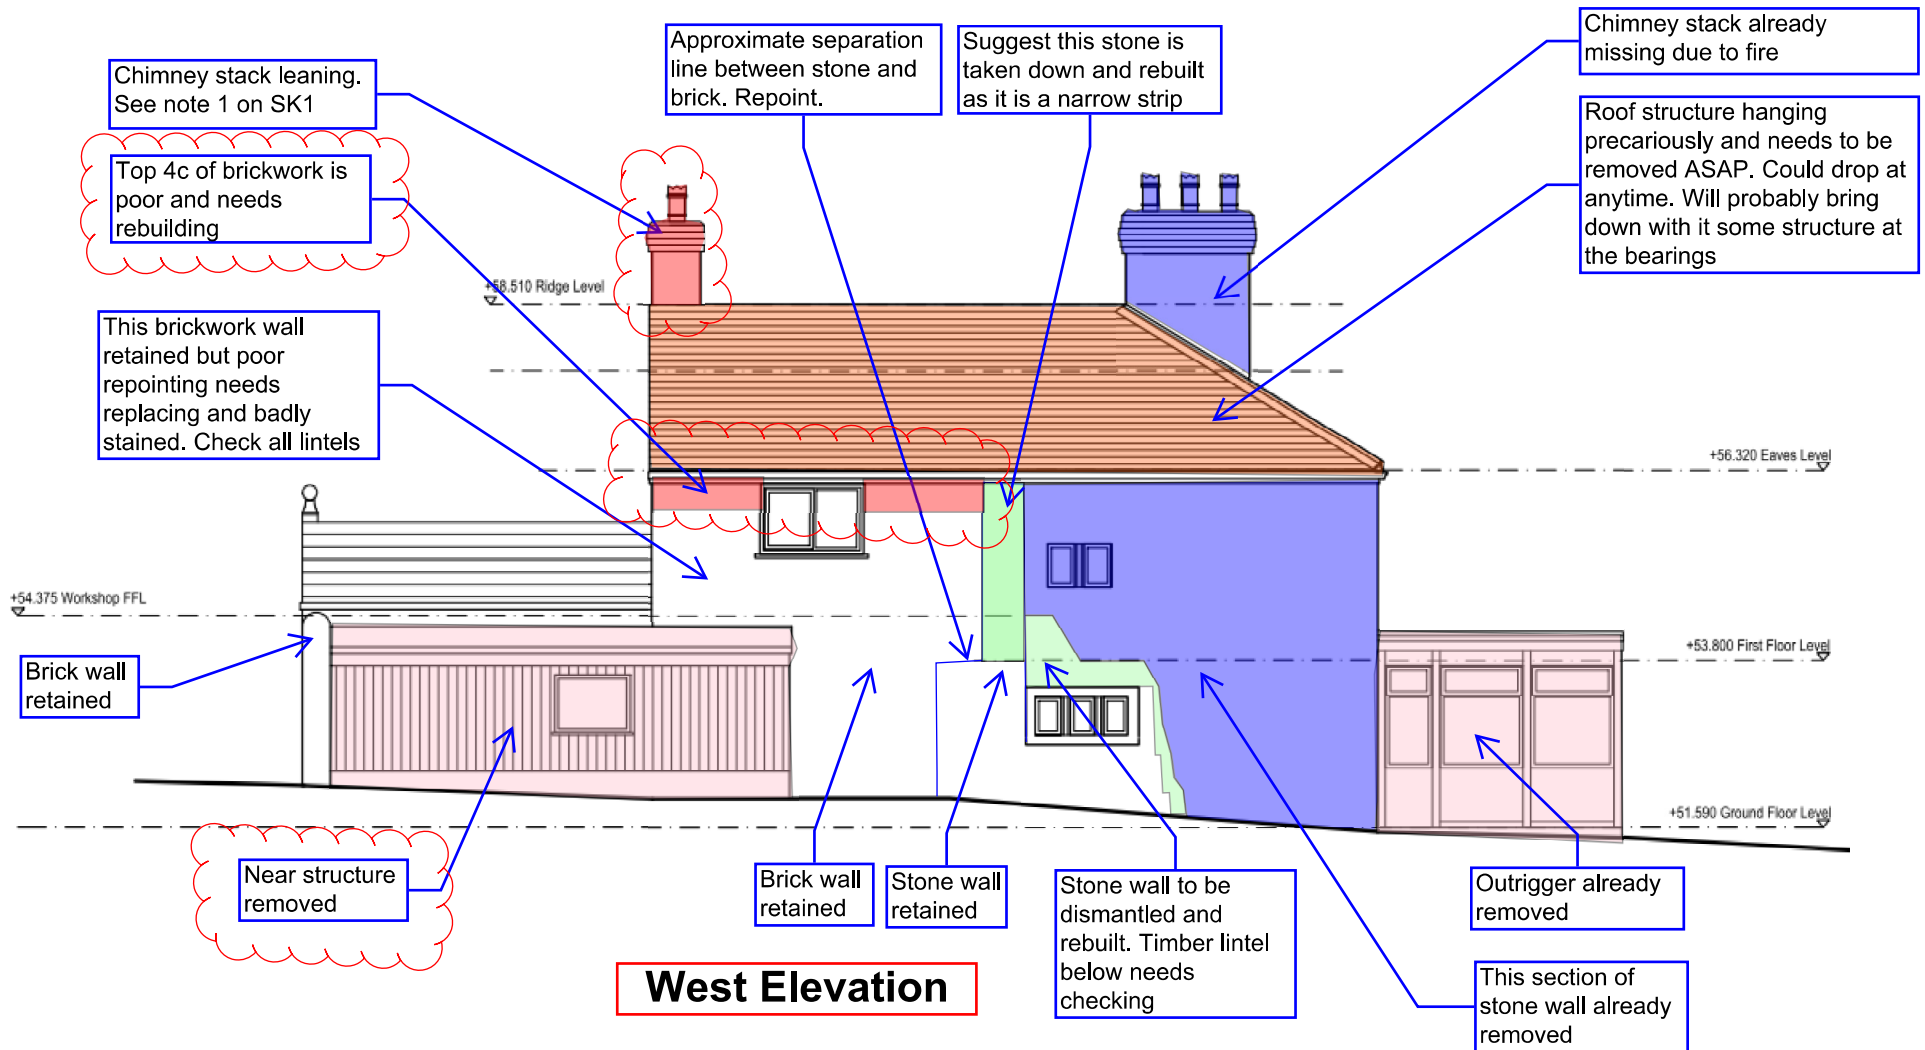
SK 3 Details of extent of further stone removal and repairs required

Stone wall in poor condition to be dismantled and rebuilt.

Roof structure hanging precariously and needs to be removed ASAP. Could drop at anytime. Will probably bring down with it some structure at the bearings

Old opening stone wall and lintel in poor condition to be dismantled and rebuilt.

Front face of stone wall missing and rear section has very open texture. Recommend dismantle and rebuild and lintel in poor condition to be dismantled and rebuilt.

Stone wall and lintel in poor condition to be dismantled and rebuilt.

Stone wall already missing due to fire
