**STRUCTURAL REPORT**

**THE BREWERY HOUSE  
NETHERLEY ROAD  
TARBOCK GREEN  
MERSEYSIDE  
L35 1QE**

**NEW START HOMES  
THE JOB BANK  
4 TUNNEL ROAD  
WAVERTREE  
LIVERPOOL  
L7 6QD**

**L1724/R01/revA**

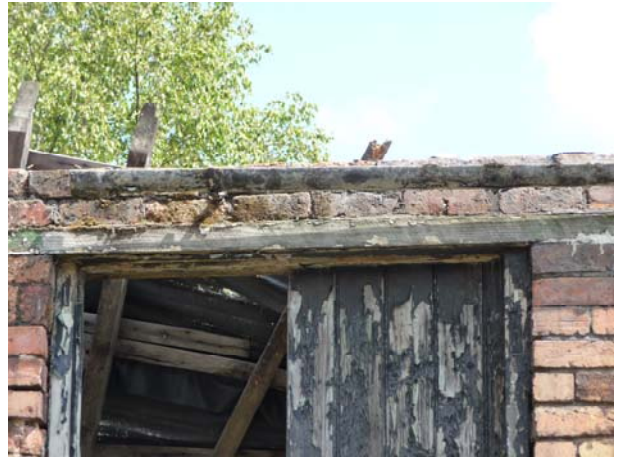
*Photograph 01*

This is constructed in English Garden Wall Bond loadbearing brickwork (*Photograph 01*). There is a header course every sixth course. The brickwork is badly weathered and the mortar joints deeply recessed. The wall is plumb up to eaves level but the triangular pike above the eaves leans inwards towards the building (*Photograph 02*). The top courses of brickwork along the verge are loose.

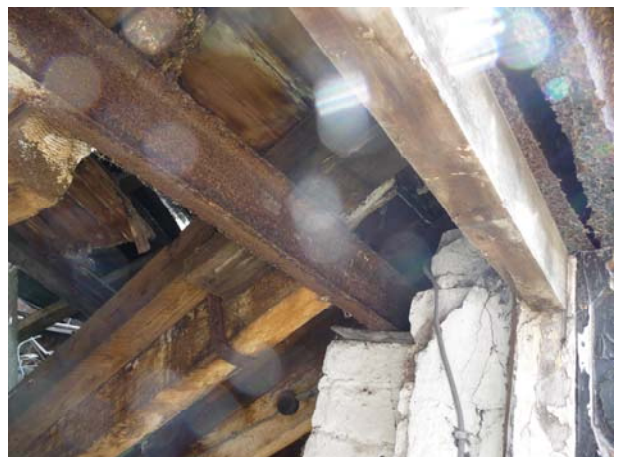
*Photograph 09*

This elevation is also constructed of English Garden Wall Bond (*Photograph 03*). All the brickwork is badly weathered and the joints deeply recessed. About 15% of the bricks are perished. There are two window openings to the loft level and two window openings to the ground level with a full height central door opening. There is a continuous timber wallplate at eaves level which acts as a lintel over the window and door openings (*Photograph 04*). There are two steel beams at loft floor level across the door opening (*Photographs 05 & 12*). These beams are exposed and rusted. The entire elevation leans outwards by 150mm above the ground floor window cill level (*Photograph 09*).

The South elevation which is presently unsafe should be demolished down to ground floor window cill level and rebuilt. Approximately 25% of the existing brickwork will remain.

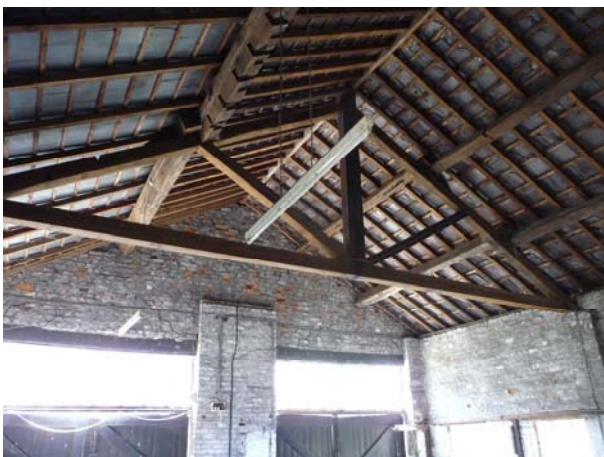
*Photograph 23*

The rear internal wall of the barn has had many former openings in it which have been infilled with brickwork and in some instances the old rotted timber lintels remain in place (*Photograph 23*). There are many vertical cracks in this wall which forms the division between the large barn and the small link building between the barn and the house.

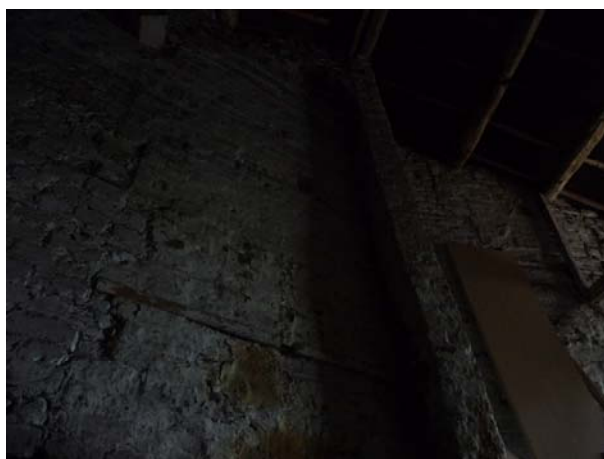
*Photograph 25*

Internally the link building was accessed through a door opening in the rear internal wall of the large barn (*Photograph 24*). An internal wall within the link appears to have collapsed and a partial concrete first floor is visible (*Photographs 25, 26, 27, 30, 31 & 32*). All of this was in a poor structural condition.

Internally this is substantially derelict and should be cleared of all collapsed walls etc. If it is intended to have a first floor the existing floor should be removed and replaced. The existing South elevation should be raked out and repointed and the block bonding to the rear of the barn should be improved and possibly concealed by the addition of a bonded in brick pier.
