# Contaminated Land Phase One Desk Study for Proposed Residential Dwellings at, Foxhill Farm, Foxhill Lane, Halewood, L26 4XG.

Revised and Updated August 2022

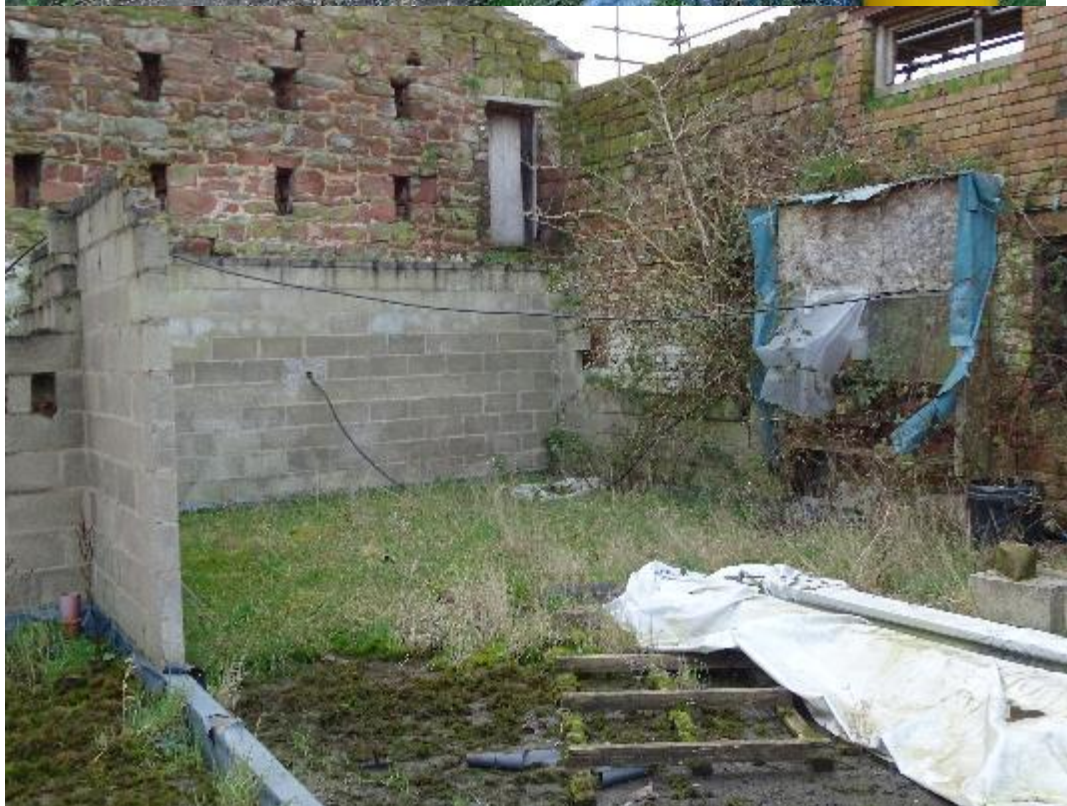
A double skinned elevated heating fuel tank is located within the two-storey barn, no signs of any leakage are present.

Remains of barn behind farm house, with double skinned fuel tank
