**HALSNEAD GARDEN VILLAGE NORTH,  
KNOWSLEY, MERSEYSIDE -**

**BAT & BARN OWL SURVEY OF  
BUILDINGS & BAT ROOST POTENTIAL  
ASSESSMENT OF TREES**

**2020**

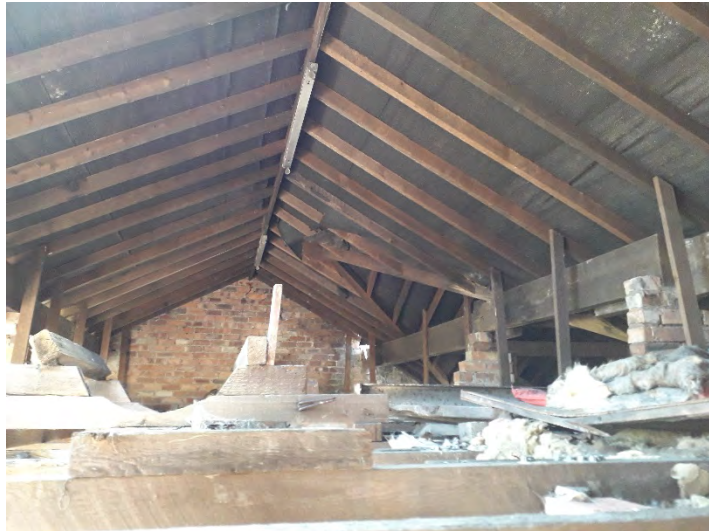
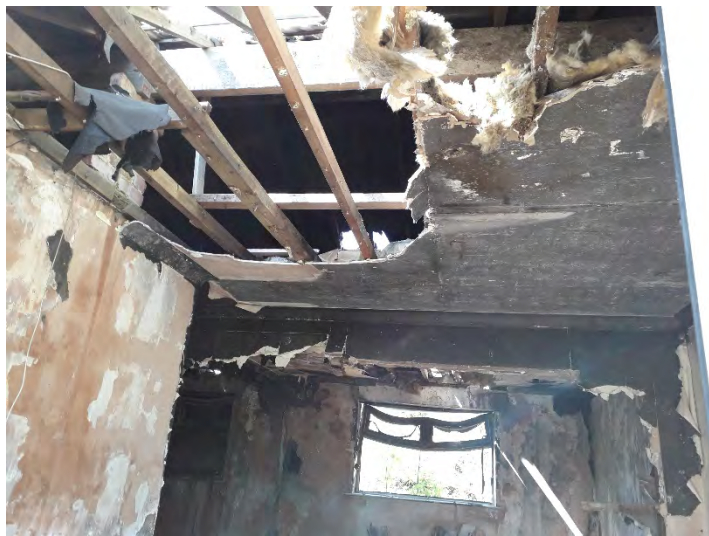
**Plate 2a, 2b: External potential roost features of Building 1**

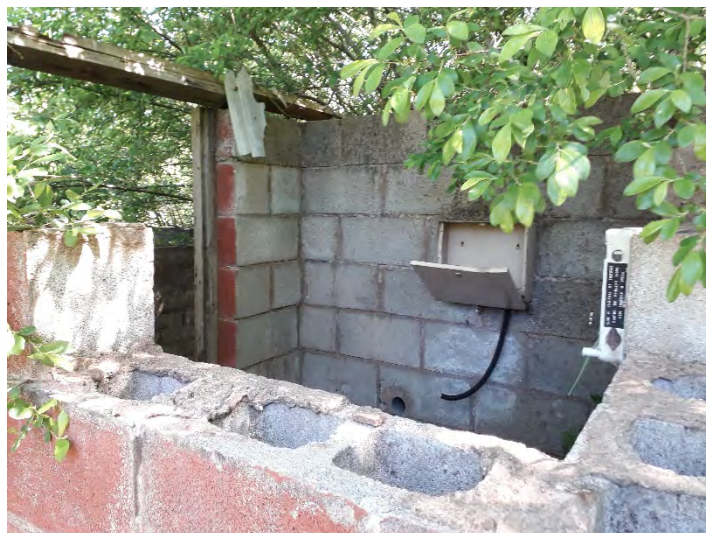
**Plate 5: View of Building 3**

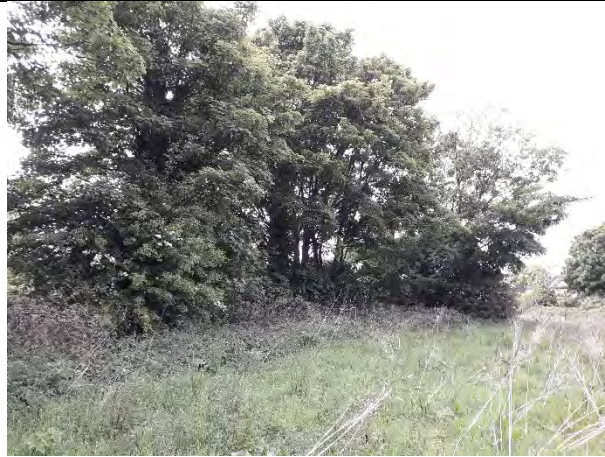
Negligible BRP

No further survey work.

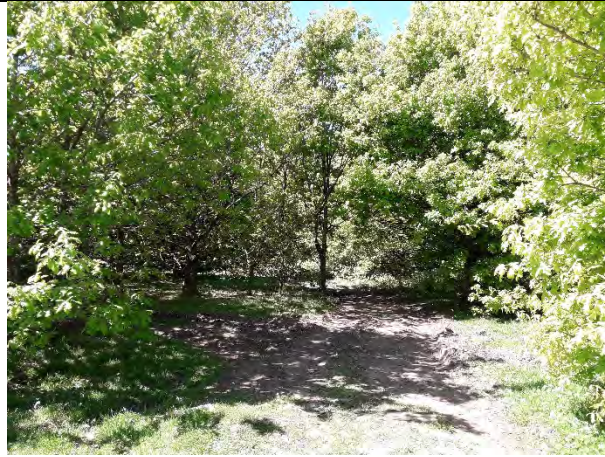
G2 – Oak

Immature oak trees with no features suitable for bat roosting.

Negligible BRP

No further survey work.

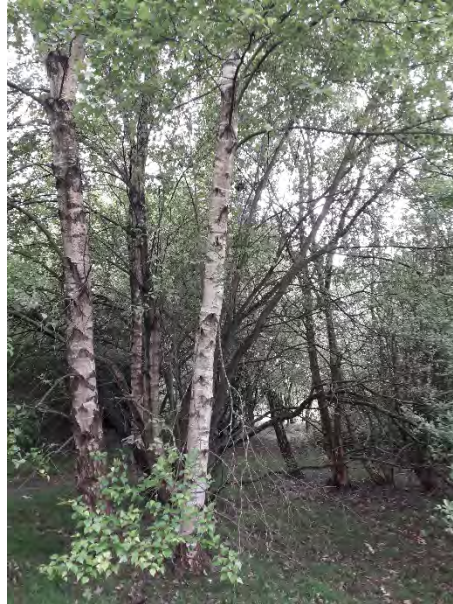
G3 – Birch

Birch trees within scrub with no features suitable for roosting bats.

Negligible BRP

No further survey work.

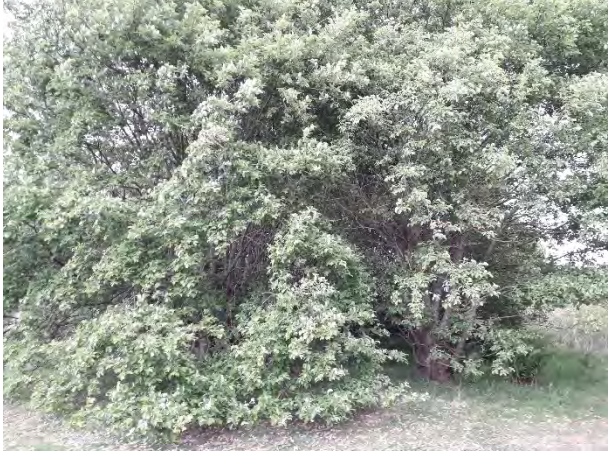
| <p>G4 – Goat willow, birch, aspen, cherry, oak</p> <p>Unmanaged scrub. No features suitable for roosting bats.</p> <p>Negligible BRP</p> <p>No further survey work.</p> | |

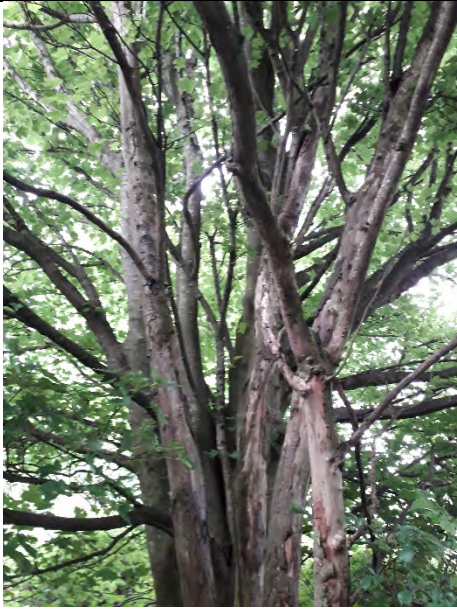
| <p>G5 – Sycamore, elm (dead)</p> <p>Semi mature sycamore trees, some peeling bark observed but no features suitable for roosting bats.</p> <p>Negligible BRP</p> <p>No further survey work.</p> | |

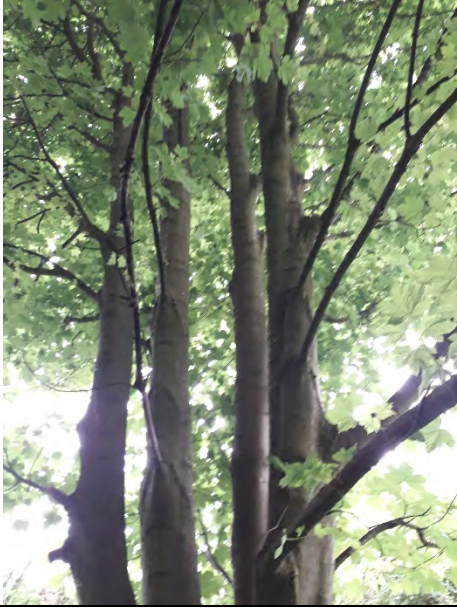
| <p>G6 – Sycamore</p> <p>Immature to semi mature sycamore trees located just outside site boundary. No features observed, but only the eastern side could be surveyed. Unlikely to be directly impacted by proposals.</p> <p>Negligible BRP</p> <p>No further survey work.</p> | |

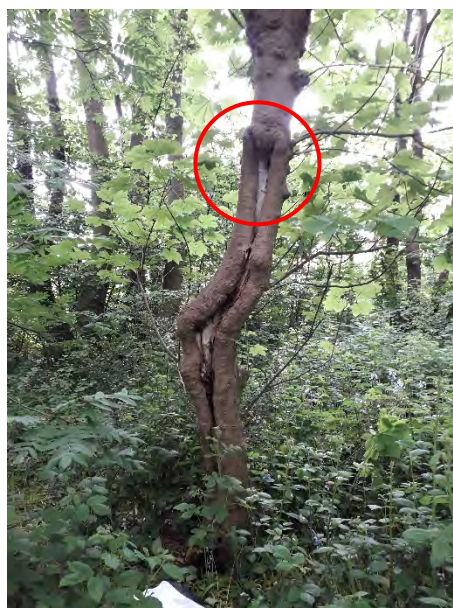
Frost crack type wound extending from the ground to 1.5m high. Rams horns developing. No apparent access into callus gaps. Cavity at apex of wound with entrance hole of 3cm x 3cm. 20cm upwards travel offering a dry cavity. Occasional woodlice.

All features fully inspected.  
Moderate BRP

Check again with endoscope prior to development. If no evidence of bats, fell under RAM.

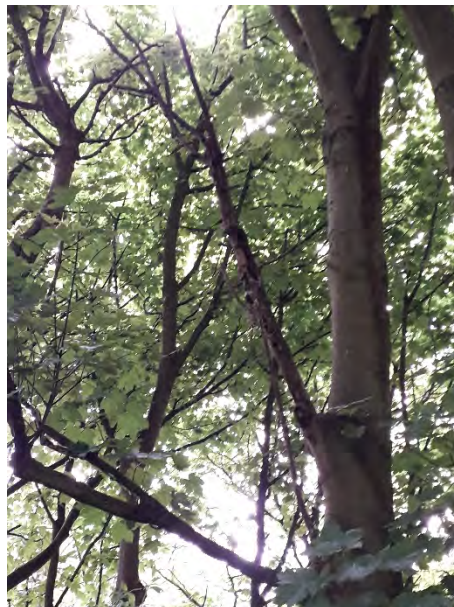
Multi stemmed tree with a dead and damaged branch facing south, at 6m high. Rot hole observed in dead wood, leading into possible cavity with an entrance hole of 5cm x 5cm.

Moderate BRP

Climb with ladders/rope access and inspect with endoscope

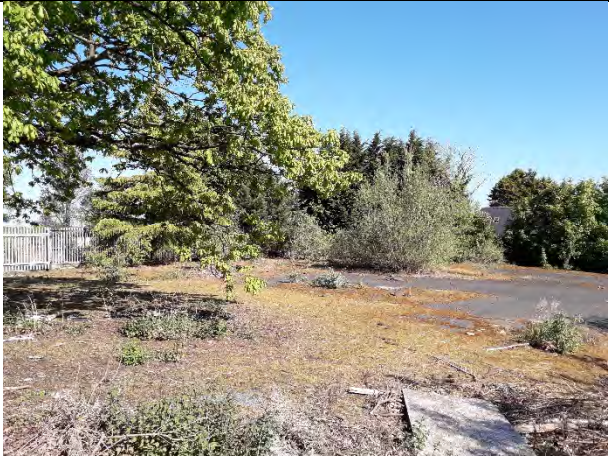
| Site area B (land immediately east of Windy Arbor Road) | |
|---|---|
| <p>T1 – Cedar<br/>T2 – Cedar<br/>T3 – Cedar<br/>T4 – Cedar<br/>G1 – Pine, spruce<br/>H1 – Leyland cypress</p> <p>No features suitable for bat roosting observed.</p> <p>Negligible BRP</p> <p>No further survey work.</p> | |

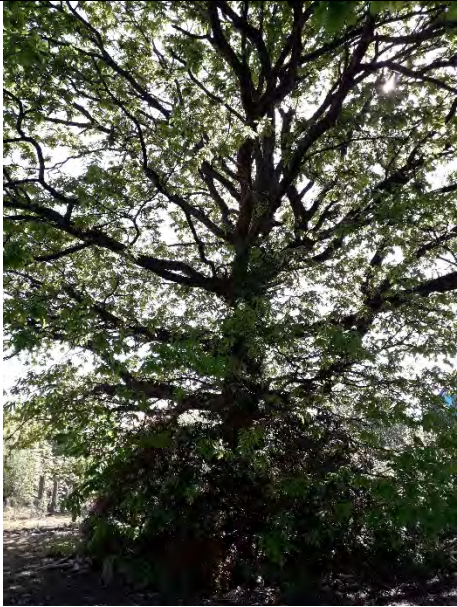
| Site area B (land immediately east of Windy Arbor Road) | |
|---|---|
| <p>T5 – Oak</p> <p>Mature oak tree with old pruning wounds in the crown which appeared superficial.</p> <p>Precautionary Low BRP</p> <p>Fell under RAM</p> | |

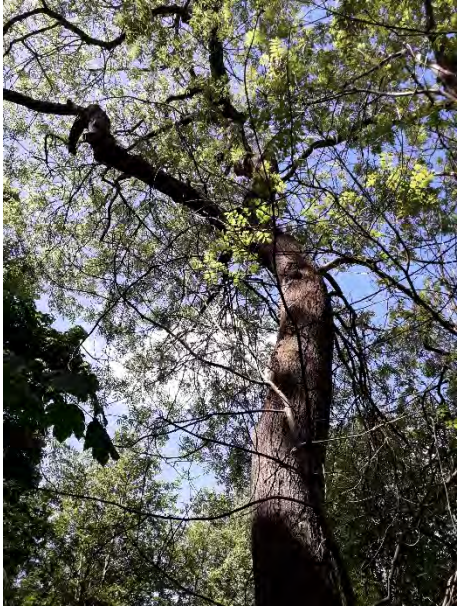
| Site area B (land immediately east of Windy Arbor Road) | |
|---|---|
| <p>G2 – Ash<br/>A group of four ash trees</p> <p>G2.1<br/>A small superficial rot hole observed at end of western branch at 5m.</p> <p>Low BRP</p> <p>Fell/prune under RAM</p> | |

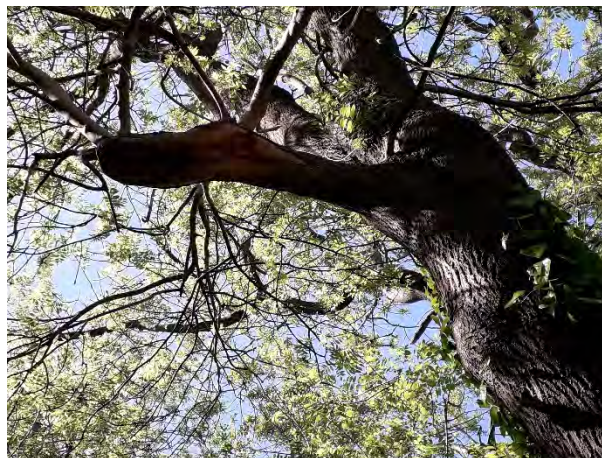
Semi mature ash with a broken branch on the western aspect at 10m. A tear out type wound is present on the underside of this branch, leading to a possible cavity with an entry hole of 5cm by 5cm.

Moderate BRP

Climb via rope access to inspect features with endoscope,

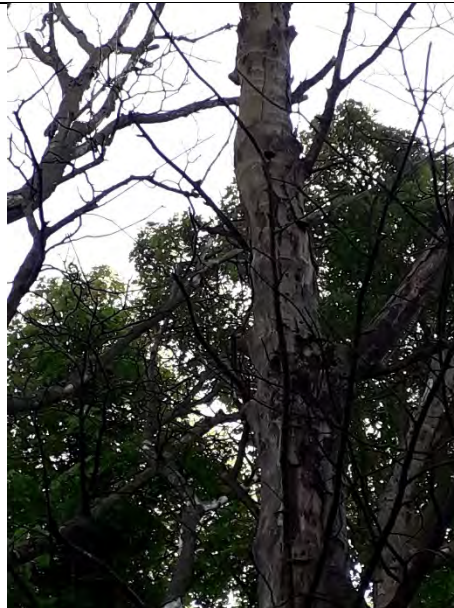
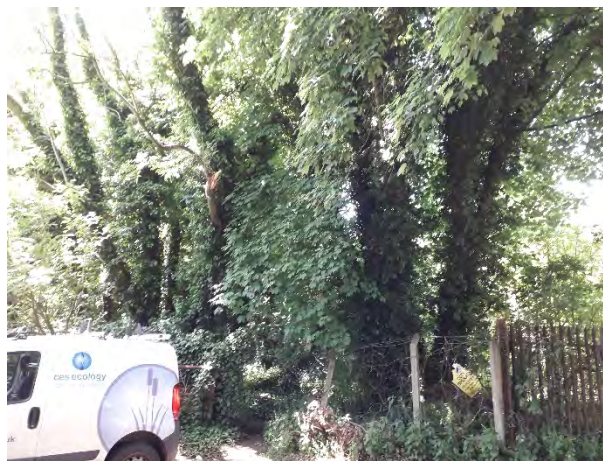
The remaining trees in G3 were semi mature to mature sycamore, many being densely ivy clad. Ivy clad trees were categorised as Low BRP

Fell under RAM

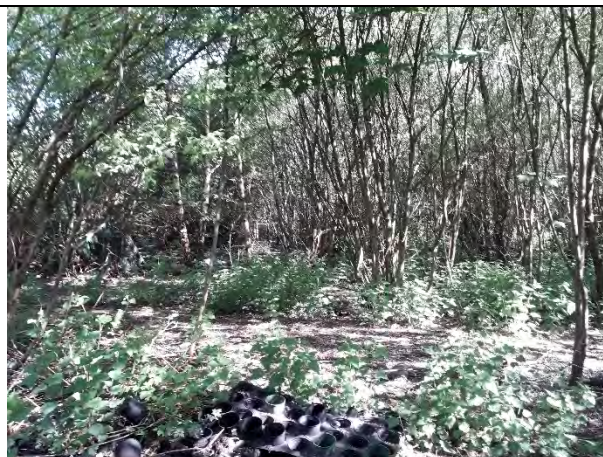
### G4 – Goat Willow

This is an area of dense willow scrub. Trees are immature and no features suitable for bat roosting were recorded.

Negligible BRP

No further survey work.

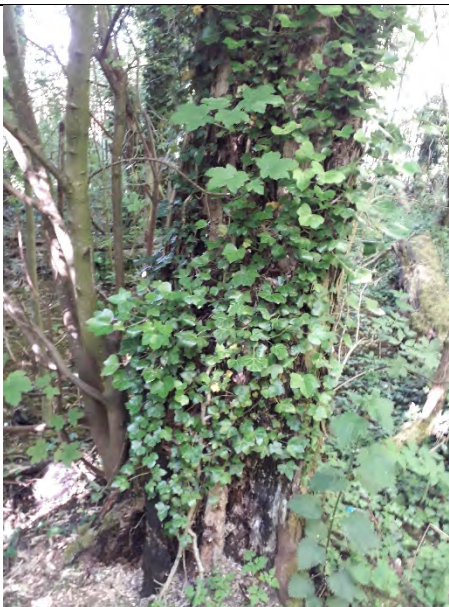
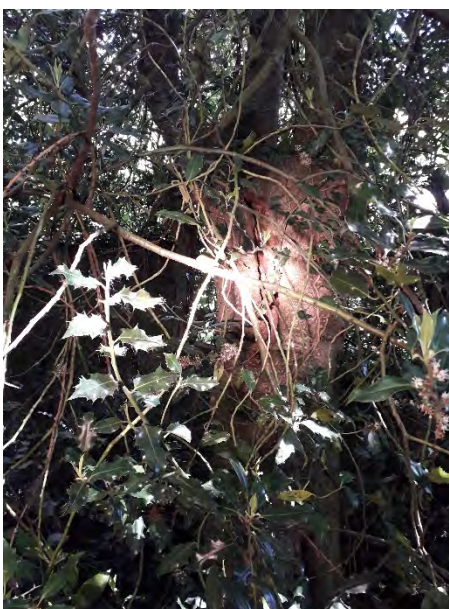
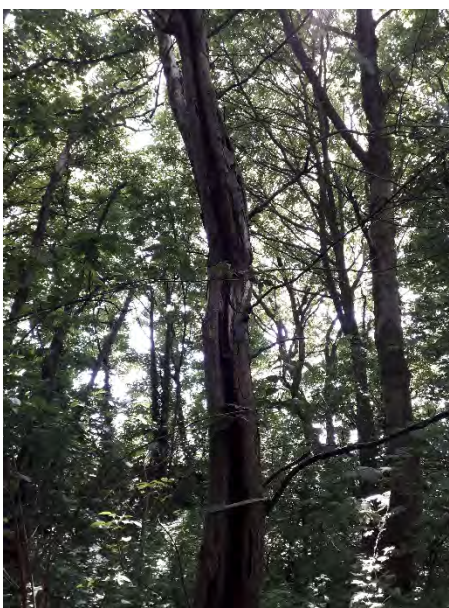
Small Y shaped tree, approx. 10m high with a DBH of 30cm. Tree had a frost crack type wound down its entire length with rams horns on both sides. They had developed into hollow callus rolls. On the left the access hole was at 1m with entrance hole of 5cm x 3cm. It extended upwards to 1m. On the right there were 2 entrance holes 5cm x 5cm and 2cm x 10cm. The lower hole extended upwards for 20cm into the callus roll. Callus rolls continued upwards with possible entry points higher up.

BRP Moderate to High

Climb with ladders to inspect higher potential features.

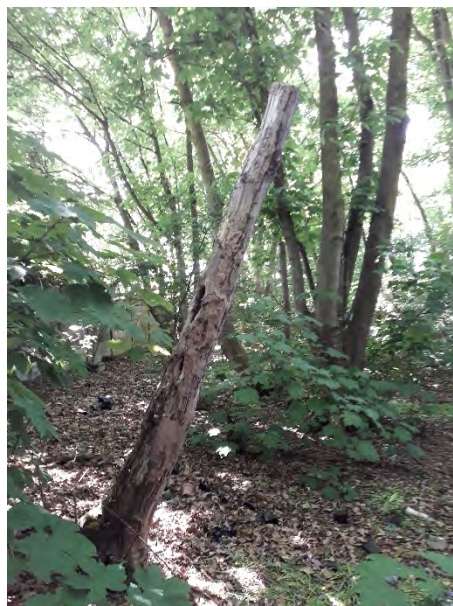
Low BRP

Fell under RAM
