Old Wood North, Whiston

Knowsley Metropolitan Borough Council

January 2022

## Technical Note – Old Wood North TWA

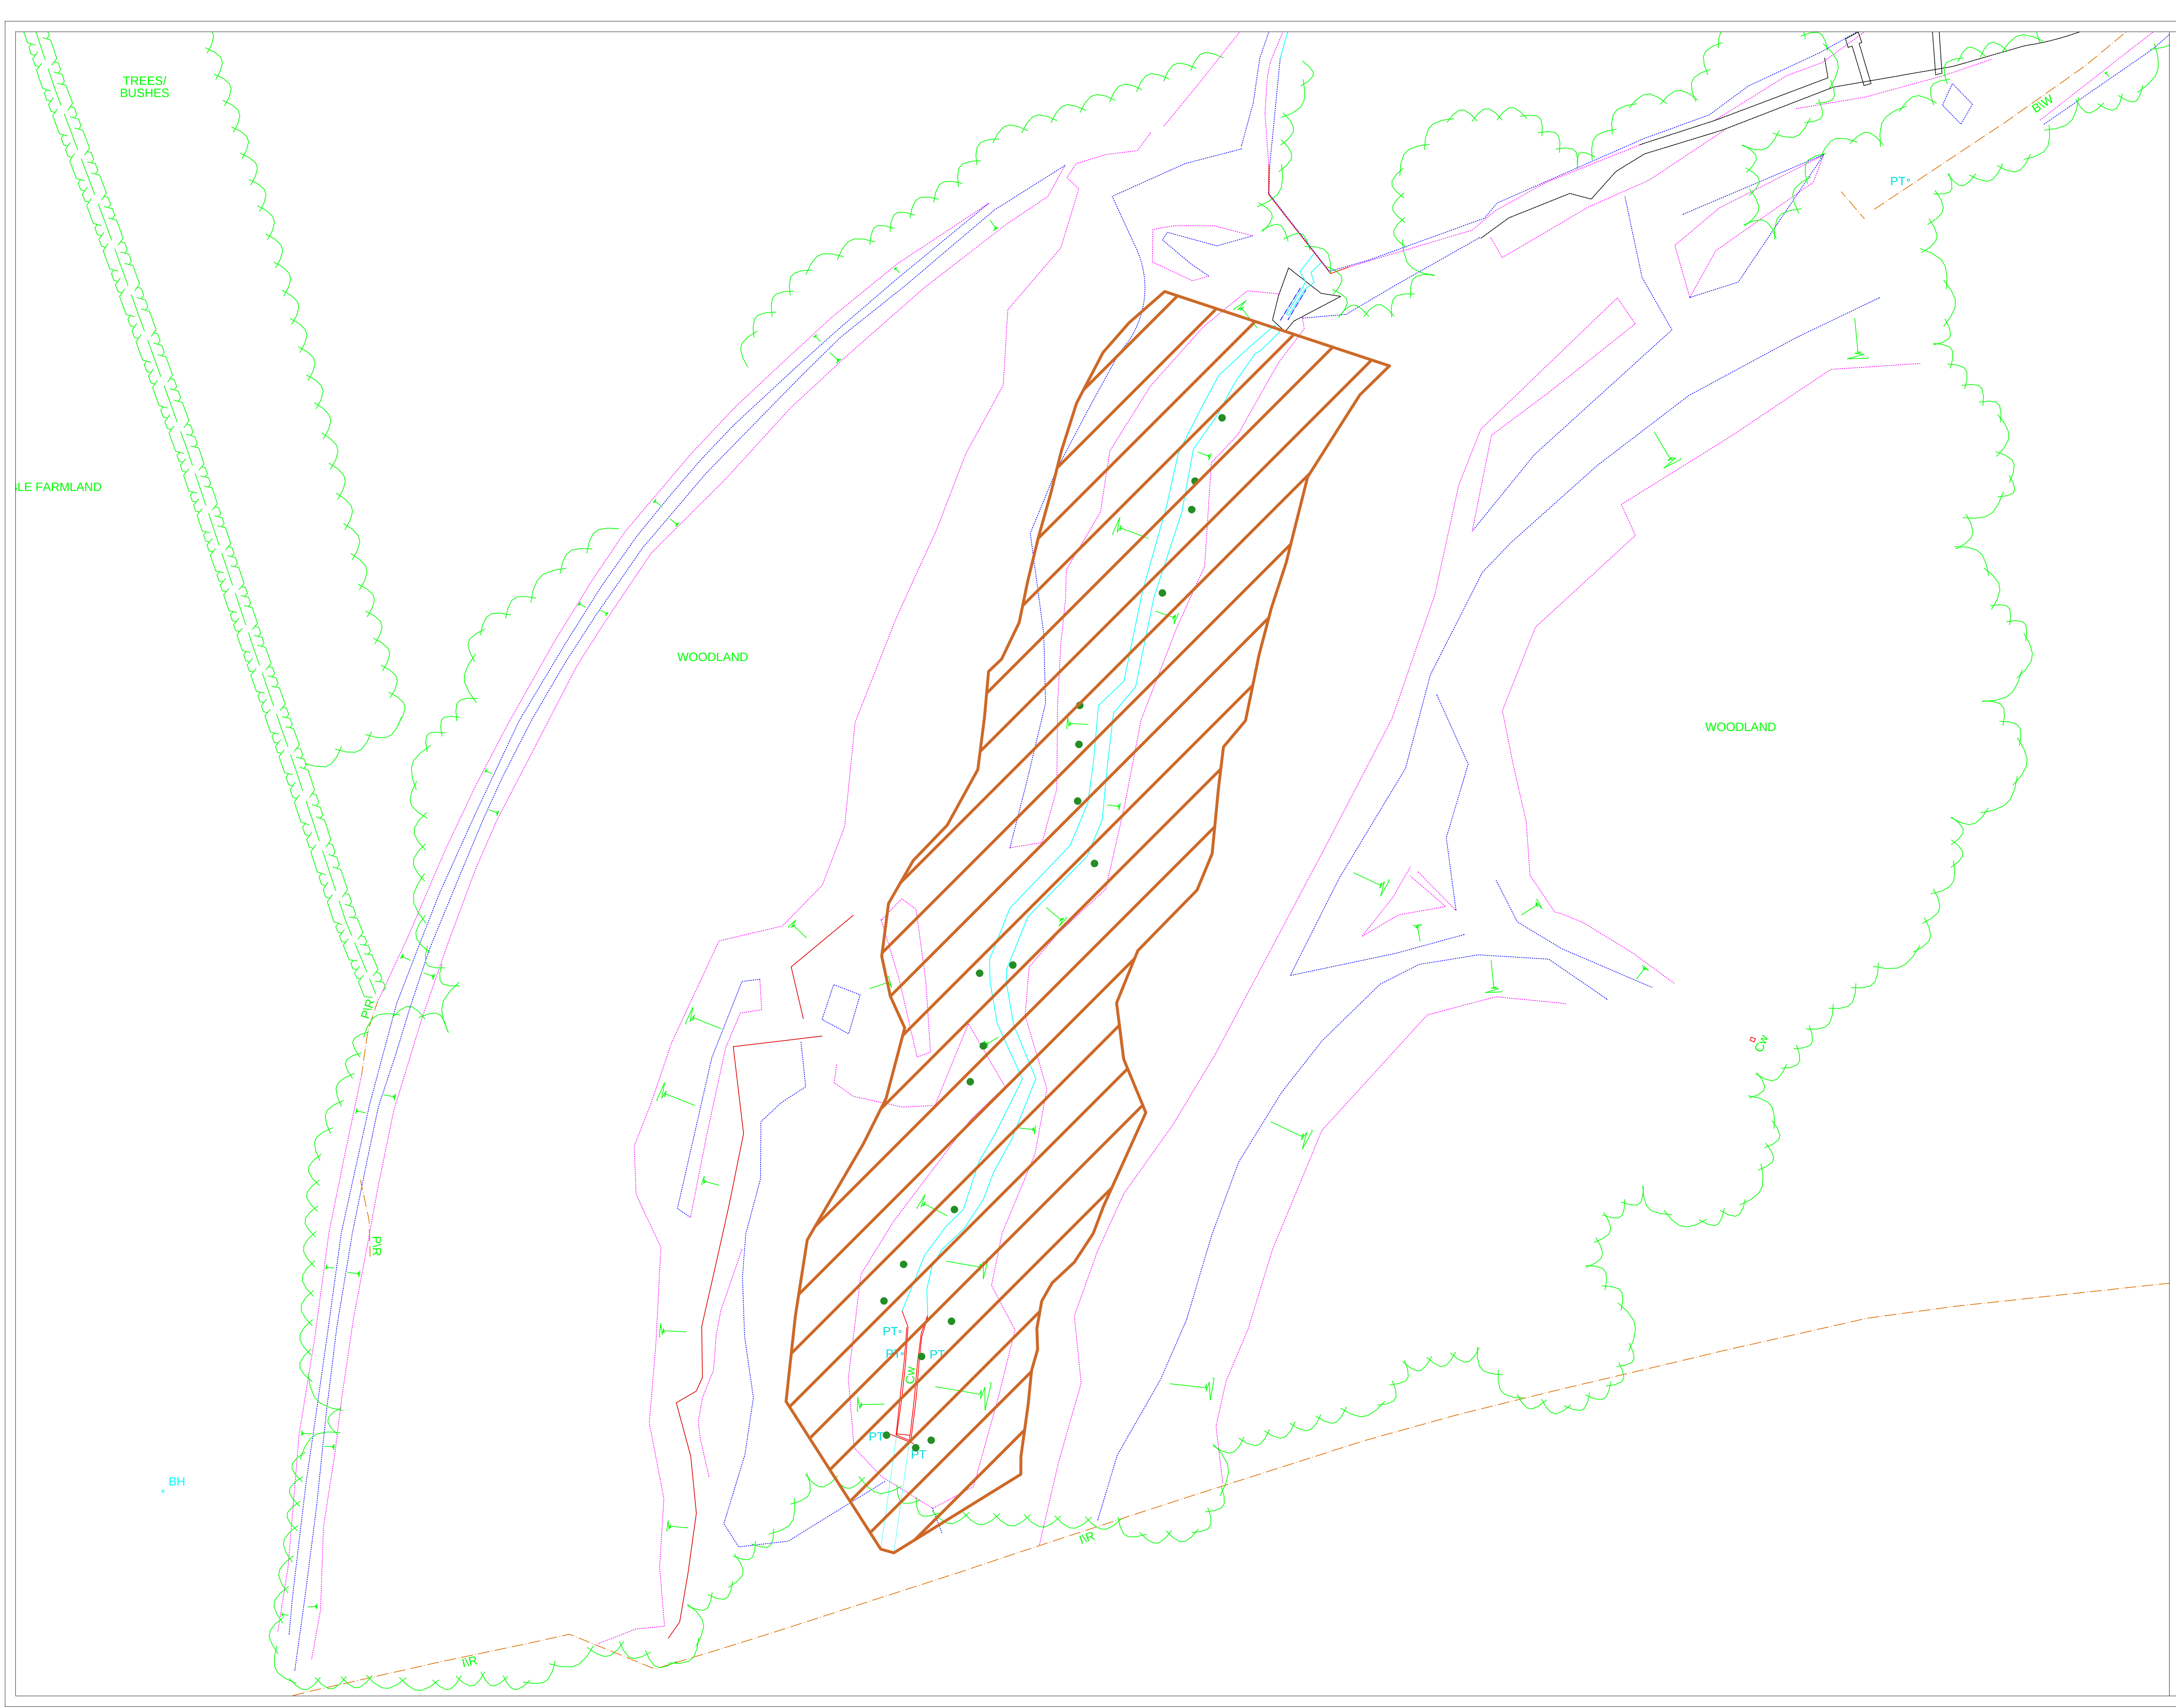
## **Appendix I.0 Tree Location Plan**

Rhododendron Removal Zone

Surrounding the watercourse within Old Wood are dense clusters of Rhododendron which could prevent access to the watercourse. Rhododendron is classified as an invasive woodland species and has been proven to have an overall negative effect on woodlands (Forestry Commission, 2022). The removal of the Rhododendron within a 10m buffer zone of the watercourse is recommended, this will allow for access to the watercourse and should improve the overall condition of the woodland (Ref: OldwoodRhod/TLP). These works are classed as exempt from a tree preservation and will not be included within the tree works application.
