# WINDY ARBOR PLAYING FIELDS

## 2021 Boundary Wall Inspection Report

**PROJECT NO. 70057126**

**DATE: SEPTEMBER 2021**

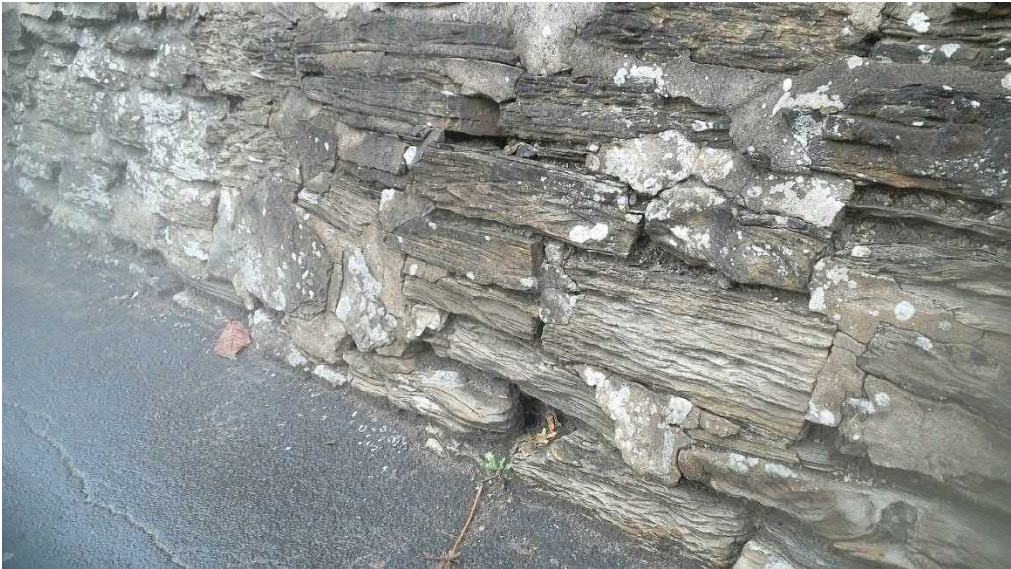
| Defect No: | 0035 | Elevation: | Roadside | Defect Chainage: | 254m |

| Defect Type: | Mortar Failure | | Severity: | Medium | |
