# WINDY ARBOR PLAYING FIELDS

## 2021 Boundary Wall Inspection Report

**PROJECT NO. 70057126**

**DATE: SEPTEMBER 2021**

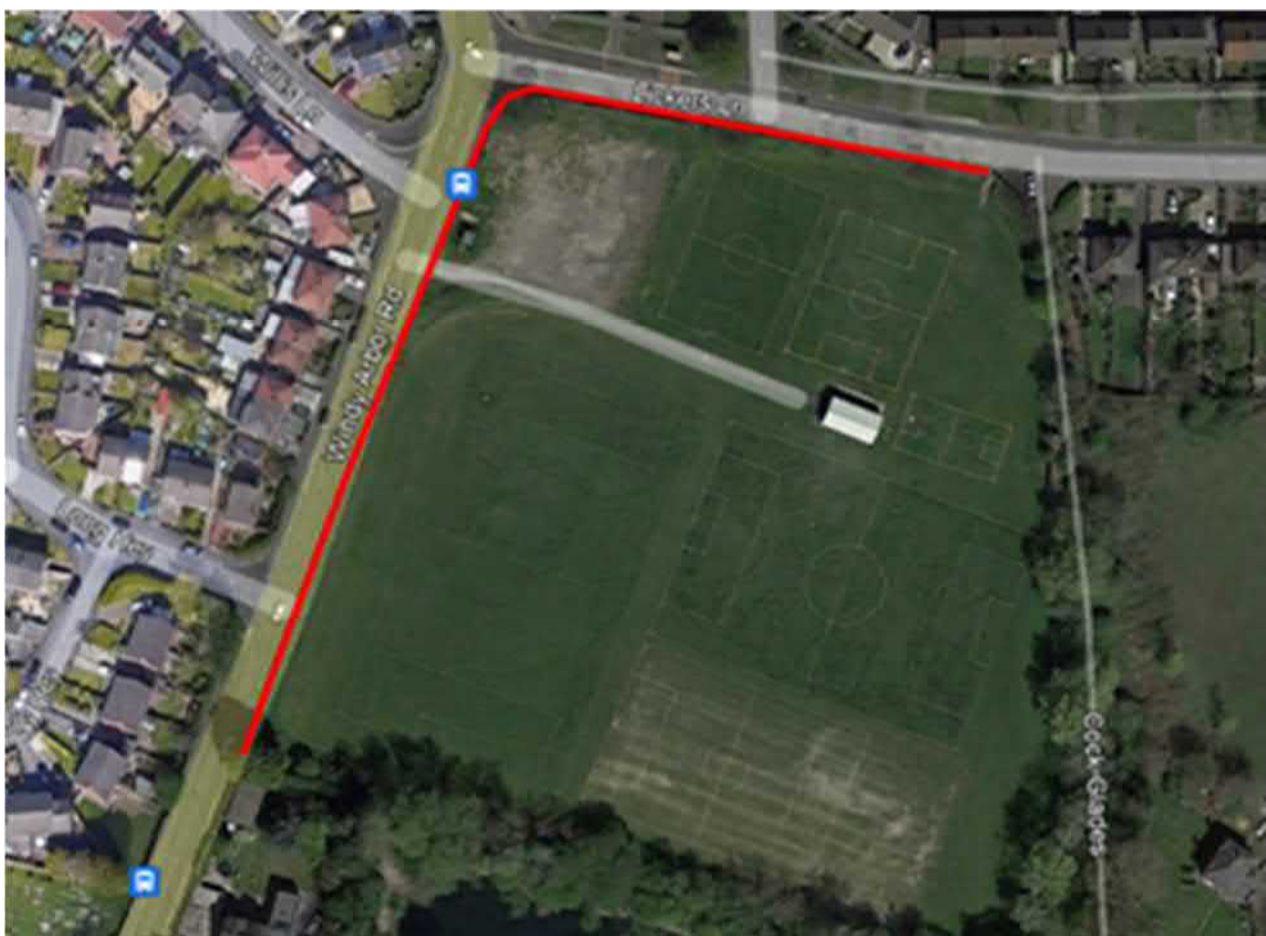
Figure 1 - Boundary Wall Extent

To comply with this recommendation KMBC have requested WSP undertaken a visual condition inspection of the full extent of the wall, running some 280m along the boundary at Lickers Lane and Windy Arbor Road, as shown on Figure 1 below.

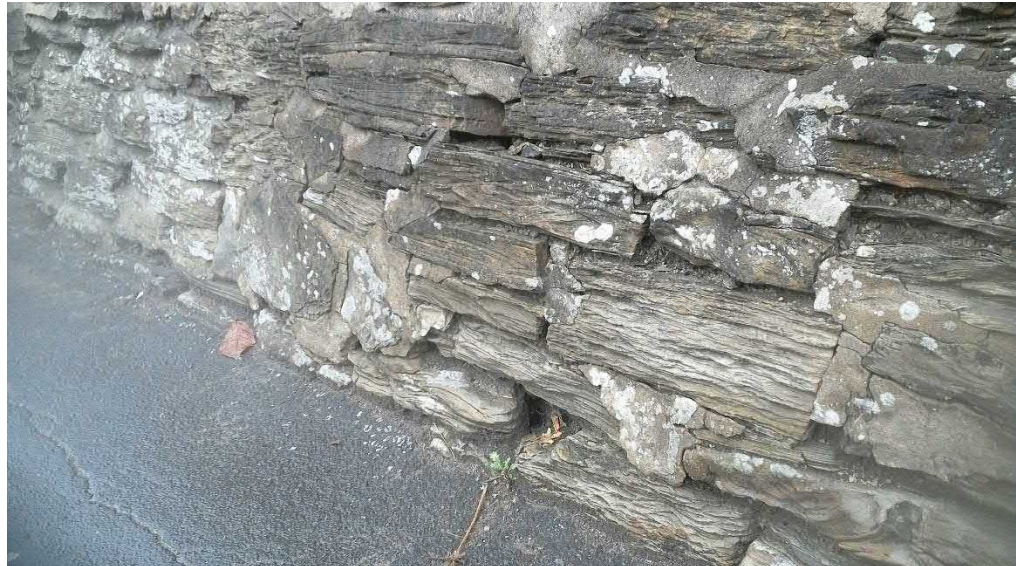
| Defect No: | 0035 | Elevation: | Roadside | Defect Chainage: | 254m |

| Defect Type: | Mortar Failure | | Severity: | Medium | |
