# Photographic Schedule of Condition

Old Halsnead Hall, Fox's Bank Lane, Widnes, Prescot L35 3SU

April 2026

Doc Ref: 04C600152

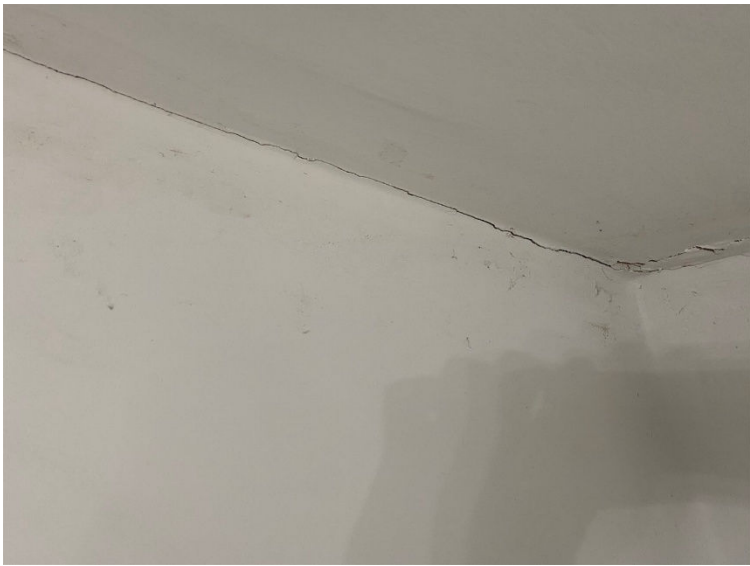
| Photo No | Photograph Description | Photograph |
|---|---|---|
| 4. | <b>Cinema Room</b><br>Crack at junction between wall and ceiling | |

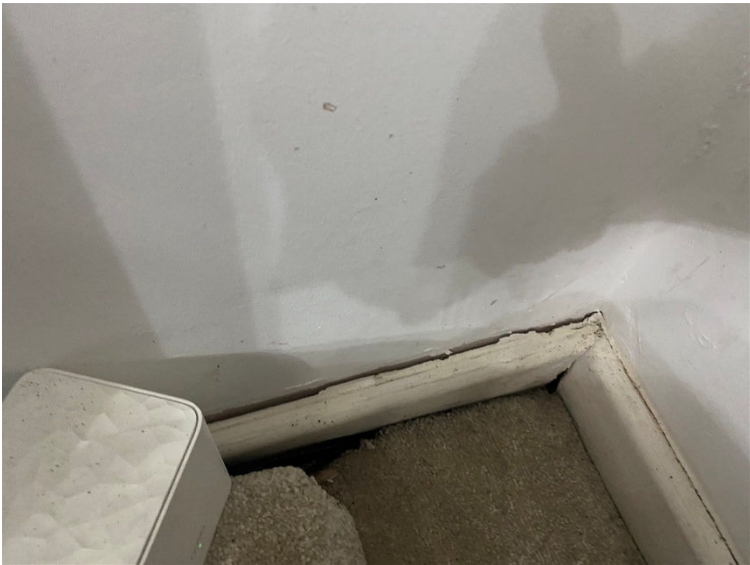
| Photo No | Photograph Description | Photograph |
|---|---|---|
| 6. | <b>Cinema Room</b><br>Open joints between skirting and wall to right of cinema screen | A photograph showing the corner of a room where a white skirting board meets a white wall. There is a significant gap between the skirting and the wall, and the skirting itself appears damaged and crumbling at the joint. |

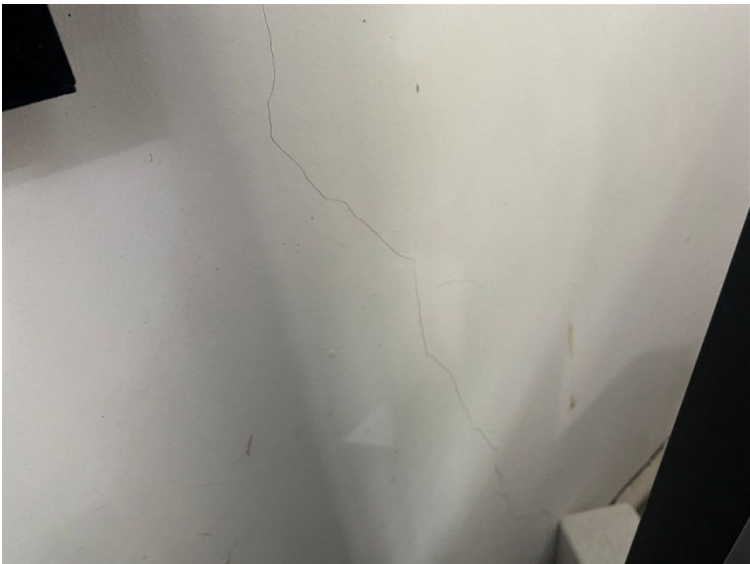
| Photo No | Photograph Description | Photograph |
|---|---|---|
| 7. | <b>Cinema Room</b><br>Crack to right of cinema screen | A photograph of a white wall with a prominent, irregular vertical crack running down it. The crack is several millimeters wide and extends from the top of the frame towards the bottom. |

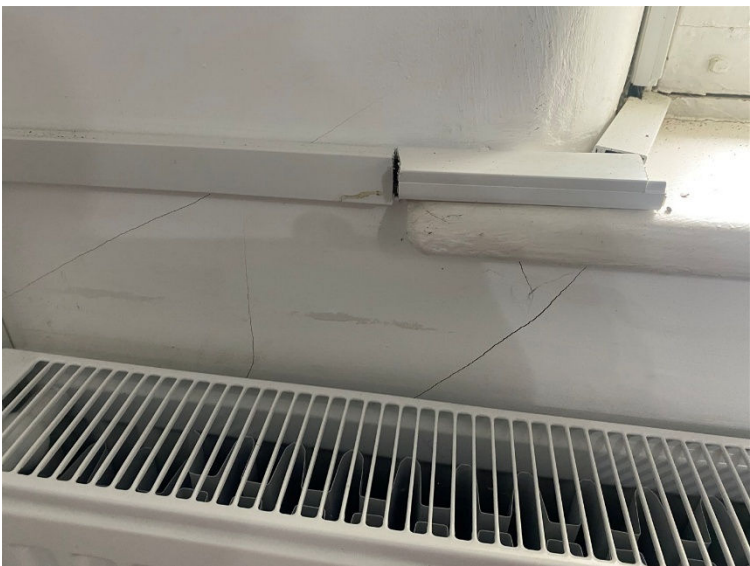
| Photo No | Photograph Description | Photograph |
|---|---|---|
| 8. | <b>Cinema Room</b><br>Crack below windowsill | A photograph showing a white windowsill and the wall below it. A crack is visible in the wall just below the sill. In the foreground, a white radiator grille is partially visible. |

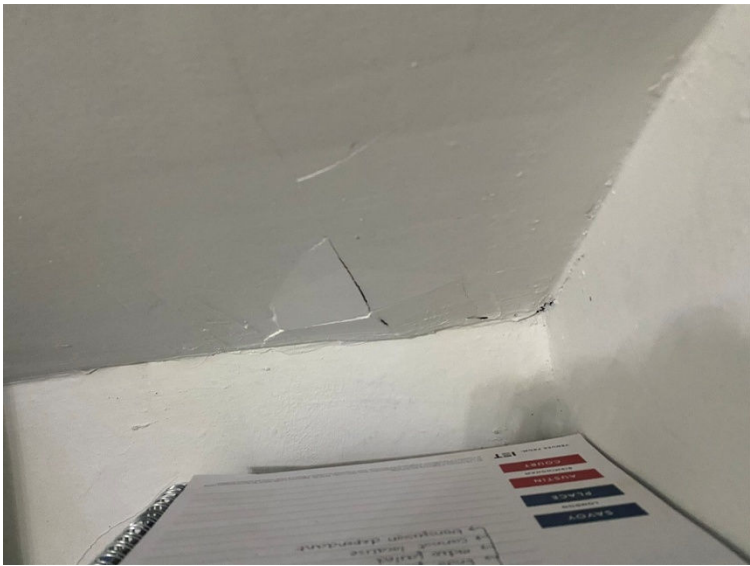
| Photo No | Photograph Description | Photograph |
|---|---|---|
| 16. | <b>Cinema Room</b><br>Crack to ceiling above recess to right of window | |

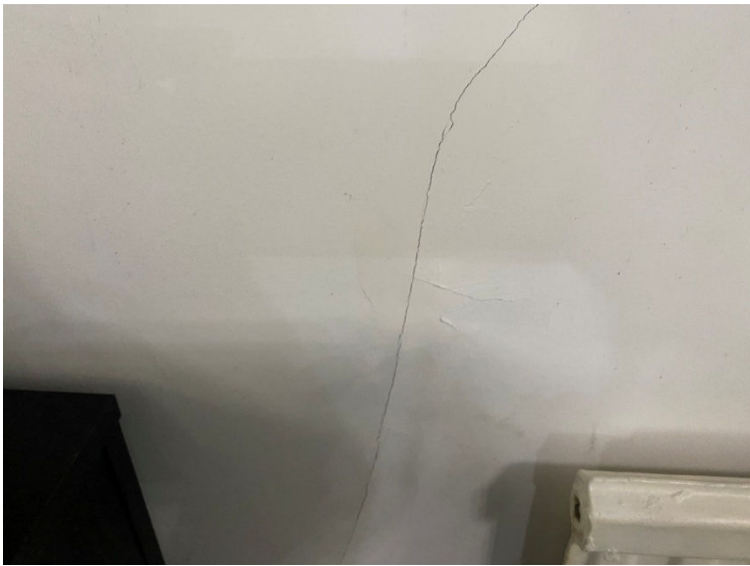
| Photo No | Photograph Description | Photograph |
|---|---|---|
| 19. | <b>Cinema Room</b><br>Close up of crack to left of radiator | |

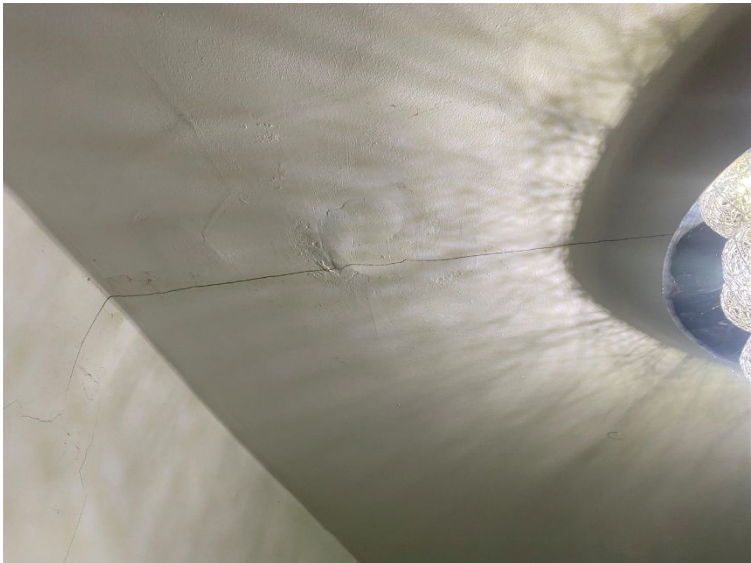
| Photo No | Photograph Description | Photograph |
|---|---|---|
| 24. | <b>Cinema Room</b><br>Hairline crack from landing wall to light fitting | |

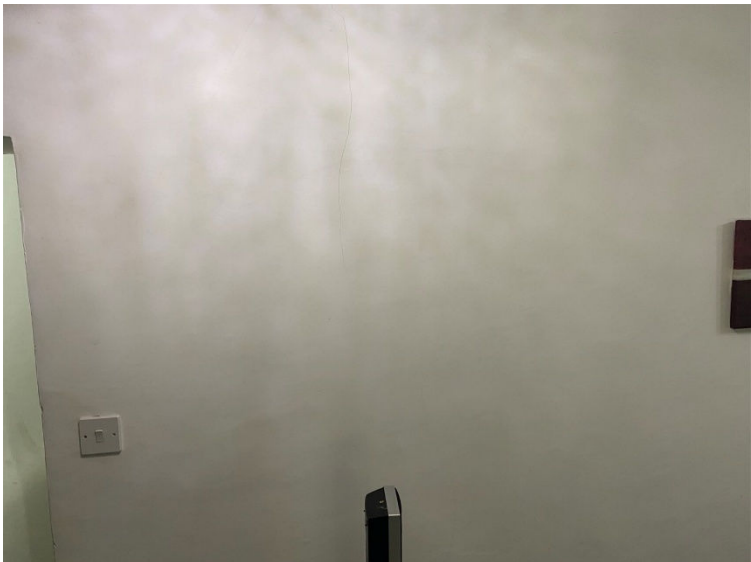
| Photo No | Photograph Description | Photograph |
|---|---|---|
| 25. | <b>Cinema Room</b><br>Vertical hairline cracking to right of door | |

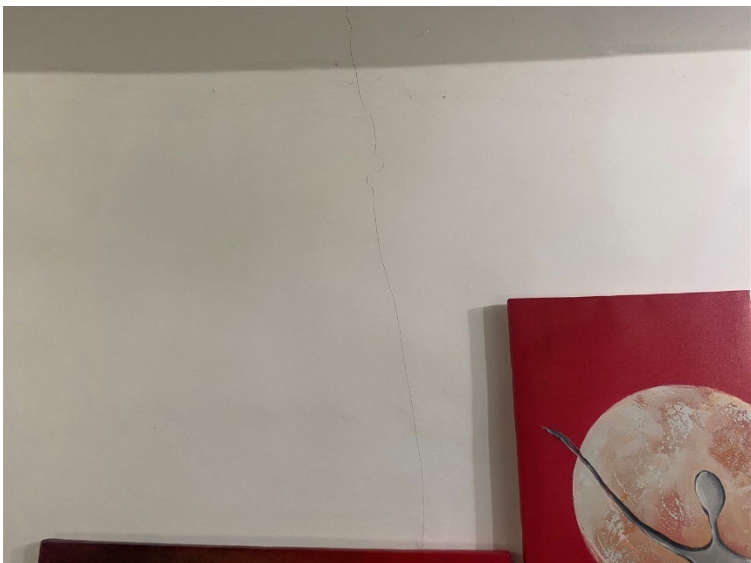
| Photo No | Photograph Description | Photograph |
|---|---|---|
| 26. | <b>Cinema Room</b><br>Vertical hairline crack to right of door | |

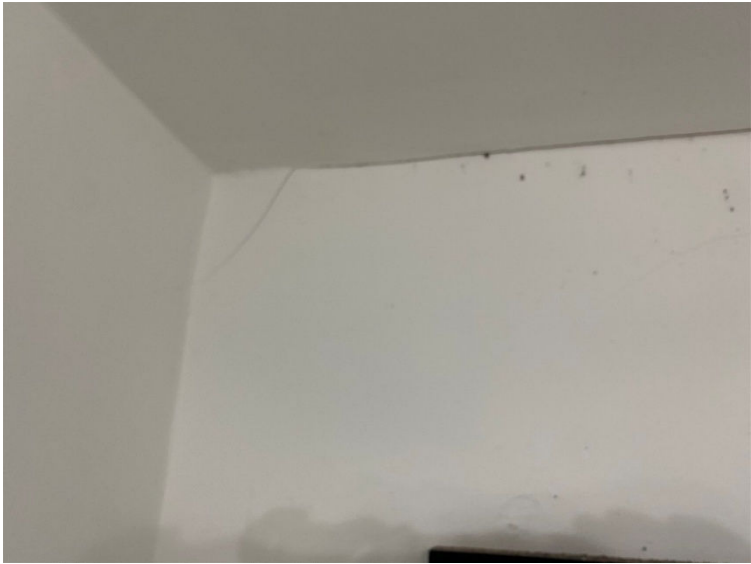
| Photo No | Photograph Description | Photograph |
|---|---|---|
| 28. | <b>Cinema Room</b><br>Hairline crack between wall and ceiling | |

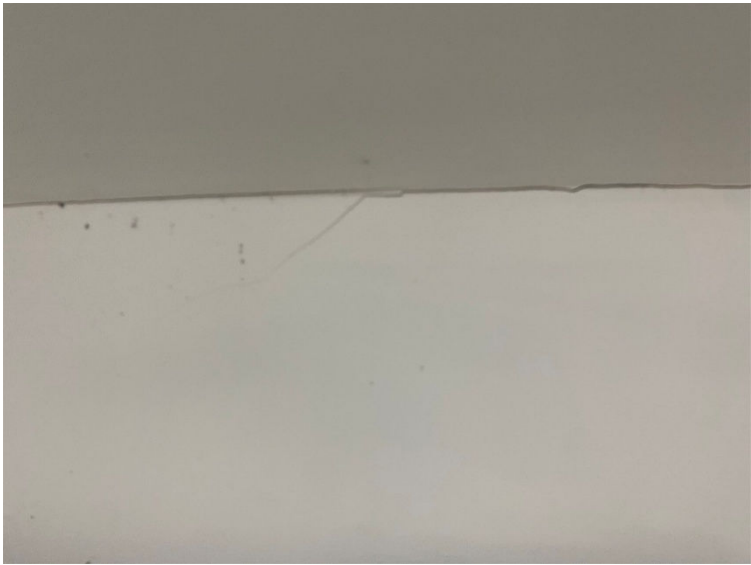
| Photo No | Photograph Description | Photograph |
|---|---|---|
| 29. | <b>Cinema Room</b><br>Hairline crack between wall and ceiling | |

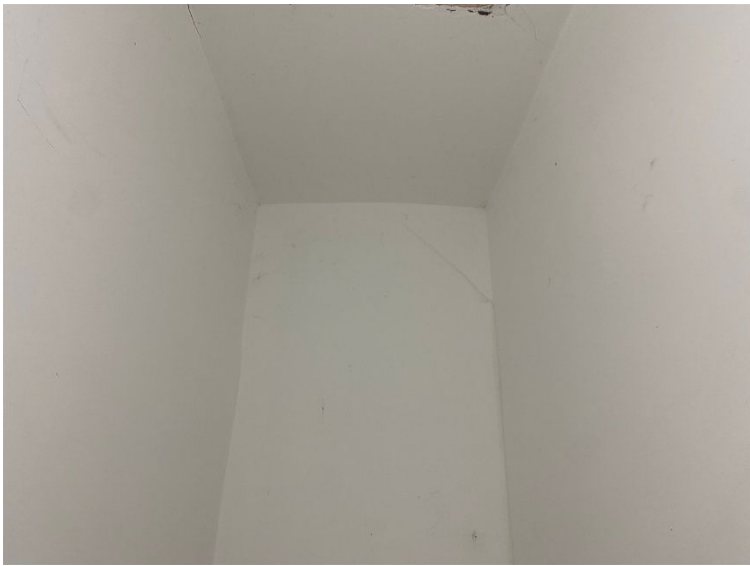
| Photo No | Photograph Description | Photograph |
|---|---|---|
| 31. | <b>East stairs</b><br>Diagonal hairline crack at tile level, extending down the internal corner | |

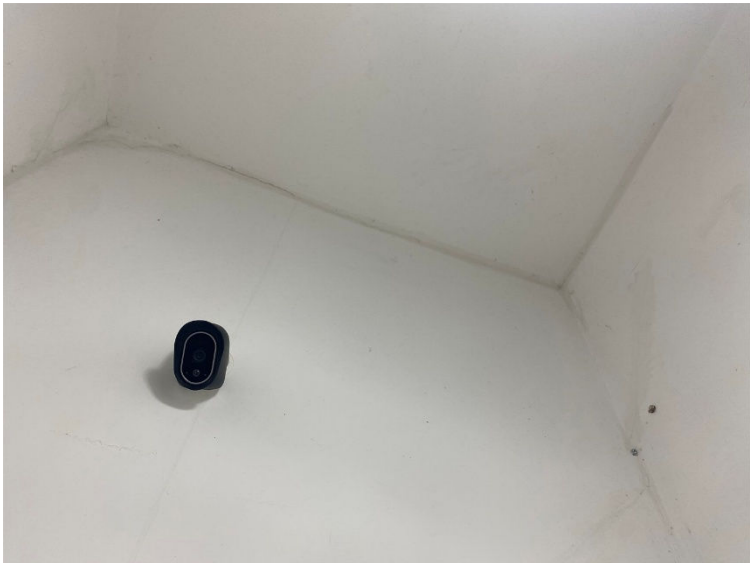
| Photo No | Photograph Description | Photograph |
|---|---|---|
| 33. | <b>East stairs</b><br>Cracks between wall and ceiling | |

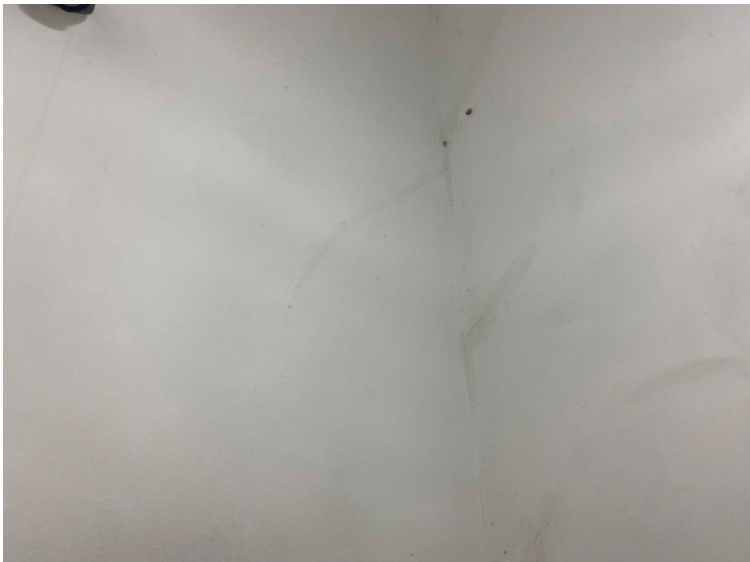
| Photo No | Photograph Description | Photograph |
|---|---|---|
| 34. | <b>East stairs</b><br>Cracks which have been made good with filler | |

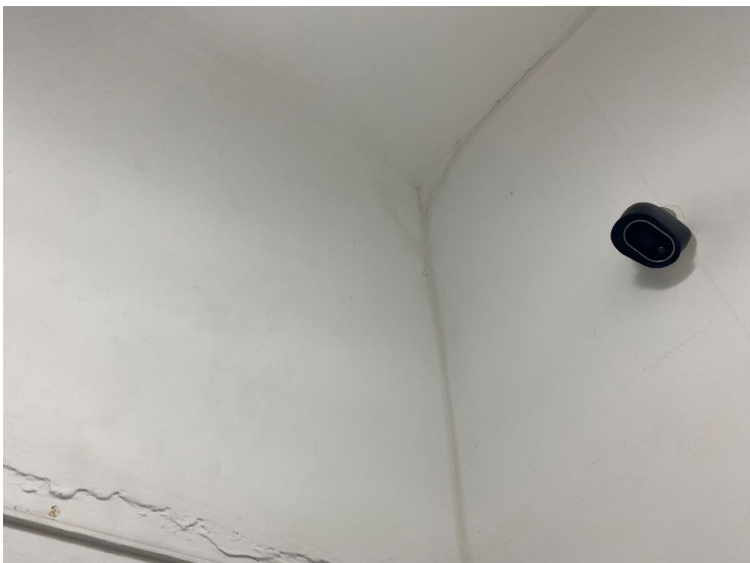
| Photo No | Photograph Description | Photograph |
|---|---|---|
| 35. | <b>East stairs</b><br>Filled cracks at internal corner and junction between wall and ceiling | |

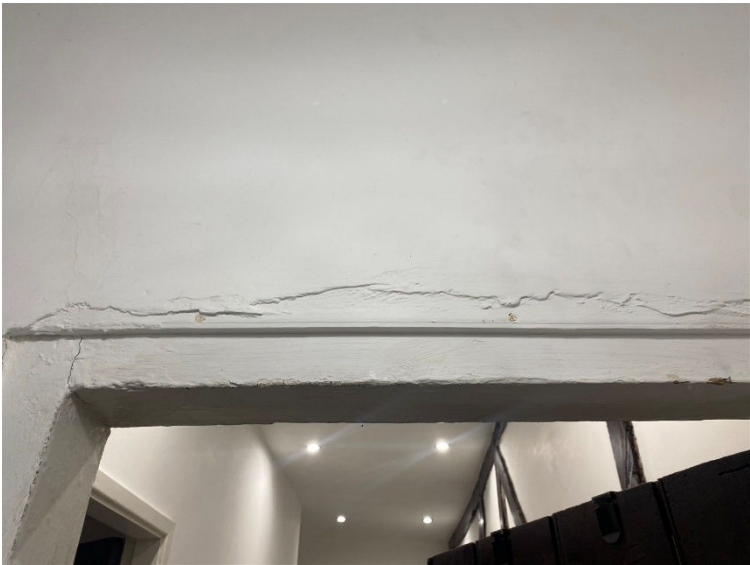
| Photo No | Photograph Description | Photograph |
|---|---|---|
| 36. | <b>East stairs</b><br>Hairline crack in door surround | |

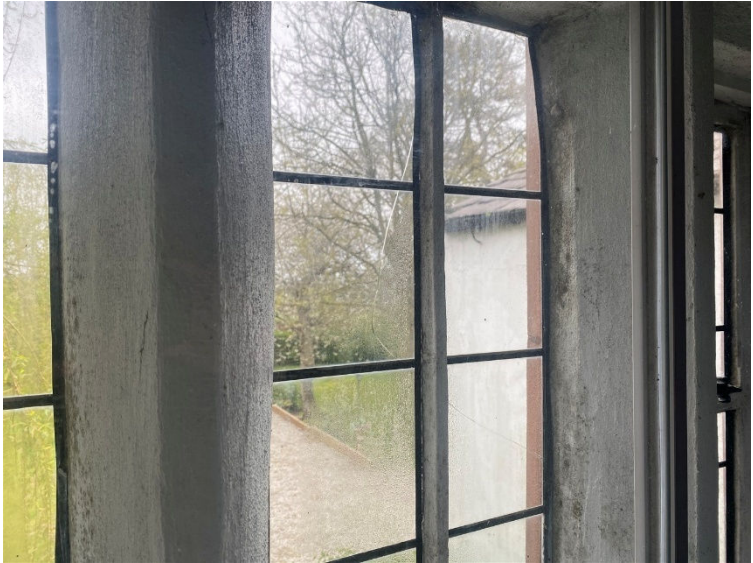
| Photo No | Photograph Description | Photograph |
|---|---|---|
| 39. | <b>East bedroom</b><br>Cracked windowpane | A photograph showing a window with a cracked pane. The window is set in a concrete frame, and the view outside shows trees and a building. |

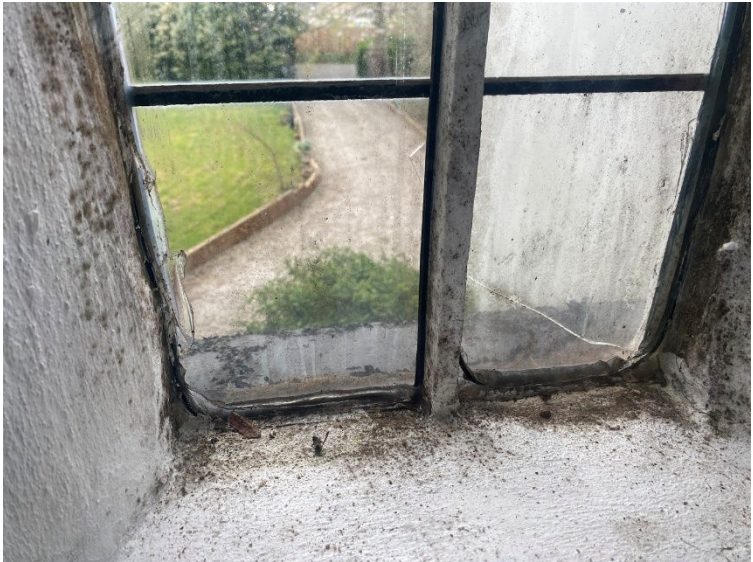
| Photo No | Photograph Description | Photograph |
|---|---|---|
| 40. | <b>East bedroom</b><br>Cracked windowpane | A photograph showing a window with a cracked pane. The window is set in a concrete frame, and the view outside shows a garden and a building. |

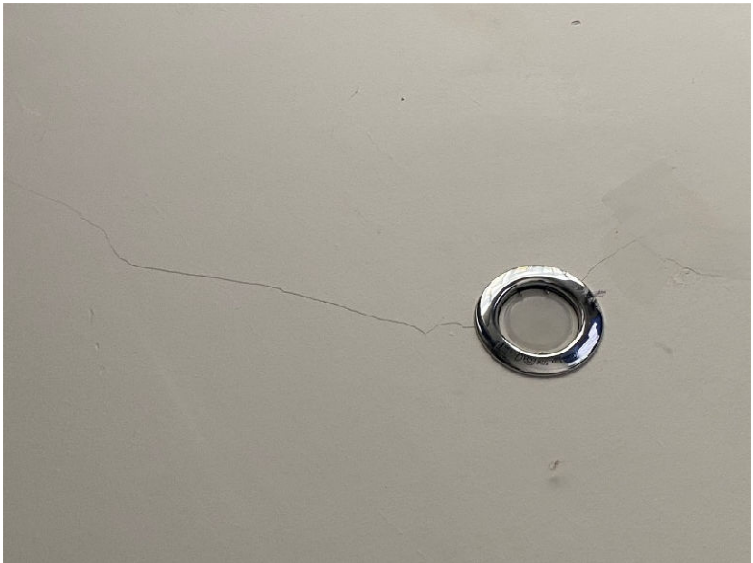
| Photo No | Photograph Description | Photograph |
|---|---|---|
| 41. | Hairline crack through ceiling<br>light fitting | A photograph showing a hairline crack in a ceiling. The crack runs horizontally across the ceiling, passing through a circular light fitting. |

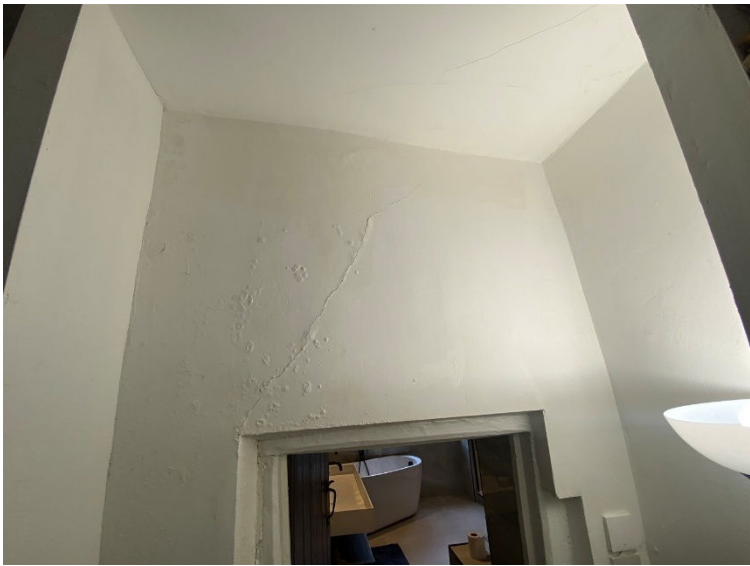
| Photo No | Photograph Description | Photograph |
|---|---|---|
| 43. | <b>East bedroom - walk-in wardrobe</b><br>Diagonal crack above door between wall in wardrobe and bathroom and crack to ceiling above | |

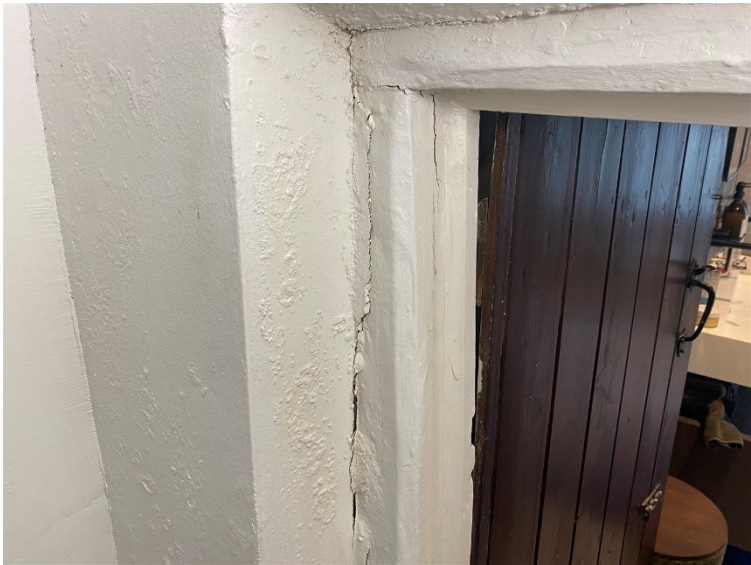
| Photo No | Photograph Description | Photograph |
|---|---|---|
| 45. | <b>East bedroom - walk-in wardrobe</b><br><br>Crack between door frame and door reveal | |

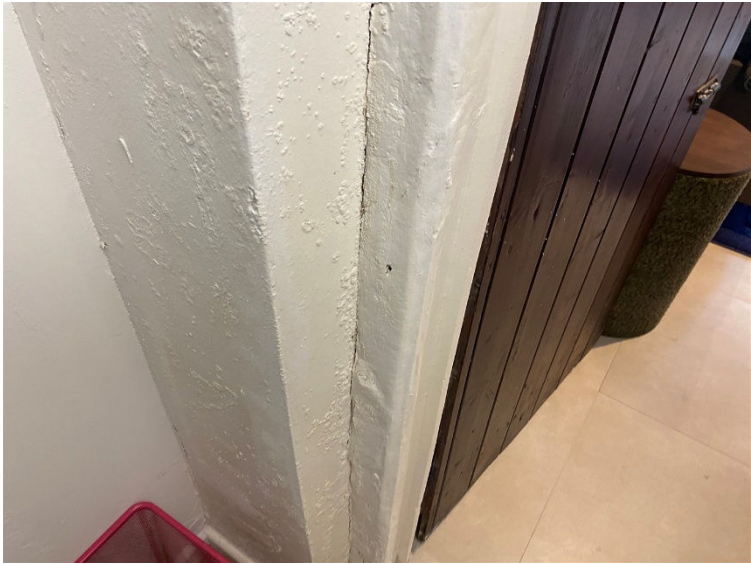
| Photo No | Photograph Description | Photograph |
|---|---|---|
| 46. | <b>East bedroom - walk-in wardrobe</b><br><br>Crack between door frame and door reveal | |

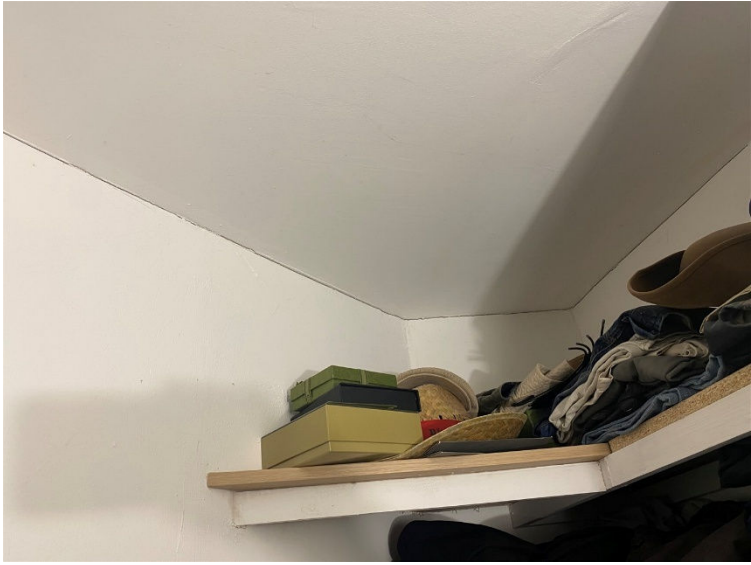
| Photo No | Photograph Description | Photograph |
|---|---|---|
| 47. | <b>East bedroom - walk-in wardrobe</b><br><br>Crack at junction between wall and ceiling | |

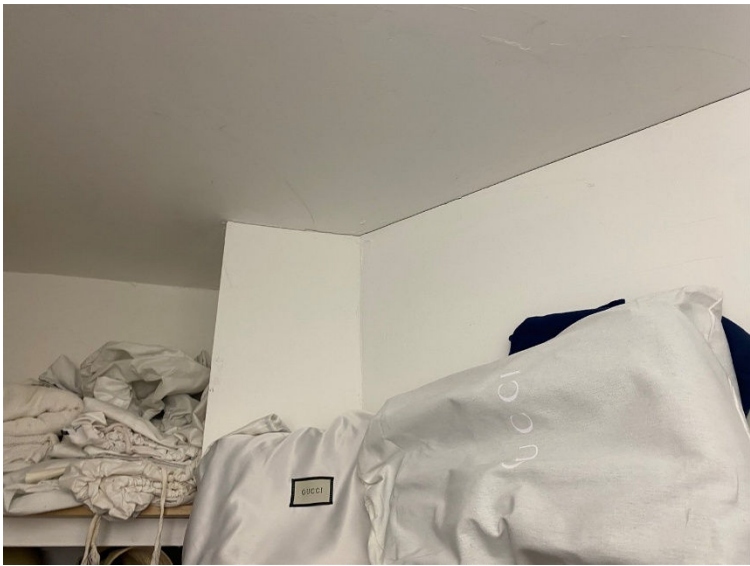
| Photo No | Photograph Description | Photograph |
|---|---|---|
| 49. | <b>East bedroom - walk-in wardrobe</b><br>Crack at junction between wall and ceiling | |

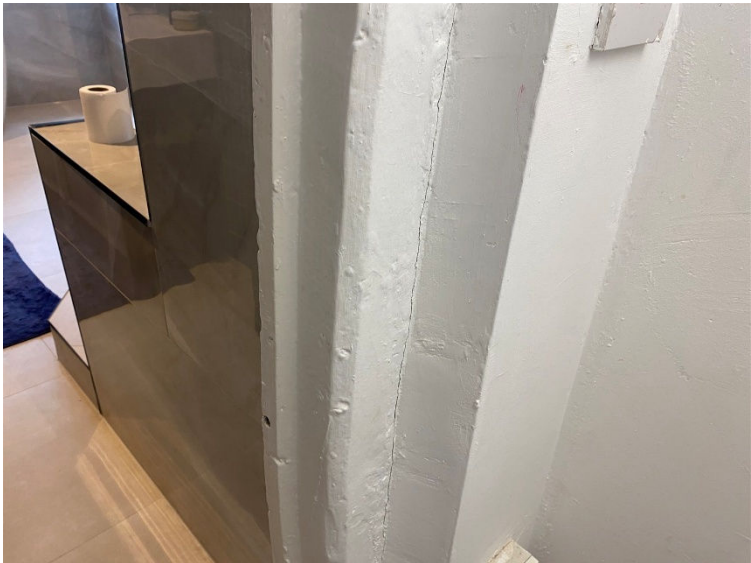
| Photo No | Photograph Description | Photograph |
|---|---|---|
| 51. | <b>East bedroom - walk-in wardrobe</b><br><br>Crack at junction between door frame and door reveal | |

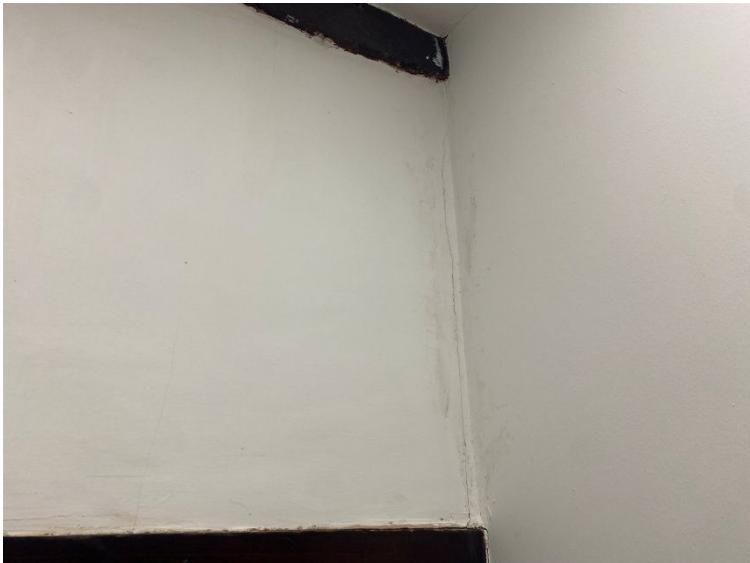
| Photo No | Photograph Description | Photograph |
|---|---|---|
| 60. | <b>Landing</b><br>Filled crack to internal corner to right hand side of door opening | |

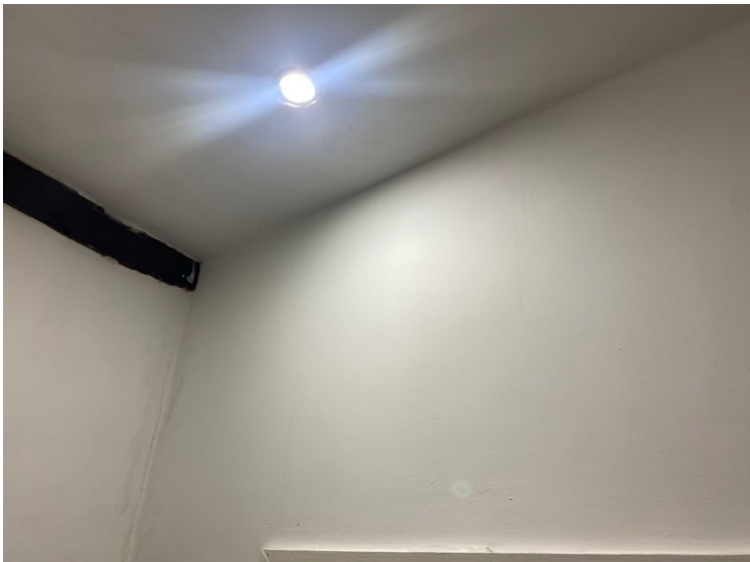
| Photo No | Photograph Description | Photograph |
|---|---|---|
| 61. | <b>Landing</b><br>Hairline crack at junction between wall and ceiling above door to bedroom | |

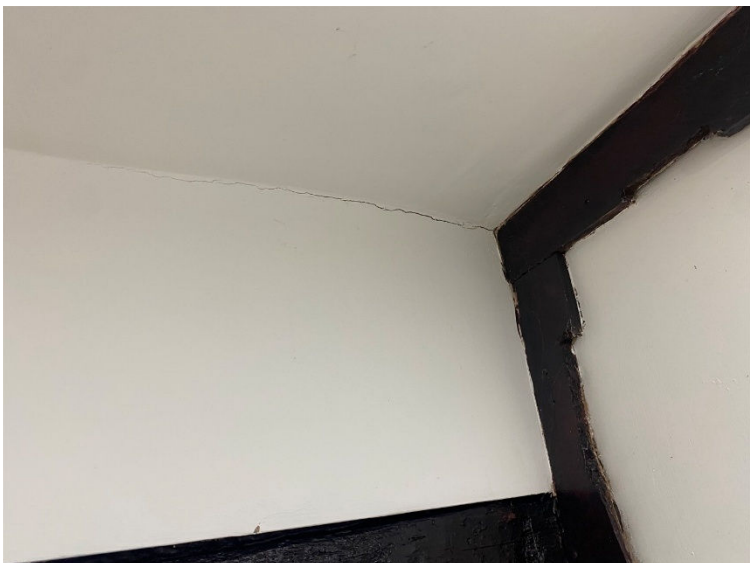
| Photo No | Photograph Description | Photograph |
|---|---|---|
| 62. | <b>Landing</b><br>Crack to junction between wall and ceiling above door opening in middle of landing | |

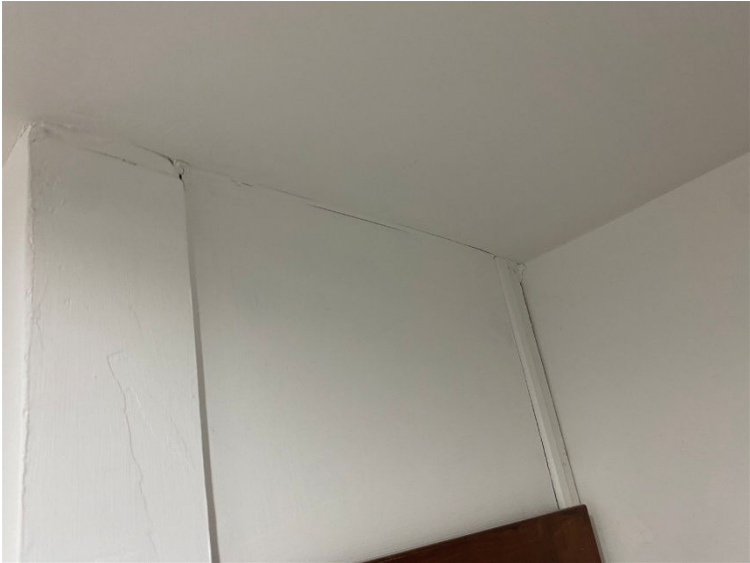
| Photo No | Photograph Description | Photograph |
|---|---|---|
| 63. | <b>Landing</b><br>Vertical hairline crack to wall on left side of photo | |

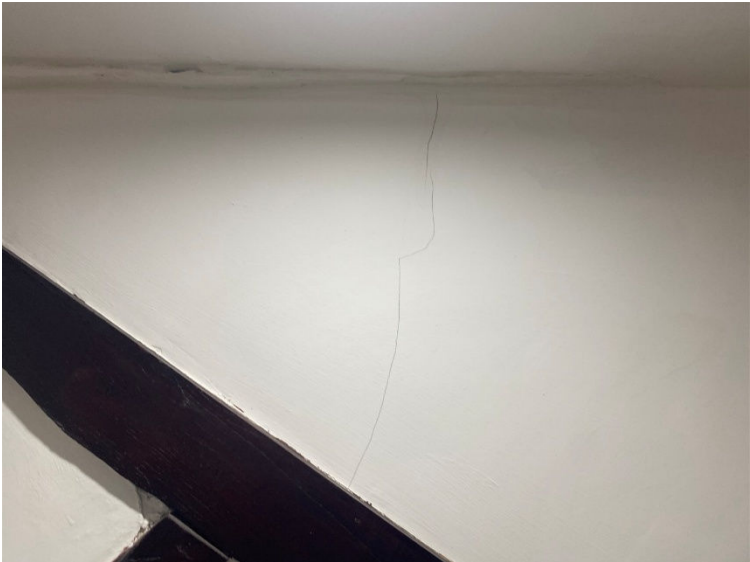
| Photo No | Photograph Description | Photograph |
|---|---|---|
| 64. | <b>Landing</b><br>Vertical hairline crack | |

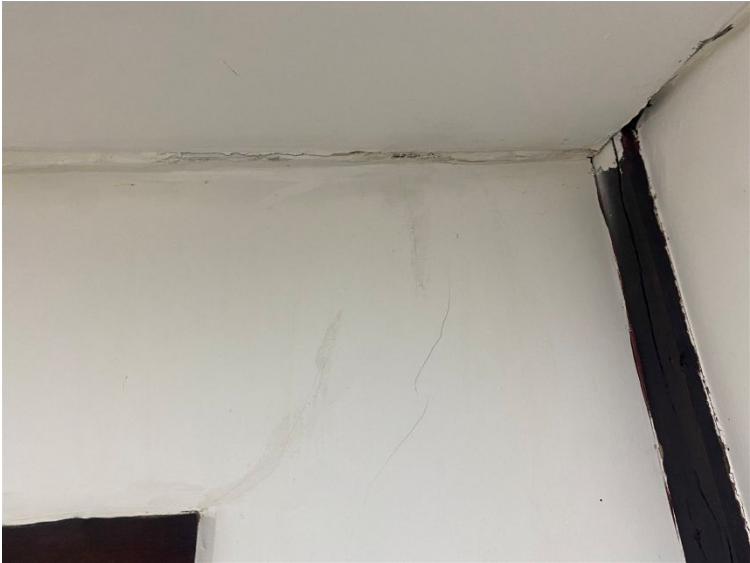
| Photo No | Photograph Description | Photograph |
|---|---|---|
| 66. | <b>Landing</b><br>Filled and open hairline cracks to right of door | |

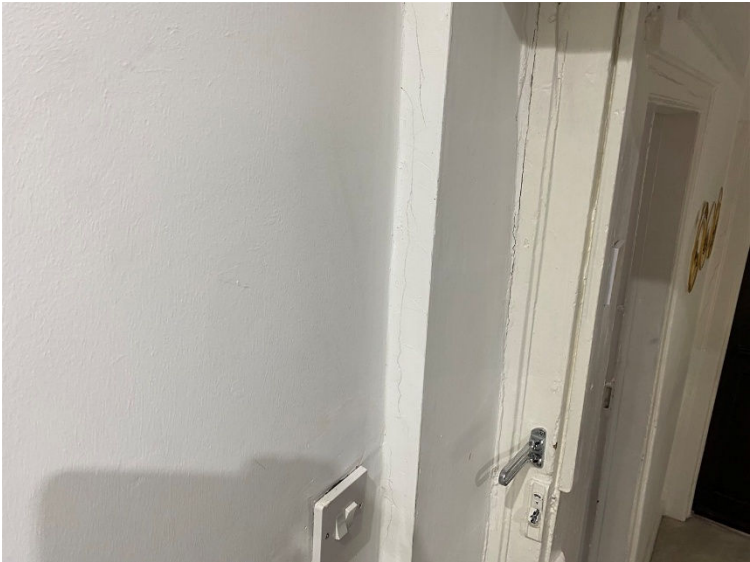
| Photo No | Photograph Description | Photograph |
|---|---|---|
| 67. | <b>Landing</b><br>Vertical hairline cracking adjacent light switch and door frame | |

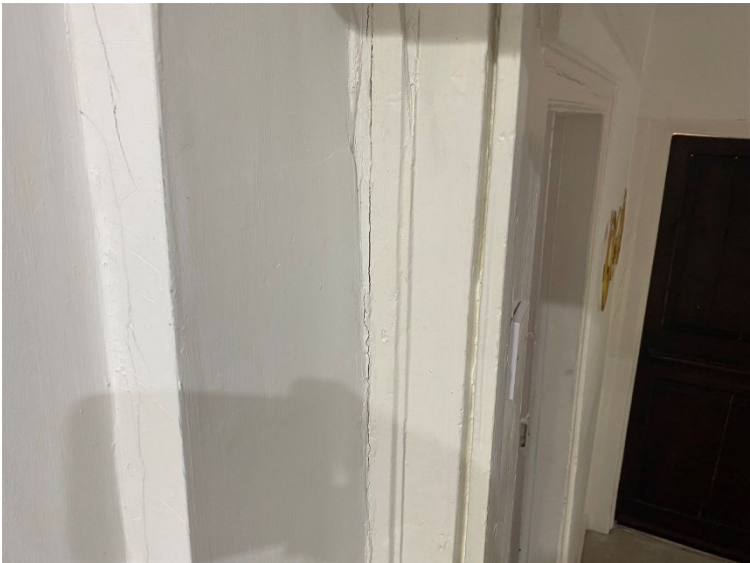
| Photo No | Photograph Description | Photograph |
|---|---|---|
| 68. | <b>Landing</b><br>Close up of cracking from previous photo | |

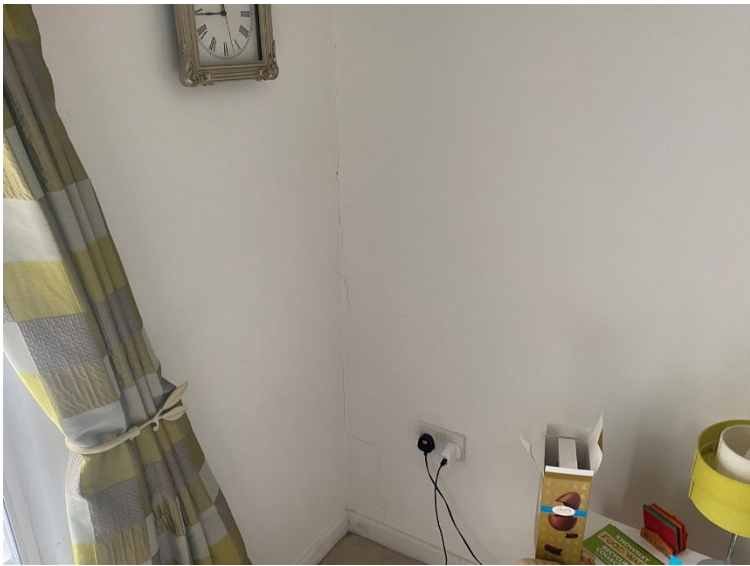
| Photo No | Photograph Description | Photograph |
|---|---|---|
| 79. | <b>Middle bedroom</b><br>Crack to internal corner, stepping out towards power socket at low level | |

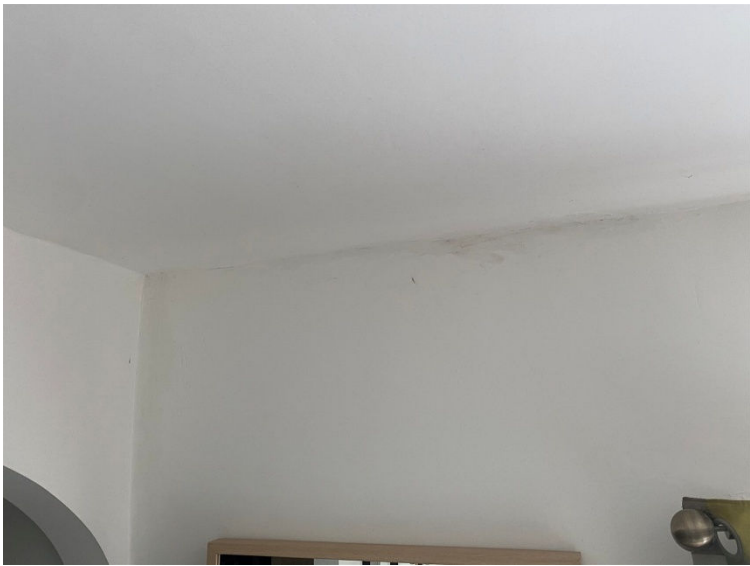
| Photo No | Photograph Description | Photograph |
|---|---|---|
| 82. | <b>Middle bedroom</b><br>Filled crack at junction between wall and ceiling | A photograph showing a crack at the junction between a white wall and a white ceiling. The crack is filled with a light-colored material. A wooden headboard is visible in the foreground, and a small lamp is on the right. |

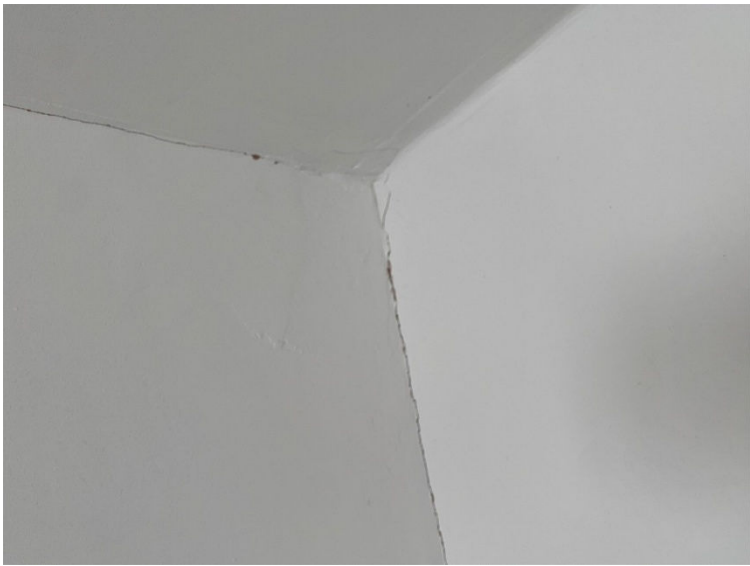
| Photo No | Photograph Description | Photograph |
|---|---|---|
| 88. | <b>Middle bedroom walk-in wardrobe</b><br><br>Hairline cracking at junction between wall and ceiling and internal corner | |

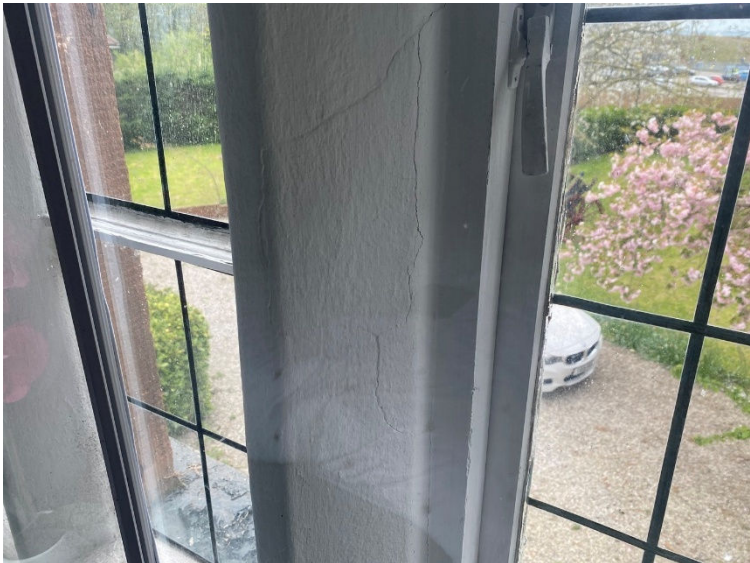
| Photo No | Photograph Description | Photograph |
|---|---|---|
| 90. | <b>Southwest bedroom</b><br>Vertical crack to mullion | A photograph showing a vertical crack in a grey wall, extending from the top of the frame down to a window mullion. The window has black frames and offers a view of a garden with green grass and pink flowering trees. A white car is partially visible in the background. |

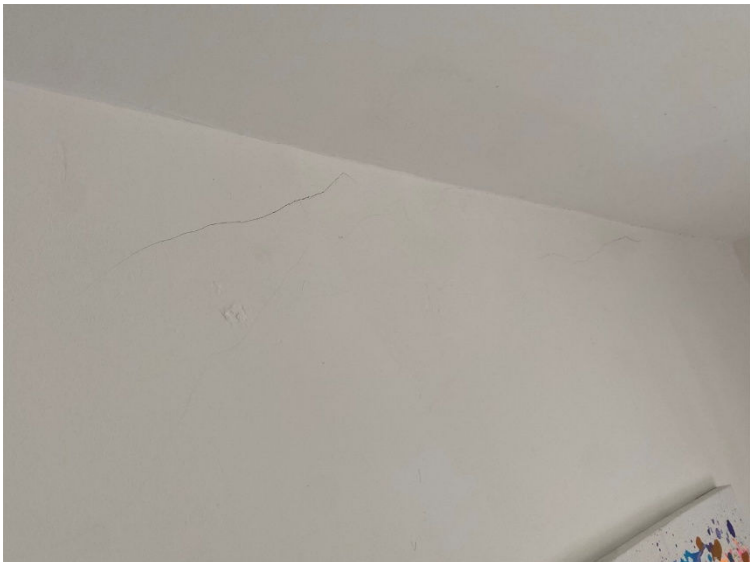
| Photo No | Photograph Description | Photograph |
|---|---|---|
| 91. | <b>Southwest bedroom</b><br>Diagonal hairline crack below ceiling | A photograph of a white wall with a diagonal hairline crack. The crack starts near the ceiling and extends downwards. The wall is otherwise plain and white. |

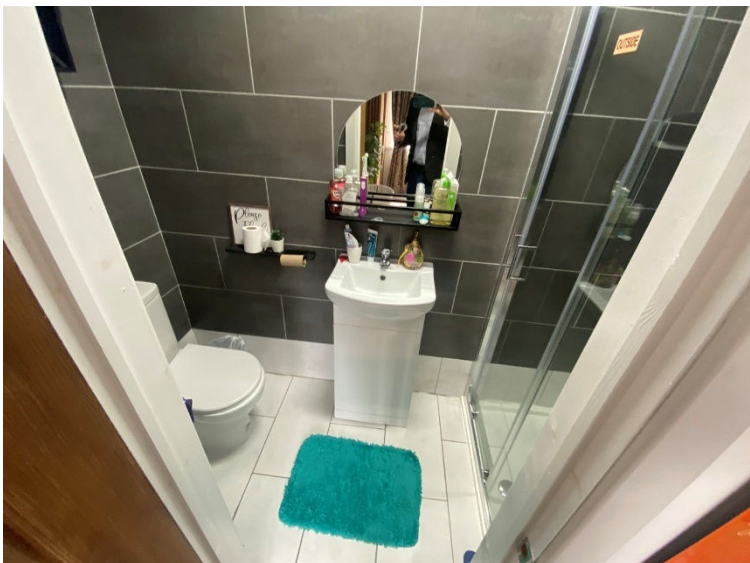
| Photo No | Photograph Description | Photograph |
|---|---|---|
| 92. | <b>Southwest bedroom en suite</b><br>General view<br>Hairline crack to full height of internal corner to left side of door to en suite | A photograph showing a general view of a bathroom. The room features dark grey wall tiles, a white pedestal sink, a white toilet, and a glass-enclosed shower area. A teal bath mat is on the floor. A mirror is mounted above the sink, and various toiletries are on a shelf above it. A hairline crack is visible on the wall to the left of the door frame. |

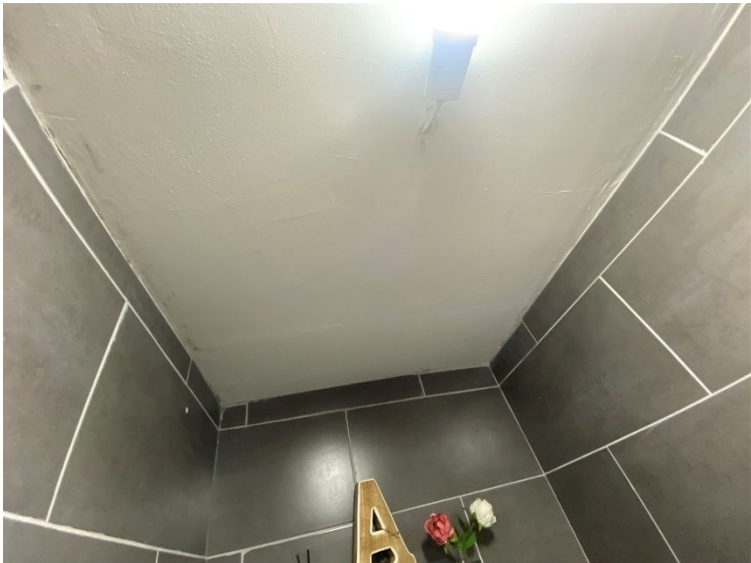
| Photo No | Photograph Description | Photograph |
|---|---|---|
| 96. | <b>Southwest bedroom en suite</b><br>Ceiling. Hairline crack along junction between wall and ceiling | |

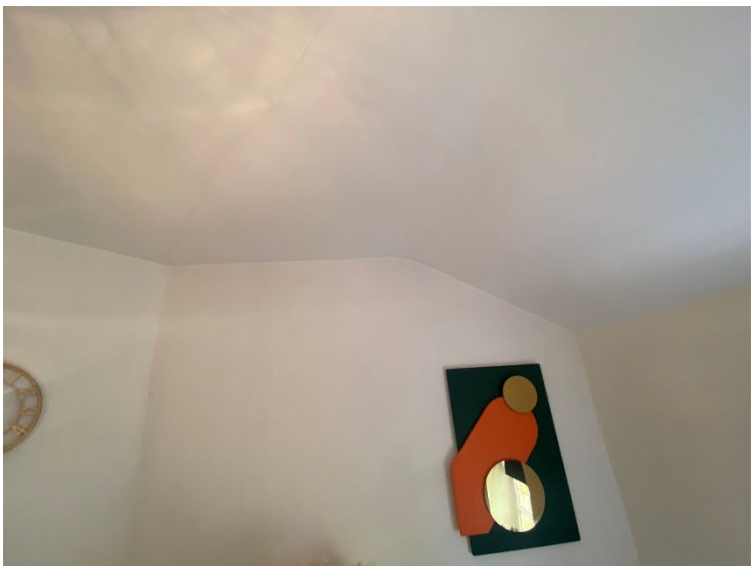
| Photo No | Photograph Description | Photograph |
|---|---|---|
| 101. | <b>Northwest bedroom</b><br>Hairline crack to ceiling approximately 1.5m long | |

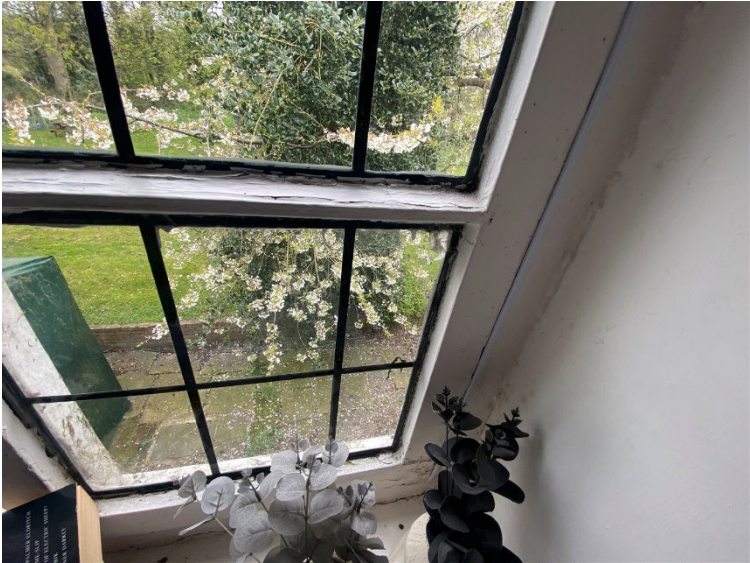
| Photo No | Photograph Description | Photograph |
|---|---|---|
| 105. | <b>Northwest bedroom</b><br>Two cracked windowpanes | |

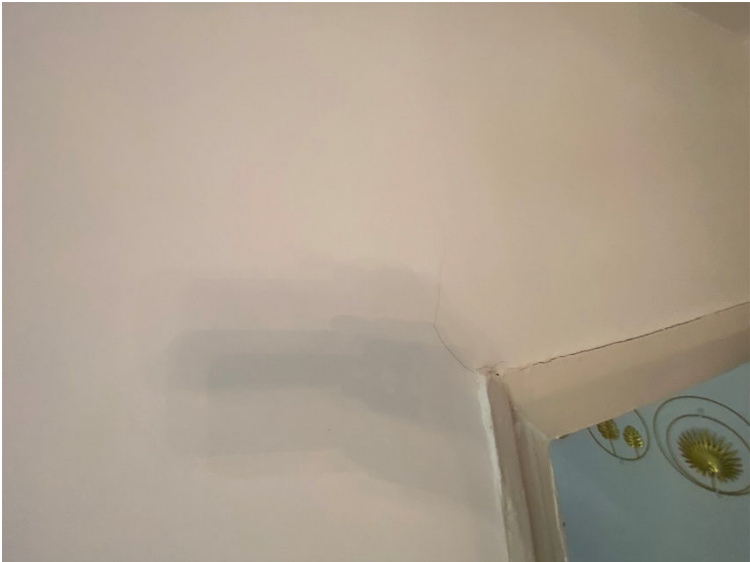
| Photo No | Photograph Description | Photograph |
|---|---|---|
| 106. | <b>Northwest bedroom</b><br>Hairline cracking to top left of door | |

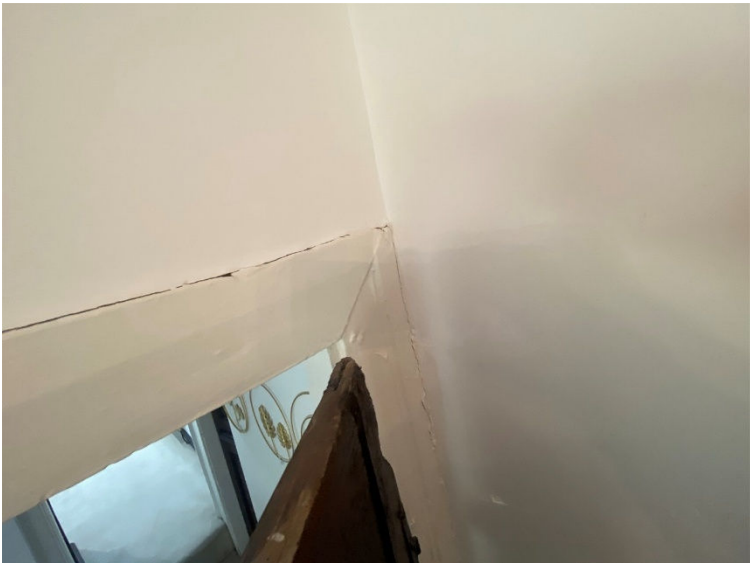
| Photo No | Photograph Description | Photograph |
|---|---|---|
| 107. | <b>Northwest bedroom</b><br>Cracking between architrave and wall | |

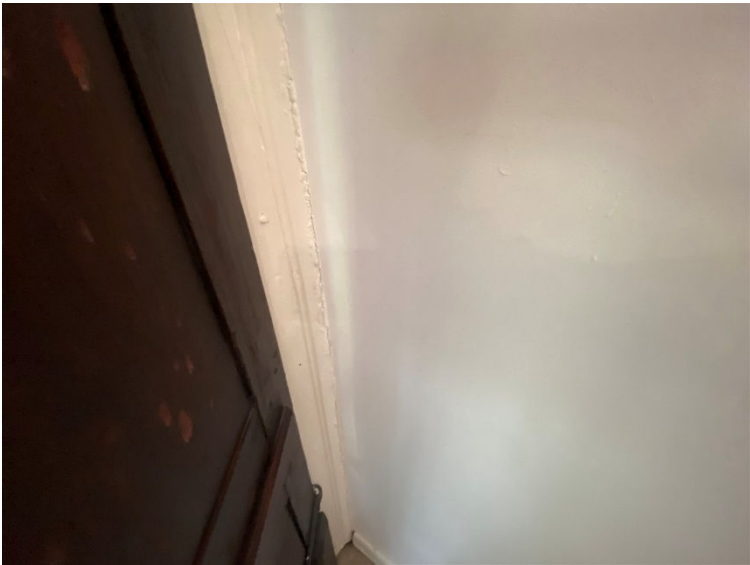
| Photo No | Photograph Description | Photograph |
|---|---|---|
| 108. | <b>Northwest bedroom</b><br>Cracking between architrave and wall | |

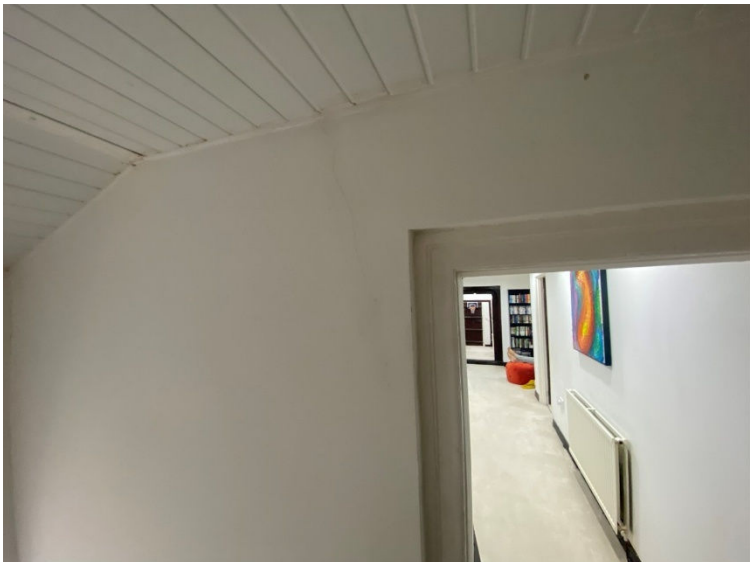
| Photo No | Photograph Description | Photograph |
|---|---|---|
| 112. | <b>West stairs</b><br>Hairline crack to left of door to corridor | |

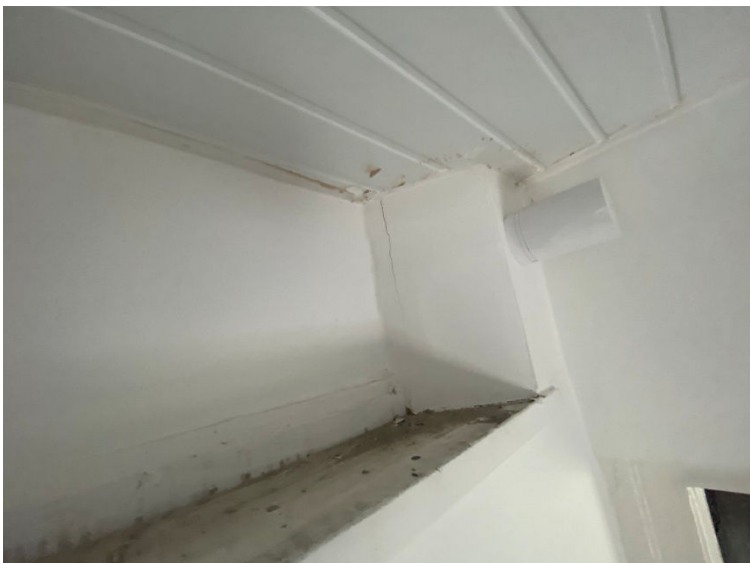
| Photo No | Photograph Description | Photograph |
|---|---|---|
| 113. | <b>West stairs</b><br>Vertical crack to recess to left of door to small bedroom | |

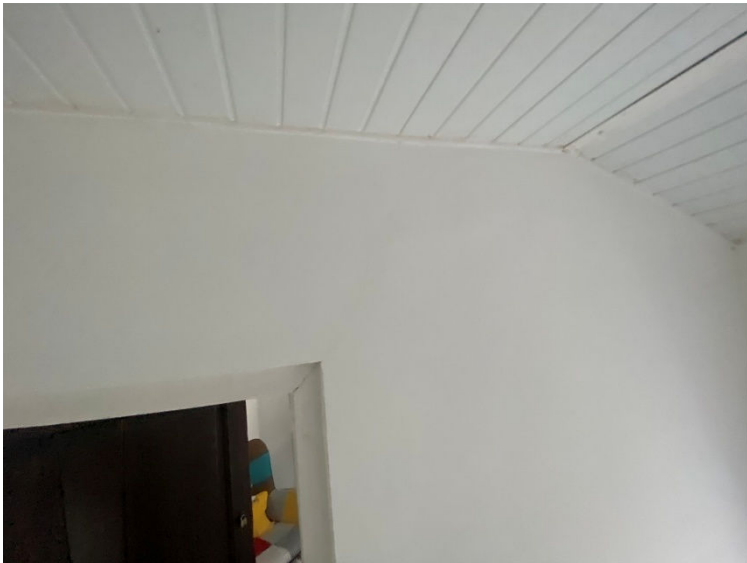
| Photo No | Photograph Description | Photograph |
|---|---|---|
| 114. | <b>West stairs</b><br>Hairline crack to right of door | |
