# Photographic Schedule of Condition

Old Halsnead Hall, Fox's Bank Lane, Widnes, Prescot L35 3SU

April 2026

Doc Ref: 04C600152

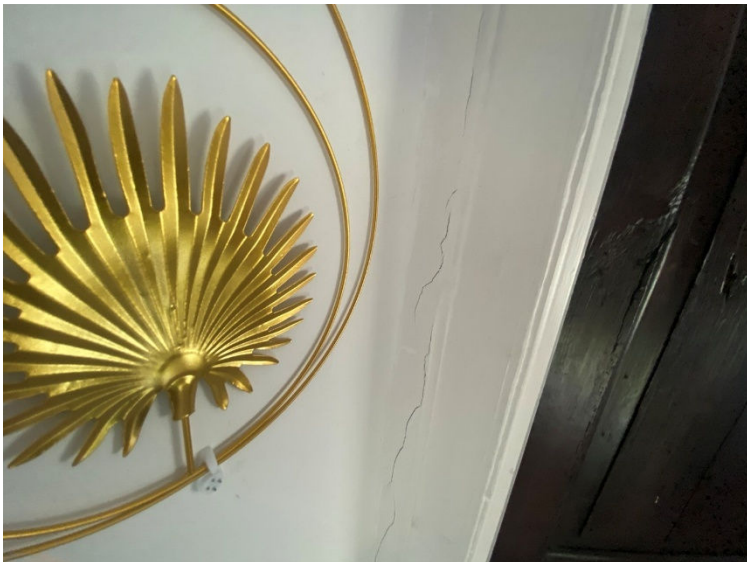
| Photo No | Photograph Description | Photograph |
|---|---|---|
| 115. | <b>West stairs</b><br>Vertical cracking to left of door | |

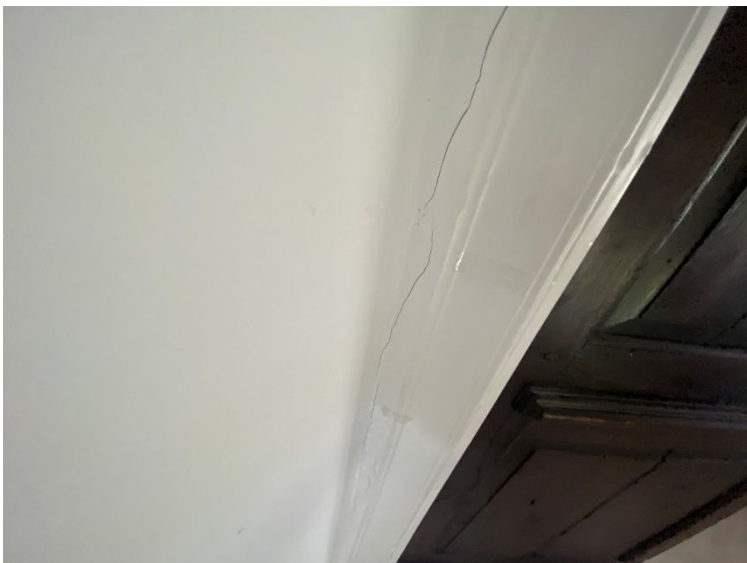
| Photo No | Photograph Description | Photograph |
|---|---|---|
| 116. | <b>West stairs</b><br>Vertical cracking to left of door | |

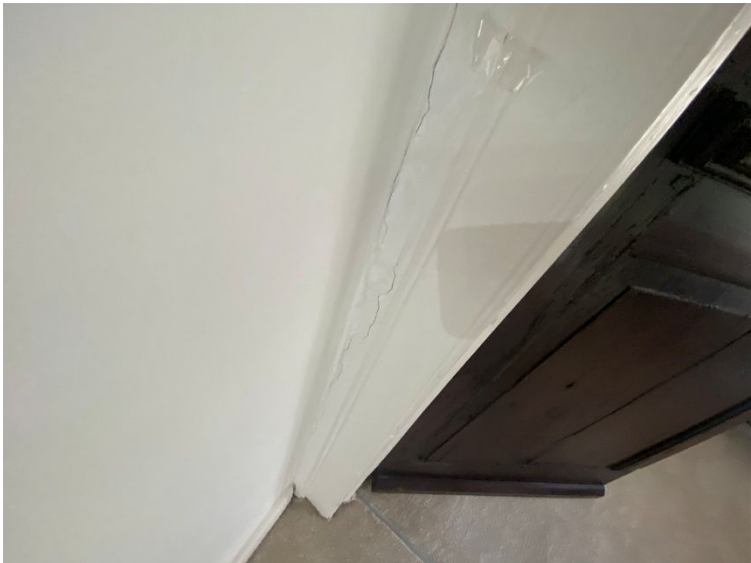
| Photo No | Photograph Description | Photograph |
|---|---|---|
| 117. | <b>West stairs</b><br>Vertical cracking to left of door | |

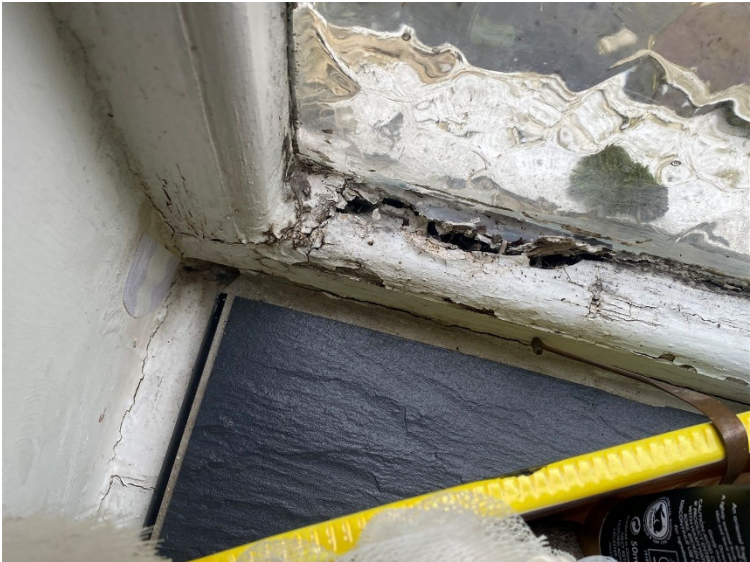
| Photo No | Photograph Description | Photograph |
|---|---|---|
| 121. | <b>Southwest ground floor bathroom</b><br>Rot to window frame | A close-up photograph showing significant structural damage and rot at the corner of a window frame. The wood is heavily decayed and crumbling. A yellow measuring tape is visible in the foreground, indicating the extent of the damage. |

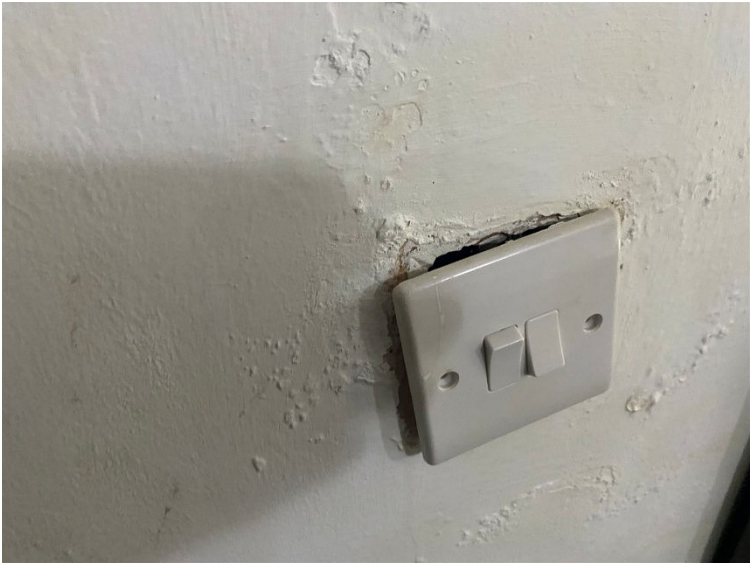
| Photo No | Photograph Description | Photograph |
|---|---|---|
| 127. | <b>Lounge</b><br>Screws missing to light switch | A close-up photograph of a white light switch plate mounted on a wall. The wall surface is textured and shows signs of wear, including peeling paint and small holes. The light switch plate is slightly recessed into the wall, and the screws that would normally hold it in place are missing. |

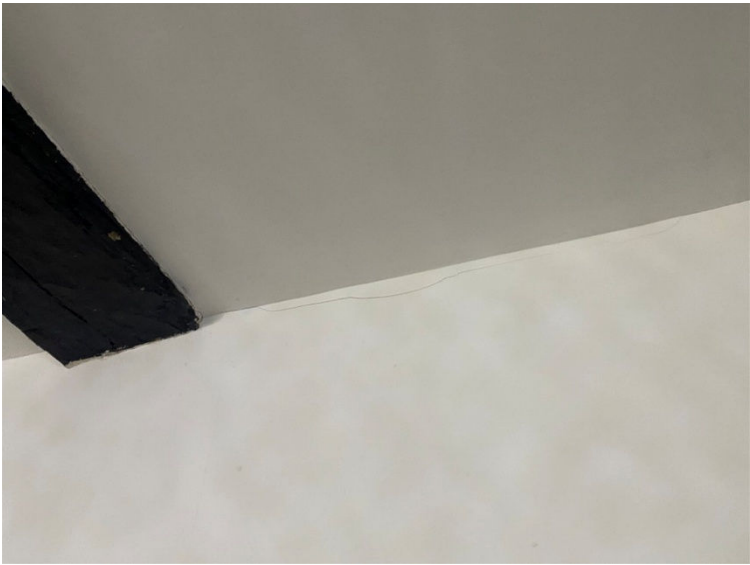
| Photo No | Photograph Description | Photograph |
|---|---|---|
| 128. | <b>Lounge</b><br>Hairline crack at junction between wall and ceiling | A close-up photograph of the junction between a wall and a ceiling. A thin, hairline crack is visible running along the edge where the wall meets the ceiling. The wall is painted a light color, and the ceiling is also light-colored. |

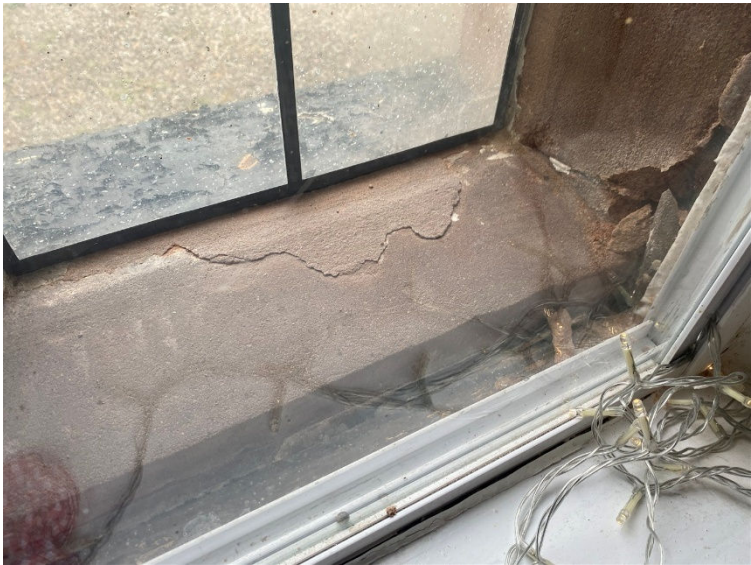
| Photo No | Photograph Description | Photograph |
|---|---|---|
| 129. | <b>Lounge</b><br>Cracking to stone window surround | |

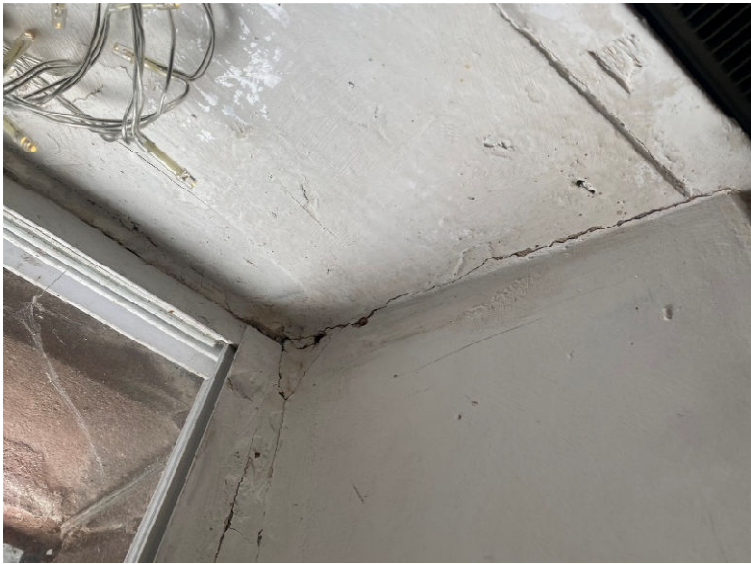
| Photo No | Photograph Description | Photograph |
|---|---|---|
| 130. | <b>Lounge</b><br>Cracking around windowsill | |

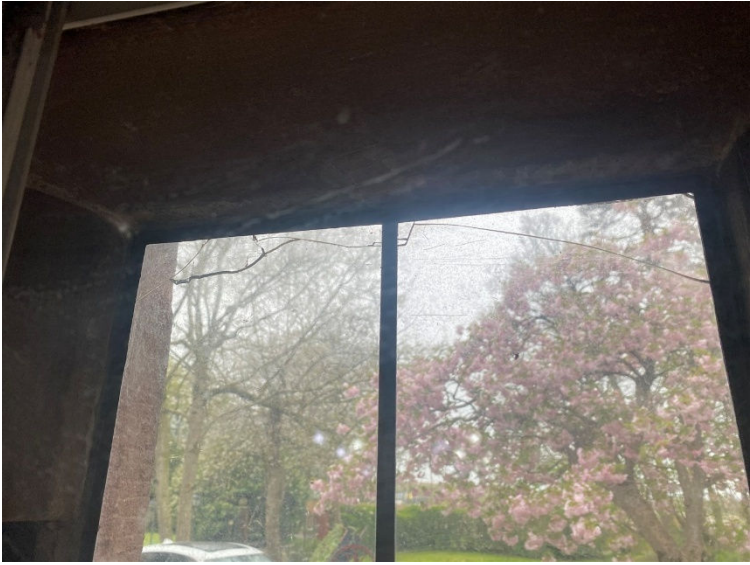
| Photo No | Photograph Description | Photograph |
|---|---|---|
| 134. | <b>TV room</b><br>Cracked windowpane | A close-up photograph of a windowpane, showing a significant crack running diagonally across the glass. The view outside the window shows trees and a car. |

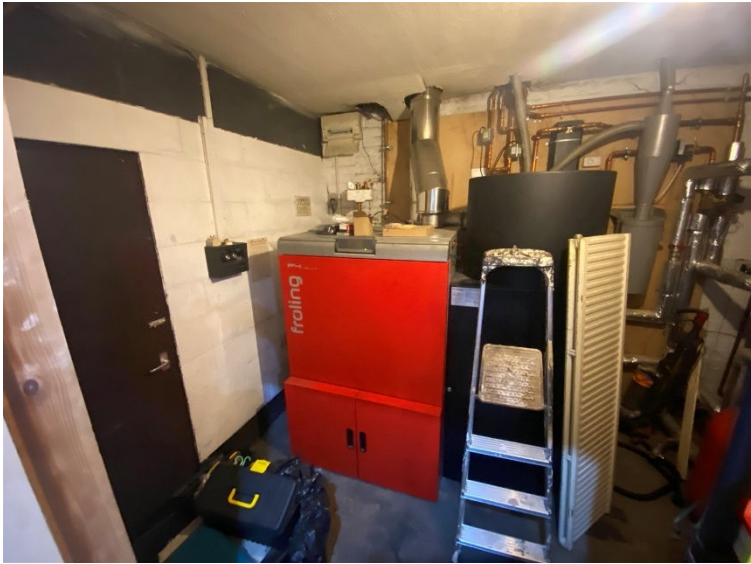
| Photo No | Photograph Description | Photograph |
|---|---|---|
| 148. | <b>Boiler room</b><br>General view<br>Vertical cracks to wall behind boiler | A photograph of a boiler room. A large red boiler is the central feature. To its right is a silver metal ladder. The walls are made of white-painted brick. There are various pipes and mechanical components visible in the background. |

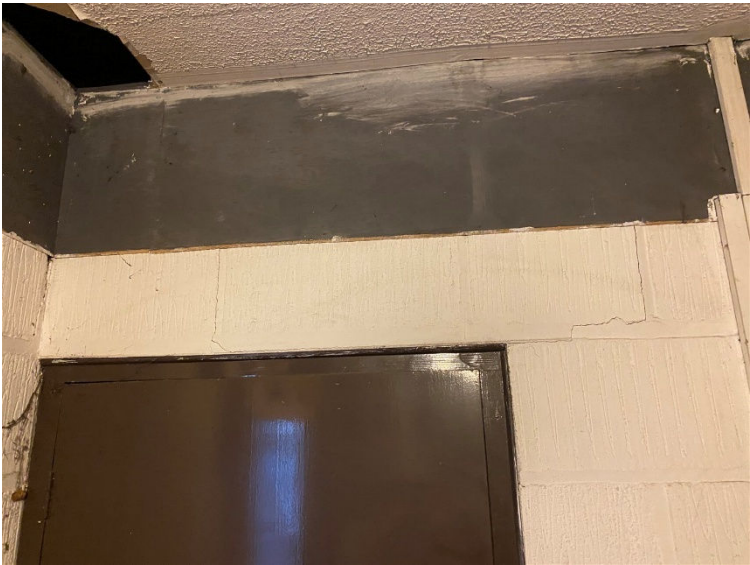
| Photo No | Photograph Description | Photograph |
|---|---|---|
| 150. | <b>Boiler room</b><br>Cracks to blockwork above door to sauna area | |

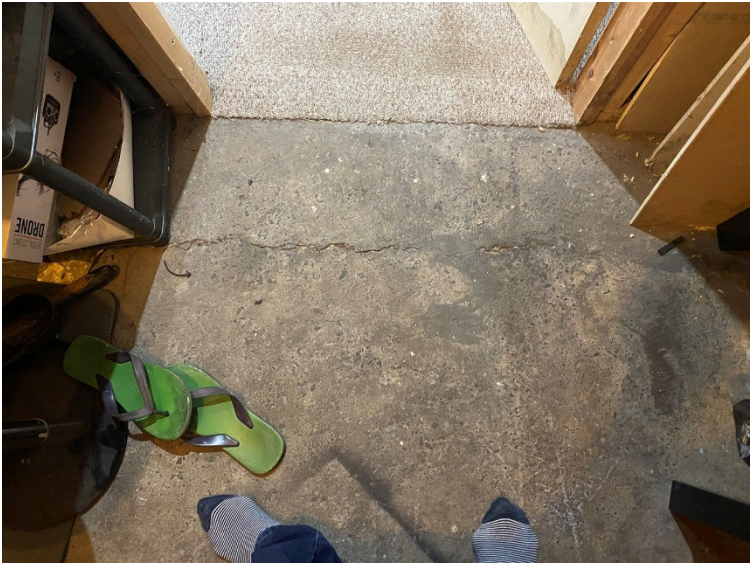
| Photo No | Photograph Description | Photograph |
|---|---|---|
| 151. | <b>Boiler room</b><br>Crack to floor | |

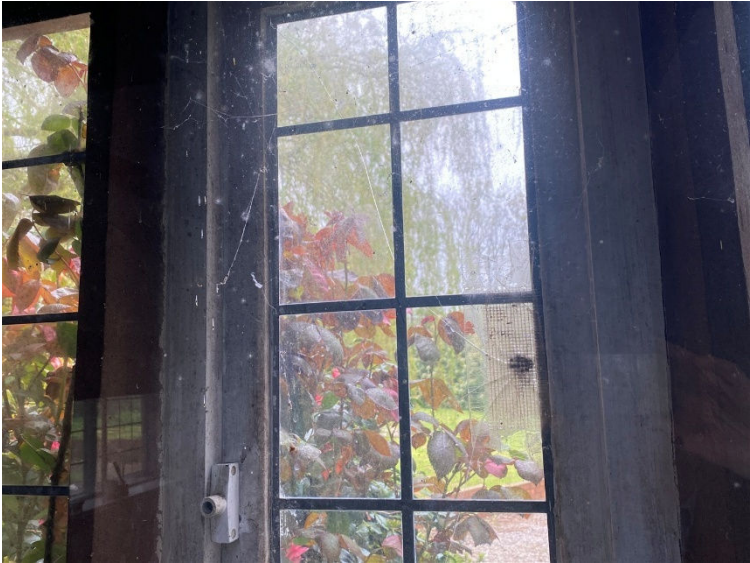
| Photo No | Photograph Description | Photograph |
|---|---|---|
| 156. | <b>Dining room</b><br>Crack to windowpane | |

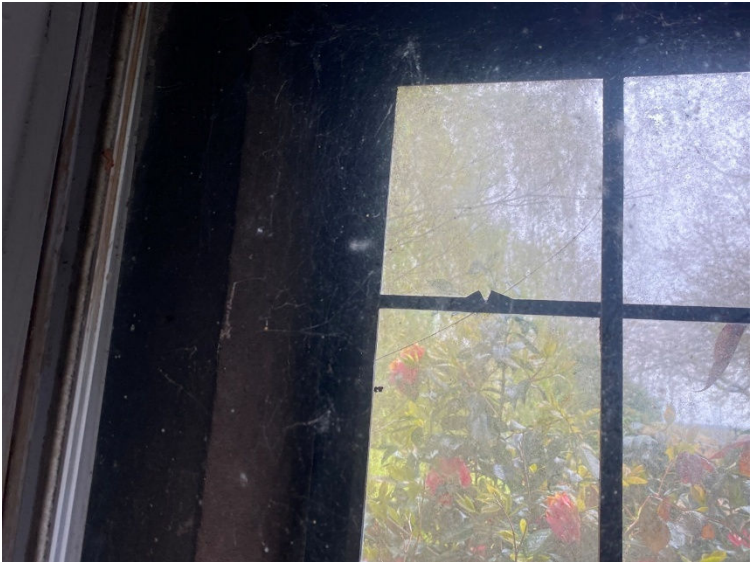
| Photo No | Photograph Description | Photograph |
|---|---|---|
| 157. | <b>Dining room</b><br>Cracked windowpane | |

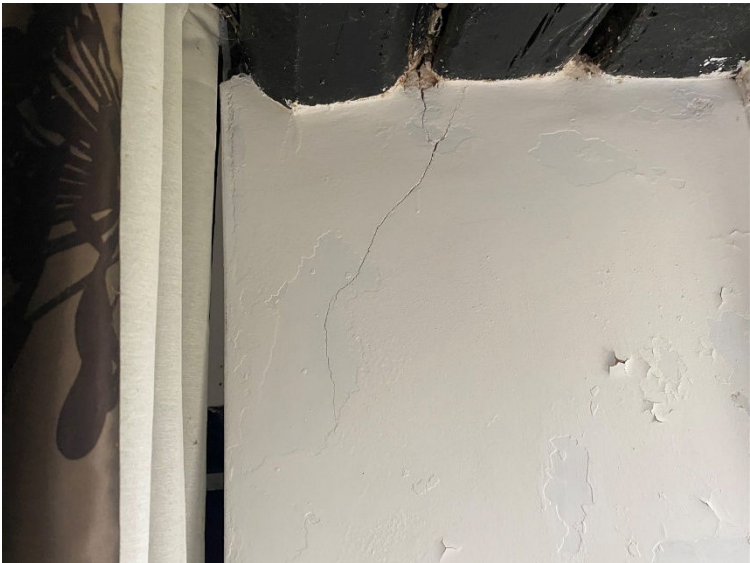
| Photo No | Photograph Description | Photograph |
|---|---|---|
| 158. | <b>Dining room</b><br>Crack adjacent window reveal | |

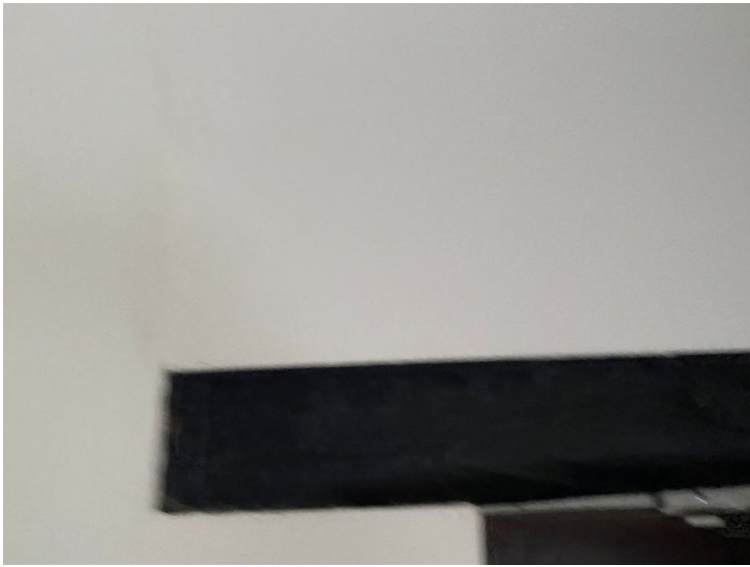
| Photo No | Photograph Description | Photograph |
|---|---|---|
| 159. | <b>Dining room</b><br>Filled cracks to both sides of lintel above external door | |

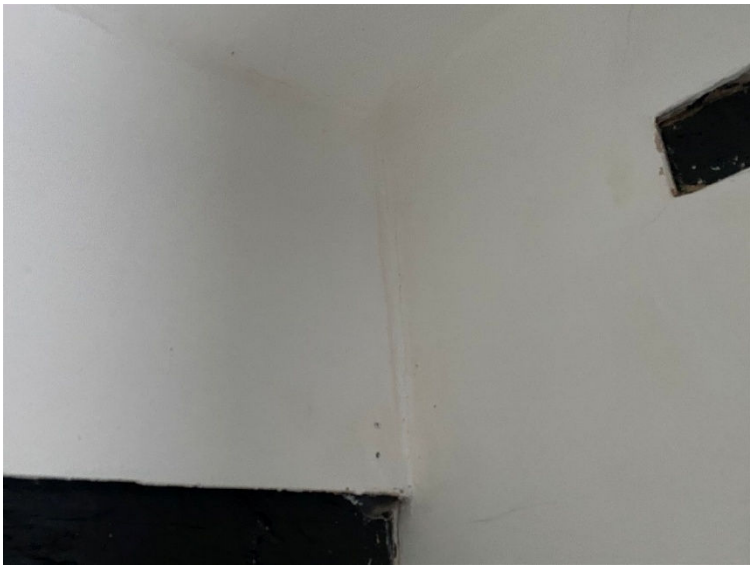
| Photo No | Photograph Description | Photograph |
|---|---|---|
| 160. | <b>Dining room</b><br>Filled crack above lintel to external door | |

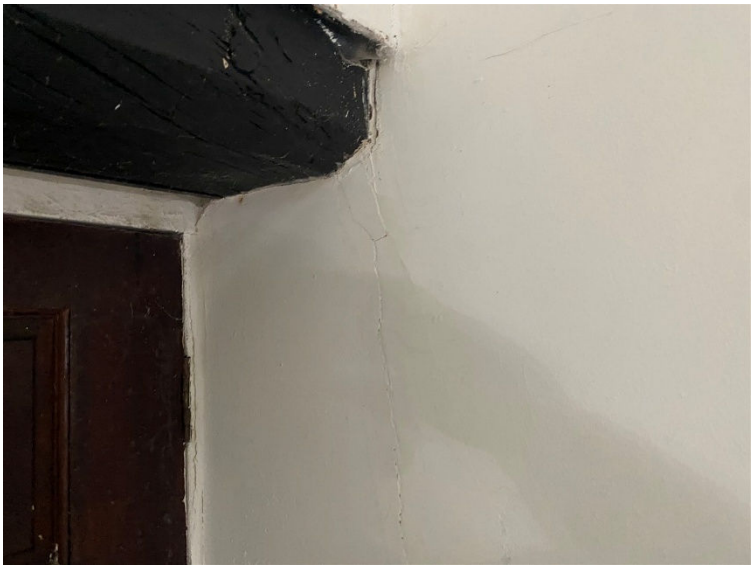
| Photo No | Photograph Description | Photograph |
|---|---|---|
| 166. | <b>Dining room</b><br>Crack below door lintel | A photograph showing a dark wooden door on the left. Above the door is a dark wooden lintel. A vertical crack is visible in the white plaster below the lintel. |

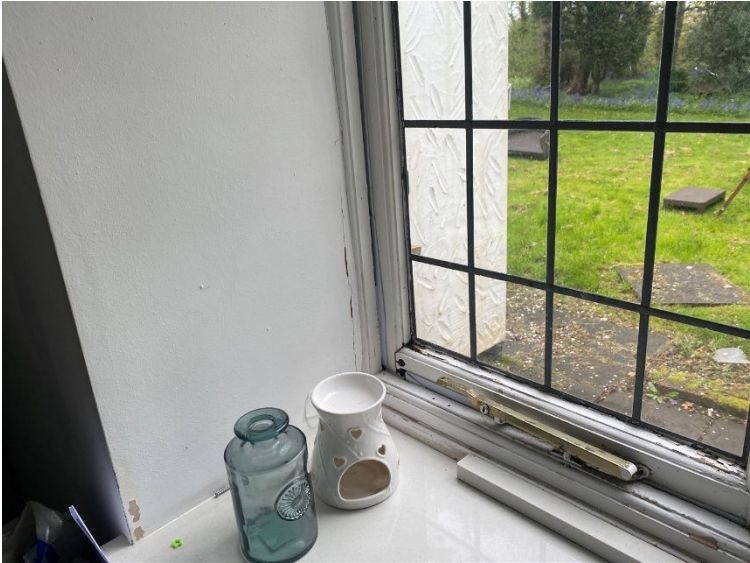
| Photo No | Photograph Description | Photograph |
|---|---|---|
| 177. | <b>Main kitchen</b><br>Cracking to window reveal | |

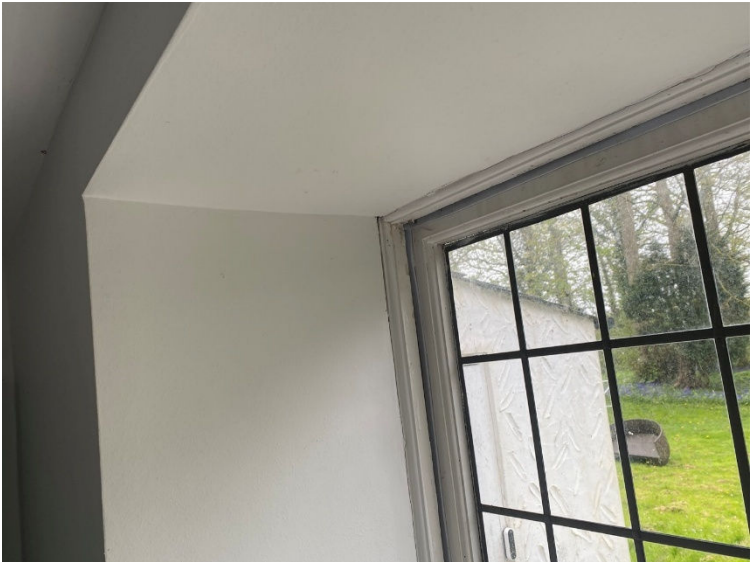
| Photo No | Photograph Description | Photograph |
|---|---|---|
| 178. | <b>Main kitchen</b><br>Cracks around window frame | |

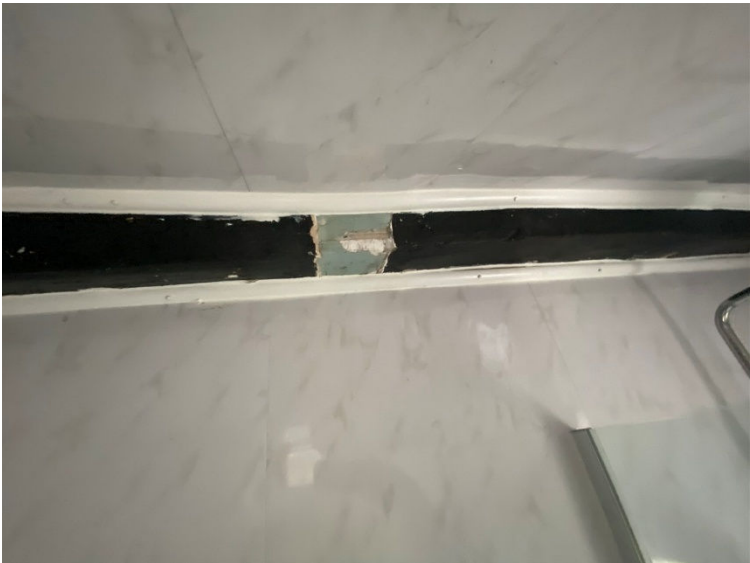
| Photo No | Photograph Description | Photograph |
|---|---|---|
| 182. | <b>Northwest ground floor bathroom</b><br>Poor finishing to ceiling beam | |

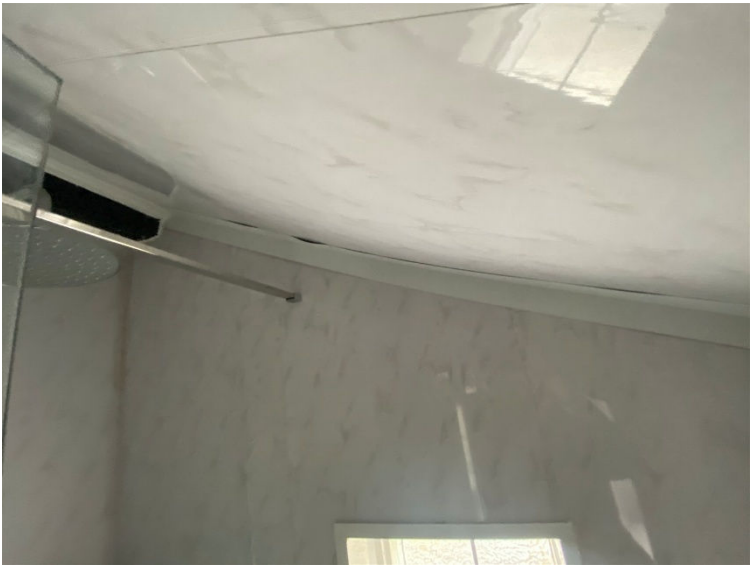
| Photo No | Photograph Description | Photograph |
|---|---|---|
| 183. | <b>Northwest ground floor bathroom</b><br><br>Open joints between corner trim and cladding | |

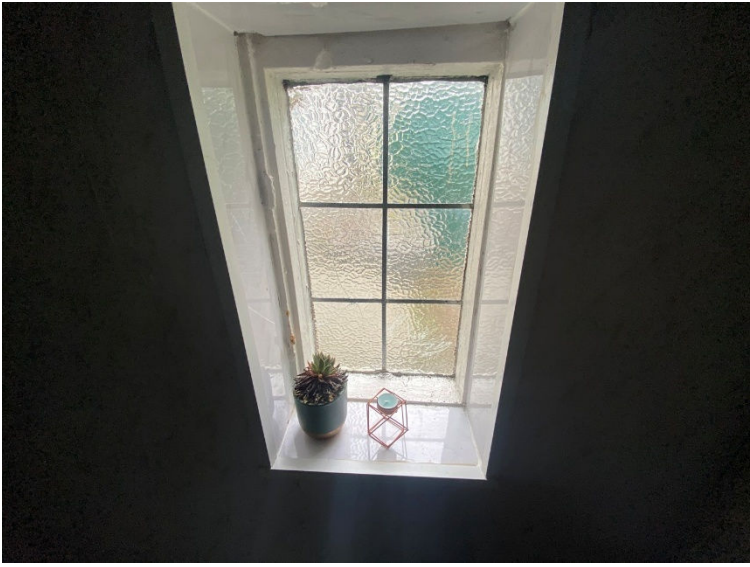
| Photo No | Photograph Description | Photograph |
|---|---|---|
| 184. | <b>Northwest ground floor bathroom</b><br><br>Cracked windowpane | |

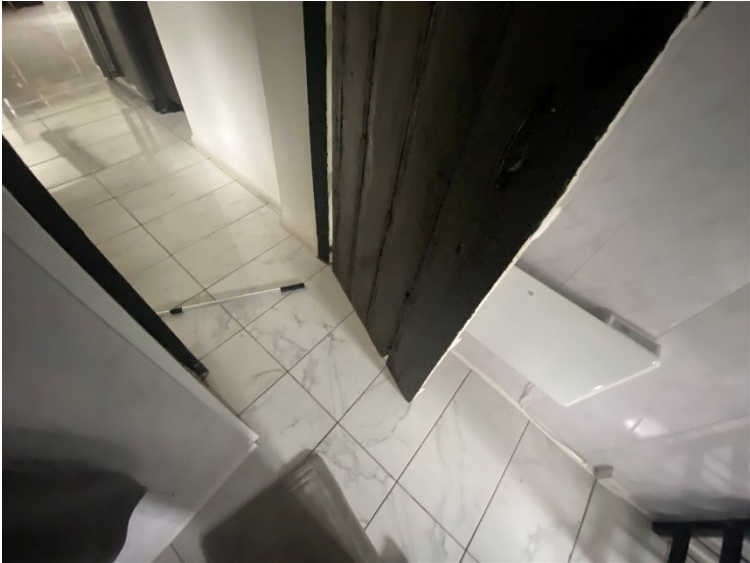
| Photo No | Photograph Description | Photograph |
|---|---|---|
| 186. | <b>Northwest ground floor bathroom</b><br>Door binding on floor | |

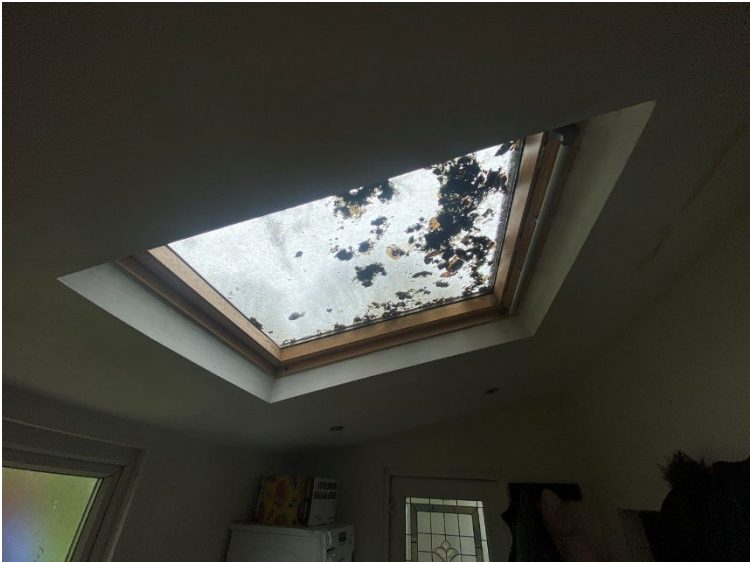
| Photo No | Photograph Description | Photograph |
|---|---|---|
| 190. | Soiled roof light | |

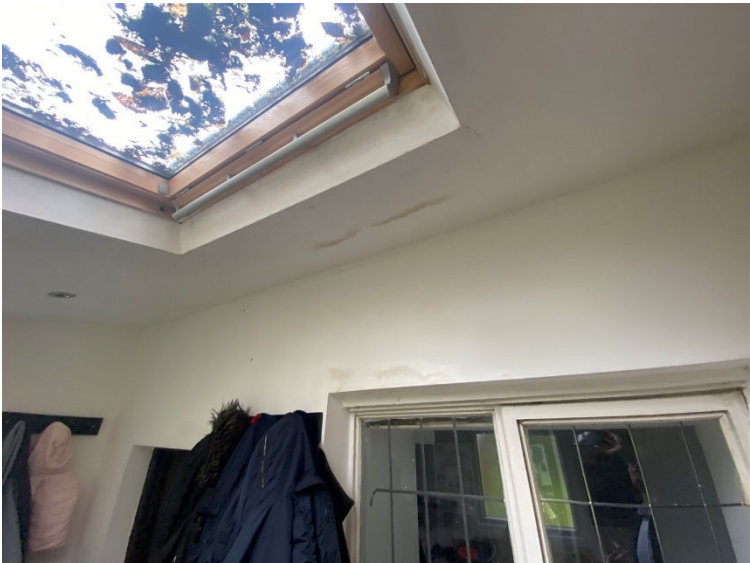
| Photo No | Photograph Description | Photograph |
|---|---|---|
| 191. | <b>Small kitchen</b><br>Water staining below Velux and open window reveal | |

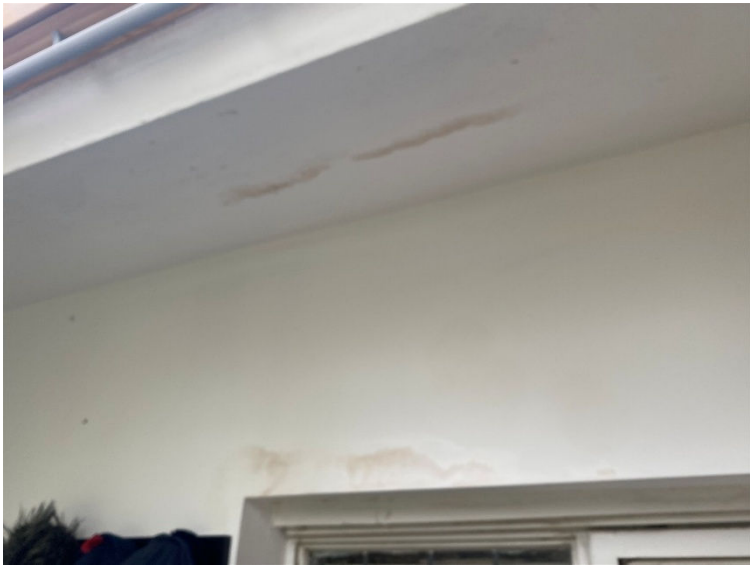
| Photo No | Photograph Description | Photograph |
|---|---|---|
| 192. | <b>Small kitchen</b><br>Close up of water staining | |

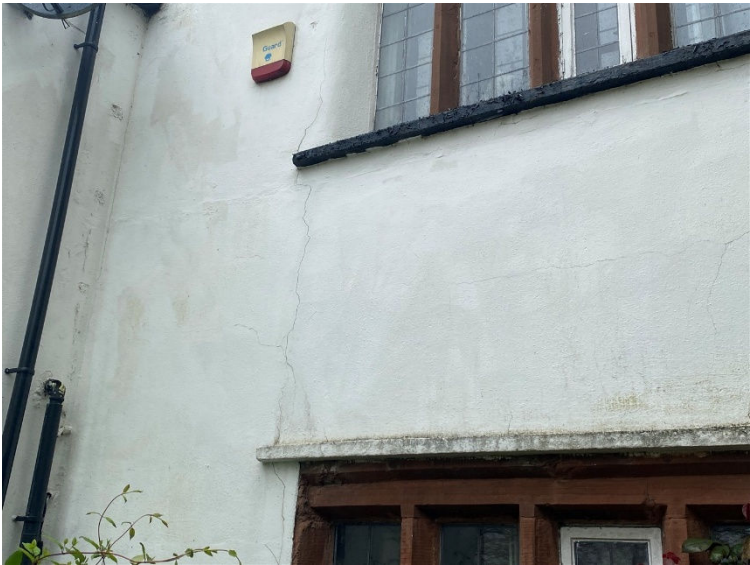
| Photo No | Photograph Description | Photograph |
|---|---|---|
| 195. | <b>Front elevation</b><br>Vertical and horizontal cracking between ground and first floor windows | |

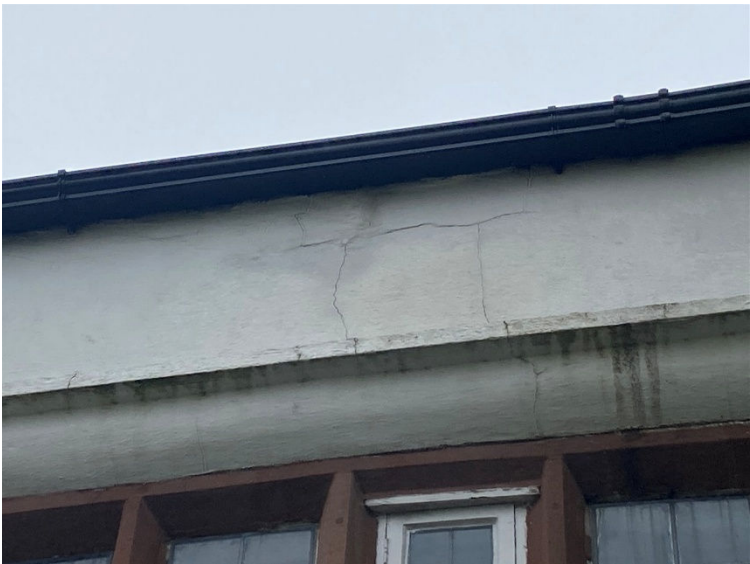
| Photo No | Photograph Description | Photograph |
|---|---|---|
| 196. | <b>Front elevation</b><br>Cracking at high level | |

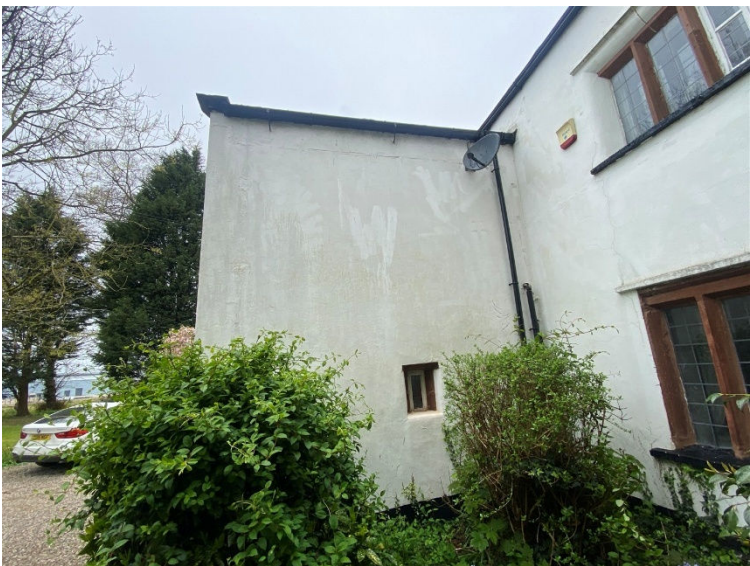
| Photo No | Photograph Description | Photograph |
|---|---|---|
| 197. | <b>Front elevation</b><br>Cracking to right side of porch | |

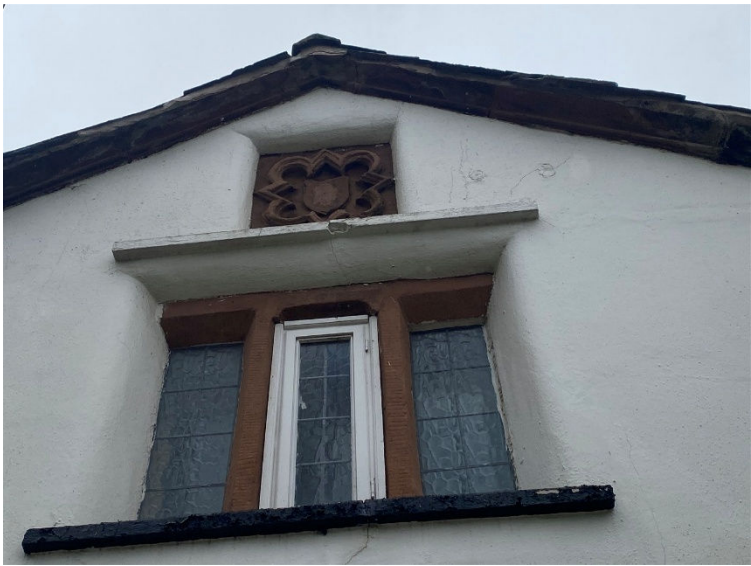
| Photo No | Photograph Description | Photograph |
|---|---|---|
| 199. | <b>Front elevation</b><br>Crack to lintel above porch first floor window | |

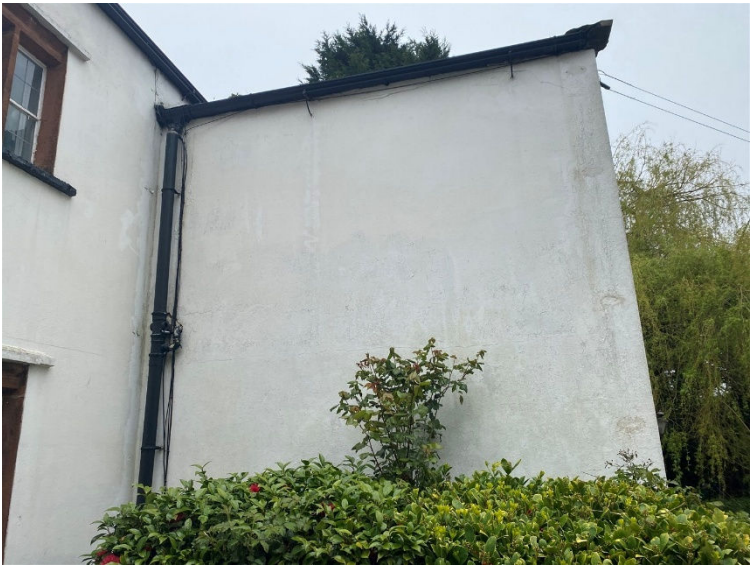
| Photo No | Photograph Description | Photograph |
|---|---|---|
| 201. | <b>Front elevation</b><br>Cracking to left side of porch | |

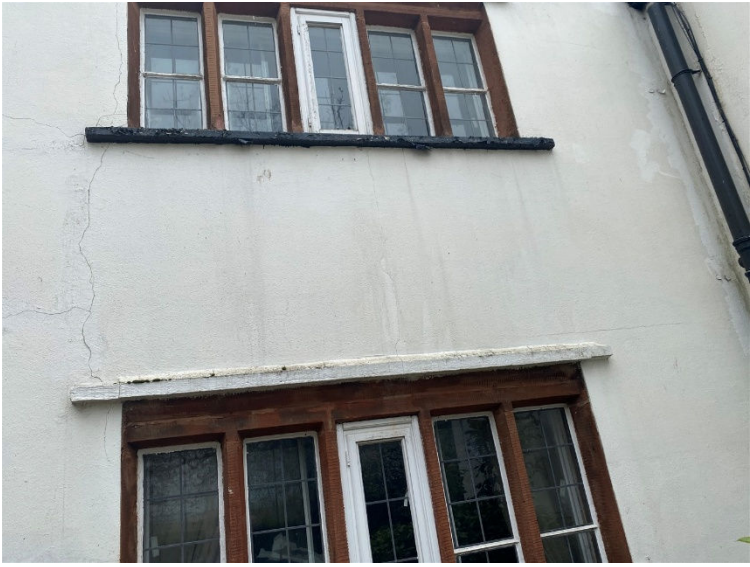
| Photo No | Photograph Description | Photograph |
|---|---|---|
| 202. | <b>Front elevation</b><br>Cracking between ground and first floor windows | |

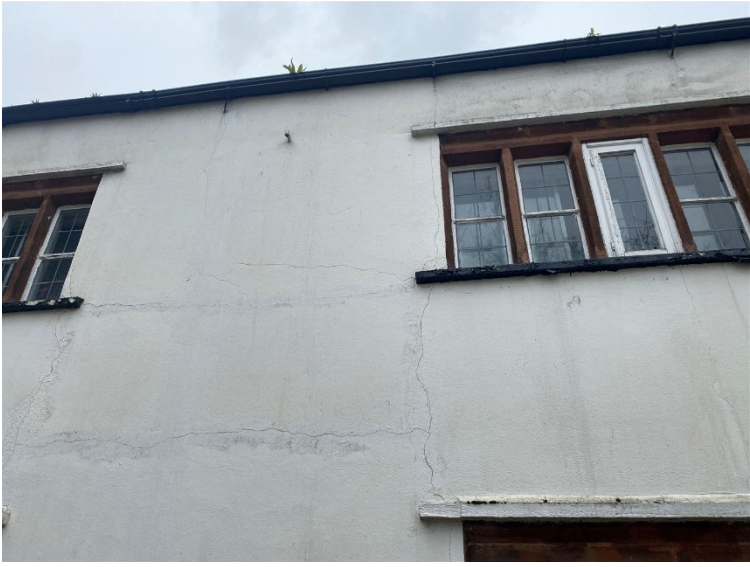
| Photo No | Photograph Description | Photograph |
|---|---|---|
| 203. | <b>Front elevation</b><br>Cracking between ground and first floor windows | |

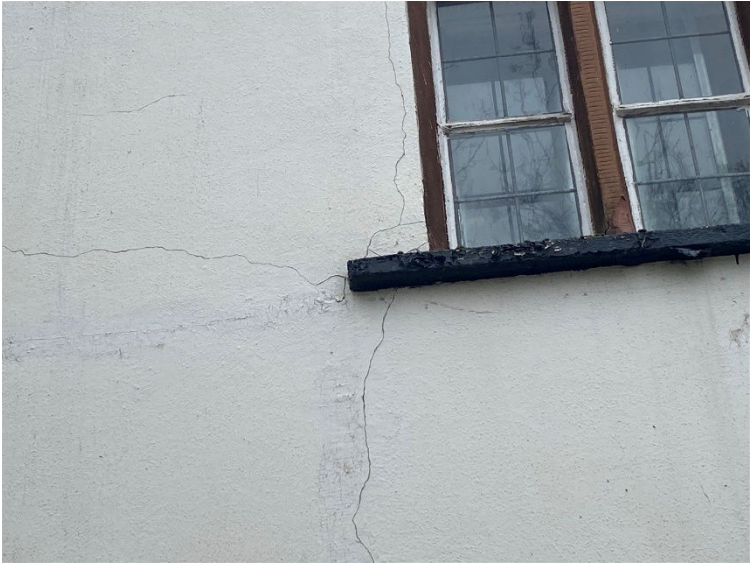
| Photo No | Photograph Description | Photograph |
|---|---|---|
| 204. | <b>Front elevation</b><br>Close up of cracking at first floor window | A photograph showing a close-up of a light-colored, textured wall. A dark, horizontal window sill is visible on the right side. A vertical crack runs down the wall to the left of the sill, and a horizontal crack runs across the wall below the sill. |

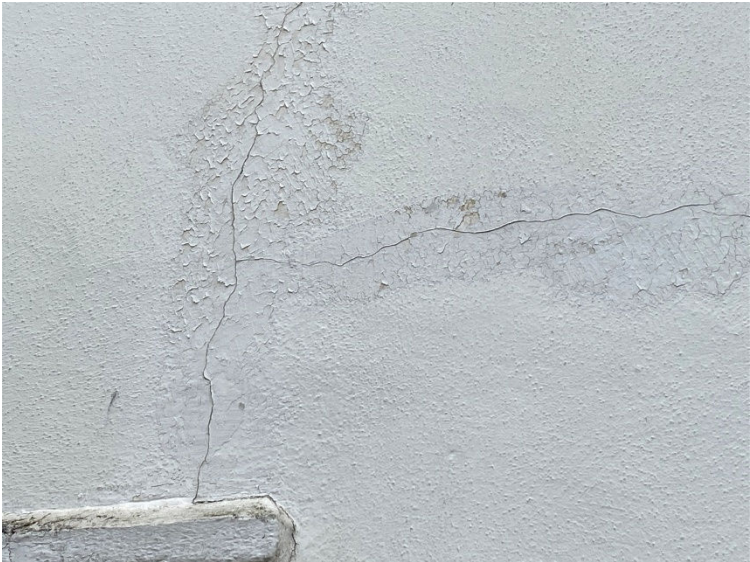
| Photo No | Photograph Description | Photograph |
|---|---|---|
| 205. | <b>Front elevation</b><br>Close up of cracking and previous making good | A photograph showing a close-up of a light-colored, textured wall. A vertical crack runs down the wall, and a horizontal crack runs across the wall. The wall shows signs of previous repair work, with some areas appearing slightly different in texture or color. |

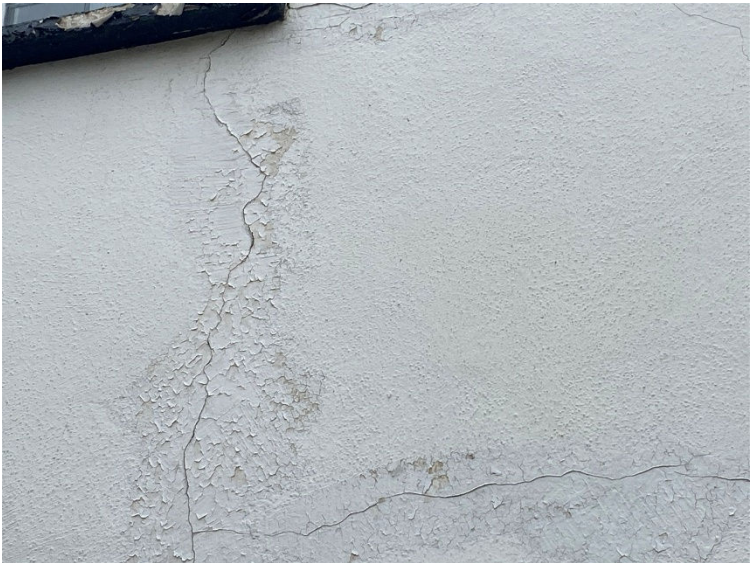
| Photo No | Photograph Description | Photograph |
|---|---|---|
| 206. | <b>Front elevation</b><br>Close up of cracking and previous making good | A photograph showing a close-up of a light-colored, textured wall. A vertical crack runs down the wall, and a horizontal crack runs across the wall. The wall shows signs of previous repair work, with some areas appearing slightly different in texture or color. |

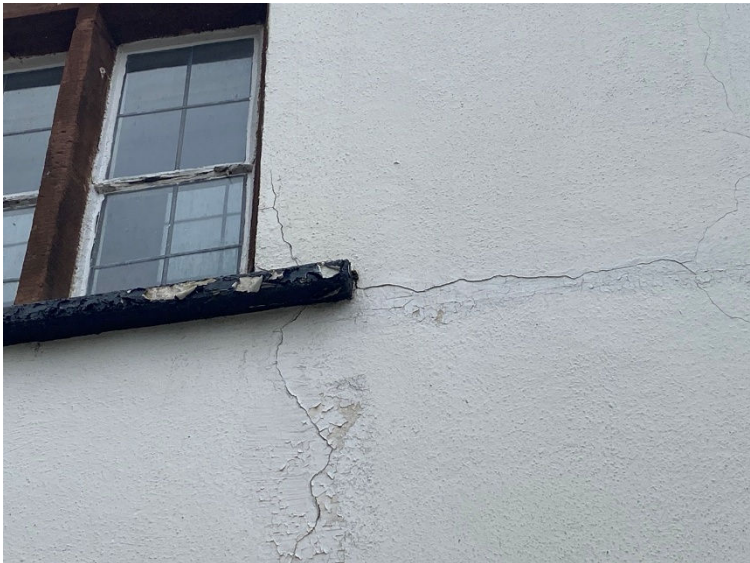
| Photo No | Photograph Description | Photograph |
|---|---|---|
| 207. | <b>Front elevation</b><br>Cracking around first floor windows | A photograph of a white-painted exterior wall. A multi-paned window is visible on the left. To the right of the window, there is a horizontal crack that runs across the wall. Below this crack, the paint is peeling and there is a vertical crack running downwards. |

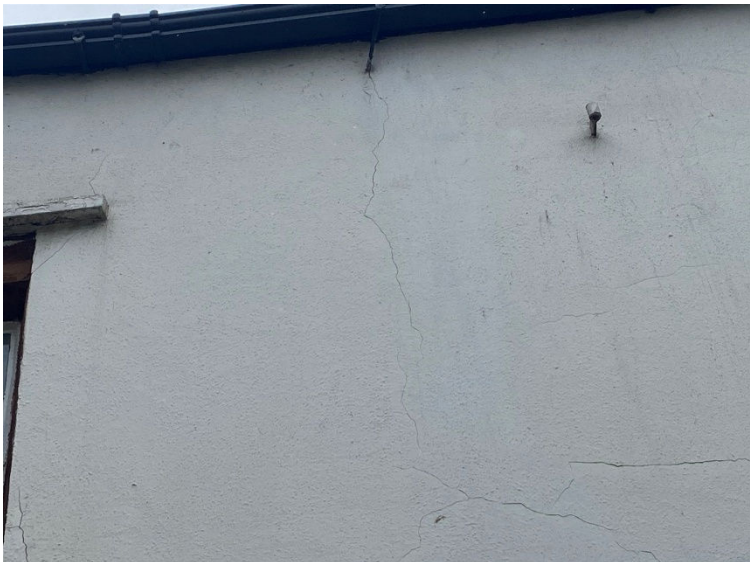
| Photo No | Photograph Description | Photograph |
|---|---|---|
| 208. | <b>Front elevation</b><br>Cracking from eaves gutter | A photograph of a white-painted exterior wall. At the top, a dark eaves gutter is visible. A vertical crack runs down the wall from the gutter area. There are also some smaller, faint cracks on the wall. |

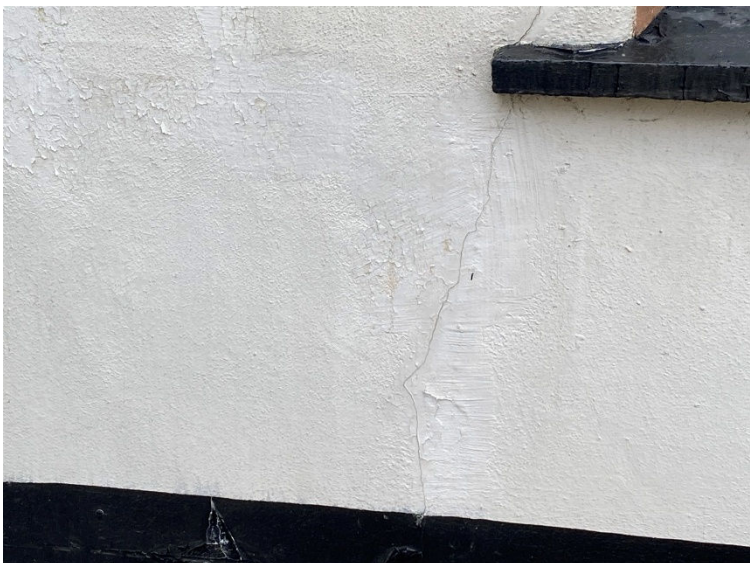
| Photo No | Photograph Description | Photograph |
|---|---|---|
| 209. | <b>Front elevation</b><br>Cracking at low level between sill and black band | A close-up photograph of a white-painted exterior wall. A horizontal black band is visible at the top. Below it, there is a vertical crack running down the wall. The paint appears slightly textured and there are some small spots of discoloration. |

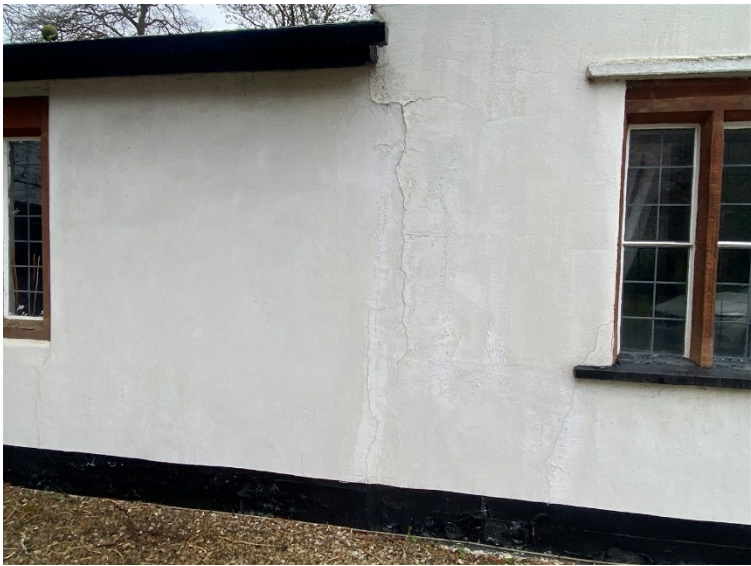
| Photo No | Photograph Description | Photograph |
|---|---|---|
| 211. | <b>Front elevation</b><br>Cracking between single and two storey sections | |

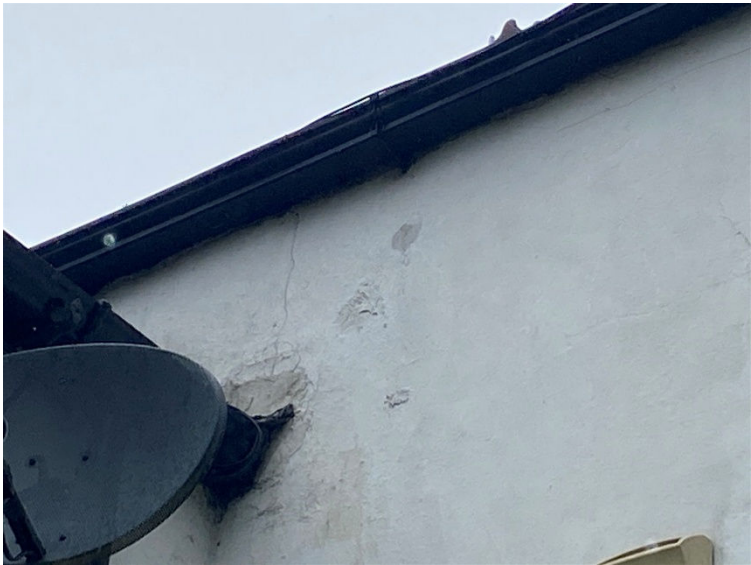
| Photo No | Photograph Description | Photograph |
|---|---|---|
| 216. | <b>Front elevation</b><br>Cracking between eaves gutter and porch gutter on right hand side of porch | |

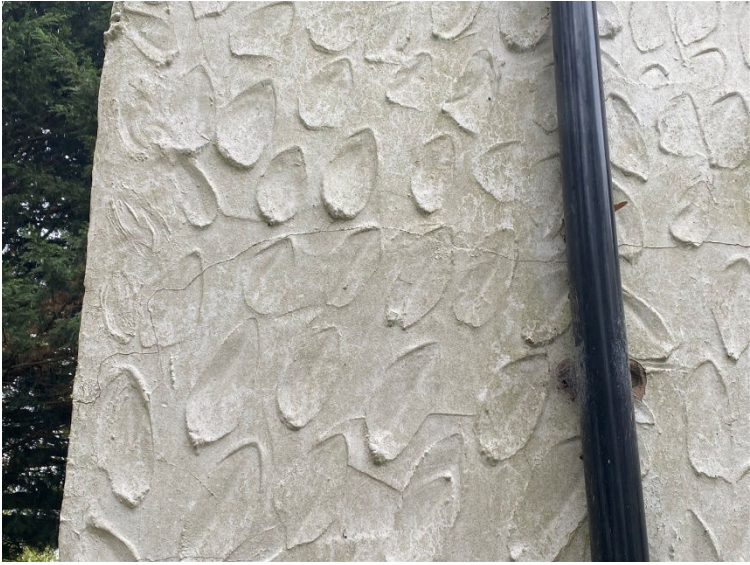
| Photo No | Photograph Description | Photograph |
|---|---|---|
| 227. | <b>North elevation</b><br>Horizontal crack behind downpipe | |

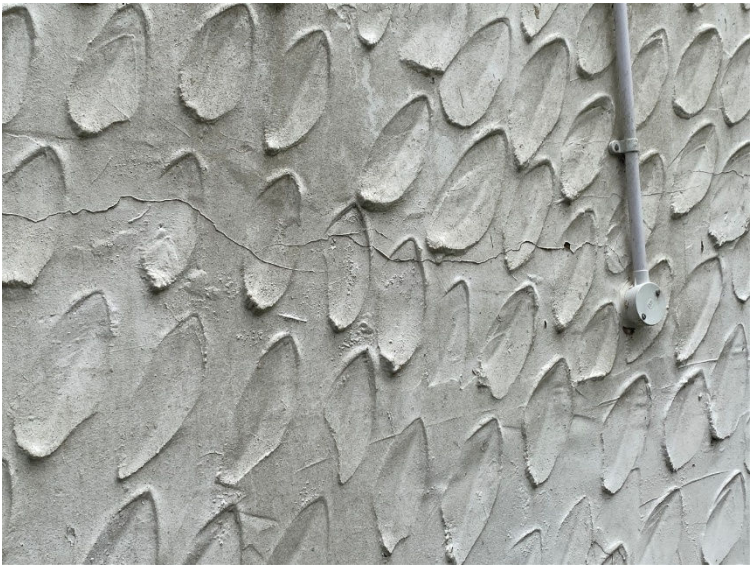
| Photo No | Photograph Description | Photograph |
|---|---|---|
| 228. | <b>North elevation</b><br>Horizontal crack running behind electrical trunking | |

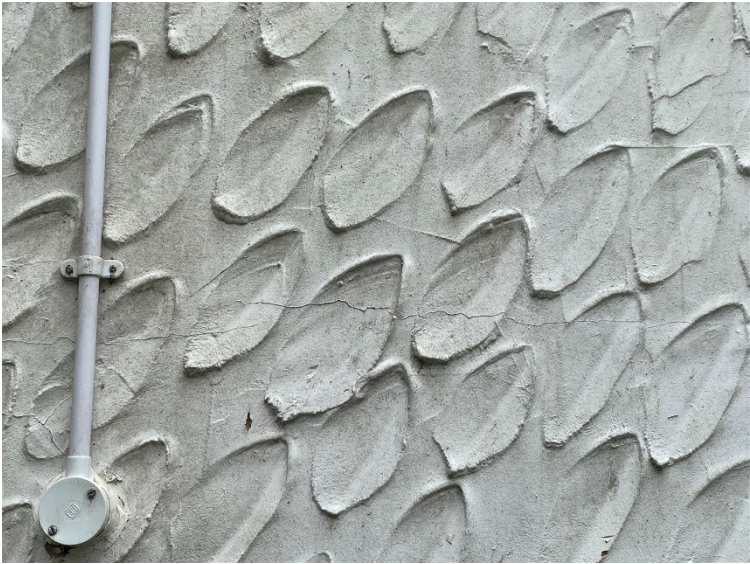
| Photo No | Photograph Description | Photograph |
|---|---|---|
| 229. | <b>North elevation</b><br>Continuation of previous crack | |

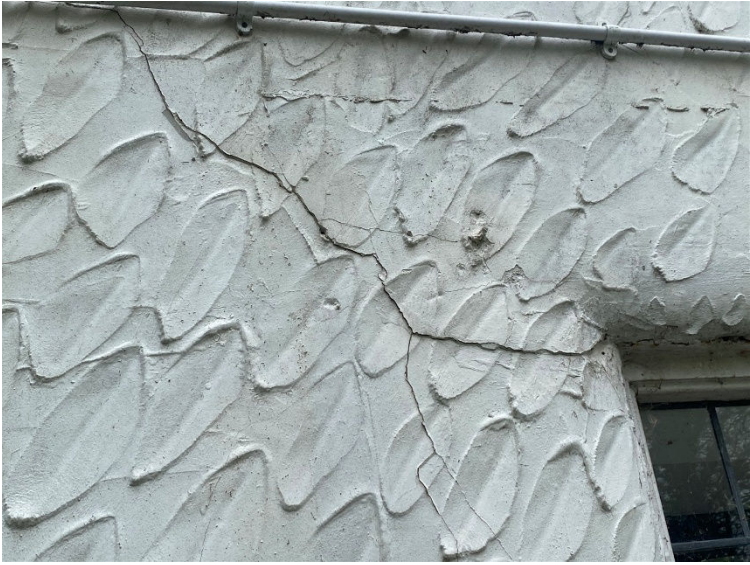
| Photo No | Photograph Description | Photograph |
|---|---|---|
| 230. | <b>North elevation</b><br>Cracking and detached render adjacent window | |

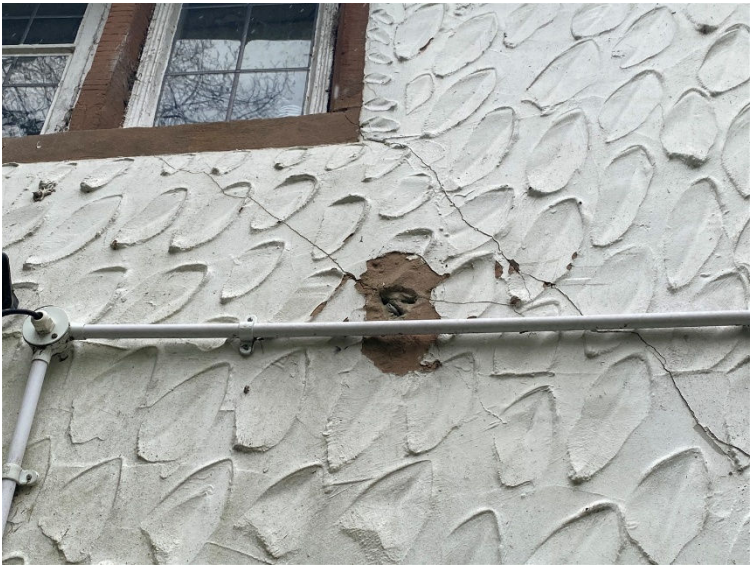
| Photo No | Photograph Description | Photograph |
|---|---|---|
| 231. | <b>North elevation</b><br>Diagonal cracking from right side of first floor window | |

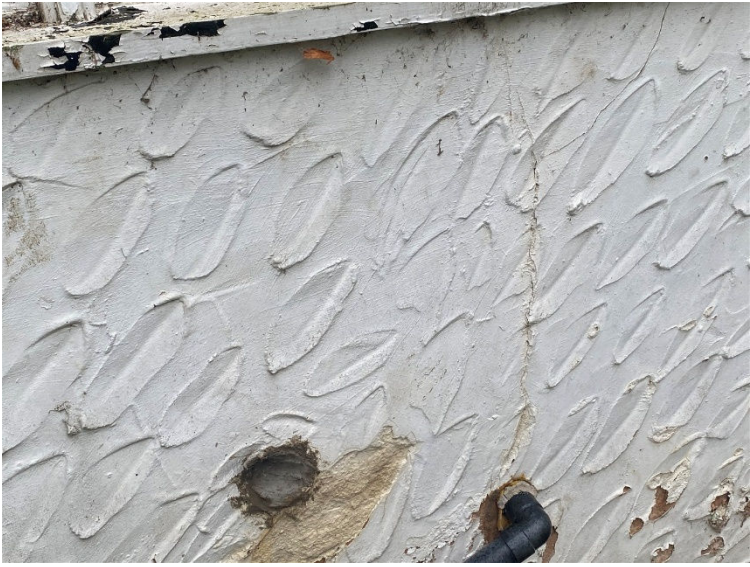
| Photo No | Photograph Description | Photograph |
|---|---|---|
| 232. | <b>North elevation</b><br>Hairline cracking near sink waste pipe | |
