# Photographic Schedule of Condition

Old Halsnead Hall, Fox's Bank Lane, Widnes, Prescot L35 3SU

April 2026

Doc Ref: 04C600152

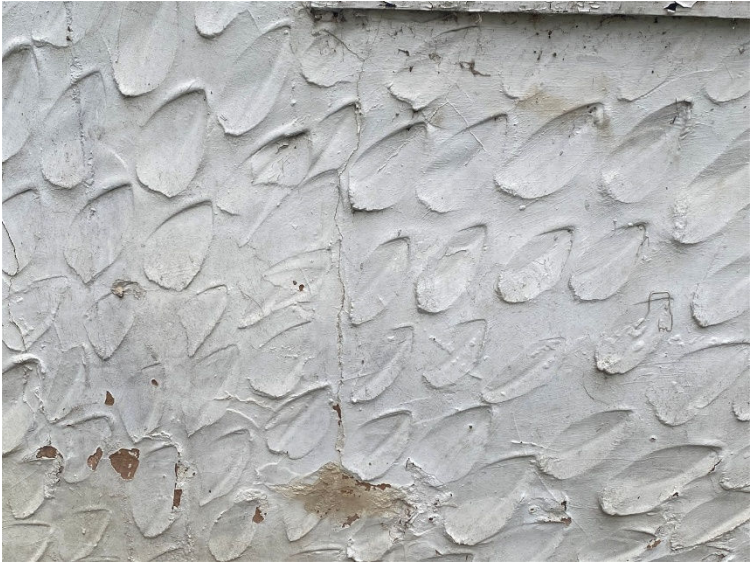
| Photo No | Photograph Description | Photograph |
|---|---|---|
| 233. | <b>North elevation</b><br>Hairline crack below window | |

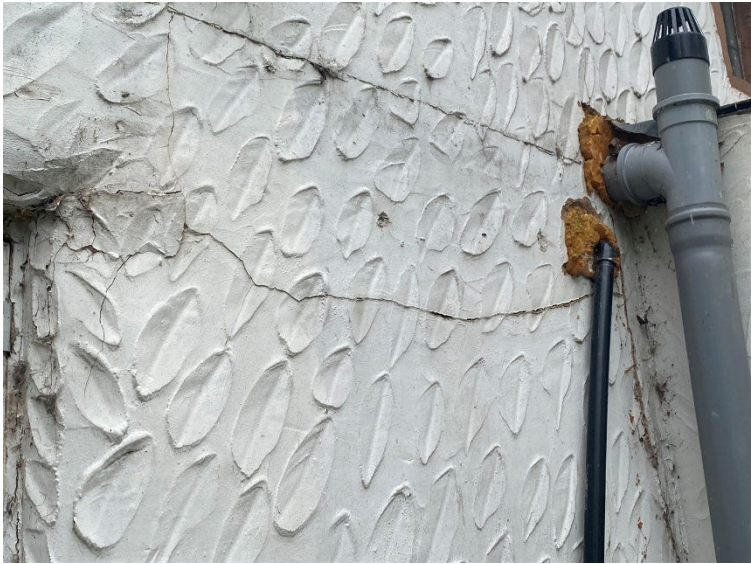
| Photo No | Photograph Description | Photograph |
|---|---|---|
| 235. | <b>North elevation</b><br>Horizontal and vertical cracking to left of soil pipe | |

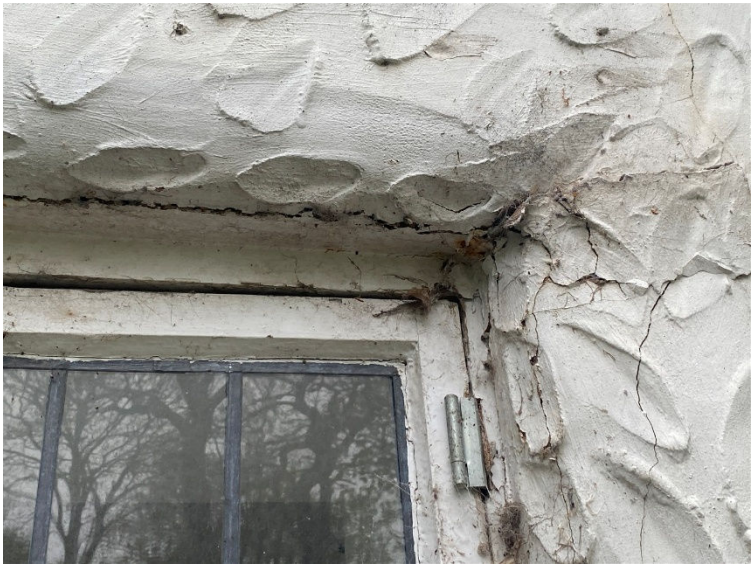
| Photo No | Photograph Description | Photograph |
|---|---|---|
| 236. | <b>North elevation</b><br>Cracking around window reveal | |

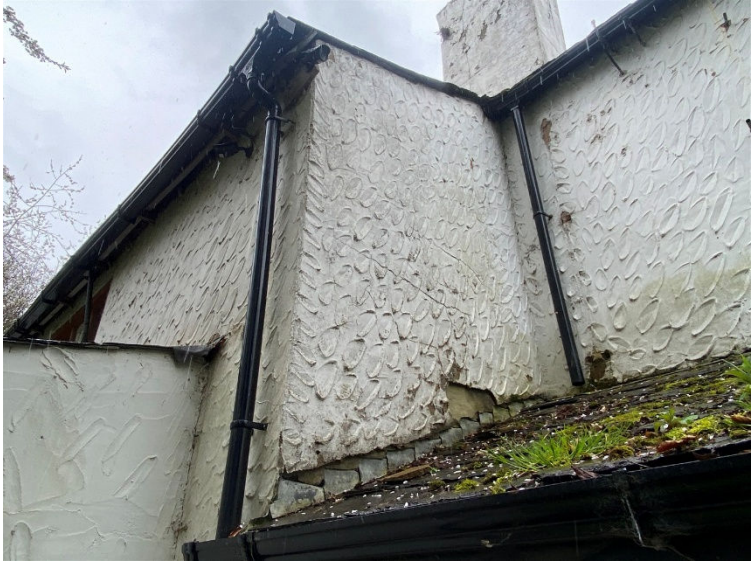
| Photo No | Photograph Description | Photograph |
|---|---|---|
| 241. | <b>North elevation</b><br>Cracking to side reveal | |

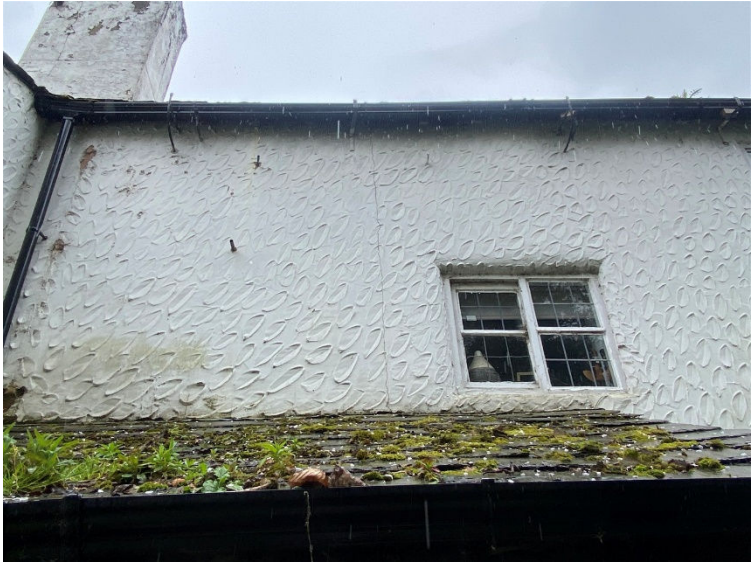
| Photo No | Photograph Description | Photograph |
|---|---|---|
| 242. | <b>North elevation</b><br>Vertical crack to left of window | |

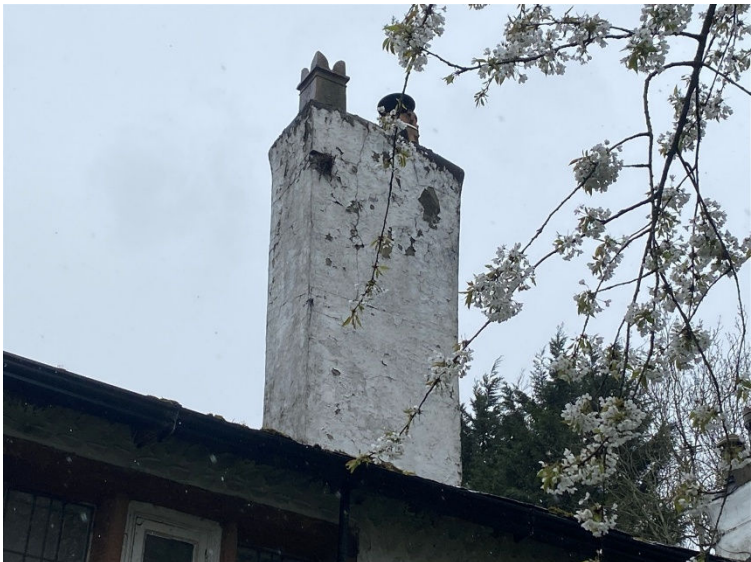
| Photo No | Photograph Description | Photograph |
|---|---|---|
| 247. | <b>North elevation</b><br>Chimney stack with extensive hairline cracks | |

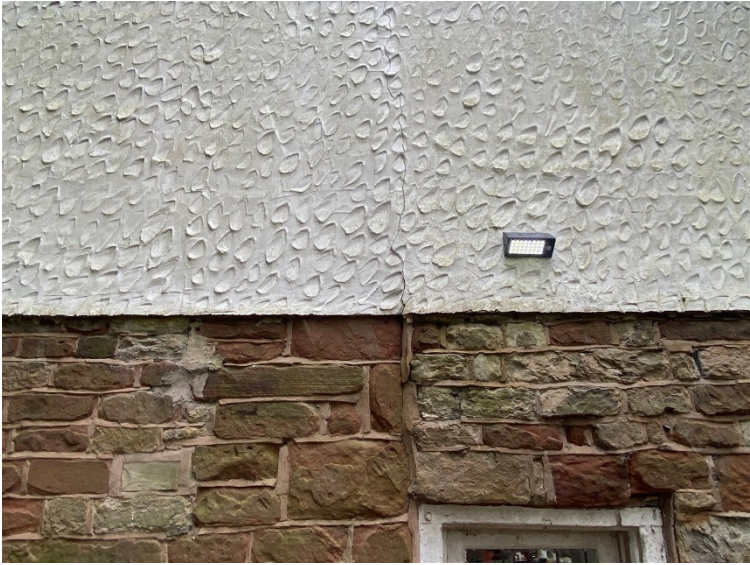
| Photo No | Photograph Description | Photograph |
|---|---|---|
| 249. | <b>East elevation</b><br>Hairline vertical crack | |

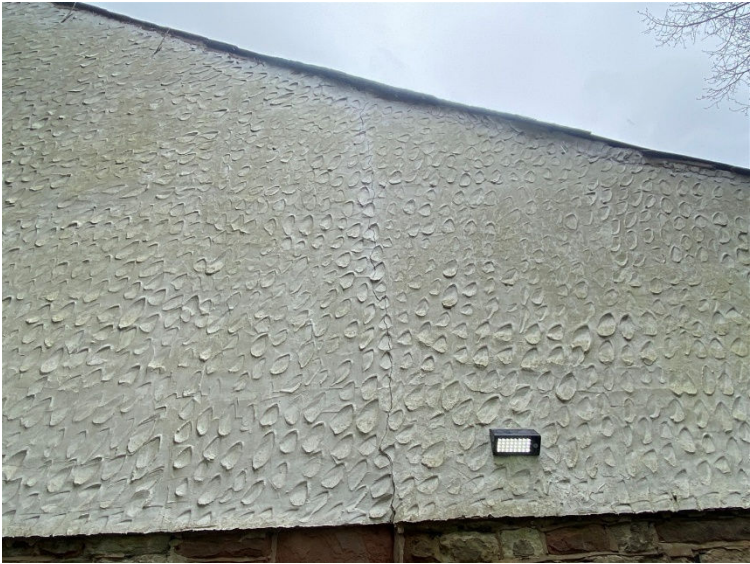
| Photo No | Photograph Description | Photograph |
|---|---|---|
| 250. | <b>East elevation</b><br>Hairline vertical crack | |

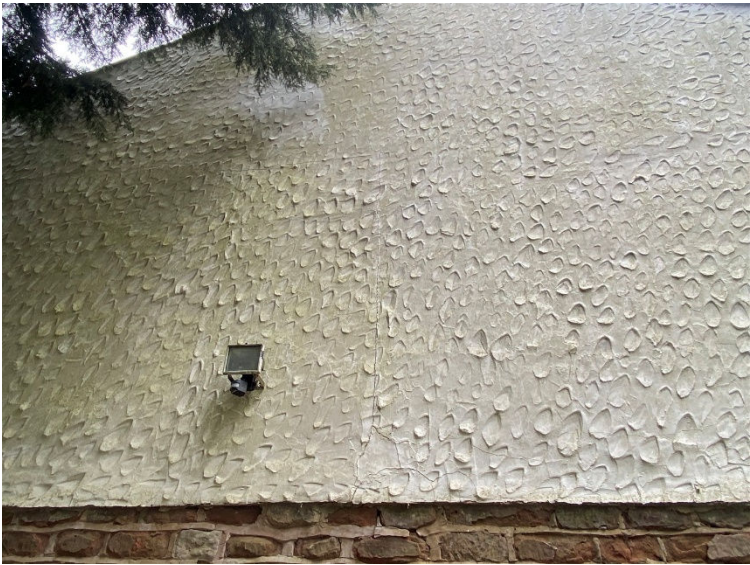
| Photo No | Photograph Description | Photograph |
|---|---|---|
| 251. | <b>East elevation</b><br>Extensive hairline cracking | |

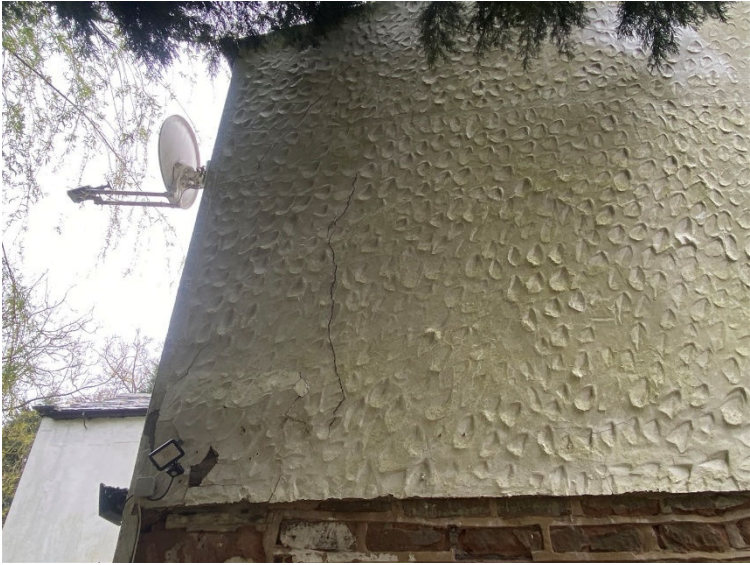
| Photo No | Photograph Description | Photograph |
|---|---|---|
| 252. | <b>East elevation</b><br>Vertical crack | |

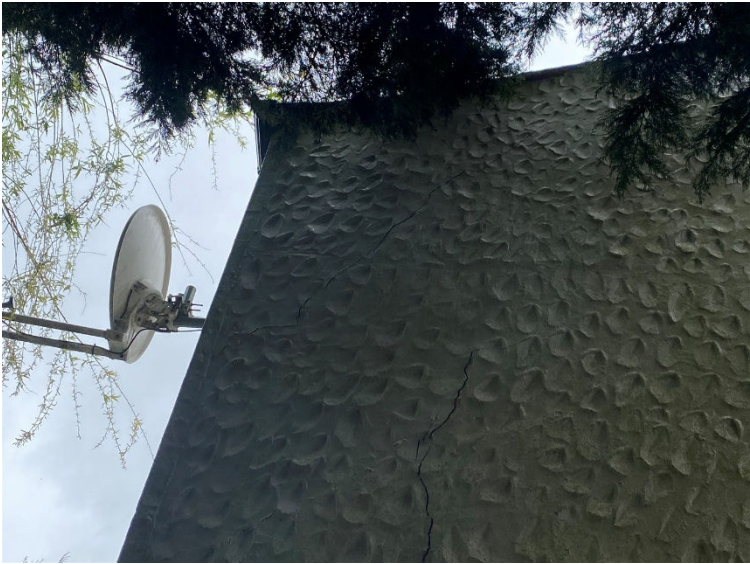
| Photo No | Photograph Description | Photograph |
|---|---|---|
| 253. | <b>East elevation</b><br>Continuation of previous crack | |

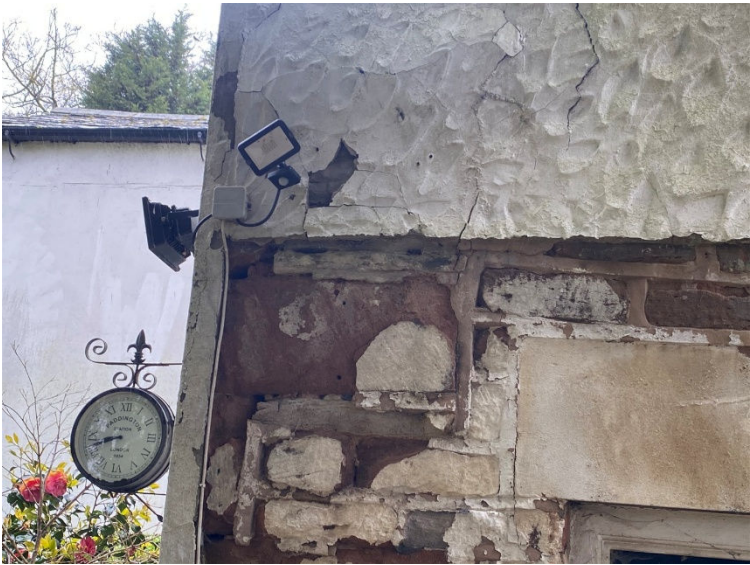
| Photo No | Photograph Description | Photograph |
|---|---|---|
| 254. | <b>East elevation</b><br>Blown render to left side | |

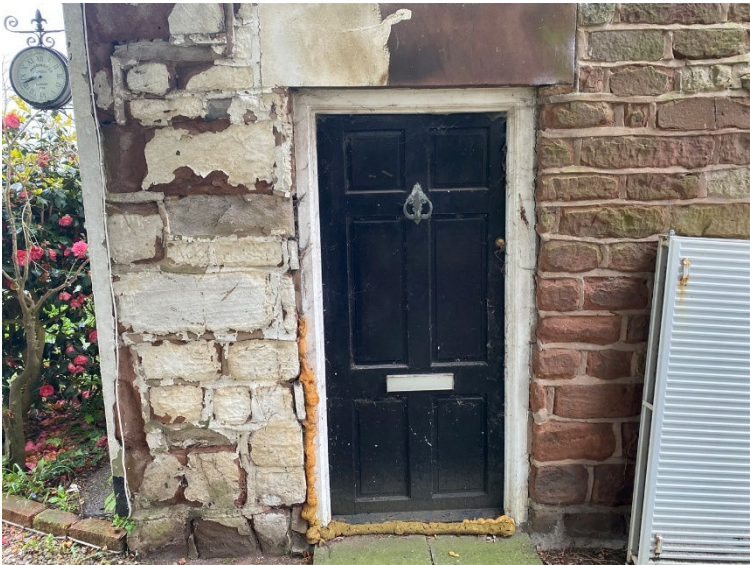
| Photo No | Photograph Description | Photograph |
|---|---|---|
| 255. | <b>East elevation</b><br>Cracking to left of door | |

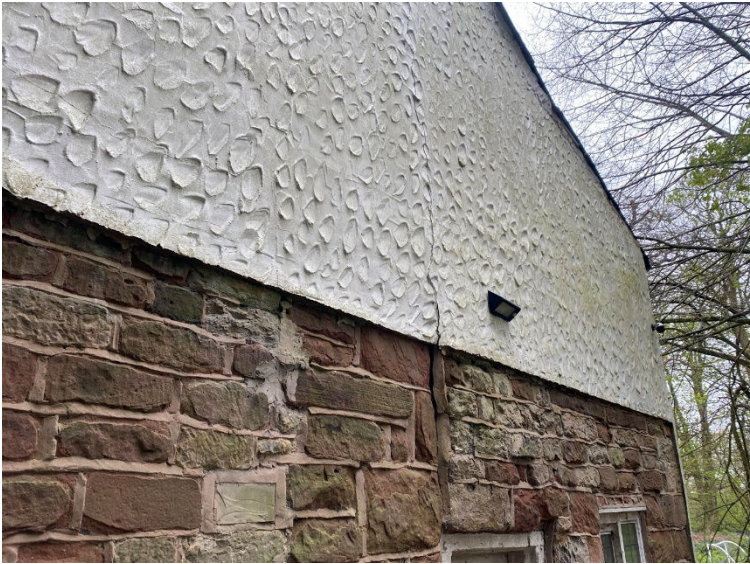
| Photo No | Photograph Description | Photograph |
|---|---|---|
| 256. | <b>East elevation</b><br>Vertical crack to render running through stonework below | |

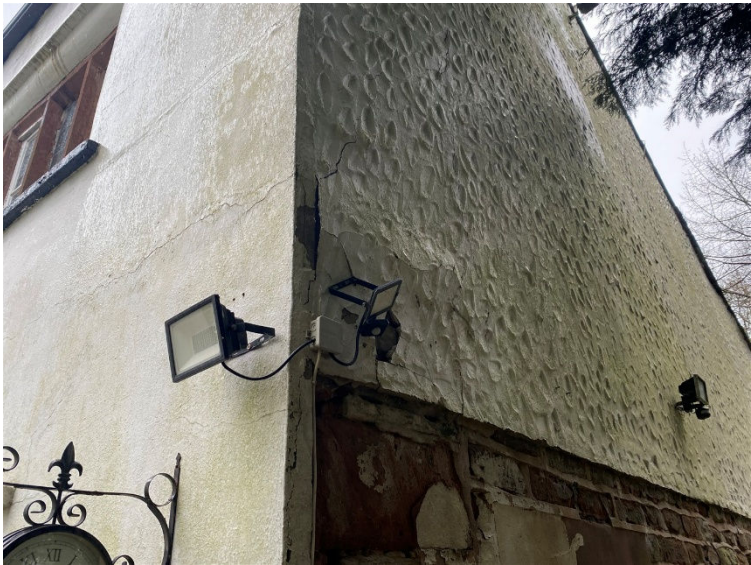
| Photo No | Photograph Description | Photograph |
|---|---|---|
| 258. | <b>East elevation</b><br>Blown render behind security light | |

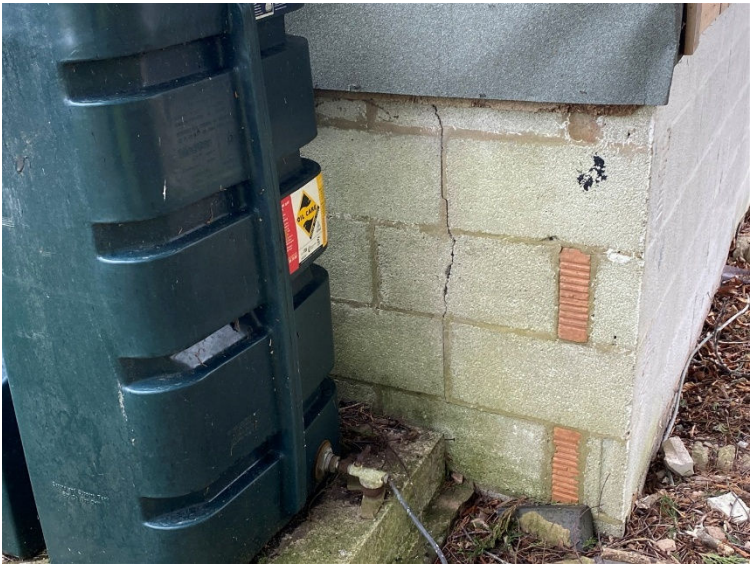
| Photo No | Photograph Description | Photograph |
|---|---|---|
| 263. | <b>Games building</b><br>Cracking to blockwork | |

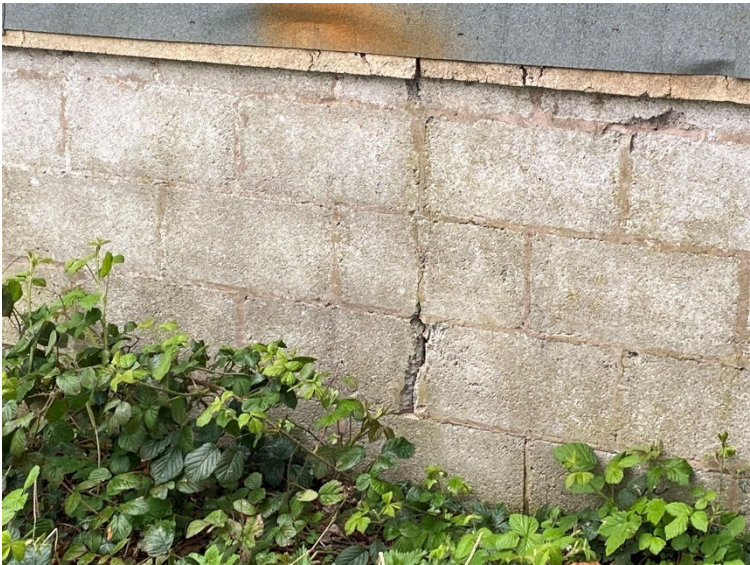
| Photo No | Photograph Description | Photograph |
|---|---|---|
| 264. | <b>Games building</b><br>Cracking to blockwork | |

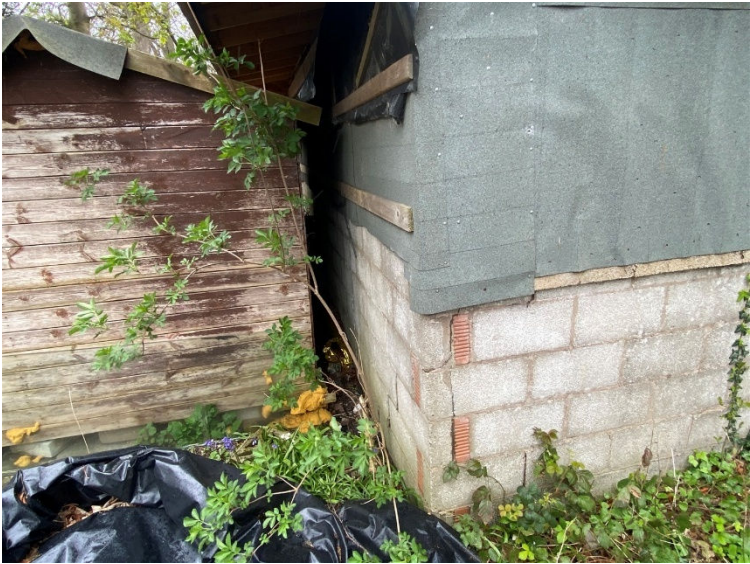
| Photo No | Photograph Description | Photograph |
|---|---|---|
| 265. | <b>Games building</b><br>Felt to elevation in poor condition | |

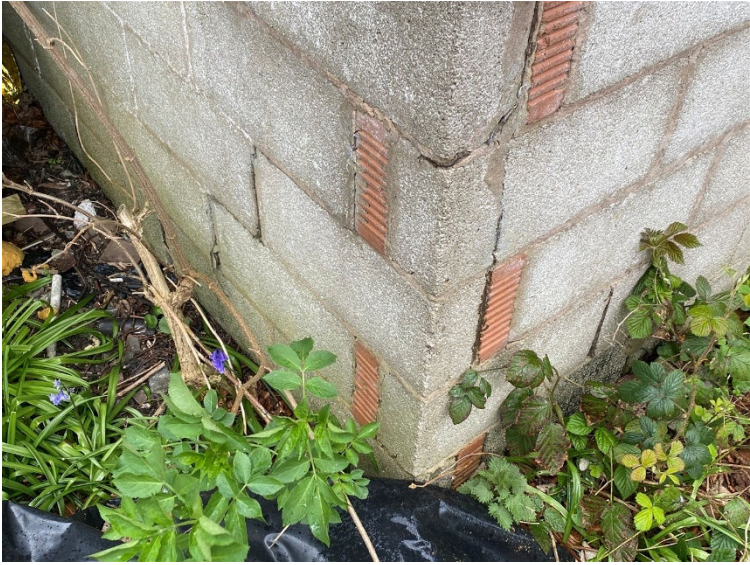
| Photo No | Photograph Description | Photograph |
|---|---|---|
| 266. | <b>Games building</b><br>Cracking to blockwork | |

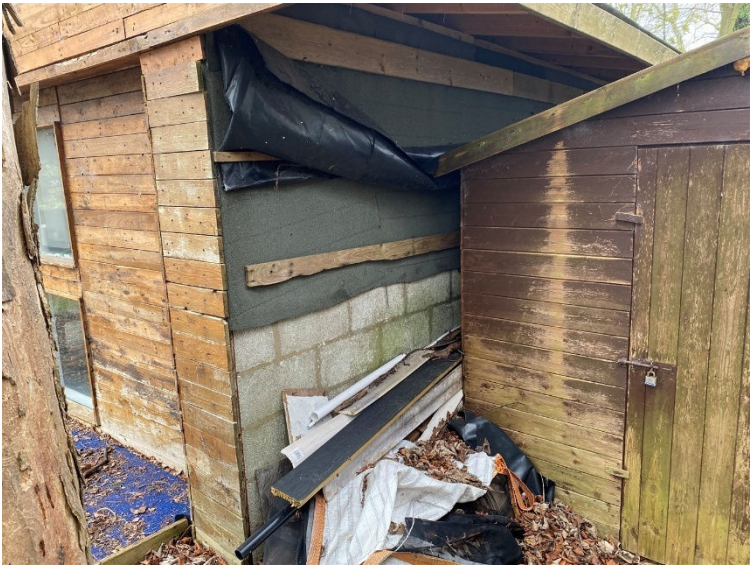
| Photo No | Photograph Description | Photograph |
|---|---|---|
| 267. | <b>Games building</b><br>West elevation in poor condition | A photograph showing the exterior of a wooden building, identified as the Games building. The structure is in poor condition, with significant damage to the roof and walls. A large section of the roof is missing, exposing the interior structure. The walls are made of weathered wood and concrete blocks, with some areas appearing to be boarded up or partially collapsed. Debris, including leaves and wood, is scattered on the ground in front of the building. |

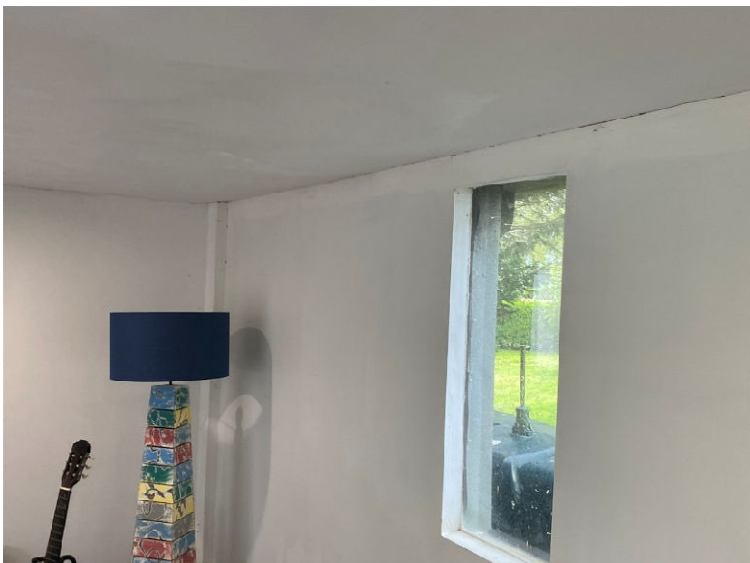
| Photo No | Photograph Description | Photograph |
|---|---|---|
| 275. | <b>Games building interior</b><br>Crack between ceiling and wall | A photograph of an interior room. A vertical crack is visible between the ceiling and the wall. In the foreground, there is a lamp with a blue shade and a colorful, patterned base. A guitar is leaning against the wall to the left of the lamp. A window on the right side of the frame looks out onto a green lawn. |

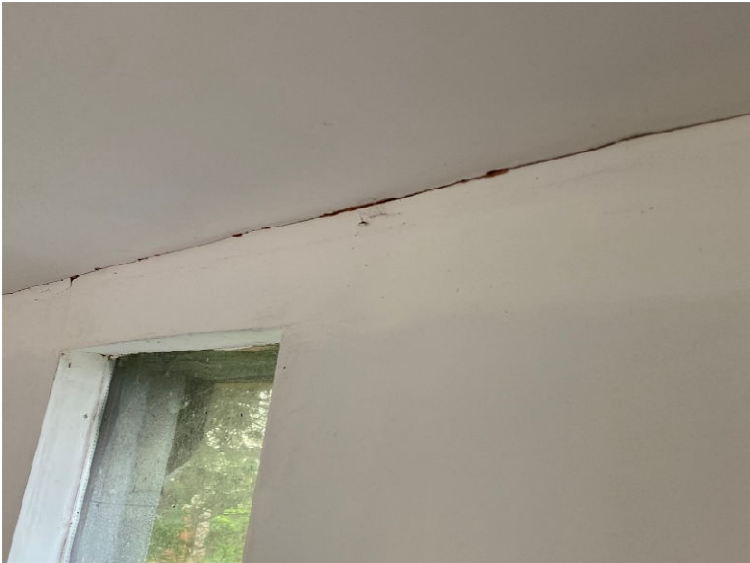
| Photo No | Photograph Description | Photograph |
|---|---|---|
| 276. | <b>Games building interior</b><br>Crack between ceiling and wall | |

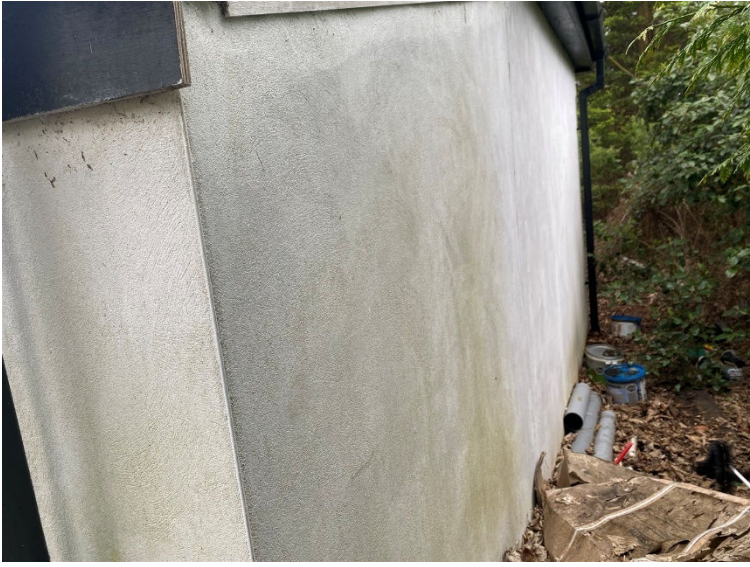
| Photo No | Photograph Description | Photograph |
|---|---|---|
| 281. | <b>Garage</b><br>East elevation; vertical crack in centre | A close-up photograph of the east elevation of the garage, focusing on a vertical crack in the white plasterwork in the center of the wall. Some debris and pipes are visible at the base of the wall. |

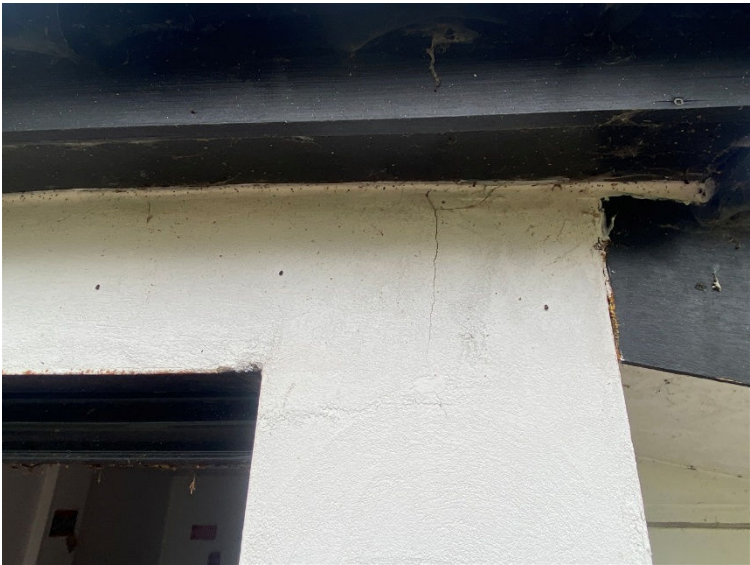
| Photo No | Photograph Description | Photograph |
|---|---|---|
| 282. | <b>Garage</b><br>Vertical crack to right of roller shutter | |

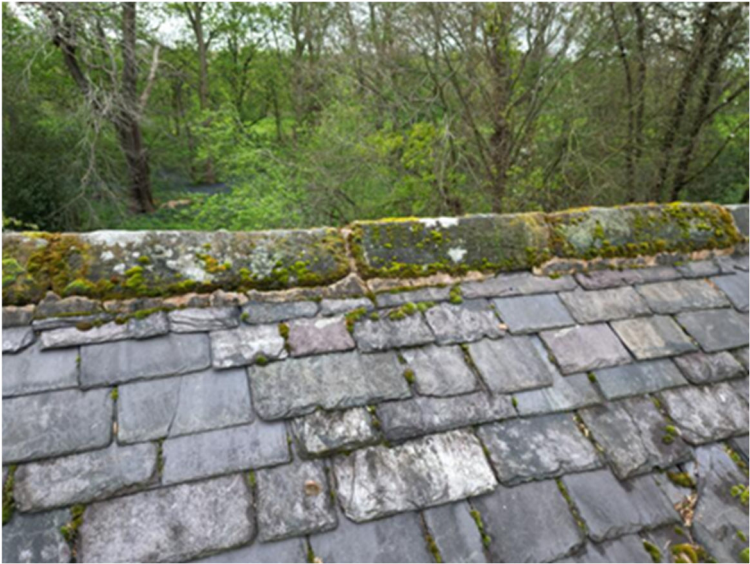
| Photo No | Photograph Description | Photograph |
|---|---|---|
| 295. | <b>Main Building Roof</b><br>Fragmenting ridge mortar bed | |

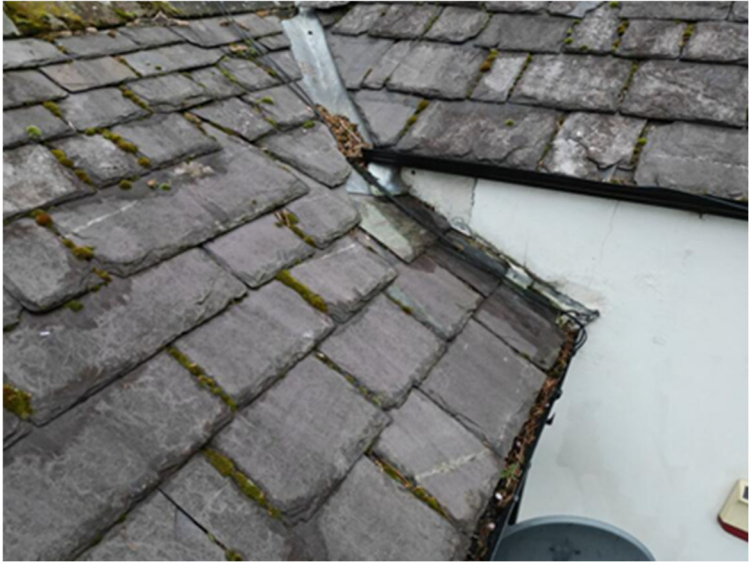
| Photo No | Photograph Description | Photograph |
|---|---|---|
| 296. | <b>Main Building Roof</b><br>Poor upstanding detailing to render | |

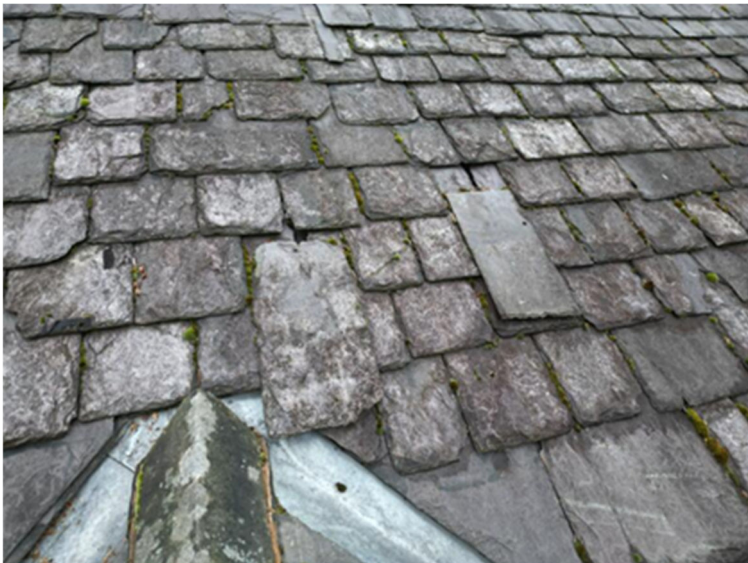
| Photo No | Photograph Description | Photograph |
|---|---|---|
| 297. | <b>Main Building Roof</b><br>Dislodged and broken slates | A close-up photograph of a roof surface covered in grey, rectangular slates. Several slates are missing or broken, revealing a lighter-colored underlayment or insulation material. The slates are arranged in a staggered pattern, and some moss is visible between them. |

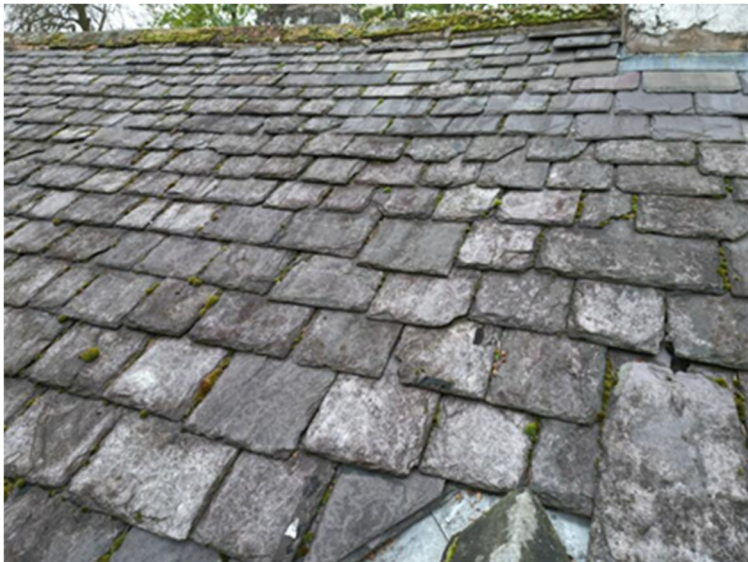
| Photo No | Photograph Description | Photograph |
|---|---|---|
| 298. | <b>Main Building Roof</b><br>Dislodged and broken slates | A close-up photograph of a roof surface covered in grey, rectangular slates. Several slates are missing or broken, revealing a lighter-colored underlayment or insulation material. The slates are arranged in a staggered pattern, and some moss is visible between them. |

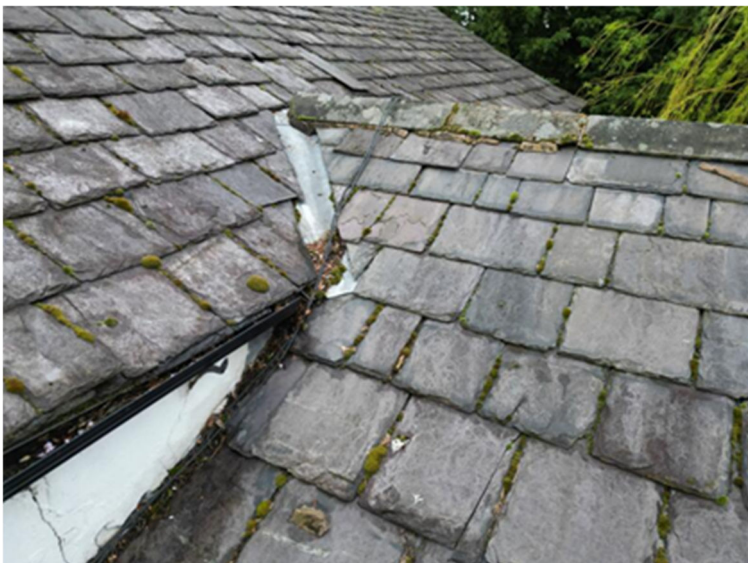
| Photo No | Photograph Description | Photograph |
|---|---|---|
| 299. | <b>Main Building Roof</b><br>Fragmenting ridge mortar | A close-up photograph of a roof ridge where two slanted roof sections meet. The mortar that binds the slates at the ridge is crumbling and fragmenting. The slates are grey and rectangular, and some moss is visible on the roof surface. |

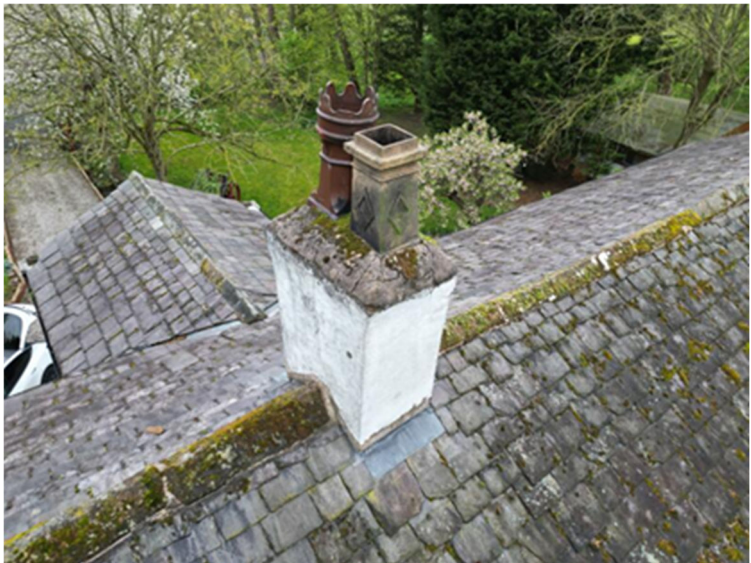
| Photo No | Photograph Description | Photograph |
|---|---|---|
| 300. | <b>Main Building Roof</b><br>Cracked chimney pot bedding mortar | |

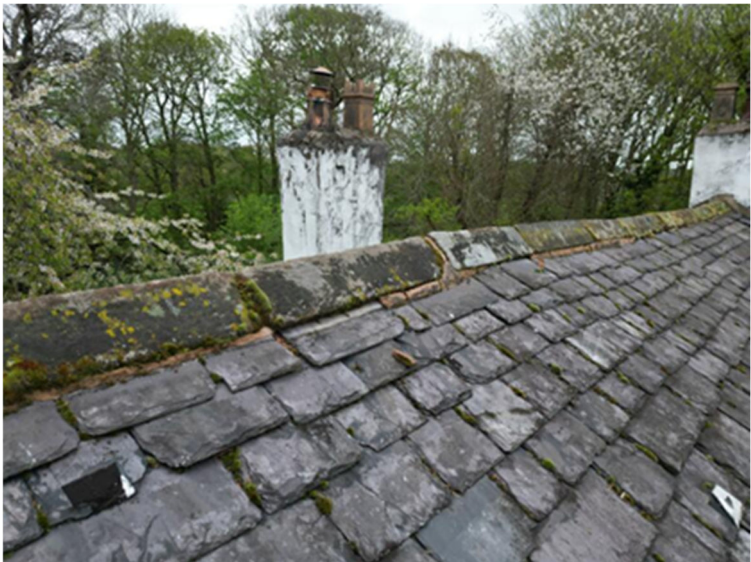
| Photo No | Photograph Description | Photograph |
|---|---|---|
| 301. | <b>Main Building Roof</b><br>Ridge mortar fragmentation | |

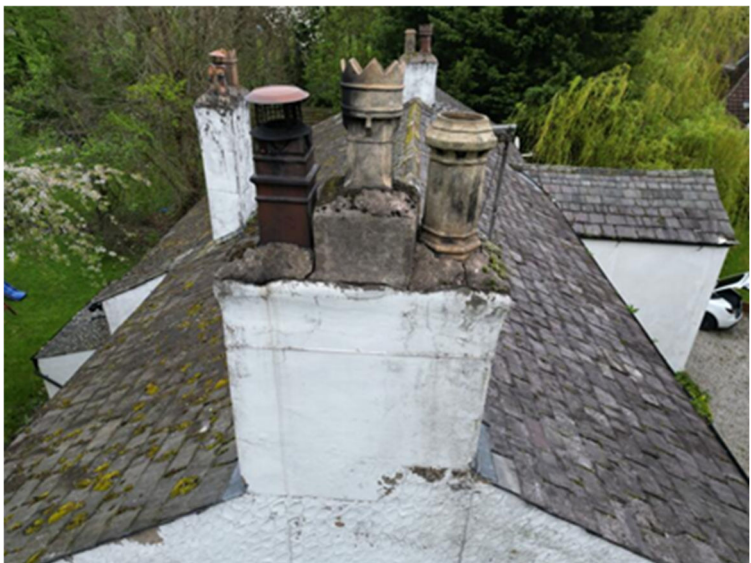
| Photo No | Photograph Description | Photograph |
|---|---|---|
| 302. | <b>Main Building Roof</b><br>Cracking chimney mortar | |

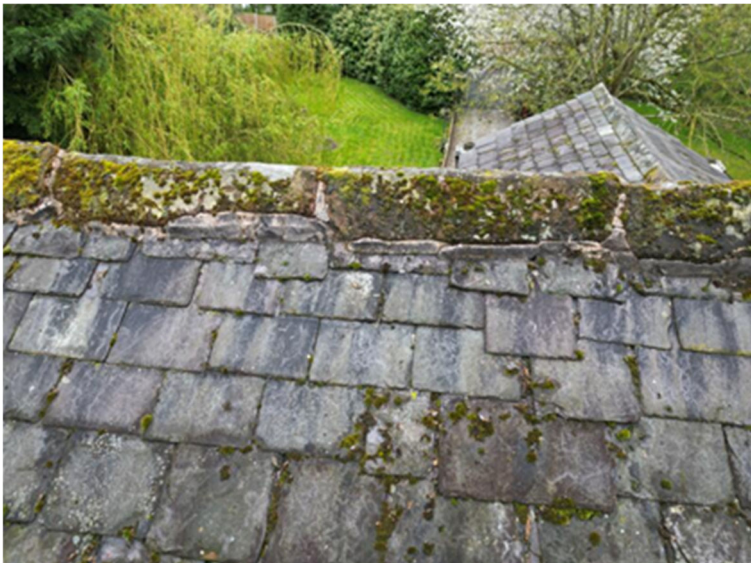
| Photo No | Photograph Description | Photograph |
|---|---|---|
| 303. | <b>Main Building Roof</b><br>Fragmenting bedding mortar | |

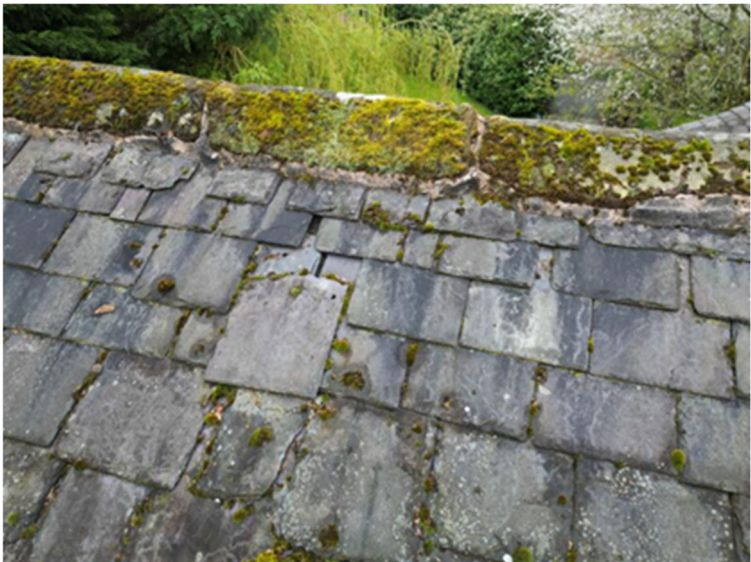
| Photo No | Photograph Description | Photograph |
|---|---|---|
| 304. | <b>Main Building Roof</b><br>Dislodged and broken slates | |

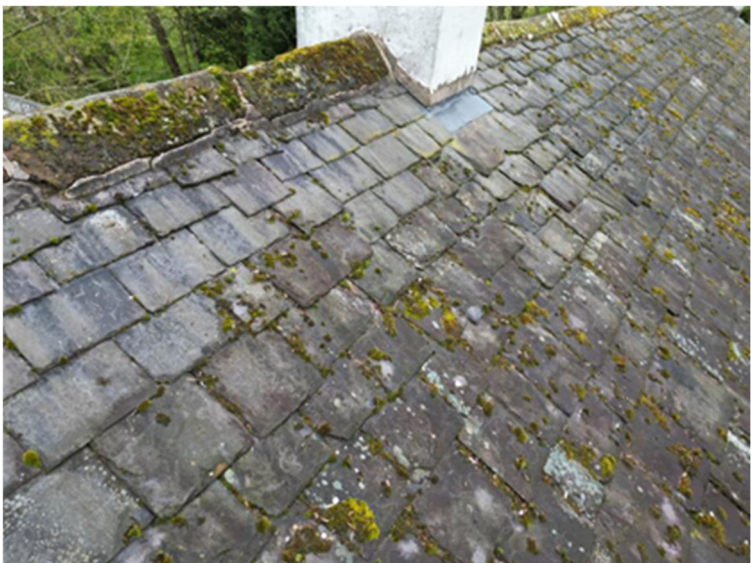
| Photo No | Photograph Description | Photograph |
|---|---|---|
| 305. | <b>Main Building Roof</b><br>Dislodged and broken slates | |

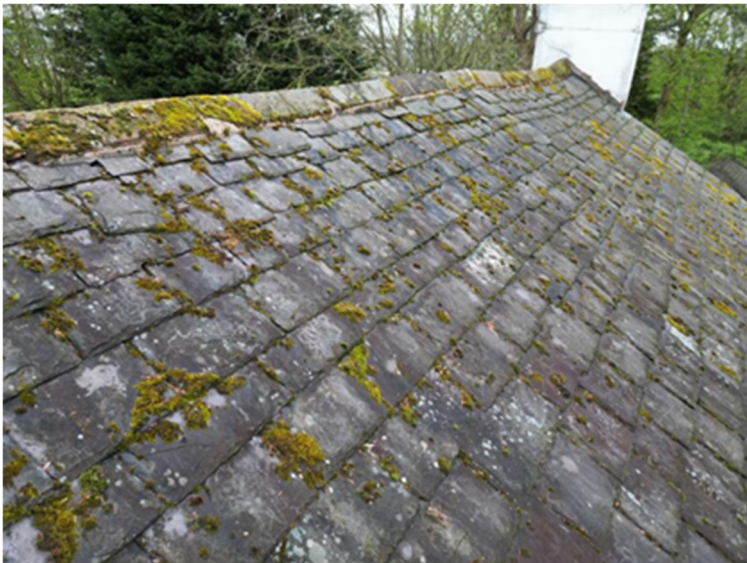
| Photo No | Photograph Description | Photograph |
|---|---|---|
| 306. | <b>Main Building Roof</b><br>Dislodged and broken slates | |

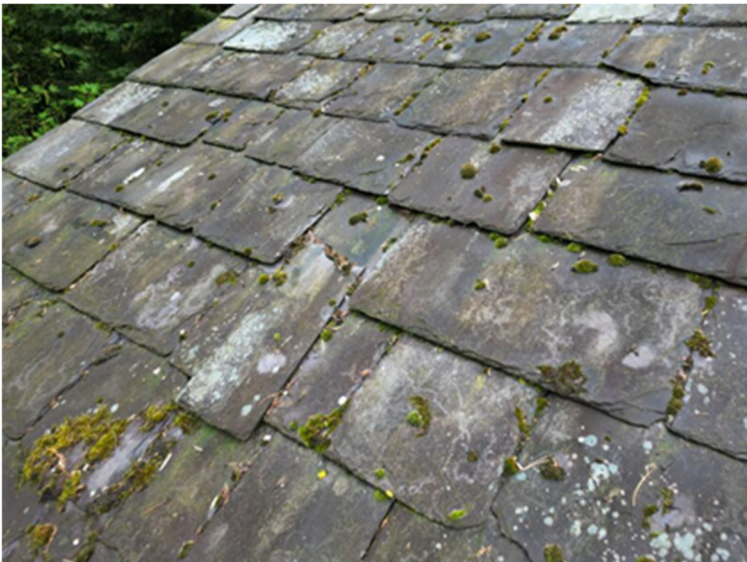
| Photo No | Photograph Description | Photograph |
|---|---|---|
| 307. | <b>Main Building Roof</b><br>Dislodged and broken slates | |

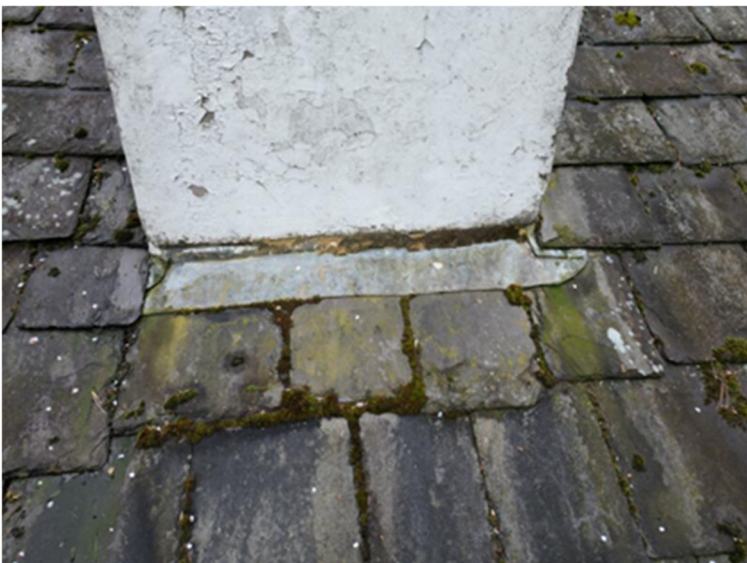
| Photo No | Photograph Description | Photograph |
|---|---|---|
| 308. | <b>Main Building Roof</b><br>Cracked and lead flashing with open joint | |

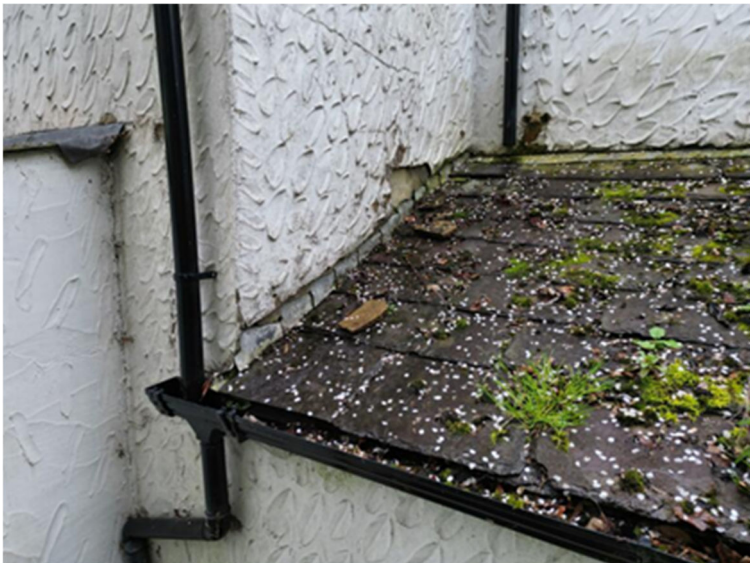
| Photo No | Photograph Description | Photograph |
|---|---|---|
| 309. | <b>Main Building Roof</b><br>Cracked and missing render | |

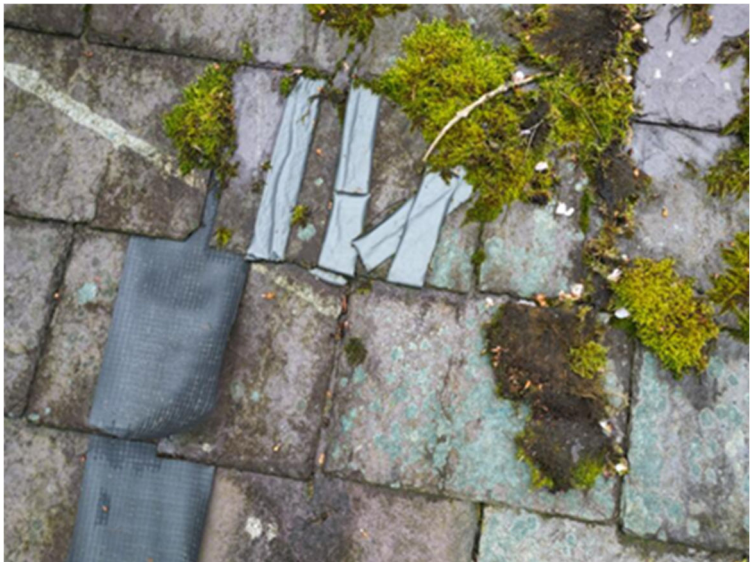
| Photo No | Photograph Description | Photograph |
|---|---|---|
| 310. | <b>Main Building Roof</b><br>Taped and patch repaired slates | |

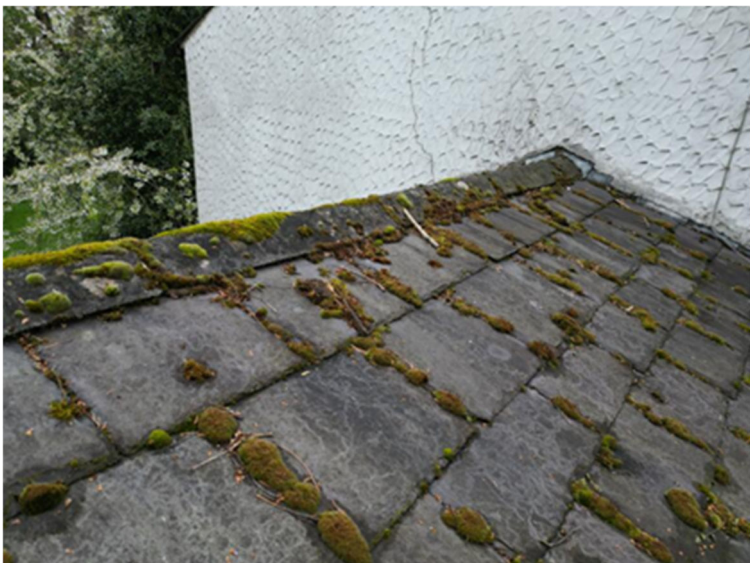
| Photo No | Photograph Description | Photograph |
|---|---|---|
| 311. | <b>Main Building Roof</b><br>Fragmenting ridge tile slate | |

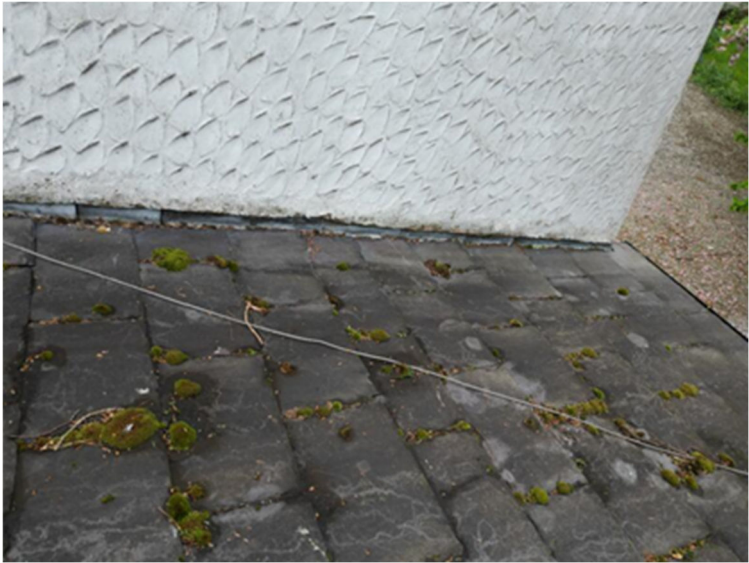
| Photo No | Photograph Description | Photograph |
|---|---|---|
| 312. | <b>Main Building Roof</b><br>Low and poorly terminated pitch-to-render detail | |

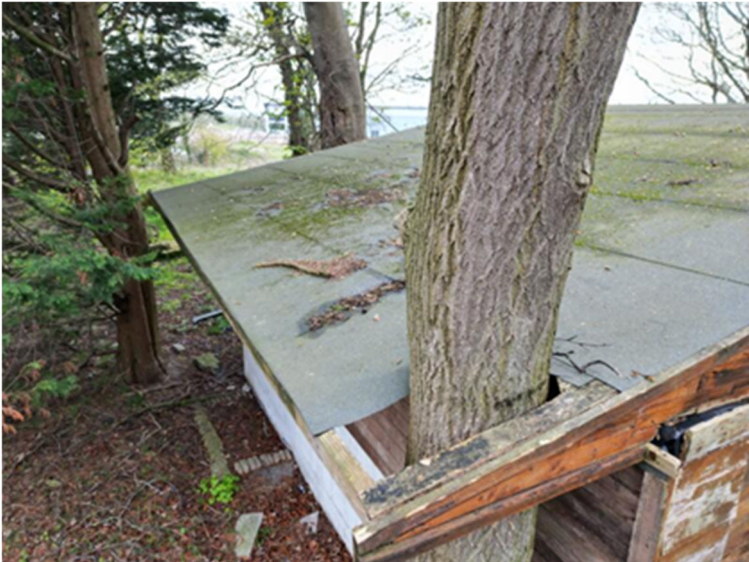
| Photo No | Photograph Description | Photograph |
|---|---|---|
| 313. | <b>Games Building Roof</b><br>Poor detailing to penetration | |

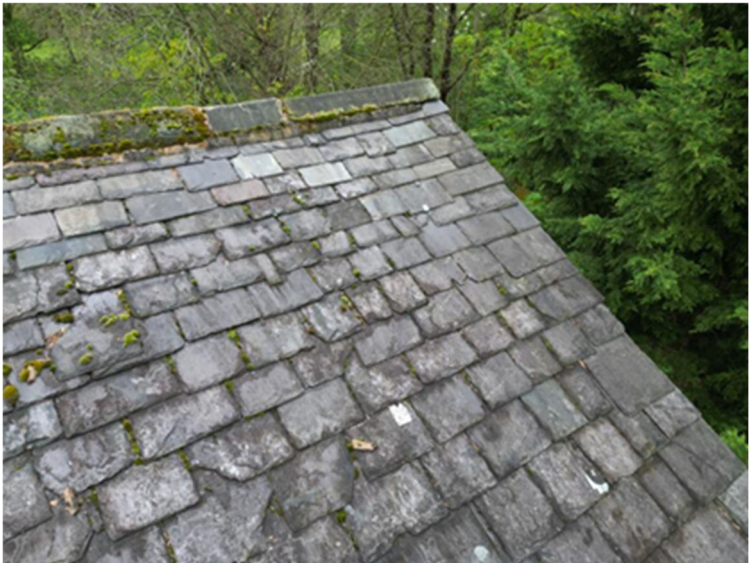
| Photo No | Photograph Description | Photograph |
|---|---|---|
| 314. | <b>Main Building Roof</b><br>Broken slates | |

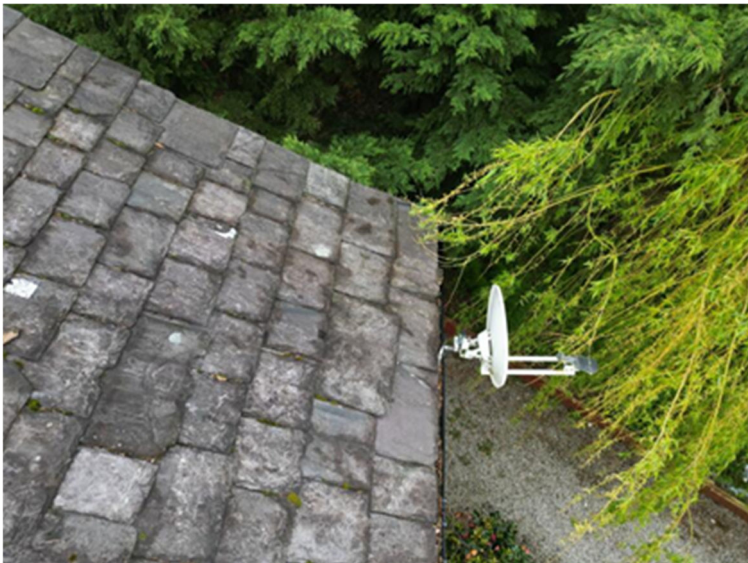
| Photo No | Photograph Description | Photograph |
|---|---|---|
| 315. | <b>Main Building Roof</b><br>Dislodged slates | An aerial photograph showing a section of a roof covered in grey slate tiles. Several tiles are missing or dislodged, revealing the underlying structure. A white satellite dish is mounted on the roof edge. Green foliage is visible in the background. |

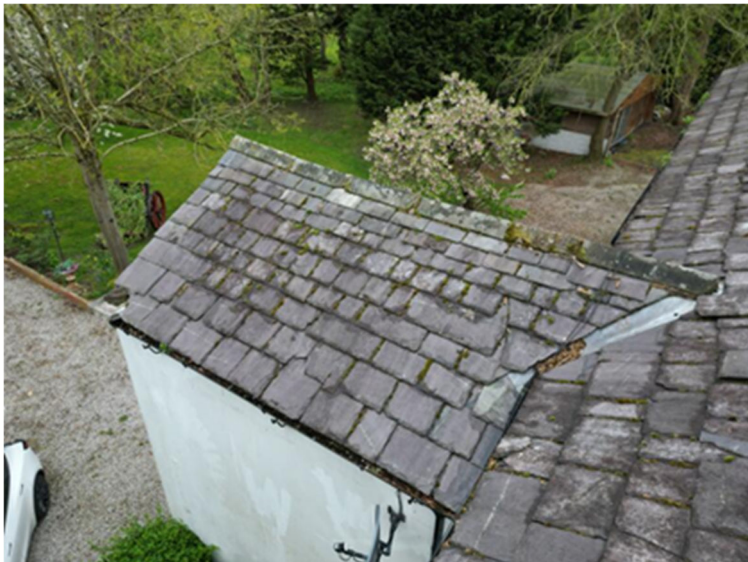
| Photo No | Photograph Description | Photograph |
|---|---|---|
| 316. | <b>Main Building Roof</b><br>Dislodged and broken slates | An aerial photograph showing a roof with grey slate tiles. A significant portion of the roof is covered in dislodged and broken slates, particularly along the edge. A white wall and a gravel area are visible in the foreground. |

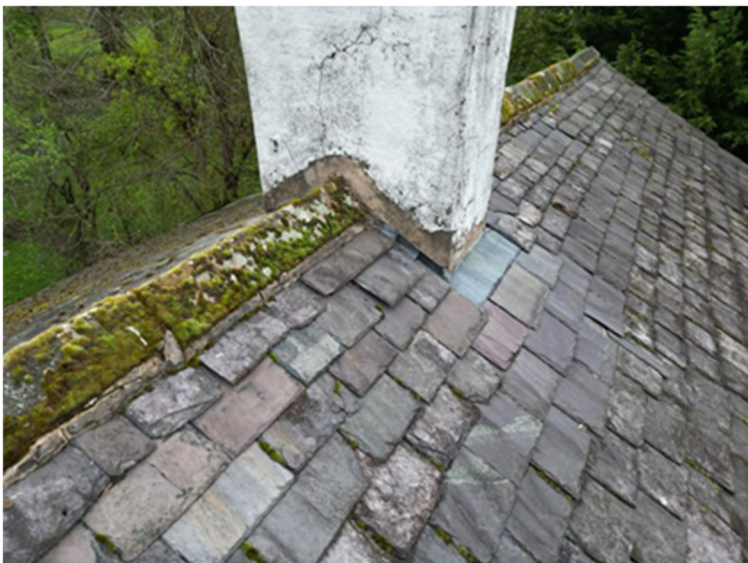
| Photo No | Photograph Description | Photograph |
|---|---|---|
| 317. | <b>Main Building Roof</b><br>Poor condition of render at chimneystack upstand | A close-up photograph of a chimney stack upstand on a roof. The render on the chimney is in poor condition, showing significant cracking and peeling. The roof tiles are grey and show signs of moss growth. |

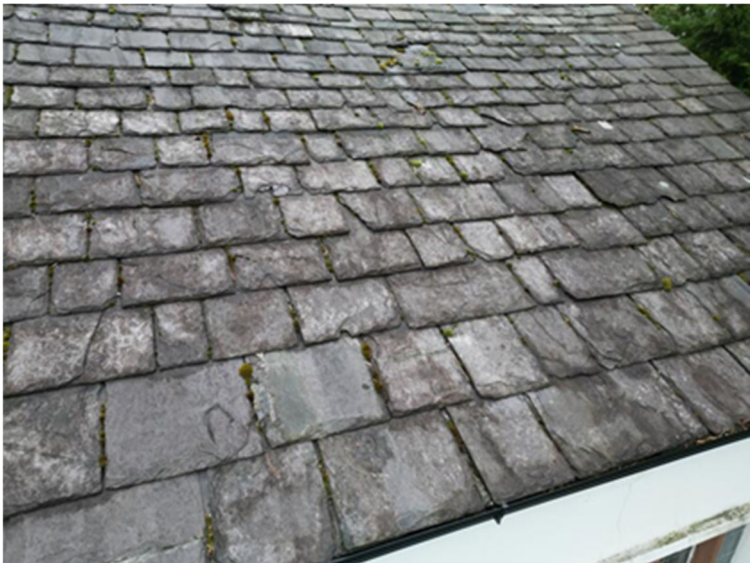
| Photo No | Photograph Description | Photograph |
|---|---|---|
| 318. | <b>Main Building Roof</b><br>Dislodged slates | |
