# Photographic Schedule of Condition

Old Halsnead Hall, Fox's Bank Lane, Widnes, Prescot L35 3SU

April 2026

Doc Ref: 04C600152

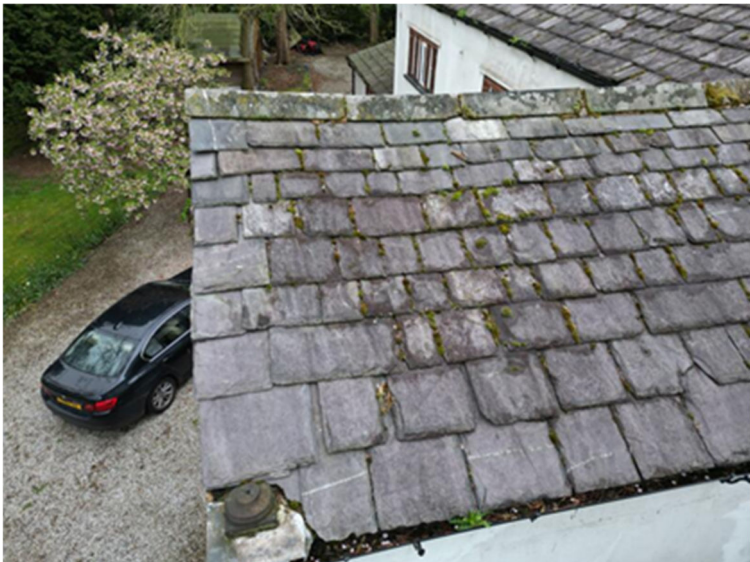
| Photo No | Photograph Description | Photograph |
|---|---|---|
| 319. | <b>Main Building Roof</b><br>Dislodged and broken slates | |

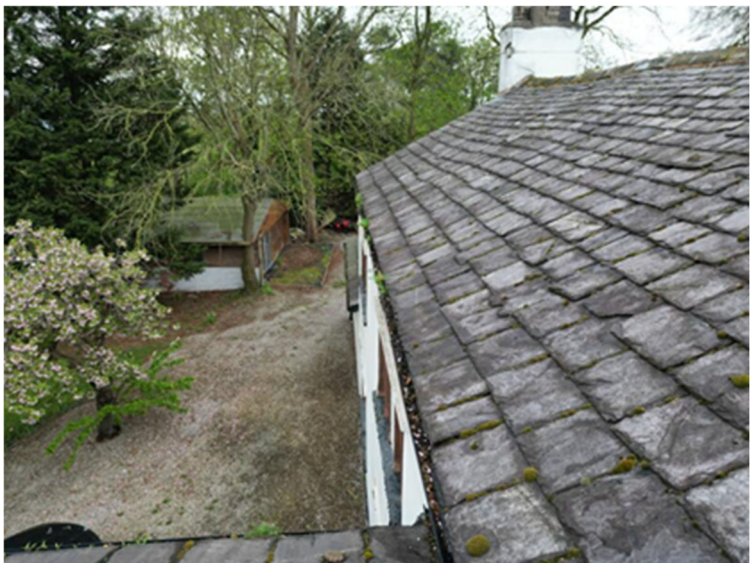
| Photo No | Photograph Description | Photograph |
|---|---|---|
| 320. | <b>Main Building Roof</b><br>Gutter build up | |

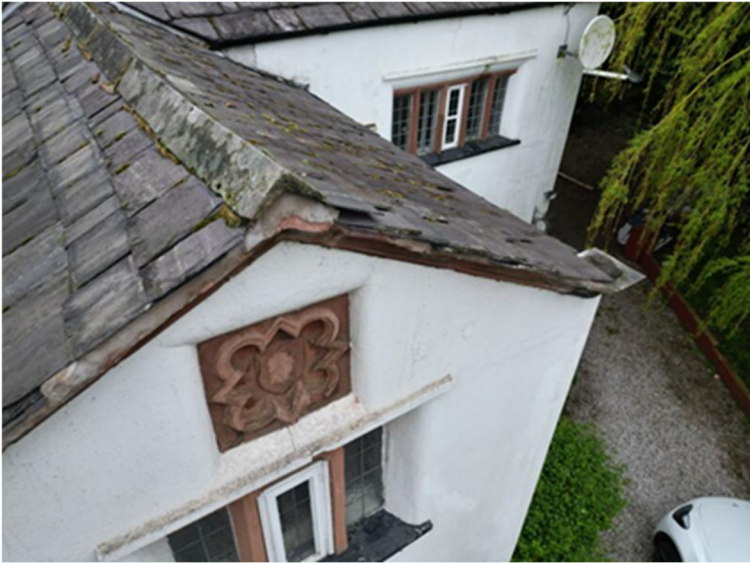
| Photo No | Photograph Description | Photograph |
|---|---|---|
| 321. | <b>Main Building Roof</b><br>Cracking to gable end mortar | |

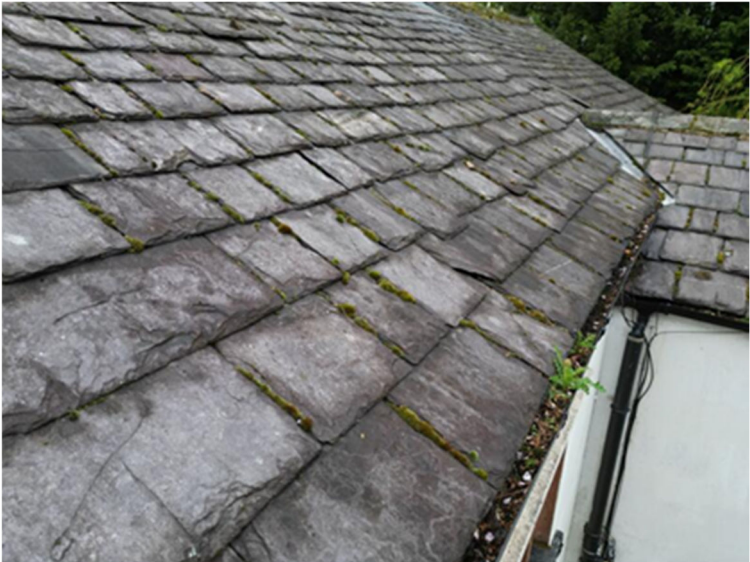
| Photo No | Photograph Description | Photograph |
|---|---|---|
| 322. | <b>Main Building Roof</b><br>Vegetation and silt to gutters | |

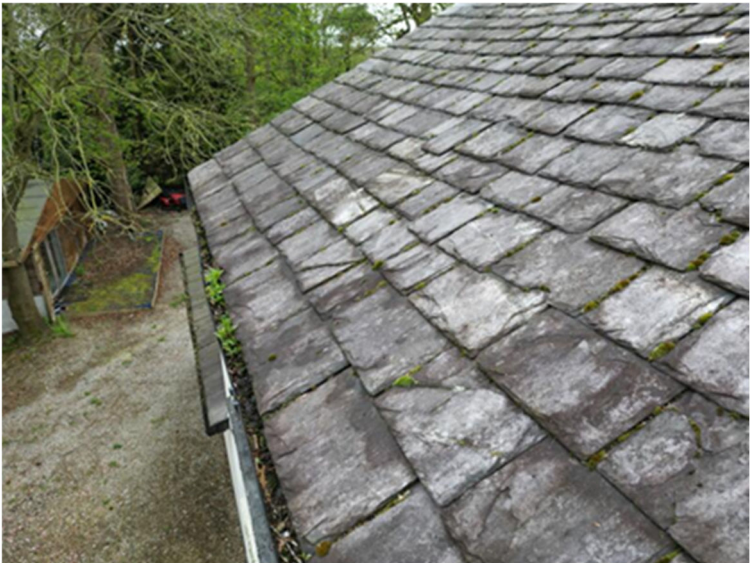
| Photo No | Photograph Description | Photograph |
|---|---|---|
| 323. | <b>Main Building Roof</b><br>Vegetation and silt to gutters | |

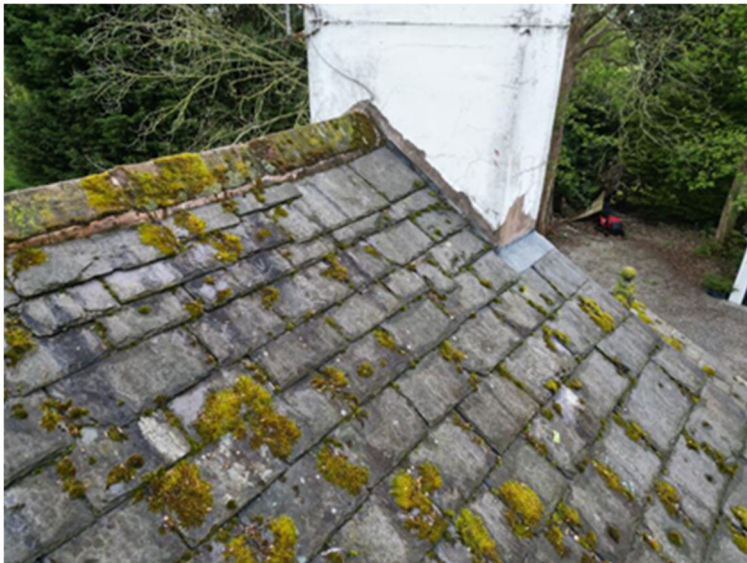
| Photo No | Photograph Description | Photograph |
|---|---|---|
| 324. | <b>Main Building Roof</b><br>Lichen build up on slates | |

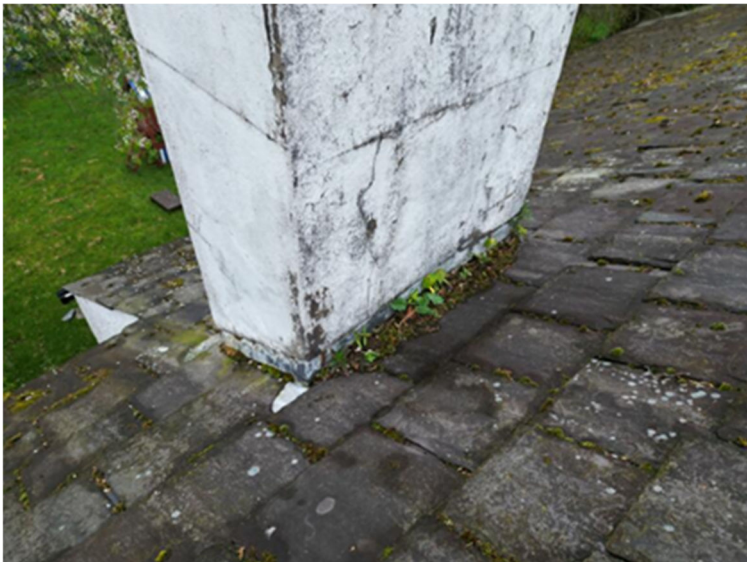
| Photo No | Photograph Description | Photograph |
|---|---|---|
| 325. | <b>Main Building Roof</b><br>Vegetation, silting and poor detailing at chimneystack-to-pitch junction | |

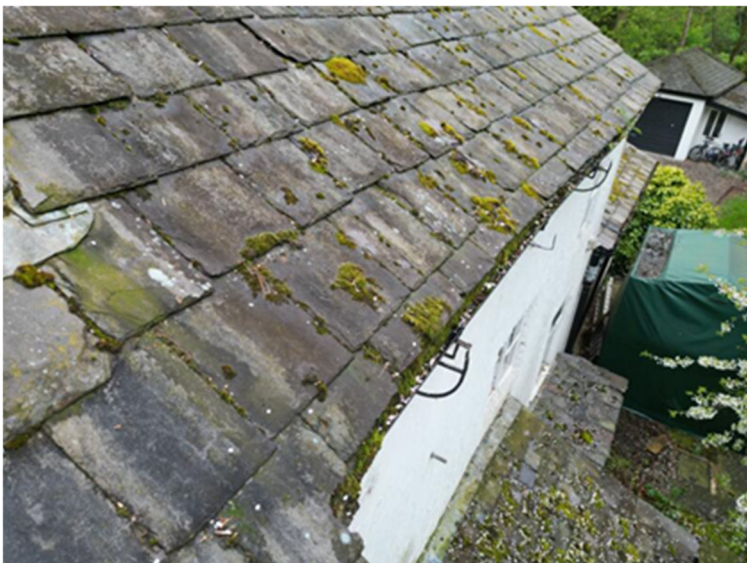
| Photo No | Photograph Description | Photograph |
|---|---|---|
| 326. | <b>Main Building Roof</b><br>Vegetation and silt to gutters | |

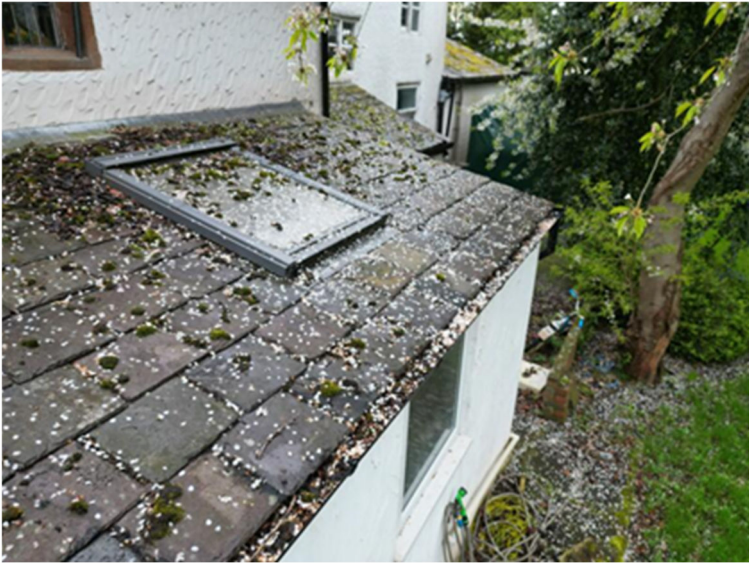
| Photo No | Photograph Description | Photograph |
|---|---|---|
| 327. | <b>Main Building Roof</b><br>Debris in gutter | |

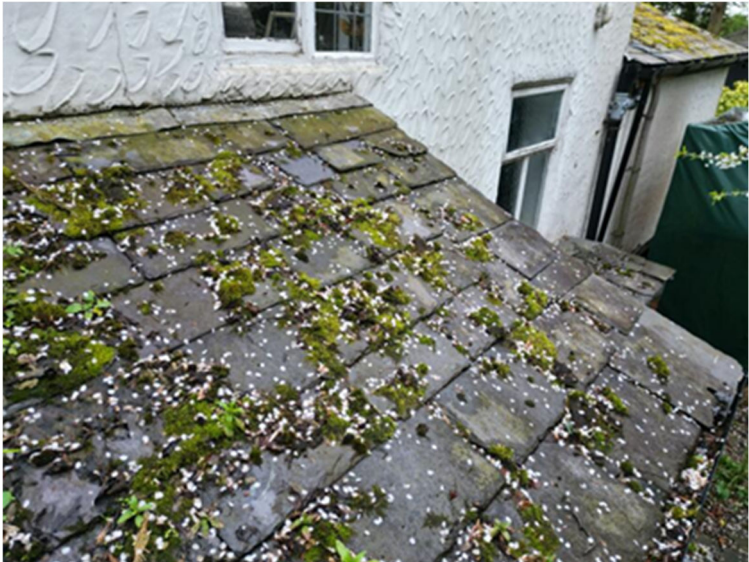
| Photo No | Photograph Description | Photograph |
|---|---|---|
| 328. | <b>Main Building Roof</b><br>Lichen build up | |

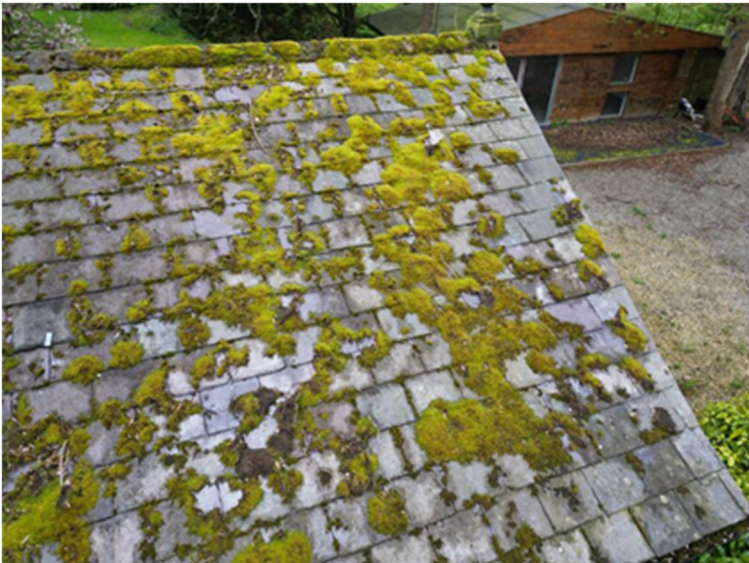
| Photo No | Photograph Description | Photograph |
|---|---|---|
| 329. | <b>Main Building Roof</b><br>Lichen and moss build up | |

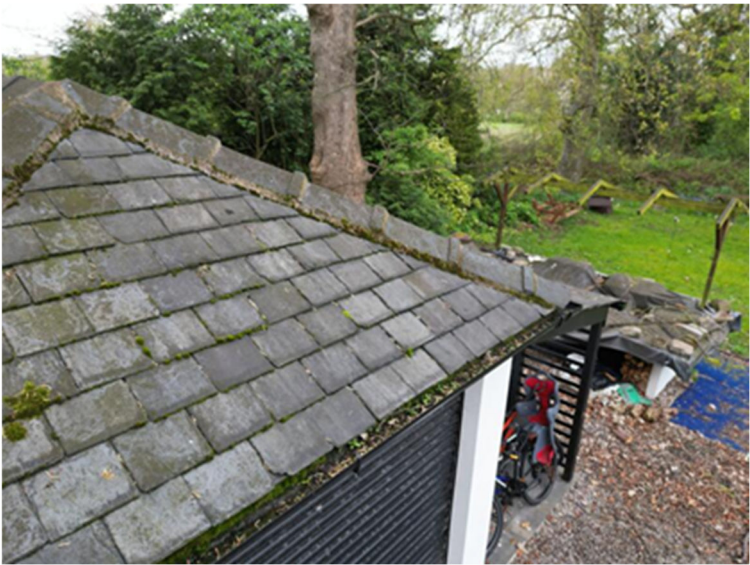
| Photo No | Photograph Description | Photograph |
|---|---|---|
| 330. | <b>Garage Roof</b><br>Silted gutter | A photograph showing a close-up of a grey slate roof. A black gutter runs along the edge, filled with brown silt and debris. A red bicycle is parked on a gravel path next to the roof. |

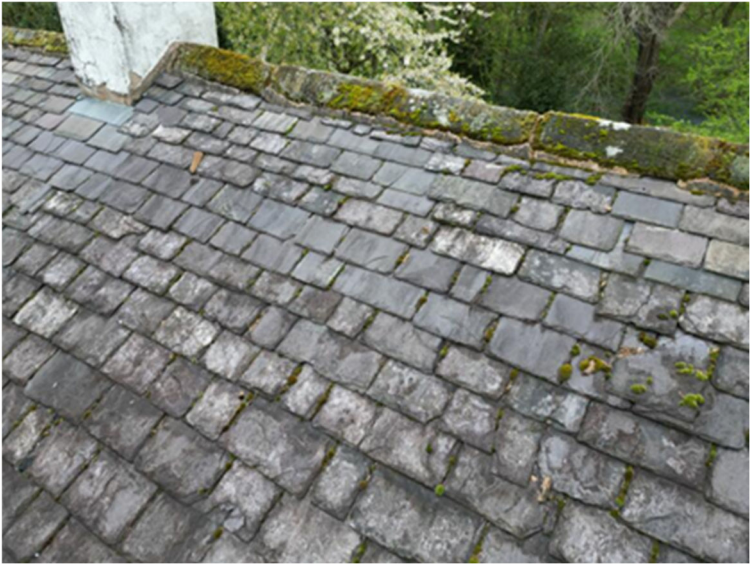
| Photo No | Photograph Description | Photograph |
|---|---|---|
| 331. | <b>Main Building Roof</b><br>Replacement slates | A photograph of a grey slate roof. A section of the roof shows newer, lighter-colored replacement slates. Moss is visible on the older slates. |

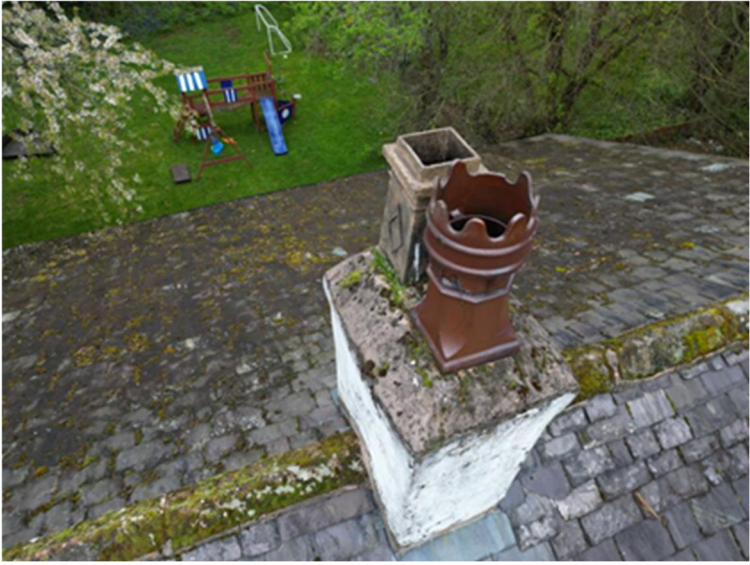
| Photo No | Photograph Description | Photograph |
|---|---|---|
| 332. | <b>Main Building Roof</b><br>General view of chimneystack | A photograph of a grey slate roof. A brick chimneystack with a brown metal cap is visible. In the background, a green lawn and a blue and red play structure are visible. |

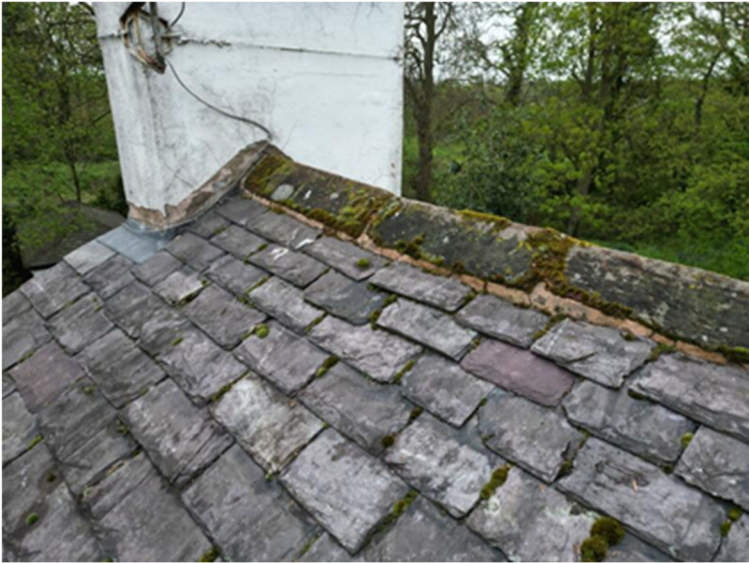
| Photo No | Photograph Description | Photograph |
|---|---|---|
| 333. | <b>Main Building Roof</b><br>General view | |

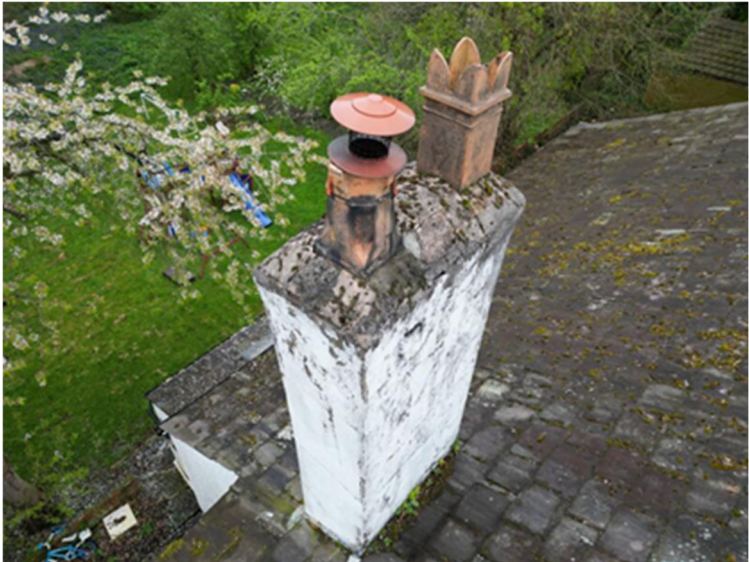
| Photo No | Photograph Description | Photograph |
|---|---|---|
| 334. | <b>Main Building Roof</b><br>General view of chimneystack | |

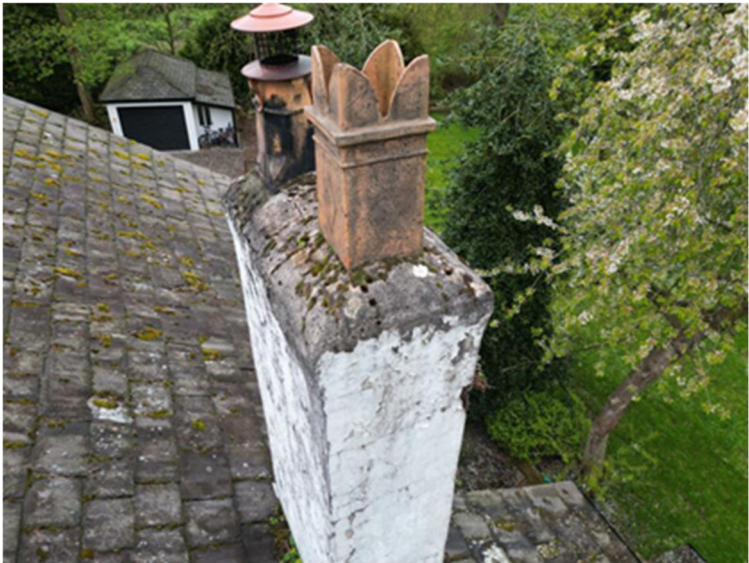
| Photo No | Photograph Description | Photograph |
|---|---|---|
| 335. | <b>Main Building Roof</b><br>General view of chimneystack | |

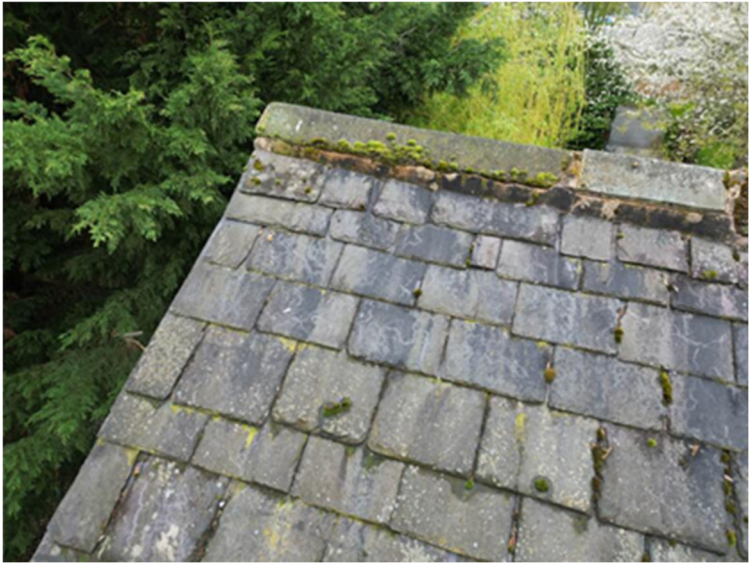
| Photo No | Photograph Description | Photograph |
|---|---|---|
| 336. | <b>Main Building Roof</b><br>General view | |

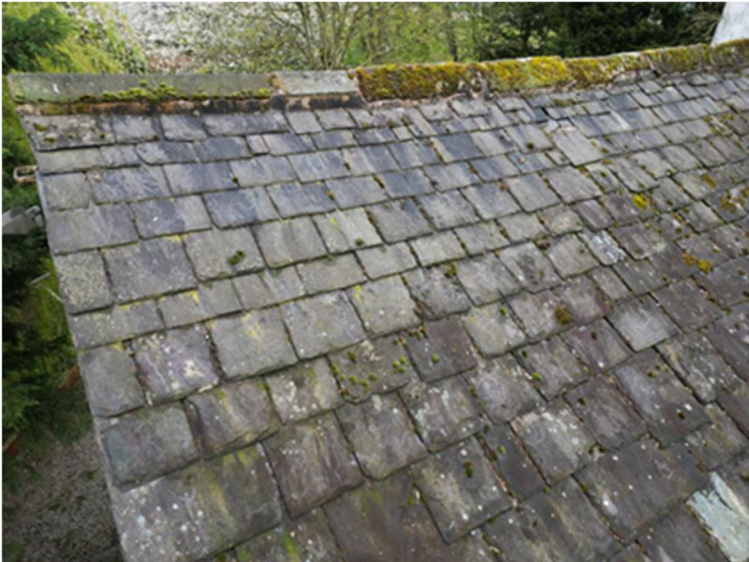
| Photo No | Photograph Description | Photograph |
|---|---|---|
| 337. | <b>Main Building Roof</b><br>General view | |

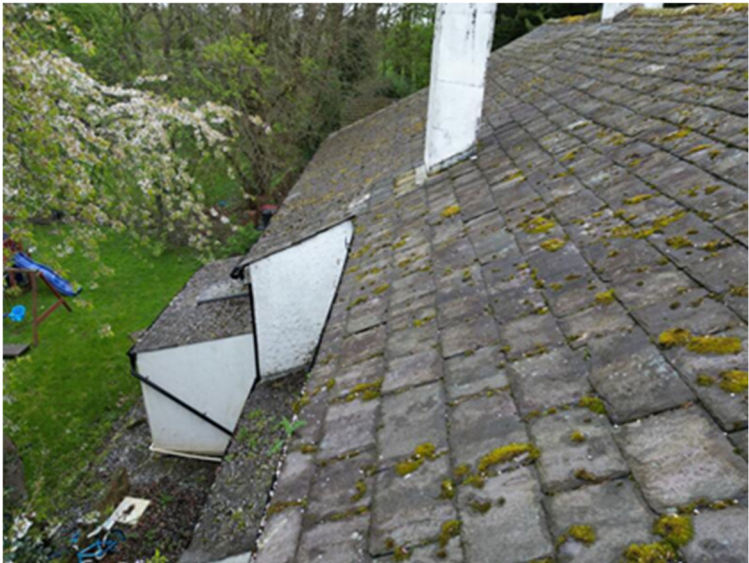
| Photo No | Photograph Description | Photograph |
|---|---|---|
| 338. | <b>Main Building Roof</b><br>General view | |

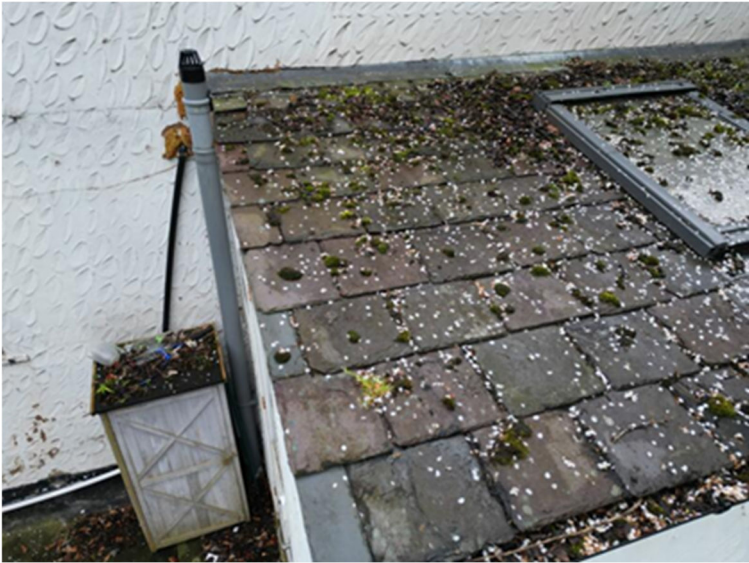
| Photo No | Photograph Description | Photograph |
|---|---|---|
| 339. | <b>Main Building Roof</b><br>Soiling to kitchen roof light | |

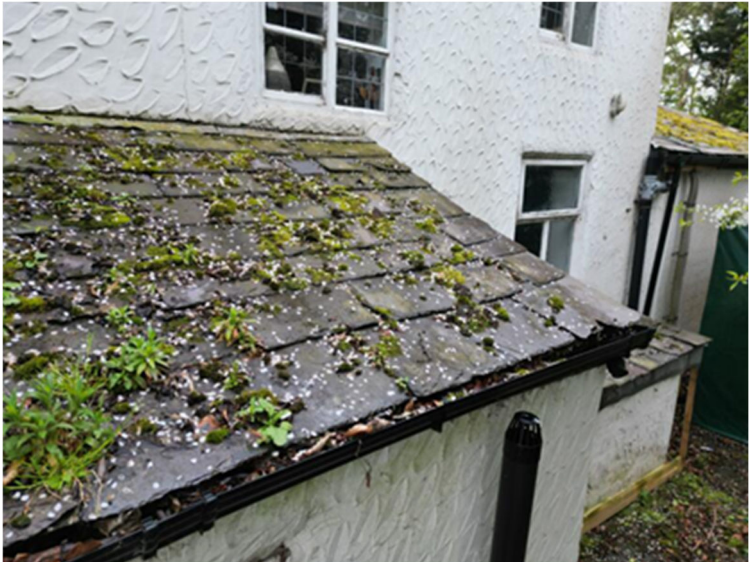
| Photo No | Photograph Description | Photograph |
|---|---|---|
| 340. | <b>Main Building Roof</b><br>Soiling and vegetation growth | |

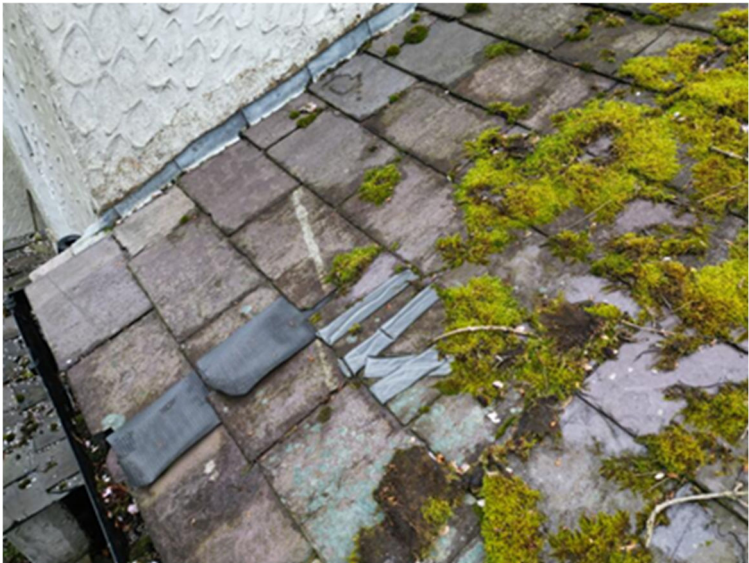
| Photo No | Photograph Description | Photograph |
|---|---|---|
| 341. | <b>Main Building Roof</b><br>Moss and patch repairs | |

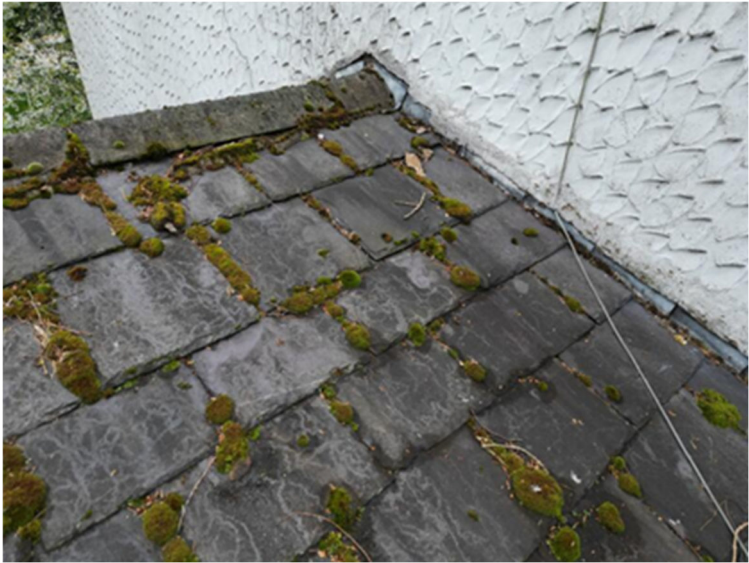
| Photo No | Photograph Description | Photograph |
|---|---|---|
| 342. | <b>Main Building Roof</b><br>Damp-affected render at junction between roof and gable | |

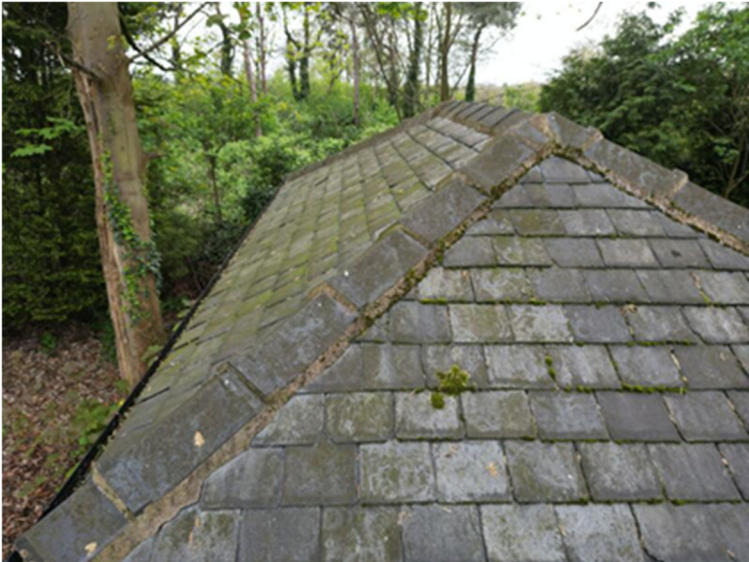
| Photo No | Photograph Description | Photograph |
|---|---|---|
| 343. | <b>Garage Roof</b><br>General view | |

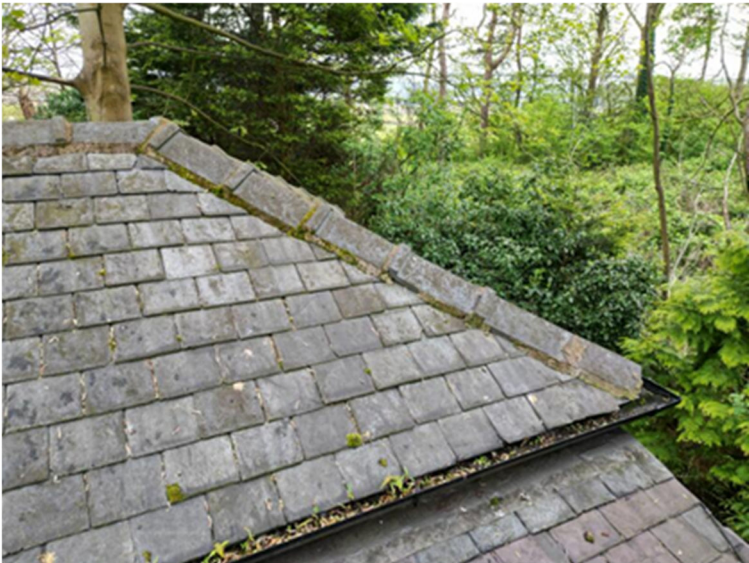
| Photo No | Photograph Description | Photograph |
|---|---|---|
| 344. | <b>Garage Roof</b><br>General view | |

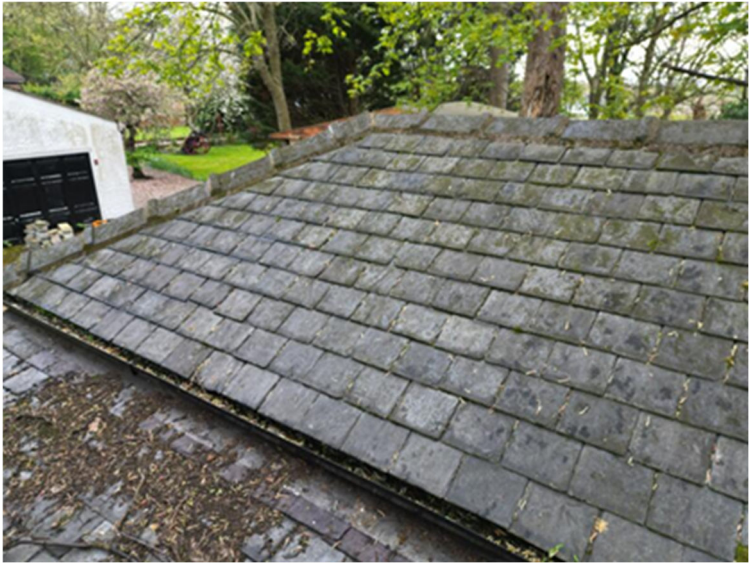
| Photo No | Photograph Description | Photograph |
|---|---|---|
| 345. | <b>Garage Roof</b><br>General view | |

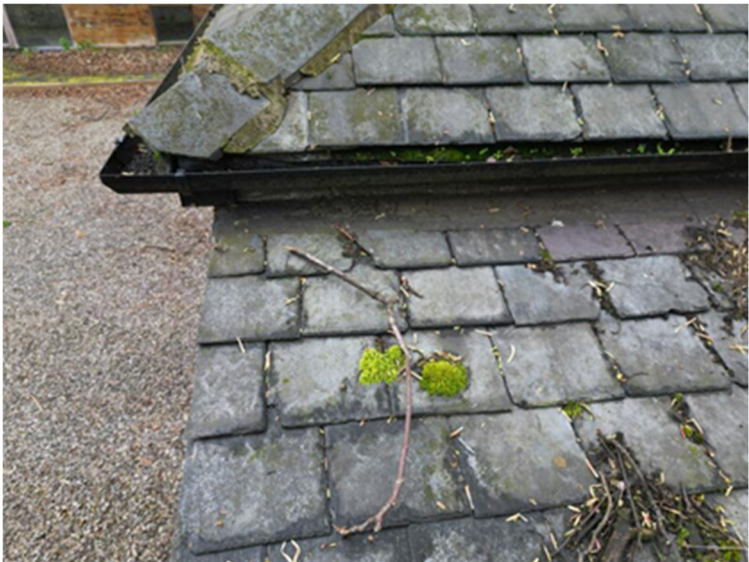
| Photo No | Photograph Description | Photograph |
|---|---|---|
| 346. | <b>Garage Roof</b><br>Close up showing soiling | |

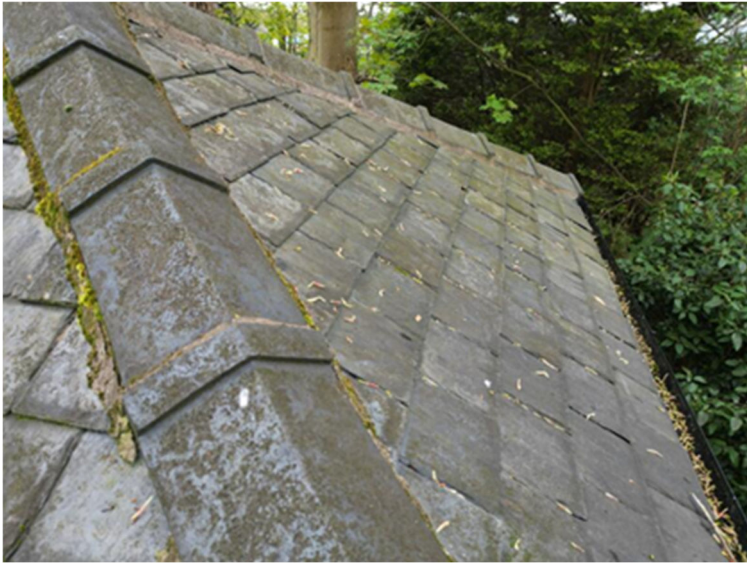
| Photo No | Photograph Description | Photograph |
|---|---|---|
| 348. | <b>Garage Roof</b><br>Missing mortar around hip tiles | |

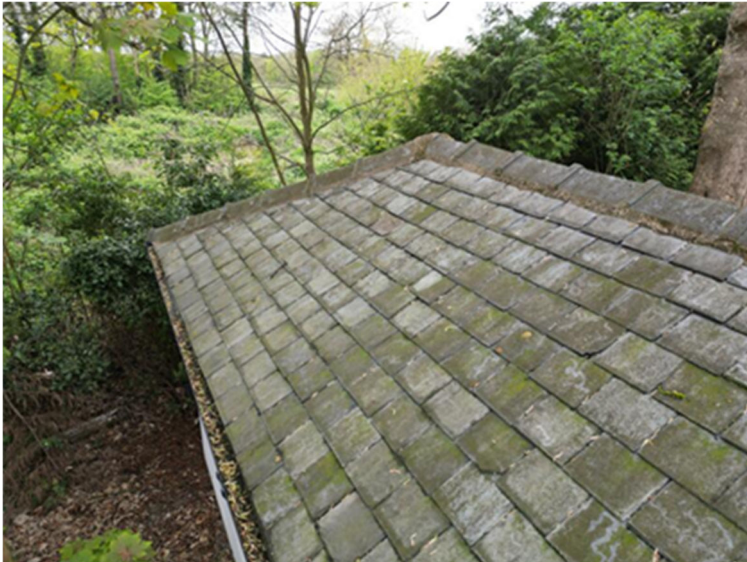
| Photo No | Photograph Description | Photograph |
|---|---|---|
| 349. | <b>Garage Roof</b><br>General view | |

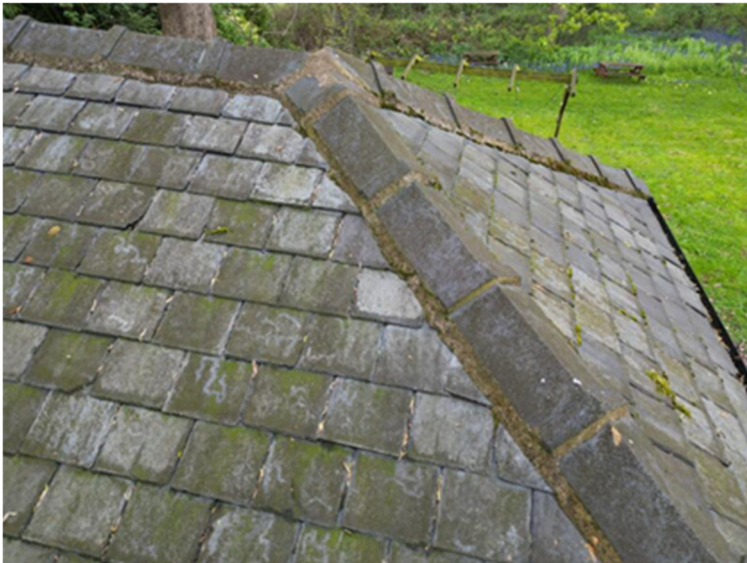
| Photo No | Photograph Description | Photograph |
|---|---|---|
| 350. | <b>Garage Roof</b><br>General view | |

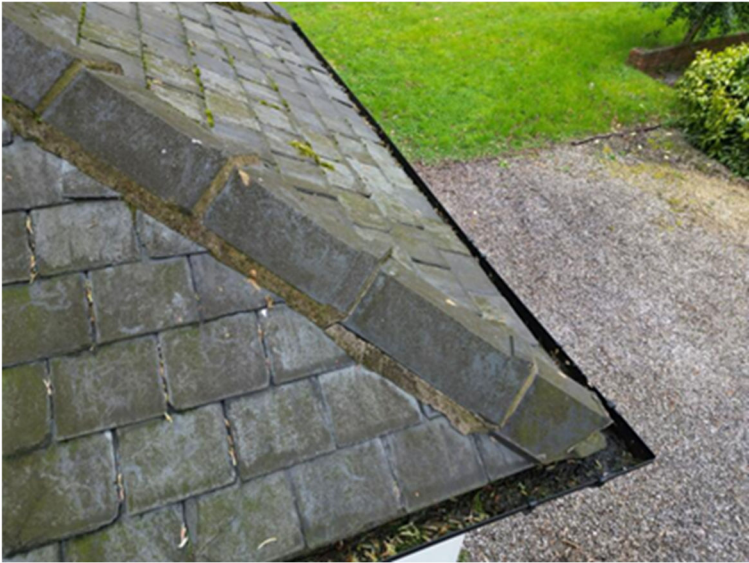
| Photo No | Photograph Description | Photograph |
|---|---|---|
| 351. | <b>Garage Roof</b><br>Missing mortar around hip tiles | |

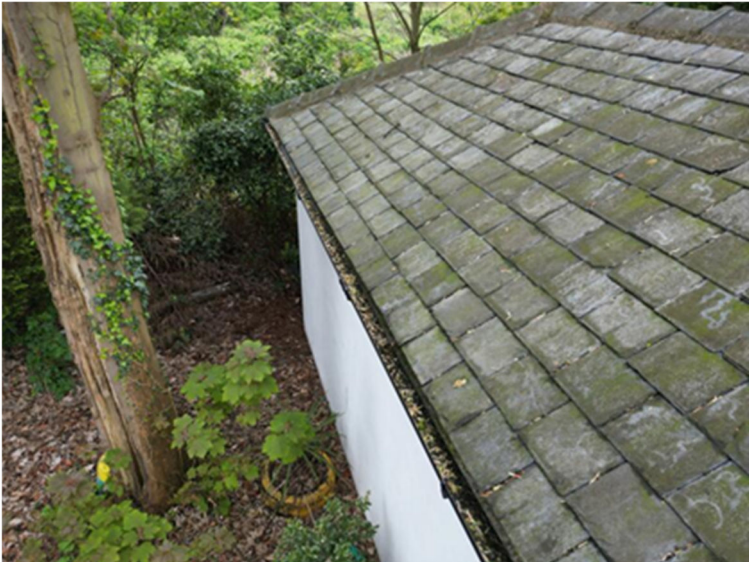
| Photo No | Photograph Description | Photograph |
|---|---|---|
| 352. | <b>Garage Roof</b><br>General view | |

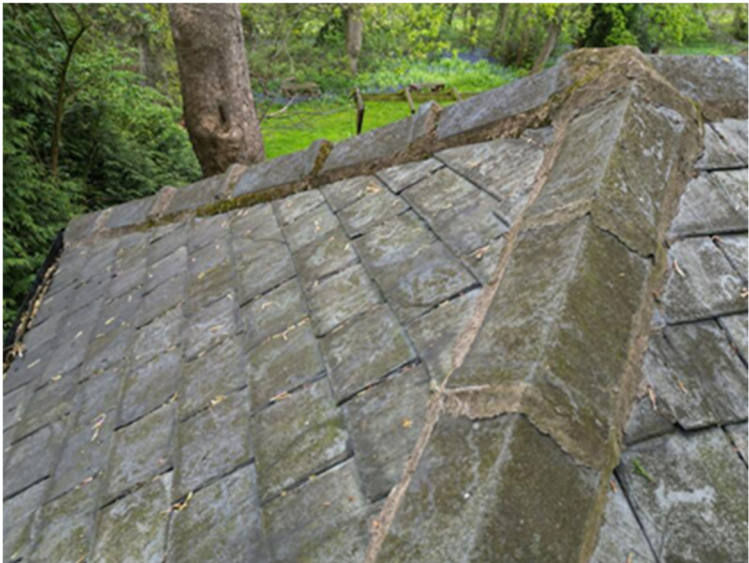
| Photo No | Photograph Description | Photograph |
|---|---|---|
| 353. | <b>Garage Roof</b><br>General view | |

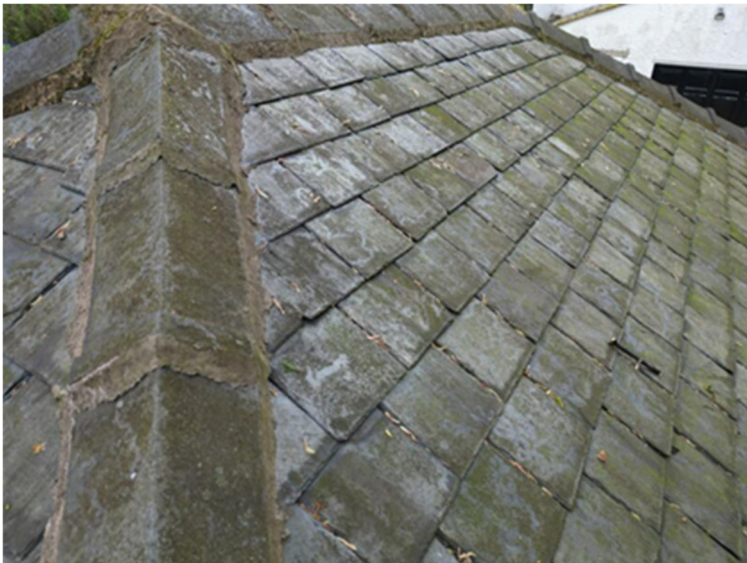
| Photo No | Photograph Description | Photograph |
|---|---|---|
| 354. | <b>Garage Roof</b><br>General view | |

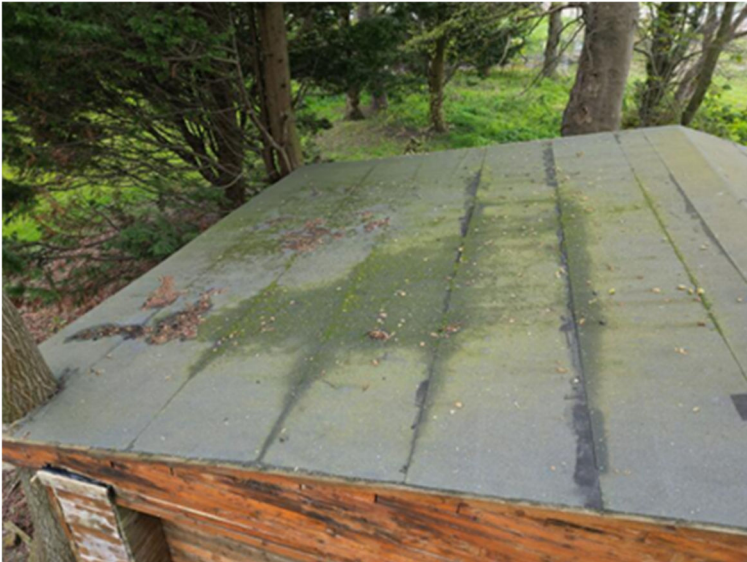
| Photo No | Photograph Description | Photograph |
|---|---|---|
| 355. | <b>Games Building Roof</b><br>General view | |

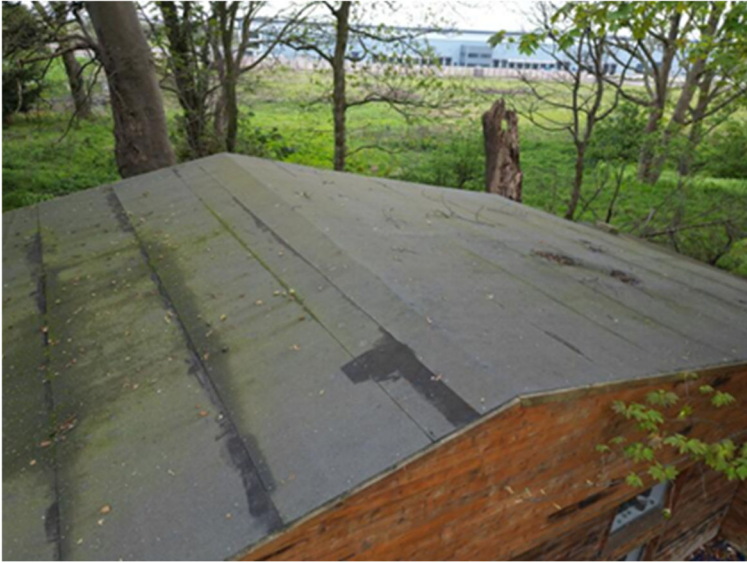
| Photo No | Photograph Description | Photograph |
|---|---|---|
| 356. | <b>Games Building Roof</b><br>General view | |

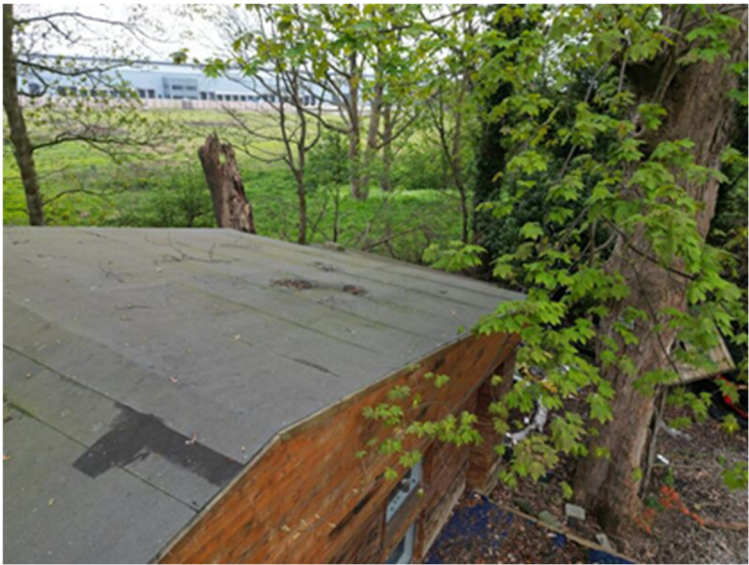
| Photo No | Photograph Description | Photograph |
|---|---|---|
| 357. | <b>Games Building Roof</b><br>General view | A photograph showing a general view of the Games Building Roof. The roof is covered in grey tiles and is surrounded by lush green trees and foliage. A wooden structure is visible on the right side of the roof. |

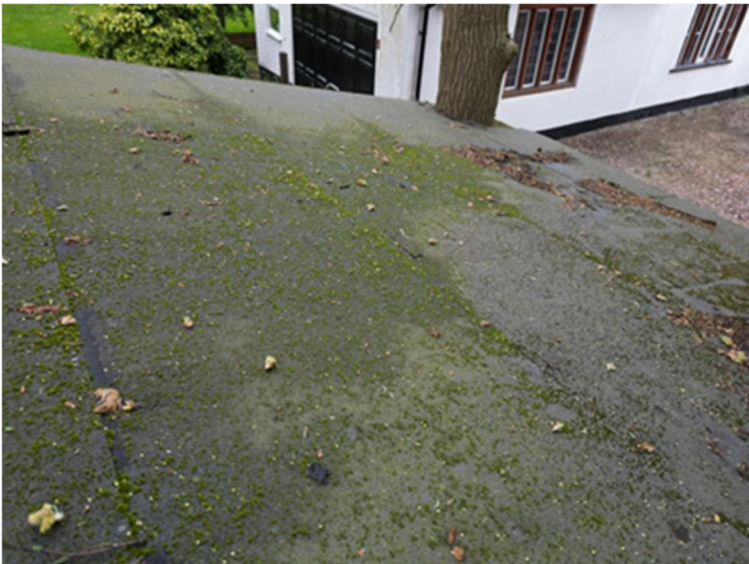
| Photo No | Photograph Description | Photograph |
|---|---|---|
| 358. | <b>Games Building Roof</b><br>Close up showing soiling | A close-up photograph of the Games Building Roof showing significant soiling. The roof is covered in a thick layer of green moss and fallen leaves, indicating poor maintenance. |

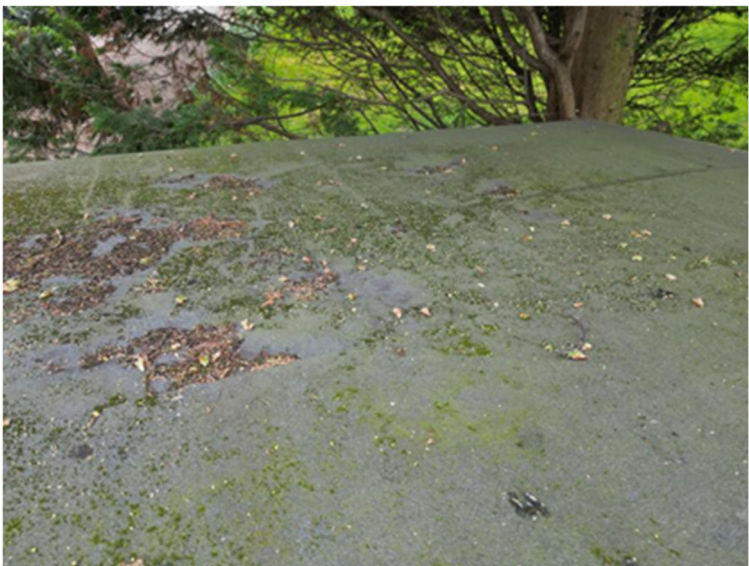
| Photo No | Photograph Description | Photograph |
|---|---|---|
| 359. | <b>Games Building Roof</b><br>Close up showing soiling | Another close-up photograph of the Games Building Roof showing soiling. The roof is covered in a thick layer of green moss and fallen leaves, indicating poor maintenance. |

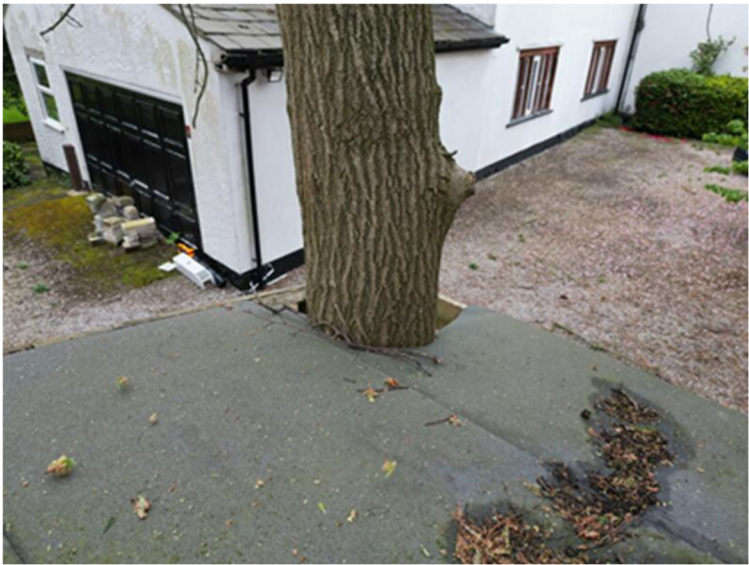
| Photo No | Photograph Description | Photograph |
|---|---|---|
| 360. | <b>Games Building Roof</b><br>Poor detailing around tree penetration | A photograph showing the exterior of a white building with a dark roof. A large tree trunk is positioned near the building, and the roof surface around the tree shows signs of poor detailing and debris accumulation. |

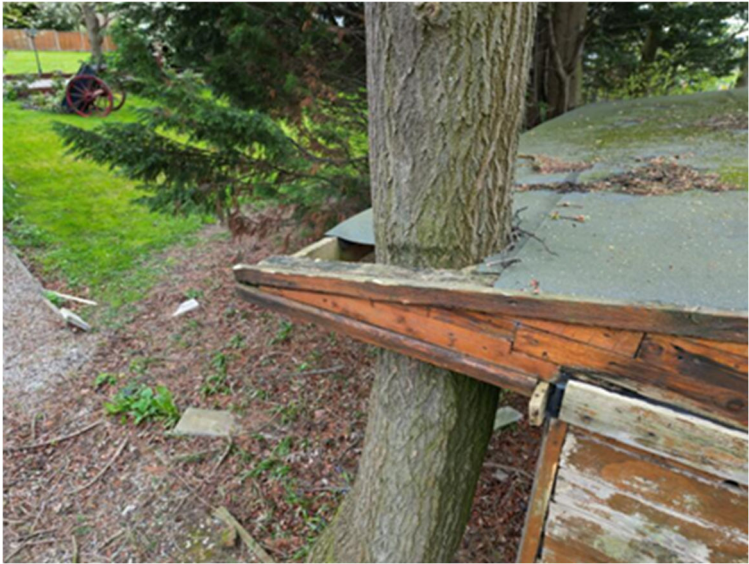
| Photo No | Photograph Description | Photograph |
|---|---|---|
| 361. | <b>Games Building Roof</b><br>Poor detailing around tree penetration | A close-up photograph of a tree trunk where it meets a roof. The roof surface is dark and shows signs of poor detailing and debris accumulation around the tree penetration. |

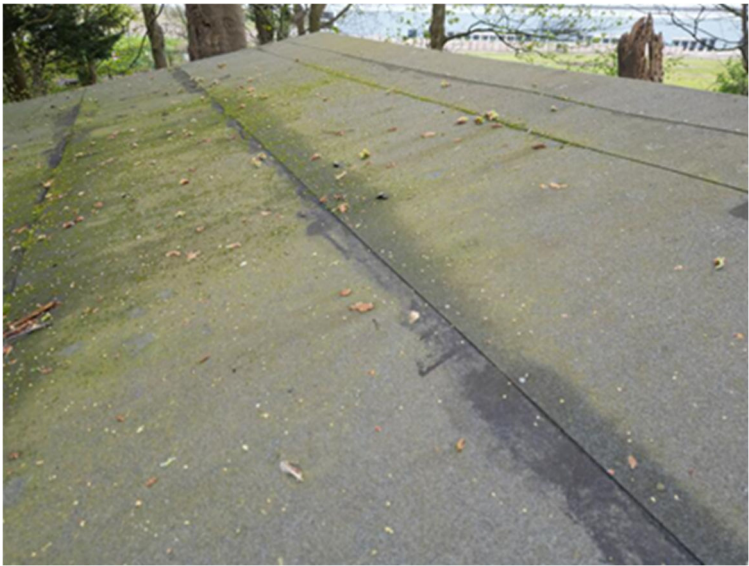
| Photo No | Photograph Description | Photograph |
|---|---|---|
| 362. | <b>Games Building Roof</b><br>Tar based sealant repairs to laps | A photograph of a roof surface showing dark, tar-based sealant repairs applied to the laps of the roofing material. The roof surface is dark and shows signs of debris accumulation. |

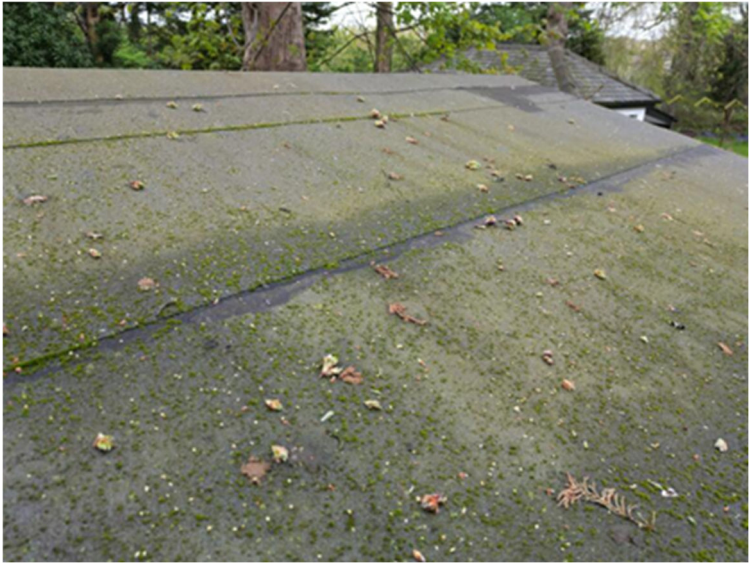
| Photo No | Photograph Description | Photograph |
|---|---|---|
| 363. | <b>Games Building Roof</b><br>Repairs | |

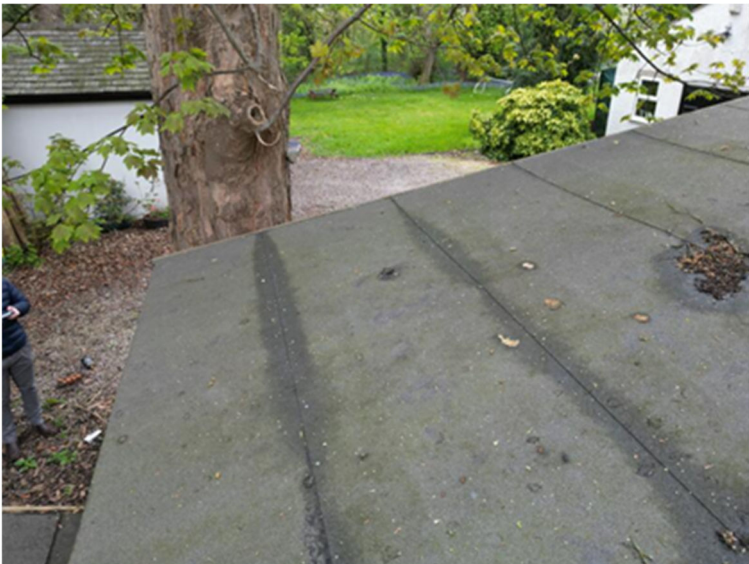
| Photo No | Photograph Description | Photograph |
|---|---|---|
| 364. | <b>Games Building Roof</b><br>Repairs | |

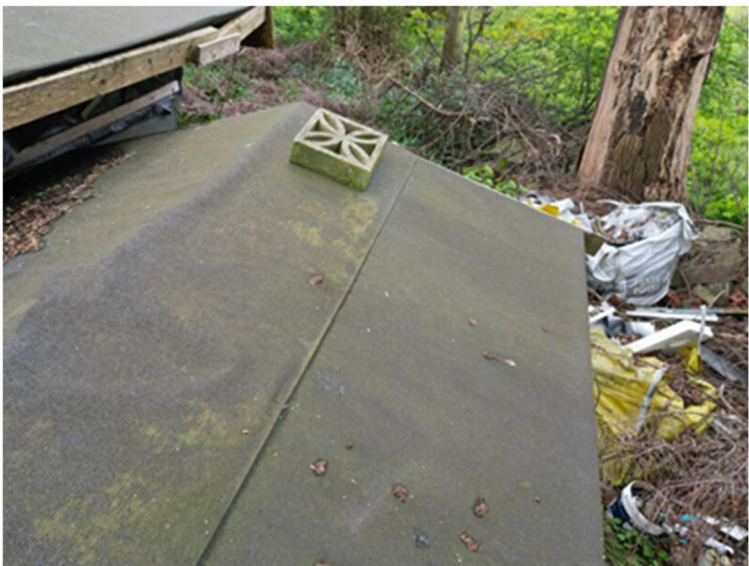
| Photo No | Photograph Description | Photograph |
|---|---|---|
| 365. | <b>Games Building Roof</b><br>Debris on shed roof adjacent | |
