# Preliminary Bat Roost Assessment

Former Ambulance and Fire Station, Huyton Lane, Huyton, Liverpool, Merseyside

A Report To: McCarthy & Stone  
Report Number: RT-MME-158942-02 Rev A  
Date: October 2022  
Revised: January 2023

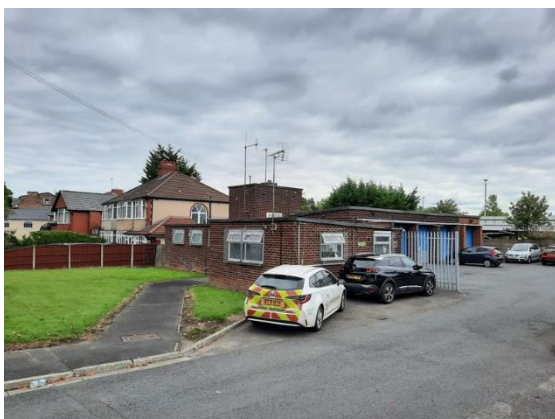
Building B1 was a flat-roofed Ambulance Station which was in use at the time of survey (Plate 4.1). It was largely single storey, but a tower-like structure (i.e. the boiler room) was present in the north of the building, which protruded above the single-storey roof. The flat roof appeared to comprise concrete with a bitumen felt overlay. This was largely in good condition, but towards one of the southern corners, a small amount of missing felt was noted around the concrete edging. However, this did not appear to form any significant potential bat roost features.

**Plate 4.1: Building B1 from North-west Viewpoint.**

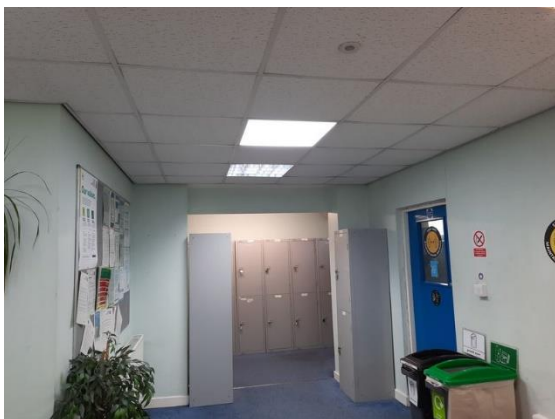
Approximately half of the building (to the north-west) was in use at the time of survey as office space and waiting/mess rooms with a kitchen also present. This section of the building had suspended ceiling tiles with light fittings present which were in good condition (Plate 4.4). The building was also well-lit internally as a result of its regular use.

No evidence of bats or suitable bat roost features were identified during the internal inspection.

**Plate 4.4: North-west Section of Building B1.**

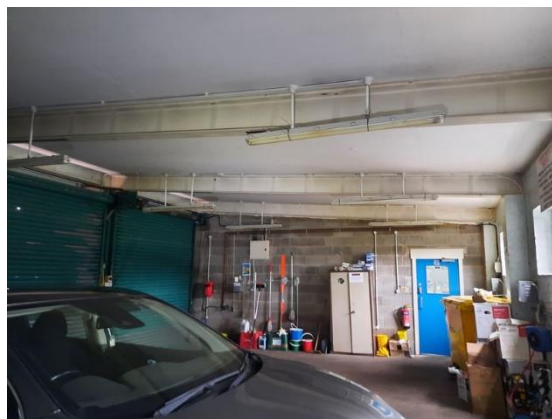
The remaining half of the building (to the south-east) comprised a garage area with windows to the north and roller shutter doors to the south (Plate 4.5). A breezeblock wall was noted to the west of this area, but the remaining elevations comprised brick. This section had a smooth boarded roof with steel beam supports and strip lights were installed.

**Plate 4.5: South-east Section of Building B1.**

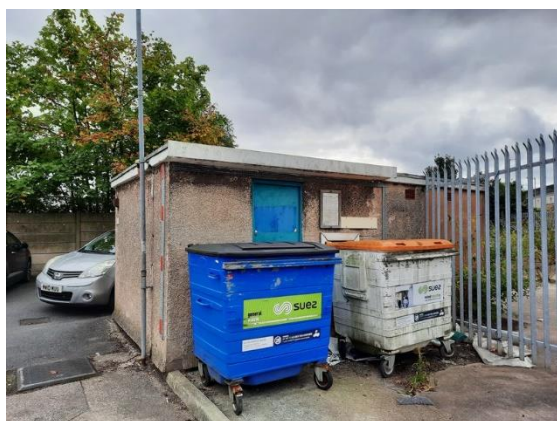
Building B2 was a small, single-storey structure located approximately 10 m south-west of Building B1 (Plate 4.6). This building had rendered walls which were part smooth and part pebbledash. A fire extinguisher unit with uPVC framework was installed into the north-west wall at low level. The framework had come away from the wall in some places, providing a potential roosting crevice for bats (Plate 4.7), although two commercial bins were stored immediately adjacent to this feature, meaning that it was partially obstructed.

**Plate 4.6: North-west Elevation of Building B2.**
