# Prescot to Cronton

Road Safety Audit Designer's Response

Project number: 60629784  
60629784-REP-30-PC-CT-0014

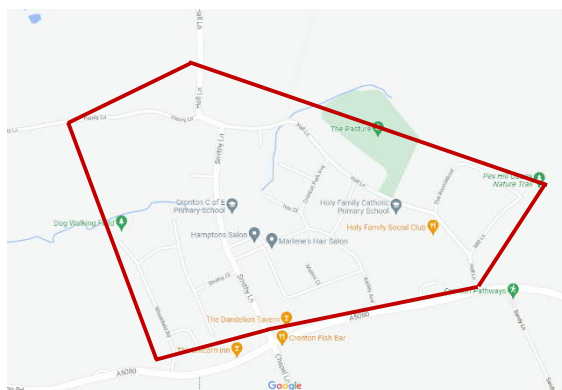
**Summary:** Risk of cyclists / pedestrians / vehicle collisions because of observed vehicle speeds.

**Description:** Drawing 60629784-SHT-30-PCP8-CT-0113 shows the proposed on carriageway cycle route along Hall Lane and Penny Lane. During the site inspection the Audit Team noted that vehicle speeds on the approach to this junction were high and evidence of collisions was also noted.

Penny Lane and Hall Lane, to the north of the junction, are narrow country lanes where vehicle must slow to pass. There is already a 20mph limit on the approach to the junction with 'SLOW' and '20' road markings. The proposals allow for the renewal of the existing 20mph roundel road mark on Penny Lane. Hall Lane & Smithy Lane, to the east, are also 20mph zones. The area is close to a village with narrow roads requiring oncoming traffic to give-way to allow passing and 20mph areas through-out, so the likelihood of high-speed traffic is low. The plan below shows the extent of the 20mph zone.

It is recommended traffic calming measures are implemented on Hall Lane and Penny Lane to reduce traffic speeds.

As well as the renewal of the existing road markings in the area, an additional 20mph roundel has been incorporated on Penny Lane further in advance of the approach to the junction. This should give further indication to drivers that they need to slow down.

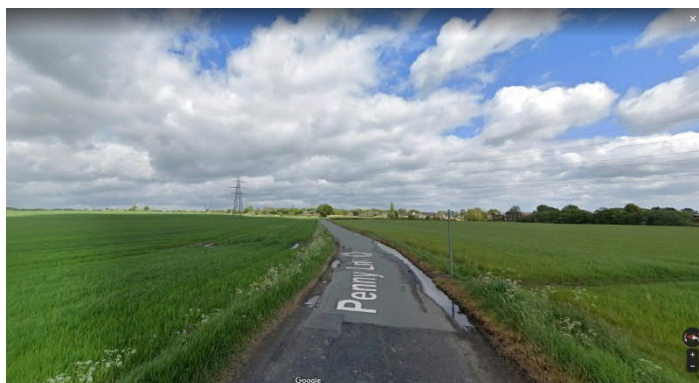
This section of Penny Lane is very narrow requiring oncoming cars to give-way to allow passing. It is thought due to the narrow nature of the existing road, this acts as an artificial traffic calming feature as it feels unnatural to travel at excessive speeds. There is also very good forward visibility along this road so that all users can see other users well in advance and make the right decision of what to do to interact and pass each other.

This is a concern that could be picked up during RSA Stage 3.

It is recommended that traffic calming and a reduction in speed limit is implemented on Penny Lane.
