# Headbolt Lane Station

## Riparian Mammal Habitat Suitability and Survey Report

**Project No:** 2593 – Headbolt Lane

**Title:** Headbolt Lane Station; Riparian Mammal Habitat Suitability and Survey Report

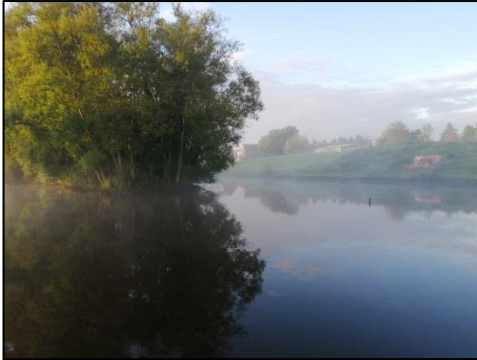
Simonswood Brook, north of Mill Lane  
(SJ 40692 99743 to SJ 40874 99564)

A man-made fishing lake is present to the west of Simonswood Brook; the banks are wooden and concrete, however a central island has more naturalised earth banks. Heavy disturbance from people due to tarmac paths around the lake perimeter, however a heron, moorhen and mallards were noted utilising the lake. A small area of bulrush planting is present within the northern corner of the lake.

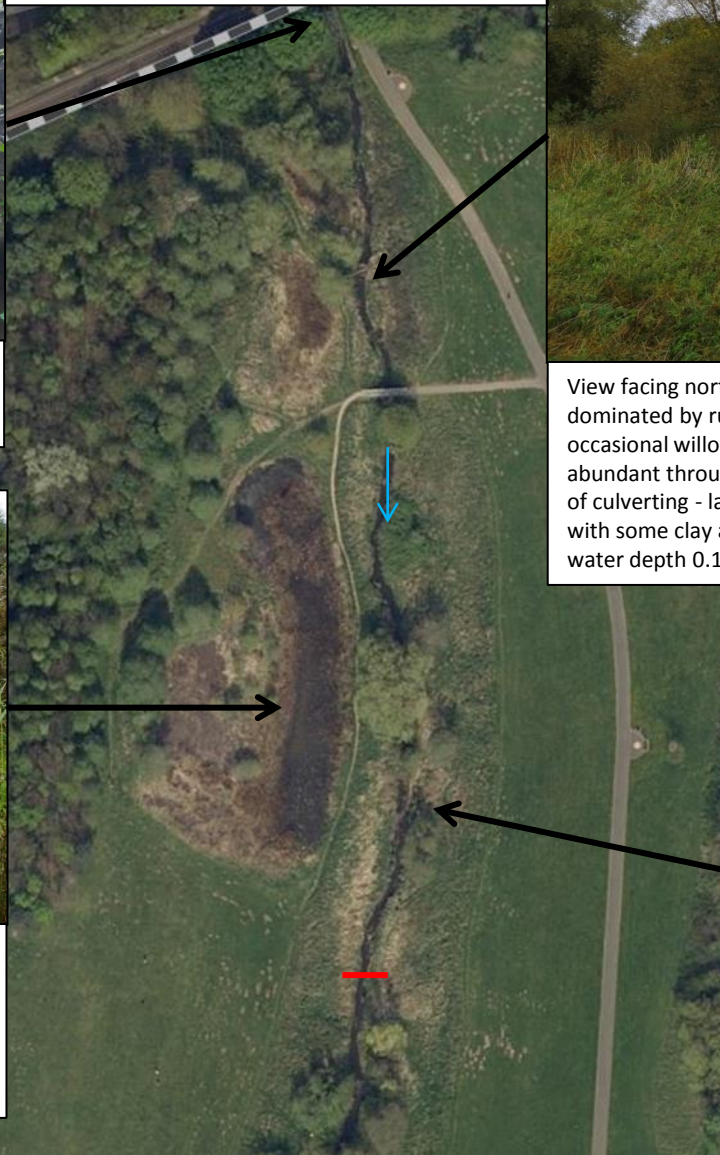
# Simonswood Brook South (SJ 40879 99554 to SJ 40892 99301)

View facing north of the brook profile; banksides dominated by ruderal vegetation and scrub with occasional willow trees. Himalayan balsam dominant / abundant throughout. Banks are steep 60 - 90° with signs of culverting - large slabs in place. Sediment is sandy silt with some clay and pebble. Flow is slow to moderate, water depth 0.1 – 0.3m and channel 1.5m wide.

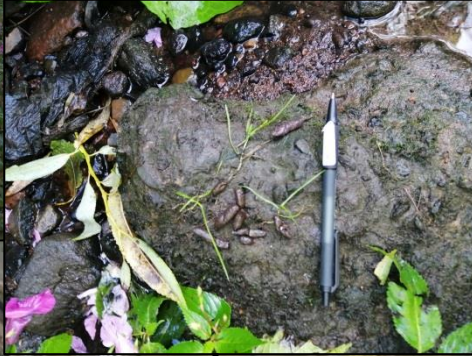
Stream is approximately 0.75 – 1.25m wide throughout and relatively shallow; 0.05 – 0.15m depth with a slow current. Sediment was rock and pebble with steep earth banks ( $\sim 75^\circ$ ). Banks were between 0.5 – 1.5m in height and densely vegetated with rank grasses, Himalayan balsam, common nettle and bramble. Rat droppings were observed in multiple locations along the length of the watercourse.

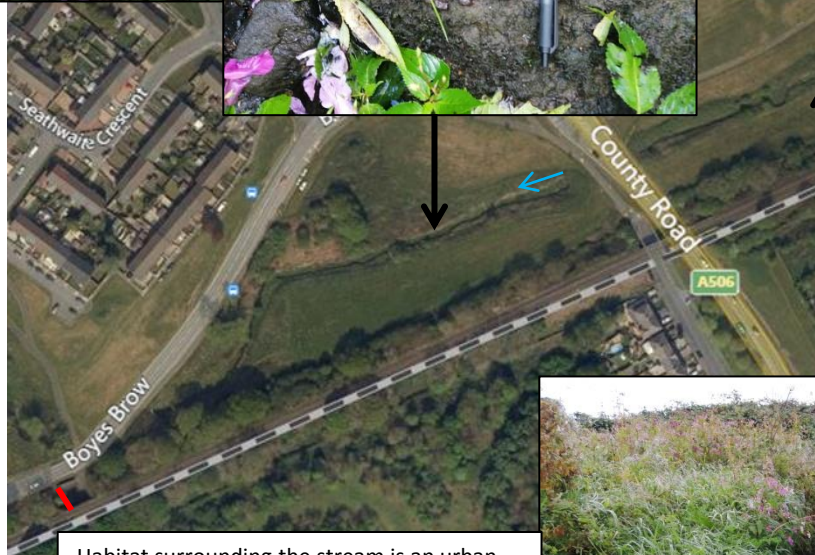
# Unnamed tributary of Simonswood Brook (SJ 40893 99562 to SJ 41498 99820)

North east of the section of the stream; bank height is maximum of 0.5m, sediment is pebble and stone, with more visible undercutting of banks. Himalayan balsam less prevalent, with coarse grasses dominating the bankside including reed canary grass, cock's-foot and false oat-grass.

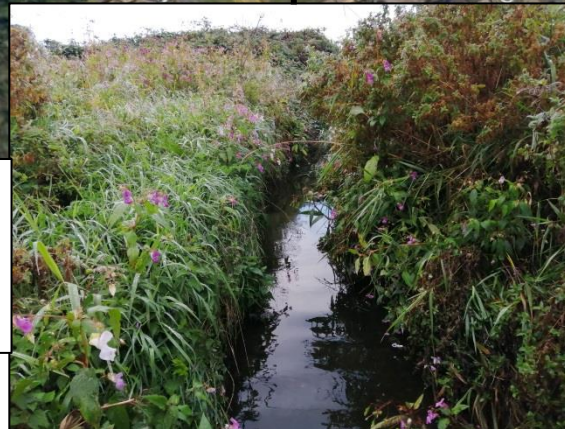
Habitat surrounding the stream is an urban greenway of semi-improved grassland which is managed through mowing. A margin of vegetation approximately 5-10m in width has been set aside along the stream embankments.
