**TECHNICAL ASSESSMENT REPORT  
on the  
SCHOOL PLAYING FIELDS  
&  
ASSOCIATED FACILITIES  
at  
PLANTATION PRIMARY SCHOOL  
KNOWSLEY**

Date: 26/2/2014

Report Ref: Plantation\_14

**Site Assessment Visit of:** February 24th, 2014

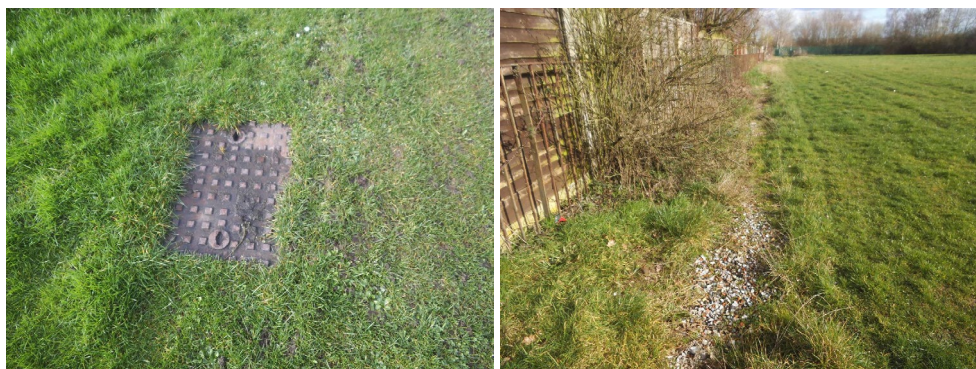
No evidence was found of under-drainage from aerial photos, local knowledge or from the site investigation. A single manhole cover is visible within the field adjacent to the service road but unable to lift cover, presumed to be the outfall point for any existing or future drainage.

***Manhole cover, north-east corner field***

Further assessment needs to be carried out, beginning with lifting the manhole cover in the corner of the field, and tracing of and land-drain found and the main system and ultimate outfall.
